# National Park Service Cultural Landscapes Inventory 2023

**East Potomac Park**

**National Mall & Memorial Parks**

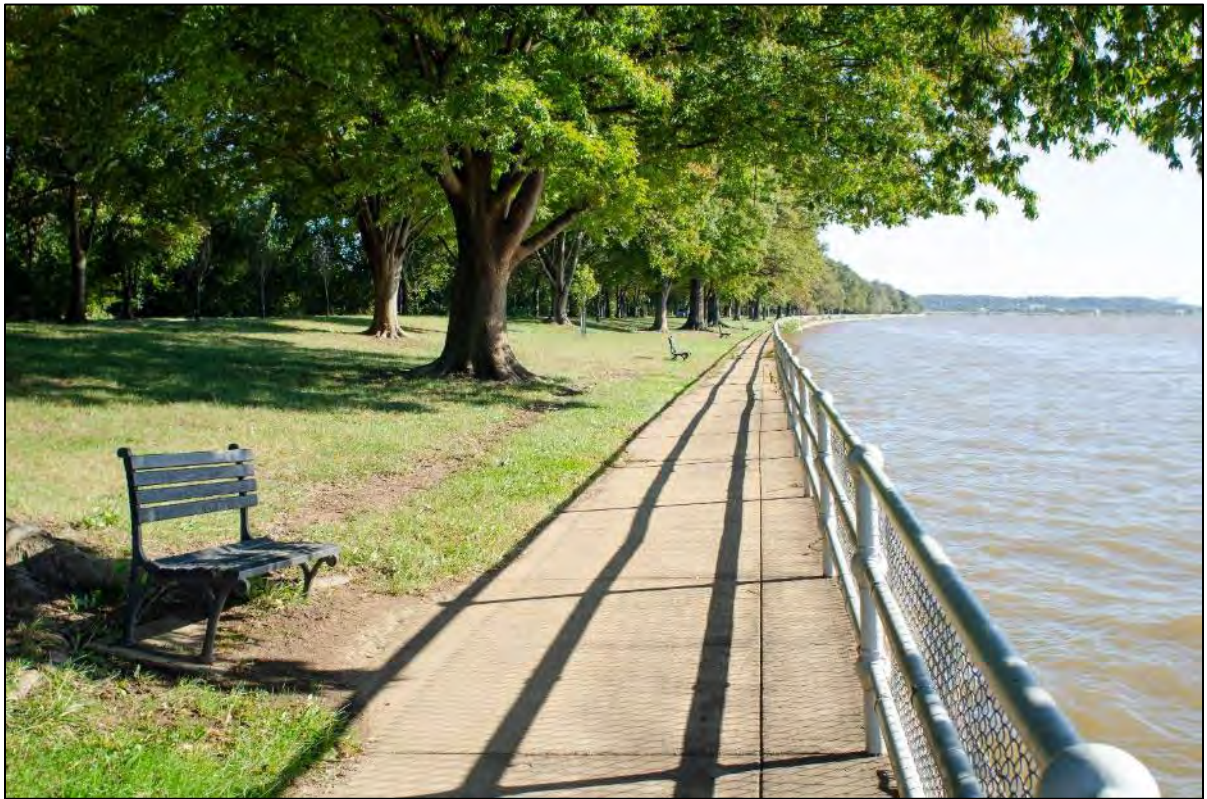
*Fig 55. Photo looking southeast depicting perimeter walk on Potomac River side of East Potomac Park (Matthew Traucht 2021).*

At approximately 3.5 miles in length, the ten-foot-wide promenade (sometimes referred to as the Hains Point Loop) traces the perimeter of the island. The perimeter walk consists of unreinforced concrete slabs set atop the bulkhead, with a pipe rail preventing falls from the walk into the adjacent waters (Fig 55). Due to deterioration and damage of the bulkhead that has resulted in buckling of the concrete pavement, the perimeter walk is unusable in several locations along its length. The promenade is a contributing resource to the East Potomac Park cultural landscape.

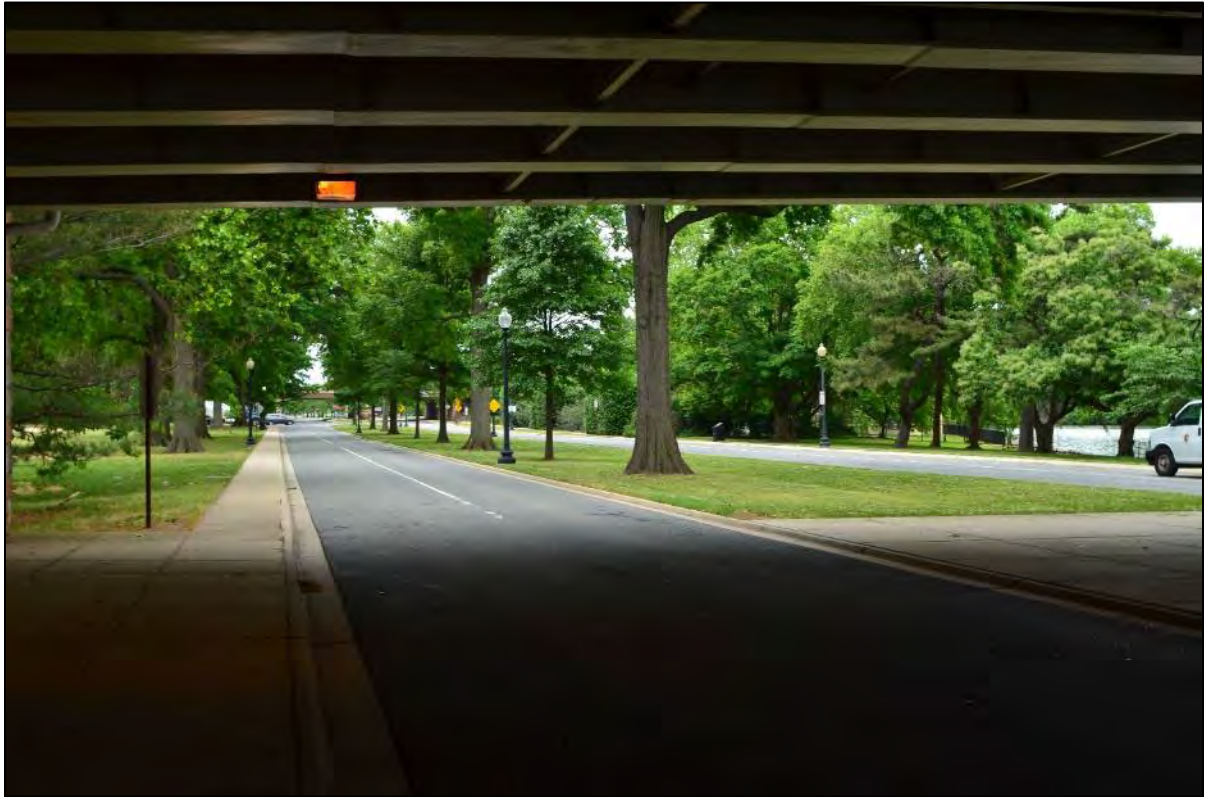
*Fig 57. Photo looking northwest showing Ohio Drive SW from beneath the Francis Case Memorial Bridge, note planted median and sidewalk, Potomac Railroad Bridge in distance (Matthew Traucht 2021).*

Today, five-foot-wide concrete walks are present along the outside curb of both the inbound and outbound lanes. Along the inbound lane, walk originates beneath the 14th Street bridge complex and terminates at a crosswalk adjacent the East Potomac Park Golf Course parking lot. On the outbound side, the walk extends from the previously mentioned crosswalk, underneath the Potomac Railroad and Southwest Freeway bridges, and continues along Ohio Drive SW where it is connected to the citywide pedestrian circulation system (Fig 57). For the remainder of Ohio Drive SW in East Potomac Park, no flanking sidewalks are present.

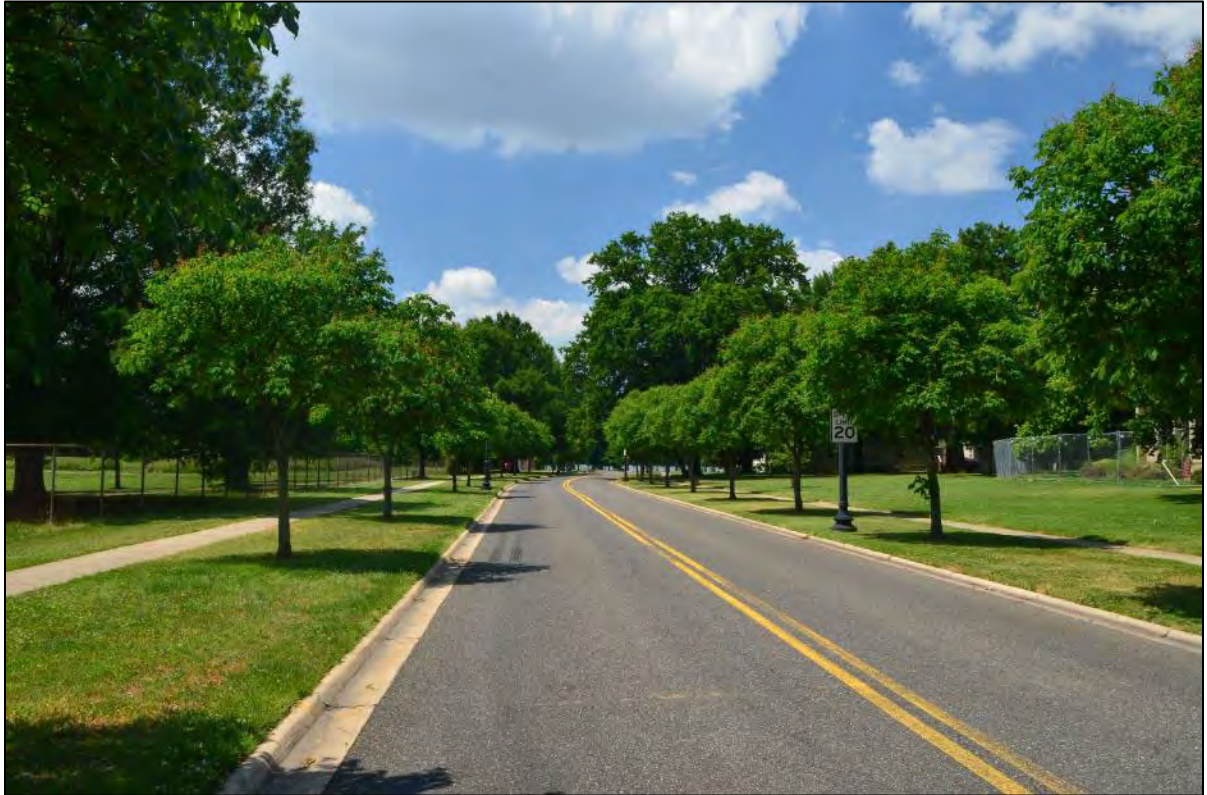
*Fig 59. Photo looking southwest depicting Buckeye Drive SW looking west. The walk on the right side of the photo is a contributing circulation feature; the walk on the left side is a noncontributing, compatible circulation feature (Matthew Traucht 2021).*

Buckeye Drive SW is flanked on the north side by a four-foot-wide concrete walk, which is offset from the roadway by an approximately ten-foot-wide planted verge (Fig 59). It provides access to the tennis courts, the NCR Headquarters Campus, and the I-395 northbound walk that extends to the Southwest Waterfront. The walk along the north side of the road alignment was installed with the construction of the road and is a contributing resource.

Buckeye Drive SW is flanked on the south side by a four-foot-wide concrete walk, which is offset from the roadway by an approximately ten-foot-wide planted verge. Based upon a review of aerial photographs taken between 1963 and 1988, no walk was present along the south side of Buckeye Drive SW, however a new walk is visible in aerial photographs from 1994 (NETR 1963, 1988, and 1994). This sidewalk is a noncontributing, compatible resource.

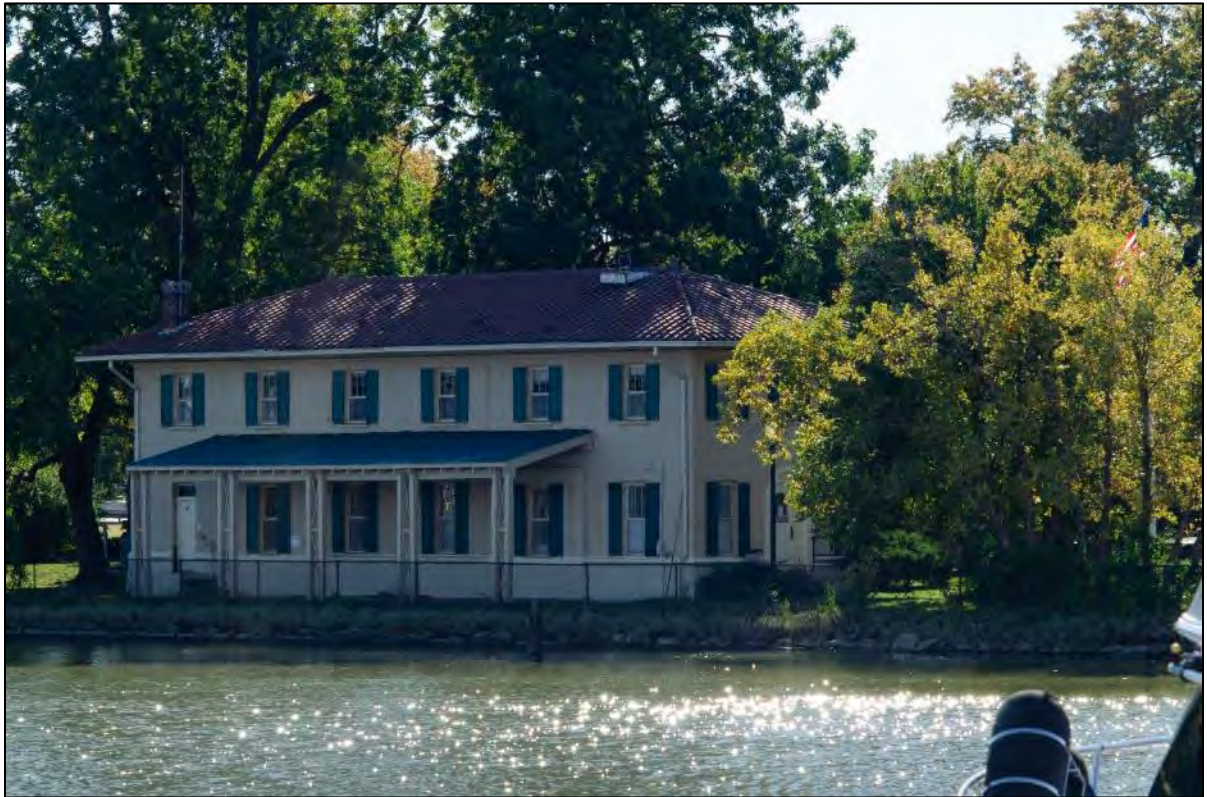
*Fig 60. Photo looking west across Washington Channel depicting U.S. Engineers' Storehouse (Matthew Traucht 2021).*

The US Engineers' Storehouse located at 900 Ohio Drive SW, just east of the Potomac River Bridge embankment was built in 1913 (Fig 60). Designed by architectural firm Wood, Donn and Deming, the two-story, six-bay rectangular building represents elements of a Mediterranean Revival style. The concrete foundation is topped by a wood frame structural system with brick walls clad in pebble-dash stucco and a low hipped roof sheathed in red terracotta tile. The building served as the administrative center for much of the land reclamation efforts for the parks and may also be the final commission of Wood, Donn and Deming (NPS 2001, 48–49). Through the years, it was modified slightly to accommodate other purposes: Between 1936 and 1940, it was a base for branches of the Girl Scouts and Boy Scouts; from 1940 to 1955 it functioned as a bicycle rental concession; from 1955 to 1965 the building was used by the NPS as a studio for model building; since 1965 (with the exception of 1976 when it was used as offices for the Tourmobile concession), the building has been used as an office by National Mall and Memorial Parks (NAMA) (NPS 2001, 62–63).

The exterior of the building retains integrity. The US Engineers' Storehouse is known for its Mediterranean Revival architectural style and is significant under Criterion C as one of the last commissions of the architectural firm Wood, Donn and Deming. It is also significant under Criterion A for its significance in engineering, as it served as the basis for much of the land reclamation efforts for the East and West Potomac Parks. It is a contributing building to the

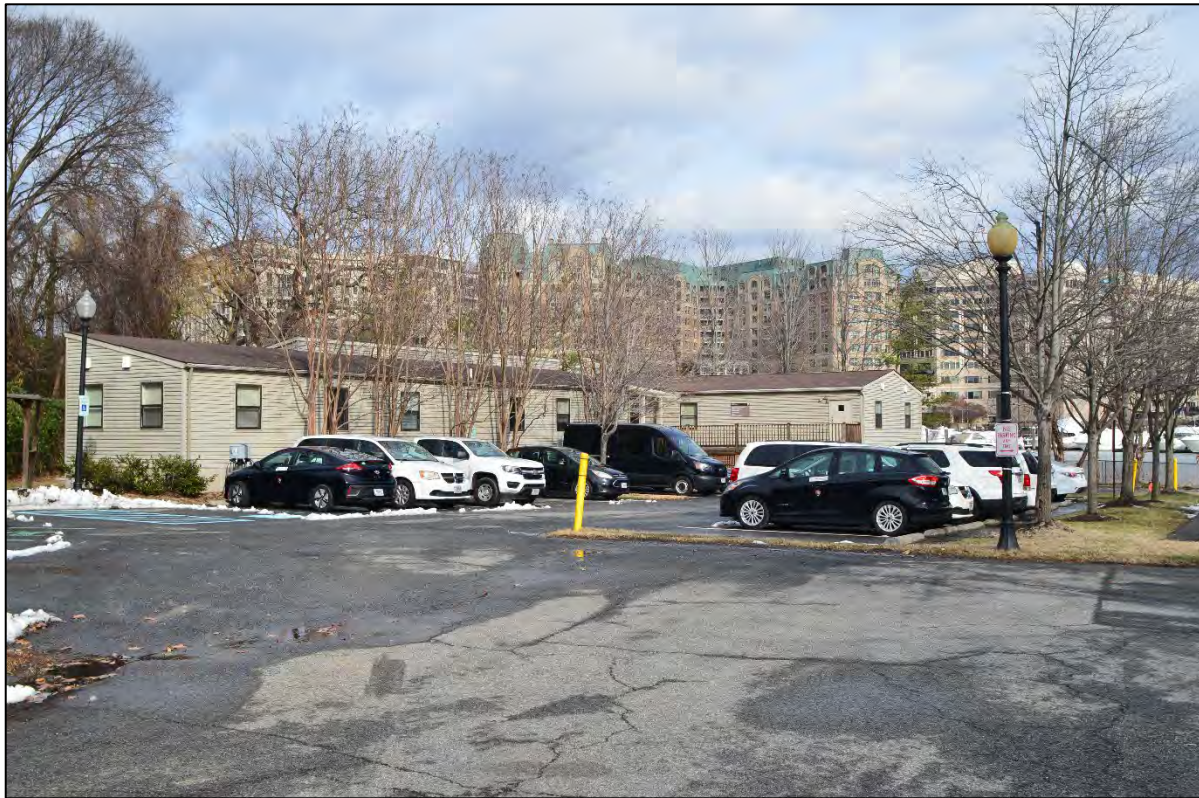
*Fig 61. Photo looking northeast depicting modular office trailers to the north of the US Engineers' Storehouse(Matthew Traucht 2022).*

The US Engineers' Storehouse located at 900 Ohio Drive SW, just east of the Potomac River Bridge embankment, has several temporary modular office trailers surrounding it (Fig 61).

According to a drawing on file in eTIC (805/80642), one trailer was installed in 1986, replacing an existing trailer, and is located to the northwest of and perpendicular to the Engineers' Storehouse, on the other side of the parking lot. Between 1986 and 2010, another trailer was added. In 2010, a proposal was put forward to the NCPC to add one additional office trailer to the two that already existed, as the office space was at capacity in the other two trailers. Landscaping was placed

around all three of the trailers to help screen them from view on Ohio Drive SW. The third office trailer is 128 feet by 32 feet, one-story tall, clad in vertical brown siding topped by a gable roof sheathed in asphalt shingles. All of these modular buildings were designed to be temporary but have remained for at least a decade (and in the case of the one from 1986, several decades). As they are not of outstanding architectural merit and are less than fifty years of age, they are noncontributing to the East Potomac Park CLI (NCPC 2010).

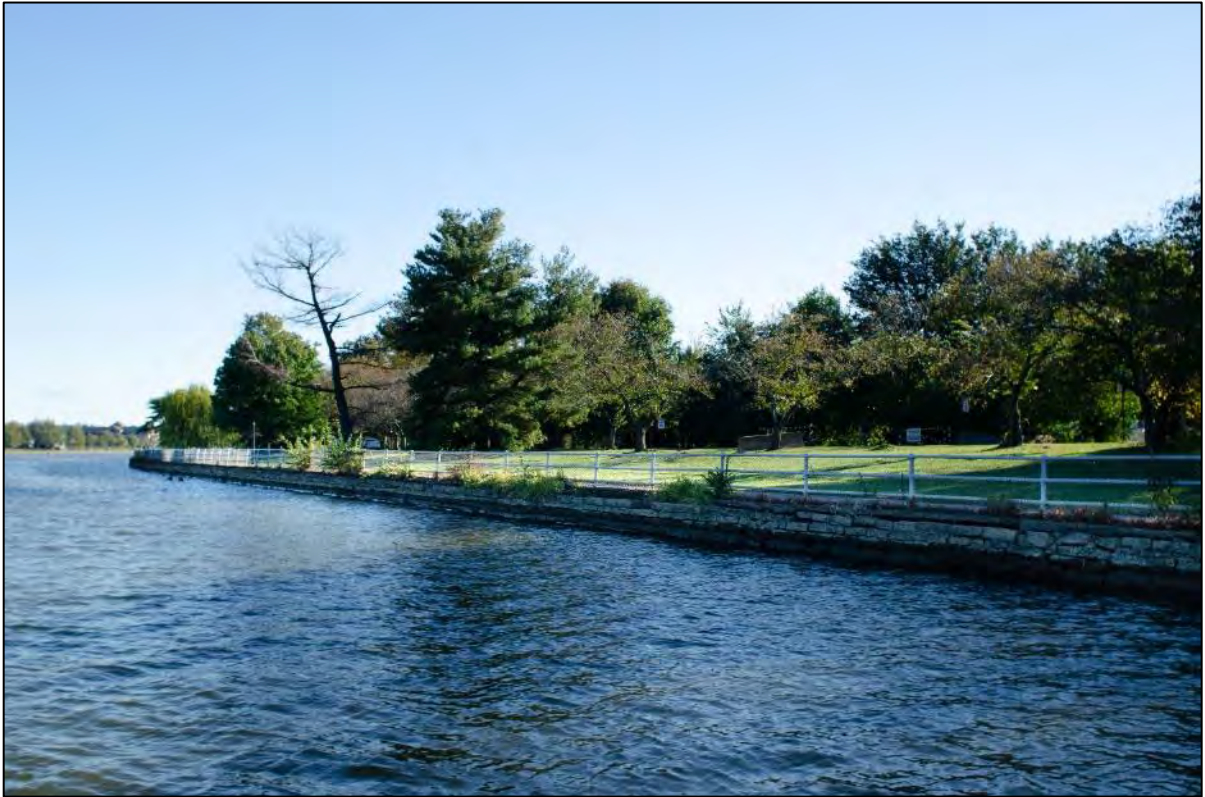
*Fig 62. Photo looking southerly depicting seawall on Washington Channel side of island (Matthew Traucht 2021).*

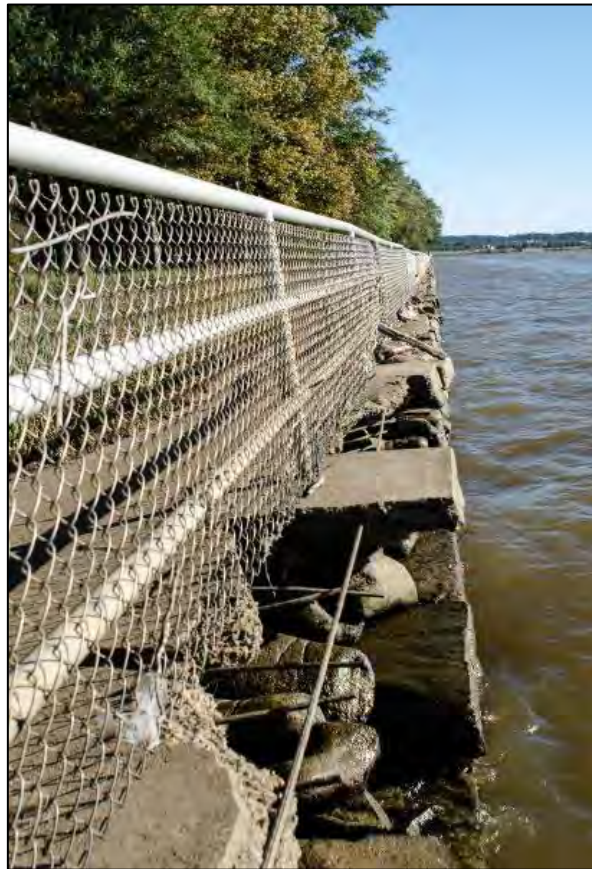
*Fig 63. Photo looking southerly depicting damage to seawall on the Potomac River side of island (Matthew Traucht 2021).*

The East Potomac Park parent cultural landscape has been determined to be in Fair condition. This determination is attributed, primarily, because the seawall that retains the constructed island is in a deteriorated condition. Although the poor condition of that feature is not, in itself, a determining factor in the overall condition of the park, the deterioration of the seawall has also impacted circulation features (the perimeter promenade), hindered recreational activities (strolling, sightseeing, fishing) along the shoreline, and has led to a decline in vegetation and the erosion of soils.

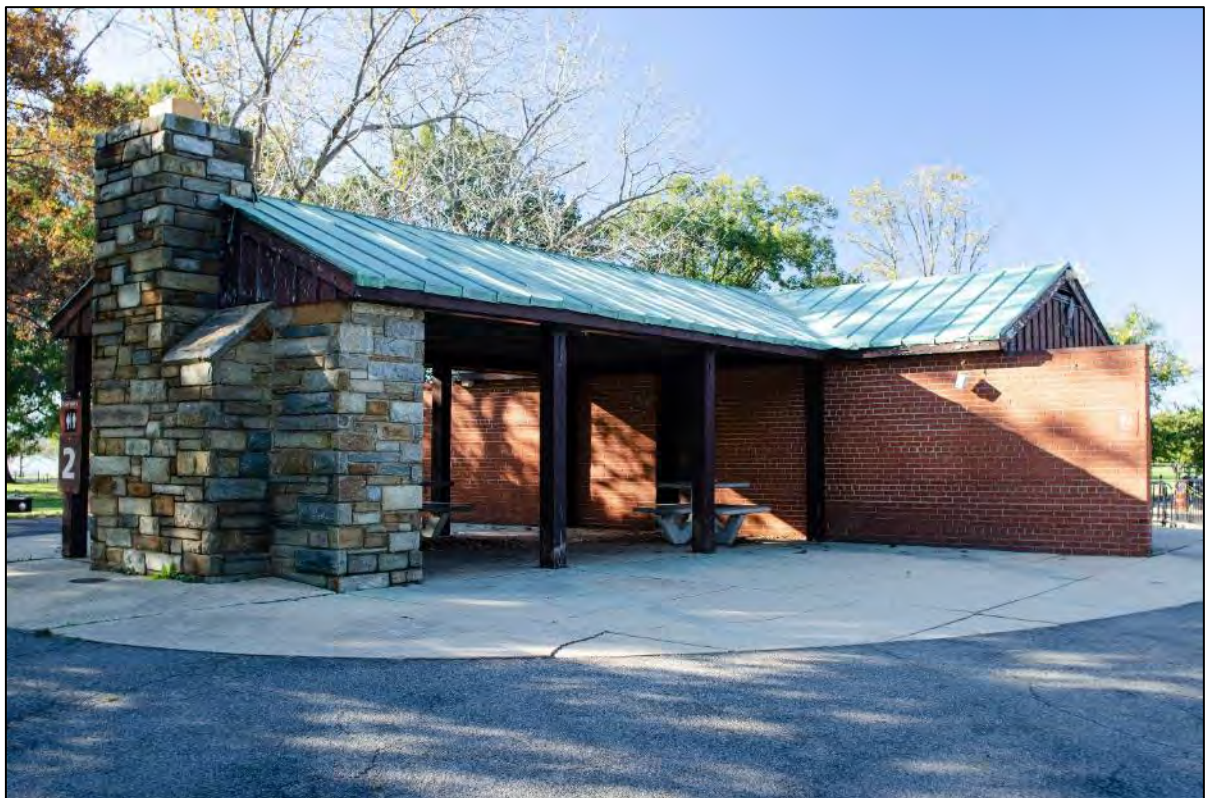
*Fig 64. Photo looking northwest depicting circa-1954 Mission 66 Comfort Station “Type B” (Matthew Traucht 2021).*

Today the Mission 66 “Type B” Comfort Station is known as Comfort Station #2 in East Potomac Park (Fig 64 and Fig 65). The stone fireplace of the East Potomac Park picnic shelter has been enclosed and is no longer functional, somewhat diminishing the integrity of the original design. All types of the Mission 66 comfort stations are described in detail in the 2019 Design and Maintenance Guidelines prepared for the NPS by Quinn Evans Architects (Quinn Evans Architects 2019, 31–39). The Mission 66 “Type B” Comfort Station in East Potomac Park is significant as a building within the park that was part of what would soon become the Mission 66 building campaign in the NCR and overall, it retains a high level of integrity. It was not described in the East and West Potomac Parks Historic District nomination, but it is contributing to the East Potomac Park CLI.

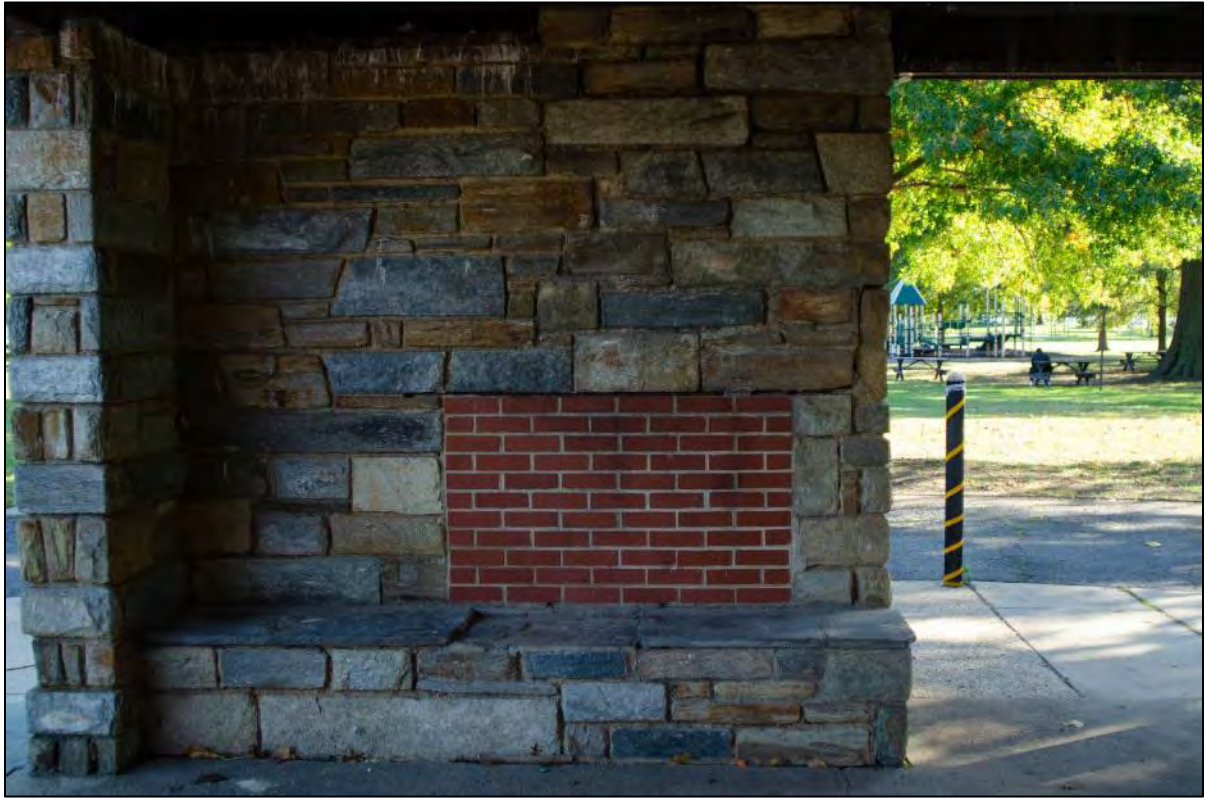
*Fig 65. Photo looking south depicting filled fireplace in Mission 66 Comfort Station “Type B” (Matthew Traucht 2021).*

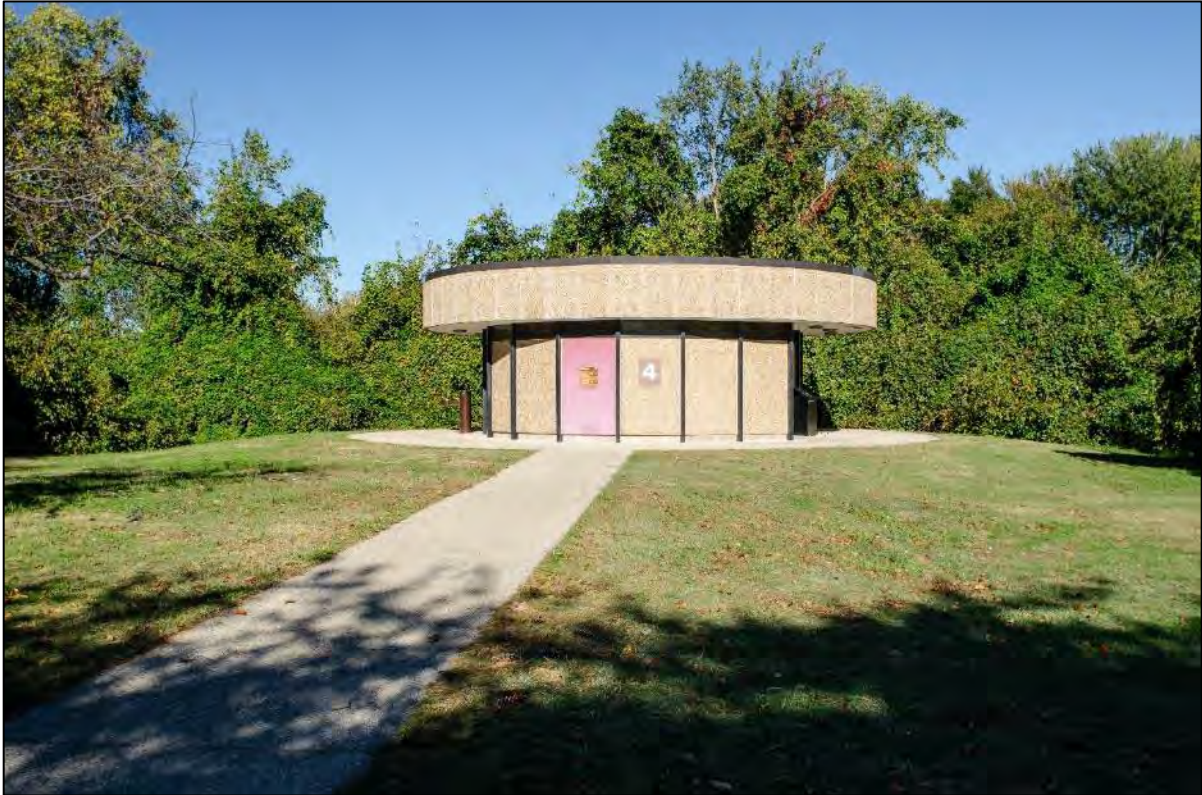
Three Elliptical Comfort Stations are located in East Potomac Park and were built between 1985 and 1988 (known as Comfort Stations # 1, 3, and 4 in East Potomac Park). The Elliptical Comfort Stations are one-story buildings with a slight elliptical shape and a flat roof (Fig 66). The structures are built of steel posts between which are panels of exposed aggregate concrete siding. They feature clerestory windows below the roofline. The building is of a type designed by NPS architect Benjamin Biderman (hence the nickname “Benji” for the comfort station) used first in the mid-1970s as part of bicentennial improvements to West Potomac Park (NPS 2008, 93–94; NPS History eLibrary 1976). The East Potomac Park Elliptical Comfort Stations were not inventoried in the East and West Potomac Parks Historic District nomination. The Elliptical Comfort Stations are outside of the period of significance for East Potomac Park CLI, and were also not constructed

*Fig 66. Photo looking northeast depicting Elliptical Comfort Station (NPS Restroom #4) on west side of East Potomac Park (Matthew Traucht 2021).*

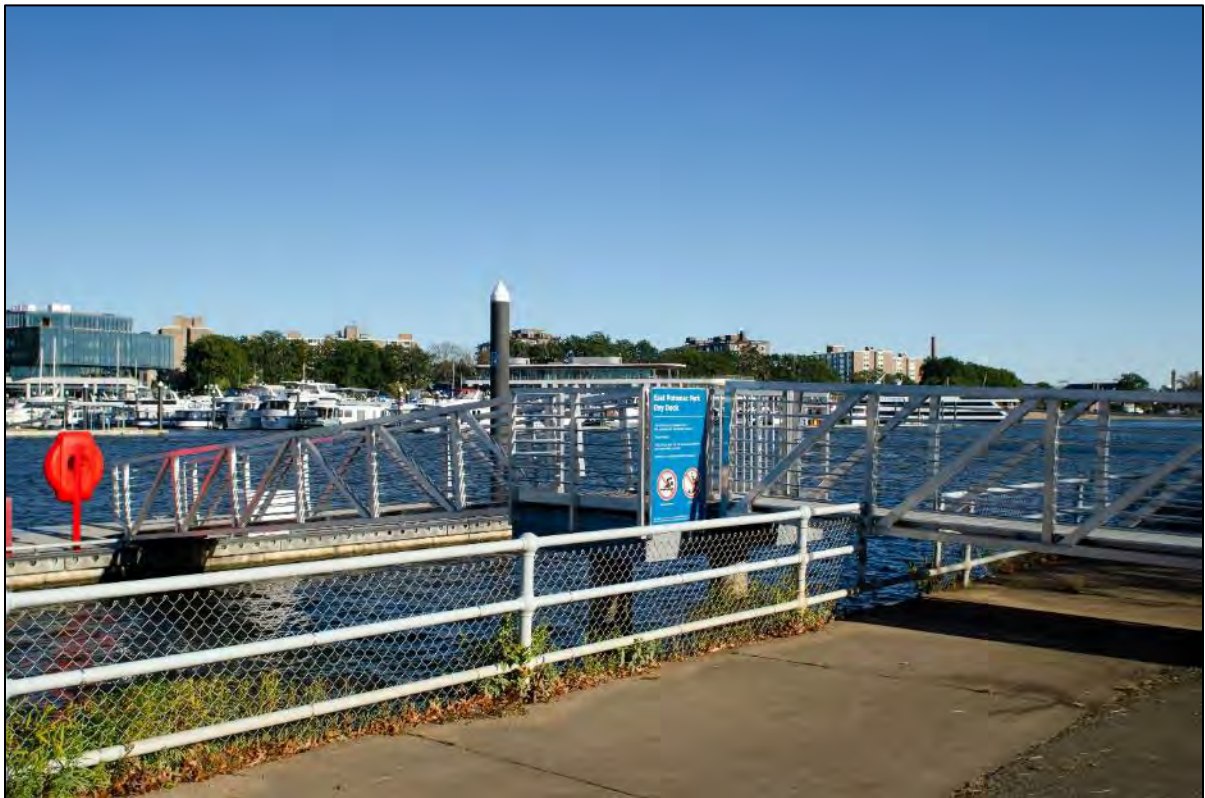
In 2017, construction of the East Potomac Park Day Dock was approved by the NCPC (Fig 67). (The original East Potomac Park Day Dock was built between 1972 and 1979 adjacent to the Washington Channel (in the vicinity of the entrance to the East Potomac Park Golf Course), but was removed in 1994.) The day dock is a recreational pier installed by the Wharf developer but attached to NPS shoreline and connected to the Wharf by a seasonal water shuttle or jitney. The floating dock provides a free public launching site for non-motorized, hand carried boats, such as canoes, kayaks, and stand-up paddle boats. The dock only operates during the day and is closed

after dark. The East Potomac Park Day Dock consists of a concrete floating dock supported by steel pipe piles with an aluminum gangway and timber landing platform (NCPC 2017). The dock post-dates the period of significance for East Potomac Park CLI, is made of common materials in a common form, is not yet fifty years of age, and is therefore a noncontributing structure.

*Fig 67. Photo looking southeast depicting East Potomac Park Day Dock (Matthew Traucht 2021).*

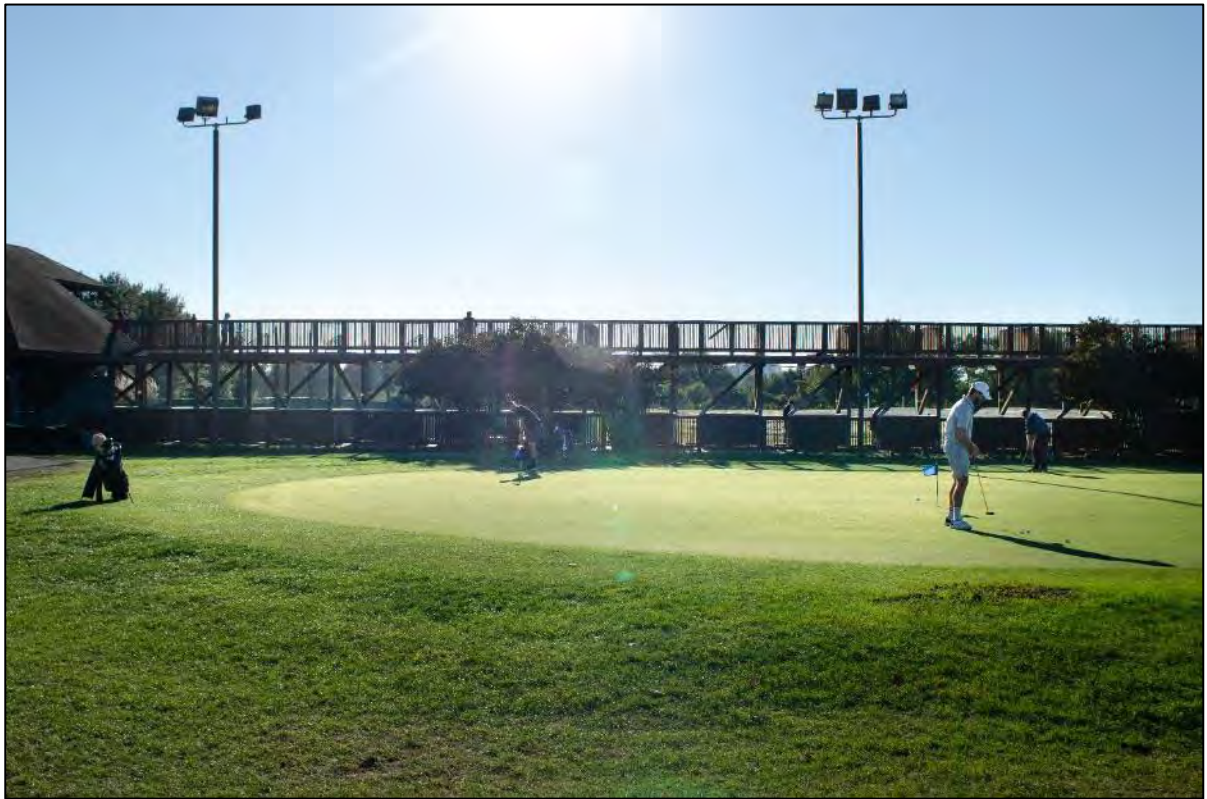
*Fig 68. Photo looking west depicting East Potomac Park Golf Course Putting Green with elevated driving range in the distance (Matthew Traucht 2021).*

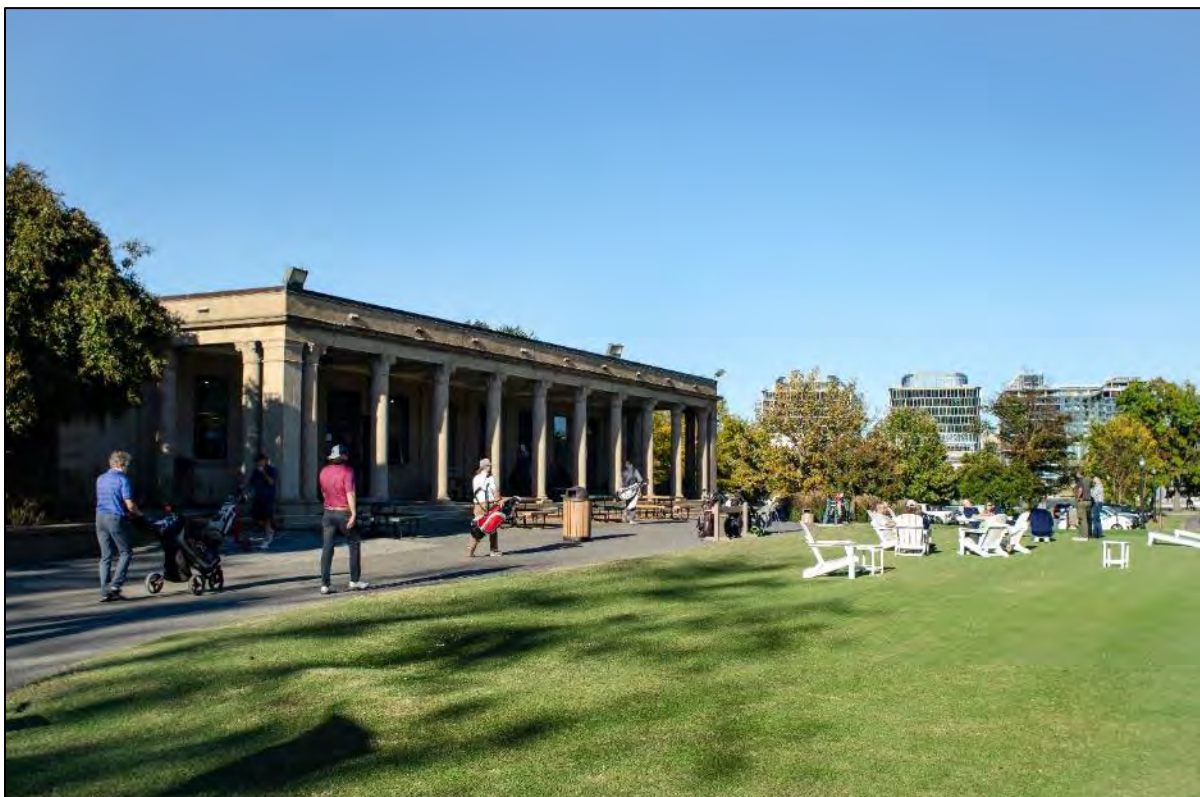
The East Potomac Park Field House was designed by architect Horace Whittier Peaslee in 1917 as a three-part Neoclassical building (Fig 69). Only two of the three wings were built, with the center portion never realized. The one-story, L-shaped concrete buildings have flat metal roofs and full basements. The buildings originally served as the men's and women's locker and changing rooms for the golf course. The buildings have long porticoes supported by columns. The Field House was constructed using the "Earley Process," a method of creating decorative exposed aggregate concrete. The technique was patented in 1921 by concrete sculptor John Joseph Earley. The Field House is constructed of a combination of pre-cast and field-applied concrete (NPS 2001, 51; NPS 2017, 4; NPS 2019b, 191–193).

Renovations to the Field House were undertaken in 1978 by NPS; the interiors of the wings have been altered to serve as a golf shop, offices, a food concession, and the former District One Substation for the USPP (the USPP have since moved to a new station next to the NCR campus). The north wing of the Field House is currently empty, while the south wing serves as a clubhouse for the golf course. The East Potomac Park Field House is significant under Criterion A-Entertainment/Recreation, as it was the first feature of the 1916 East Potomac Park development plan to be built and was continuously used for recreation for most of the twentieth century. The Field House is also significant under Criterion C for its architecture, a collaboration between architect Horace W. Peaslee and concrete artist John Joseph Earley. The East Potomac Park Field House is a contributing building to the NRHP-listed East and West Potomac Parks Historic District and the East Potomac Park CLI (NPS 2001, 51; NPS 2017, 4; NPS 2019b, 191–193).

*Fig 69. Photo looking northeast depicting Field House (south elevation of south wing) (Matthew Traucht 2021).*

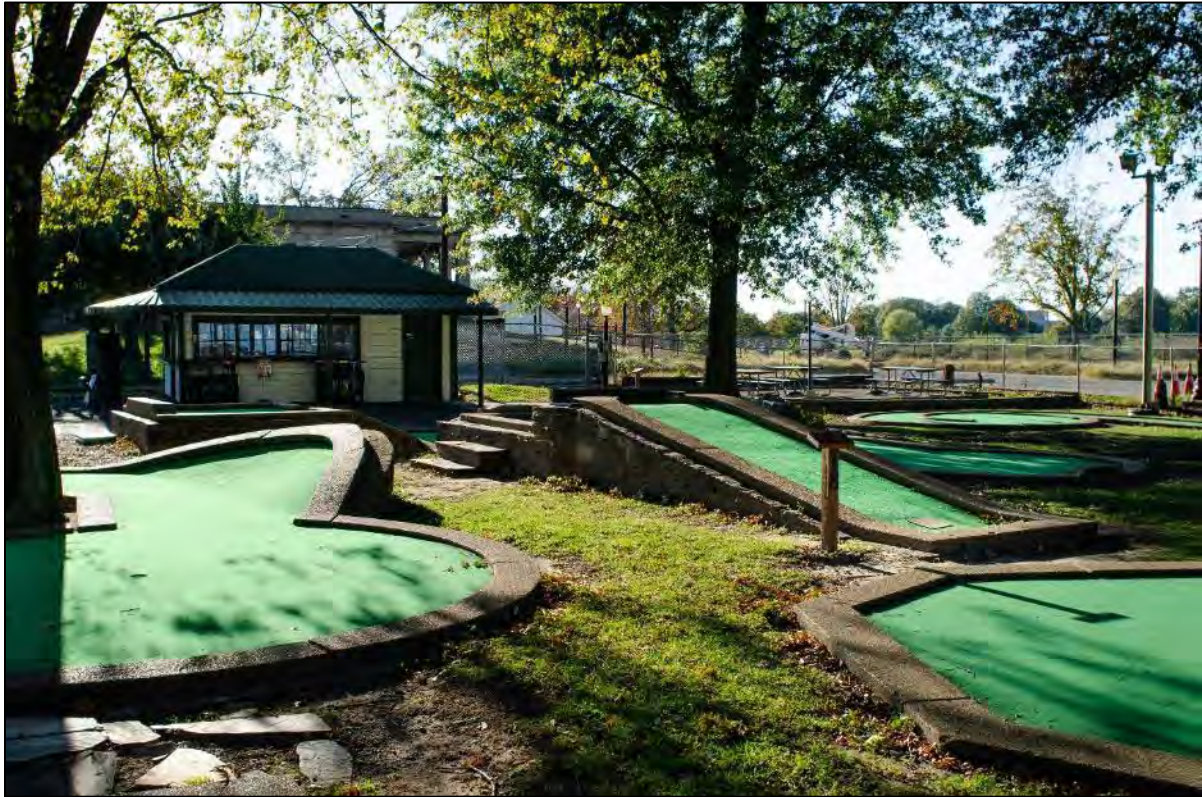
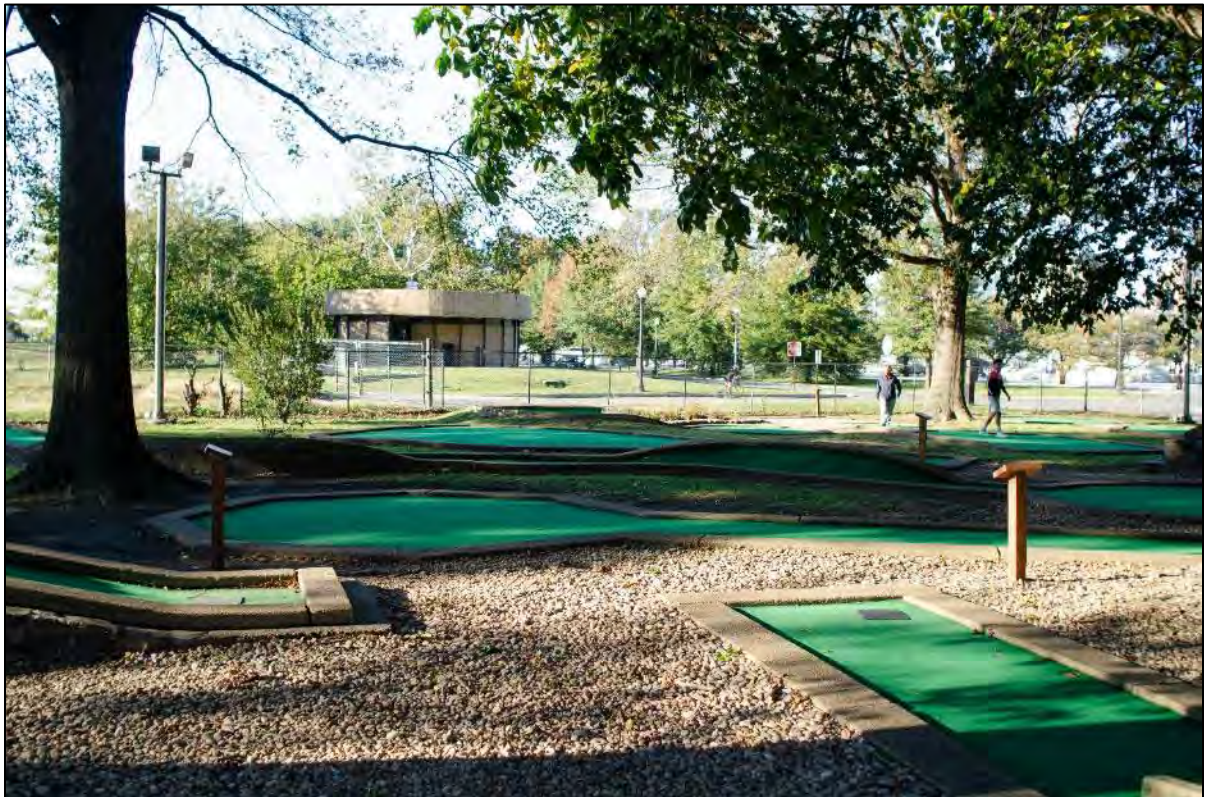
The East Potomac Park Miniature Golf Course is located east of the Field House (Fig 70 and Fig 71). It was the first miniature golf course to be constructed by NPS on Federal land (in 1931) and has been in continual operation ever since. The miniature golf course was renovated in the 1960s. Inside the miniature golf course is the ball house, which serves as both the ticket booth and snack bar. The building was constructed in 1949 and replaced an earlier and similar building on the site (NPS 2001, 51–52).

*Fig 70. Photo looking west depicting East Potomac Park Miniature Golf Course (Matthew Traucht 2021).*

*Fig 71. Photo looking north depicting East Potomac Park Miniature Golf Course with Elliptical Comfort Station in background (Matthew Traucht 2021).*

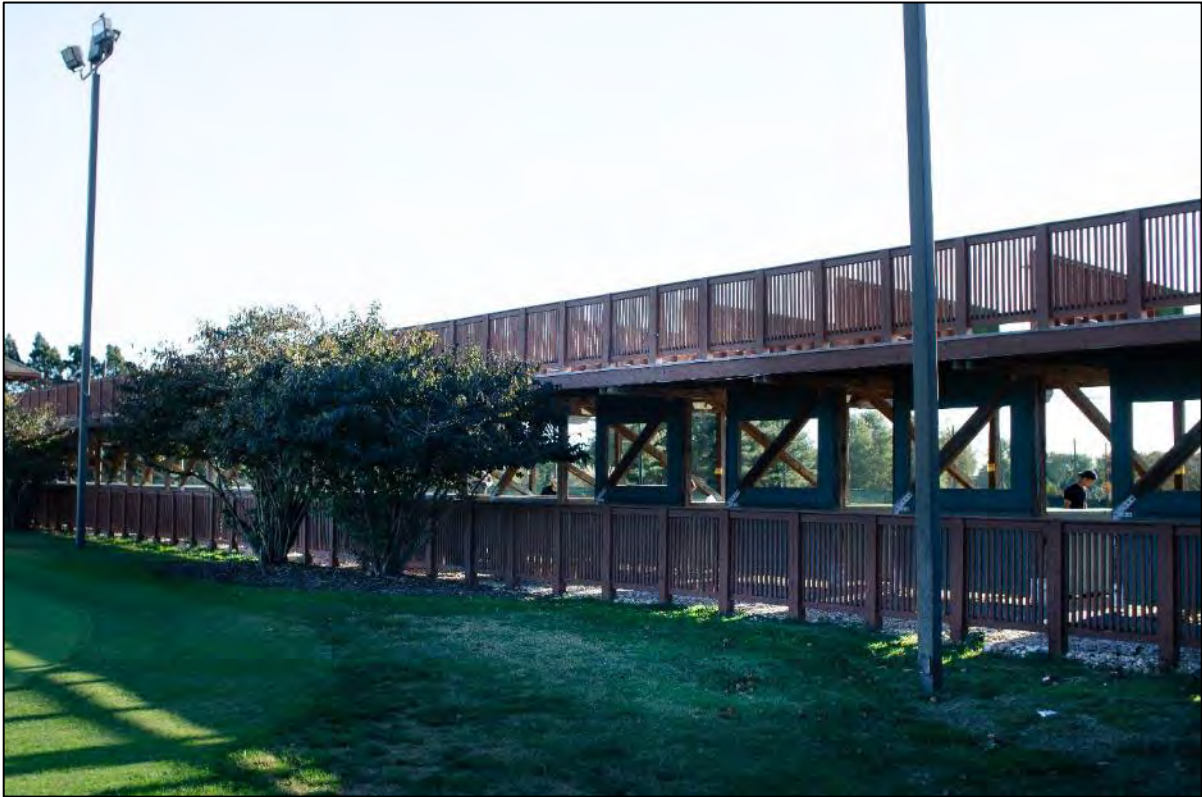
The East Potomac Park Driving Range Building was designed by architectural firm Oehrlein & Associates Architects and completed in 1995 (Fig 72). The two-story frame building has one hundred practice stalls for golfers. The driving range is covered by artificial turf. The East Potomac Park Driving Range Building was a noncontributing building to the NRHP-listed East and West Potomac Parks Historic District, as it had not yet reached fifty years of age. It is still less than fifty years of age and although it was designed by an architectural firm, it is not of outstanding architectural merit; therefore, it is a noncontributing building to the East Potomac Park CLI (NPS 2001, 52).

*Fig 72. Photo looking southwest depicting East Potomac Park Driving Range Structure (Matthew Traucht 2021).*

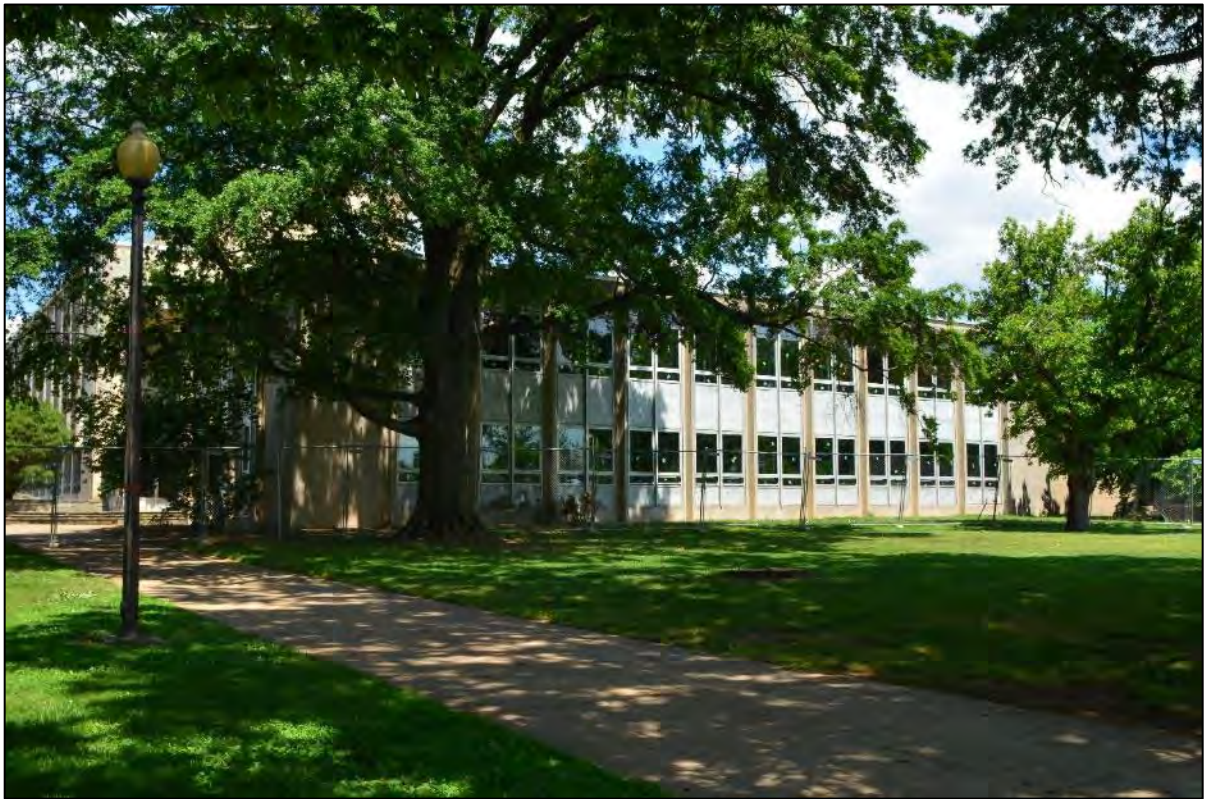
The NPS NCR Headquarters Building is located at 1100 Ohio Drive SW and was constructed from 1962 to 1963 as part of the Mission 66 campaign (Fig 73). The Modernist building was designed by NPS staff (William M. Haussmann) and built by Victor R. Beauchamp Associates, Inc., as a regional interpretation and manifestation of the Mission 66 program. The three-story building has a two-story wing. A concrete foundation is topped by beige brick walls with regular fenestration and a flat metal roof. In 1969 a Cafeteria and Training wing was added to the building by L. J. Robinson, Inc. The building is also connected to the USPP Headquarters Building (described below). The two headquarters buildings share an entrance lobby that features a slate patio and a pool with aquatic plants, which is also described below (NPS 2001, 49).

The headquarters buildings have had few changes made since their initial construction. Vestibules and ramps to make the building more accessible have been added over time, but overall, the buildings retain a high level of integrity. Beginning in 2018 and continuing in 2023, the Headquarters buildings were rehabilitated in conjunction with the construction of the new USPP Central District Station in the parking lot. Temporary trailers were installed onsite during construction. New mechanical systems were added, new ramps and a new elevator in Wing D (new NAMA offices) were added to provide greater accessibility, and character-defining light fixtures and window glazing were refurbished or replaced as needed. The interior floor plan was also opened back up per the original design by Haussmann (Beyer Blinder Belle 2015, 9–12). All of these rehabilitation efforts will only help to increase the integrity of design, workmanship, and materials. The NPS NCR Headquarters Building was a noncontributing building to the NRHP-listed East and West Potomac Parks Historic District, as it had not yet reached fifty years of age (NPS 2001, 49). The building has now reached fifty years of age and it is a good example of the administrative buildings in East Potomac Park and of the regional manifestation of the Mission 66 campaign. According to the draft National Capital Region and United States Park Police (NCR-USPP) Headquarters National Register nomination, the NPS NCR Headquarters Building is eligible under Criterion A at the state and local levels in the area of community planning (park planning) and under Criterion C at the state and local levels in the areas of architecture and landscape architecture; therefore, it is also a contributing building to the East Potomac Park CLI (NPS 2020, 23–25).

*Fig 73. Photo looking north from Buckeye Drive SW depicting NPS National Capital Region Headquarters Building (Matthew Traucht 2021).*

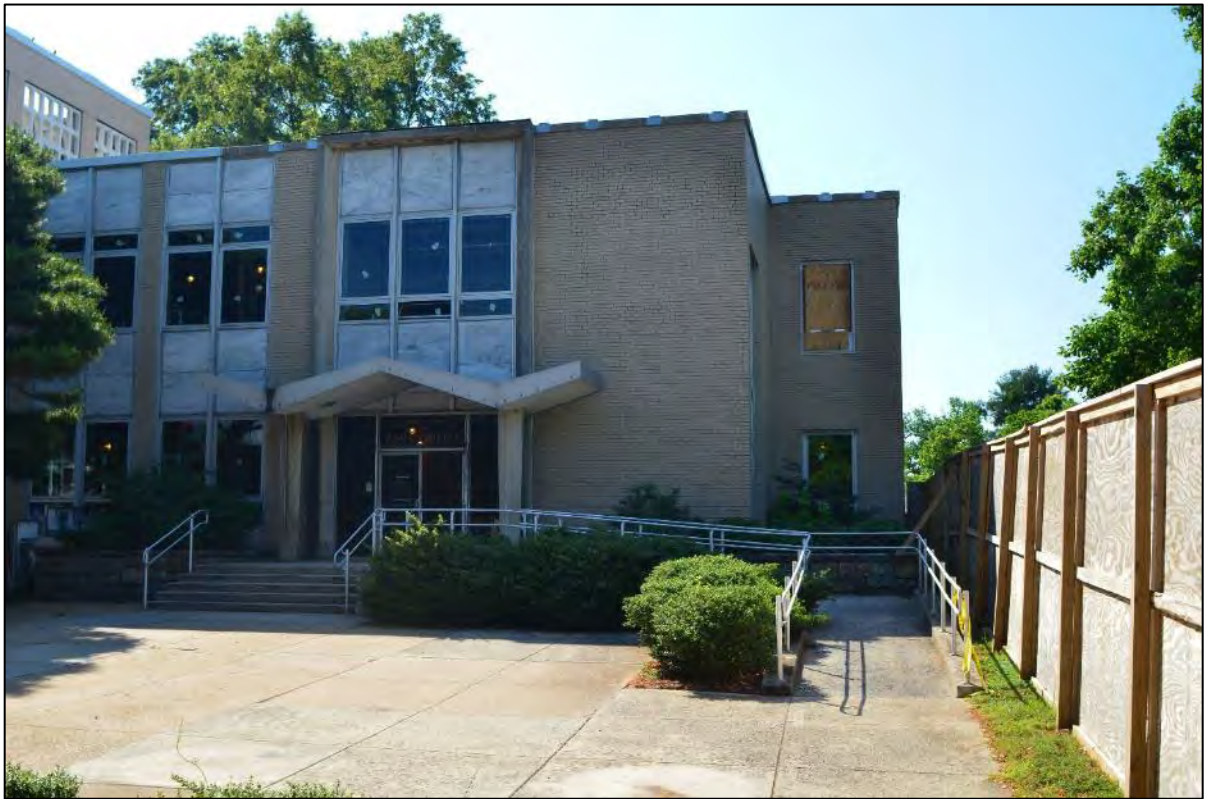
The USPP Headquarters Building is located at 1100 Ohio Drive SW and was constructed from 1962 to 1963 as part of the Mission 66 campaign (Fig 74). The Modernist building was designed by NPS staff and built by Victor R. Beauchamp Associates, Inc. at the same time as the NPS NCR Headquarters Building, as a regional interpretation and manifestation of the Mission 66 program. The two-story building has a concrete foundation that is topped by blond brick walls with regular fenestration and a flat metal roof. The two headquarters buildings share an entrance lobby that features a slate patio and a pool with aquatic plants (NPS 2001, 49).

*Fig 74. Photo looking south depicting entrance terrace at the United States Park Police Headquarters Building. Note noncontributing accessible ramp (Matthew Traucht 2021).*
