# National Park Service Cultural Landscapes Inventory 2023

**East Potomac Park**

**National Mall & Memorial Parks**

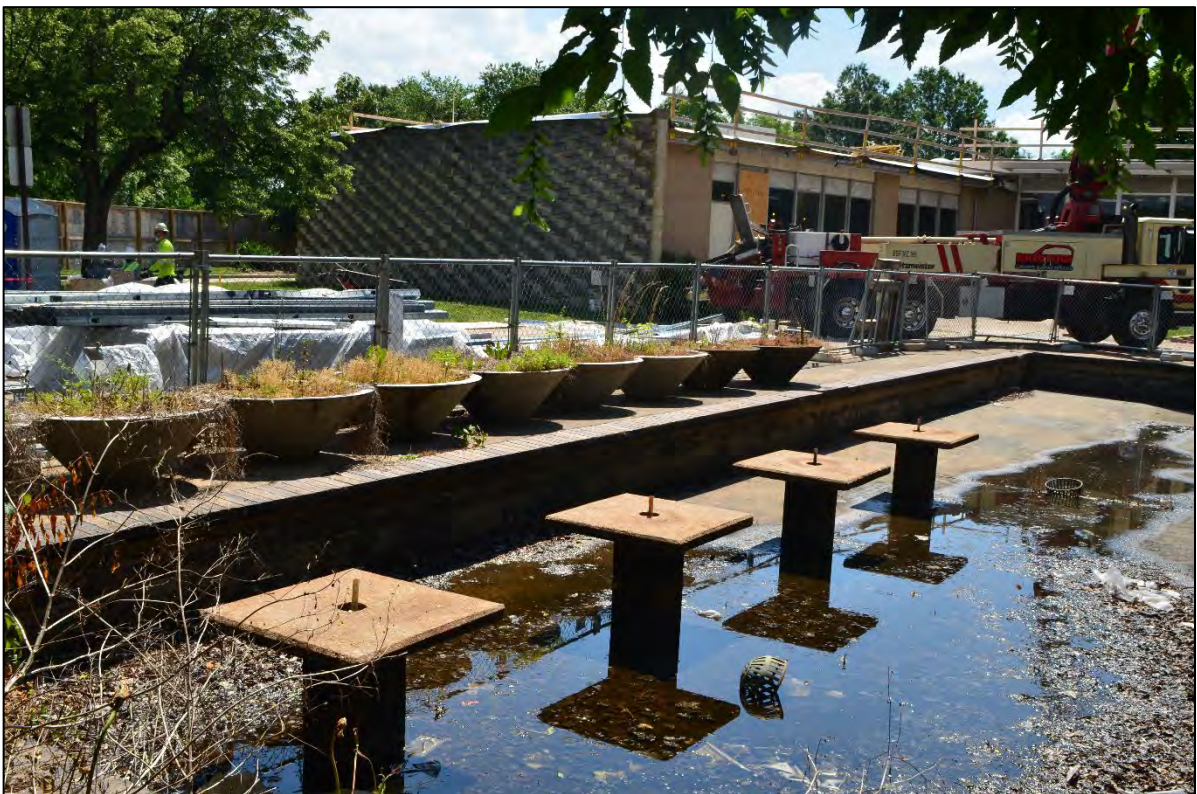
The NPS NCR and USPP headquarters buildings share an entrance lobby that features a slate patio and a pool with fountains and aquatic plants (Fig 75). The rectangular pool includes four square metal fountains and large conical concrete planters were grouped in clusters around the pool. The pool is surrounded by a brick edge and aggregate concrete walkways. This pool was part of the original design of the buildings and part of the Mission 66 building campaign in the DC area (NPS 2020, 37).

The pool and fountains are still in-situ today and have now reached fifty years of age. Concrete benches with wood slats currently stand on the south and west sides of the pool. Since they are not shown on early plans or photographs of the pool terrace, it appears they were added after the initial construction period (NPS 2020, 39). According to the draft NCR-USPP National Register nomination, the NPS NCR and USPP Headquarters Buildings are eligible under Criterion A at the state and local levels in the area of community planning (park planning) and under Criterion C at the state and local levels in the areas of architecture and landscape architecture (NPS 2020, 23–25). The pool and fountains are a good example of Mission 66 administrative landscape architecture features and “Park Service Modern” design, retain significant integrity, and are contributing structures in the East Potomac Park CLI.

*Fig 75. Photo looking southeast of the landscaped pool and fountain at the NCR Headquarters. The buildings and pool were under renovation at the time of the field survey (Matthew Traucht 2021).*

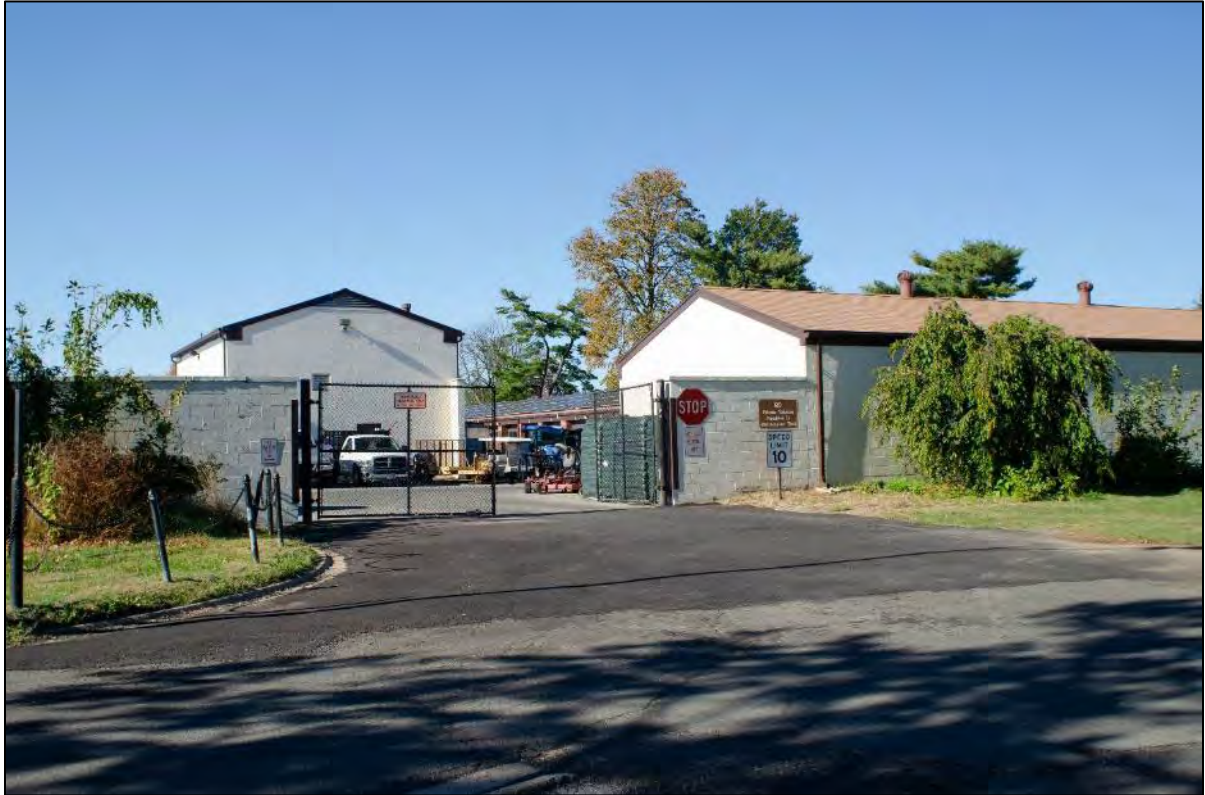
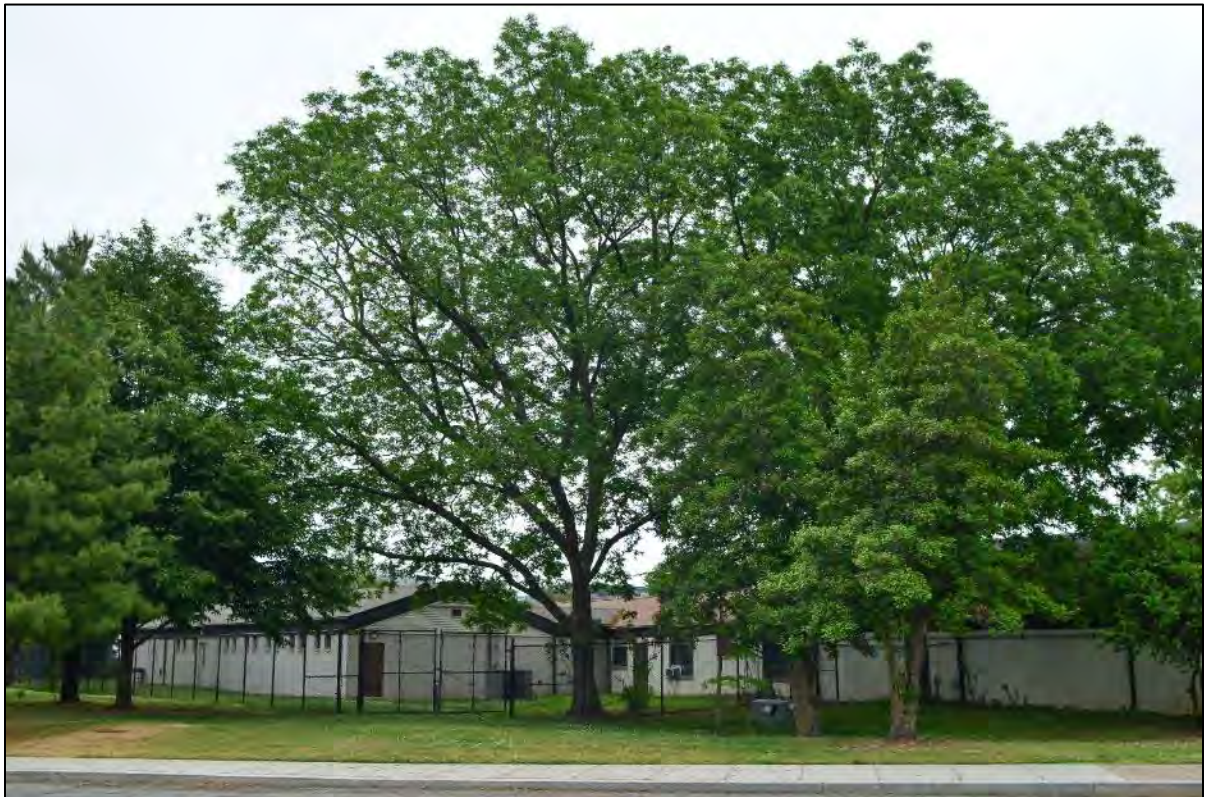
The East Potomac Park Maintenance Facility was built around 1955 and is of a utilitarian design (Fig 76 and Fig 77). While the maintenance yard was previously recorded in the East and West Potomac Parks Historic District nomination as the “National Capital Parks-Central Maintenance Yard” built in the late 1970s, historic aerials and a bird’s eye view photograph from 1955 from the DC History Center’s Whetzel Aerial photograph collection suggest the yard was completed a few years before Buckeye Drive SW (completed in the late 1950s) and several years before the NCR and USPP Headquarters buildings (DC History Center 2022; NPS 2001, 49; NETR 1963, 1964, 1979; Robinson & Associates 2008). The East Potomac Park Maintenance Facility is made up of a series of one-story, concrete-block buildings topped by gabled roofs sheathed in asphalt shingles. The long L-shaped buildings almost form a complete U-shape, except for an opening at the northwest corner. In the center of the two L-shaped buildings is a two-story concrete-block building and three large metal carport-style structures with solar panels on the roofs.

It is likely that these buildings have been modified over the years as maintenance needs and equipment have changed (for example, the addition of the solar panels to the carport shed roofs). This has somewhat diminished the integrity of the maintenance yard. The East Potomac Park Maintenance Facility was called the “National Capital Parks-Central Maintenance Yard” in the NRHP-listed East and West Potomac Parks Historic District, and was a noncontributing building as it had not yet reached fifty years of age, according to their assigned construction date (NPS 2001, 49). While it is more than fifty years of age now, it is not of outstanding architectural merit or directly related to the administrative or recreational uses for which East Potomac Park is significant. Based on current research, there is no evidence that it was specifically built as part of the Mission 66 building campaign, despite being during that approximate time period. Maintenance yards are described in the NPS Mission 66 Era Resources Multiple Property Documentation Form (MPD), and while the East Potomac Park Maintenance Facility does possess some of the architectural characteristics outlined in the MPD, such as concrete block construction

*Fig 76. Photo looking north from Buckeye Drive SW depicting East Potomac Park Maintenance Facility (Matthew Traucht 2021).*

*Fig 77. Photo looking east from Southwest Freeway entrance ramp depicting East Potomac Park Maintenance Facility (Matthew Traucht 2021).*

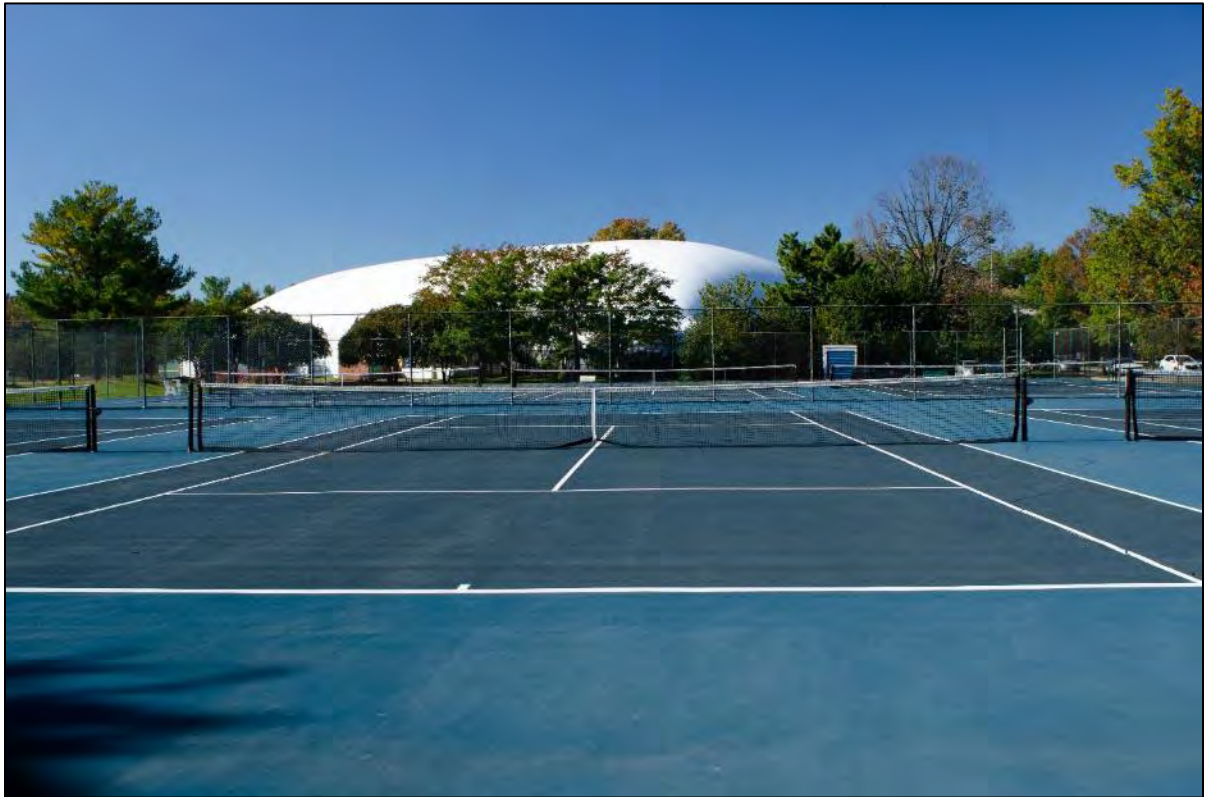
Today there are nine outdoor hard courts, ten outdoor clay courts, and five indoor hard courts inside the bubble (described below). It is likely that material replacements (resurfacing, etc.) have

occurred many times since then, but the footprint of the tennis courts remains largely the same (NETR 1963, 1964). The East Potomac Park Tennis Courts are contributing to the East Potomac Park CLI.

*Fig 78. Photo looking west depicting East Potomac Park tennis courts with tennis bubble in background (Matthew Traucht 2021).*

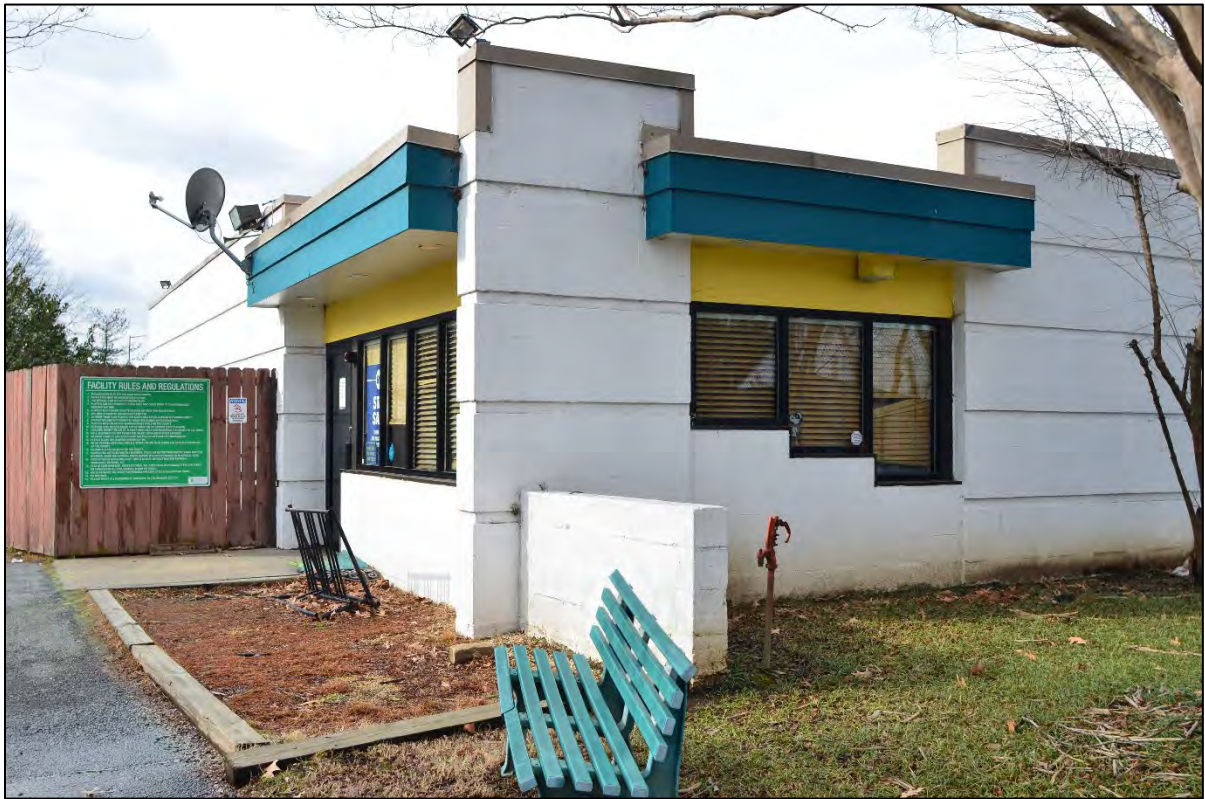
An Administrative Building was built for the East Potomac Park tennis facility from 1994 to 1995 (Fig 79). The East and West Potomac Parks Historic District nomination assigned the building the name of “Administrative Building” and a construction year of 1995, but historic aerials show a building in place in 1994; it may have been under construction in 1994 (NPS 2001, 53; NETR 1994). It should also be noted that the building is called “locker room” on a planting plan for the East Potomac Park Tennis Facility from 1994 (eTIC 805/80657). It is possible that the building has both administrative functions and serves as a locker room, that its uses have changed over time, or that it was mistakenly named in the East and West Potomac Parks Historic District nomination. The one-story building is of concrete-block construction with a flat roof and parapet wall with metal coping. The concrete blocks project slightly outward to give the illusion of coursing. The building has fixed, metal windows and a fully glazed, metal, single-leaf door. The East Potomac Park Tennis Facility (which included the Administrative Building) was a noncontributing site to the NRHP-listed East and West Potomac Parks Historic District, as it had not yet reached fifty years of age. It is still less than fifty years of age and is not of outstanding architectural merit, built with common materials and a common form; therefore, it is a noncontributing building to the East Potomac Park CLI (NPS 2001, 53).

*Fig 79. Photo looking northwest depicting East Potomac Park Tennis Administrative Building (Matthew Traucht 2021).*

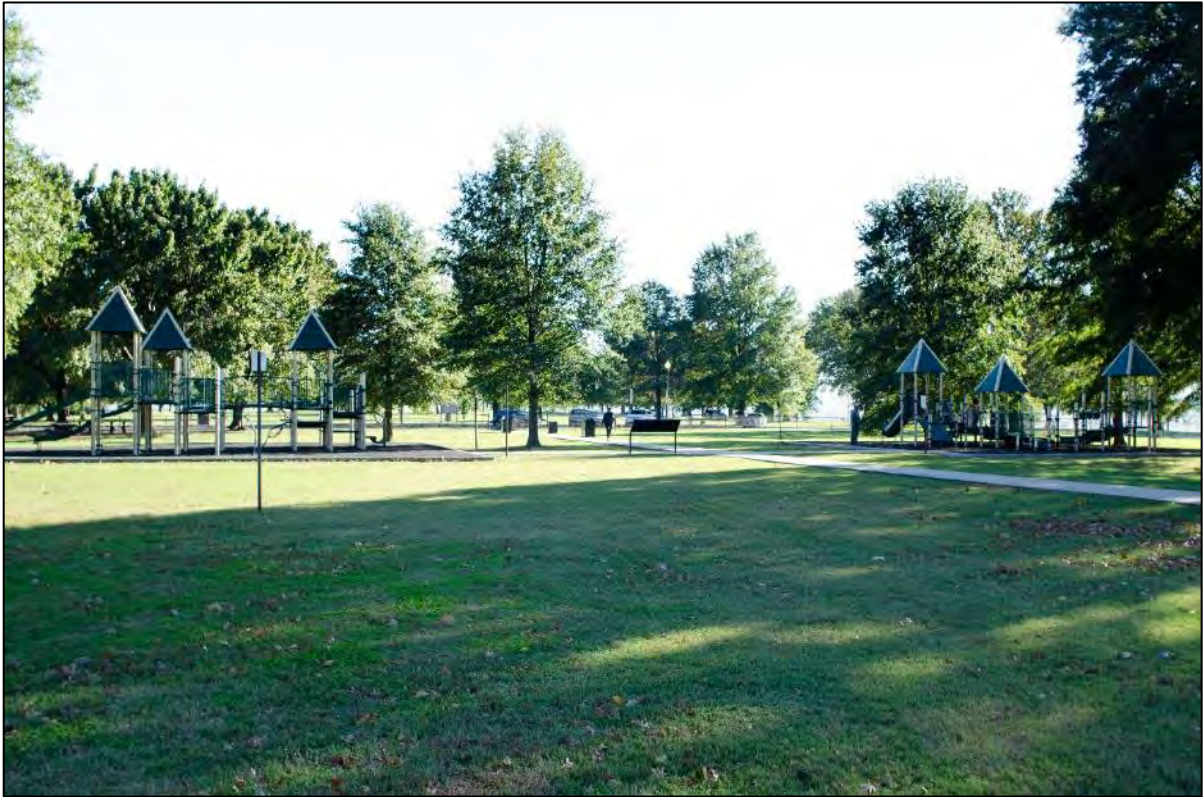
Existing Hains Point playground equipment and surfacing was replaced in-kind in 2006 (Fig 80). Today there are several prefabricated/off-the-shelf playground equipment pieces in a mulched area contained by wooden landscape timbers. Although the recreational feature was present during the period of significance, the current East Potomac Park Playground is outside of the period of significance for East Potomac Park, is less than fifty years of age, and is made of

*Fig 80. Photo looking southwest depicting off-the-shelf playground equipment near Hains Point, installed in 2006 (Matthew Traucht 2021).*

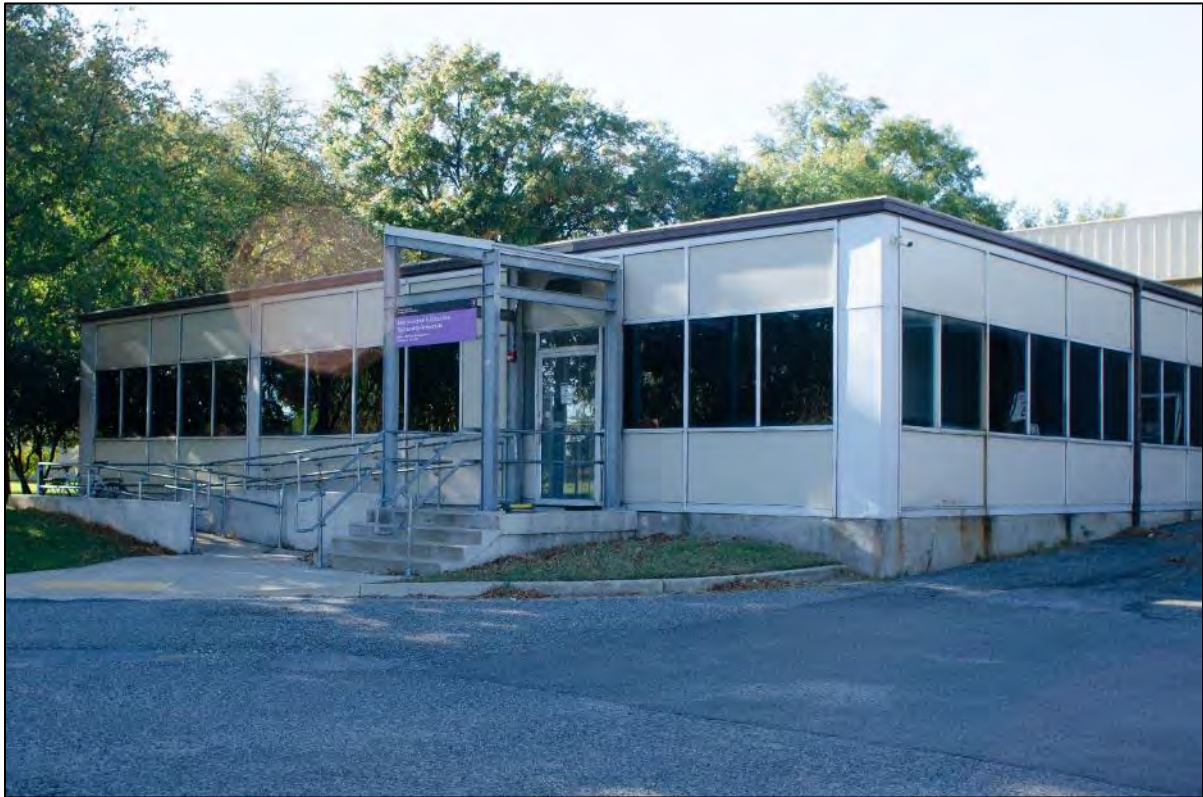
The Buckeye Building, formerly known as the Tourmobile Headquarters Building, is located at 750 Buckeye Drive SW (Fig 81). Built in 1979 by the Jack Bays Construction Company, the building includes offices, a bus garage, and a maintenance shop. The one-story building has a concrete foundation and steel walls and roof. Today the building is called the Transit Facility and is used by the Circulator, which has a contract with NAMA to provide transportation to the memorials throughout the park. A portion of the building is also currently used to house the Interpretation & Education and the Partnerships-Volunteer divisions. The Buckeye Building (formerly Tourmobile Headquarters) was a noncontributing building to the NRHP-listed East

*Fig 81. Photo looking west from Buckeye Drive SW depicting the Buckeye Building, formerly the Tourmobile Headquarters, which houses the Interpretation & Education and Partnerships-Volunteer divisions (Matthew Traucht 2021).*

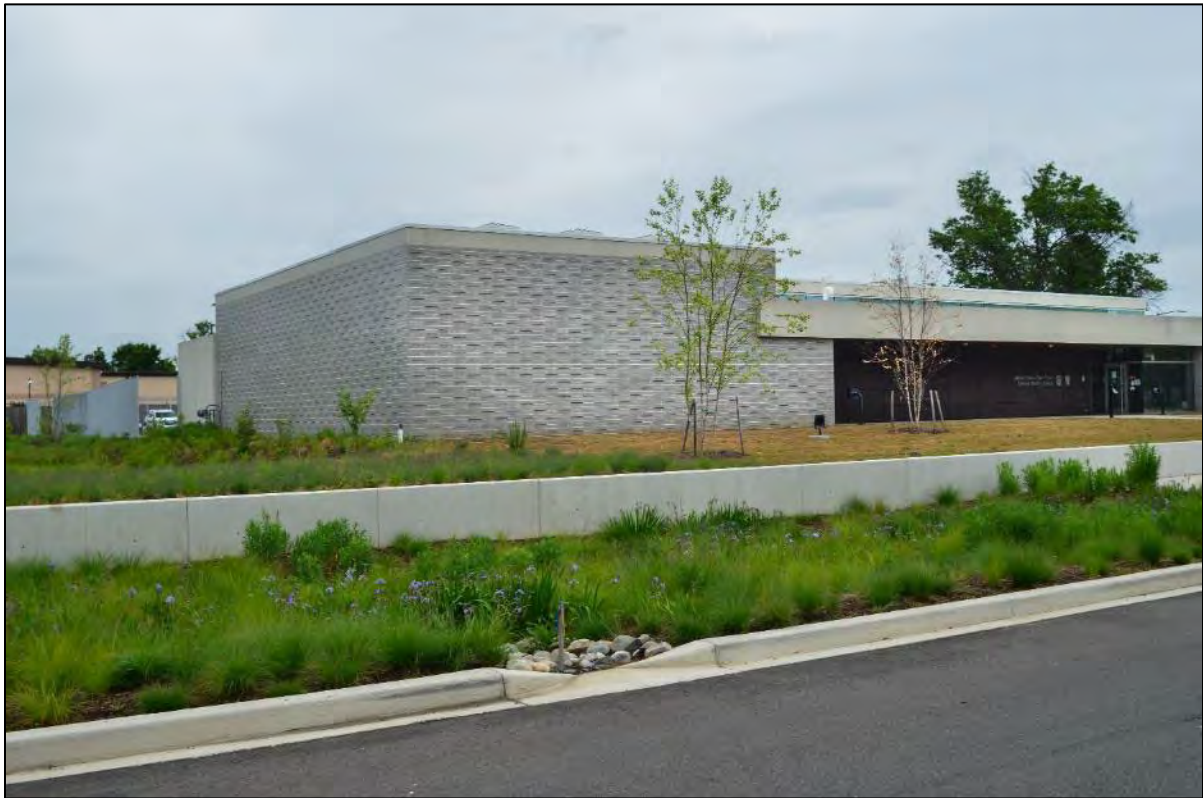
A new USPP Central District Station at 1200 Ohio Drive SW was approved by the CFA in 2015 and the NCPC in 2016. Construction began in 2017. The building is located on a portion of the parking lot near the NCR and USPP Headquarters Buildings. The new 13,000 square-foot, one-story building was completed in 2020 (Fig 82). This relocates the USPP out of the East Potomac Park Field House and into a purpose-built facility. The materials chosen for the new building were designed for safety, durability, and compatibility with the historic NCR headquarters buildings. The exterior is of cast in place concrete with a flat membrane roof with parapet. A

steel-clad niche is featured at the public entrance to the building. The building design considered flooding concerns . Textured ground-faced block is featured on the gym side and lower portions of the west façade (Beyer Blinder Belle 2015, 18). The USPP Central District Station post-dates the period of significance for the park and has not yet reached fifty years of age; it is, therefore, a noncontributing building to the East Potomac Park CLI.

*Fig 82. Photo looking northeast depicting United States Park Police Central District Station (Matthew Traucht 2021).*

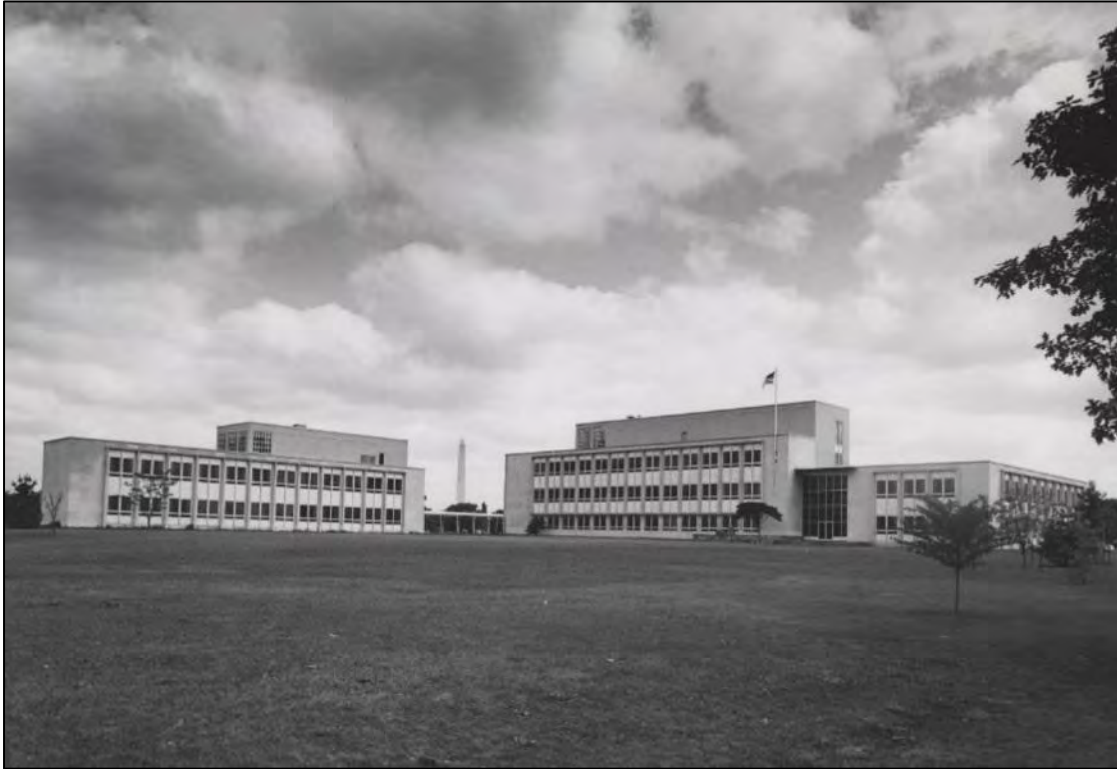
No documentation about any designed vistas within the NPS NCR Headquarters Campus was found in researching for this Cultural Landscape Inventory. The two main buildings of the campus—the NCR Headquarters and the USPP Headquarters—were sited at right angles to one another yet were not connected to one another, except by a low covered walkway. This small separation between the two buildings provided a striking vista of the Washington Monument from the intersection of Ohio Drive SW and Buckeye Drive SW (Fig 85). Similarly, the north entrance to the NCR Headquarters, located at the intersection of the east-west wing of the building with the north-south wing of the building, is situated on a direct axis with the Washington Monument. Although these vistas may have occurred incidentally, further research

*Fig 85. View of the Washington Monument between the National Capital Region Headquarters (right) and the U.S. Park Police Headquarters (left) (NPS 1964b).*

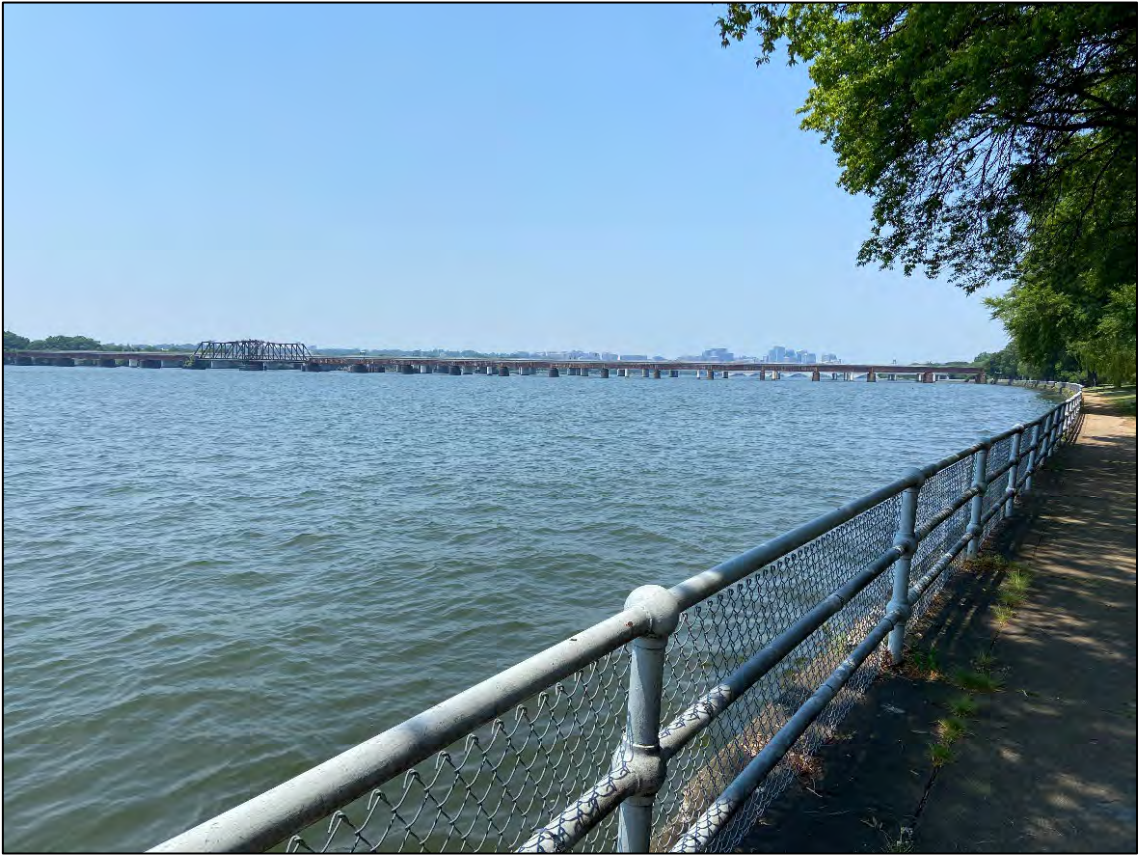
Views of the Long Bridge, the Air Force Memorial, and the Pentagon are accessed from the northwest section of the park (Fig 86 and Fig 87). The maintenance of the treeless areas along the Washington Channel providing vistas of the opposite shore has continued to present day. The view of the Washington Monument from the north entrance to the NCR Headquarters building across the pool and fountains remains unimpeded (Fig 88 and Fig 89). The maturation of trees has blocked some of the views of the surrounding East Potomac Park and of the Potomac River, but the vista of the Washington Monument, partly due to its height, remains unobstructed. Although the maturation of vegetation both within the East Potomac Park Golf Course and along the periphery of the island has undoubtedly obscured views of certain landmarks from some vantagepoints, these views remain generally available to visitors to the golf course. These include views to the Washington Monument, the Jefferson Monument dome, the Washington Channel, the Potomac River, and the National Defense University at Fort McNair (Fig 90–Fig 93).

*Fig 86. Photo looking north depicting the view of the Long Bridge from the pedestrian promenade on the west side of the park (Alexander Bailor 2021).*

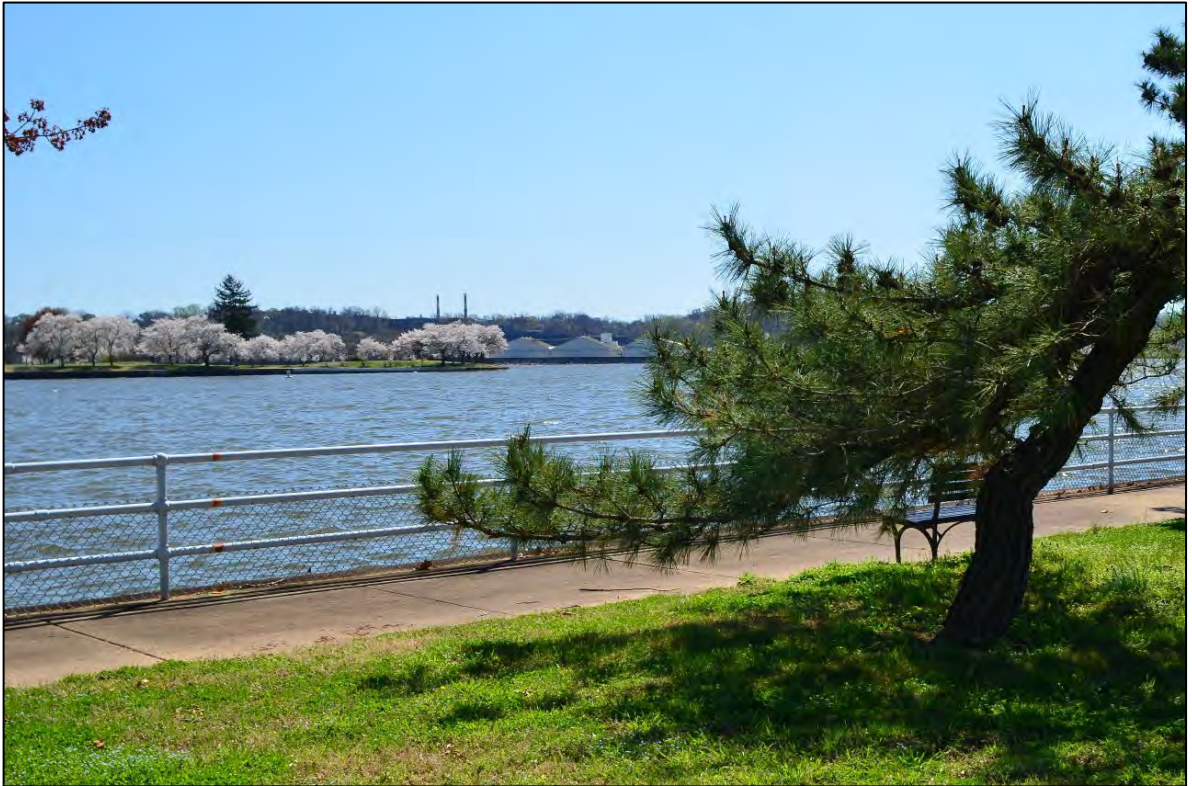
*Fig 87. Photo depicting the view of cherry trees at the National War College (Fort McNair) across the Washington Channel from the east side of East Potomac Park near Hains Point (Matthew Traucht 2021).*

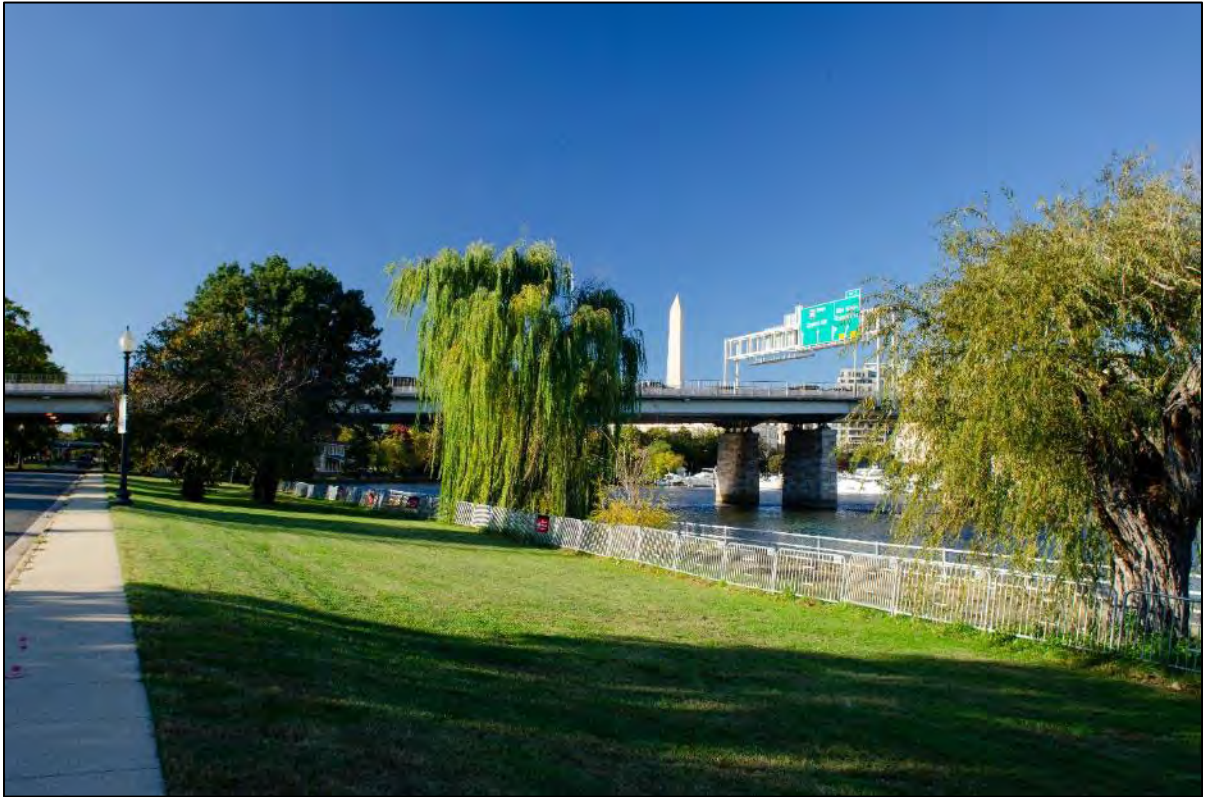
*Fig 88. Photo depicting the view of the Washington Monument beyond the Francis Case Memorial Bridge (Matthew Traucht 2021).*

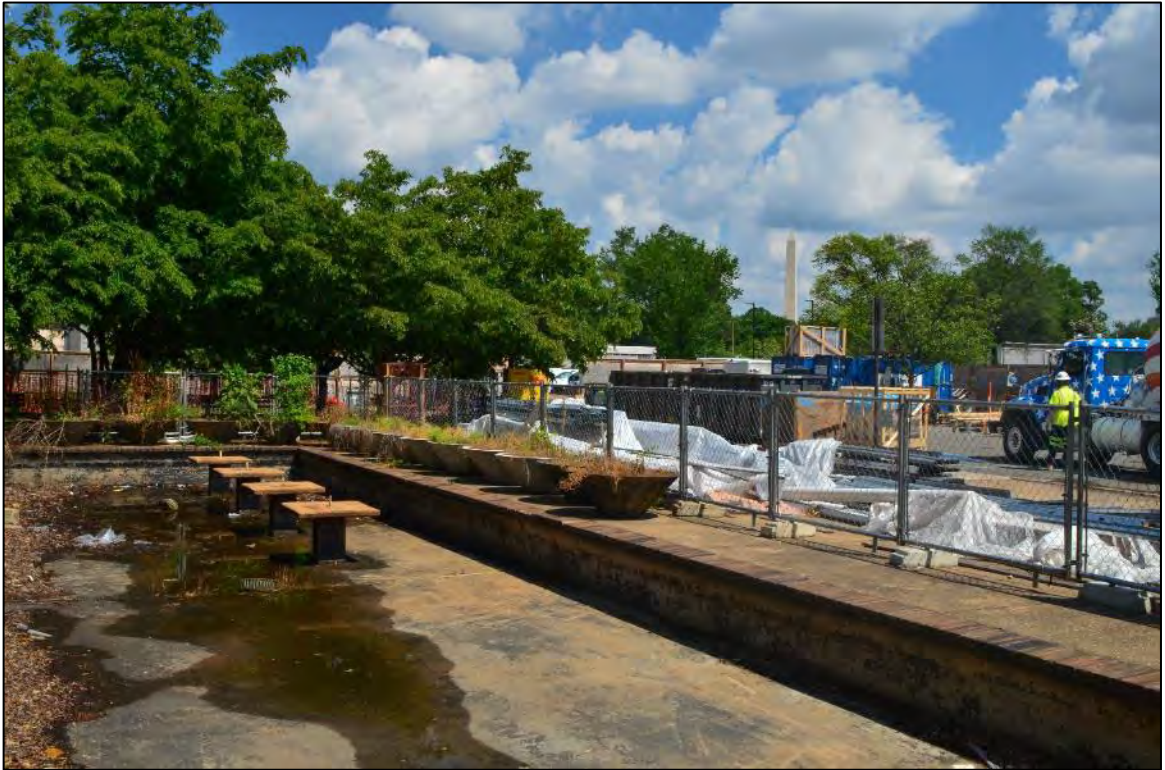
*Fig 89. Photo depicting the view of the Washington Monument along the axis of the north entrance to the National Capital Region Headquarters (note, renovation of pool and buildings ongoing at time of site survey) (Matthew Traucht 2021).*

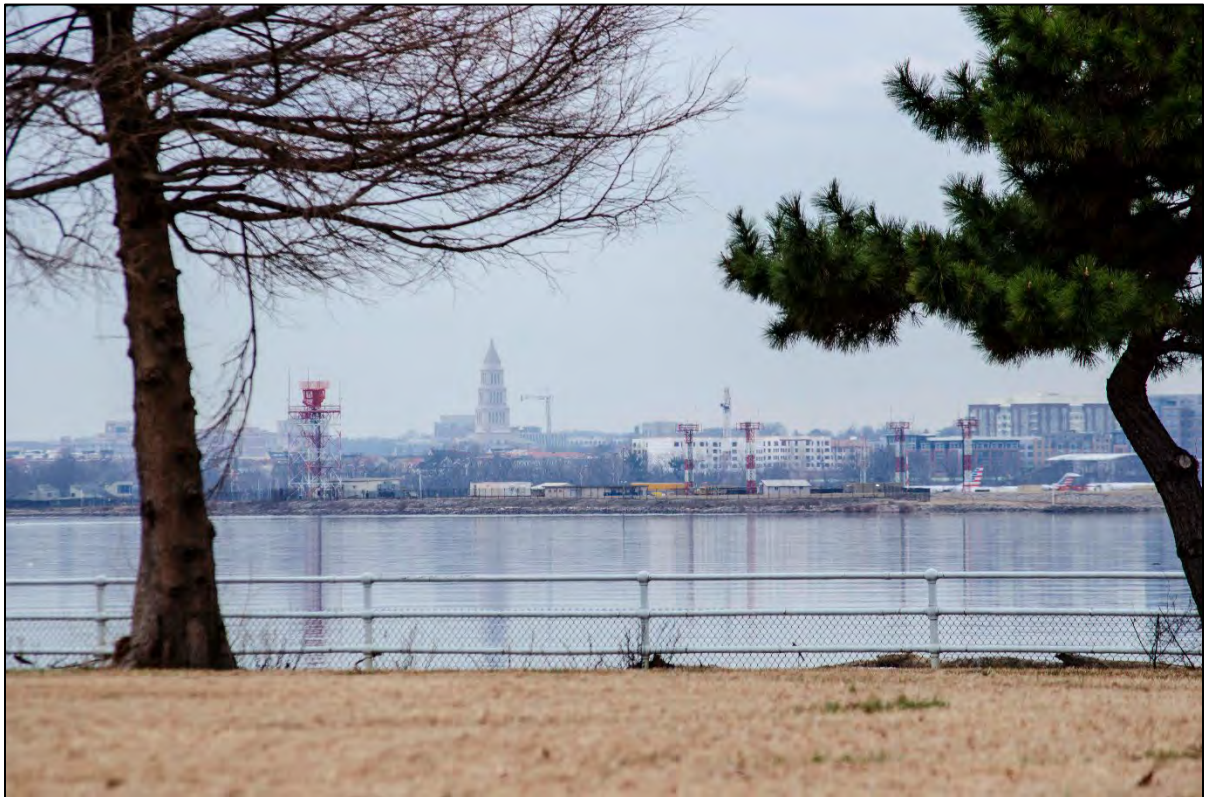
*Fig 90. Photo depicting the view of the George Washington Masonic National Memorial and the Washington National Airport (Matthew Traucht 2022).*

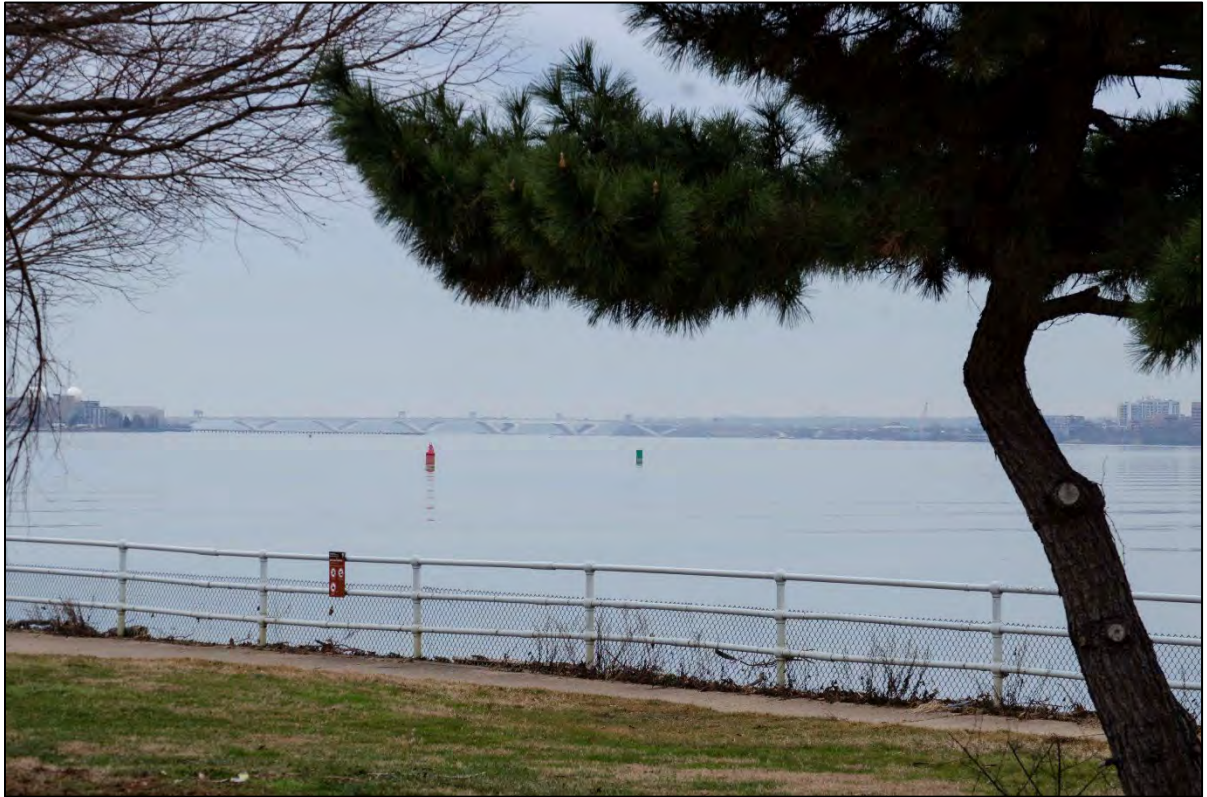
*Fig 91. Photo depicting the view of the Woodrow Wilson Memorial Bridge from Hains Point (Matthew Traucht 2022).*

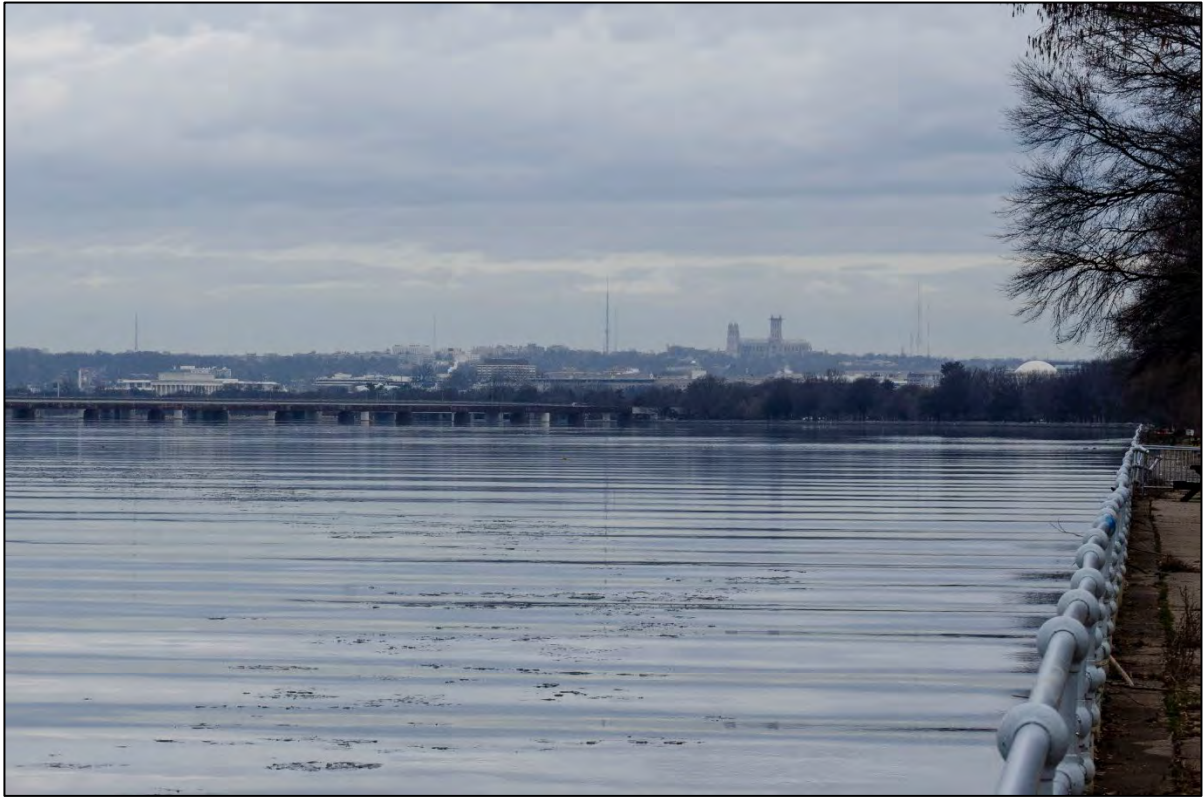
*Fig 92. Photo looking northwest depicting the view of the Lincoln Memorial and the Thomas Jefferson Memorial from Hains Point (Matthew Traucht 2022).*

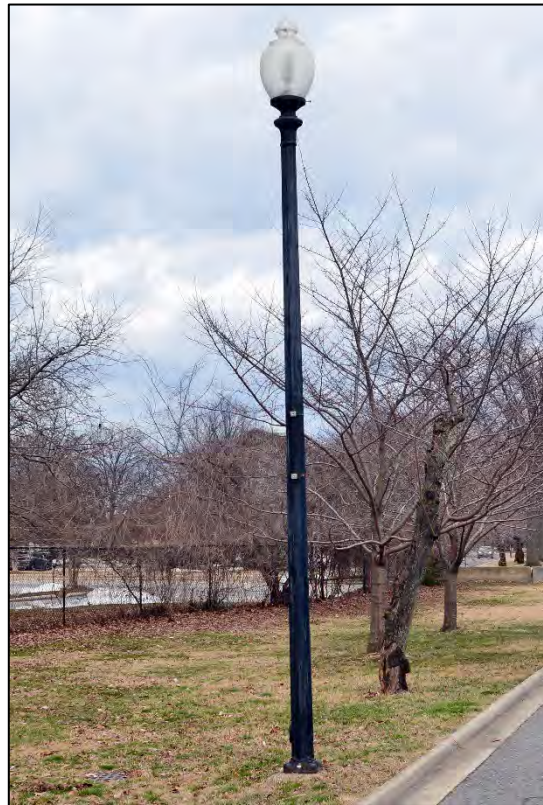
*Fig 94. Photo depicting typical light standard (Washington Globe #16) in East Potomac Park (Matthew Traucht 2022).*

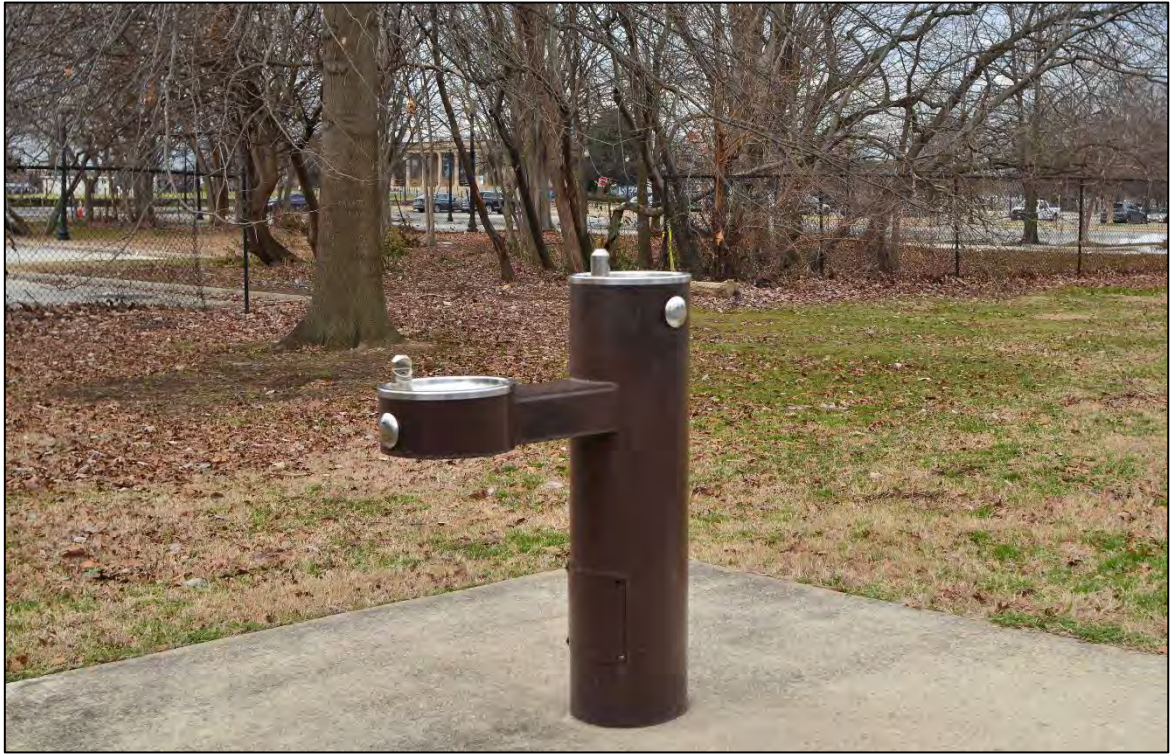
Throughout East Potomac Park there are brown, metal, freeze-resistant, wheelchair-accessible drinking fountains known as hi-low fountains (Fig 95). These were installed after the period of significance for the East Potomac Park CLI. They match other drinking fountains in the National Mall. The drinking fountains are noncontributing small-scale features of the East Potomac Park CLI as they are utilitarian in nature and less than fifty years of age.

*Fig 95. Photo depicting typical drinking fountain in East Potomac Park (Matthew Traucht 2022).*

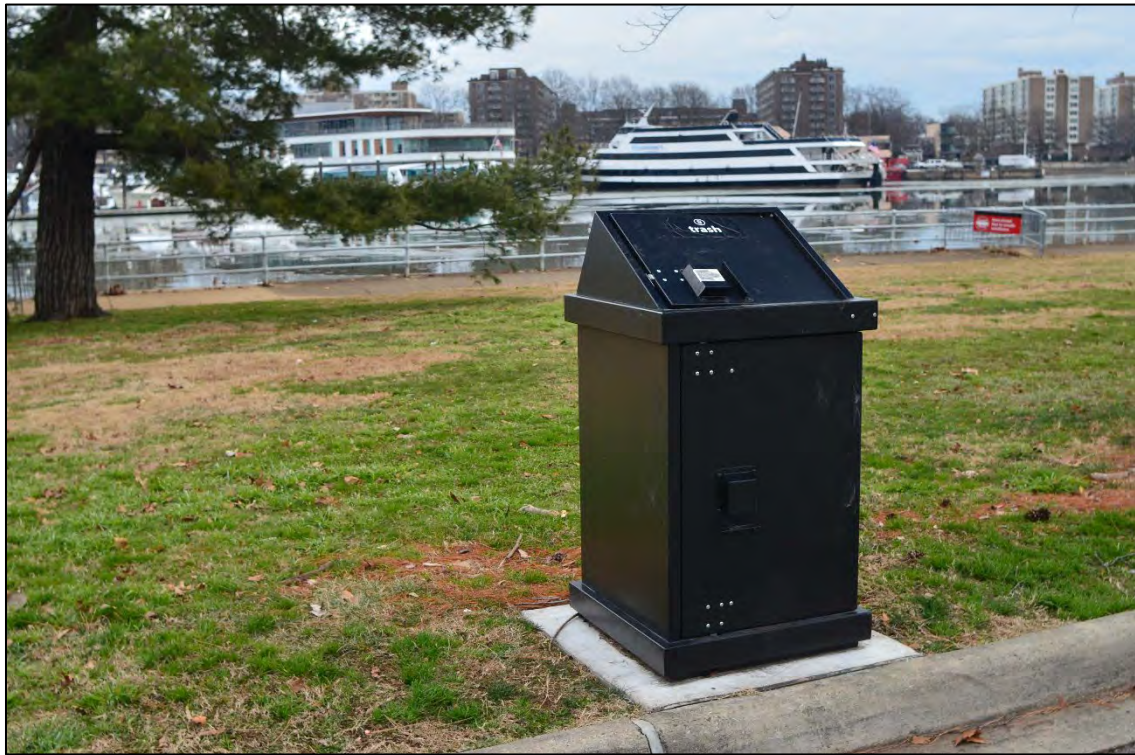
Two types of trash cans were observed in East Potomac Park. A few round wire mesh trash cans were observed, with a plastic liner inside. However, the majority of trash cans, especially along Ohio Drive SW are square, brown, metal trashcans with an angled top, known as bearsaver trash cans (Fig 96). The trash cans are noncontributing small-scale features of the East Potomac Park CLI as they are utilitarian in nature and less than fifty years of age.

*Fig 96. Photo depicting a typical trash receptacle in East Potomac Park (Matthew Traucht 2022).*

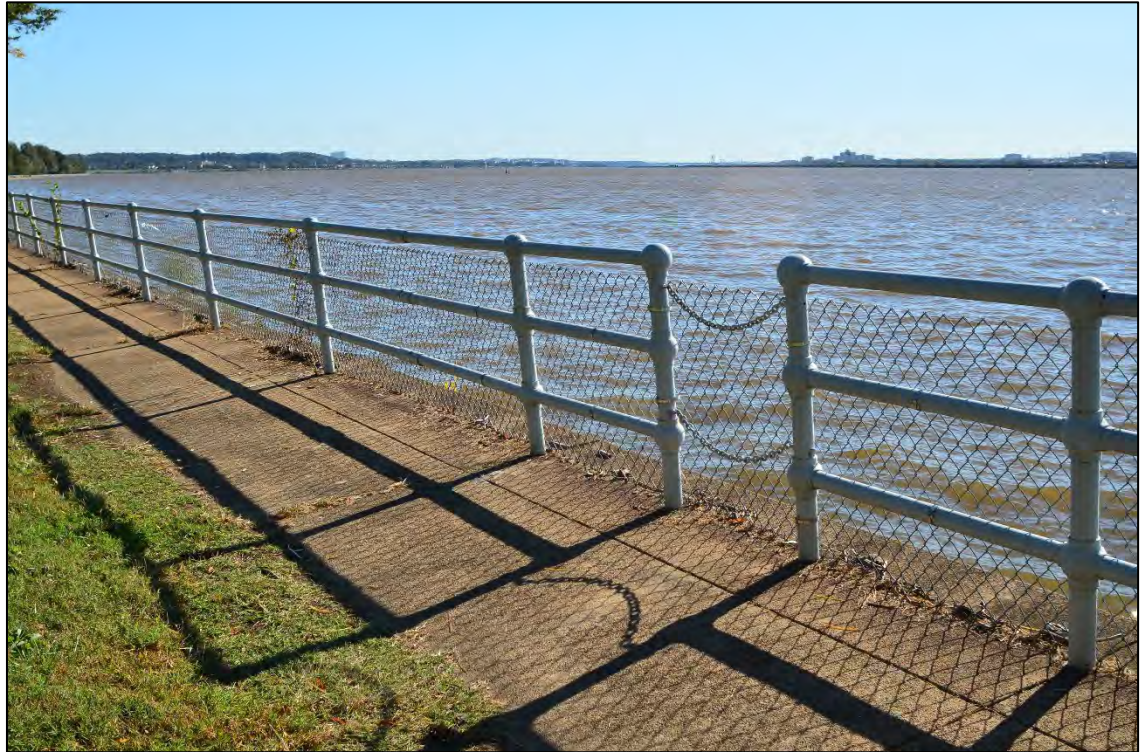
*Fig 97. Photo depicting pipe railing in East Potomac Park. Occasional openings occur along the length of the railing at irregular intervals (Matthew Traucht 2021).*
