# National Park Service Cultural Landscapes Inventory 2023

**East Potomac Park**

**National Mall & Memorial Parks**

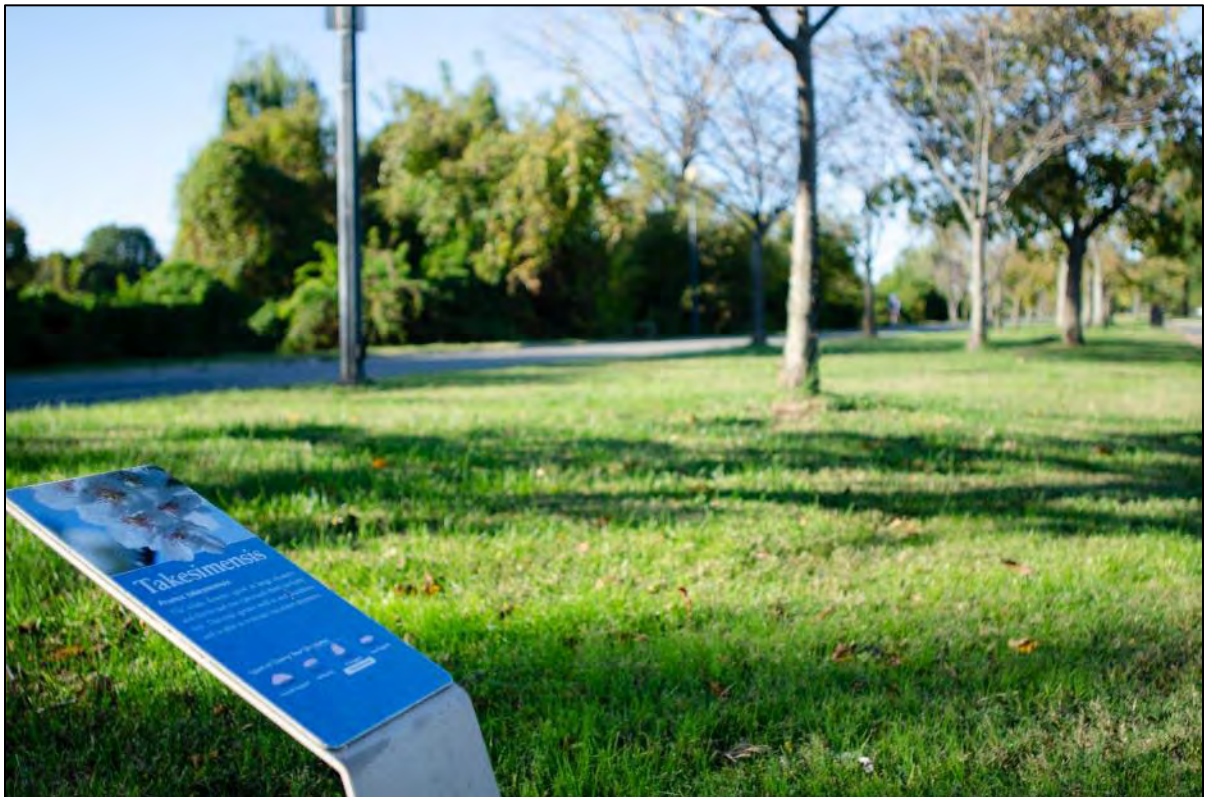
There is both interpretive and wayfinding signage throughout East Potomac Park (Fig 98 and Fig 99). Many are the standard NPS brown wayside signs with the NPS logo. There are also vertical dark grey rectangular signs known as pylons with wayfinding information on all four sides with

white text. The wayfinding pylons consist of an aluminum frame skinned with porcelain enamel panels atop a granite block base. There are also small, silver-colored interpretive signs that describe various plant species in East Potomac Park (Matson Knapp 2009). The signage is a noncontributing small-scale feature of the East Potomac Park CLI as they are utilitarian in nature and less than fifty years of age.

*Fig 98. Photo of an example of interpretive signage within the park (Matthew Traucht 2021).*

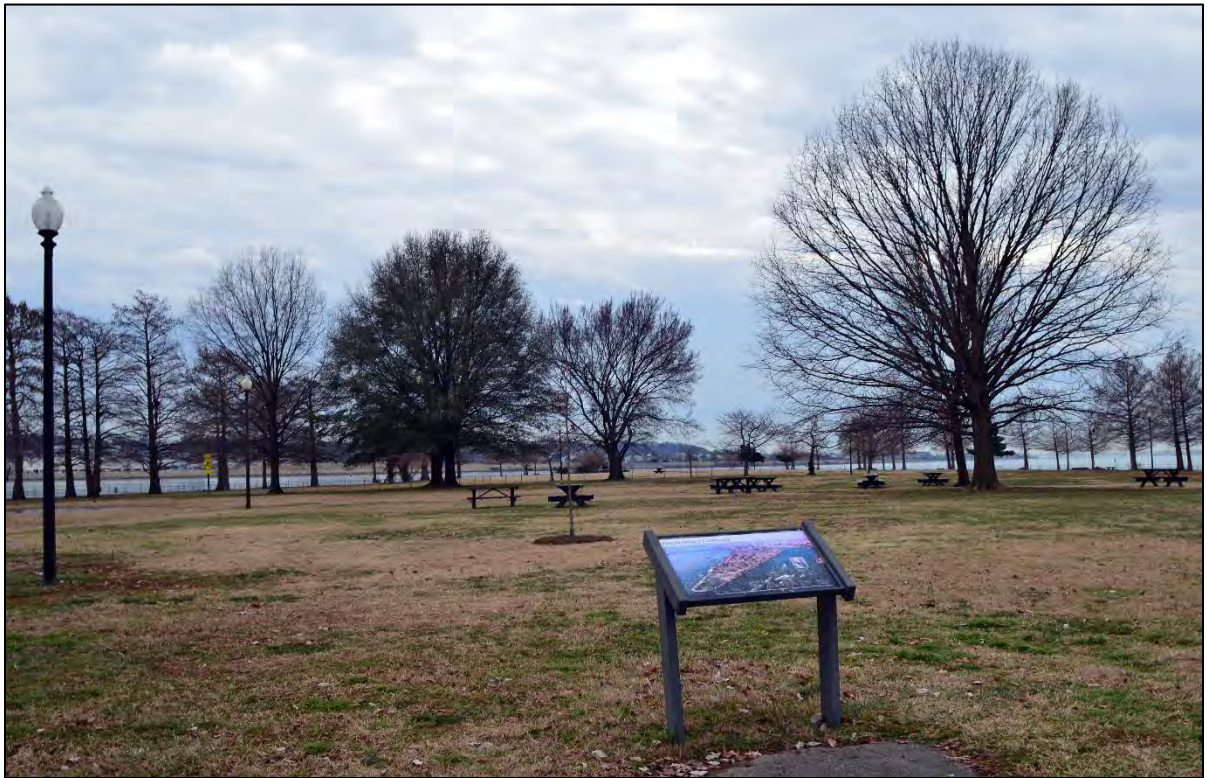
*Fig 99. Photo of a wayside within the park (Matthew Traucht 2022).*

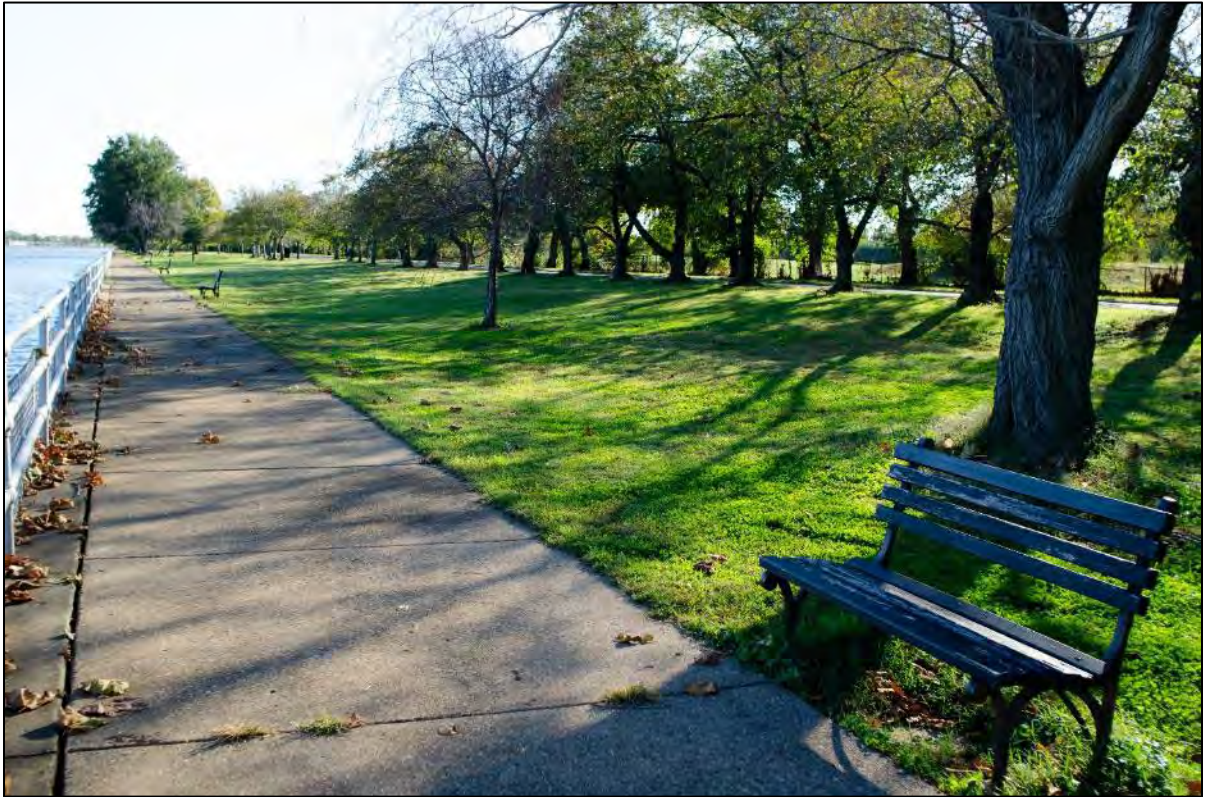
Although no documentation was found during the research of this CLI about the date of construction and installation of benches, there are three main types found within the park. The standard NPS bench, which is located at regular intervals along the perimeter of the park oriented towards the water, is a steel and wood bench with backs but no arms (Fig 100). The other benches are described below. Many of the standard NPS benches in East Potomac Park are damaged or deteriorating and in need of repair.

*Fig 100. Photo looking south along the Washington Channel depicting the standard wood and steel bench along the perimeter walk (Matthew Traucht 2021).*

| Deferred Maintenance | | No | Yes | Numerous benches found in East Potomac Park exhibit deterioration due to deferred maintenance. Some are in a state of disrepair that prevents their safe use and should be replaced or repaired. The poor condition of the seawall and the perimeter walk, although associated with inundation, is also related to deferred maintenance. | June 2021 |

It was observed that some benches are damaged, and a stabilization measure would be either to repair these benches, remove them from the area, and/or replace in-kind. Overall, routine maintenance is needed on contributing resources in order to maintain their individual integrity and the integrity of the East Potomac Park CLI. Now that the North Field House is empty with the departure of the USPP, make plans to either re-use and maintain this space, or consider mothballing it if it will remain vacant. Stabilization of the East Potomac Park Pool is recommended in coordination with the DC Department of Recreation. The groundwater intrusion has stopped work on the construction of a new pool, but the site as it currently stands is an eyesore that detracts from the integrity of the cultural landscape.

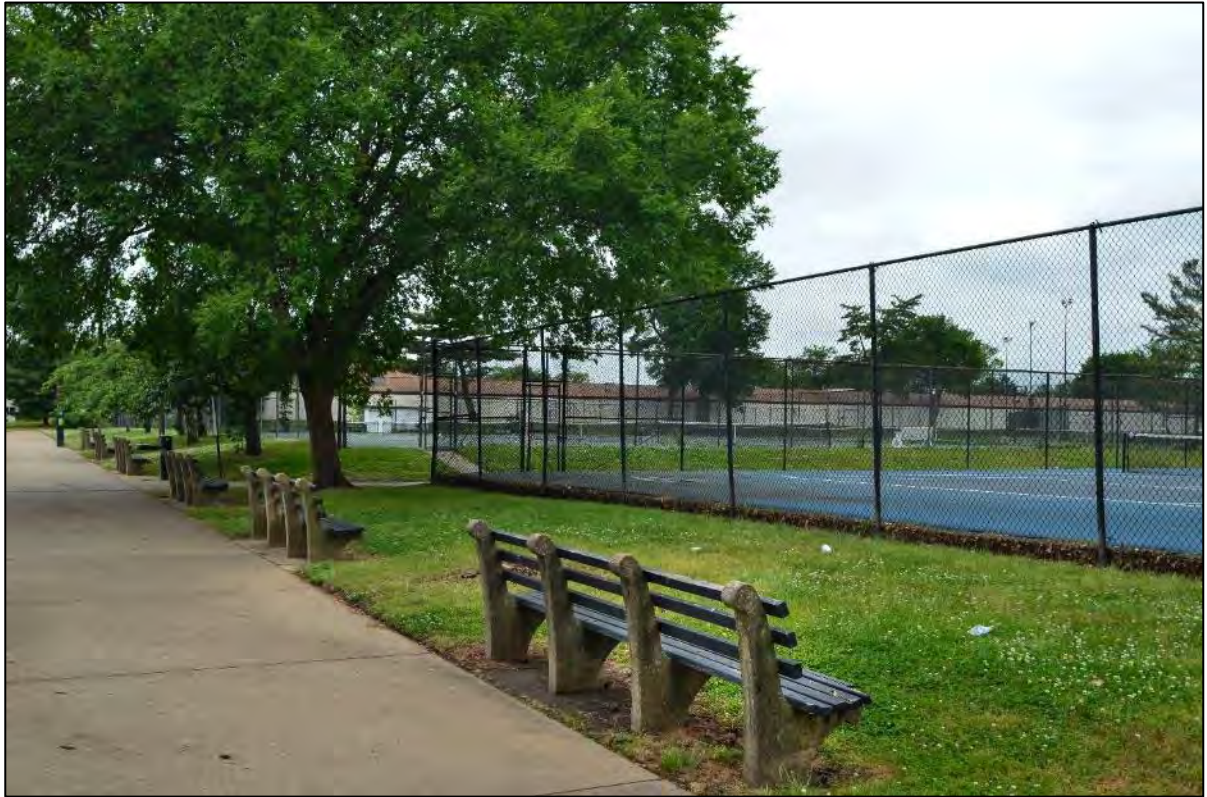
Another bench type has also been used in two distinct places and may date to a shared period of installation: Along the south side of the tennis courts and in the paved terrace of the NCR and USPP Headquarters, a bench comprising exposed aggregate concrete legs and supports with wood slats can be found. There is a slight difference in design; the benches along the tennis court have curved tops to the exposed aggregate concrete legs, whereas the benches at the NCR and USPP Headquarters have flat, or squared off tops for the legs (Fig 101 and Fig 102). The site plan for the NCR and USPP Headquarters does not call out benches specifically but, given that the tennis courts and the NCR and USPP Headquarters were built approximately during the same period (some tennis courts were in place around 1960, but the tennis bubble was installed in 1974; 1963–1964 for the NCR and USPP Headquarters), there is the possibility that these benches were all installed using a similar design during the same decade from 1964 to 1974. Further research is needed to confirm if any of these benches were part of the original construction. As a result, the concrete and wood benches are an undetermined feature of the East Potomac Park CLI.

*Fig 101. Photo looking southwest depicting concrete and wood benches at the tennis courts (Matthew Traucht 2021).*

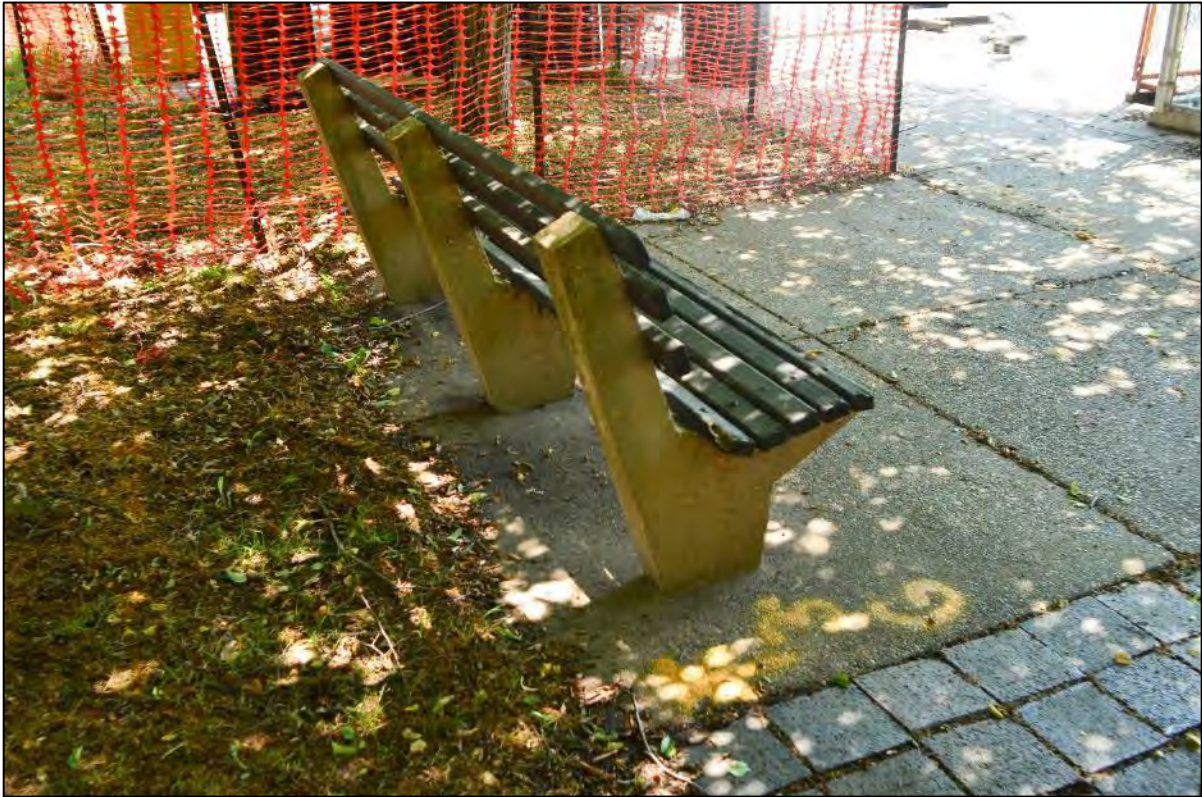
Fig 102. Photo of concrete and wood benches at the NCR Headquarters (Matthew Traucht 2021).
