National Park Service  
Cultural Landscapes Inventory  
2012

Washington Circle  
National Mall & Memorial Parks - L'Enfant Plan  
Reservations

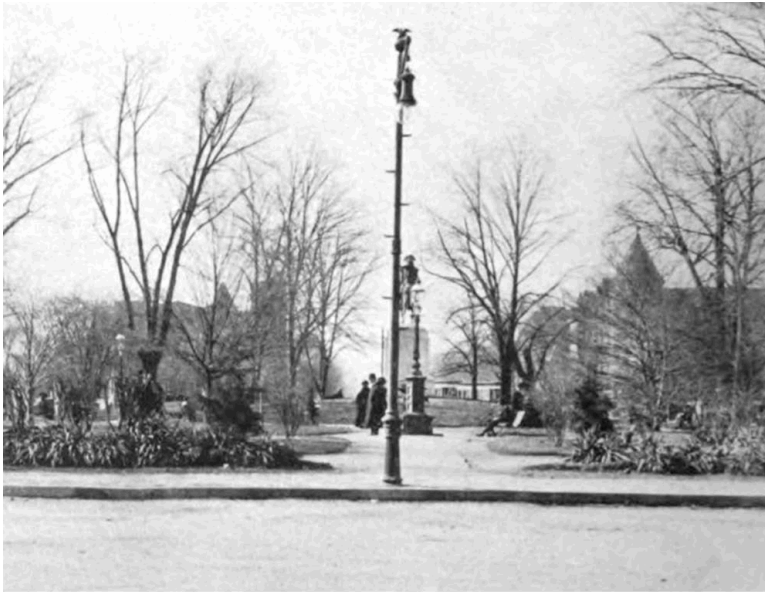
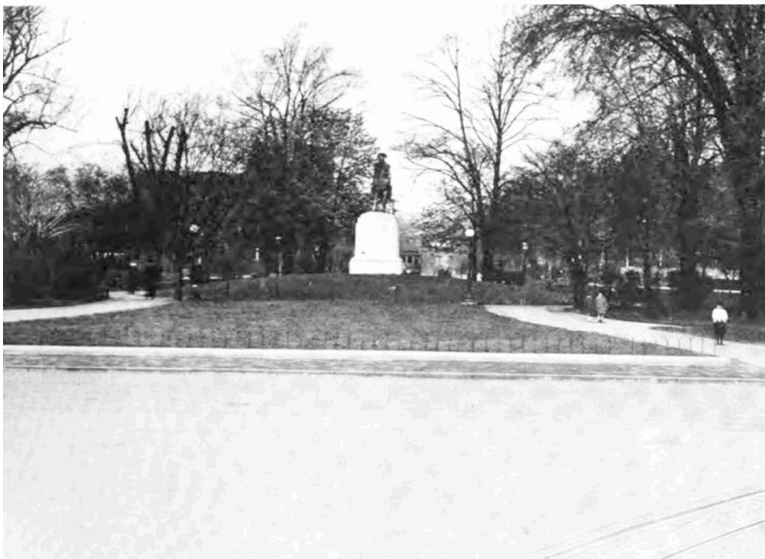
*Top: Before Burnap redesign. Bottom: After redesign (Burnap 1916).*

| CE 1911 | Designed | Landscape Architect George Burnap modifies the existing landscape plan of Washington Circle. His new design is approved by Major Spencer Crosby on January 18, 1911, and features an open grass panel in line with Pennsylvania Avenue east of the Washington Statue. This panel is to be flanked by walkways, and a note on the plan states that a gas light that had had previously interrupted the view toward the statue is to be removed. Although not specifically mentioned on the plan, it also appears that any offending vegetation will also be removed, as well as one of the two drinking fountains (Burnap 1916: 72-73; DSC TIC 824_80008; DSC TIC 824_80009). |

| | Altered | The new east ``entrance`` to Washington Circle is constructed according to Burnap's plan. Period photographs from his 1916 book <i>Parks: Their Design, Equipment, and Use</i> , show the circle before and after his redesign. The new approach is open and unobstructed, whereas the old arrangement appeared cluttered and congested. In conjunction with this work, the District of Columbia constructs a new eight-inch cement coping around the circle in April of 1911. The total length of this coping measures 975 feet, and it presumably replaces the original 19th-century granite coping. After the new coping is installed, the Office of Public Buildings and Grounds raises the grade of the adjacent ground, covers it with soil, and lays down sod (AR 1911: 1104, 2969; Burnap 1916: 72-73). |
| CE 1911 - 1912 | Paved | Within Washington Circle, 181.7 square yards of asphalt are laid along the new walks flanking the open grass panel at the east entrance to the park. The paved walks are clearly visible in the period photograph appearing in Burnap's book (AR 1912: 3490; Burnap 1916: 73; DSC TIC 824_80013). |

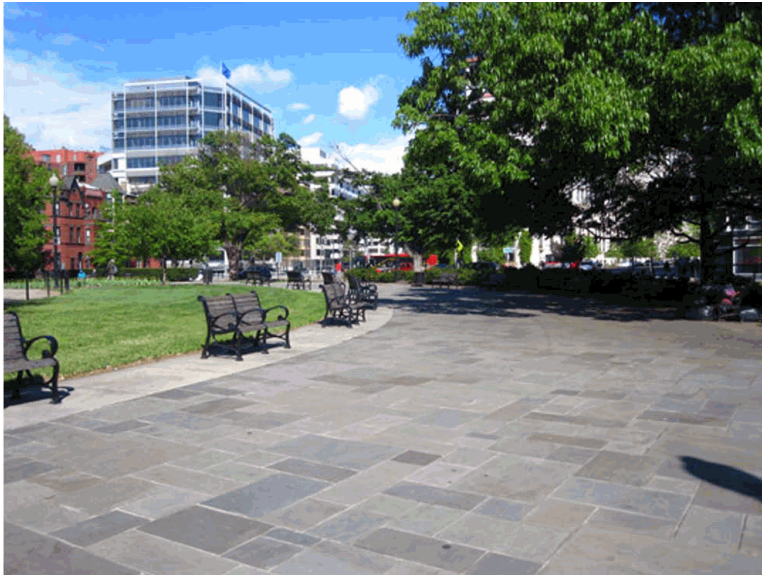
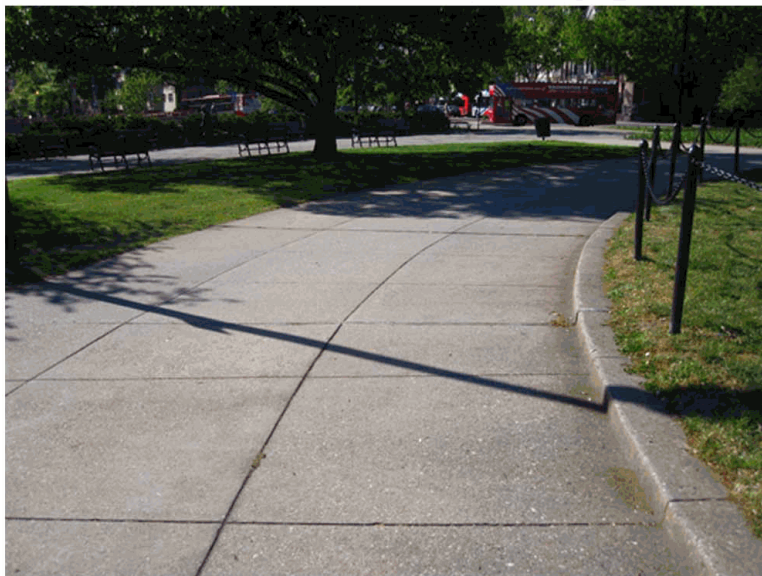
*Flagstone and scored concrete paving (CLP 2012).*

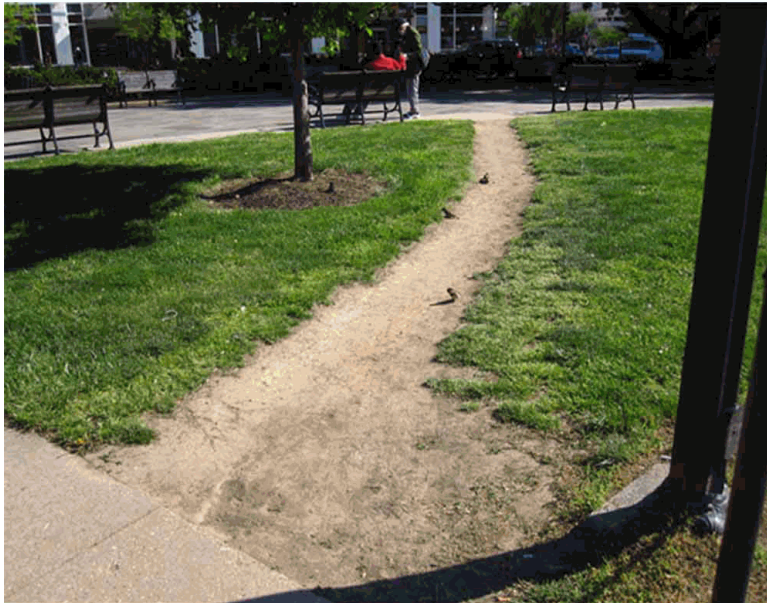
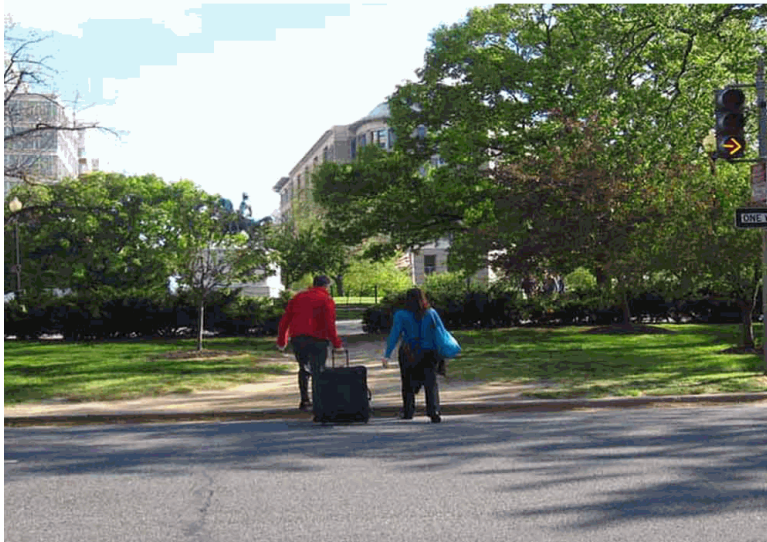
*Social trails on the southeast (top) and northeast (bottom) sections of the circle (CLP 2012).*

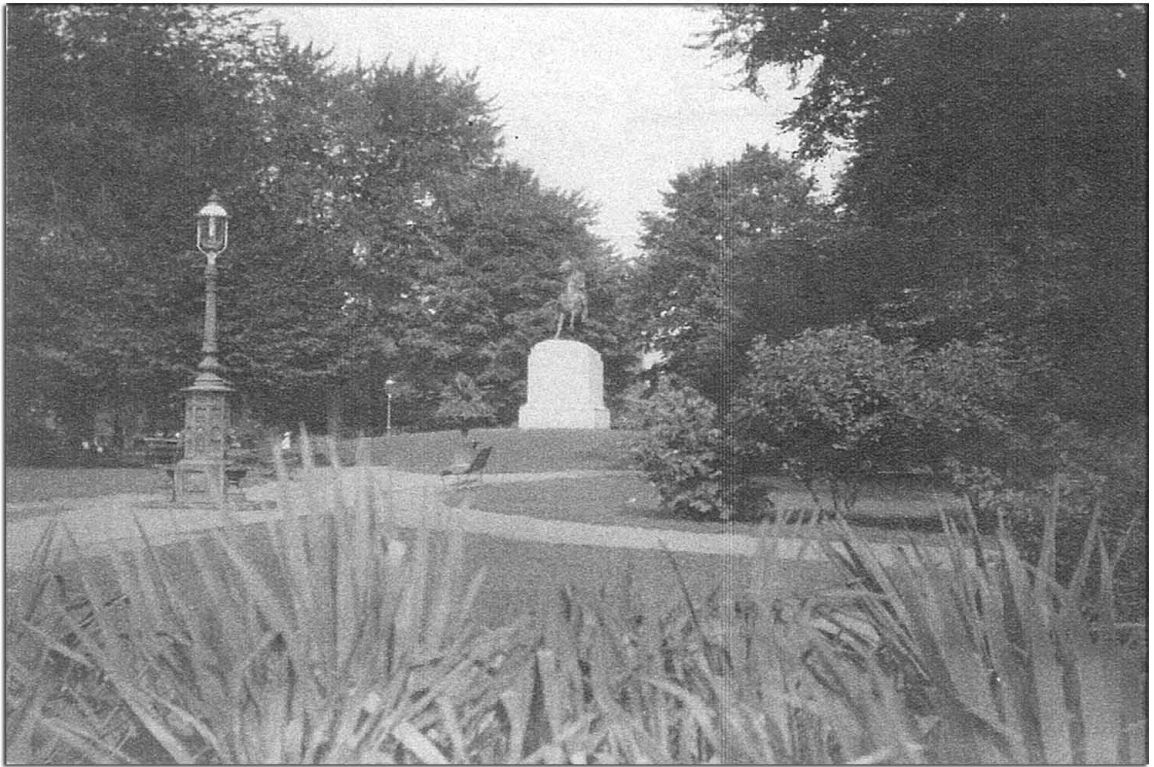
*Early 20th century view showing elevation of earthen mound. Note presence of Boulevard-style lamp (Washingtoniana Collection).*

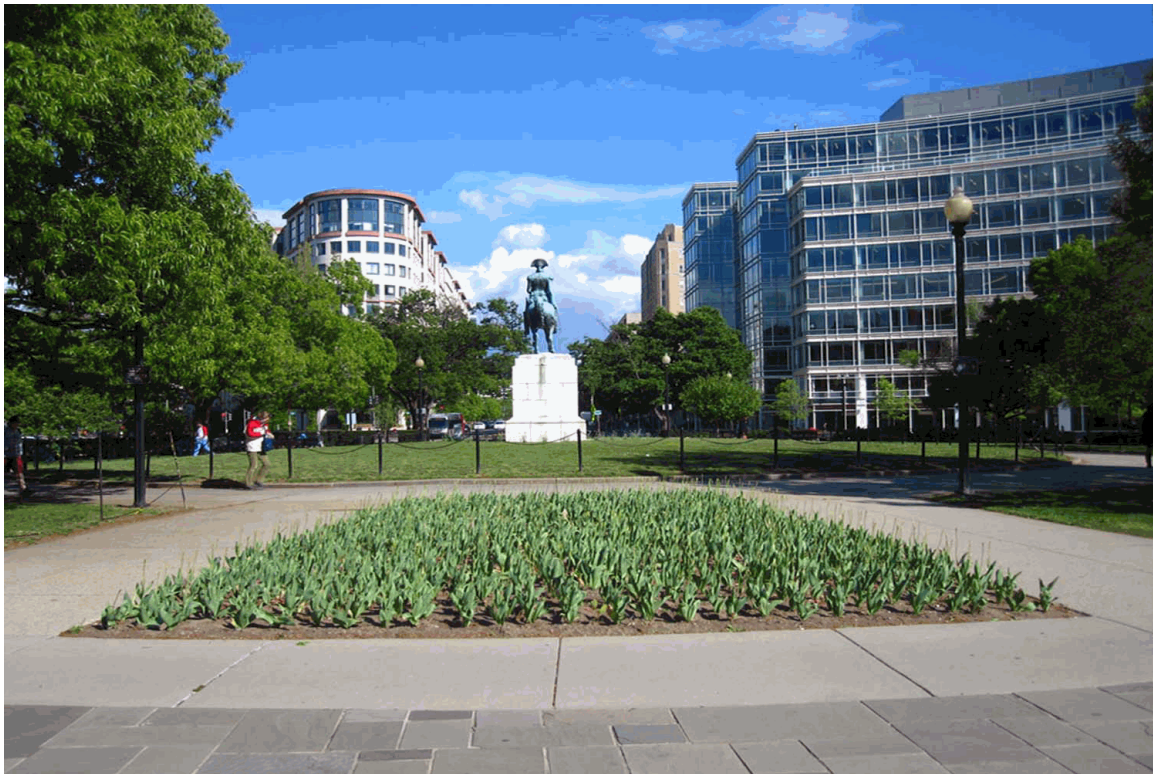
*Present day view showing change in elevation (CLP 2012).*
