Natchez National Historical Park  
Natchez, Mississippi

# William Johnson House Cultural Landscape Report

January 2022

Laura L. Knott, Historical Landscape Architect, LLC

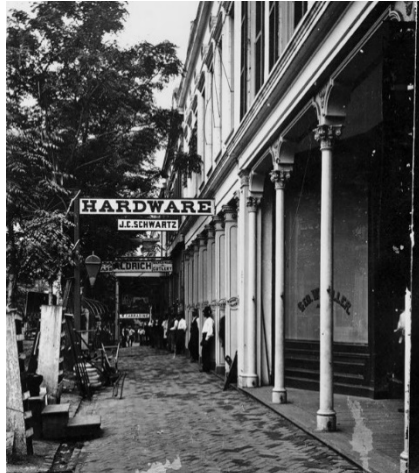
FIGURE 2-9. Photograph taken ca. 1890s of the J.C. Schwartz store, showing wood tree boxes built to protect the chinaberry trees (left). Gandy-Norman Collection.

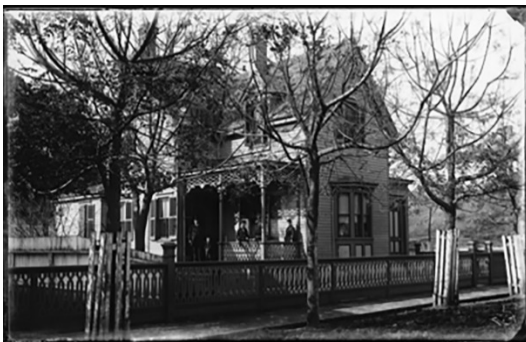
FIGURE 2-10. Photograph taken ca. 1890s of a residential street with its chinaberry trees protected with tree boxes. Stewart Collection.

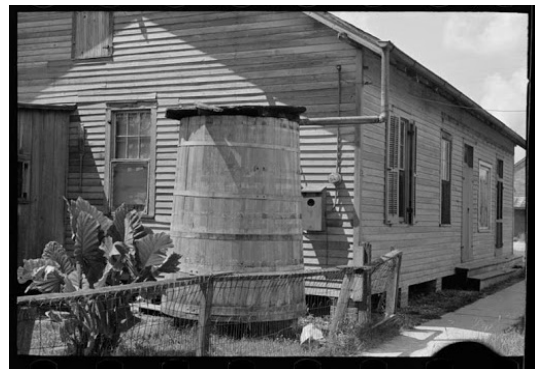
FIGURE 2-11. Photograph of wood cistern near Destrehan, Louisiana. Library of Congress.

Other work on the property included installing a wood cistern and building a hen house. On March 10, 1841, Johnson moved a wood cistern to his property, and on June 24 added a pump on a stand and paid a carpenter to install a windlass (Figure 2-11).<sup>65</sup> On March 12, Johnson recorded building a hen house in preparation to move his family to State Street on March 15, 1841. On June 17, he reported that “I got three Little chickens to day from Mother as a Present, 2 of them was Freeslings—the whitish Rooster.”

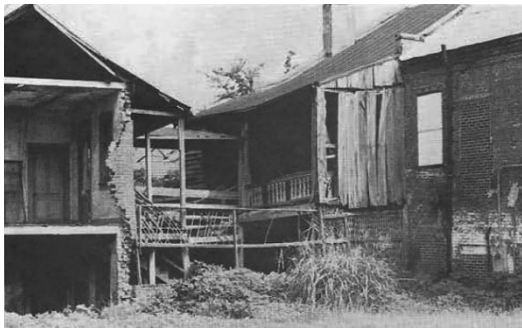
FIGURE 2-12. Photograph taken of the rear gallery of the William Johnson House in the 1970s before restoration. The crisscross lattice is used here as a privacy screen. Padgett.

On July 22, Johnson reported putting up lath as a lattice enclosing part of the first-floor back gallery for outdoor dining. Pre-restoration photographs taken in the 1970s show a remnant of a lattice enclosure with lath criss-crossed at a 45-degree angle (Figure 2-12). The back gallery faced southwest, and a lattice would have provided shade and privacy. Lattice was also used to cover cisterns, crawl spaces under houses on piers, and galleries in the Natchez area (Figure 2-13).<sup>67</sup>

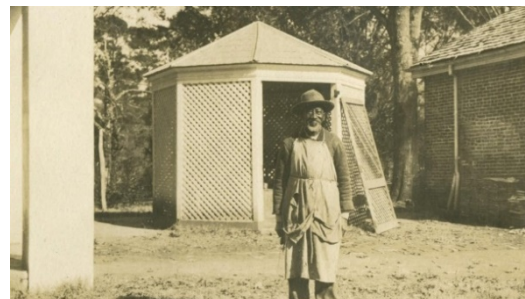
FIGURE 2-13. Photograph of the lattice-covered cistern building at Melrose. The stuccoed neck of the cistern can be seen behind the standing man. National Archives.

On March 15, Johnson ordered some lumber to be brought up to build a cistern house, and on March 29, he paid a carpenter named St. Clair to complete it. The cistern house was most likely a small, latticed building similar to the extant cistern houses and gazebos at Melrose, The Elms, Hope Farm, and Myrtle Bank, which are documented in historic photos (see Figure 2-13).<sup>87</sup>

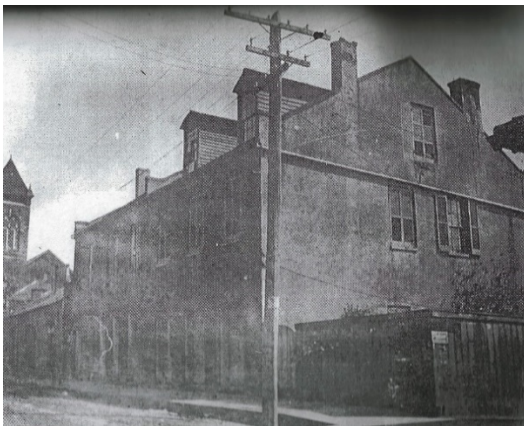
FIGURE 2-15. Photograph from 1979, showing a downspout leading to the rear of the house. Building Conservation Society.

then had a “Mr Oblemis” top the structure with a brick arch on the nineteenth. On March 8, he reported that he and Winston “put One Course of Bricks on the Cistern Top and then put on the Top and Cut a hole through the Top for the pipe and planted a post for the Pipe to Rest on—Mr Walker, the Tiner, put up the pipe from House and Kitchen to the Cistern for which he Charged me \$5.75.” This cistern was likely a hole in the ground that was plastered to make it watertight, with the brick neck added on top (Figure 2-14). A historic photograph of the front and west side of the house shows a downspout from the front gutter across the side towards the rear, perhaps to supply this or subsequent cisterns (Figure 2-15).

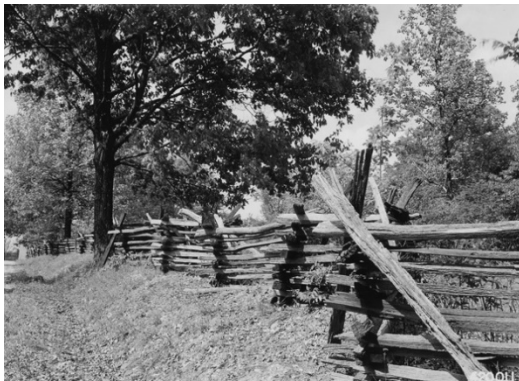
FIGURE 2-20. Photograph of a zig-zag style fence, also called a snake rail or Virginia rail fence. National Archives.

would likely have been the zig-zag style, a sturdy, but temporary fence (Figure 2-20).

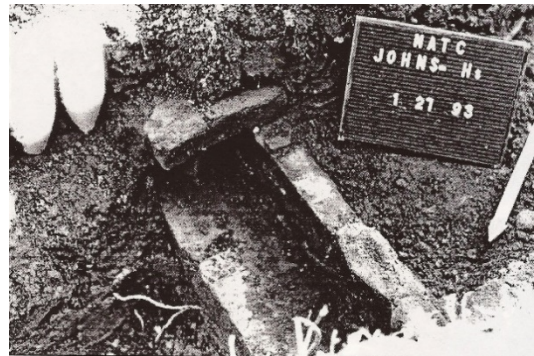
FIGURE 2-24. Brick gutter drain uncovered in 1993 by archeologists. Atkinson.

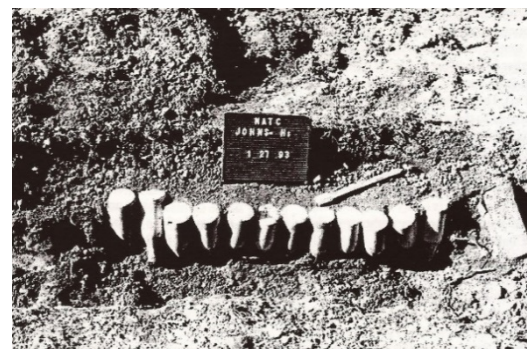
FIGURE 2-29. Photograph of row of ale bottles found during 1993 utility trench investigation. Atkinson.

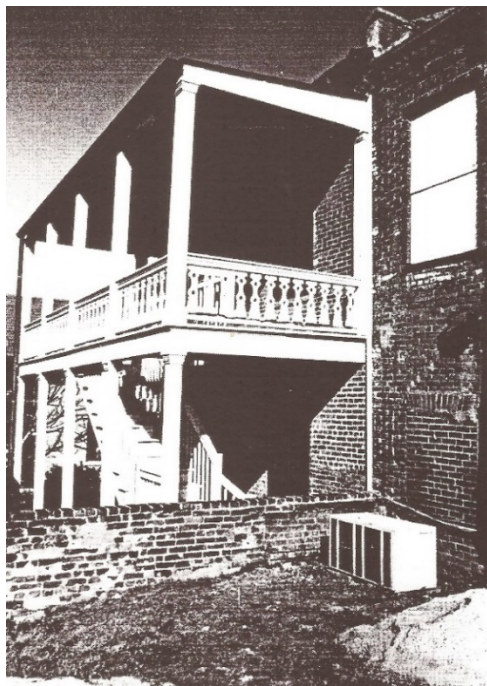
FIGURE 2-31. Photograph taken in the 1990s, showing a freestanding wall between the Johnson and McCallum courtyards. Atkinson.

likely have been added between 1897 and 1917.<sup>147</sup> In addition, it is possible that the freestanding wall between the Johnson and McCallum courtyards was also constructed in 1897 (Figure 2-31).

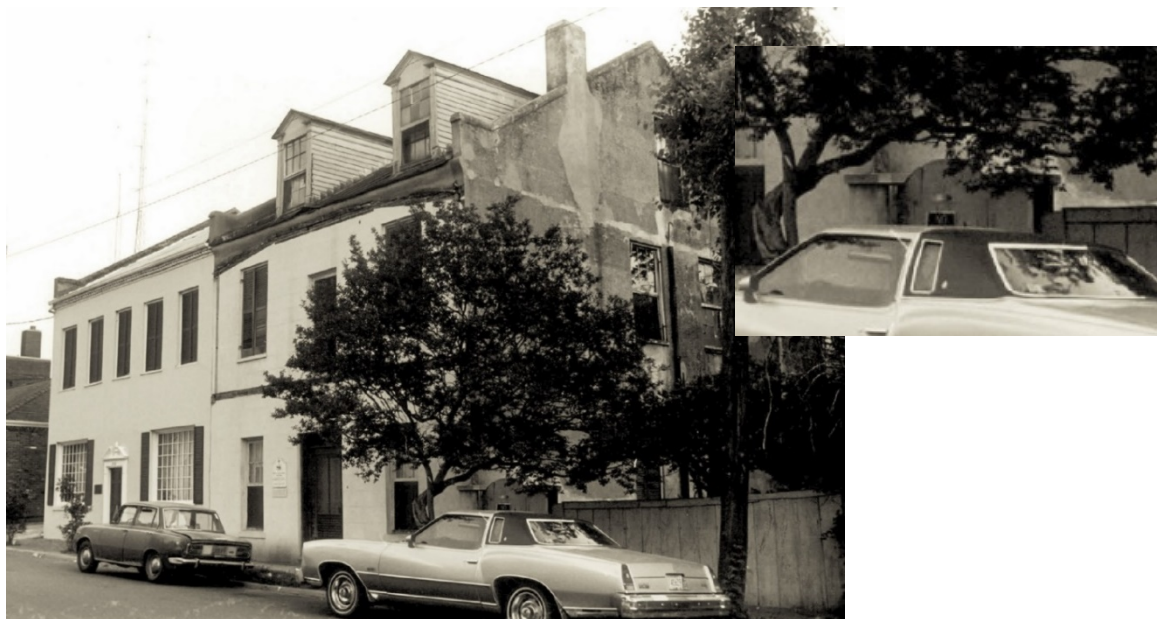
FIGURE 2-36. Photograph taken around 1975 of the front of the William Johnson House, and detail showing concrete gate piers. Over the Hill Historic District National Register Nomination.

The improvements made to the property in the 1920s also likely included the concrete gate piers that were still present when the property was acquired for preservation in 1975 (Figure 2-36). These were also removed by the NPS in 2004 when staff replaced the 42" single-leaf gate with a wood, double-leaf gate centered on the north fence. Concrete began to be used to

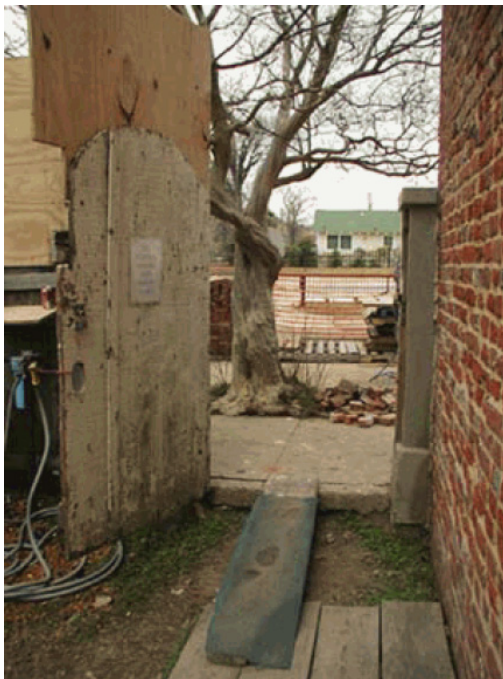
FIGURE 2-39. Arch-top, vertical plank entrance gate at the William Johnson House in 2003. Jaeger Associates.

Starting in 2003, a cultural landscape inventory (CLI) was conducted at the William Johnson House. During field work for the CLI, researchers documented the white-painted wood fence with wide vertical planks along the north property line from the Johnson House to the depot building. Its hinged, arch-top, vertical plank gate, which gave access from the yard to the street at the northwest corner of the house, was flanked by two cast concrete square piers (Figure 2-39). This gate or one similar in design was present in the early twentieth century according to an interview with Mrs. Mary Louise Miller, who lived in the Johnson House as a child in the 1920s.<sup>188</sup> When it replaced the fence in 1992, the NPS had left the old gate in place.

In 2004, after the archeological investigation was complete, NPS staff replaced the site's perimeter fence. The work included removing and replacing the original concrete posts of the Johnson-era fence with wood posts. The concrete posts had stood at approximately ten feet on center along with west and southwest property lines (Figure 2-41). Work also included removing the original arch-top gate and replacing it with a double-leaf wood gate centered on the north fence, making it easier to bring equipment into the site for construction projects.<sup>194</sup> The gate is currently in storage at the park shop.<sup>195</sup>

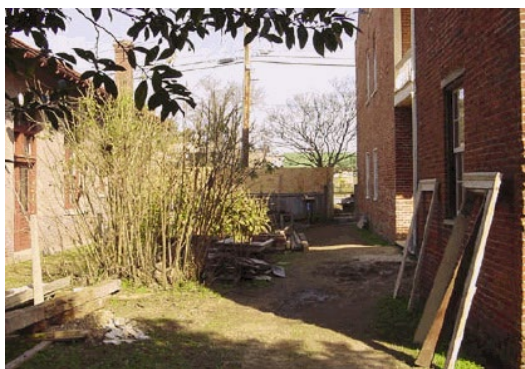
FIGURE 2-41. Johnson House side yard 2003-2004, with concrete fence post to the left, devilwood clump in left center, and crape myrtle beyond far fence. Jaeger Associates.

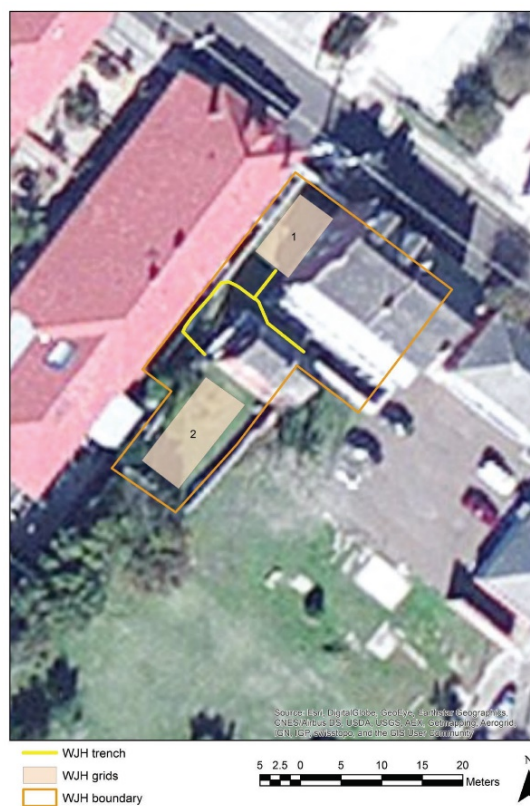
FIGURE 2-43. Diagram showing the location of the trenching and the two GPR grid surveys. Seibert.

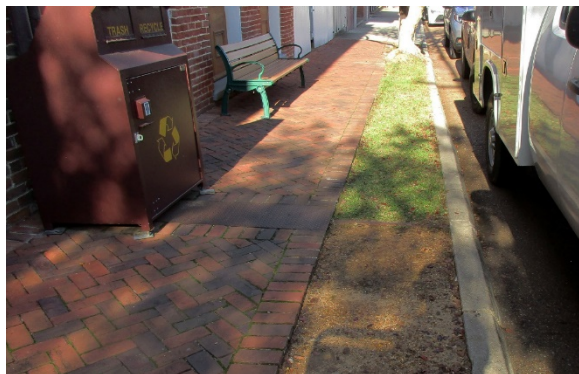
FIGURE 3-4. Photograph of front sidewalk, looking west. The William Johnson House is to the left. Suzanne Turner Landscape Architecture.

**Front Sidewalk.** A 5-foot, 8-inch brick herringbone sidewalk runs the length of the front of the Johnson and McCallum houses; it connects to the concrete sidewalk that runs along the rest of the block (Figure 3-4). The brick sidewalk is flush with the building façades on its south edge and is separated from the concrete street curb by a 3-foot-wide yard locally called the “neutral ground.”

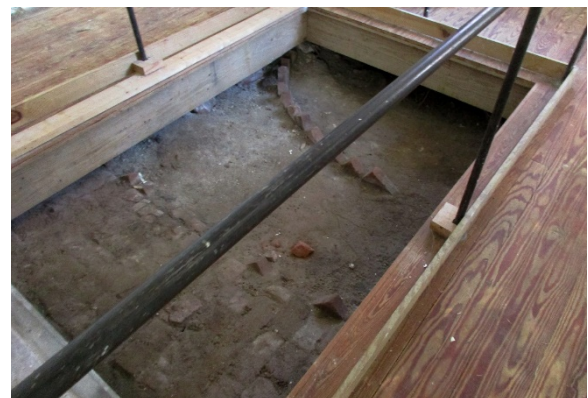
FIGURE 3-5. Interpretive exhibit on the first floor of the kitchen dependency, showing the brick sidewalk and planter edging associated with the 1841 dependency. Suzanne Turner Landscape Architecture.

**Brick Walkway Ruin (CRIS 091815).** This remnant brick walkway was discovered by archeologists under the 1897 dependency. Bricks are laid in east to west rows in a mixed running bond-Flemish bond pattern, bordered by a sawtooth brick edging. This feature survives from the period between 1841 and 1897 and would have been built in association with the 1841 dependency, non-extant. The walkway is exposed on the interior of the 1897 dependency as an interpretive feature (Figure 3-5).

This remnant planting bed border made of bricks arranged in a sawtooth pattern was discovered by archeologists under the 1897 dependency (see Figure 3-5). This feature survives from the period between 1841 and 1897 and would have been built in association with the 1841 dependency. The border is exposed on the interior of the 1897 dependency as an interpretive feature.

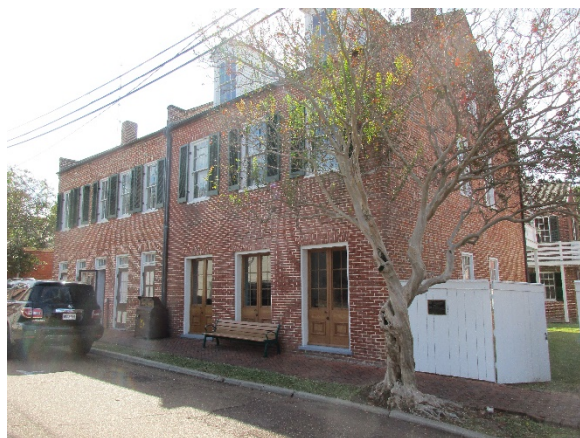
FIGURE 3-6. View of the front of the William Johnson House, looking east. Suzanne Turner Landscape Architecture.

**William Johnson House (CRIS 090307).** The William Johnson House is two-and-one-half-story brick townhouse built in a simplified Greek Revival style (see Figure 3-6). Its footprint measures 42.5 feet by 28 feet, with the long side oriented generally north to south. The peaked roof of the building has two dormers on the street side. To the rear, the Johnson House has a full width, two-story gallery facing south with a stair that connects it to the second floor (Figure 3-7). There are 3 double doors on the front façade of the building and a central single door at the rear on the first and second floors. An opening in the gallery floor provides access to a root cellar located under the west side of the

Views to the William Johnson House from the street are available but often blocked by cars parallel-parked along that side and utility wires (see Figure 3-6).

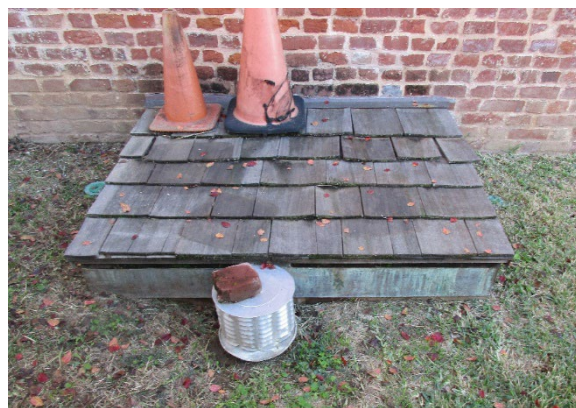
FIGURE 3-8. Photograph taken in 2019 of the cover of the coal chute opening on the west side of the William Johnson House. Suzanne Turner Landscape Architects.

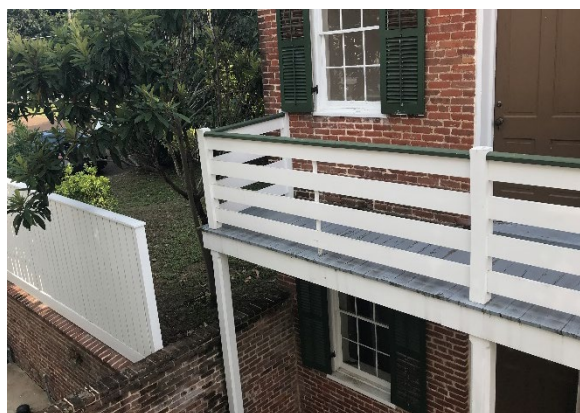
FIGURE 3-9. Photograph taken in 2019 of the north side of the 1897 kitchen dependency. Suzanne Turner Landscape Architects.

**1897 Kitchen Dependency (CRIS 090308).** The kitchen dependency, built in 1897 to replace the 1841 kitchen, is a two-story gabled brick building oriented east-to-west (Figure 3-9). It measures approximately 31 feet long and 15.5

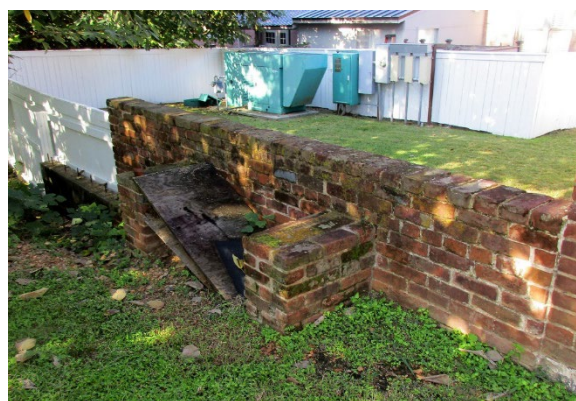
FIGURE 3-11. Photograph taken in 2019 of the combined retaining and free-standing brick wall and its concrete extension. Suzanne Turner Landscape Architects.

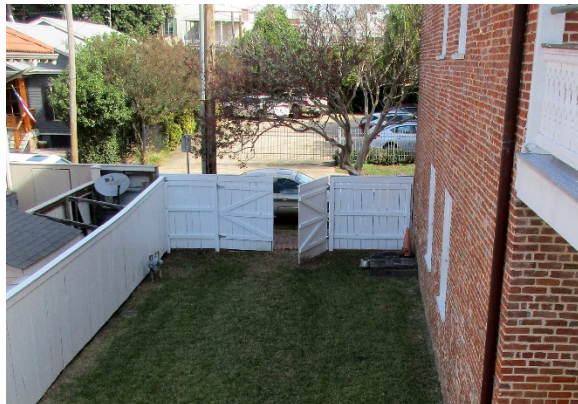
FIGURE 3-12. In 2004, the park constructed a new fence around the site and replaced the old gate with a new double-leafed gate for easier access. Suzanne Turner Landscape Architecture.

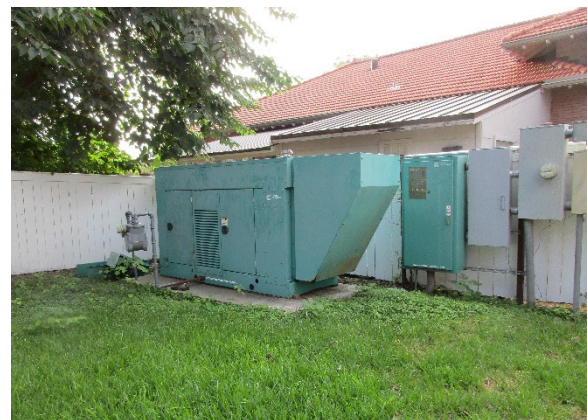
FIGURE 3-13. Photograph taken in 2019 of the site's electric generator and electrical panels. Suzanne Turner Landscape Architecture.

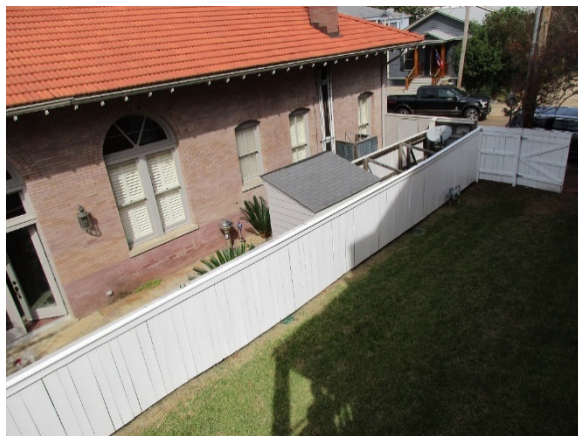
FIGURE 3-14. Photograph taken in 2019 of the view into the storage area behind the historic passenger depot. Suzanne Turner Landscape Architects.

Views into the surrounding city from the house are available to the east and west from the second-floor galleries (Figures 3-14 and 3-15). These include some views of utilities, storage, and a small outdoor dining area associated with the depot, as well as several HVAC units behind the McCallum House. From the ground level within the rear site, views to the south are dominated by the large, aqua-painted electric generator and associated electrical panels.

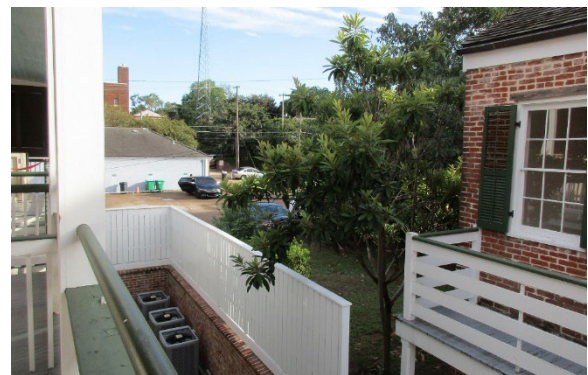
FIGURE 3-15. Photograph taken in 2019 of the view into the surrounding neighborhood to the east taken from the second story gallery of the William Johnson House. Suzanne Turner Landscape Architects.

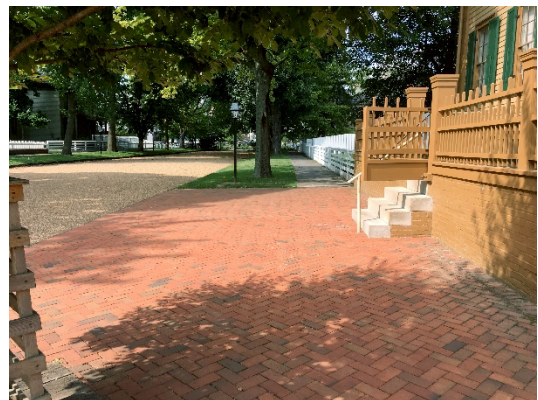
FIGURE 5-1. Brick walkway at Lincoln Home Historic Site. The walkway was designed and installed to meet ABAAS standards. Christina Osborn.

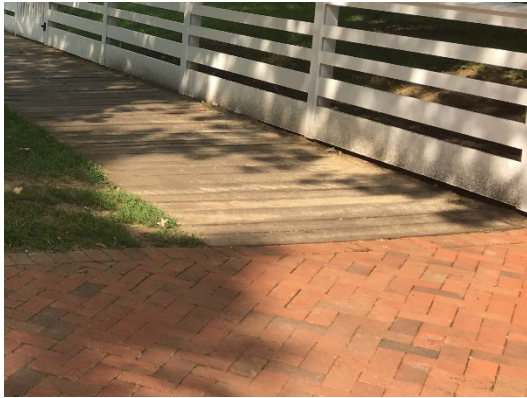
FIGURE 5-2. Wood boardwalk adjoining brick walkway at Lincoln Home Historic Site. The two materials were joined to meet ABAAS standards. Christina Osborn.

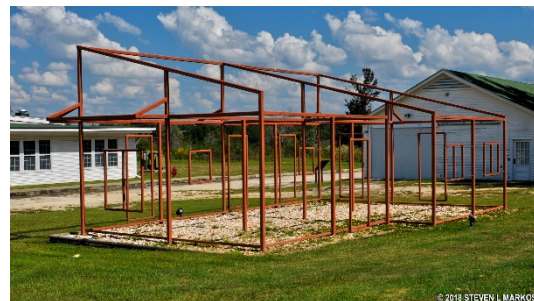
FIGURE 5-7. Ghost structures at Tuskegee Airmen National Historic Site were constructed to indicate the scale and shape of missing buildings. National Park Planner (npplan.com).
