Natchez National Historical Park  
Old Fort Rosalie Gift Shop  
**Historic Structure Report**

June 2006

2006  
Historic Structure Report  
Old Fort Rosalie Gift Shop  
Natchez National Historical Park  
Natchez, MS

**Old Fort Rosalie Gift Shop**

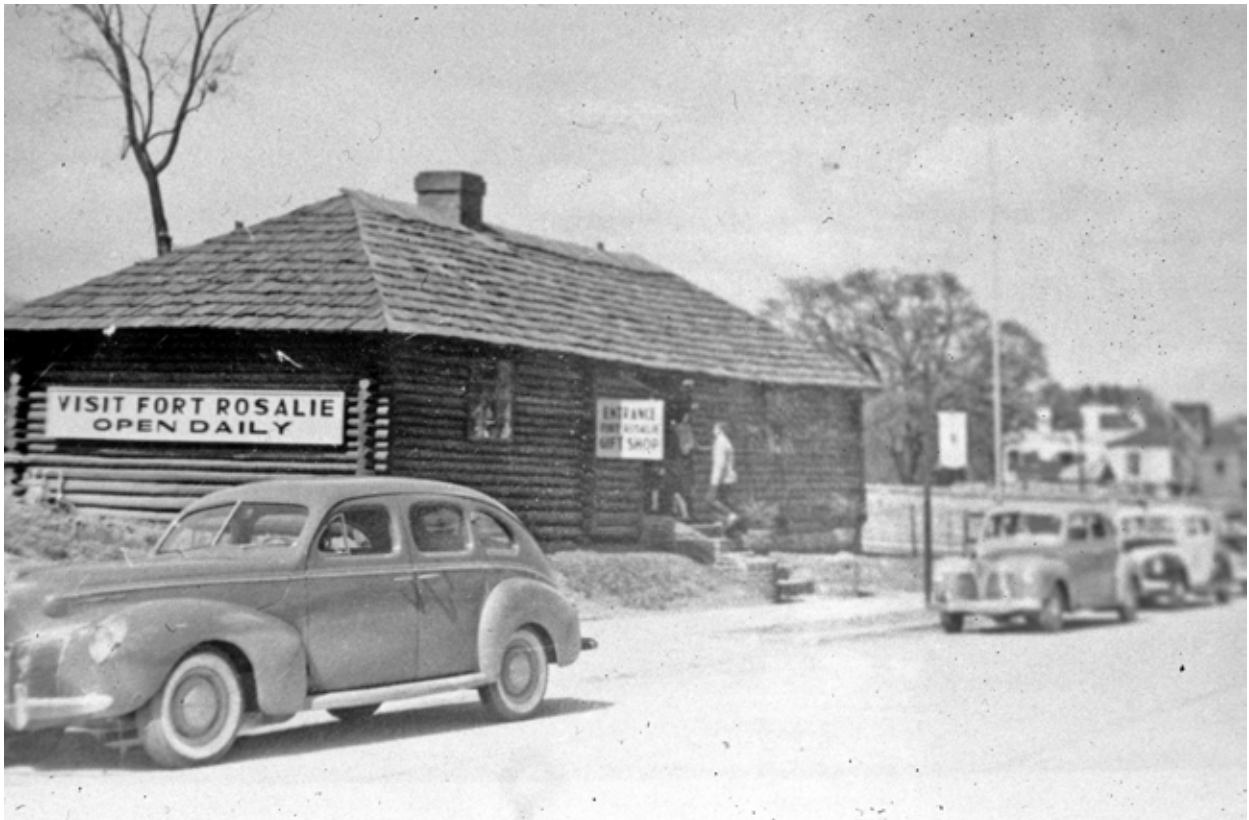
FIGURE 11. View of Old Fort Rosalie Gift Shop in the 1940s. The sign at the front door reads "ENTRANCE FORT ROSALIE GIFT SHOP."

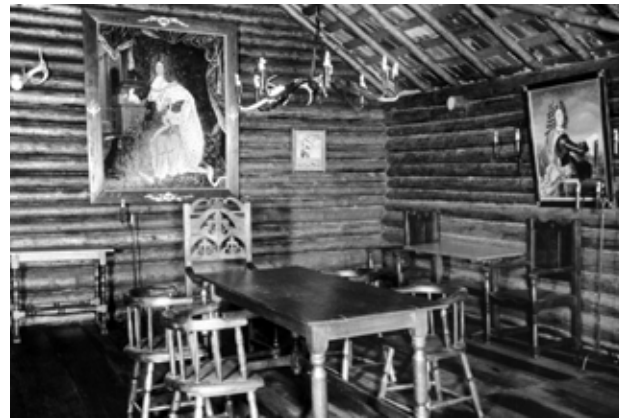
**FIGURE 13.** The interior of one of the reconstructed buildings at Fort Rosalie, showing log walls and an open ceiling similar to what was probably originally present in the large pen of the Old Fort Rosalie Gift Shop.

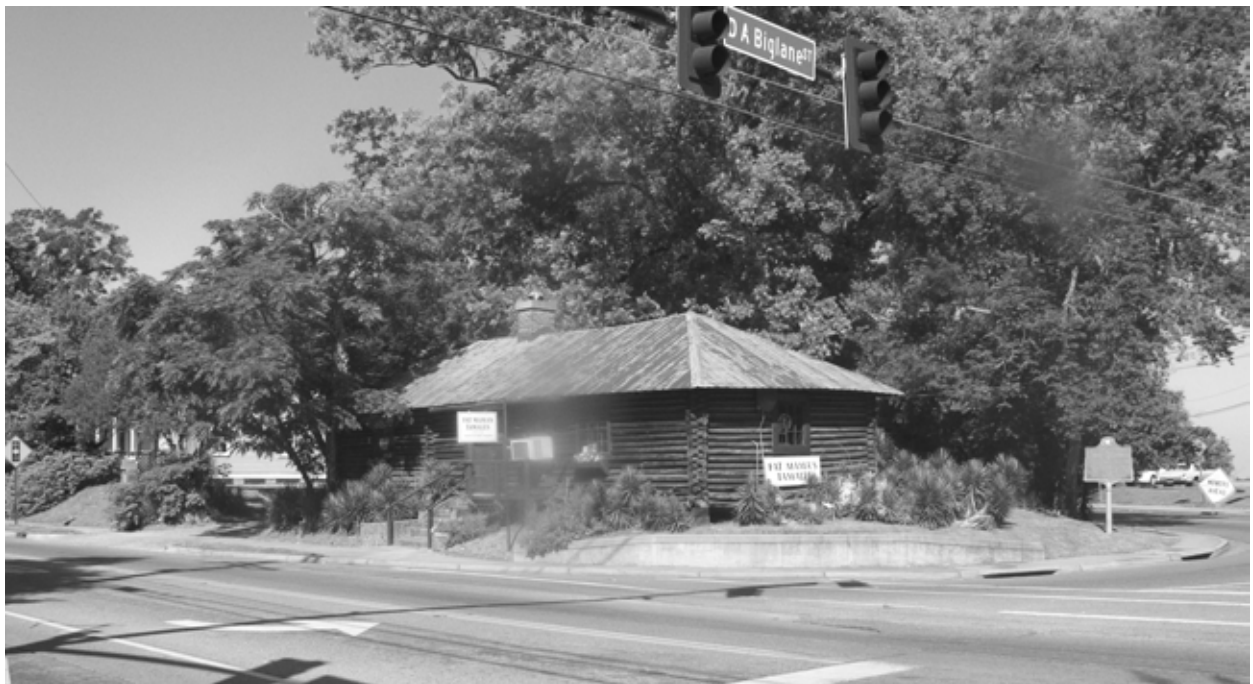
FIGURE 17. View to west of Old Fort Rosalie Gift Shop.

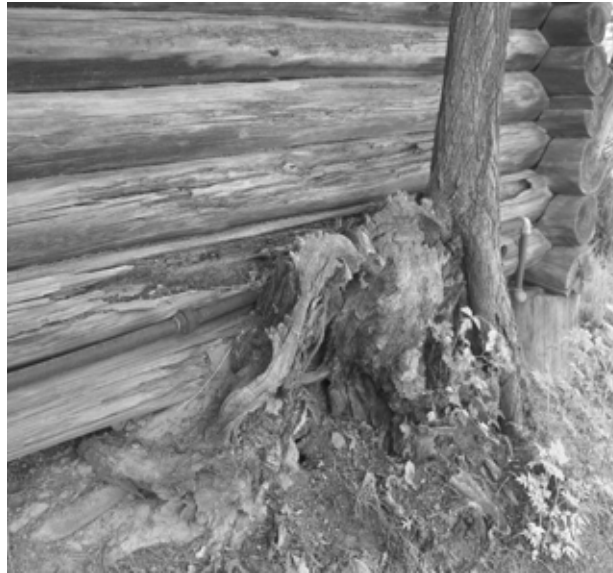
FIGURE 18. View of chinaberry tree stump at southwest end of building.

**Problems of Repair.** The chinaberry trees around the south corner of the building provide attractive shade for the building but their proximity to the building is causing severe damage. In addition, the changes to the historic grade level at the rear of the building has caused some of the worst damage to the structure, as will be discussed in more detail below.

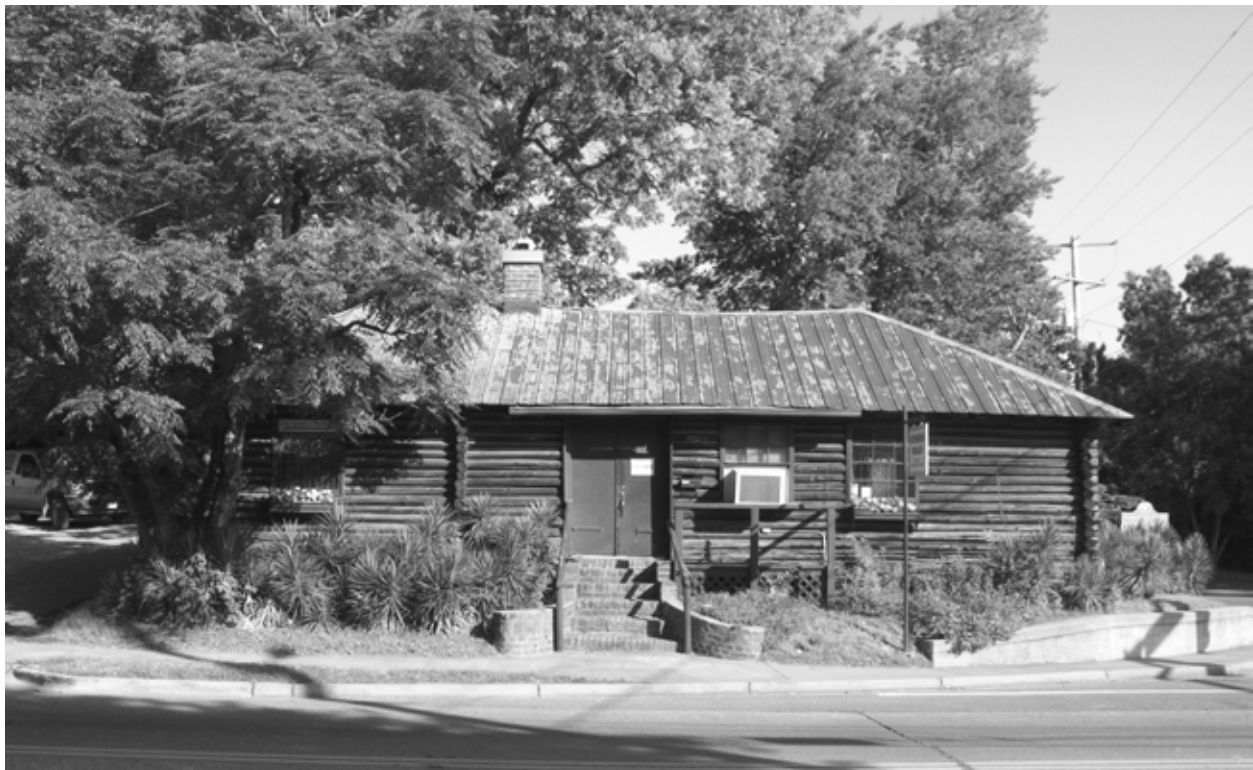
FIGURE 19. View to northwest of Old Fort Rosalie Gift Shop.

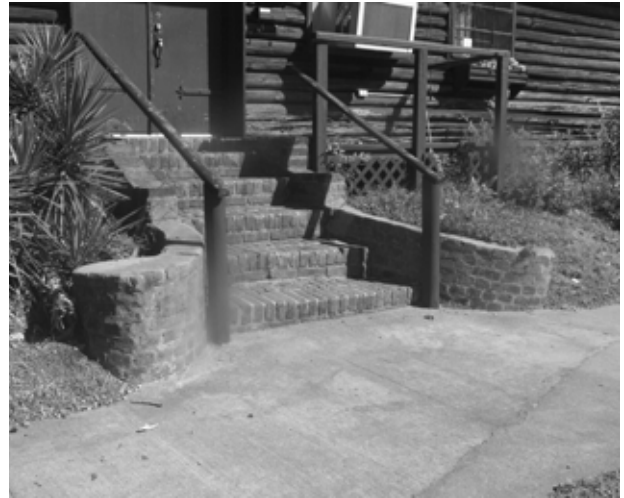
FIGURE 21. View of front steps.

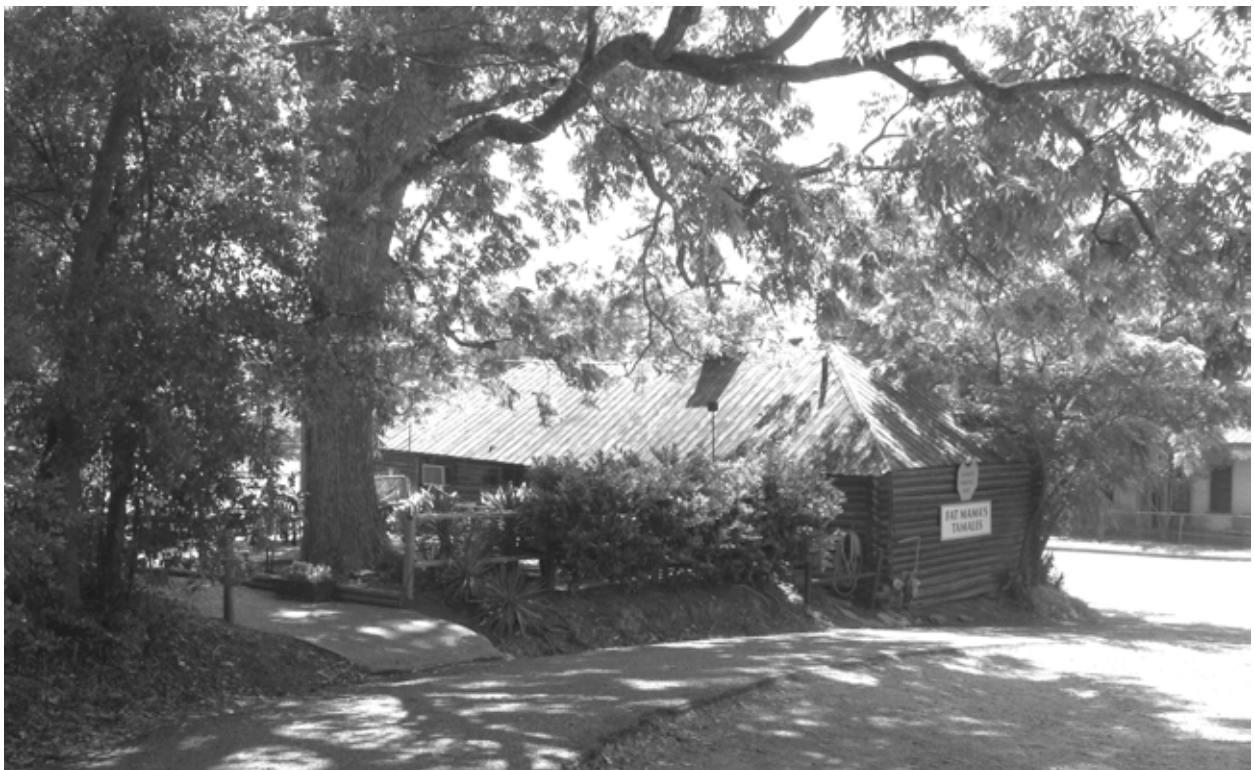
Uncontrolled rainwater runoff from the roof has caused severe erosion at the southwest end of the building, but behind the building, run-off has been managed by a shallow concrete trough on the ground below the building's roof drip line. Dense stands of yucca on the northeast and southeast sides of the building have grown up since the 1980s and have helped deter erosion on those sides of the building.

FIGURE 20. View north east showing driveway at southwest end of the building. The terrace at the building's rear is visible at center left in this

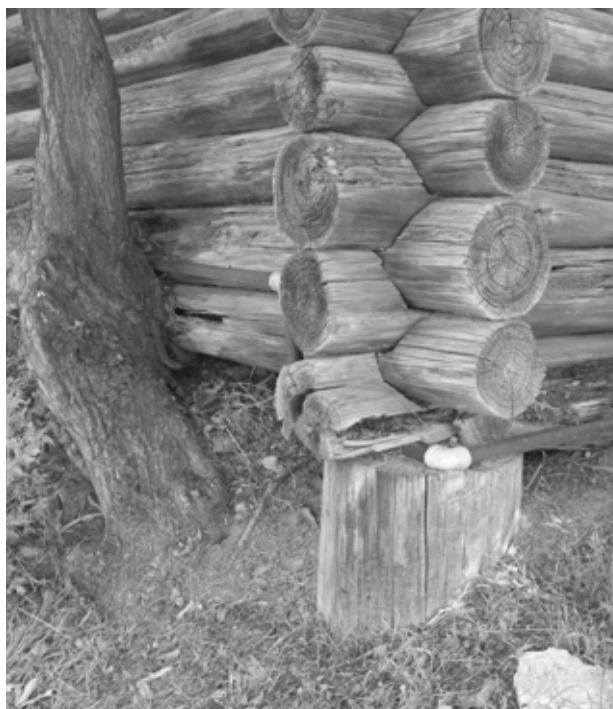
FIGURE 22. View of south corner of building.

**Problems of Repair.** At the east and south corners of the building, the original piers have been replaced by short lengths of what appear to be creosoted poles of the sort used for telephone and electrical transmission lines. In addition wooden posts appear to have been added to provide support under some of the joists around the center of the building.

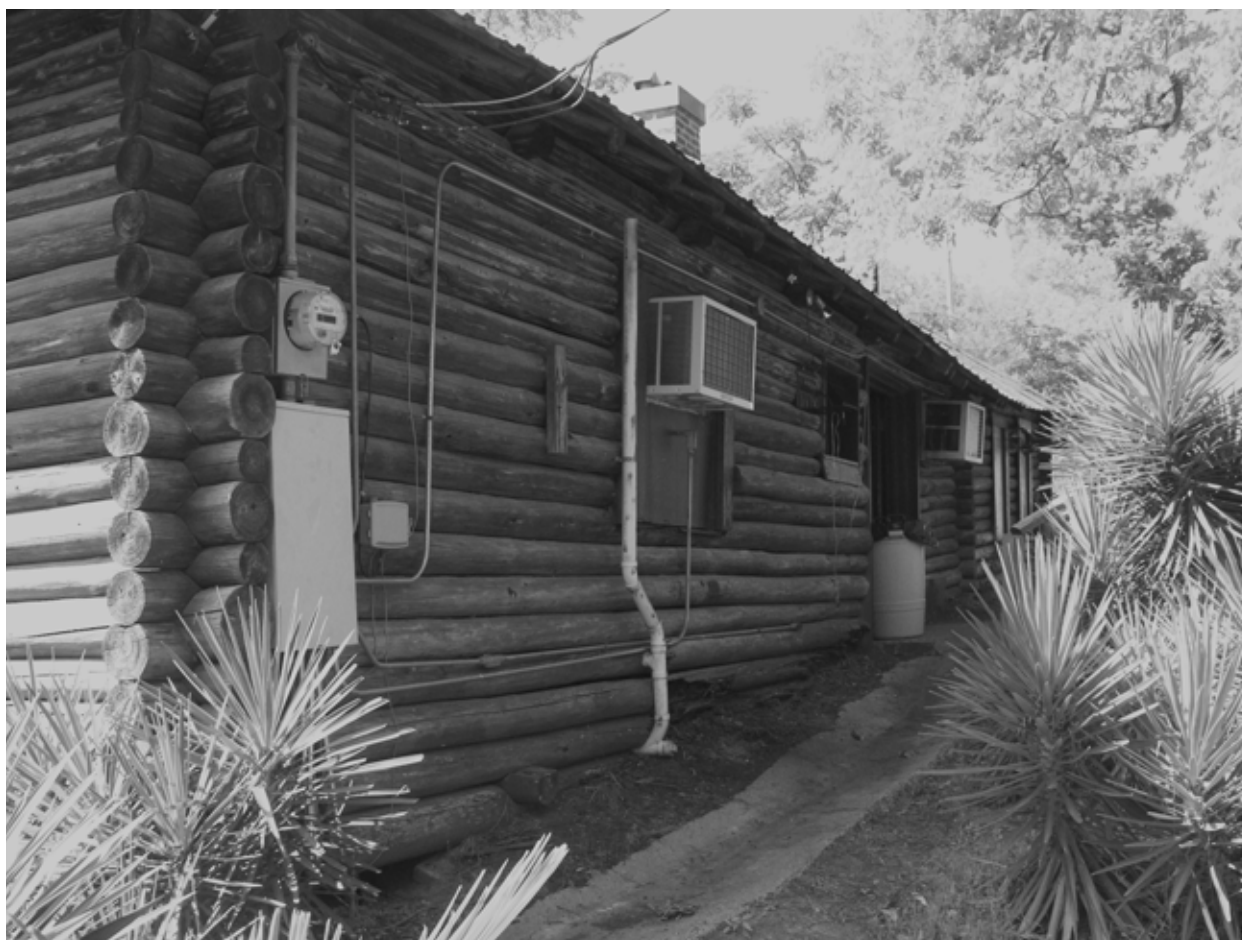
FIGURE 23. View south of rear of building.

**Problems of Repair.** The soft pine log walls on all sides of the building are severely deteriorated due to a combination of rot and termites. The northeast corner of the building remains elevated, as much as 18" above grade, so that most of the southeast (front) and northeast sides of the building are not in contact with the ground. However significant portions of the log walls on the other two sides are in direct contact with the ground, and because of erosion and fill behind the building, much of the sill on the northwest (rear) of the building is covered with earth and has deteriorated completely. Except close to the north end, most of that sill is currently resting on the ground, which has also allowed part of the southwest wall to come into ground contact as well. In addition, long-term exposure of the unpainted wood to UV light, wind-blown sand, and rain has caused especially significant degradation of the logs on the unshaded northeast and southeast sides of the building.

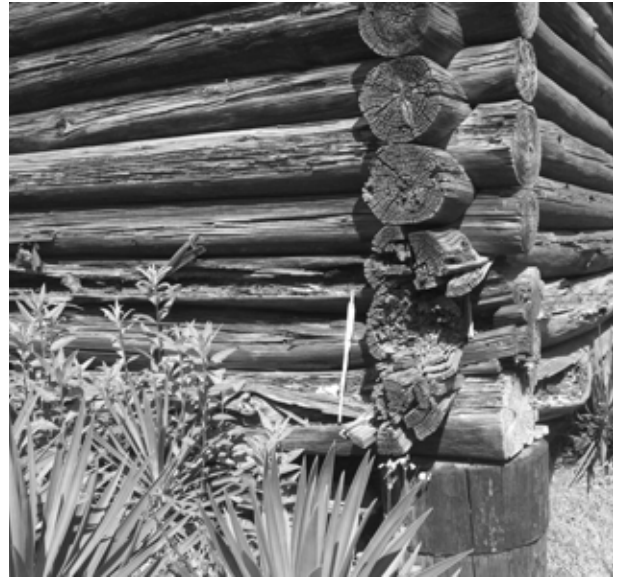
FIGURE 25. View of deteriorated logs around building's north corner.

- clear crawl space of debris and construct new piers as needed
- establish drainage system that will move rainwater quickly away from the building
- replace first three or four logs around perimeter of building and elsewhere as necessary
- repair floor systems as necessary
- repair and repaint metal roofing

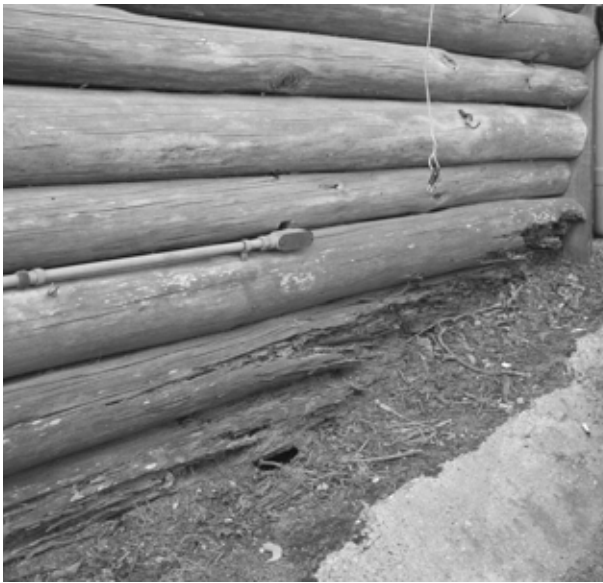
Around the back door, the grade has been raised to eliminate a step and, in the process, has buried the sill log for as much as ten or twelve feet of its length. As a result there has been severe deterioration of the log walls in that area. Immediately behind the building is a stone terrace, reached by a flight of steps from the building's rear entrance. Constructed by the present tenants after 1989, the terrace provides seating for the restaurant's patrons.<sup>18</sup> The rear of the site is shaded by a large oak tree located on the southwest side of the terrace. Three chinaberry trees

**FIGURE 26.** View of partially buried, badly deteriorated logs near back door. The sill log is

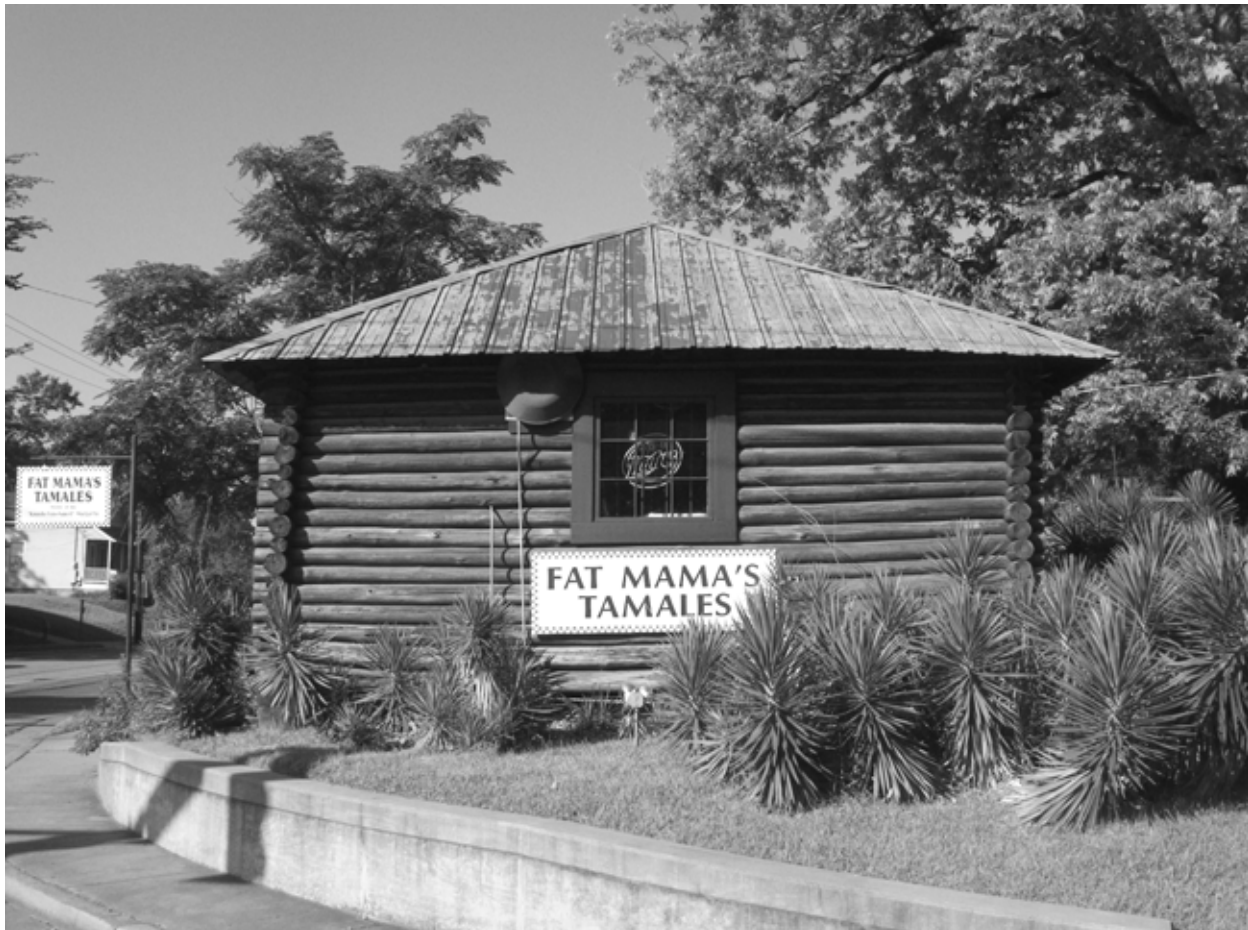
**FIGURE 27.** View of northeast end of building.

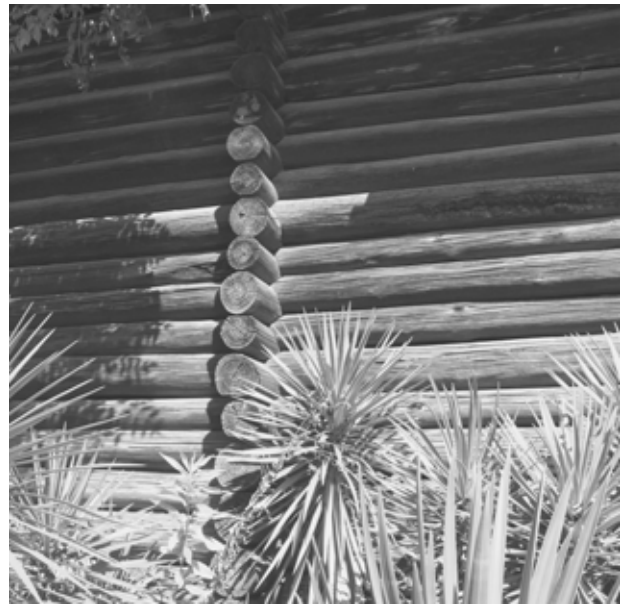
FIGURE 28. View of ends of logs forming the building's crosswall.

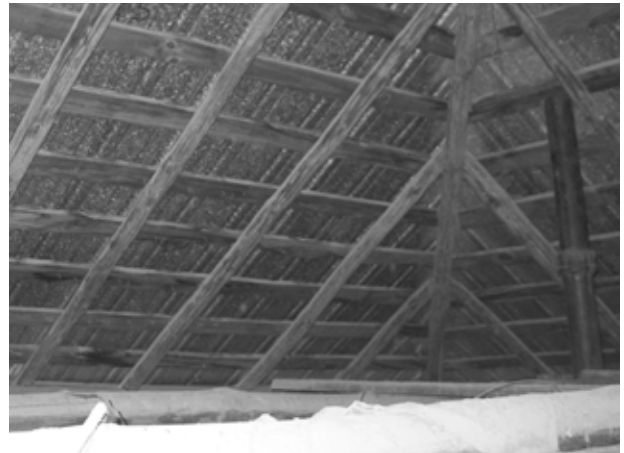
**Problems of Repair.** The roof and wall framing appears to be in mostly good condition, but the same is not true for the floor framing. Much of the floor framing could not be inspected, but it is clear from what can be seen that it has been severely compromised, particularly across the northwest side of the building where joists are resting on or close to the ground. In addition, wood-to-ground connection provided by the wooden posts under some of the joists at the center of the building has probably precipitated significant termite damage, particularly through the southern and western sides of the building.

FIGURE 29. View of roof framing at southwest corner of building.

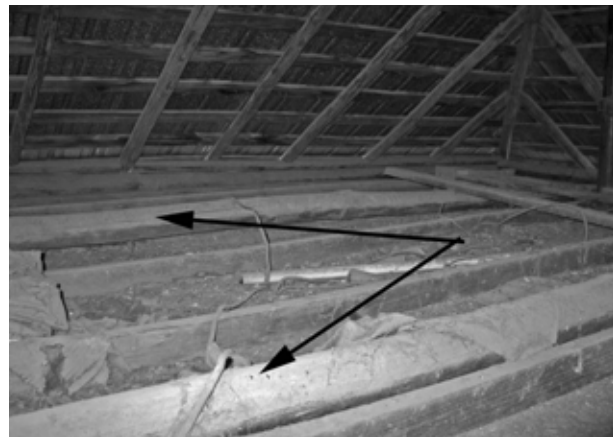
FIGURE 30. View of tie logs (indicated by arrows) and ceiling joists at southern end of building.

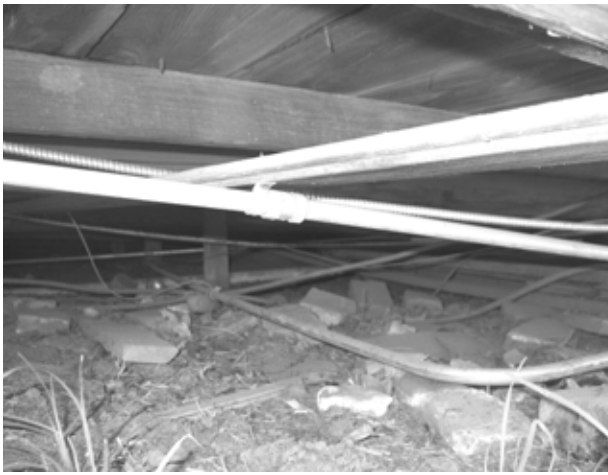
FIGURE 31. A view toward the west of the crawl space under the building.

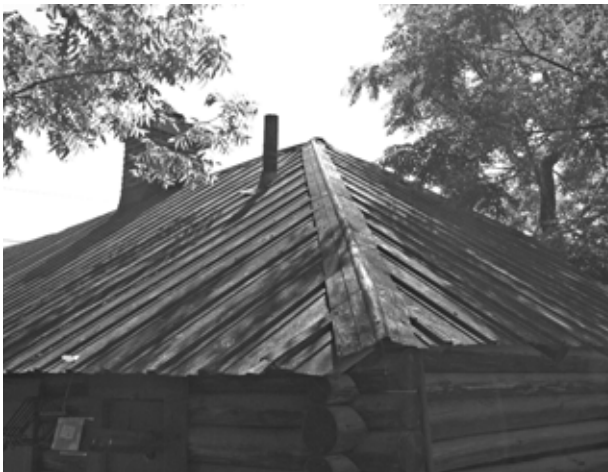
FIGURE 32. View of western hip of roof, showing typical metal roofing.

**Problems of Repair.** Although the roofing has lost some fasteners, it remains in fair condition with no evidence of leaks observed. Paint has disappeared from much of the roof, and much of the galvanized coating has worn away, allowing the surface of the metal to begin oxidation.

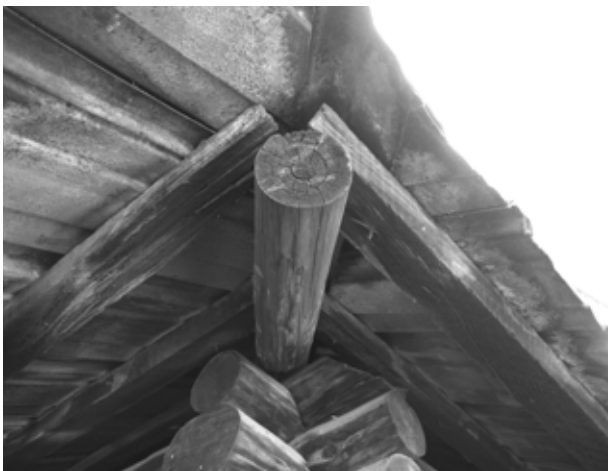
FIGURE 33. View of southwest corner of roof.

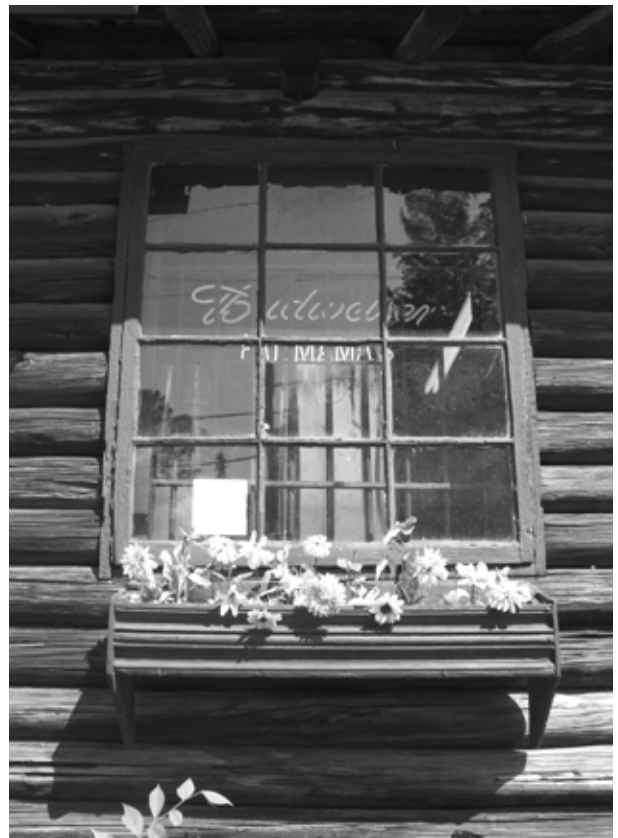
Window C: 3'-4" by 3'-7", single twelve-light, top-hinged sash, probably original.

FIGURE 35. View of Window C, the only relatively unaltered original window in the building.

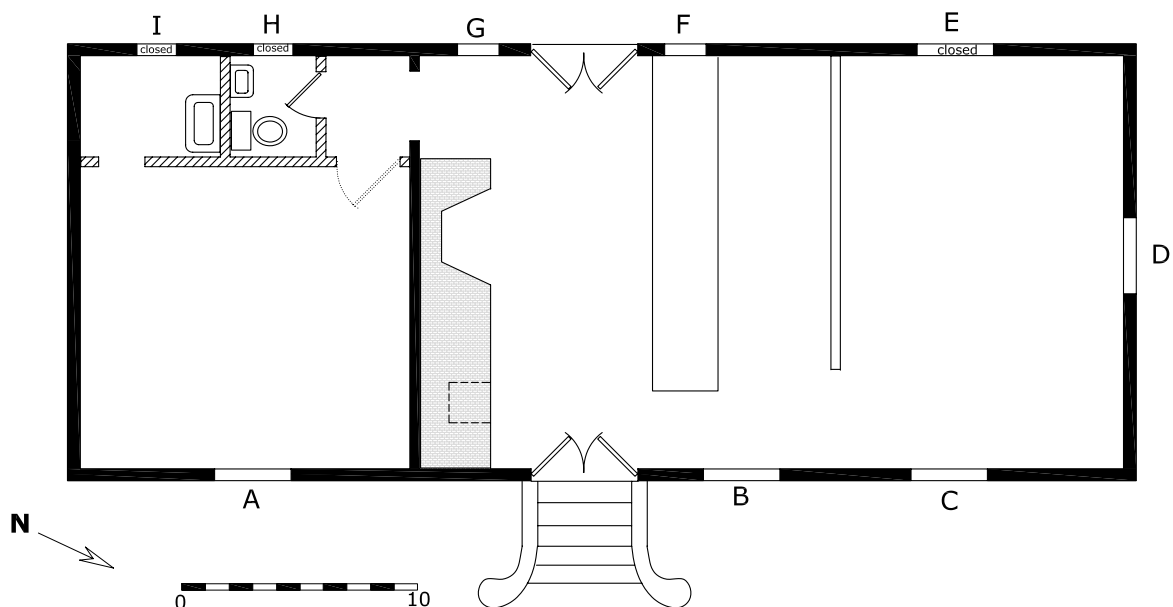
The original openings seem to have been finished without exterior casing of window and door frames, similar to what remains at windows A and C, and with similar interior casing (see below). The original building appears to have had two windows (A and C on the plan in Figure 18) on the front (southeast); one window (D) on the northeast end; and one window (E), now blocked by an air-conditioning unit, on the rear (northwest) side of what is now the kitchen, all of which were similar in size and configuration. Each of these window openings was proba-

bly around 3'-7" by 3'-4" but all but one have been altered to accommodate modern sash or air-conditioning units. Surviving mortises for hinges at windows A, D, and E indicate that each window had a single, top-hinged, twelve-light sash similar to the one that survives at window C. In addition, windows H and I, which open into the two small rooms on the northwest side of the southern pen were probably original features. Both windows are now covered with plywood but portions of Window I are visible. Both windows were probably similar, and the double-hung four-over-four sash may remain behind the plywood on both windows.

FIGURE 34. Plan of windows.

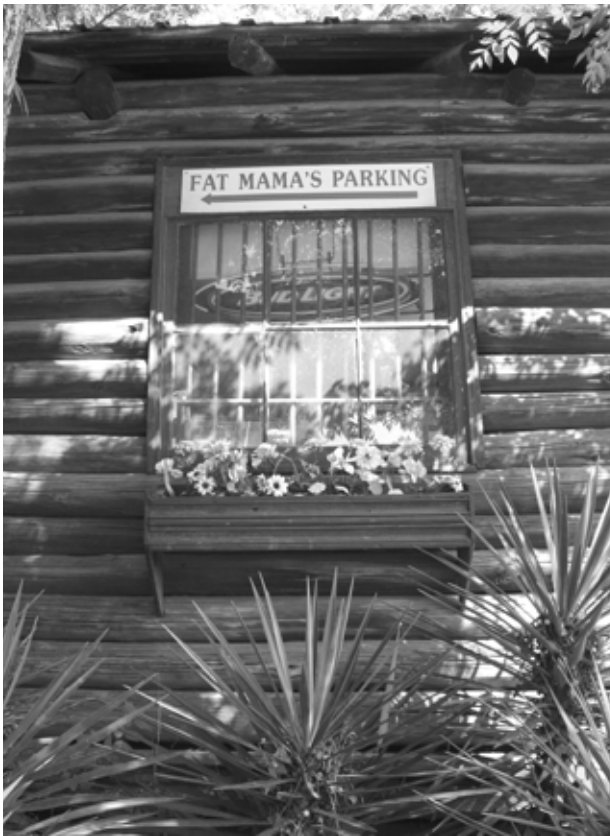
FIGURE 36. View of Window A, which is an original opening that has been altered to fit modern sash.

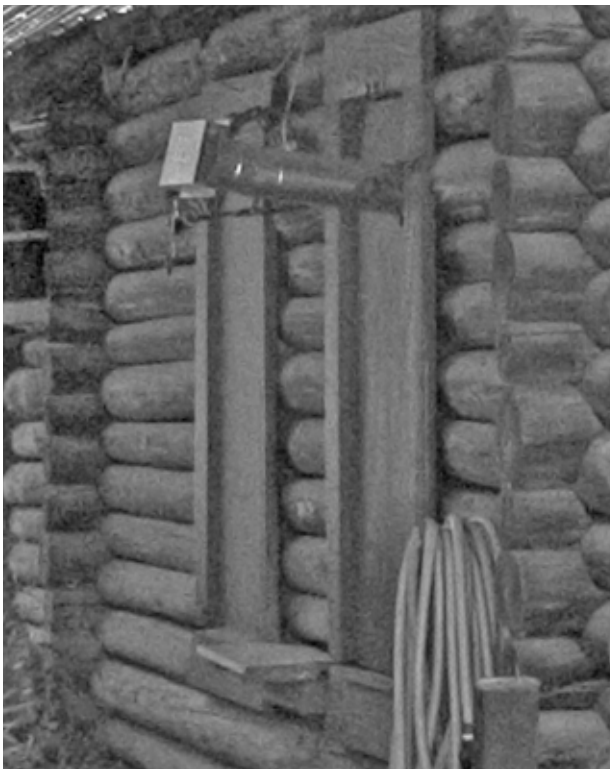
FIGURE 37. View of Windows H and I.

**Problems of Repair.** In addition to the added window on the front facade, which compromised the character of the historic building, the other windows have a variety of problems. As noted above, four windows, one of which is historic, are completely boarded up, and another is partially obstructed by a window air-conditioning unit. All of the remaining windows except window C have been altered for new sash. The one remaining original sash, in window C, is degraded but remains in fair condition.

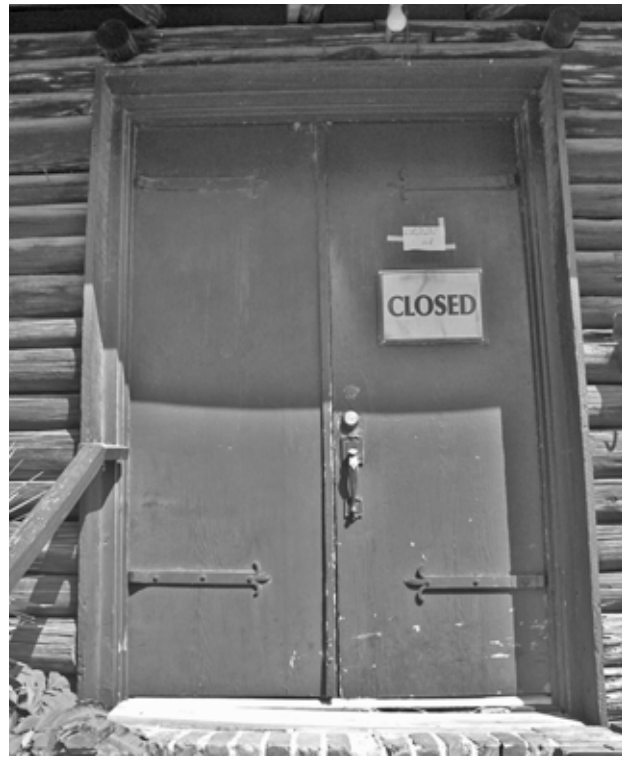
**Problems of Repair.** Although the doors are in fair condition, they are most likely not the original doors. In addition, all of them have been shortened to accommodate the raised floor in the northern end of the building (see below).

FIGURE 39. View of front doors.

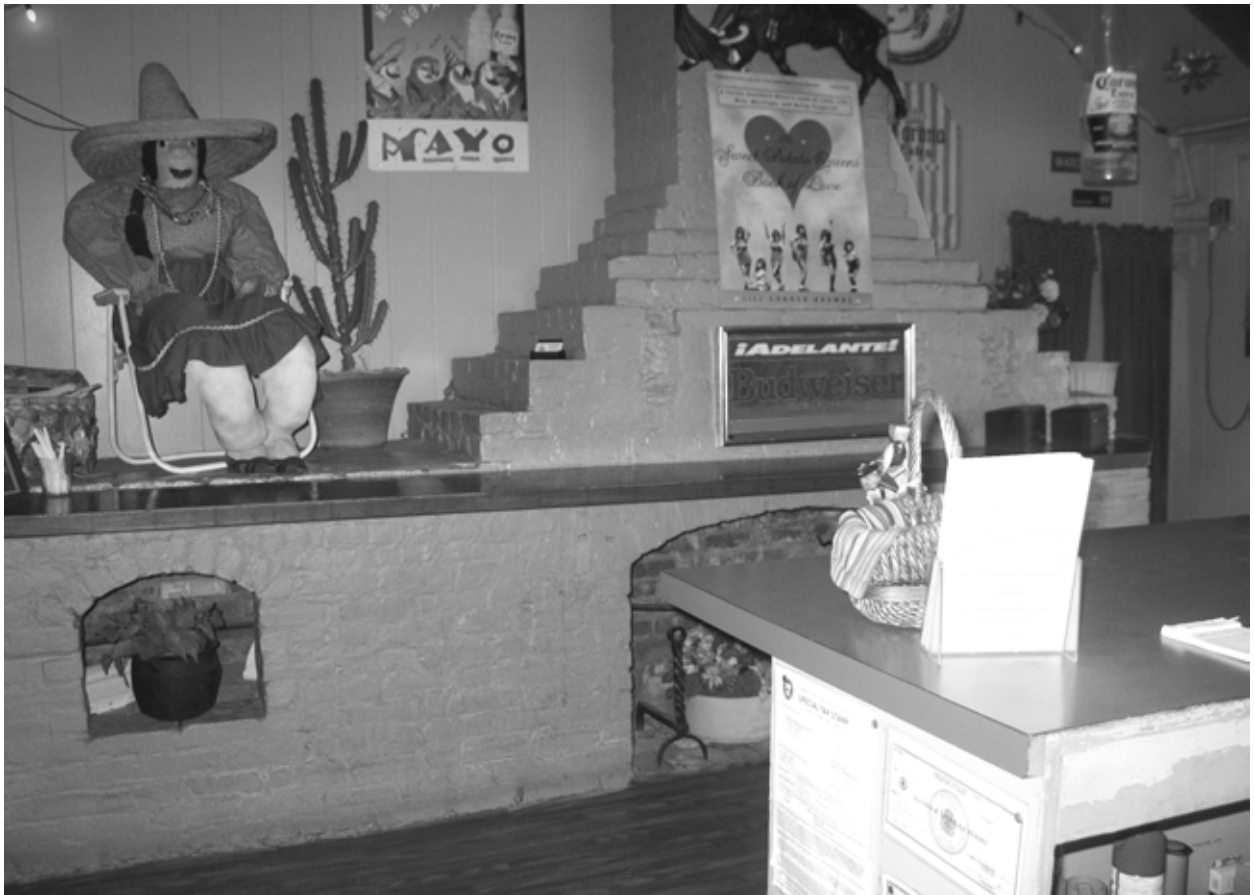
The building features a single fireplace with an inside chimney and extended chimney breast that includes a representation of a medieval oven. Brick, which are painted except inside the firebox, are around 4" by 8" by 2- 1/2". The entire structure, which must be original, is around 13'- 2" long, 3'- 0" deep, and 3'- 4", except the chimney stack, which is

FIGURE 38. View of fireplace and oven.

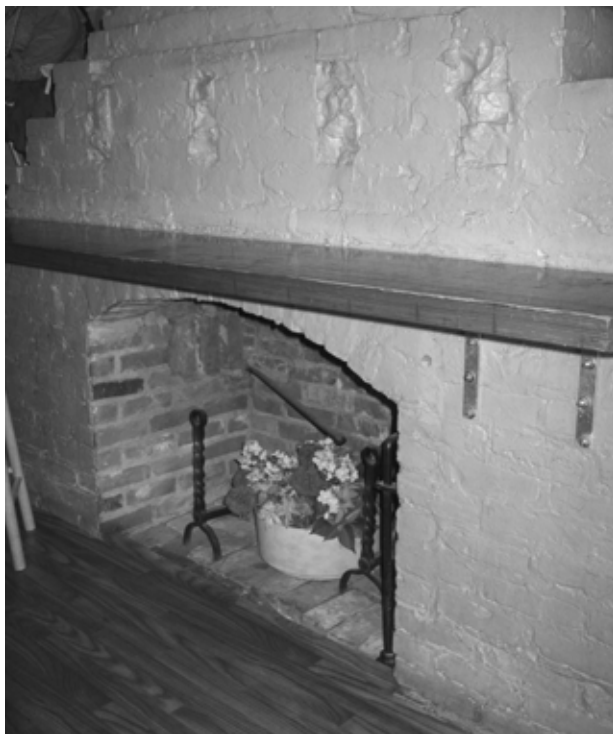
FIGURE 41. View of fireplace.

The firebox opening is around 3'-10" wide, with a relieving arch that rises from 28" to 33-1/2". The oven opening is 1'-7" wide with a shallow relieving arch rising from around 1'-1" by 1'-5". A wooden shelf or bar is mounted above the fire box and runs the length of the brick chimney breast. It was added to provide additional table space for restaurant clientele. In addition, the remains of what appear to have been four brick brackets are visible above the fire box. They were probably originally intended for a mantel shelf and appear to have been broken off.

**Problems of Repair.** The raised floors in the large pen (see below) are higher than the firebox floor and probably cover a brick or stone hearth, but that is not certain. The floor of the firebox has been raised to meet the altered floor level by dry-laid brick laid flat over the original firebox floor. In addition, what appear to be the remains of four brick supports for a mantel shelf, which no longer exists, are evident on the chimney breast just above the fireplace opening. In its place, a long wooden slab, around 3" by 10", is mounted a few inches above the firebox opening and runs the length of the brick structure.

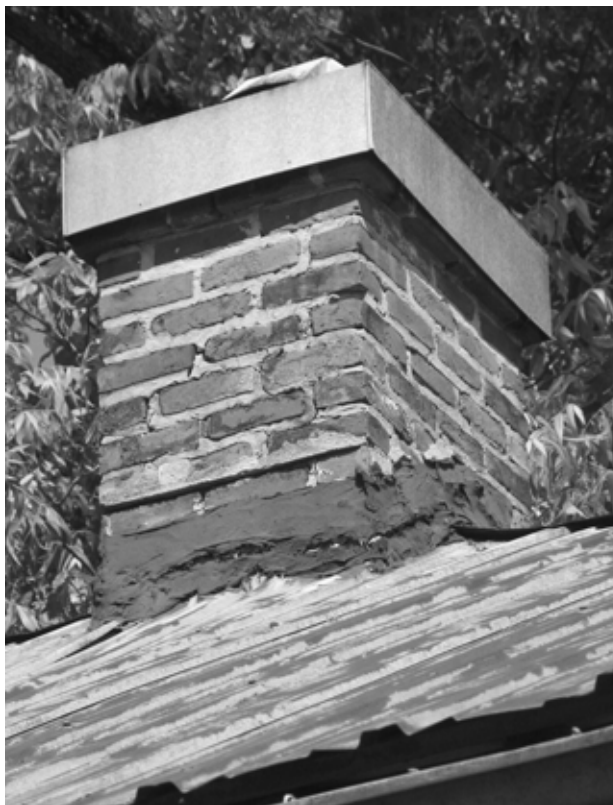
FIGURE 40. View of chimney.

corbeled to a stack approximately 2'-6" by 1'-10 1/2" that rises through the roof. Above the roof line, the chimney rises approximately 2-1/2" and is capped by a metal cover which obscures the corbeled courses at the top of the chimney.

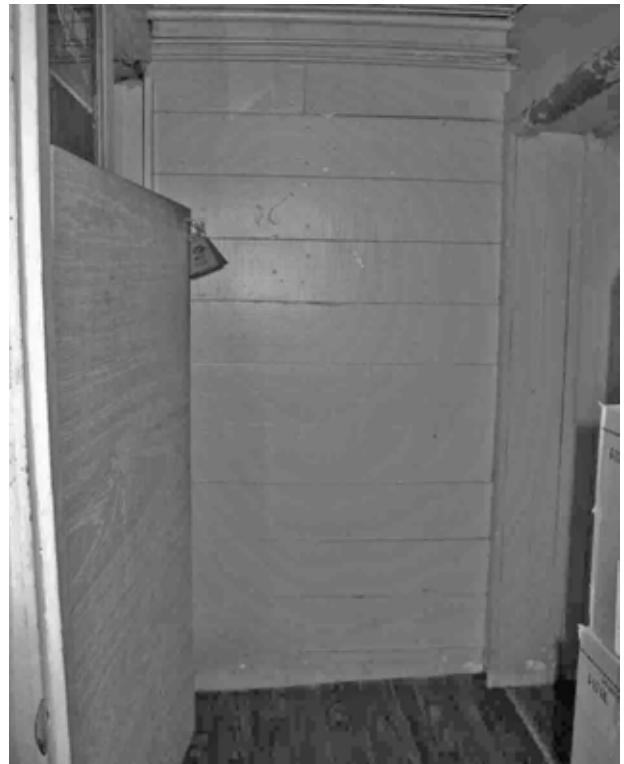
FIGURE 42. View of board walls in hall, typical of original wall finishes in the small pen.

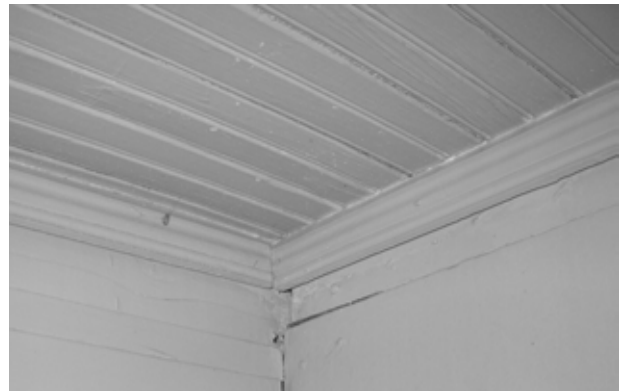
FIGURE 43. View of a corner of the hall showing what was probably the typical ceiling finish in the building's smaller pen.

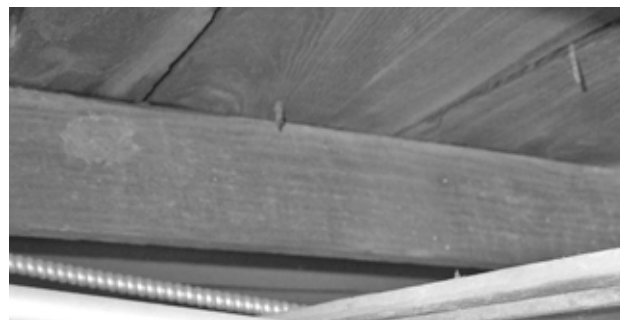
**Problems of Repair.** The close proximity of the floor system to the ground, especially along the northwest and southwest sides, virtually guarantees significant if not severe damage to the floor system and probably to much of the flooring as well. As with walls and ceilings, modern materials covering the floors make it impossible to fully assess their condition.

FIGURE 44. A glimpse of typical original flooring under the building's large pen.

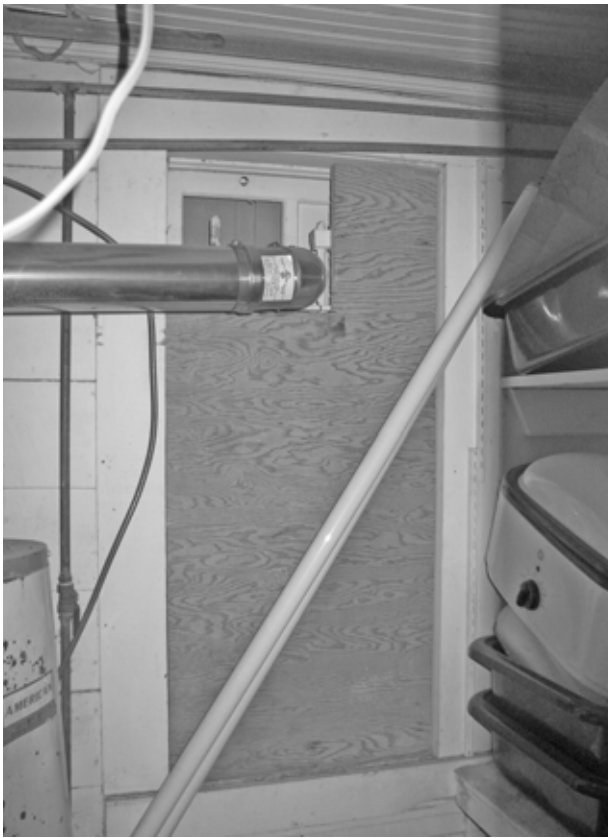
FIGURE 45. View of typical original window casing.

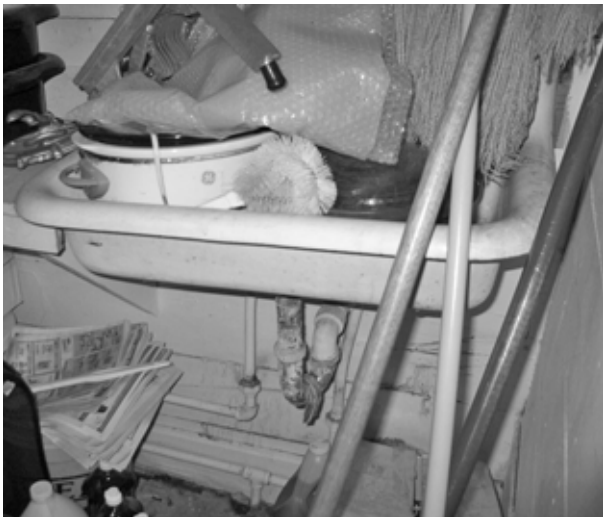
FIGURE 46. View of cast-iron sink in original Kitchen.

The original wall- hung cast- iron sink remains in the small original kitchen at the southwest corner of the small pen. The original cast- iron lavatory remains in the rest room as well, but the original toilet has been replaced.

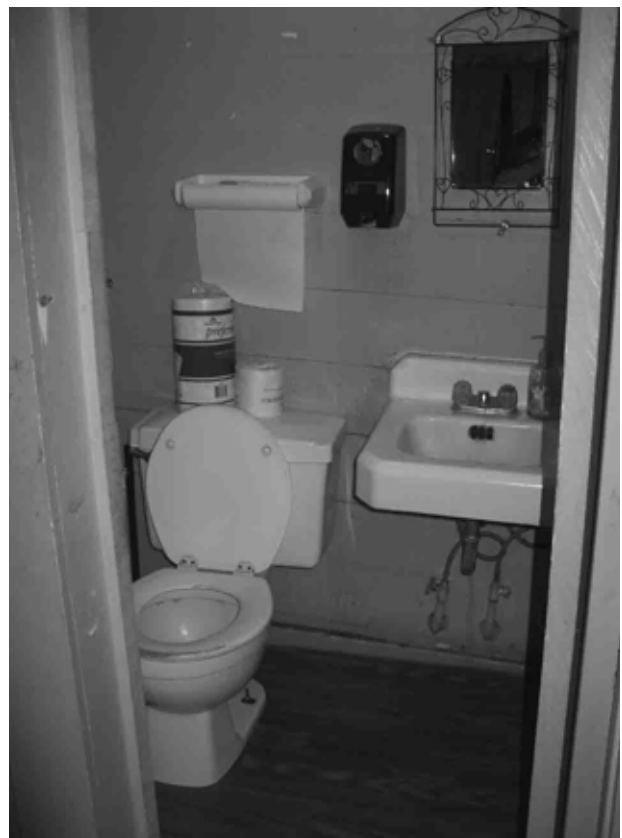
FIGURE 56. View south of Rest Room.

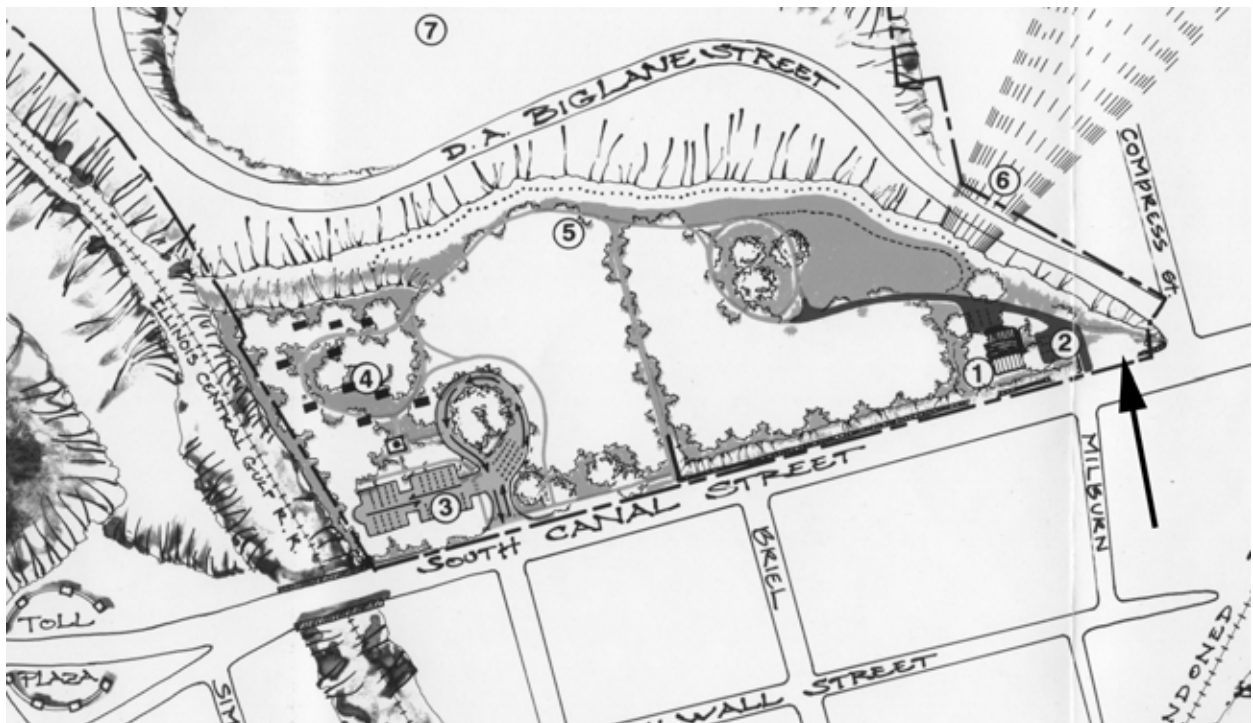
FIGURE 57. Preferred alternative for redevelopment of the Fort Rosalie site, as depicted in the park's GMP. The arrow at right indicates the site of the Old Fort Rosalie Gift Shop, which was proposed for removal. The building designated "1" is the Steitenroth House; the area designated "2" is a proposed staff parking lot. The park's headquarters are in a structure connected to the now defunct "Toll Plaza" at lower left.

Reconsideration of the Preferred Alternative in the GMP is highly recommended. The decision to remove the building from its historic location should be reversed and the building rehabilitated in situ. The proposed development plan (Figure 49) proposes nothing more than clearing the site of the Gift Shop, which seems needless considering that the Steitenroth House as well as the retaining walls along Canal Street south of the Gift Shop are proposed for retention. Constructed as a sort of entrance or visitors center for the reconstructed Fort Rosalie, the building is situated in such a way that it does not intrude on the integrity of the site as a whole and is in a zone that has already been selected for rehabilitation and adaptive use.

Reconsideration of the Preferred Alternative in the GMP would allow the park to develop a plan that more nearly achieves the goal of that standard, which is especially important for the Old Fort Rosalie Gift Shop. The decision to remove the building from its historic location should be reversed and the building rehabilitated in situ. The proposed development plan (Figure 49) proposes nothing more than clearing the site of the Gift Shop, which seems needless considering that the Steitenroth House as well as the retaining walls along Canal Street south of the Gift Shop are proposed for retention. Clearly there is no compelling reason to remove the building from its current location, especially since it is difficult to envision another location on the site that would retain any sense of the building's historic context along Canal Street. Constructed as a sort of entrance or visitors center for the reconstructed Fort Rosalie, the building is situated in such a way that it does not intrude on the integrity of the site as a whole and is in a zone that has already been selected for rehabilitation and adaptive use.
