National Park Service  
Cultural Landscapes Inventory  
2002

Camp Brookside  
New River Gorge National River

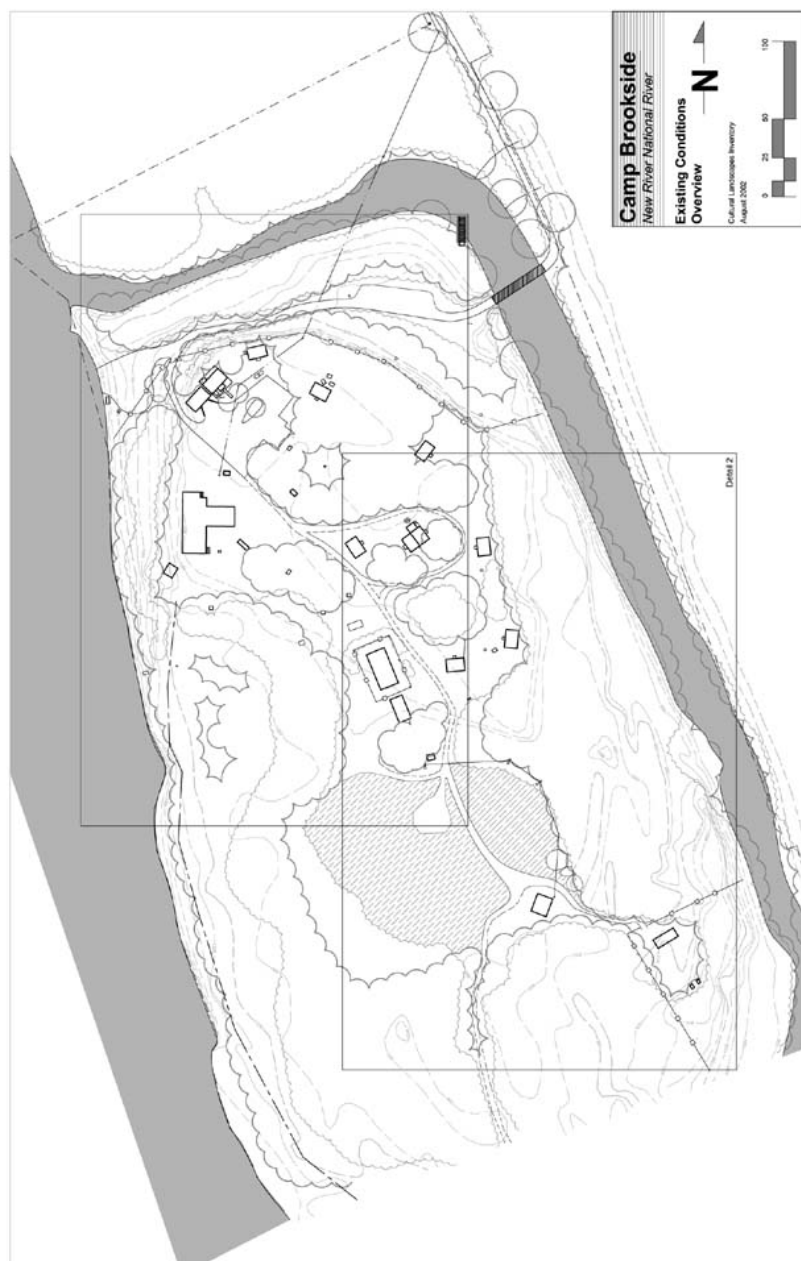
*Camp Brookside Existing Conditions: Map 1 of 3 (See Addenda for enlargement).*

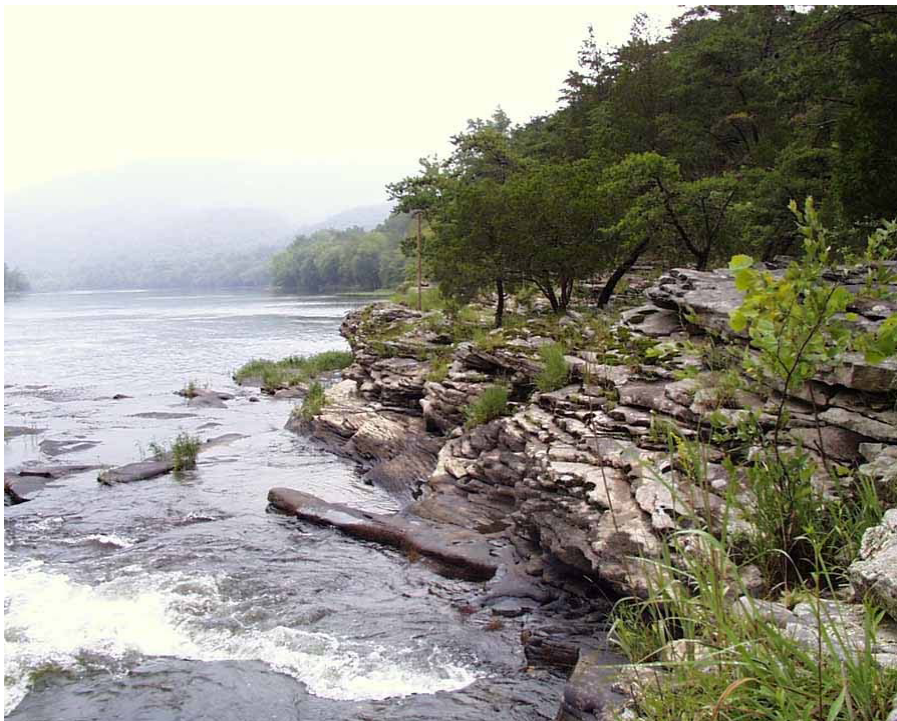
*Stepped sandstone cliff at river's edge (PHSO 2001).*

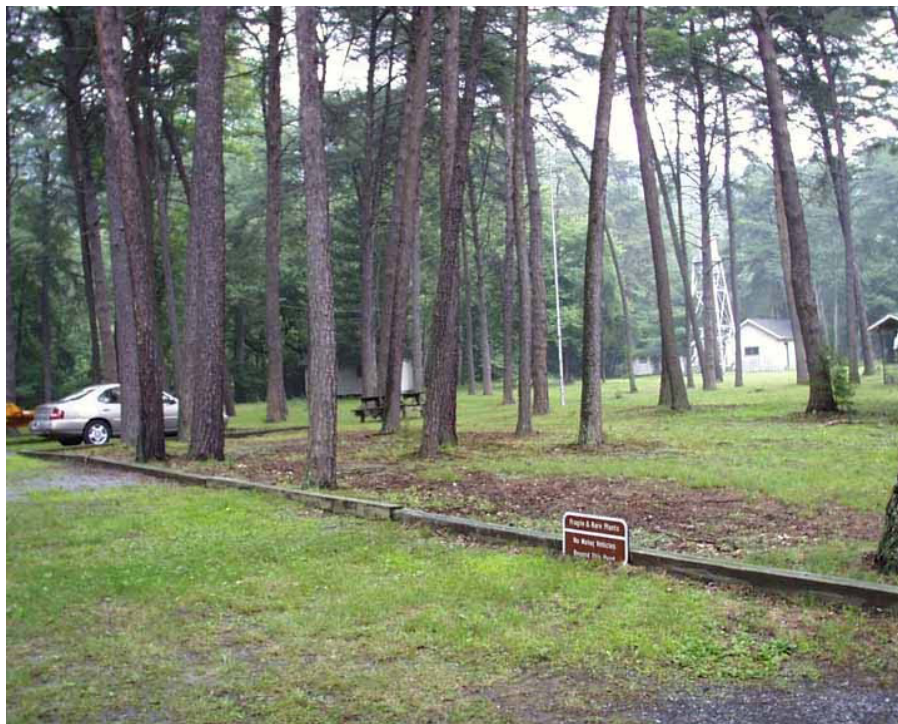
The vegetative feature that is the primary focal point within the campsite itself is a grove of mature pine trees [*Pinus* sp. - Possibly *Pinus virginiana*] planted in the northern part of the clearing. The National Park Service has posted a sign indicating that these trees are fragile and rare. If a Level II CLI is done, it should try to determine the type and background of these pine trees. The campsite clearing also has several White Pine [*Pinus strobus*] trees and some Tulip Poplar [*Liriodendron tulipifera*]. The administration building has several ornamental shrubs and foundation planting of ferns. There are some Rhododendron plants as well.

*Grove of pine trees planted adjacent to camp site parking. Note sign in foreground indicating fragile trees (PHSO 2001).*

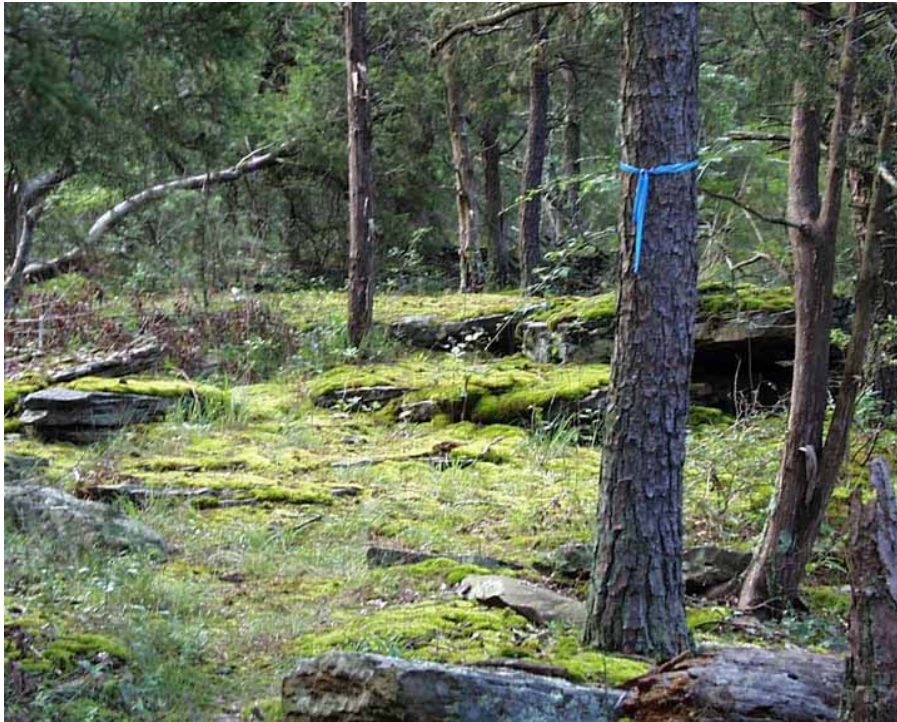
The flat rock community includes a rare assemblage of plant materials that are not found in many other places in the New River Gorge. The ecosystem located here is specifically called an Appalachian Riverside Flatrock Community, which occurs along high-energy rivers. The community is formed by intermittent floods flushing the hard, flat sandstone located along the riverbank and washing away the soil. This loss of soil forces the plants located here to enter a perpetual state of renewal. A slow succession of plants occurs on the rocks. First lichens form on the rocks to form a soil. Then moss and small-rooted plants then grow in this soil, which are later replaced by shrubs and trees that can survive in harsh conditions and thin soil (NPS wayside 2001). The community located at Camp Brookside has advanced to the point where shrubs and trees have rooted. Cedar [*Juniperus* sp.] and some Scrub Pines [*Pinus* sp.] have taken root among the moss-covered rocks. There are herbaceous plants such as Yarrow [*Achillea*] and Lowbush Blueberry [*Vaccinium angustifolium*] scattered amongst the rocks as well.

*Flat rock plant community located adjacent to New River (PHSO 2001).*

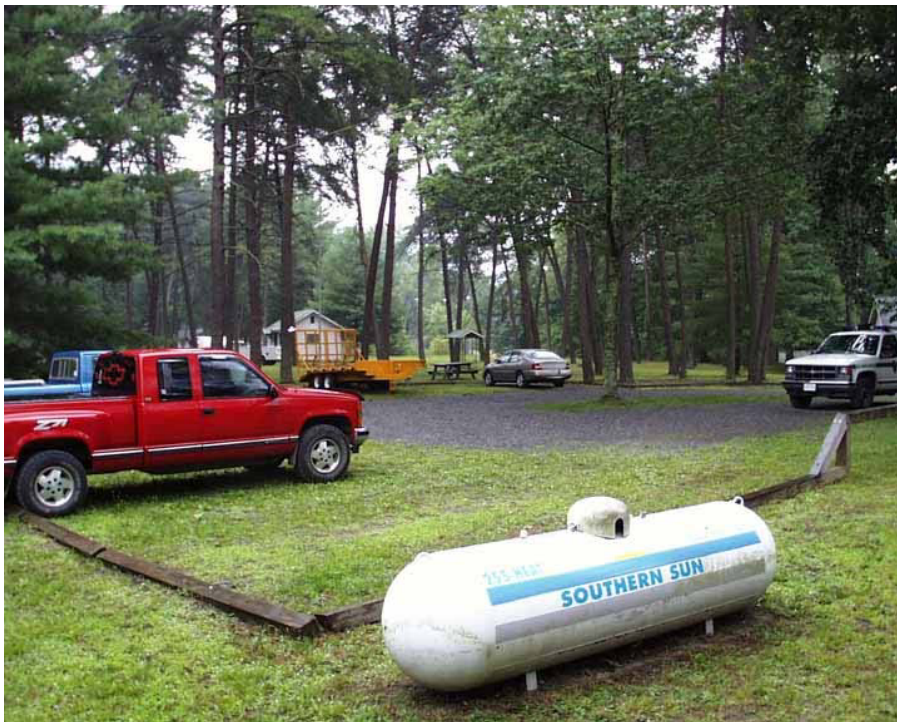
*Campsite parking area. Note gas tank mentioned in Small Scale Features section.*

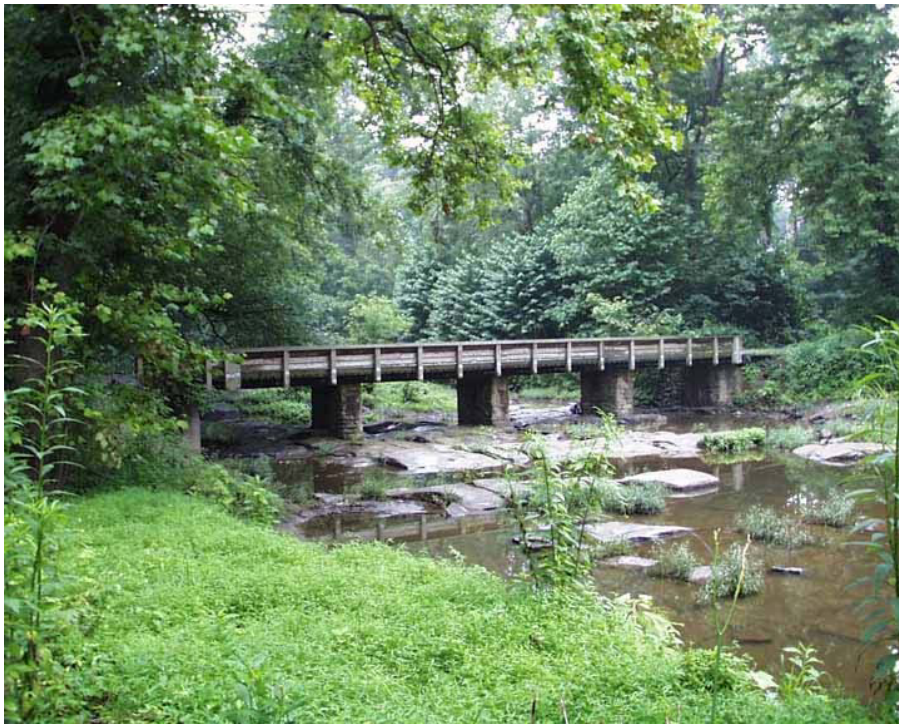
The structures at Camp Brookside include a bridge that provides vehicular access across the mill slough. The wooden bridge is supported on stone piers. The road bed is planked with wooden rails running cross width for support and by planks running length wise to support the vehicle tires. Another structure that is quite noticeable on the site is a large, metal water tower placed near the restrooms/utility building. The final structure is a pumping station located at the river’s edge. This structure would pump river water into a pipe system to fill the swimming pool and water tower.

*Entry drive bridge crossing mill slough (PHSO 2001).*

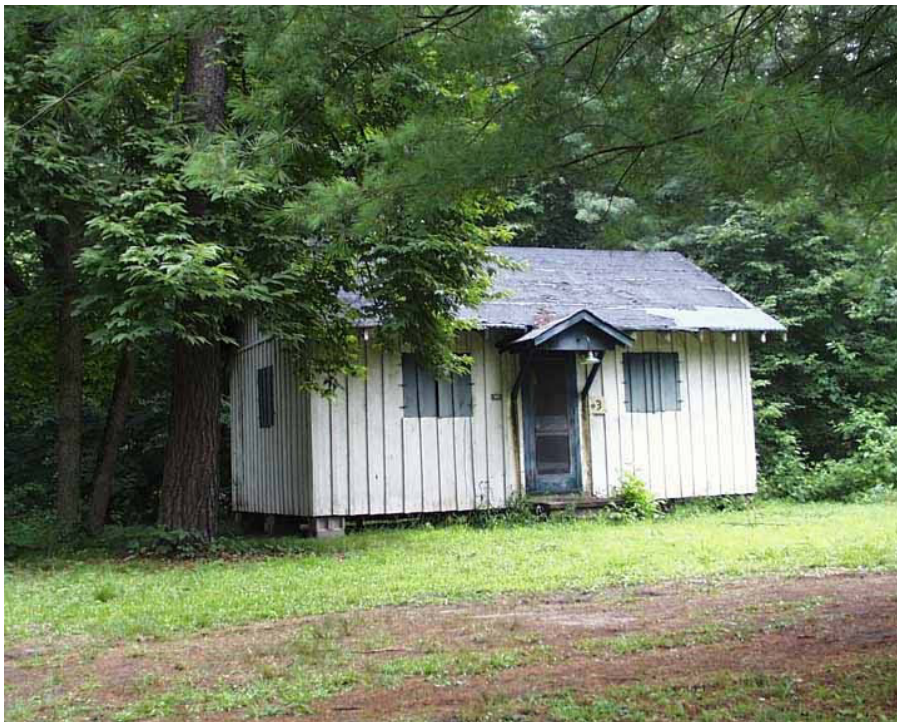
The six bunkhouses where the campers would have slept and the dispensary all have similar construction. They measure approximately 10x15 feet, have gabled roofs covered with rolled asphalt, board and batten siding, shuttered windows and rest on concrete block foundations. A multi-use building containing restrooms/showers, a laundry is located in the center of the bunkhouses. A small athletic equipment storage building is located at the north end of the athletic fields and a larger craft shed is placed at the southern end. Beyond the craft shed is a rifle range shelter. All of these buildings match the style of the bunkhouses.

*One of six bunkhouses (PHSO 2001).*

Structural deterioration is an impact that is adversely affecting the condition of the Camp Brookside landscape. The camp buildings are deteriorating and show water damage. It is the recommendation of the CLI that the park initiate putting the buildings and structures of Camp Brookside on the List of Classified Structures, which will then provide stabilization measures and costs to preserve the buildings.

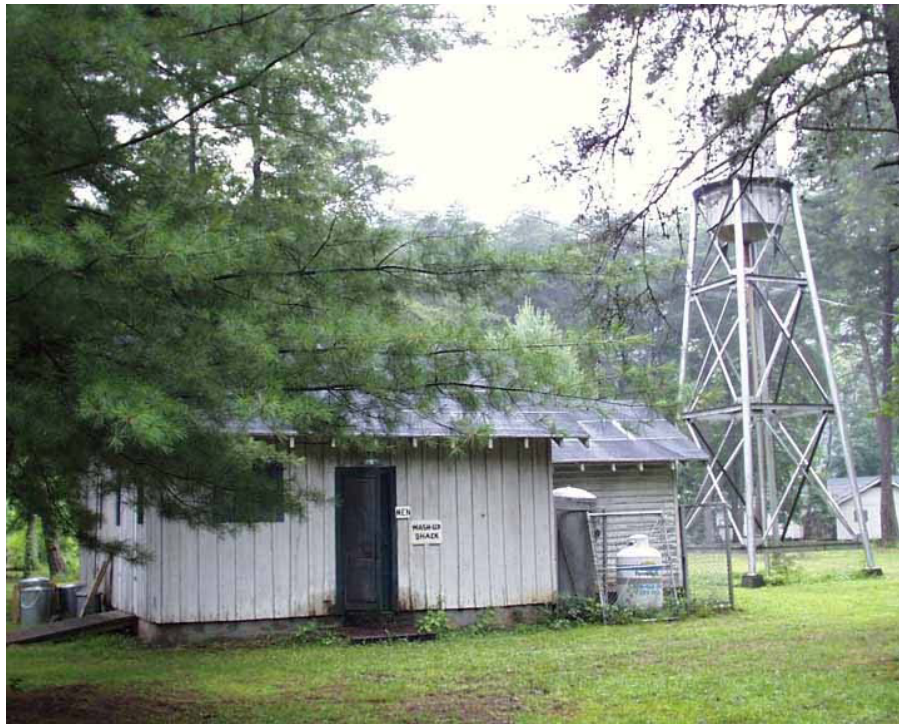
*Wash house and water tower (PHSO 2001).*

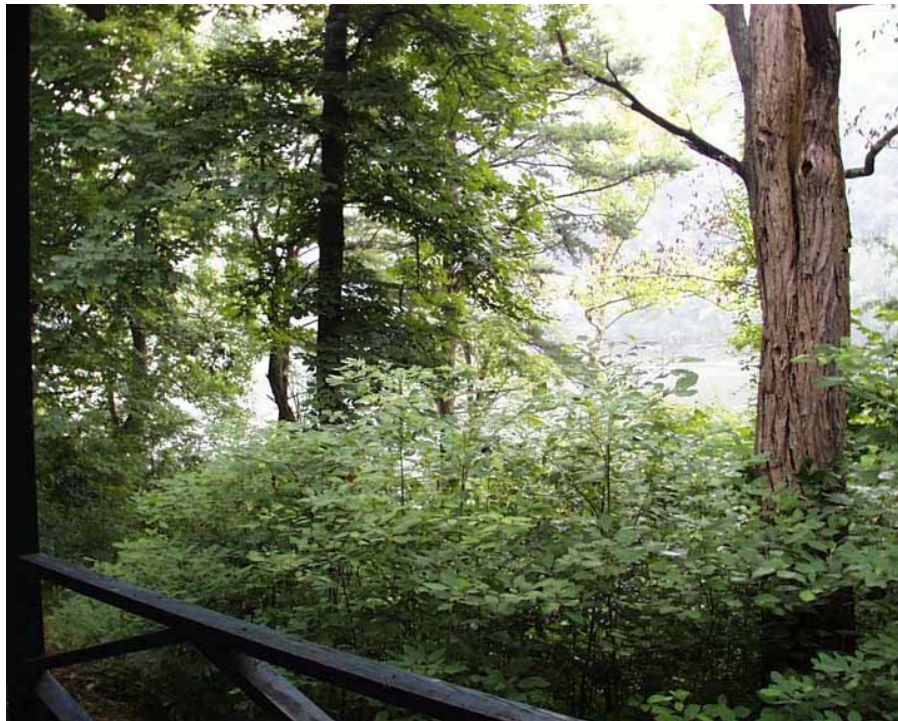
The view of the New River Gorge from Camp Brookside is one of the reasons that this location was an ideal site for a camp. The river running through the gorge at this location is very scenic and there are several good views found on the site. The Brooks Falls trail leads out to the water's edge at an elevation above the water that gives a very picturesque view of the falls and mountains. The boat ramp location also has an ideal view both up and downstream of the river. However, the views from the campsite, particularly from the porch of the administration building, have been partially blocked by emergent vegetation along the riverbank. The mill slough now has the appearance of a natural stream, of which the entry drive and bridge offer an excellent view.

*View to river from the administration building porch blocked by vegetation (PHSO 2001).*

Uncontrolled vegetative growth is adversely affecting Camp Brookside, and is most prevalent along fencerows, along the mill slough and river's edge and at the edges of open spaces, such as the athletic fields. The CLI recommends taking stabilization measures in the areas where the cultural resources are being irreversibly damaged.

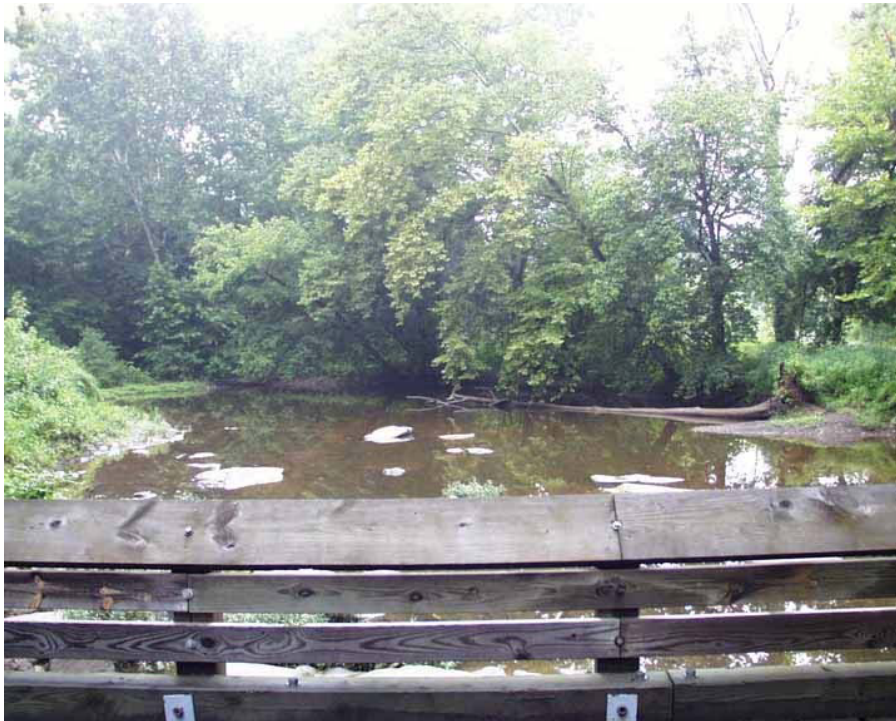
The second constructed water feature is more difficult to pick out because due to its age it can be mistaken for a natural system. The small stream that is crossed upon entering the site is actually a man-made mill slough carved into the landscape to provide energy to a well. The formation of this feature actually makes the Camp Brookside site an island. The water would be diverted into the slough south of the camp by the river's energy and return the water to the river at a point directly adjacent to boat ramp. More research is necessary to determine when the mill slough was built, how long it was used, and the actual location of the mill.

*View of mill slough from entry drive bridge (PHSO 2001).*

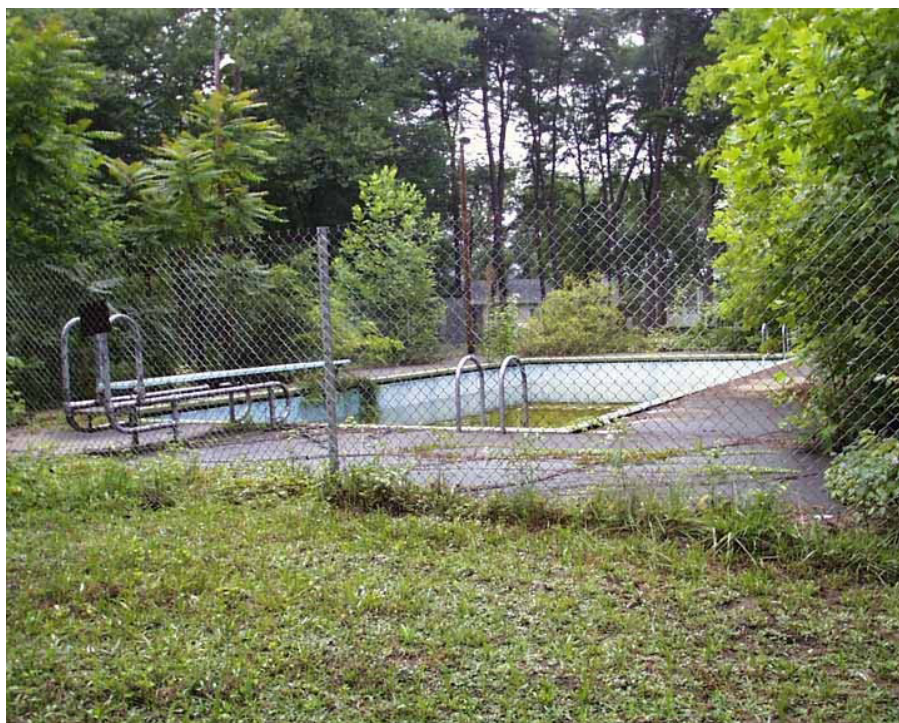
The most noticeable constructed water feature at Camp Brookside is the in-ground swimming pool. The pool is constructed of poured concrete and has both a shallow and deep end. A diving board is placed on a metal stand at the deep end. A concrete patio surrounds the pool and the entire area is blocked by a tall security chain length fence. There is a concrete-block structure located immediately south of the pool that most likely houses the electricity, pump and filter for pool maintenance.

*Swimming pool (PHSO 2001).*
