National Park Service  
Cultural Landscapes Inventory  
2002

Richmond-Hamilton Farm  
New River Gorge National River

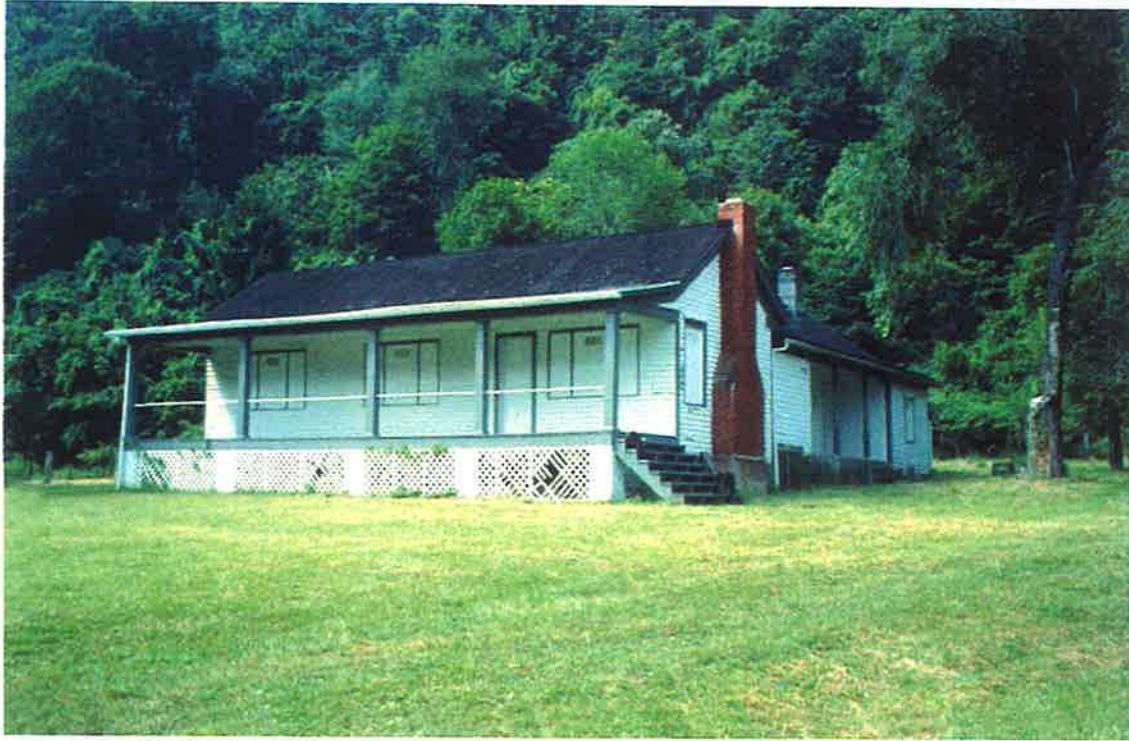
The National Park Service purchased the Richmond-Hamilton Farm in 1992. After purchase, the NPS stabilized and painted some of the buildings, and keeps up general maintenance of the landscape. The house is currently vacant.

*Vacant Richmond-Hamilton Farmhouse (PHSO 2001).*

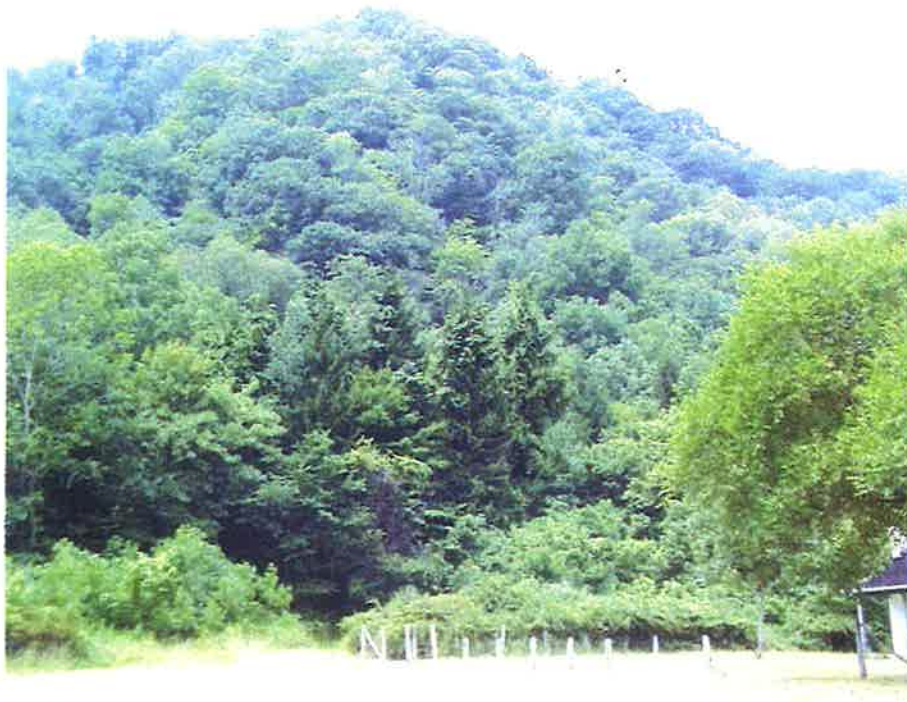
The topography changes distinctly at the rear of the house. The grade begins to slope more steeply for the first 200 feet from the house, then climbs sharply up the mountain. This steeper topography has not been cleared of its forest vegetation.

*Sharply sloping topography located directly behind farmhouse. Note grove of spruce mentioned in Vegetation section (PHSO 2001).*

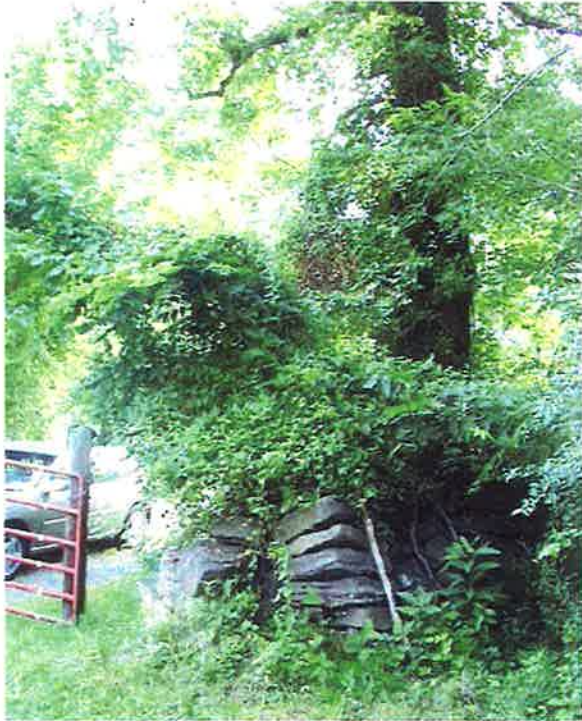
Unplanned vegetation growth is having an impact around the site as well. There are thick growths of vegetation, such as poison ivy [*Rhus radicans*], sweet pea [*Lathyrus latifolius*], and honeysuckle vines [*Lonicera* sp.], in drainage swales and on the property boundary along Route 26.

*Looking south at gate entrance to farm with Route 26 immediately behind photographer. Understory invasive vegetation typical on the site. Note dry-laid masonry wall mentioned in the Buildings and Structures section of this report (PHSO 2001).*

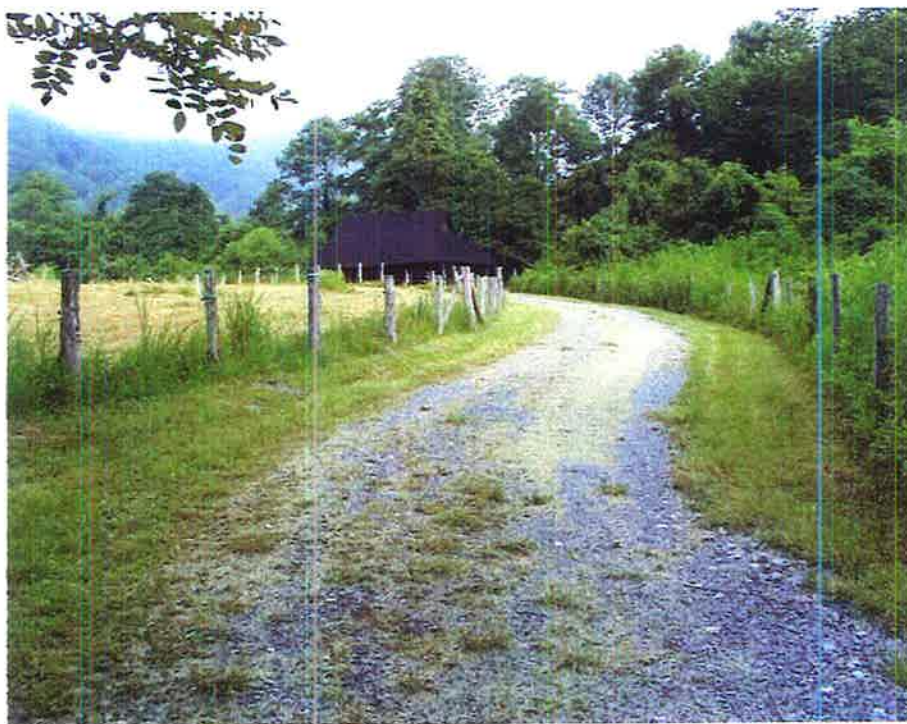
*Gravel entry drive heading toward the first log barn (PHSO 2001).*

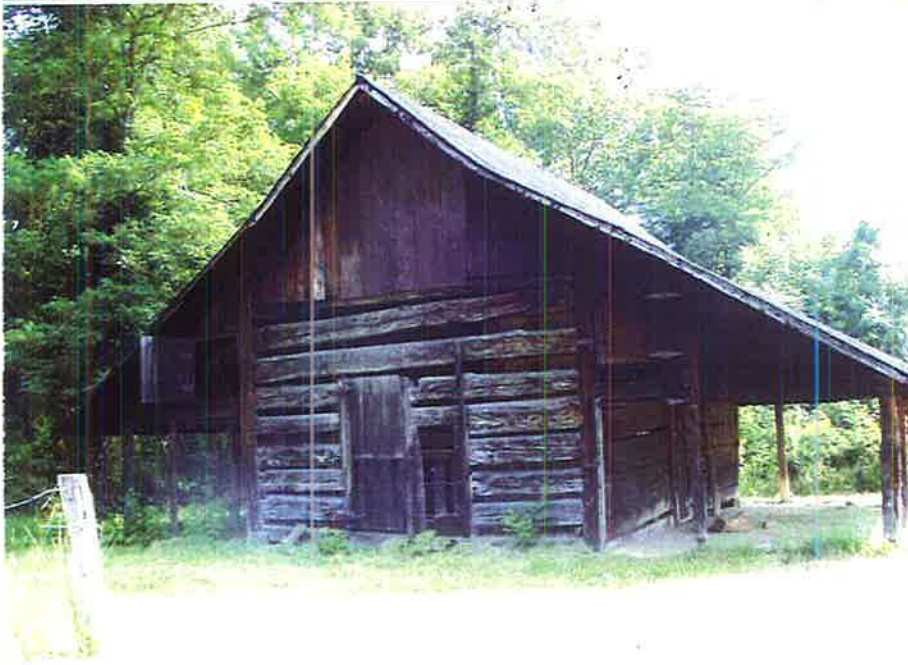
*Log barn 1 looking northwest from entry drive (PHSO 2001).*

Structural deterioration is another impact that is adversely affecting the condition of the Richmond-Hamilton Farm landscape. While the house has been closed up with vented windows and painted to aid its preservation, some of the other buildings and structures need some stabilization measures as well. It is the recommendation of the CLI that the park initiate putting the buildings and structures of the Richmond-Hamilton Farm on the List of Classified Structures, which will then provide stabilization measures and costs to preserve the buildings.

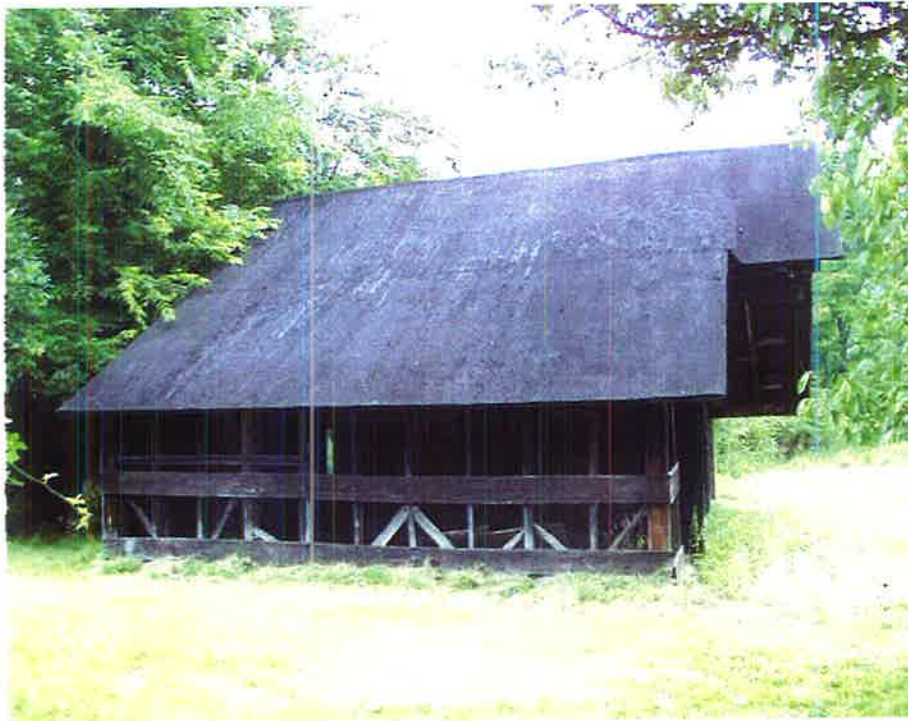
*Log barn 2 (PHSO 2001).*

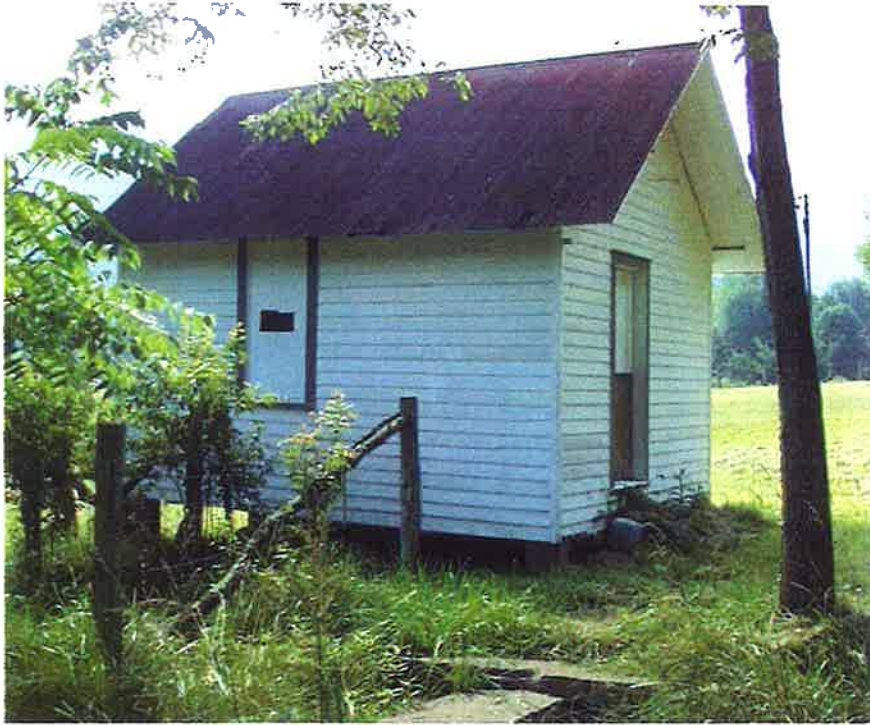
Between the house and the second barn is a small frame outbuilding that is supported on concrete piers. The one-room building has clapboard siding and a gable metal roof. Several of the clapboards are rotting or missing.

*Frame outbuilding looking southeast from stone bridge over stream bed (PHSO 2001).*

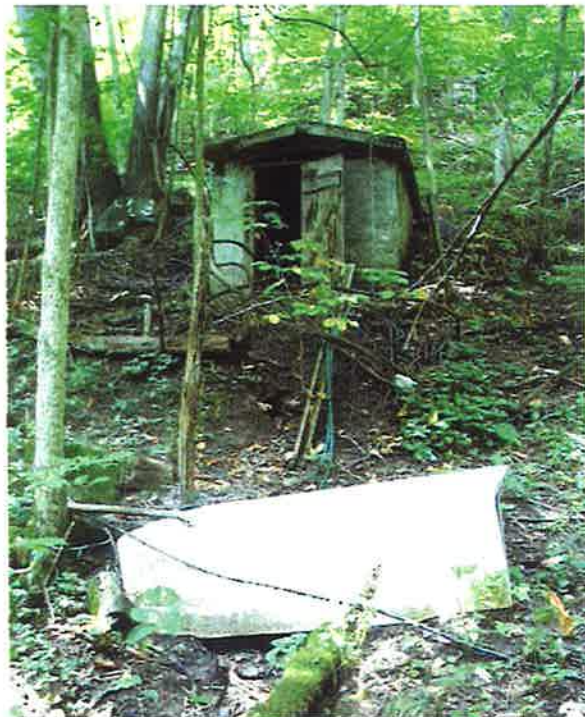
Located west of the house and built into the hillside is a small springhouse. The structure is wood framed, but sided with poured concrete. The gable roof is also covered with poured concrete resting on wood planks. The springhouse is situated at a spring head so that it collects the water emerging from the mountain, and transports it via a wooden trough. More research will be necessary to determine the age of all the buildings located at the Richmond-Hamilton Farm.

*Springhouse located on hillside. (Note tub in foreground, which is mentioned in Small Scale Features section (PHSO 2001).*

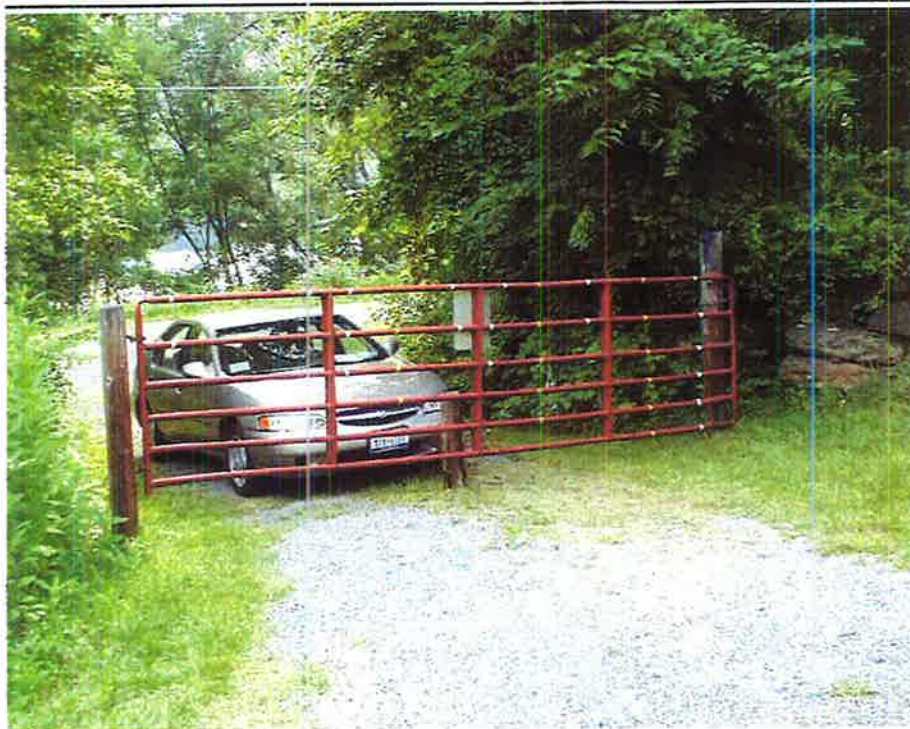
*Locked metal entry gate barring access to site from Route 26 (PHSO 2001).*

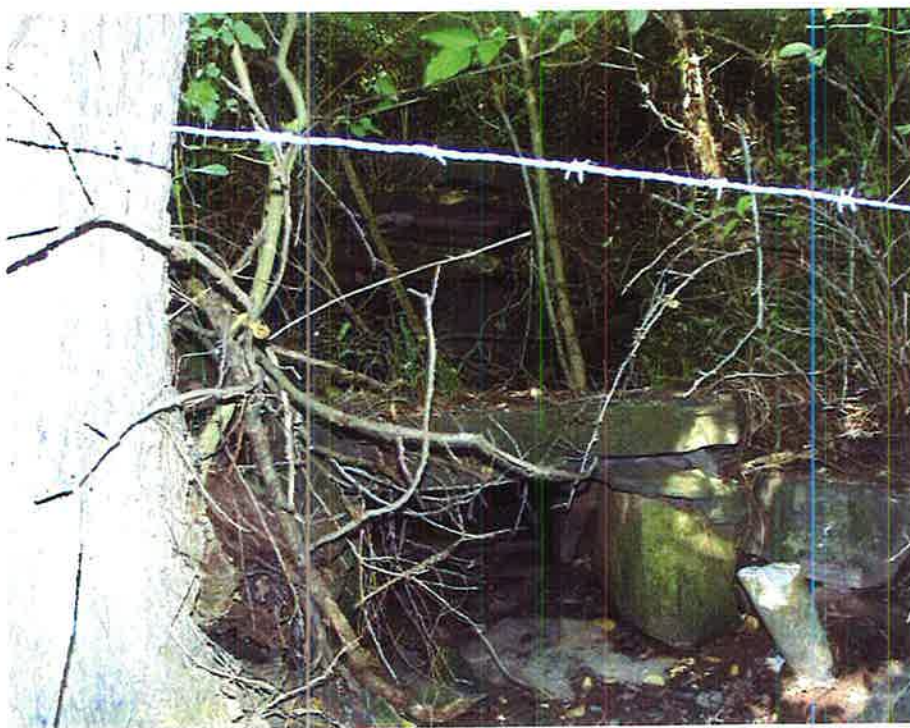
*Stone culvert built over stream bed adjacent to barn 1 (PHSO 2001).*

Uncontrolled vegetative growth is adversely affecting the Richmond-Hamilton Farm, and is most prevalent along fencerows, walls, within the drainage swale, at the edge of the forest canopy and within the field located on the northern tract of the property. The CLI recommends taking stabilization measures in the areas where the cultural resources are being irreversibly damaged. Specifically, vegetation is growing on and around the stone wall located along Route 26 on both sides of the entry drive, and at the locations where there are stone bridges and culverts over the drainage swale. Uncontrolled vegetation in both these areas is causing the wall to collapse and the culverts to fail.
