# Proposed Demolition of Historic Structures

## Environmental Assessment

**US Department of the Interior – National Park Service  
New River Gorge National Park and Preserve**

**Proposed Demolition of Historic Structures  
Environmental Assessment  
PEPC 111561  
October 2024**

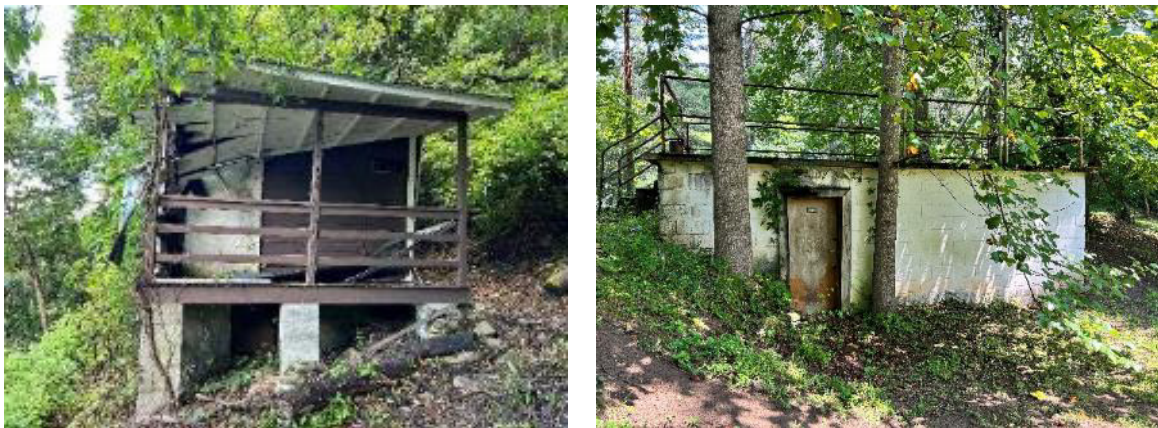
**Figure 8.** The Erskine Pugh Rental House (left) and the Camp Brookside Pool Chemical Treatment Building (right) are examples of the overgrown, deteriorated, unused structures within the park.

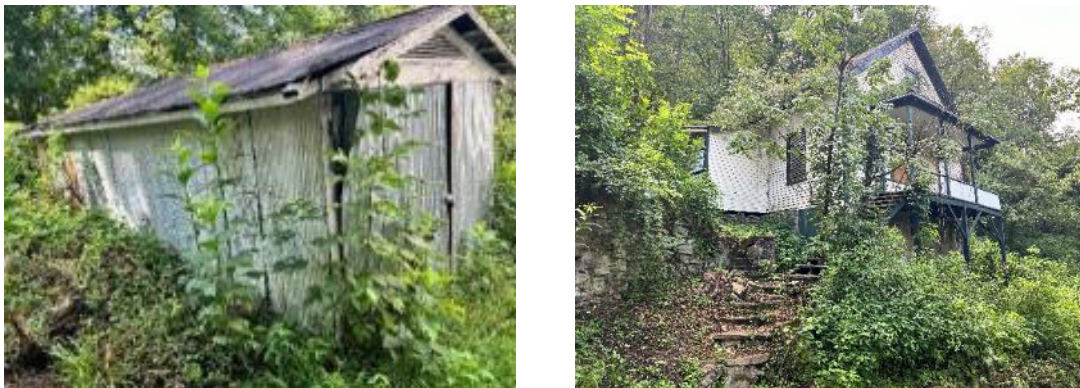
**Figure 9.** The McGuffin Garage (left) and the Wedzel Young House (right) are examples of overgrown, unsafe, deteriorated historic structures within the Thurmond Historic District that are proposed for demolition.

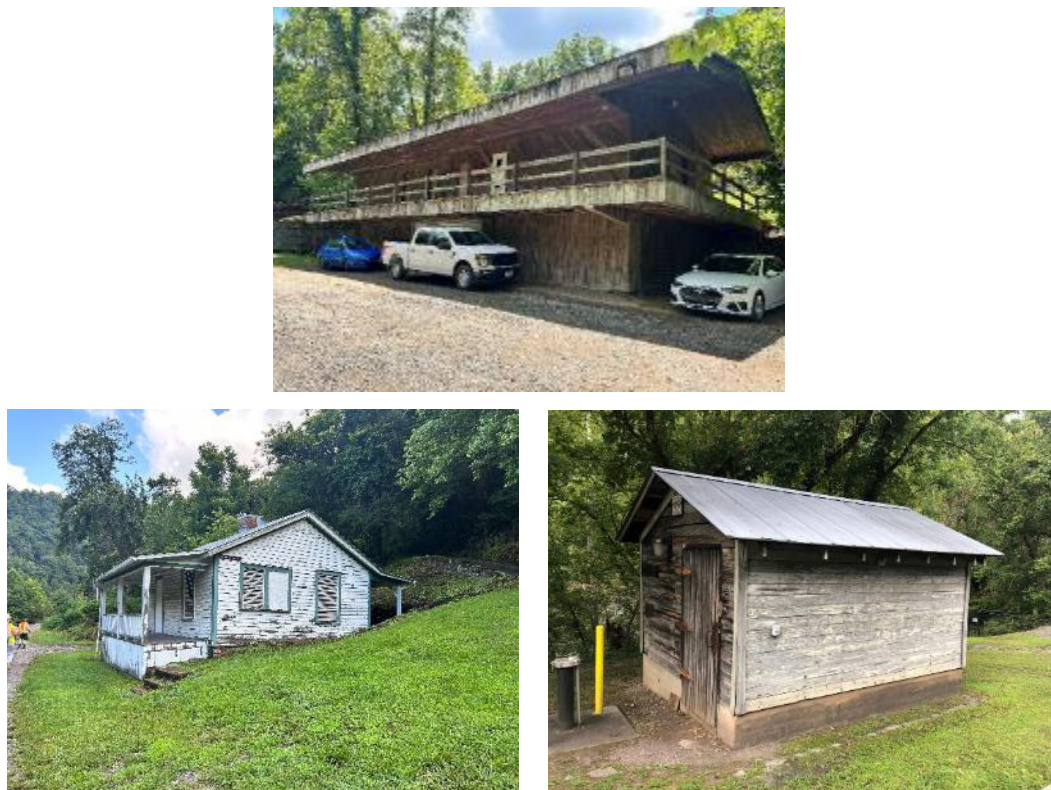
**Figure 10.** The Dun Glen Ark (top), the Marilyn Brown House (bottom left), and the Thurmond Ice House (bottom right) would be retained under alternative C.

District; and the Marilyn Brown house in Thurmond, which represents the simple architecture of a railroad worker's house and is easily accessible from the town's railroad level, along the main pedestrian route between Commercial Row and the Fatty Lipcomb house. Details of the demolition and restoration process would be the same as described under alternative B above.

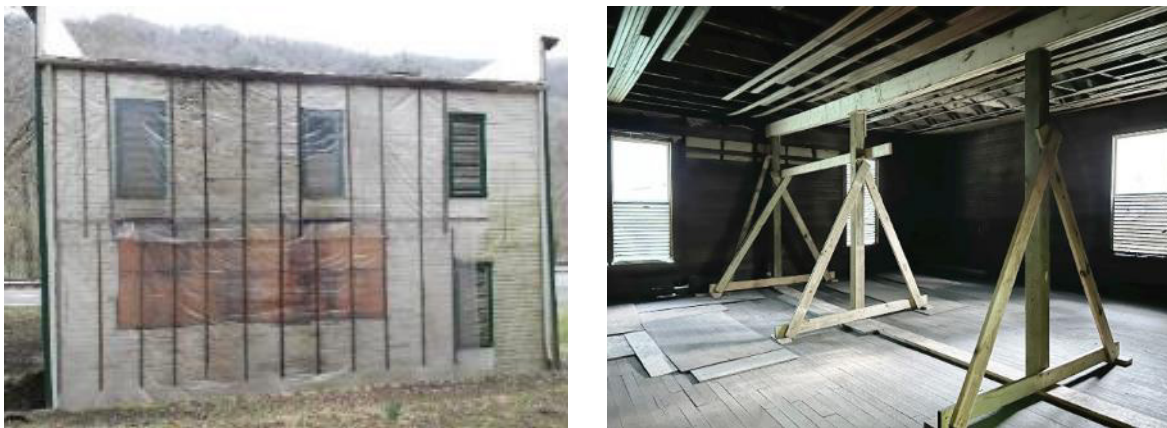
**Figure 11.** The Prince Brothers General Store has suffered extensive water damage, resulting in an unstable structure and collapsing rear wall (left) that continues to degrade over time. An interior beam truss system (right) was installed in 2021 as an extreme stabilization measure.

The Prince Brothers General Store is currently in poor condition due to substantial water damage caused by deterioration of the roof, gutter, and downspouts. The balloon construction of the building has pushed the exterior walls outwards 11 inches, and the structure is now listing from left to right. The roof pitch sheds water from the structure directly down the rear of the building, causing extensive damage to the framing and exterior components. Despite routine repairs and numerous focused projects to improve the

roof and drainage system over the past two decades, the rapid progressive deterioration of the building has outpaced the effort. In 2021, the NPS took extreme stabilization measures to build a base beam support system on the lower and upper floors to catch the implosion of the building. See appendices A and B for additional information on the condition of the Prince Brothers General Store.

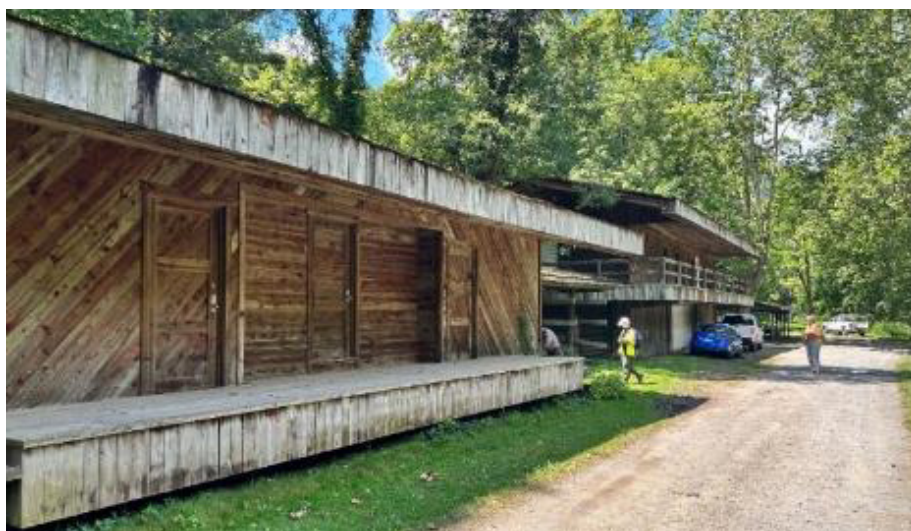
**Figure 12.** The Dun Glen Mini Ark (foreground), Boat Storage Rack (center) and Ark (background right) are associated with the statewide whitewater rafting industry.

These structures are currently used by the NPS for storage and are in stable condition. The NPS carries out routine maintenance on these structures such as repairing or replacing broken doors and hardware, clearing overgrown vegetation, maintaining light fixtures, and repairing or replacing rotting wood features. These structures are located within the floodplain due to their proximity to the New River and the first floor storage areas experience water inundation during flood events; this flooding limits the reuse potential for these structures. See appendices A and B for additional information on the condition of these structures and additional photos.

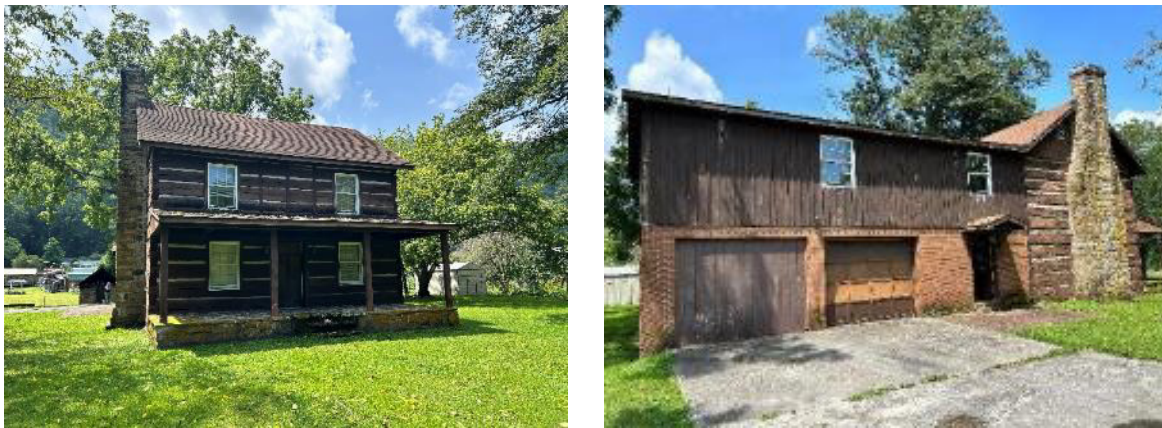
**Figure 13.** The historic Vallandingham House (left) is a late-19th century log cabin farmhouse with a non-historic rear addition (right) which detracts from its historic character.

The Vallandingham House is currently unused and is in stable condition. The NPS carries out routine maintenance on the structure such as repairing or replacing broken windows and hardware, clearing overgrown vegetation, maintaining light fixtures, and repairing or replacing rotting wood features. See appendix A for additional information on the Vallandingham House.

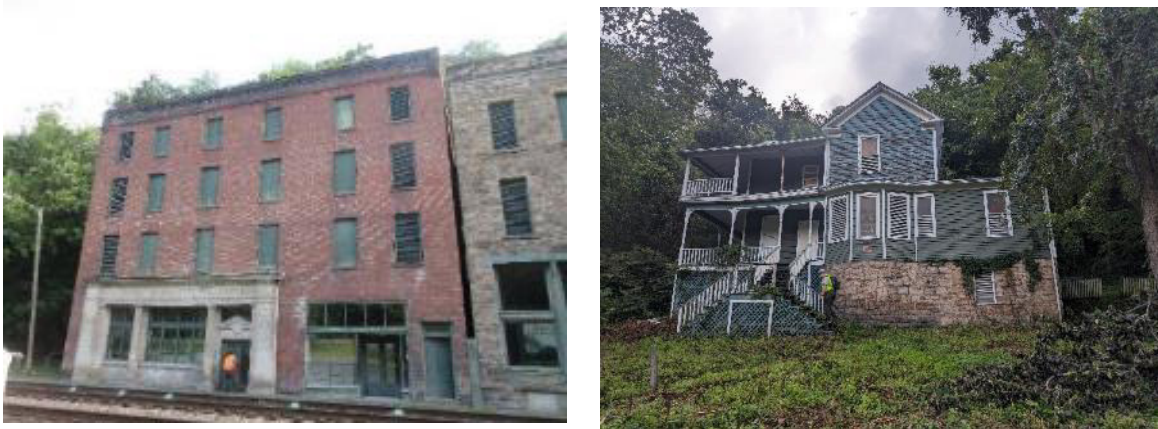
**Figure 14.** The Bank of Thurmond (left) and the Fatty Lipcomb House (right) are examples of historic buildings within the Thurmond Historic District (not included in this demolition project).

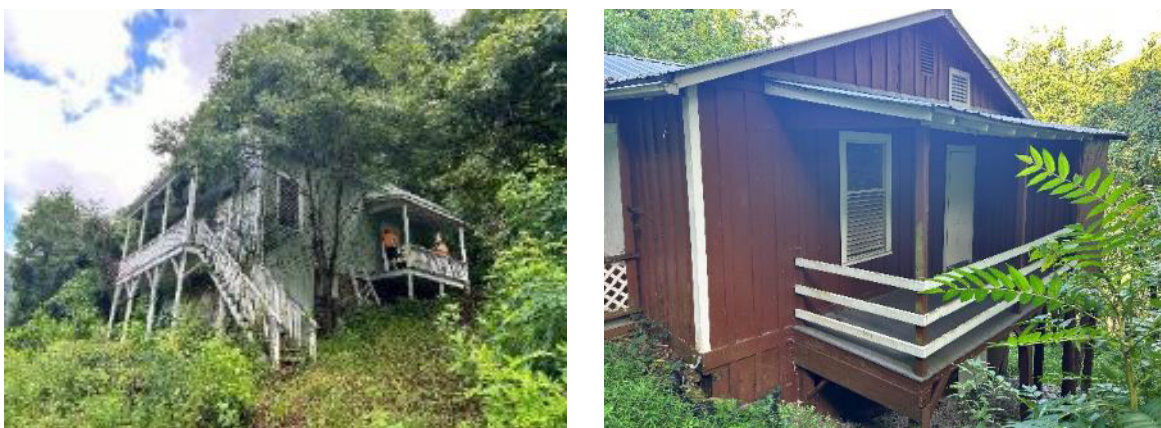
**Figure 15.** The Sidney Allen Ward House (left) and the Harold Smith House (right) are examples of houses for railroad managers and railroad workers, respectively; both are proposed to be excess.

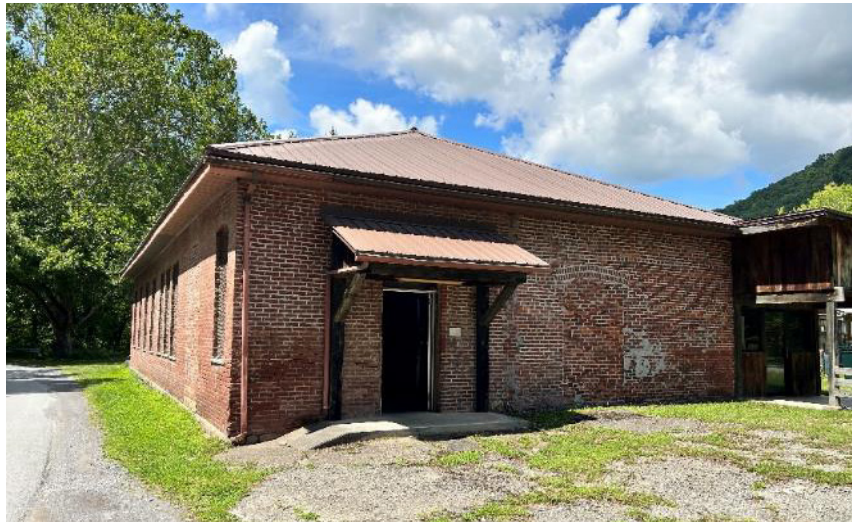
**Figure 16.** The Dun Glen Building/Ranger Station is a remnant of the former Dun Glen Hotel, which was documented as a pivotal structure to the Thurmond Historic District.

The final proposed excess structure located in the Thurmond Historic District is the Dun Glen Building/Ranger Station, which is located on the south side of the New River. This structure is the re-roofed first floor remnant of the west wing of the 1900 Dun Glen Hotel, built by William McKell, that was destroyed by an arson fire in 1930. The building represents the last remaining above-ground portion of the former hotel, a pivotal structure to the Thurmond Historic District; however, it is only a small portion of the much larger pivotal structure that includes the below-ground foundation of the former hotel. The foundation of the former hotel remains intact below ground, including physical evidence of the intense fire (Franz et al. 2023). In the late 20th century, the structure was used as a staff building by Whitewater Expeditions Unlimited, the first whitewater rafting company in southern West Virginia, which was established by the Dragan brothers in 1968. The Dun Glen Building/Ranger Station is currently in stable condition and used for NPS storage space. See appendices A and B for more detail of the Dun Glen Building/Ranger Station.

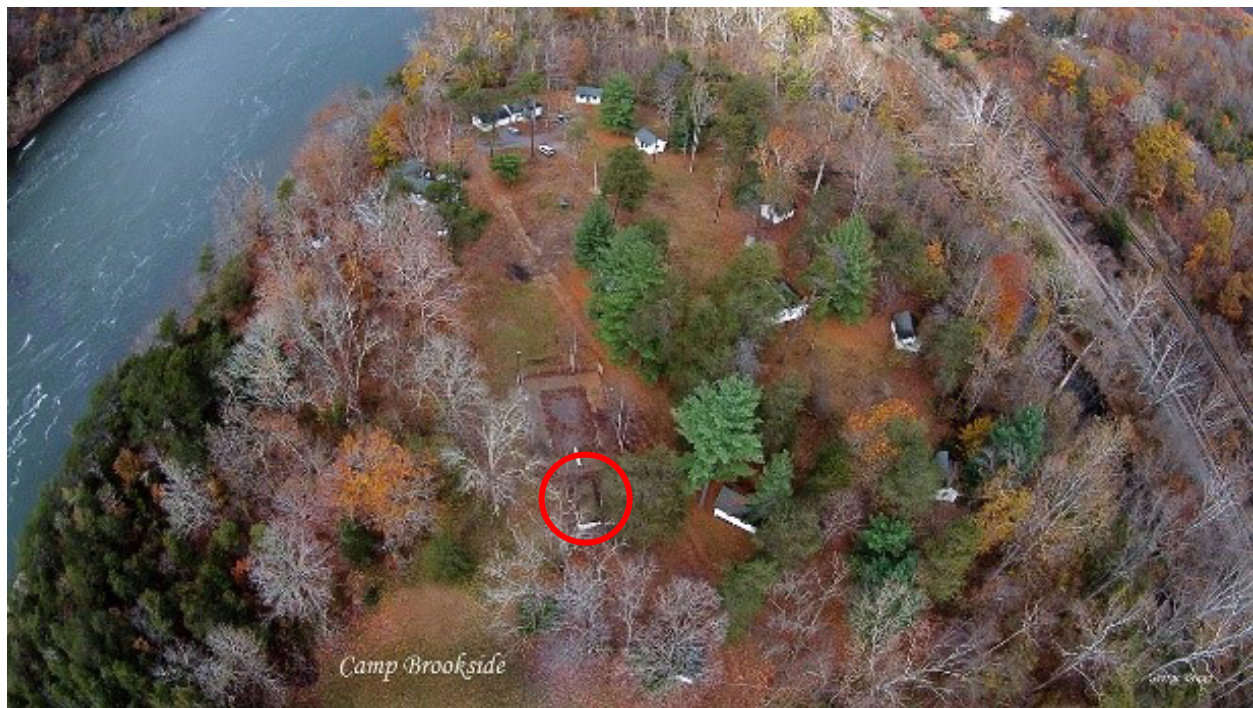
**Figure 17.** Aerial photograph of Camp Brookside showing pool's chemical treatment building (circled) and other historic structures with New River's Brooks Falls to the left (George Bragg, photographer).

The cultural landscape inventory for Camp Brookside classified the pool chemical treatment building, which was built along with the pool in the early 1950s, as a potentially contributing resource to the historic district and cultural landscape. The structure is a rectangular, concrete block building built into a slope, so it is partially below grade. Although the associated swimming pool has since been filled, the building remains eligible as a contributing resource to Camp Brookside. See appendices A and B for more detail of the pool chemical treatment building.

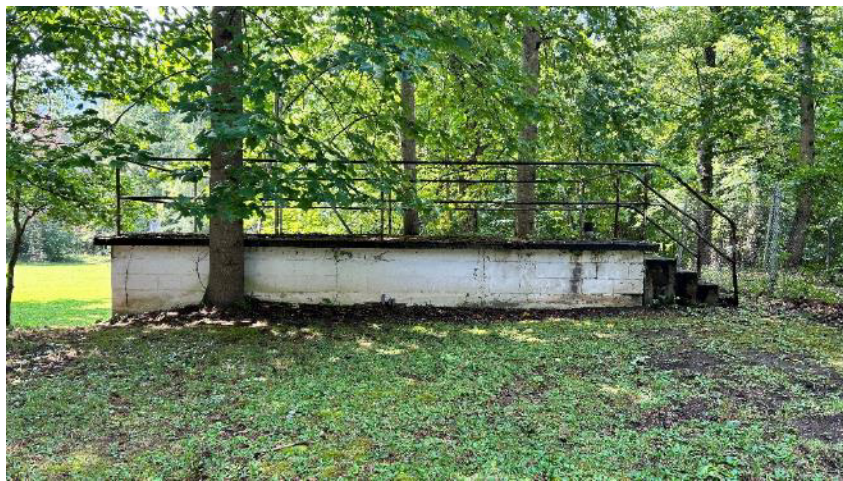
**Figure 19.** The Camp Brookside Pool Chemical Treatment Building, partially obscured from view from the main camp areas by topography and vegetation.

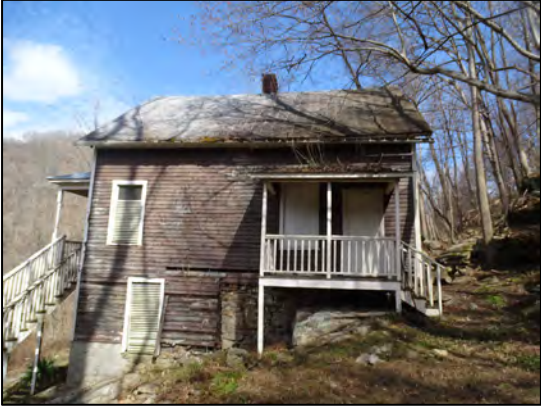
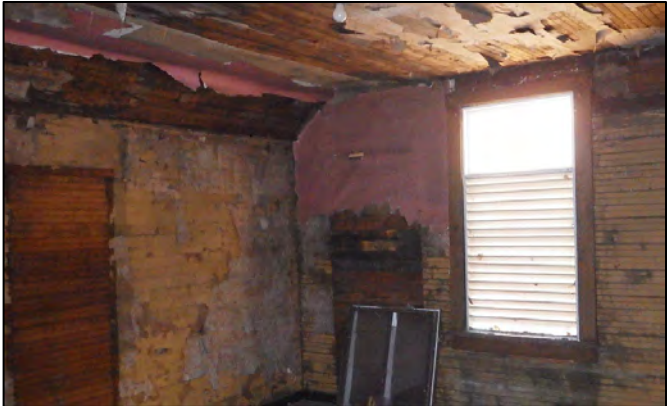
| <b>Benefits from demolition:</b><br>Serious fall hazards are eliminated and \$355,059 deferred maintenance and repair are retired. Return site to natural surroundings. | |

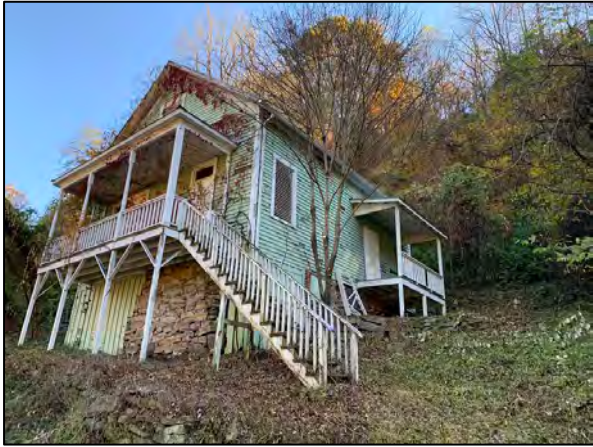
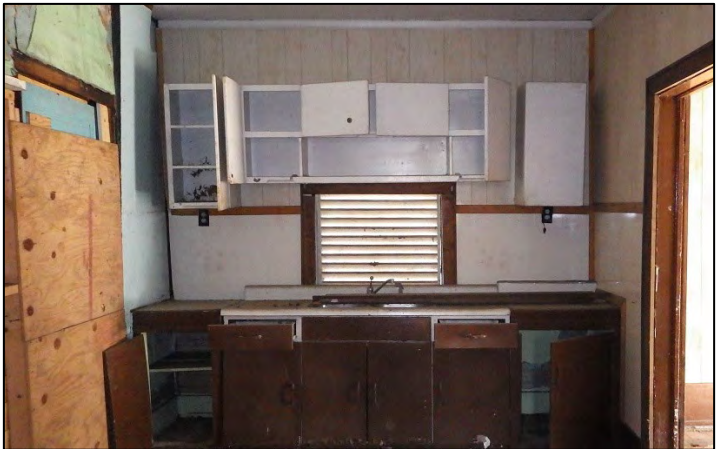
| <b>Benefits from demolition:</b><br>Retire \$242,154 deferred maintenance and repairs and return location to natural vegetative landscape. | |

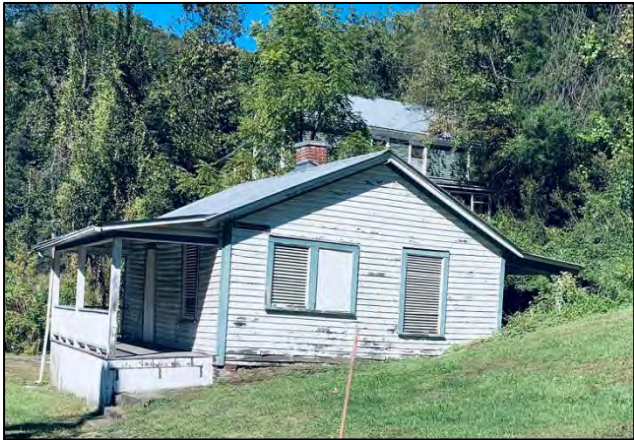
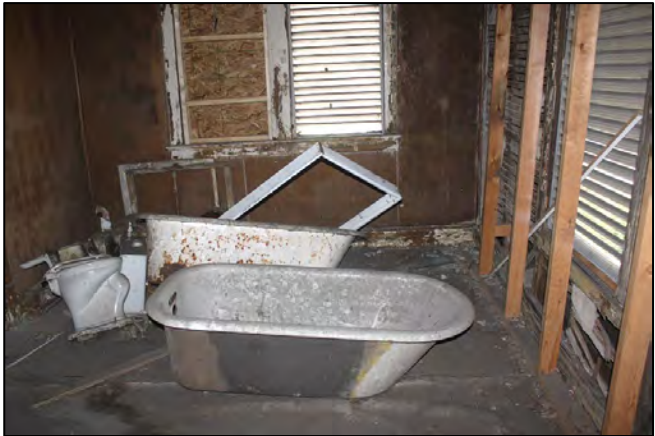
| <b>Potential for reuse:</b><br>Due to location, size/status comparison to Fatty Lipcomb House, and history of house this structure has significant potential for interpretive reuse. Only interpretive opportunities from exterior of house currently without substantial rehab/utility/asbestos abatement work for occupancy. | |
| <b>Benefits from demolition:</b><br>Deferred maintenance is retired and no future Operations and Maintenance Cost. | |

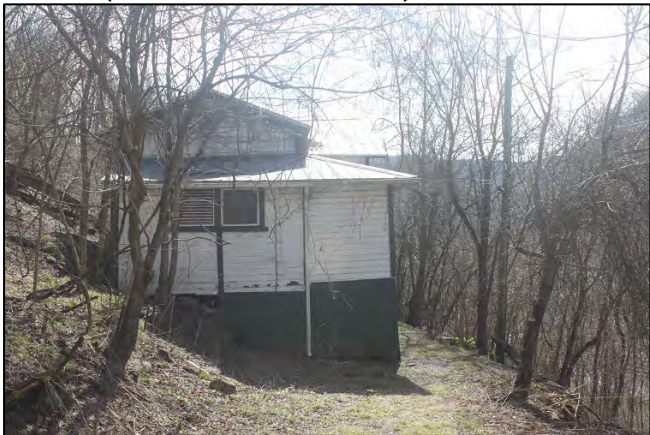
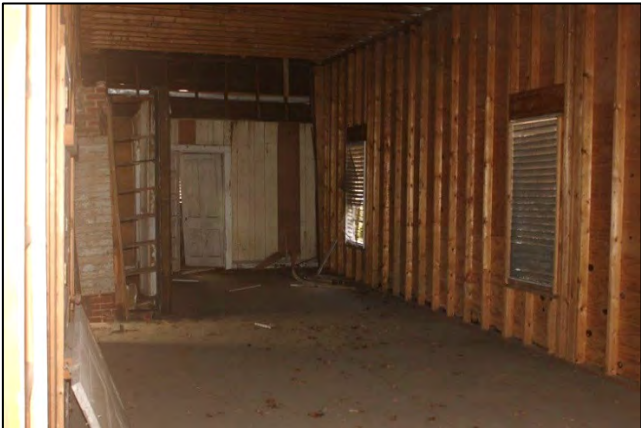
| <b>Benefits from demolition:</b><br>Deferred maintenance of \$195,624 retired. No future operational costs. Return site to natural surroundings. | |

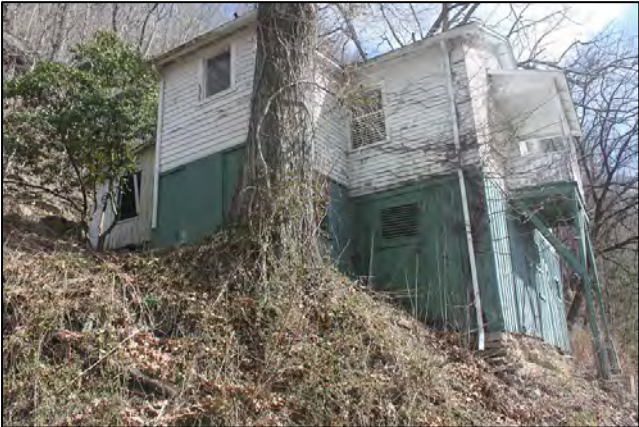
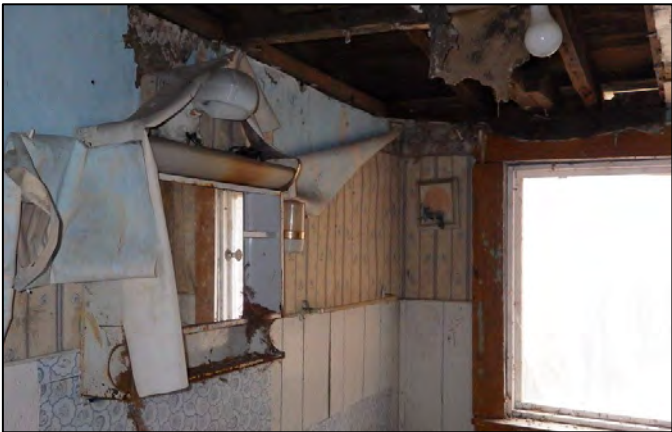
| <b>Benefits from demolition:</b><br>Retire \$266,739 of deferred maintenance and repair, restore steep hillside to natural surroundings. | |

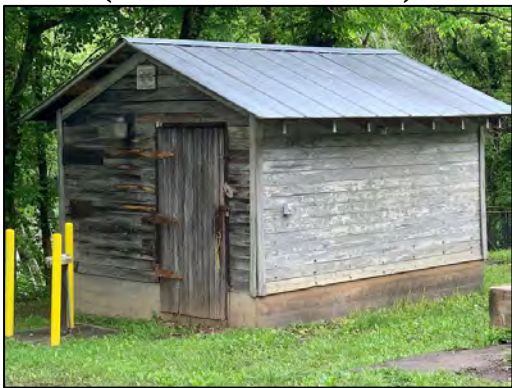
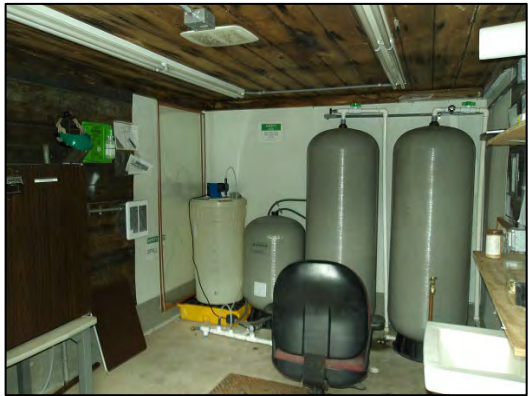
| <b>Benefits from demolition:</b><br>Building is removed from CSX property, water system volume can be improved in a more appropriate structure and \$6,353 of deferred maintenance is retired. | |

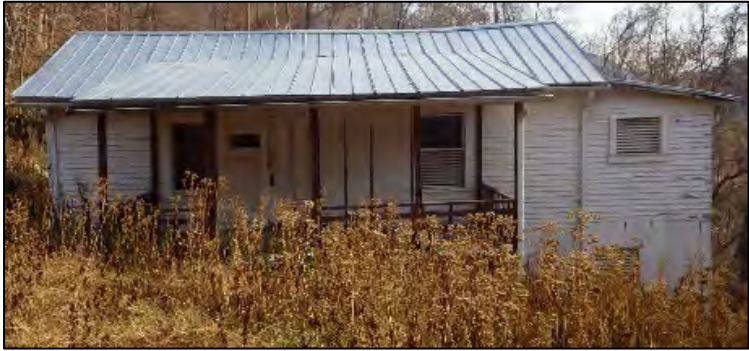
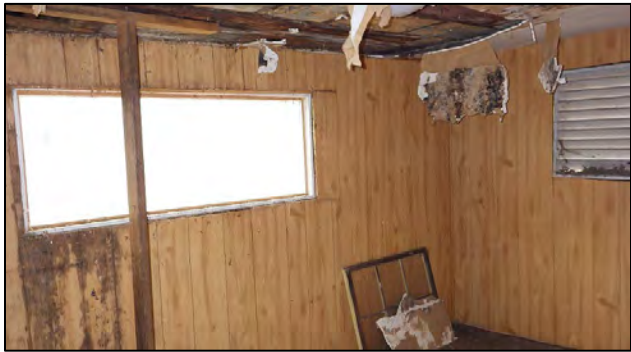
| <b>Benefits from demolition:</b><br>Retire \$417,957 of Deferred Maintenance and eliminate future operations and maintenance costs. Return site to natural surroundings. | |

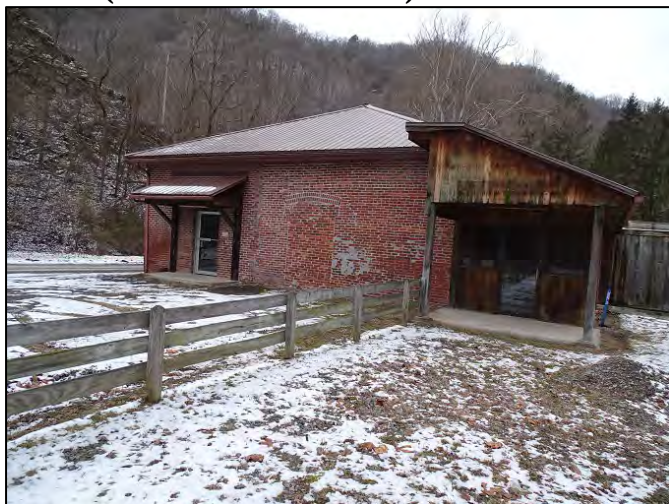
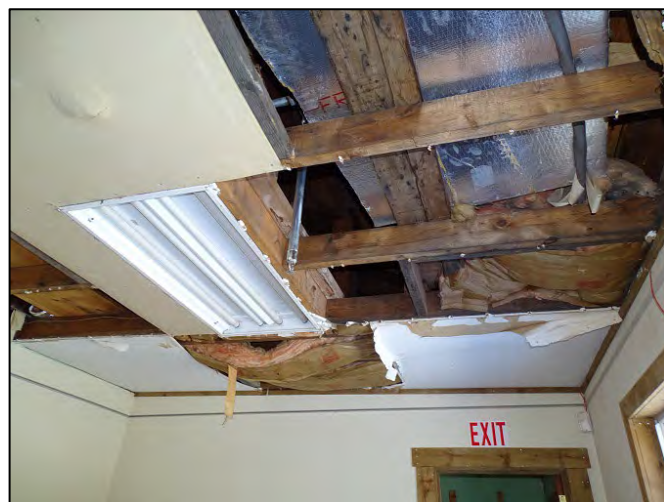
| <b>Benefits from demolition:</b><br>Park would retire \$1.6 million dollars in deferred maintenance and repair. Provide for better space utilization within park's maintenance complex. | |

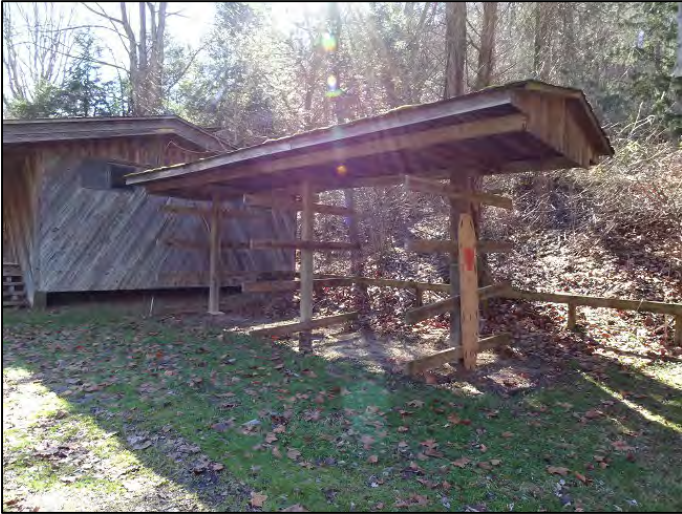
| <b>Site/Structure Name:</b><br>3369 Dun Glen Boat Storage Rack | <b>Date:</b><br>June 17, 2024 |

| <b>Existing Condition:</b><br>FMSS condition listed as Serious. | |
| <b>Concerns/Issues:</b><br>Unused, fifty-year old boat storage rack could be a hazard to visitors recreating in the area. | |

| <b>Benefits from demolition:</b><br>Structure removed from river corridor/floodplain and the space could be repurposed for improved day use area. | |

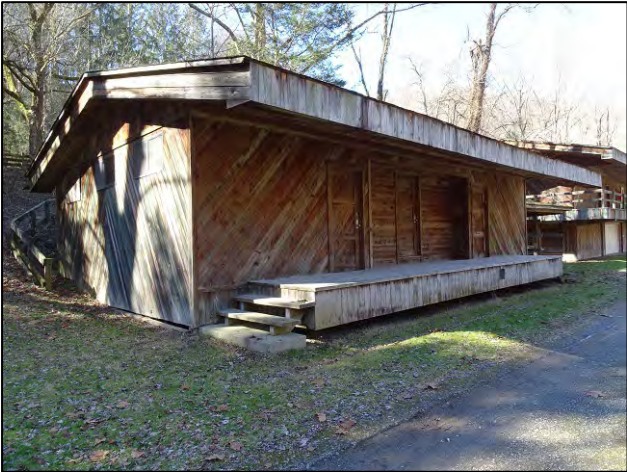
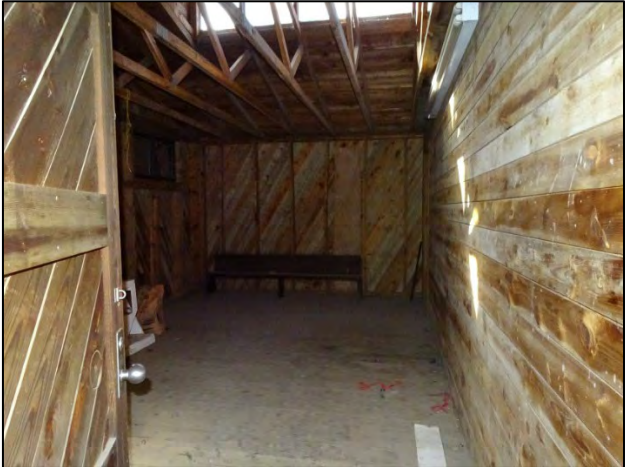
| <b>Existing Condition:</b><br>FMSS condition listed as Serious. | |
| <b>Concerns/Issues:</b><br>The almost fifty-year old wooden structure has no fire suppression system and an electrical system not up to code and needs complete replacement. The building resides in the floodplain of the New River and has flooded in the past and further flooding could damage structural integrity. The high visibility/location of the building does require diligent security from threat of vandalism and intrusion. | |

| <b>Benefits from demolition:</b><br>The park would retire \$285,846 in deferred maintenance and repair costs in addition to removing buildings from the floodplain alongside the river and allow for more available space for improvements to the day use area. | |

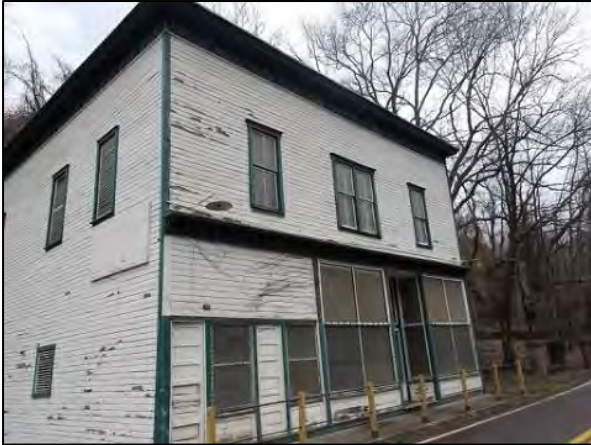
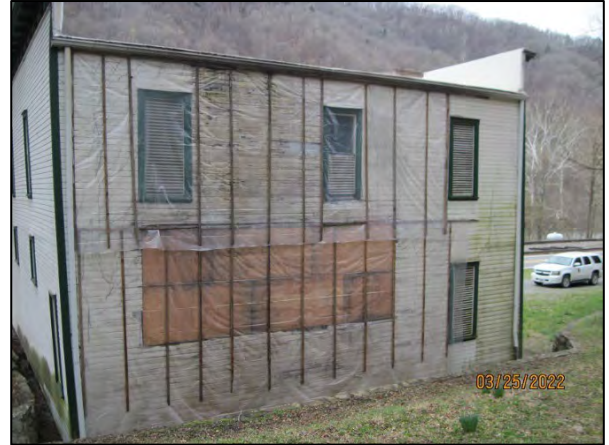
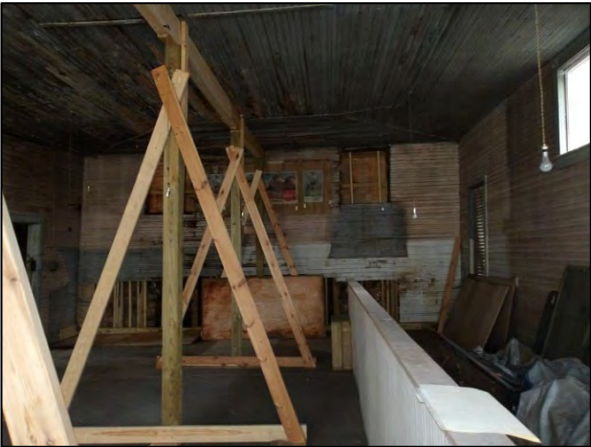
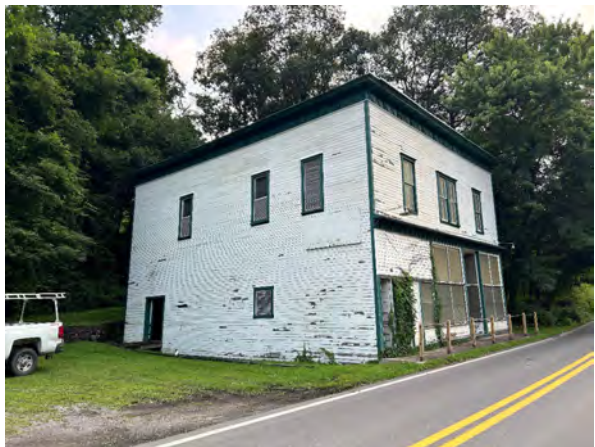
| <b>Existing Condition:</b><br>FMSS condition listed as Serious | |
| <b>Concerns/Issues:</b><br><p>The structural integrity of the building has diminished beyond repair. The back wall of the building is severely compromised. The main structure to include the building's roof system is being protected from imploding by a base beam support system on the lower and upper floors. The building's balloon construction technique has resulted in the building bowing out in the center and lean 11 inches from top to bottom. This building technique is ineffective for long-term stability. The original loose stacked rocks used as a makeshift foundation have shifted and deteriorated over the years causing the building to severely sag. The building is located at the base of a steep hillside with drainage issues that have damaged the building's integrity.</p> <p>The building (built ca. 1900) is immediately adjacent to a state highway (see photo below), making visitor and employee use very hazardous for vehicles entering and exiting site as well as pedestrian use around the building. The building has no substantive water or electric utilities. The scope and scale of repairs needed for any occupancy of staff or visitors and the high level of restoration work required and mitigation of safety issues in and around store far exceed the value of the structure.</p> | |
| <b>Stabilization Efforts and Prior Costs:</b><br><p>The balloon construction has pushed the center midline of the exterior walls outwards 11 inches and the structure is listing from left to right. The 1 in 12 pitch roof sheds water from the structure directly down the rear of the building, causing extensive water damage to the framing and exterior components.</p> <p>In 2003, the park invested \$17,600 for the installation of a new single-ply PVC roof membrane and new gutters for the Prince Brothers Store. The roof was in very poor condition and had been leaking into the building causing considerable damage within the interior. After completion of the project, the building remained in poor condition, due to ongoing deterioration of the exterior walls and the listing of the building.</p> <p>In 2005, the park invested \$79,873 for the purpose of repairing, prepping, and painting the exterior wood siding using the historic colors. The park also rehabilitated of the front storefront windows and doors and window rehabilitation including some replacement with wood louvers to provide adequate light and ventilation. In addition, a structural engineer was hired to evaluate the pronounced lean in the two-story structure. As a result, some plywood sheer walls were installed in the attempt to stabilize the building.</p> <p>In 2006, the park invested \$12,287 to complete some additional emergency repairs and improvements to help stabilize the structure. An exterior siding replacement and exterior painting project was completed in 2013 for an additional \$27,500.</p> <p>In 2021, the park discovered the building had deteriorated to such an extent, extreme stabilization measures were taken to build a base beam support system on the lower and upper floors to catch the implosion of the building. Through the years, routine repairs have been made on numerous occasions to try to keep the building intact, but the rapid progressive deterioration has outpaced our efforts.</p> | |

Roadway hazard mitigated and \$2.6 million dollars in deferred maintenance and repair is retired.

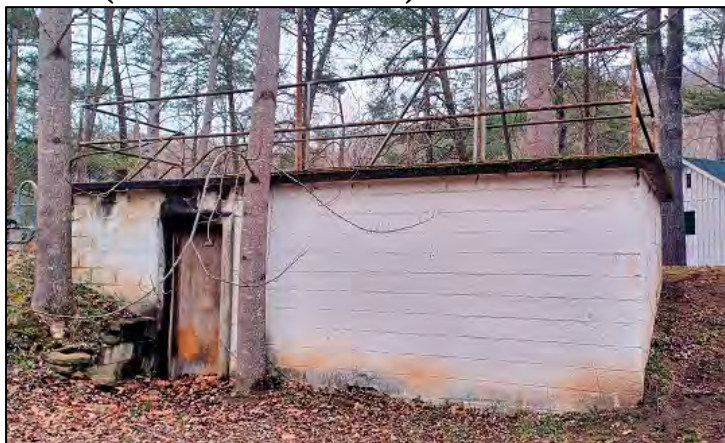
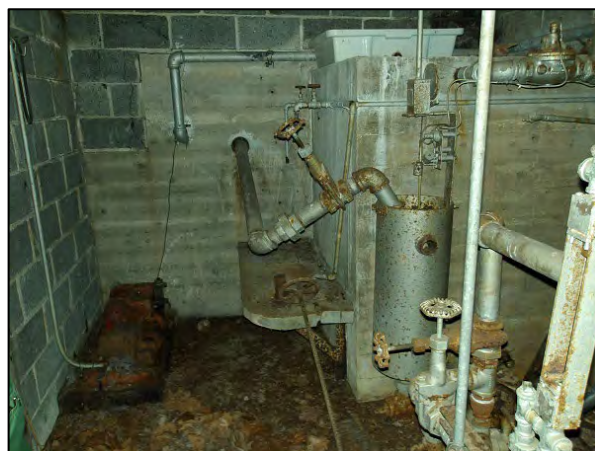
| <b>Existing Condition:</b><br>Poor, non-functioning. Solid concrete/block building. Swimming pool has been filled in with soil. Roof of structure is flat with access (steps) atop on same level as old pool with railing around site, perhaps a previous patio for pool. | |
| <b>Concerns/Issues:</b><br>320 SF building (built ca. 1950-60) is built adjacent to old pool site and is built directly into hillside beside pool site. The building's interior is filled of old metal pipes and plumbing for the pool's chemical treatment. These pipes and system have been impacted by years of heavy chemical use during pool operations and has now sat idle for decades eroding and corroding and compromising the plumbing's integrity. The structure has no function at the Brookside Education Center in current condition nor in any future planning. The building is solid and made of block and concrete construction but the potential for vandalism or other safety hazard exists as long as building remains. The building is a potential hazard due to biological pests finding ways into structure and the remnants of the pool system has shown no findings in HazMat surveys but will continue to deteriorate over time. The roof of structure poses safety hazards due to ease of access to visitors and potential for failure of guardrails around roof. | |

| <b>Benefits from demolition:</b><br>Utilitarian block building is demolished from scenic historic landscape. \$70,975 of deferred maintenance and repair is retired. | |
