National Park Service  
Cultural Landscapes Inventory  
2015

Golden West Lodge Historic District  
North Cascades National Park Complex

## **Golden West Lodge Historic District** **North Cascades National Park Complex**

CONDITION ASSESSMENT:    **Fair**

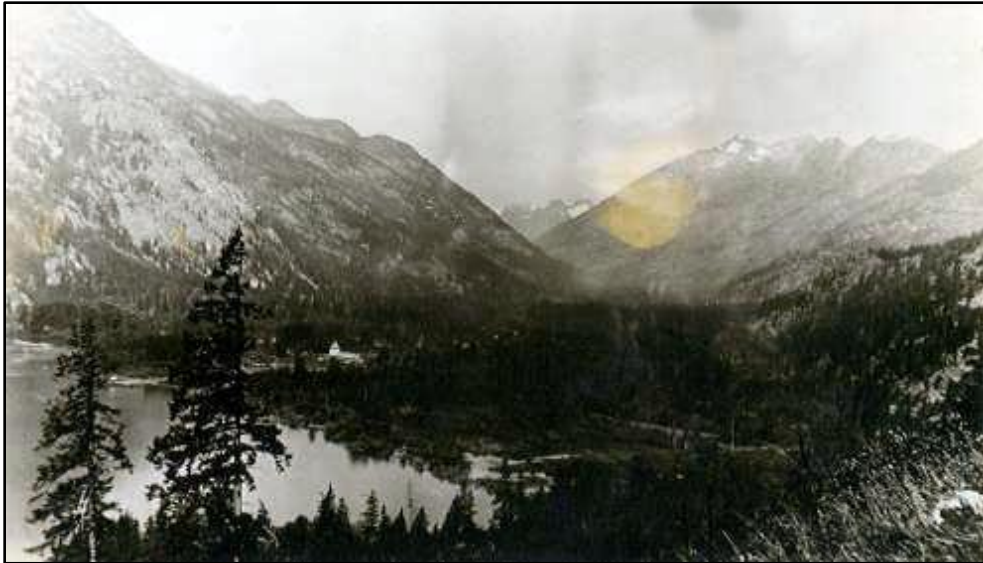
History #1: Photograph showing the Field Hotel at the head of Lake Chelan, 1920. This photo was taken prior to the damming of the lake, which dramatically changed the character of the area after 1929 (NOCA 11537).

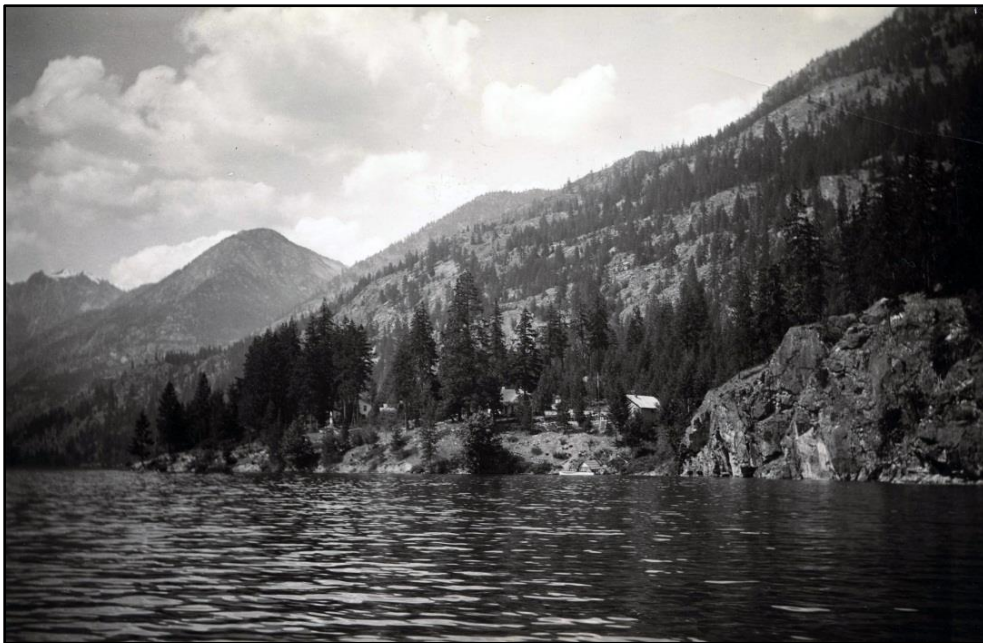
History #3: View of a portion of the Golden West Lodge (left) and the U.S. Forest Service Stehekin Ranger Station residence, warehouse and boat dock (right) as seen from Lake Chelan, post 1926 (NOCA 11923).

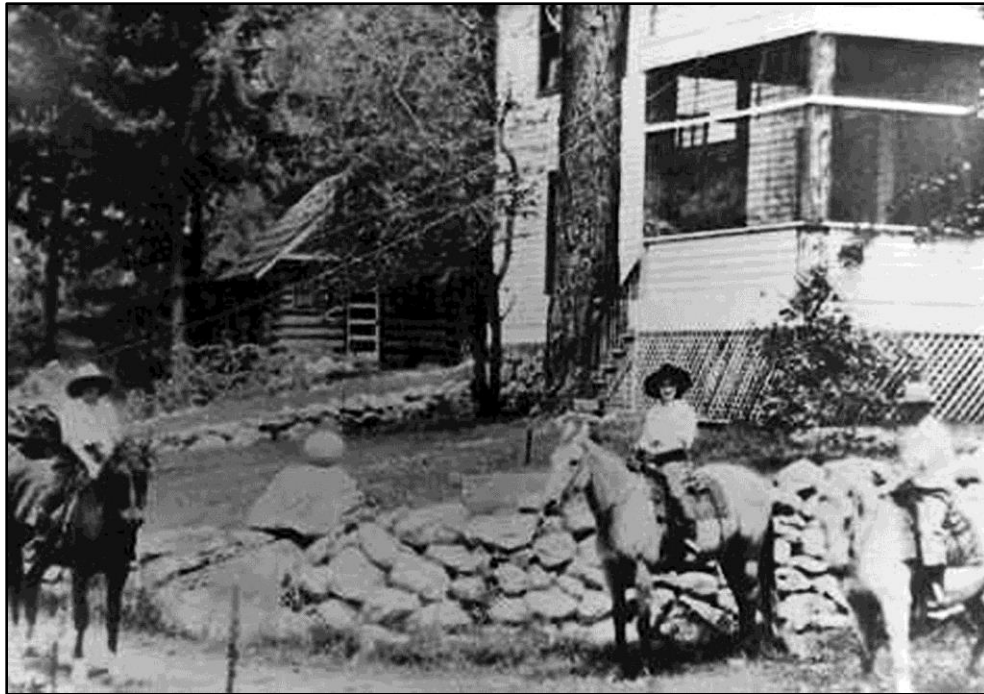
History #4: Early photograph of the Golden West Lodge and the cabin known as “The House That Jack Built”, n.d (NOCA).

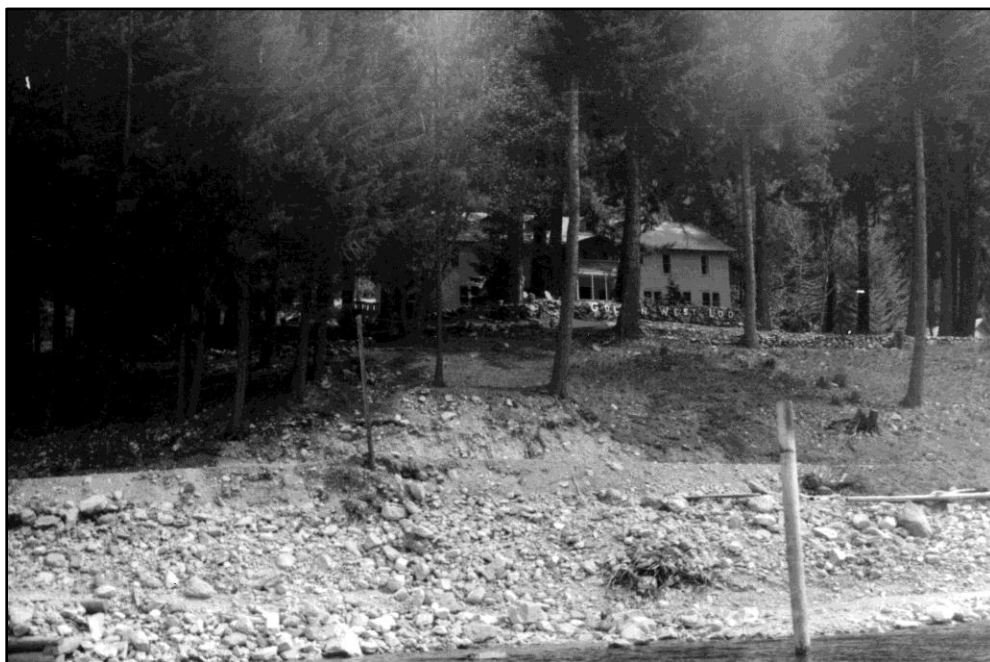
History #6: Photograph looking northeast of the Golden West Lodge and the terraced slope leading to the water, 1940 (NOCA 11901).

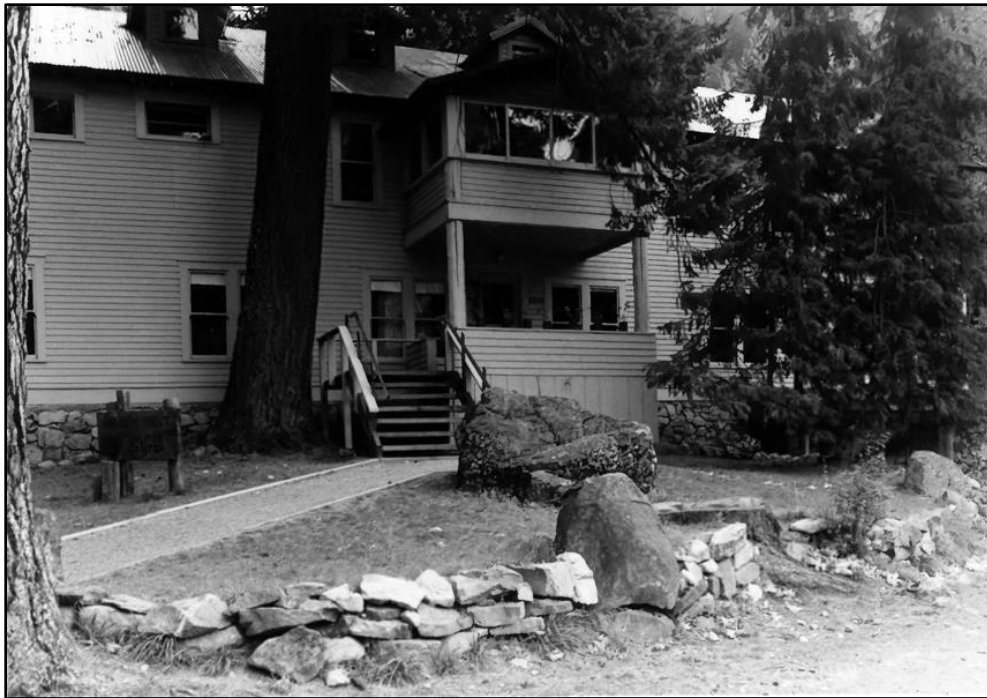
History #11: Photograph of the front of the Golden West Lodge, circa 1988. Note that the original orientation of the stairs changed, extending from the building at a 90 degree angle (Golden West Lodge Historic District National Register nomination).

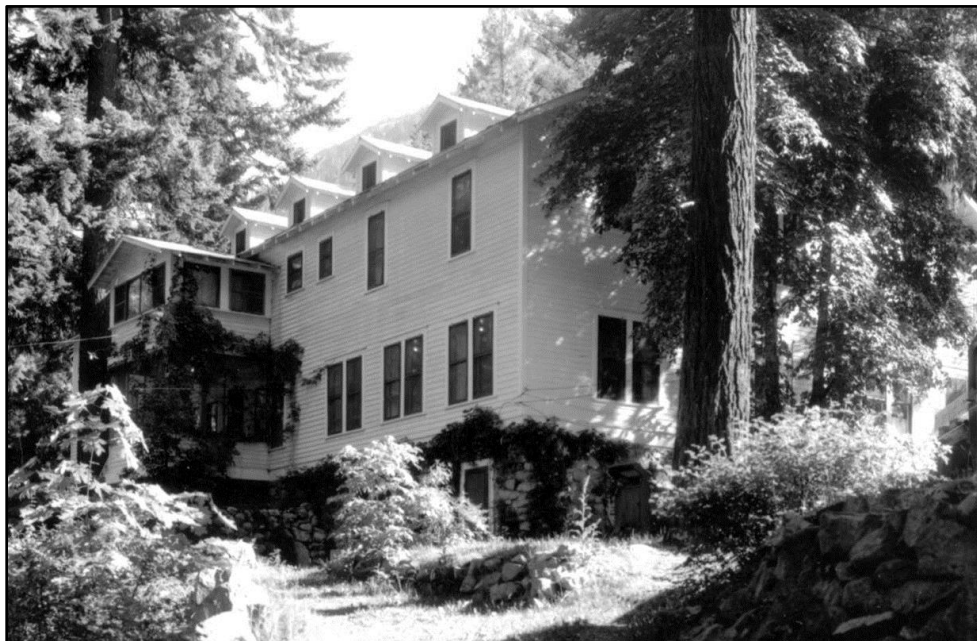
History #12: View of the Golden West Lodge from the south showing its overall character, 1980. Note the manipulation of topography and associated stacked stone walls visible in foreground (NOCA 19458).

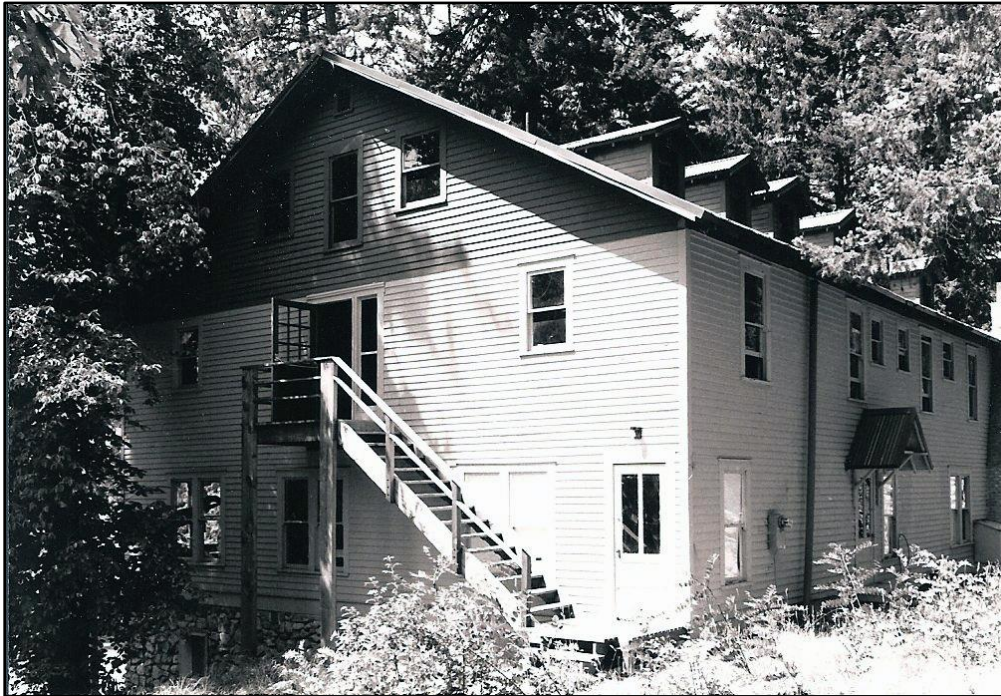
History #13: Photograph of the side and rear of the Golden West Lodge, circa 1980s. This photograph was taken prior to rehabilitation work, which modified both elevations (NOCA 17304-30).

In the fall of 2002, a large rehabilitation project was undertaken on the Golden West Lodge in an effort to achieve the above-mentioned desired goals. As part of the project, the original rock rubble and mortar foundation was replaced to ensure that current building codes and associated seismic requirements were addressed. At least 18 hydraulic jacks were used to lift the Golden West, including the building’s large stone fireplace.<sup>10</sup> The interior of the building was also renovated to meet additional requirements. As a

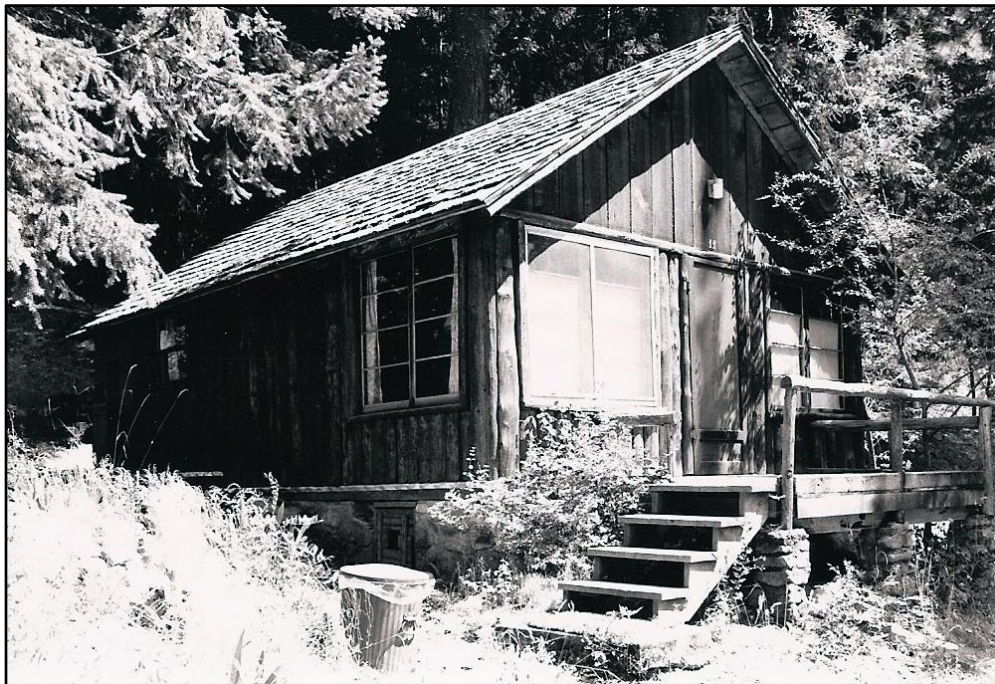
History #14: Photograph of Cabin #11, circa 1980s. Today, the overgrown area to the left contains a small garden demarcated by stones, which may be covered in this image (NOCA 17304-25).

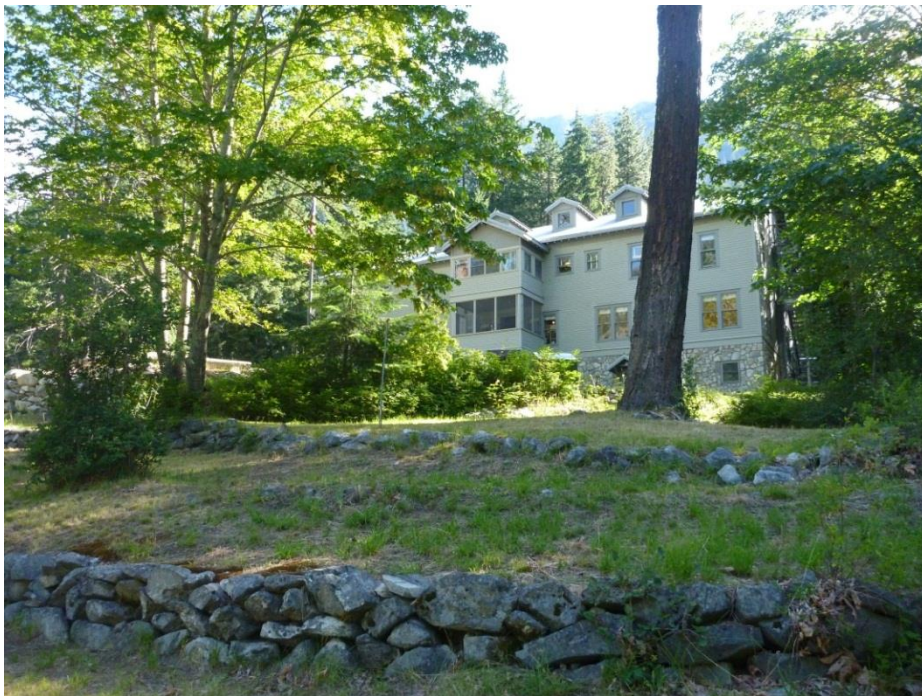
Natural Systems and Features #2: An abundance of native rocks on site were used to construct features throughout the district, such as buildings (note the lower level of the Golden West Lodge) and rock retaining walls. The walls supported the terraces that were constructed to make usable spaces on the steeply sloped site. (PWR, June 2103)

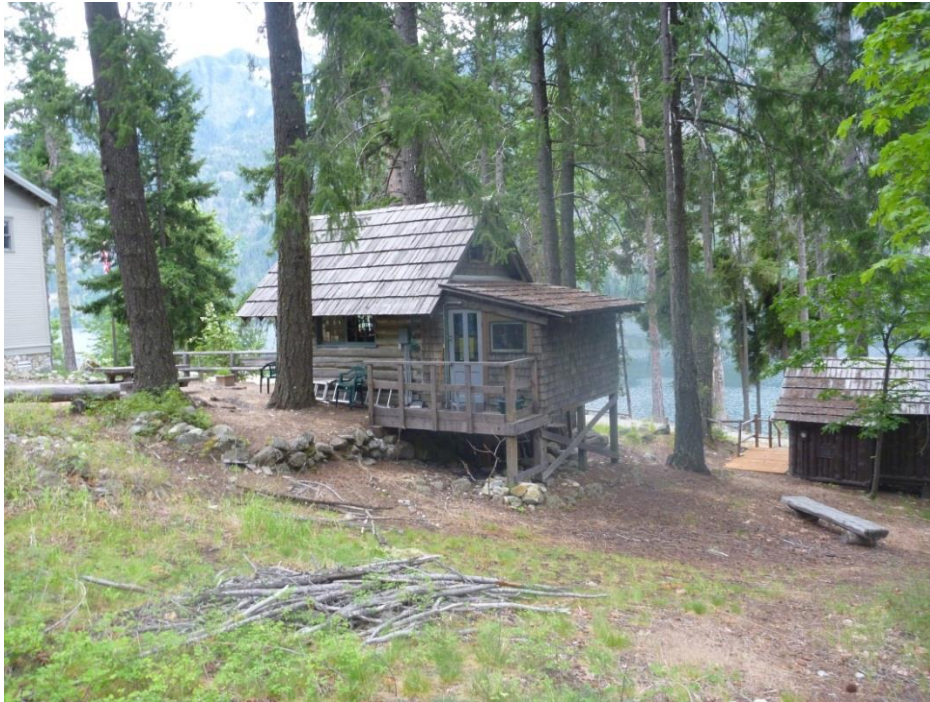
Natural Systems and Features #3: In the areas where the hillside was not terraced, buildings were built upon tall post and rock foundations to accommodate the change in grade. Photo of Cabin #14 (The House that Jack Built), looking southwest. (PWR, June 2103)

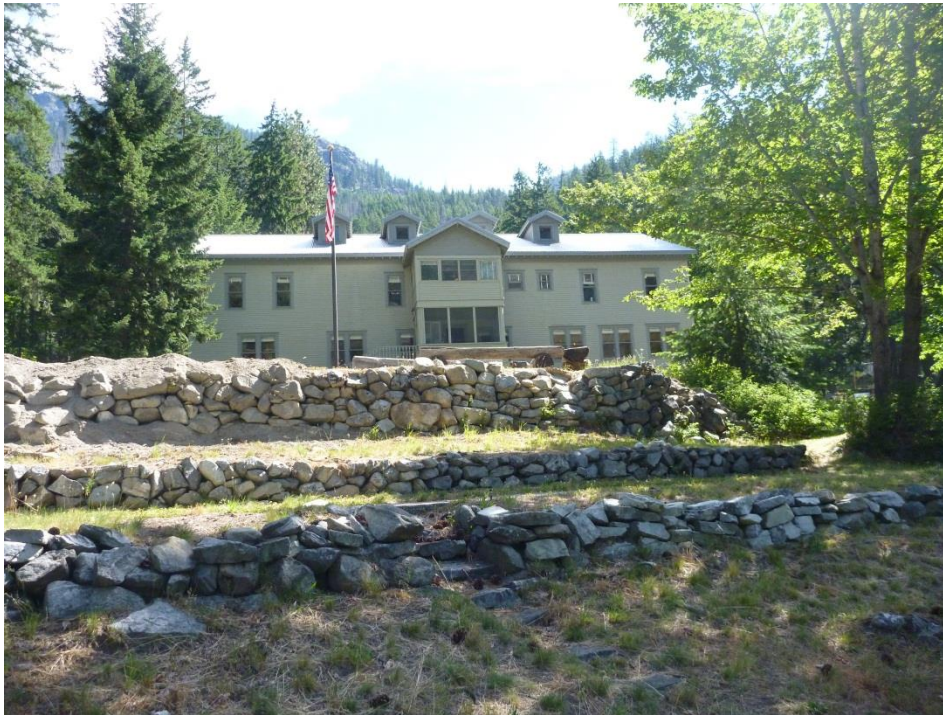
Spatial Organization #1: Golden West Lodge oriented toward Lake Chelan, perched above the terraces, looking northeast. (PWR, June 2013)

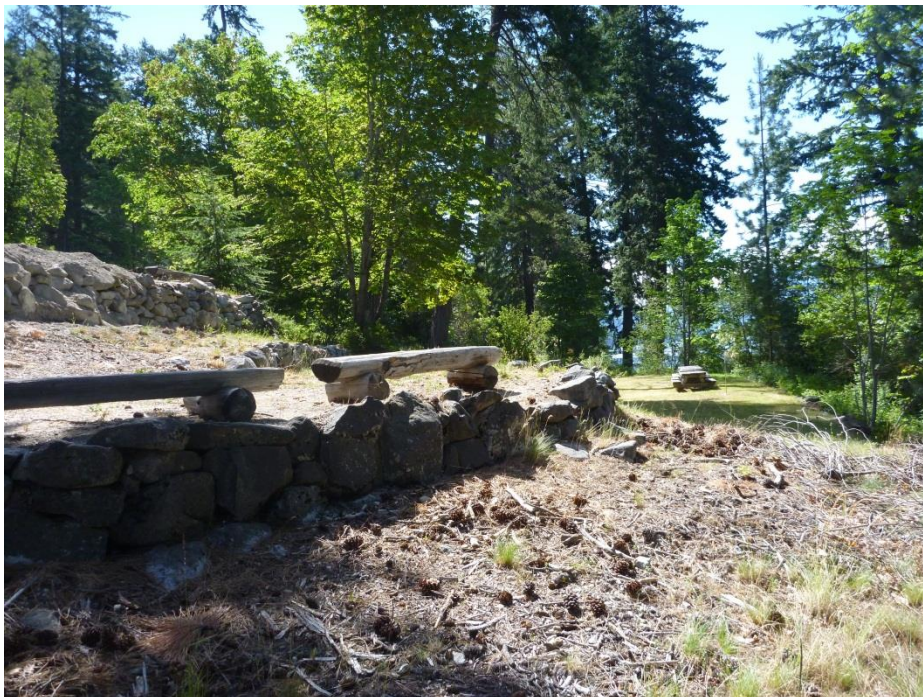
Spatial Organization #2: A series of terraces stepping down the slope provide flat areas for passive recreation. Open spaces are interspersed with groups of vegetation. (PWR, June 2013)

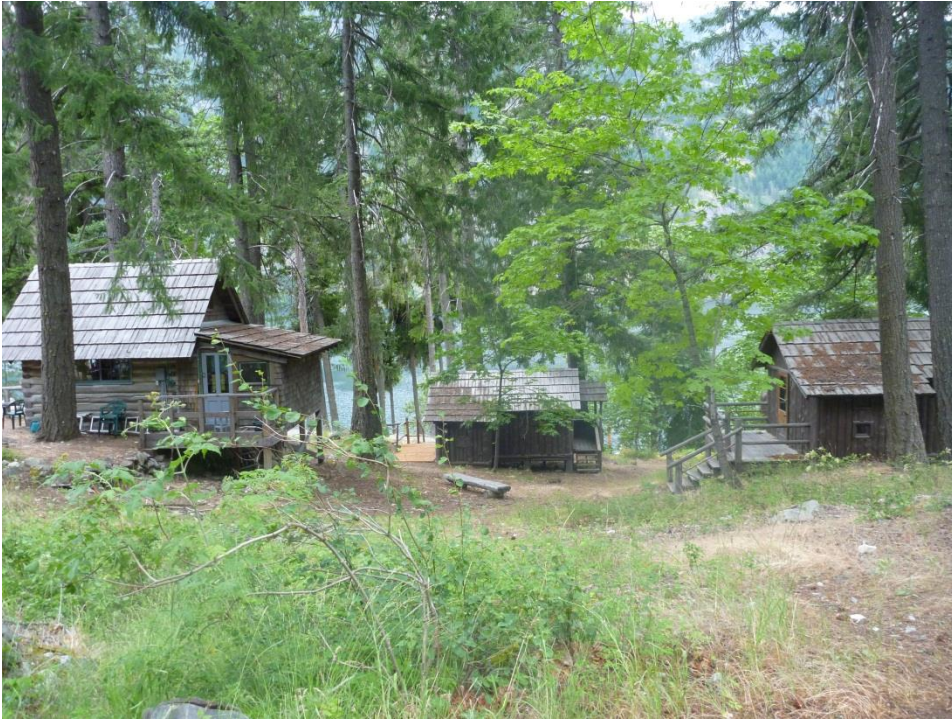
Spatial Organization #3: Cluster of cabins north of the Golden West Lodge: Cabins #14, #15, and #13 (from left to right), looking southwest. (PWR, June 2013)

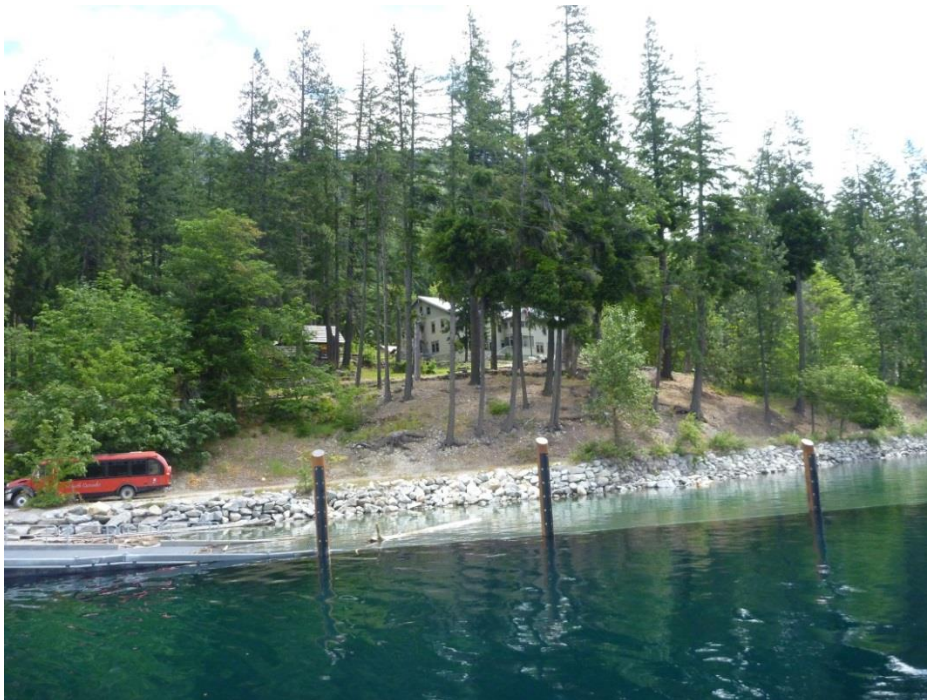
Views and Vistas #3: View of the Golden West Lodge, looking southeast, from the boat docked at Stehekin Landing. This view of the lodge is very similar to the historic view from the landing. (See History #6 photo.)

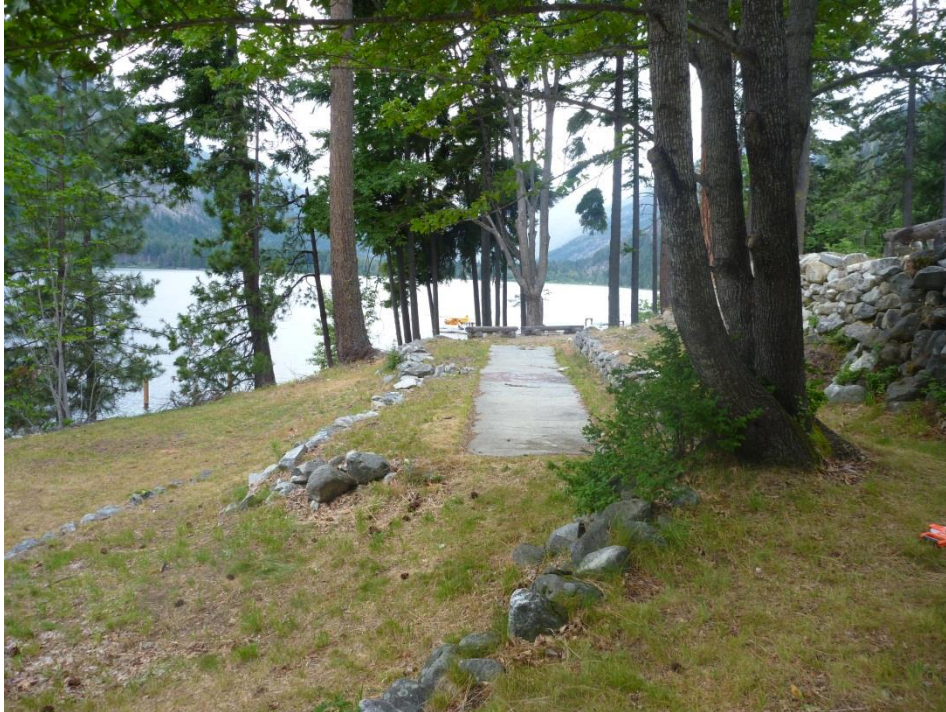
Topography #2: Shuffleboard located on one of the terraces southwest of the lodge, looking northwest. (PWR, June 2013)

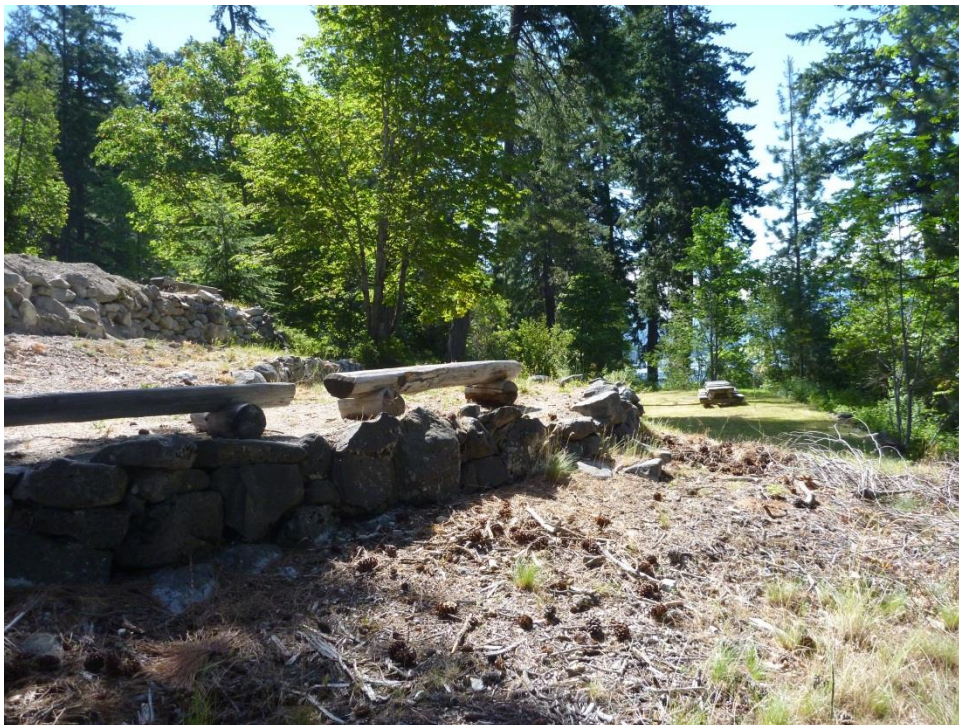
Topography #3: Series of terraces southwest of the lodge, looking southeast. (PWR, June 2013) Note the picnic area near the right side of photo.

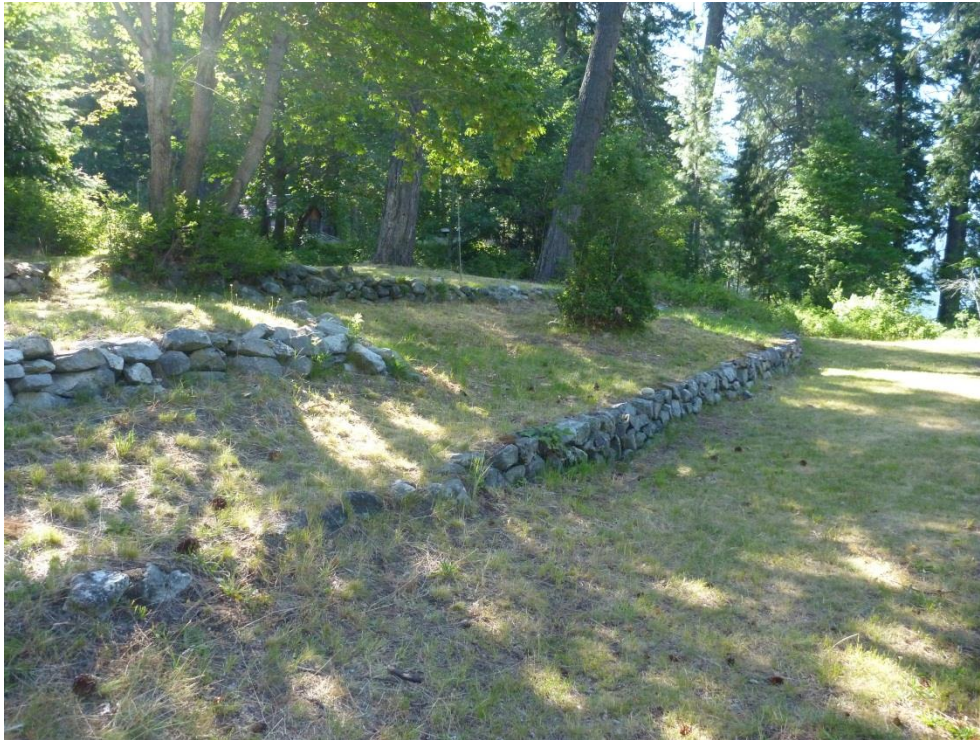
Topography #4: Terraces and walls located southwest of the lodge, looking southeast. (PWR, June 2013)  
The picnic area is the lowest terrace visible in photo (right).

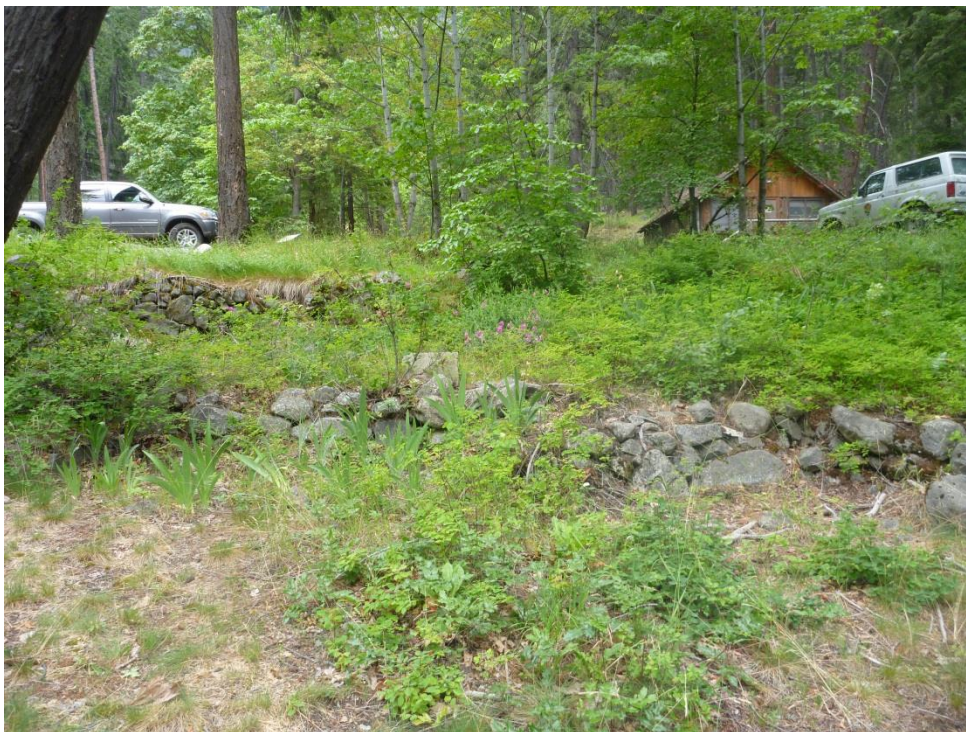
Topography #5: Overgrown terraces and walls south of the lodge, looking northeast, in the areas where the NPS removed several outbuildings in 1976. (PWR, June 2013)

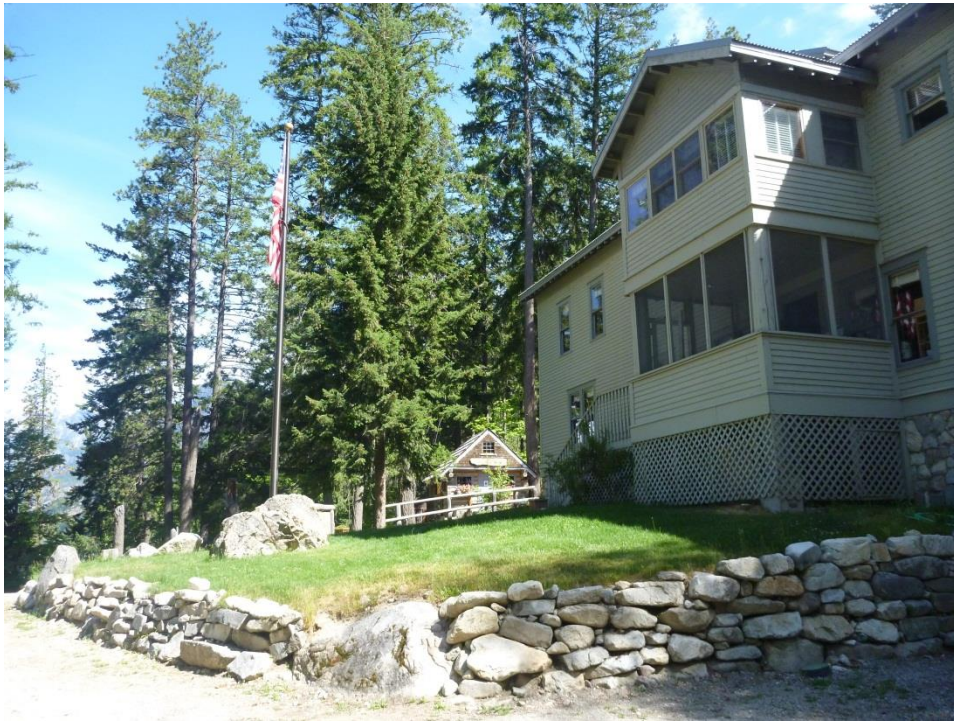
Topography #6: Rock walls in front of the lodge, looking northwest. (PWR, June 2013)

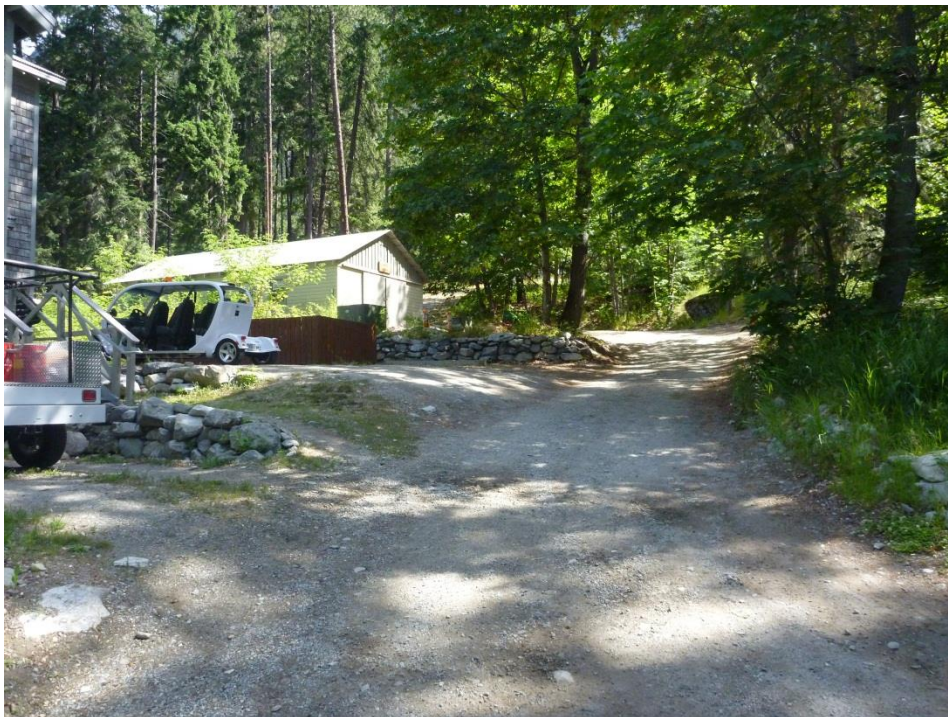
Topography #7: Terraces constructed more recently to create parking spaces east of the lodge, looking north. (PWR, June 2013)

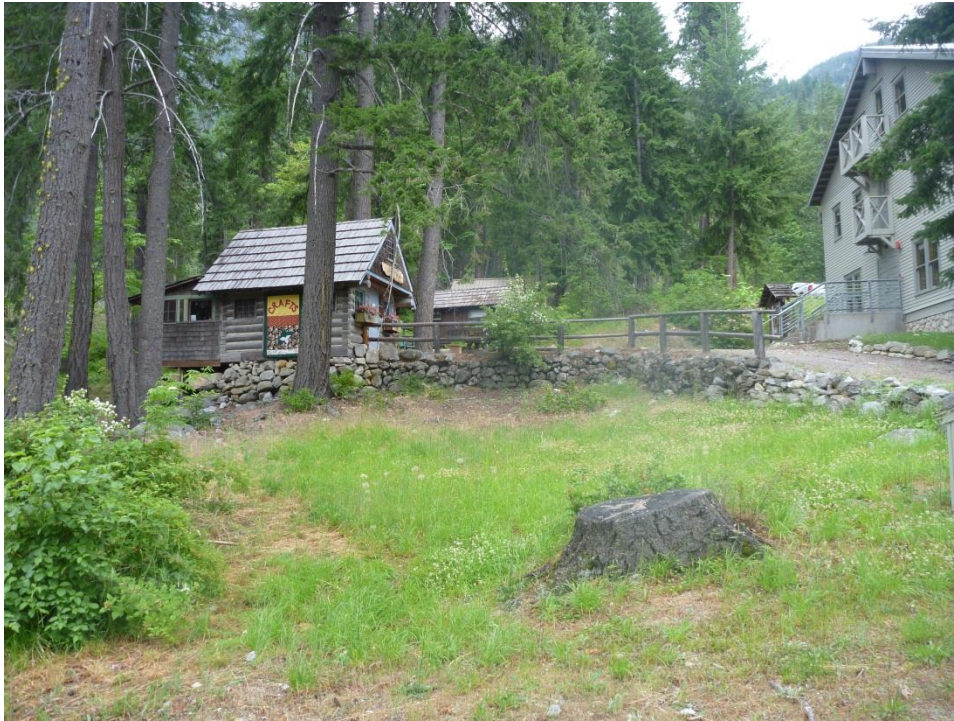
Topography #8: Rock wall on downhill side of the road around the lodge and Cabin #14 (The House that Jack Built), looking northeast. (PWR, June 2013)

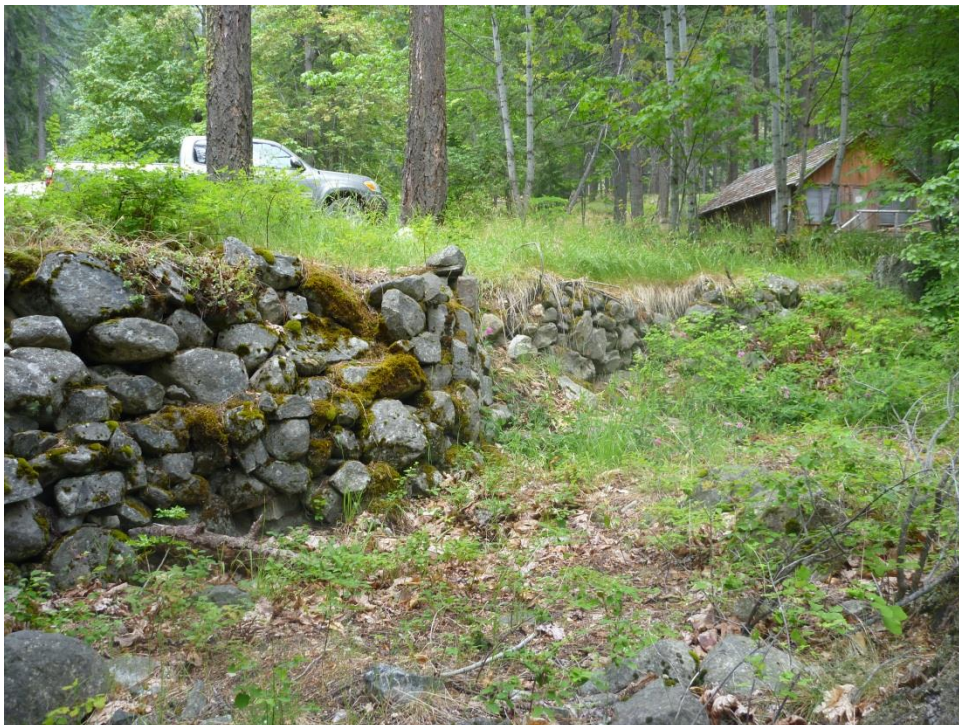
Topography #9: Rockwall supporting road segment near Cabin #11, looking east. (PWR, June 2013)

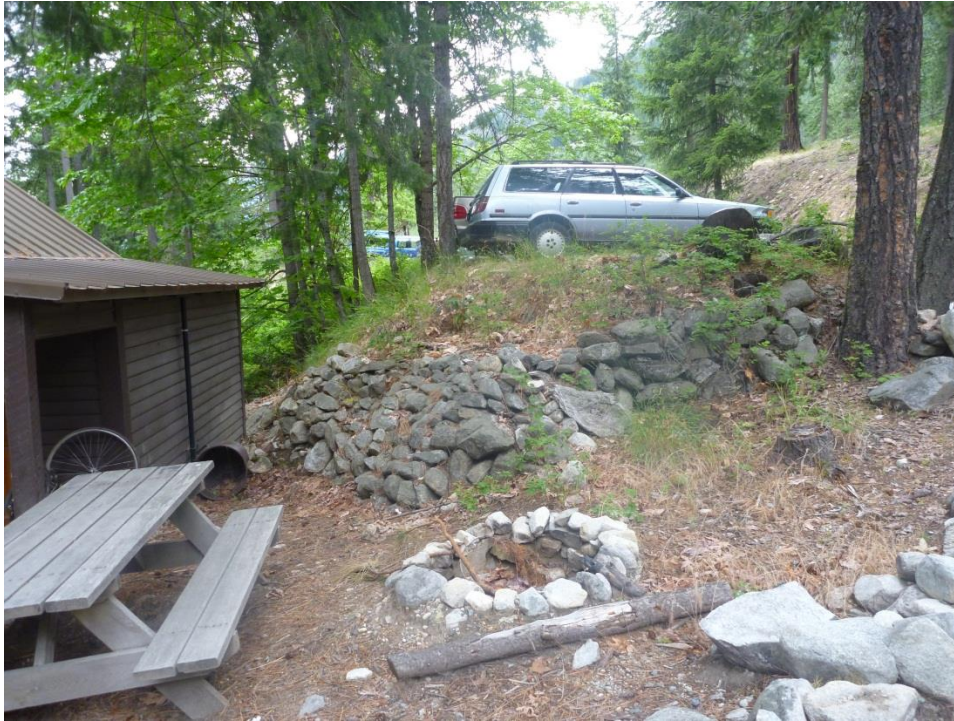
Topography #10: Retaining wall behind Cabin #10, looking northwest. (PWR, June 2013)

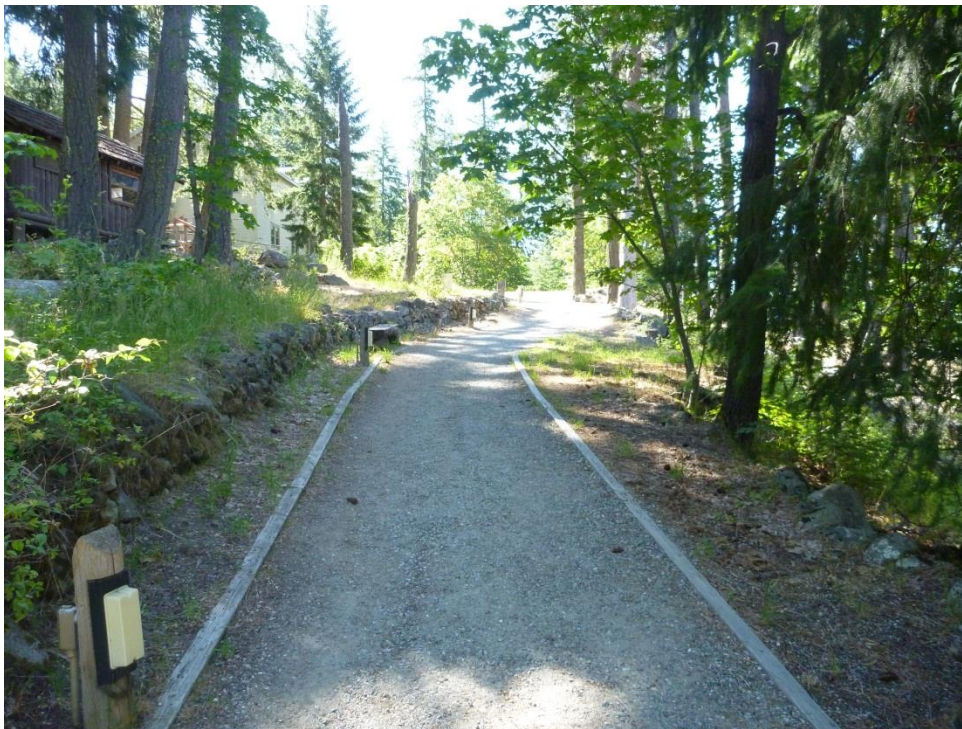
Circulation #1: Historic Access Road to the lodge, looking southeast. (PWR, June 2013) Note the historic width of the road bed is still visible between the rock walls on the uphill and downhill sides of the path.

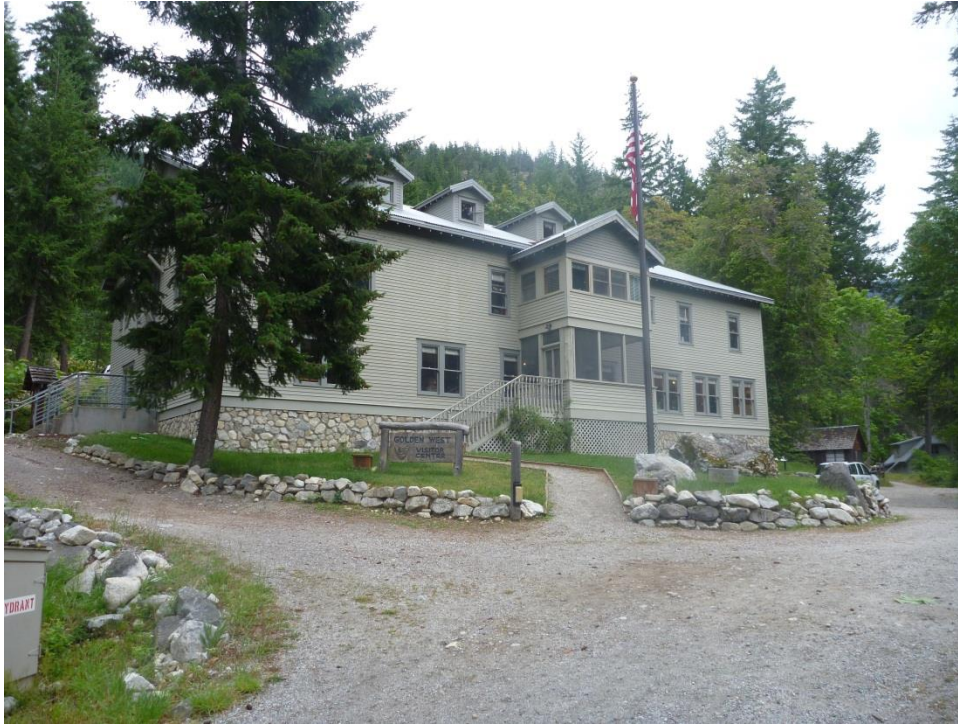
Circulation #2: Road around the Lodge and the reestablished entrance path to the lodge, looking east. (PWR, June 2013)

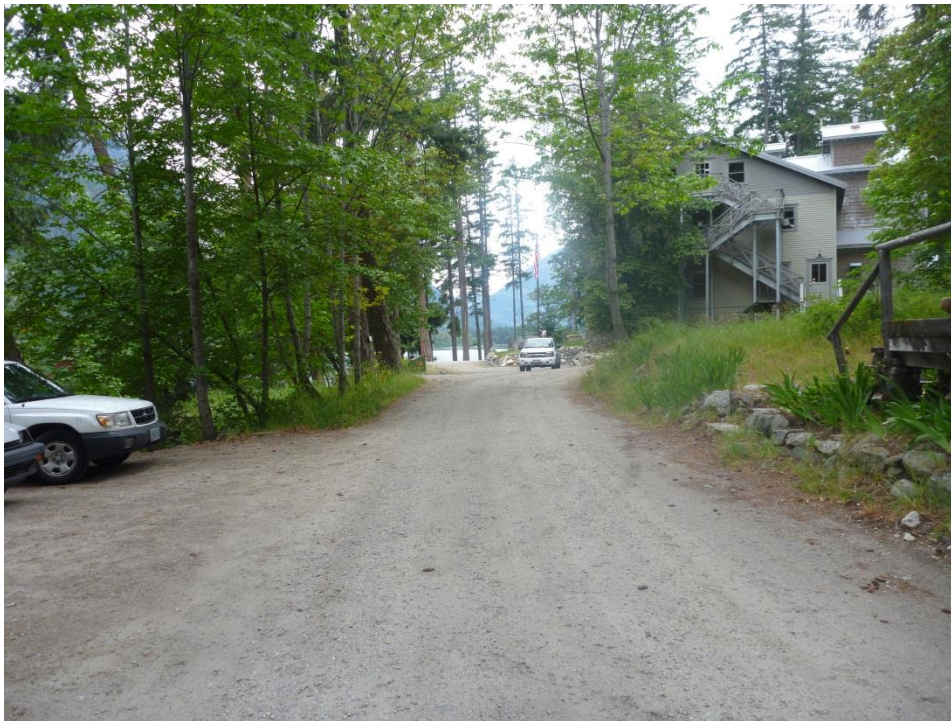
Circulation #3: Contributing road segment near Cabin #11, looking northwest. (PWR, June 2013)

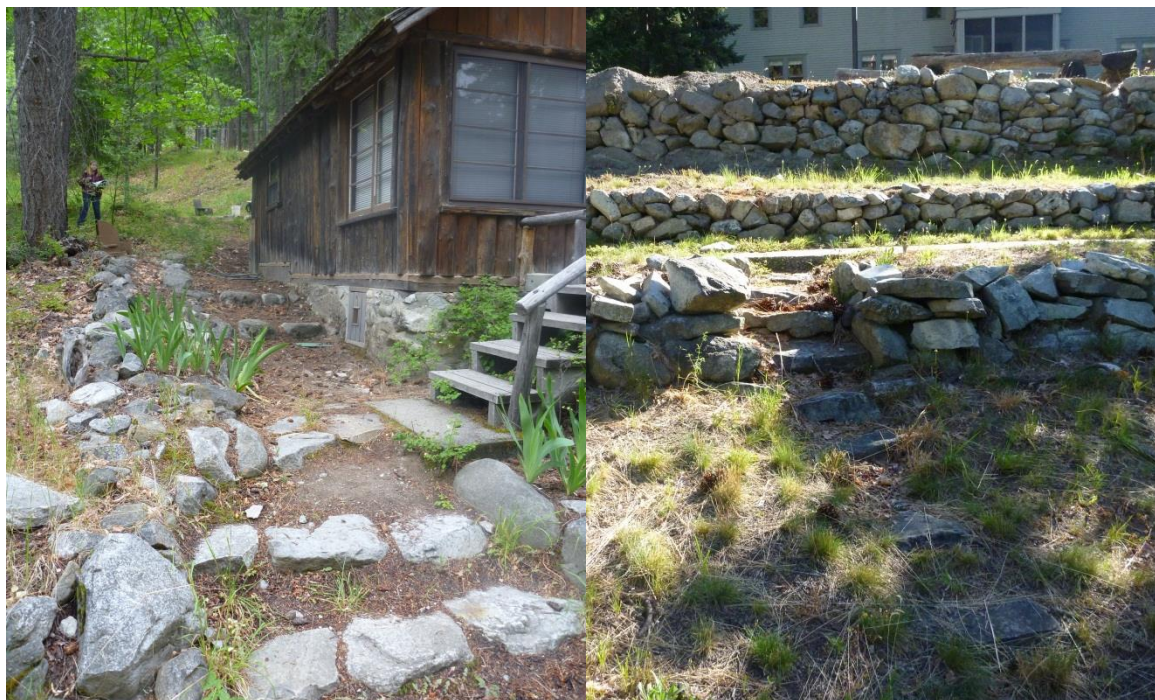
Circulation #4: Stone steps and paths at Cabin #11 (left) and the shuffleboard court (right). (PWR, June 2013)

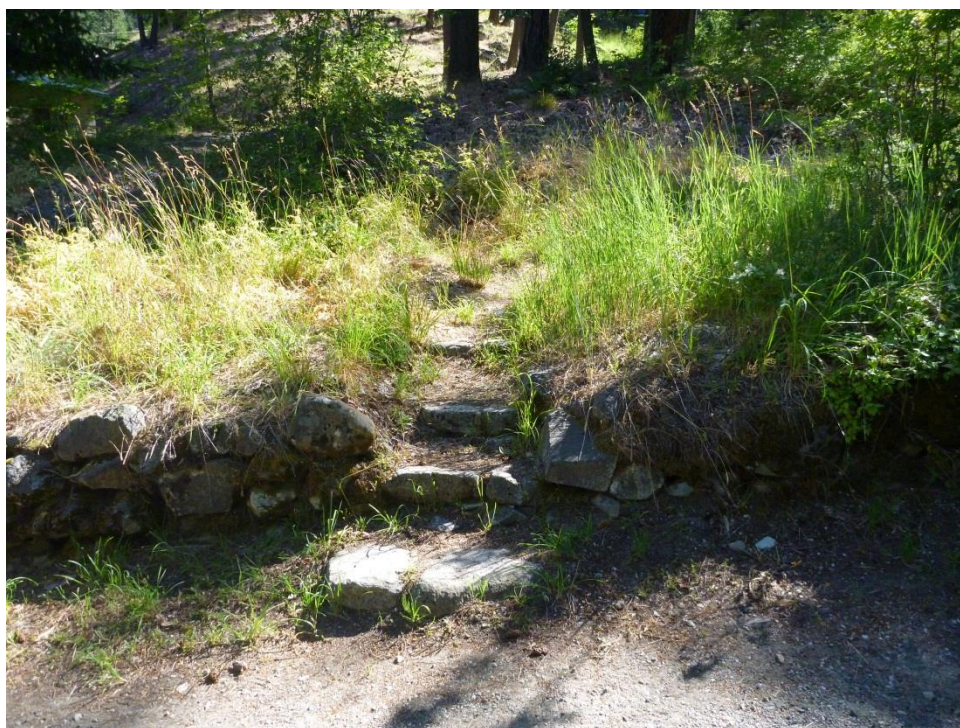
Circulation #5: Stone steps and path along the Historic Access Road, looking northeast. (PWR, June 2013)

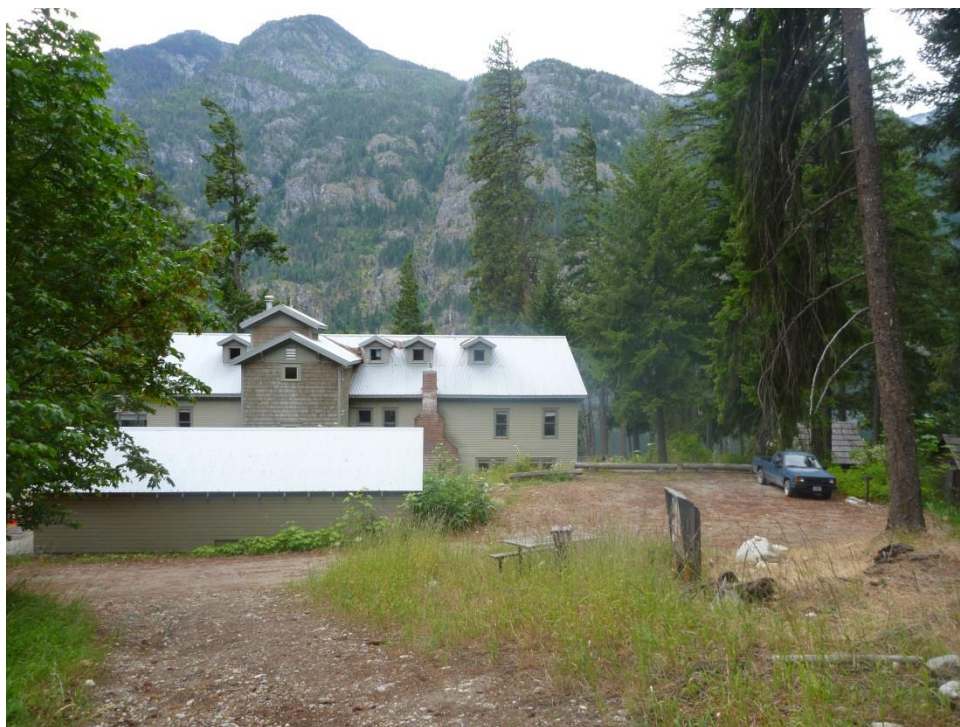
Circulation #6: Non-historic parking area near the Garage/Workshop, looking southwest. (PWR, June 2013)

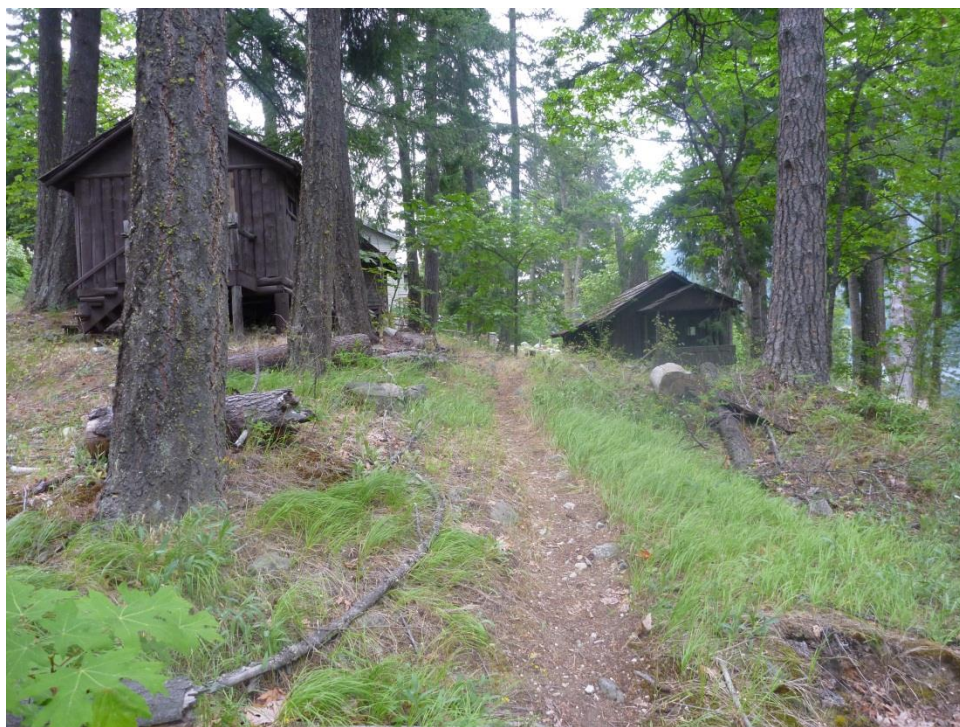
Circulation #7: Informal foot paths to cabins north of the lodge, looking southeast. (PWR, June 2013)

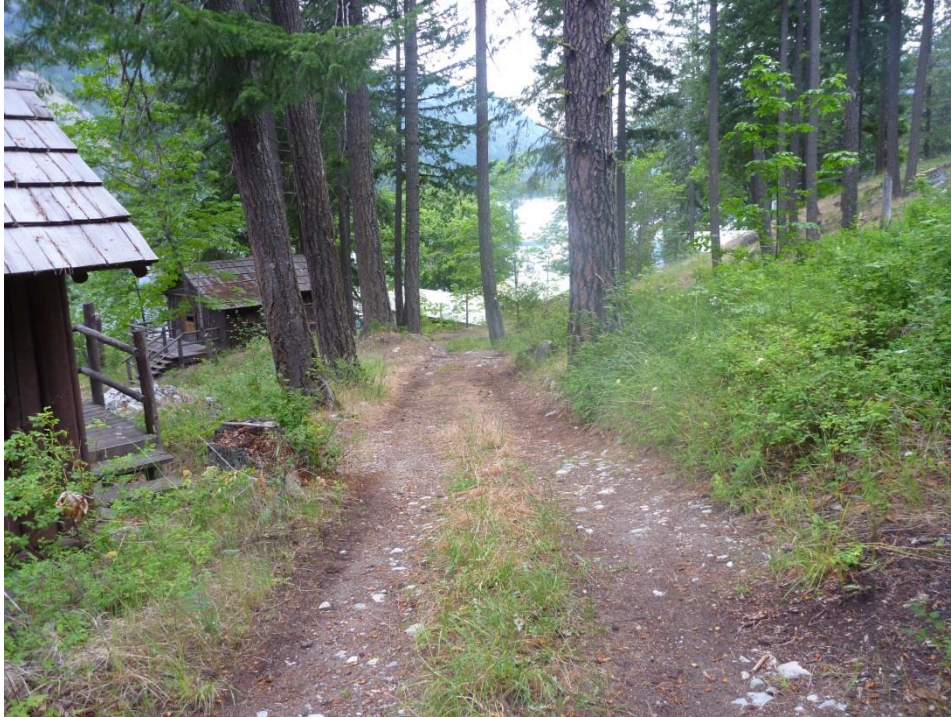
Circulation #8: Non-historic dirt road through cabin area, looking northwest. (PWR, June 2013)
