National Park Service  
Cultural Landscapes Inventory  
2015

Golden West Lodge Historic District  
North Cascades National Park Complex

## **Golden West Lodge Historic District** **North Cascades National Park Complex**

CONDITION ASSESSMENT:    **Fair**

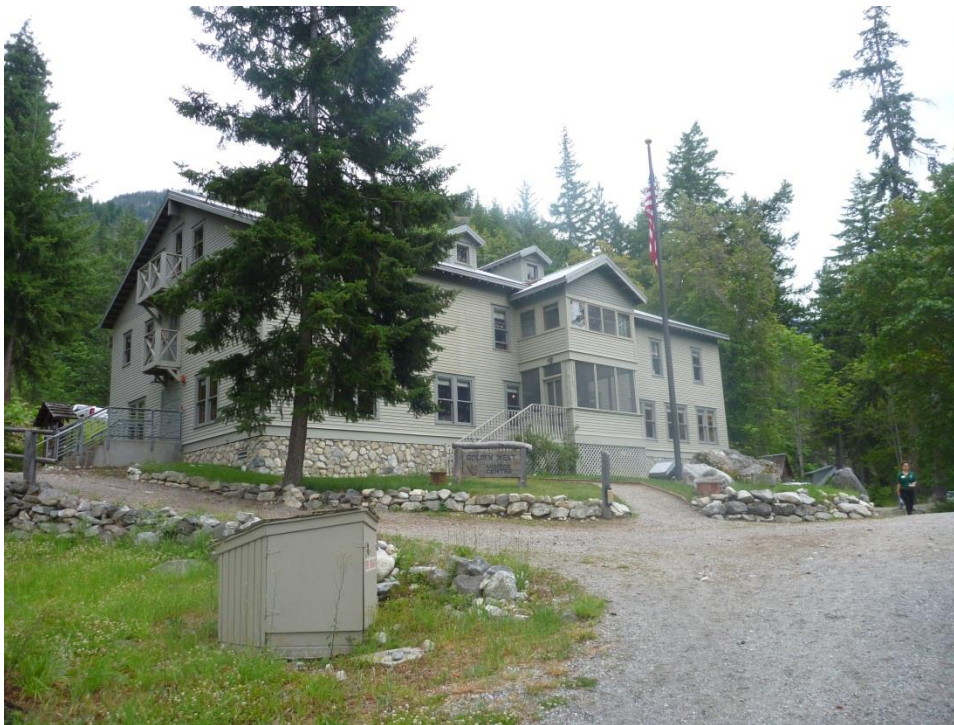
Buildings and Structures #1: Golden West Lodge, looking southeast. (PWRO, June 2013)

In the fall of 2002, a large rehabilitation project was undertaken on the Golden West Lodge in an effort to achieve the above-mentioned desired goals. As part of the project, the original rock rubble and mortar foundation was replaced to ensure that current building codes and associated seismic requirements were addressed. At least 18 hydraulic jacks were used to lift the Golden West, including the building’s large stone fireplace.<sup>10</sup> The interior of the building was also renovated to meet additional requirements. As a

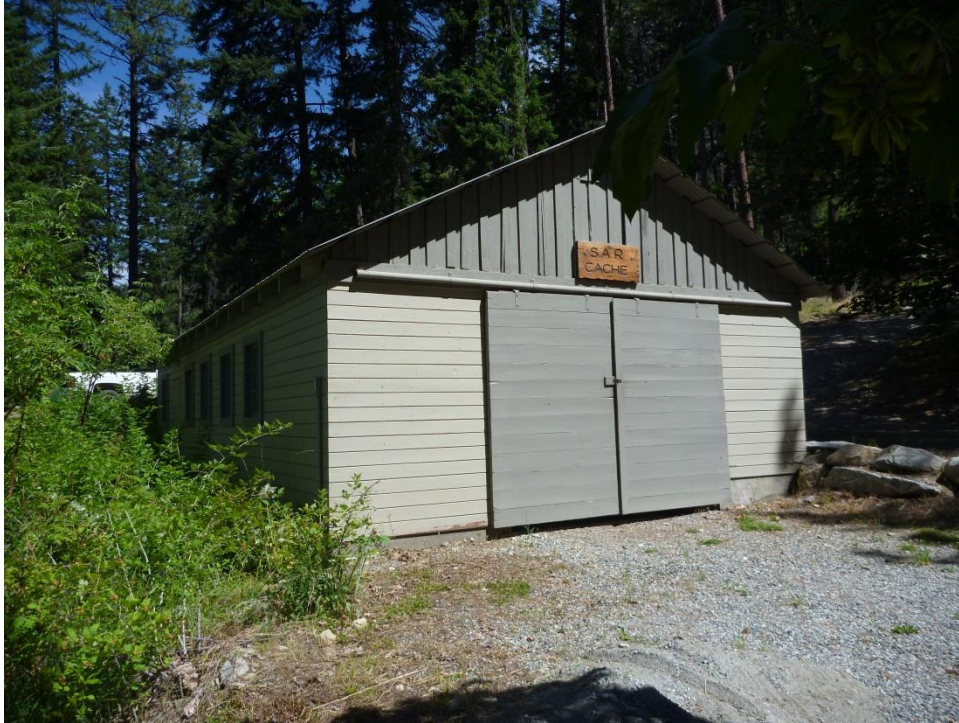
Buildings and Structures #2: Garage/Workshop, looking north. (PWRO, June 2013)

| 2008 | 2008 | Rehabilitated | The Garage/Workshop was rehabilitated. As part of this effort, a North Cascades National Park historic preservation crew disassembled the deteriorating structure, poured a new concrete slab with stem walls, rebuilt the walls with new and restored material, structurally upgraded the truss system, re-roofed the building, replaced missing windows, rebuilt the exterior door and repainted the building. |

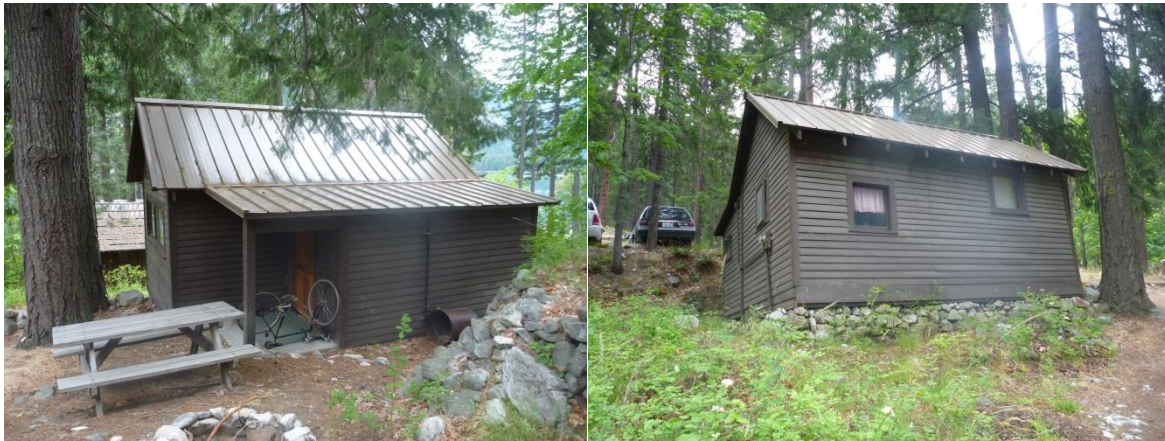
Buildings and Structures #3: Cabin #10, looking west (left) and east (right). (PWRO, June 2013)

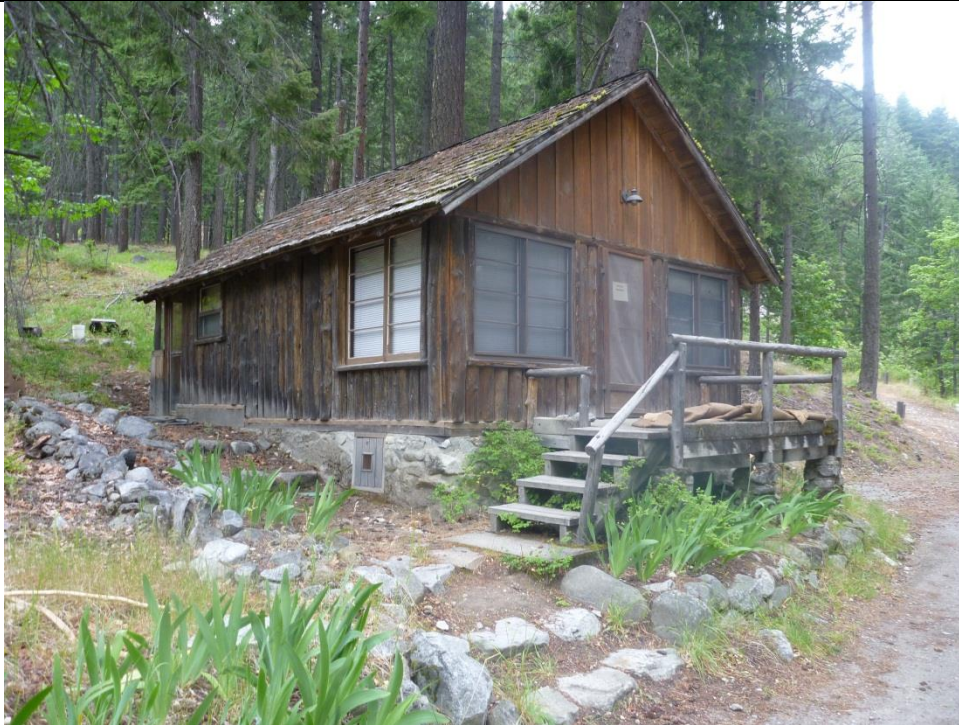
Buildings and Structures #4: Cabin #11, looking northeast. (PWRO, June 2013)

| 2002 | 2003 | Stabilized | Preservation maintenance activities were undertaken on Cabin #11, which included replacement of porch support timbers, steps and log hand railings as well as the replacement of pine board and batten on the front gable end of the building. In addition, many interior improvements were made and the building was finished with a new cedar shake roof and cedar cap. |

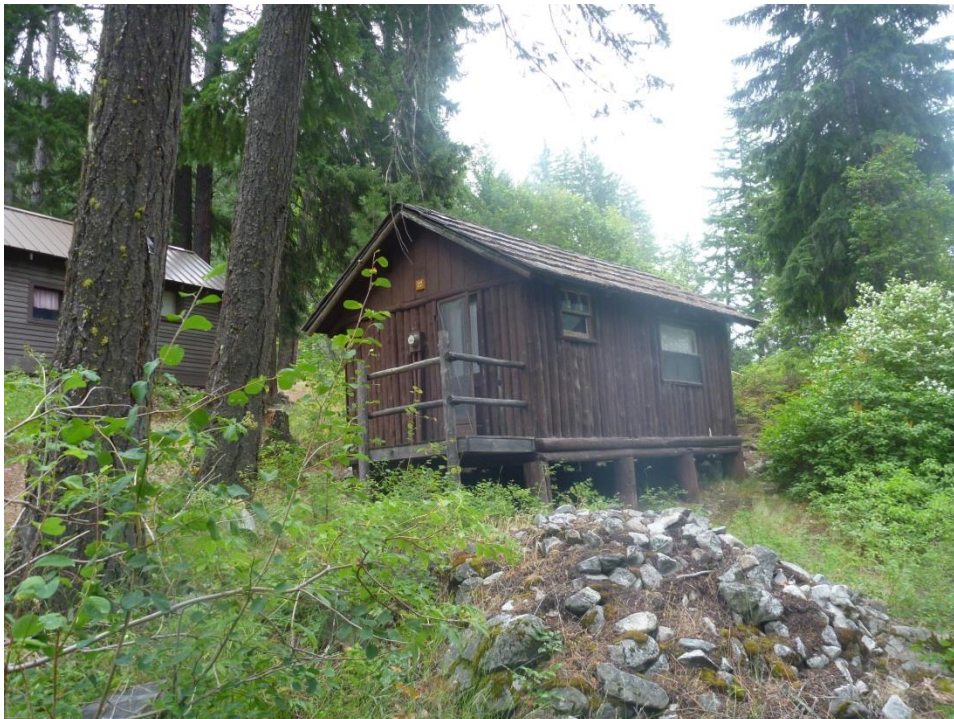
Buildings and Structures #5: Cabin #12, looking east. (PWRO, June 2013)

| 2003 | 2003 | Stabilized | Preservation maintenance activities were undertaken on Cabin #12, which included replacement of broken windows, rotten exterior siding, the roofing ridge cap and shingles. In addition, structural timbers were replaced as necessary. |

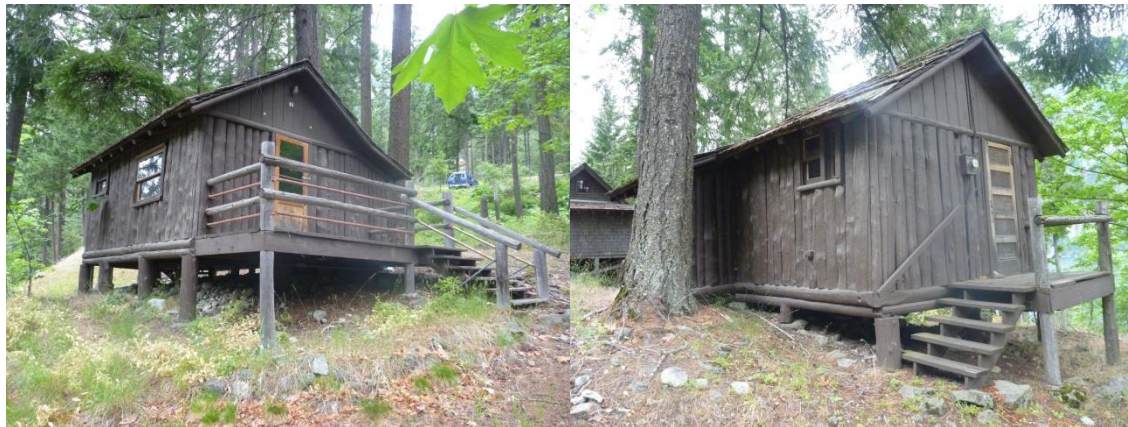
Buildings and Structures #6: Cabin #13, looking north (left) and east (right). (PWRO, June 2013)

| 1997 | 1997 | Stabilized | Preservation maintenance activities were undertaken on Cabin #13, Cabin #14 and Cabin #15. Work addressed structural deficiencies. |

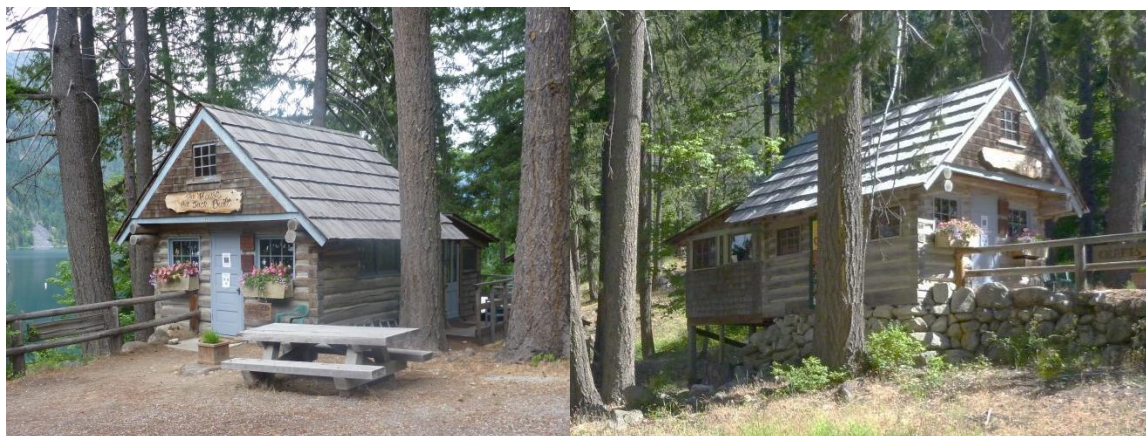
Buildings and Structures #7: Cabin #14 (House that Jack Built), looking west (left) and north (right). (PWRO, June 2013)

| 2002 | 2002 | Stabilized | Preservation maintenance activities were undertaken on Cabin #14, which included the replacement of 800 square feet of cedar roofing and sheathing. |

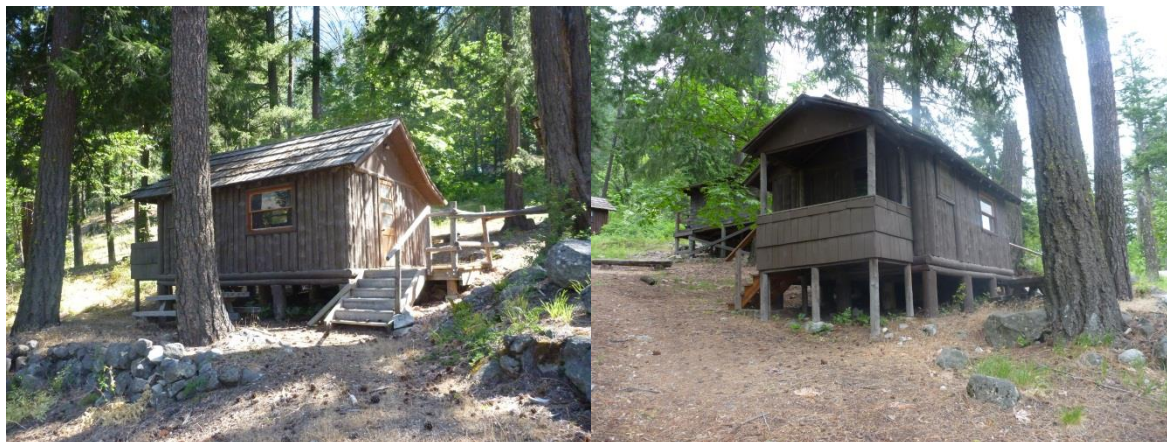
Buildings and Structures #8: Cabin #15, looking north (left) and east (right). (PWRO, June 2013)

| 2002 | 2002 | Stabilized | Preservation maintenance activities were undertaken on Cabin #15, which included the replacement of 499 square feet of cedar roofing, sheathing and associated structural components. |

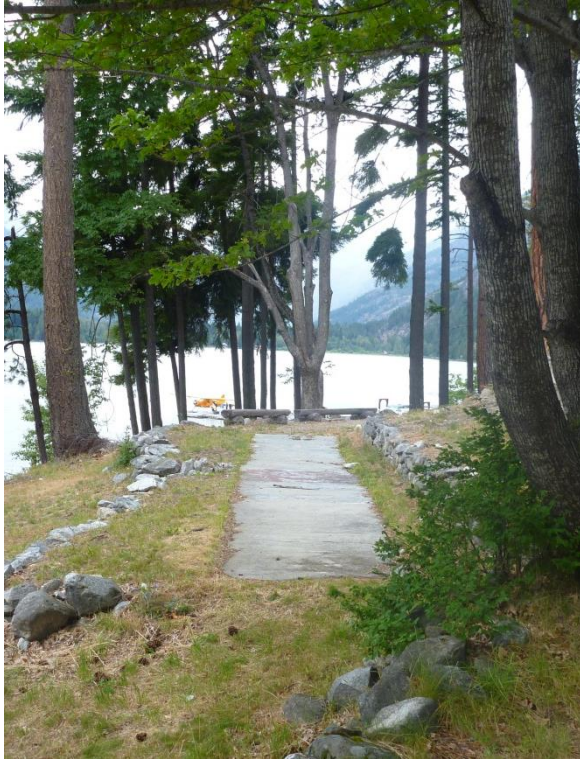
Buildings and Structures #9: Shuffleboard Court, looking northwest. (PWRO, June 2013)

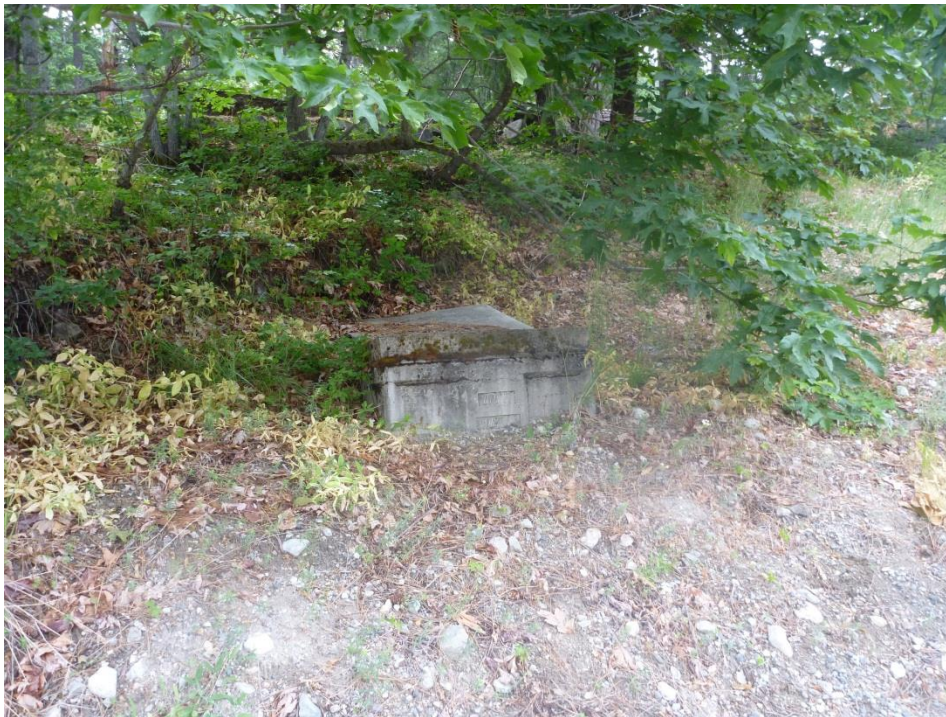
Buildings and Structures #10: Concrete Vault, looking northeast. (PWRO, June 2013)

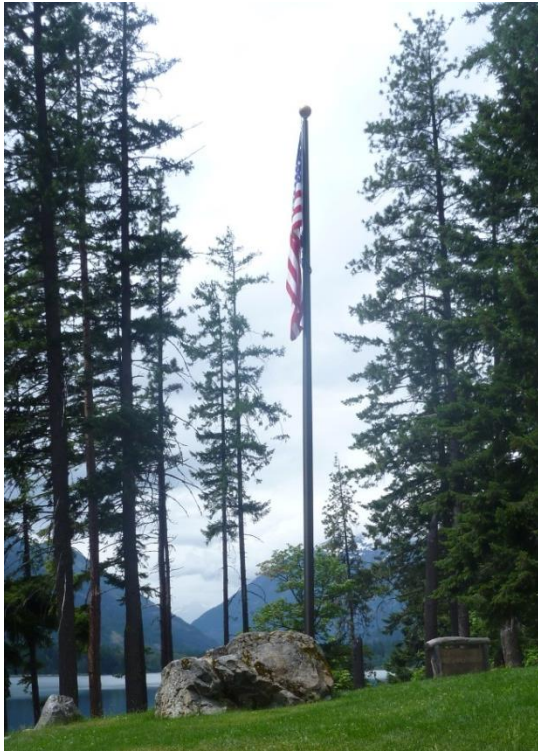
Small Scale Features #2: Flag pole located in front of the Golden West Lodge, looking northwest. (PWR, June 2013)

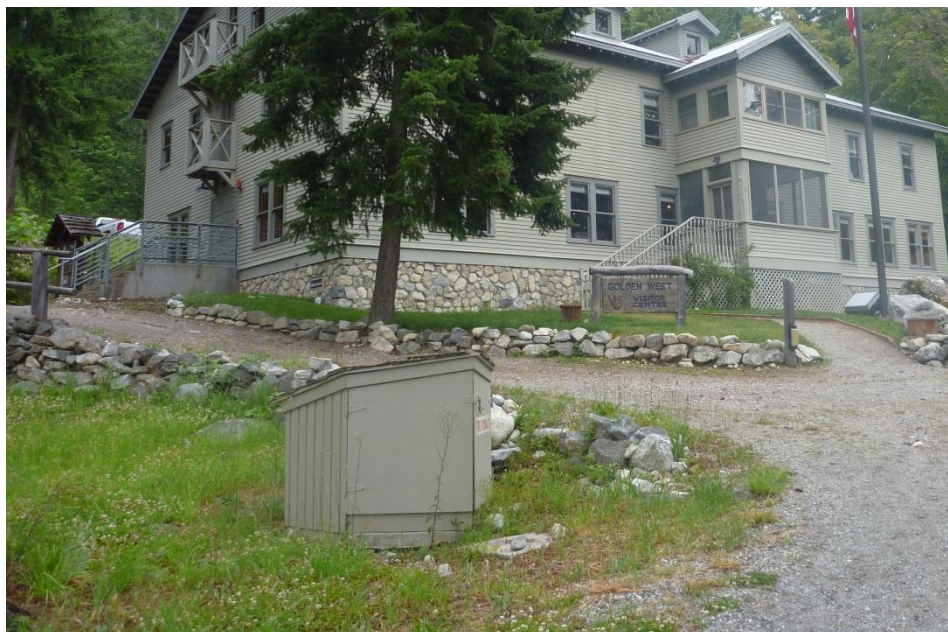
Small Scale Features #4: A firehouse located near the Golden West Lodge at the southernmost end of the Historic Access Road (current pedestrian route), looking southeast. (PWR, June 2013)

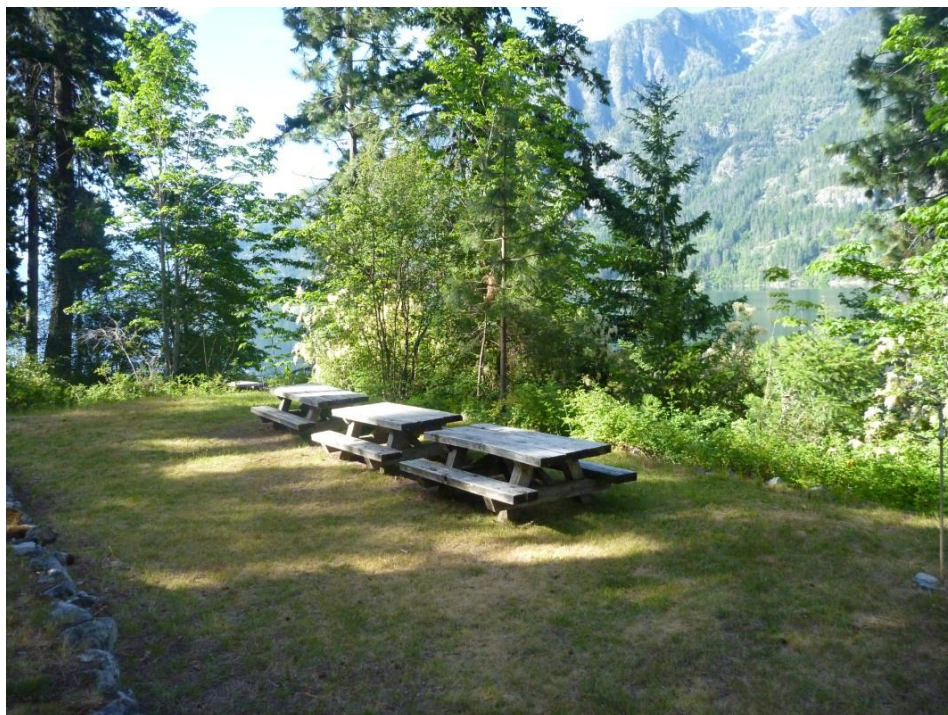
Small Scale Features #5: Wood picnic tables located on a terrace downhill from the Golden West Lodge, looking south. (PWR, June 2013)

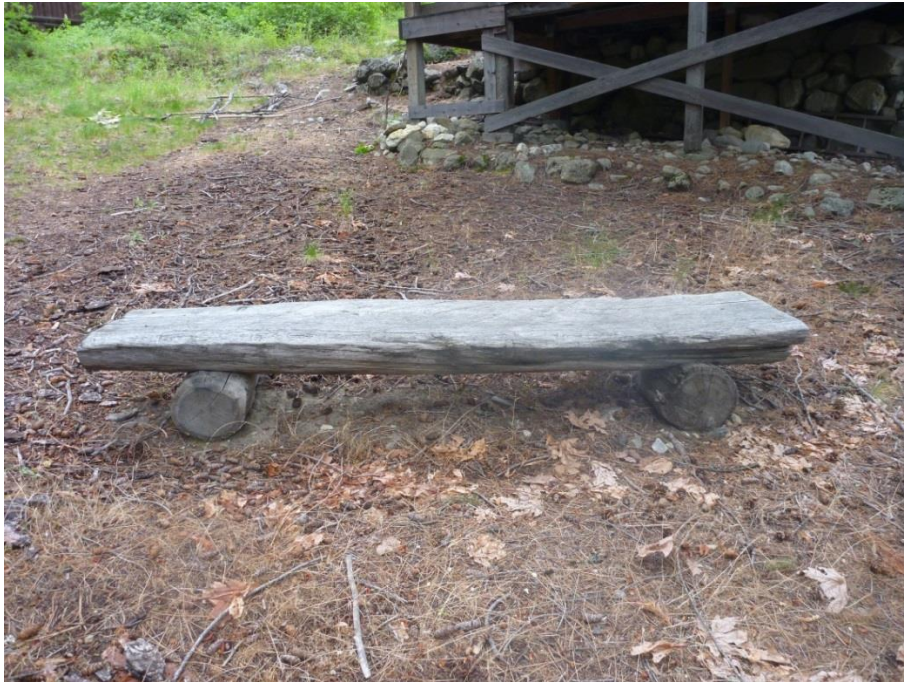
Small Scale Features #6: Example of a typical log bench found at the Golden West Lodge Historic District. (PWR, June 2013)

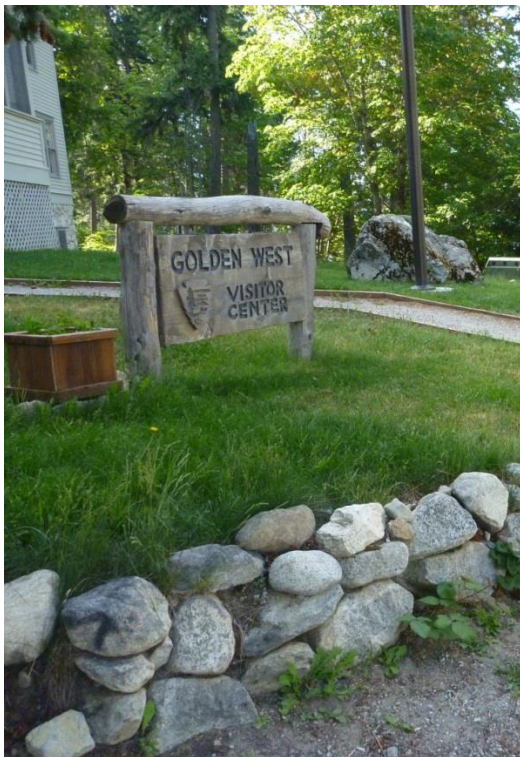
Small Scale Features #7: Wooden sign at front entrance of the Golden West Lodge (Visitor Center), looking northeast. (PWR, June 2013)

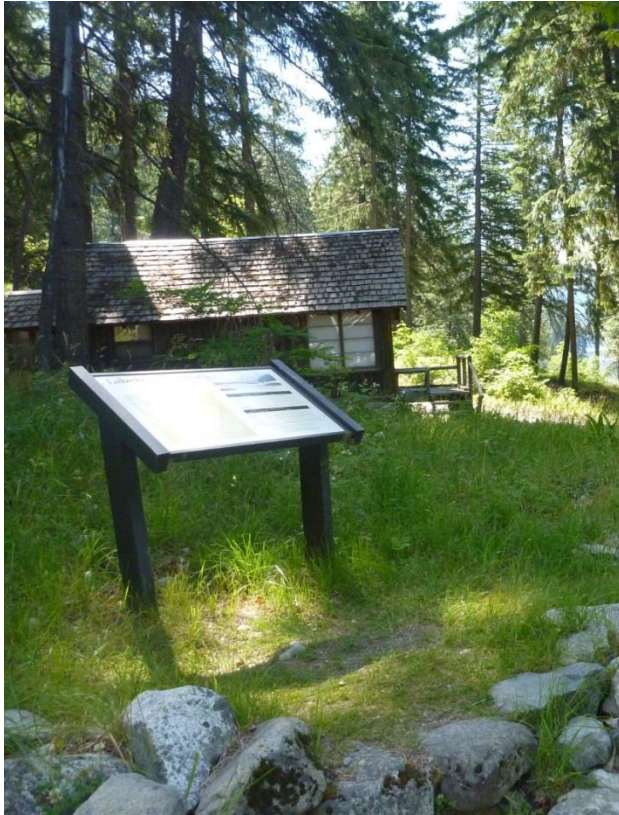
Small Scale Features #8: Example of an interpretive sign located near Cabin #11, looking south. (PWR, June 2013)

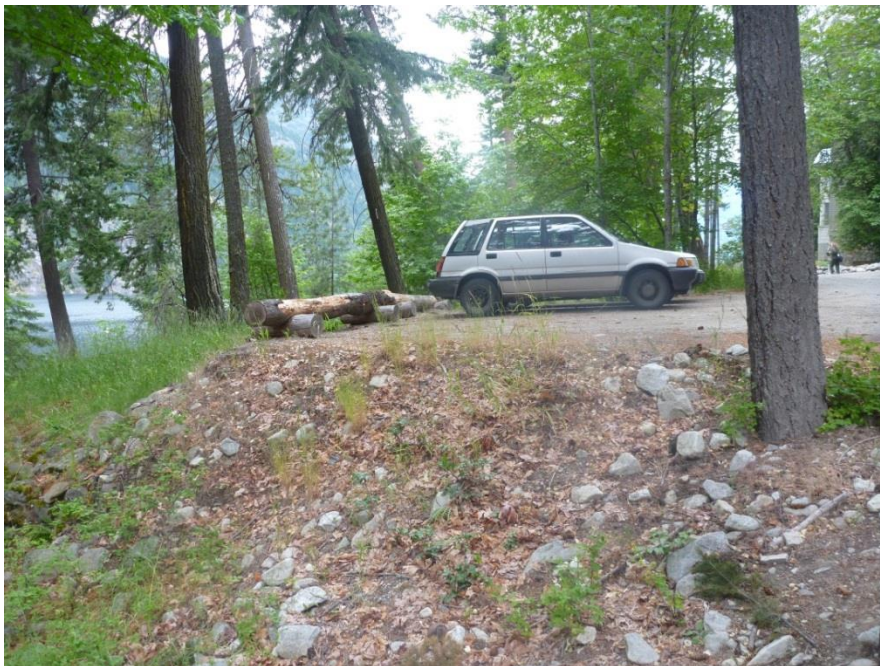
Small Scale Features #9: Log barriers in a parking area south of the Golden West Lodge, looking northwest. (PWR, June 2013)

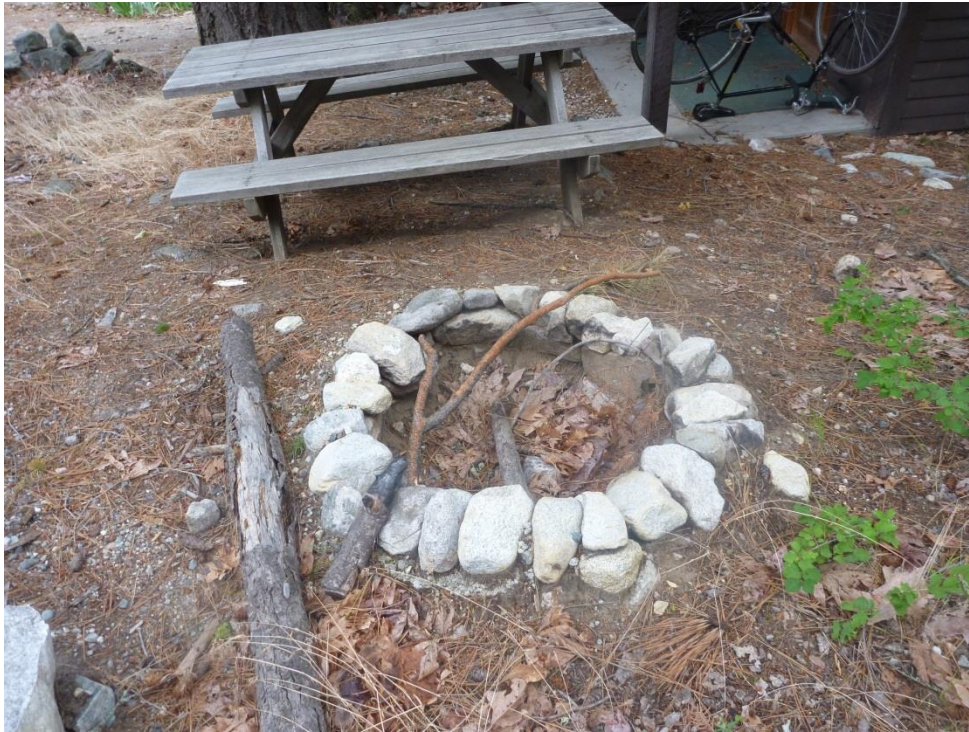
Small Scale Features #10: Fire pit located at eastern corner of Cabin #10. (PWR, June 2013)

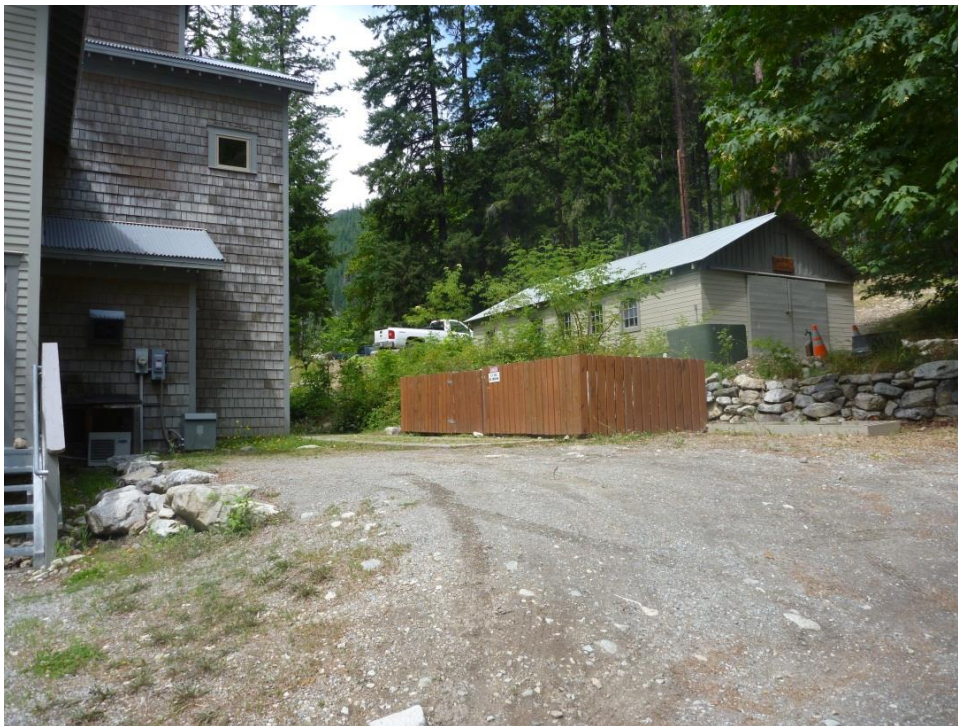
Small Scale Features #11: Fence around propane tank, at southeastern corner of the Golden West Lodge, looking northeast. (PWR, June 2013)

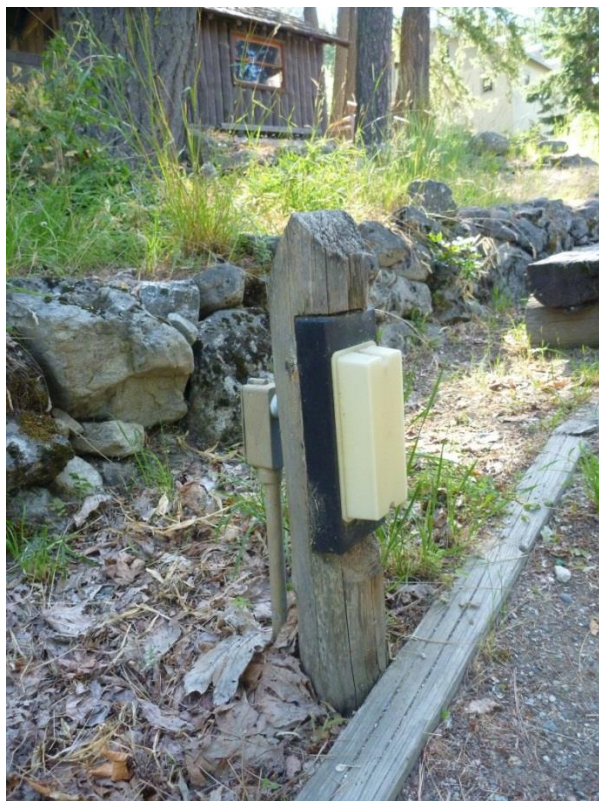
Small Scale Features #12: Lighting along main path, looking southeast. (PWR, June 2013)

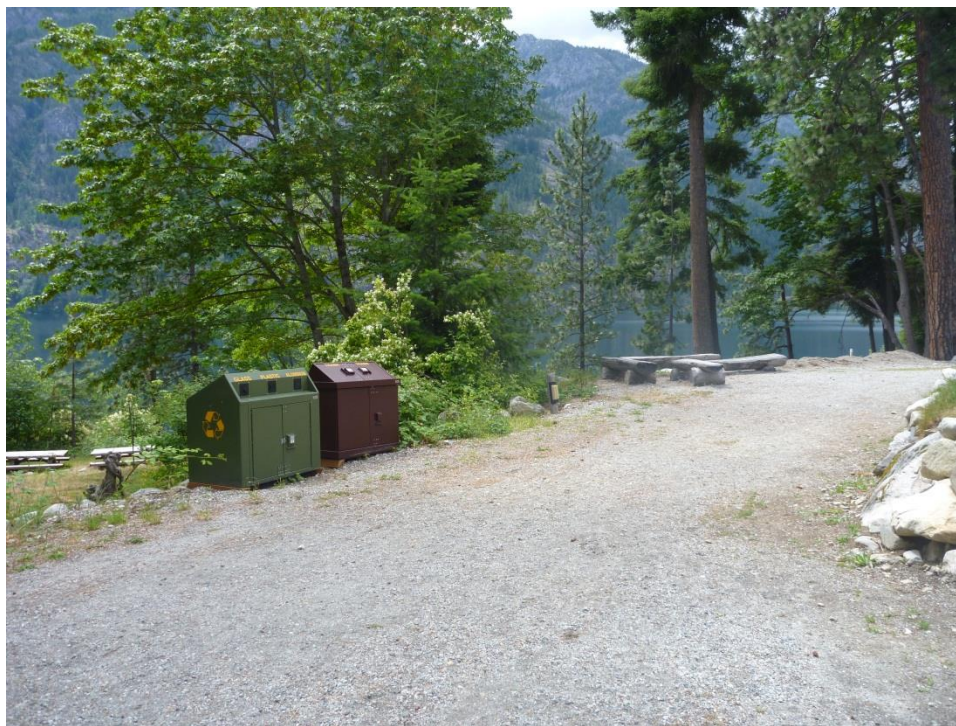
Small Scale Features #13: Garbage and recycling cans located southwest of the Golden West Lodge, looking northwest. (PWR, June 2013)

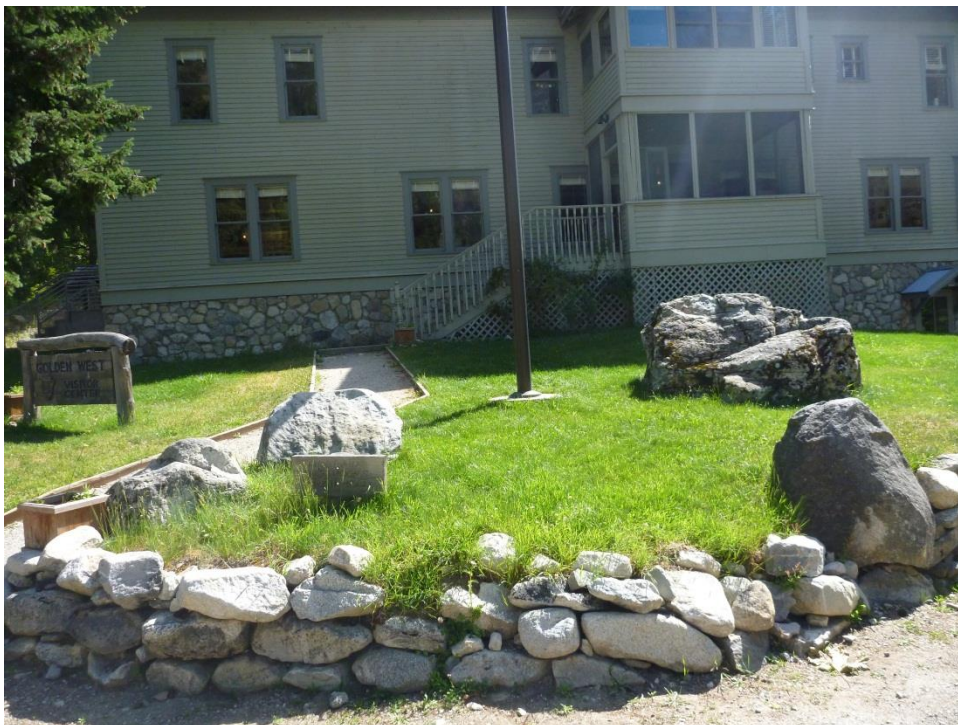
Vegetation #1: Lawn in front of the lodge, looking northeast. (PWR, June 2013)

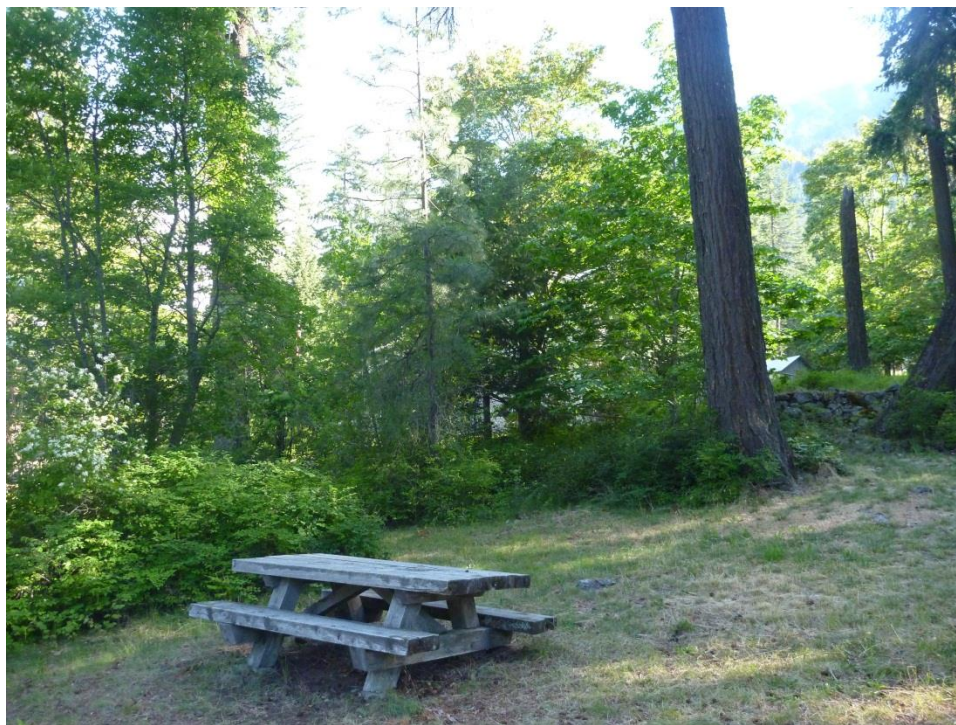
Vegetation #2: Groupings of native and non-native plants interspersed with lawn south of the lodge, looking north. (PWR, June 2013)

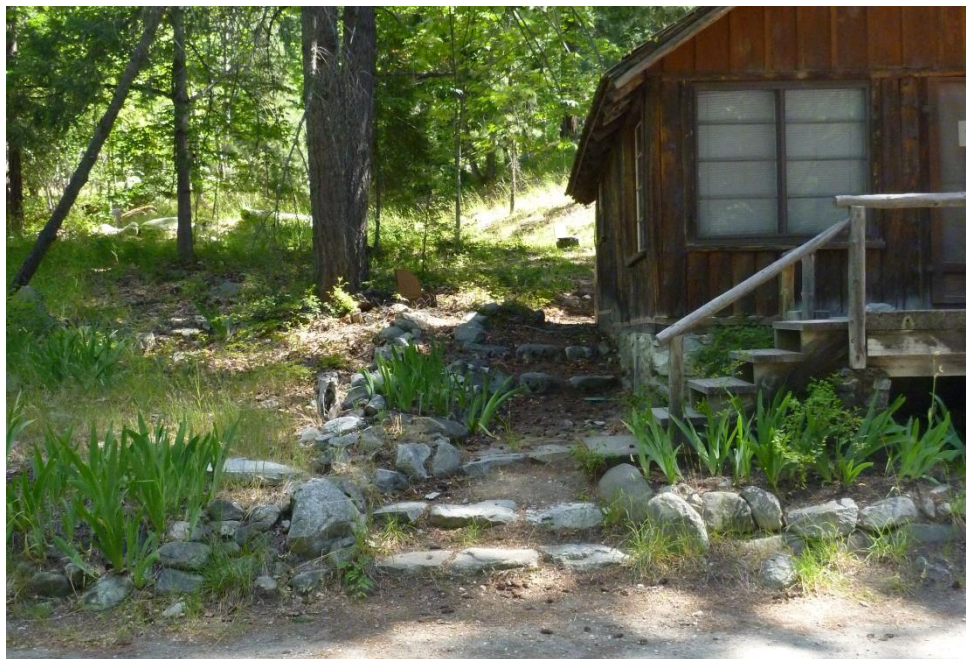
Vegetation #3: Irises growing around Cabin #11, looking northeast. (PWR, June 2013)

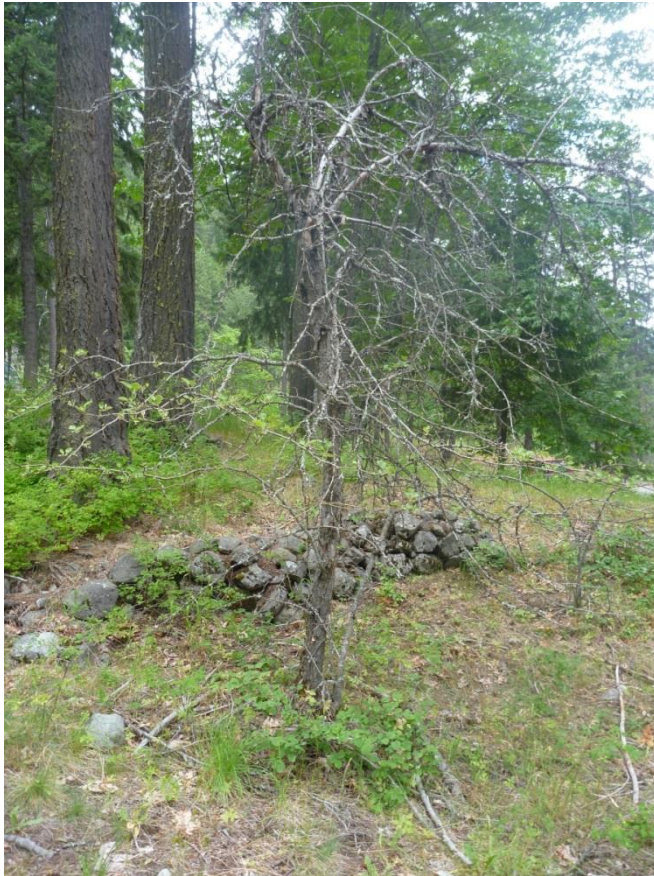
Vegetation #4: A struggling fruit tree located in terraced area south of the lodge, looking south. (PWR, June 2013)

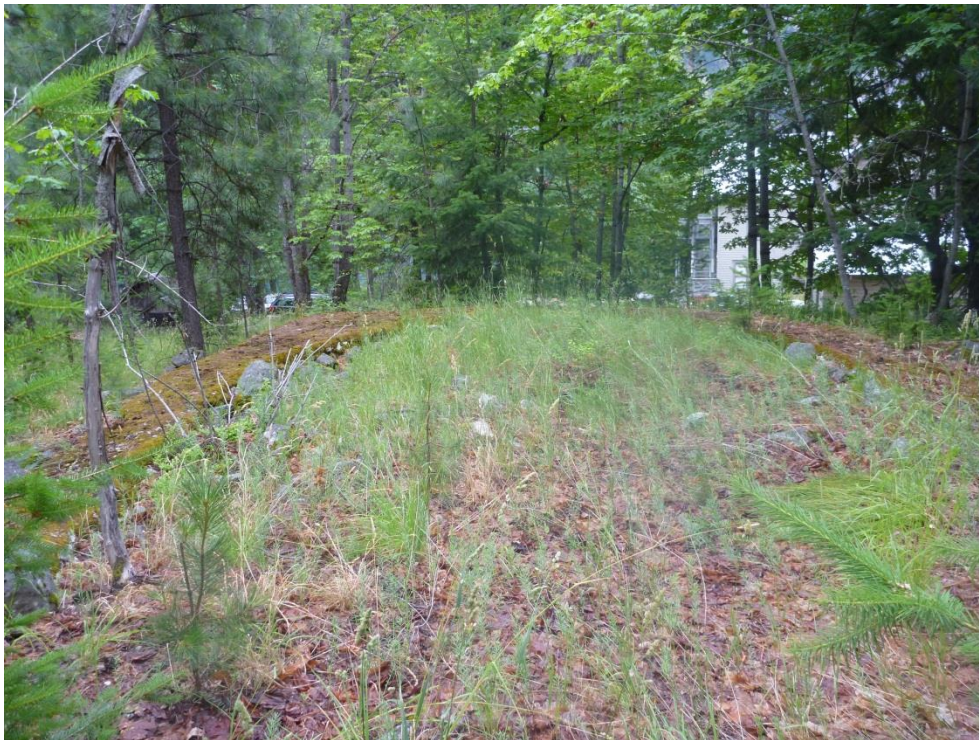
Archeological Sites #1: Swimming Pool Ruin, looking southwest. (PWR, June 2103)

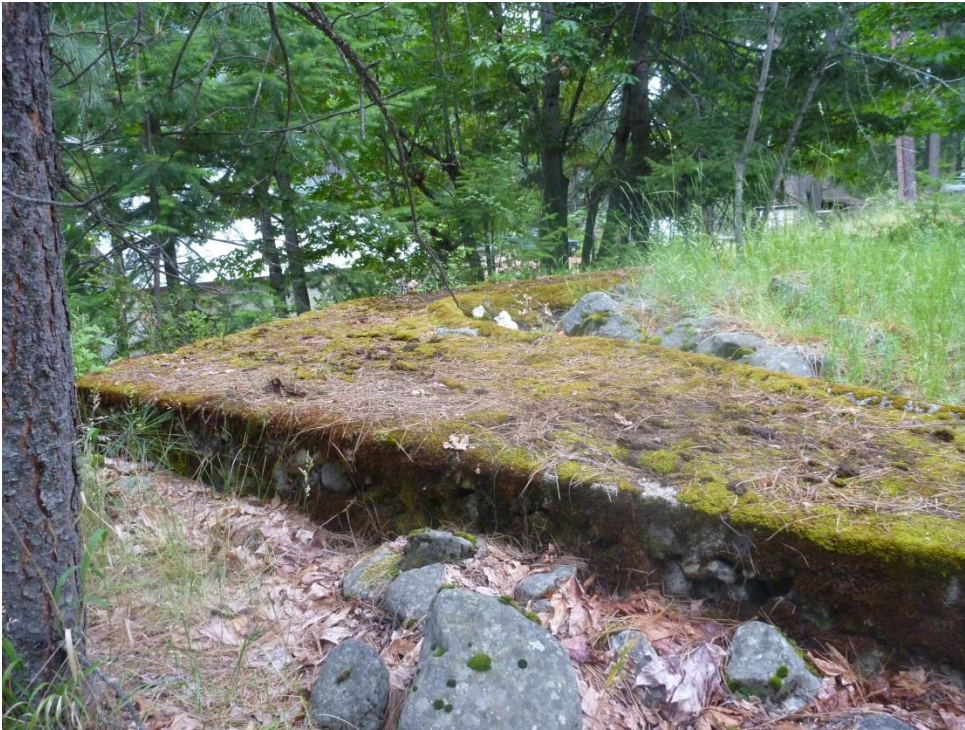
Archeological Sites #2: Southwestern end of the Swimming Pool Ruin, looking west. (PWR, June 2103)

**Impact Description:** Plants, grasses, small woody vegetation, leaf litter and woody debris has filled the swimming pool. Additionally, mosses and lichens have become established on the perimeter walls, which are trapping moisture hastening the deterioration of this feature.

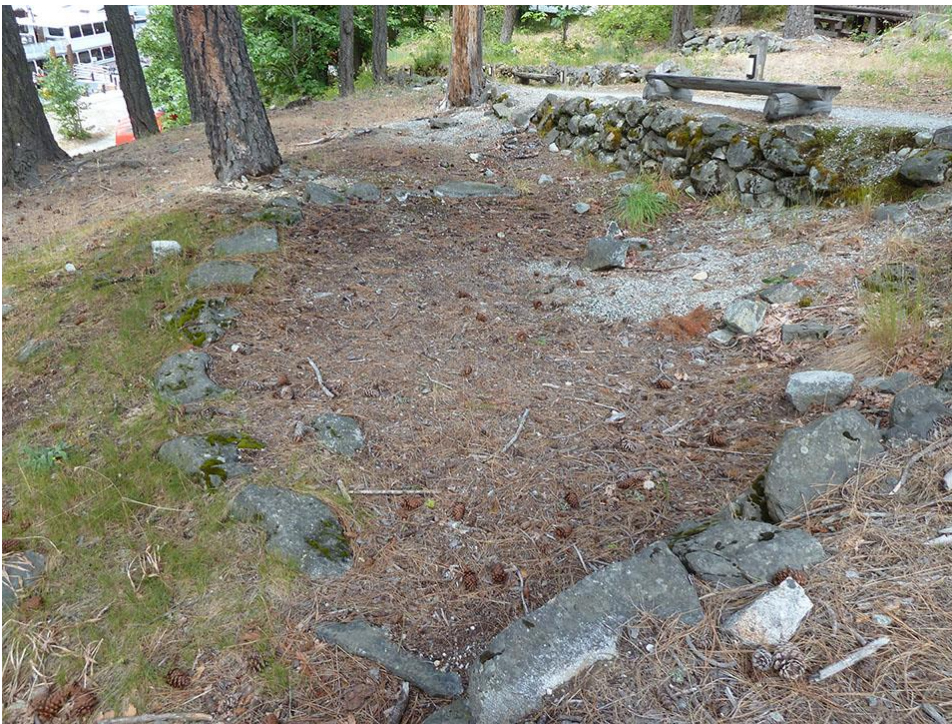
Archeological Sites #3: Fish Pond Ruin, looking northwest. (PWR, June 2103) The edges of the oval pond are still evident by the stones set in the ground in the shape of an arc.
