National Park Service  
Cultural Landscapes Inventory  
2002

High Bridge Ranger Station  
North Cascades National Park

**National Park Service  
Cultural Landscape Inventory  
2002**

**High Bridge Ranger Station  
North Cascades National Park**

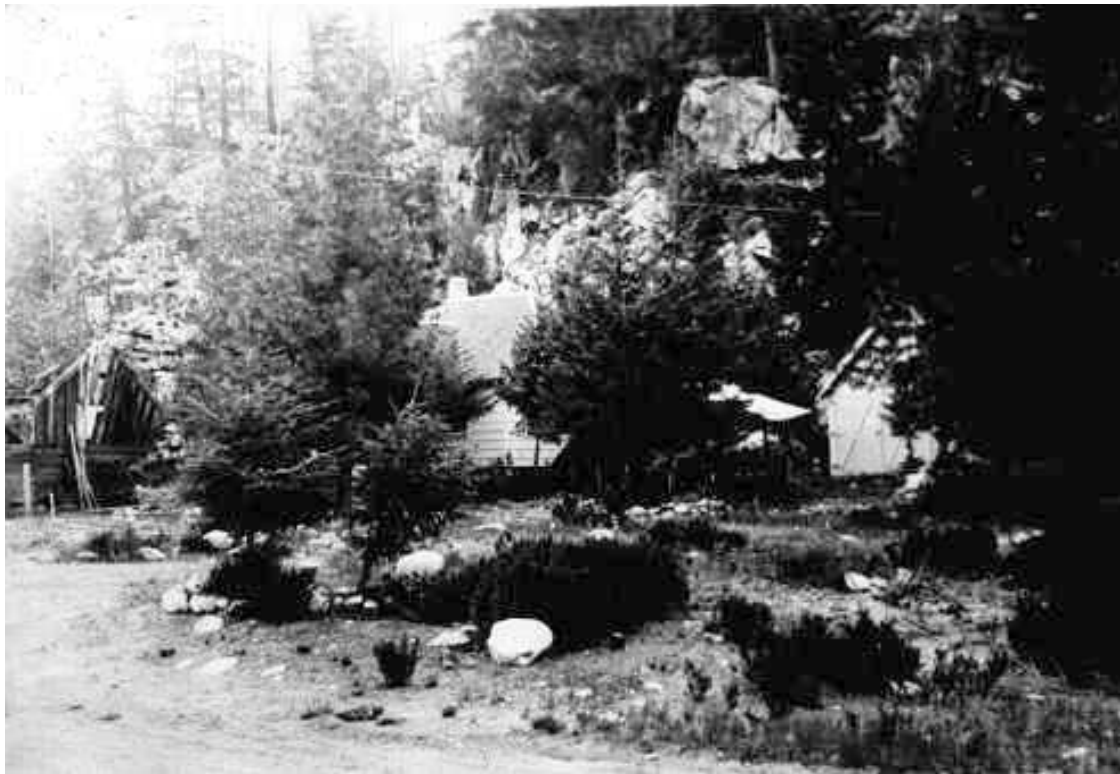
Historic photograph c. 1935 showing High Bridge Ranger Station in the background and Stehekin Road in the foreground. Note the dilapidated barn on the left. This structure is no longer standing (NOCA Collection).

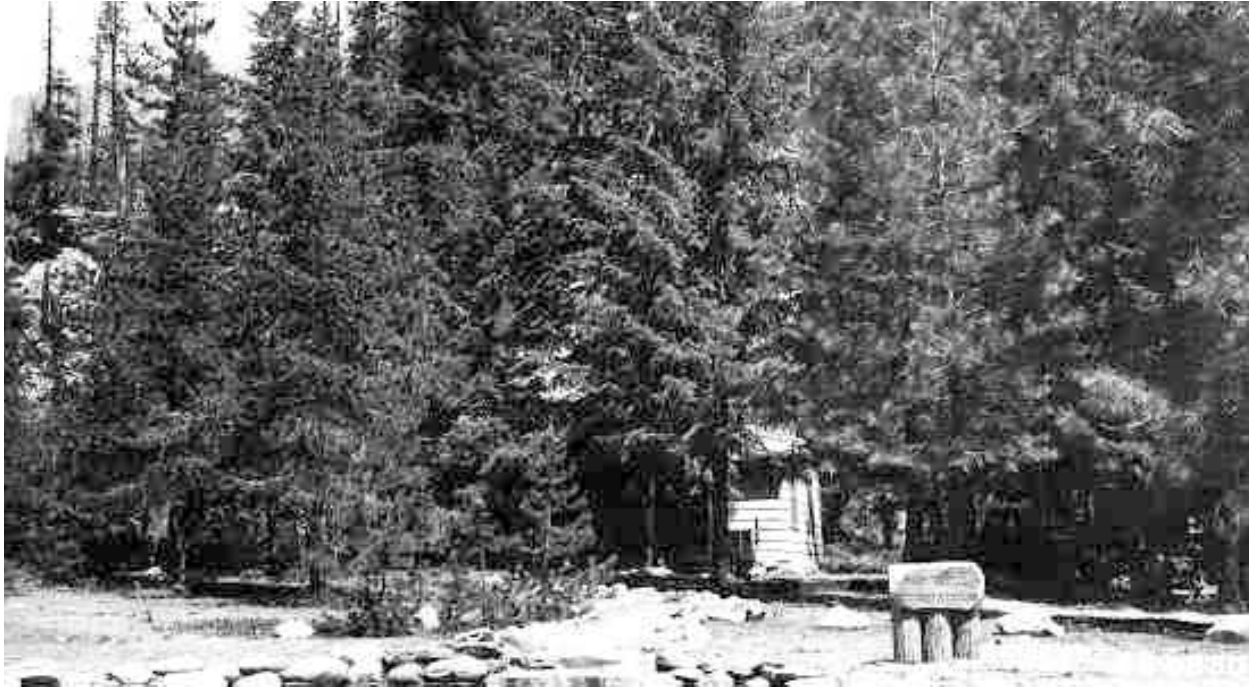
*Historic photograph c. 1947 showing how High Bridge Ranger Station was densely vegetated during the historic period (NOCA Collection).*

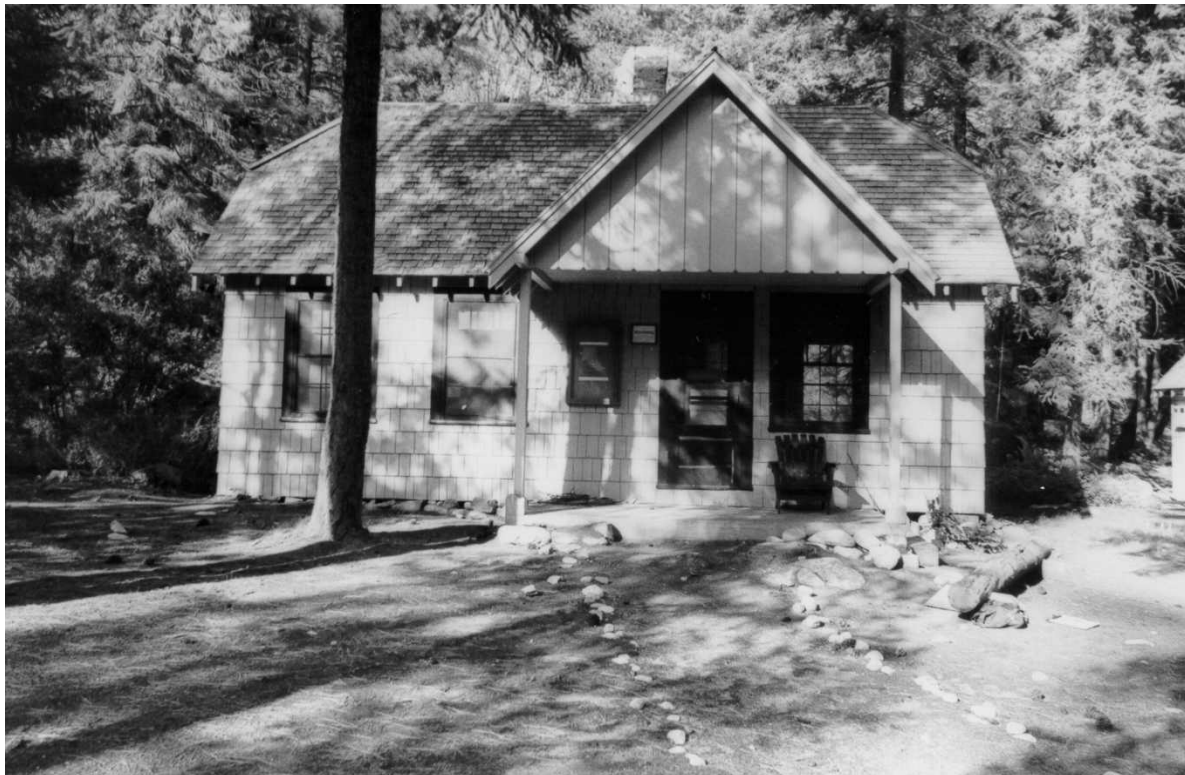
*Historic photograph showing stone lined entrywalk in front of the residence (Classified Structure Field Report, 1976).*

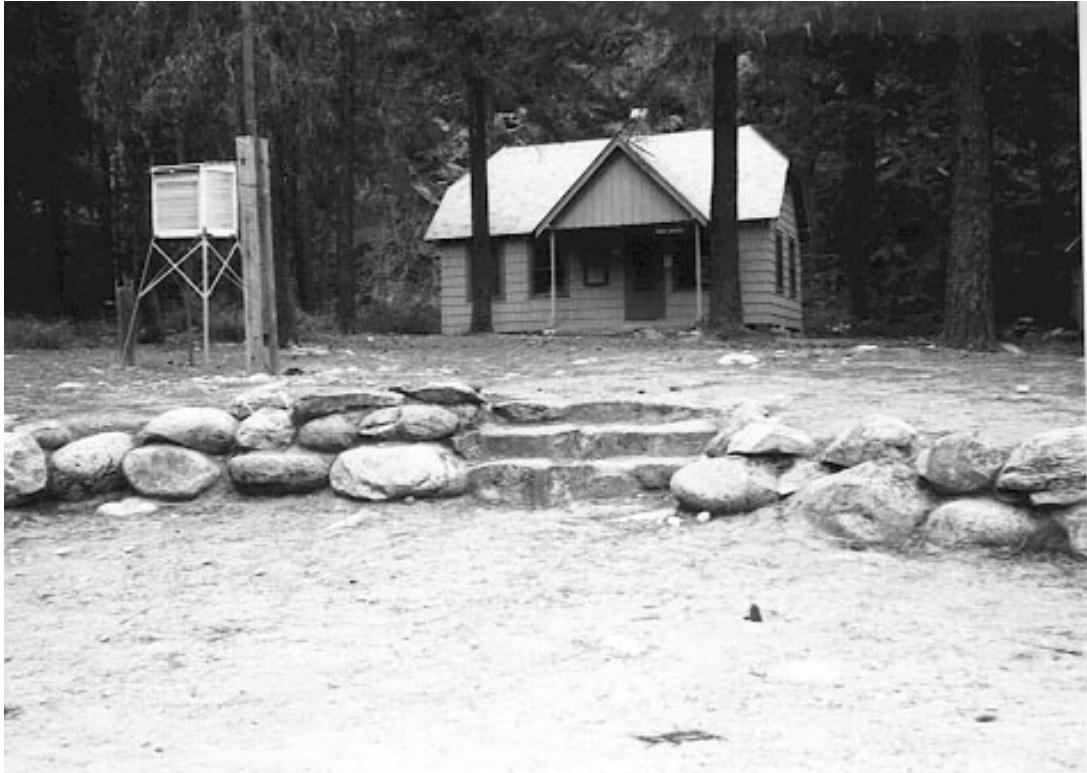
*Photograph c. 1984 showing residence in the background and the weather station on the left. As there were no designated trails aligned to the weather station, vegetation was trampled by foot traffic (NOCA Collection).*

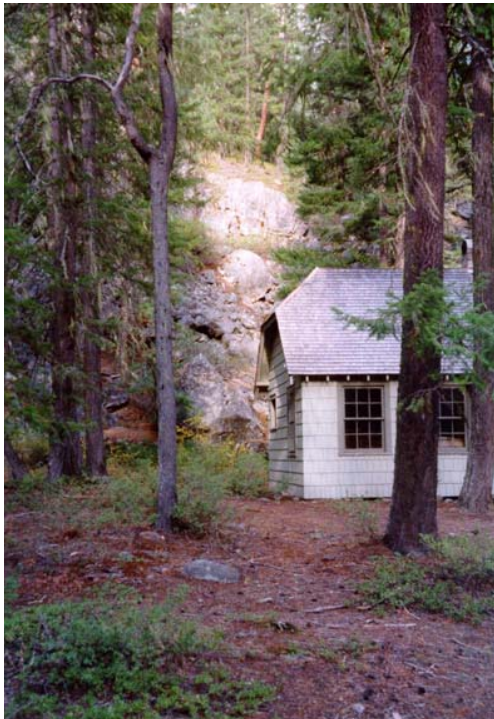
The glacial terrace provided a level land area that could be built upon, the creek provided fresh drinking water, and the slope behind the ranger station, which is the base of McGregor Mountain (8122'), primarily provided a site to store water, while simultaneously providing a head of pressure for delivery down slope to the residence.

*Contemporary photograph showing talis slope behind residence at High Bridge Ranger Station (CCSO 2001).*

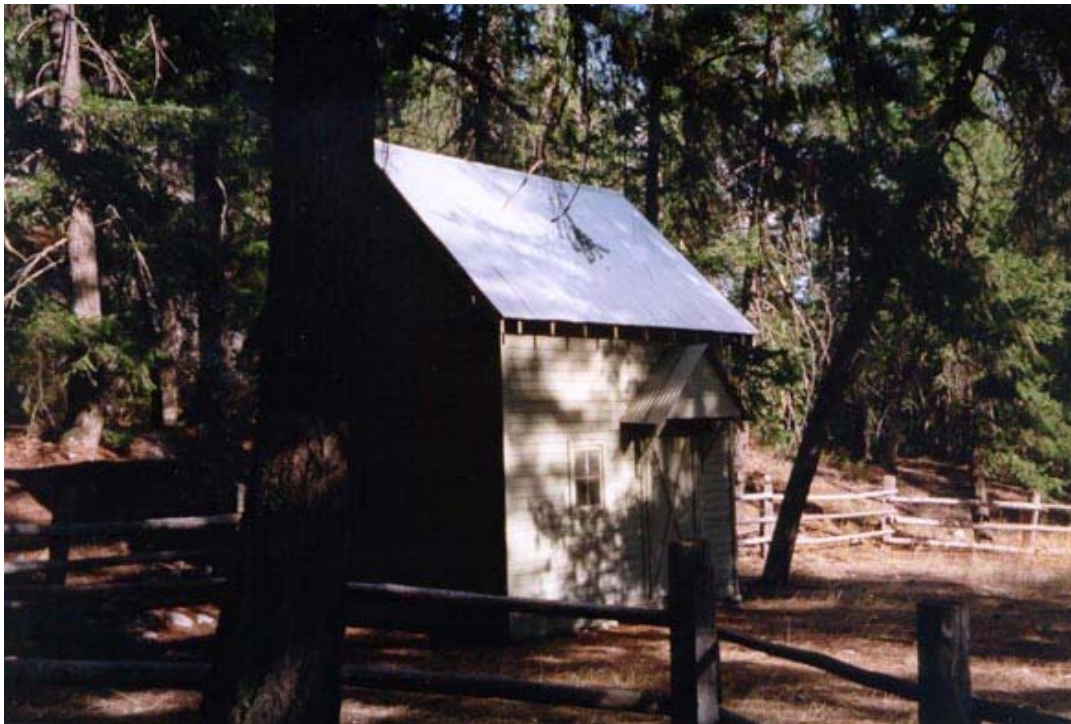
*Contemporary photograph showing Douglas fir canopy near the barn at High Bridge Ranger Station (CCSO 2001).*

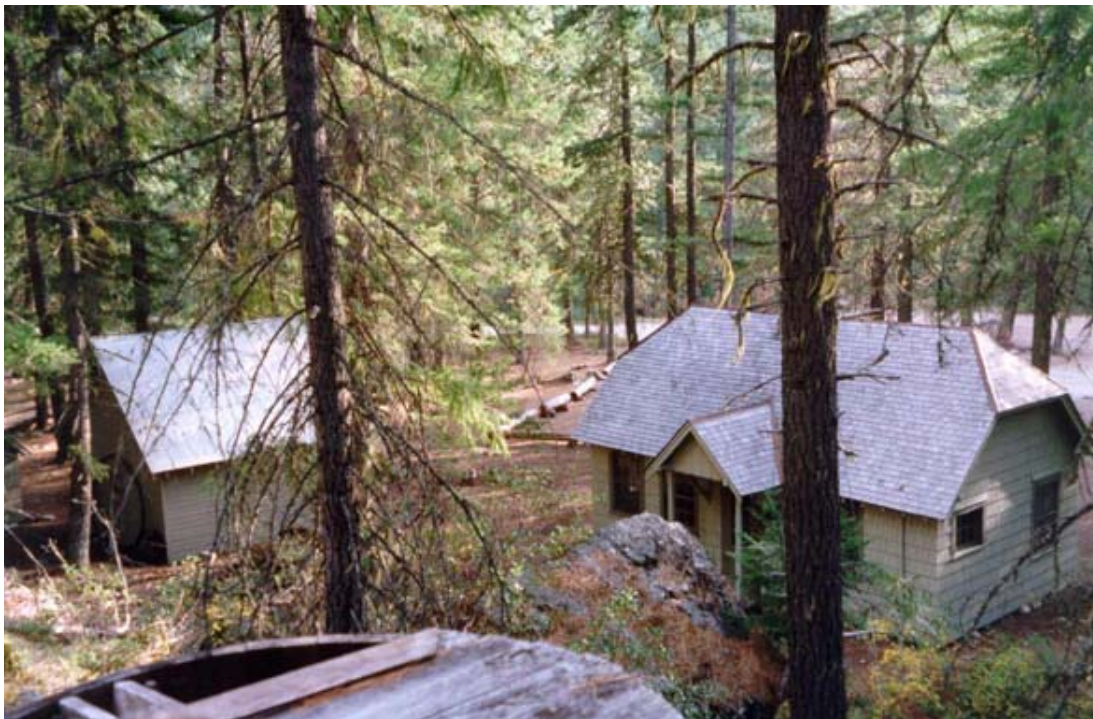
Today, High Bridge Ranger Station’s plantings are consistent with this historic memo. Native plants are primarily found within the historic district with exception of the corral, a result of exotic seeds found in horse feed. The remaining vegetation consists of approximately 30 mature native trees. Photographic evidence reveals that these conifers date to the 1930s. The conifers are primarily Ponderosa pine (*Pinus ponderosa*), Lodgepole pine (*Pinus contorta* var. *latifolia*), and Douglas fir (*Pseudotsuga menziesii*). The flat building site has plant understory communities of Mountain huckleberry (*Vaccinium membranaceum*), Wild lilac (*Ceanothus velutina*), Western spirea (*Spirea douglasii*), Evergreen huckleberry (*Vaccinium ovatum*), Western serviceberry (*Amelanchier alnifolia*), Thimbleberry (*Rubus parviflora*), Oregon boxwood (*Pachistima myrsinites*), Kinnickinick (*Arctostaphylos uva-ursi*), and Parsley fern (*Cryptogramma acrostichoides*). The northern edge of the terrace bearing the ranger station, down to the Stehekin gorge, retains indigenous plant communities of Sitka alder (*Alnus sitchensis*), Western sword fern (*Polystichum munitum*), Alaska yellow cedar (*Chamaecyparis nootkatensis*), Grand fir (*Abies grandis*), and Pacific yew (*Taxus brevifolia*).

*Contemporary photograph showing Douglas firs found throughout High Bridge Ranger Station (CCSO 2001).*

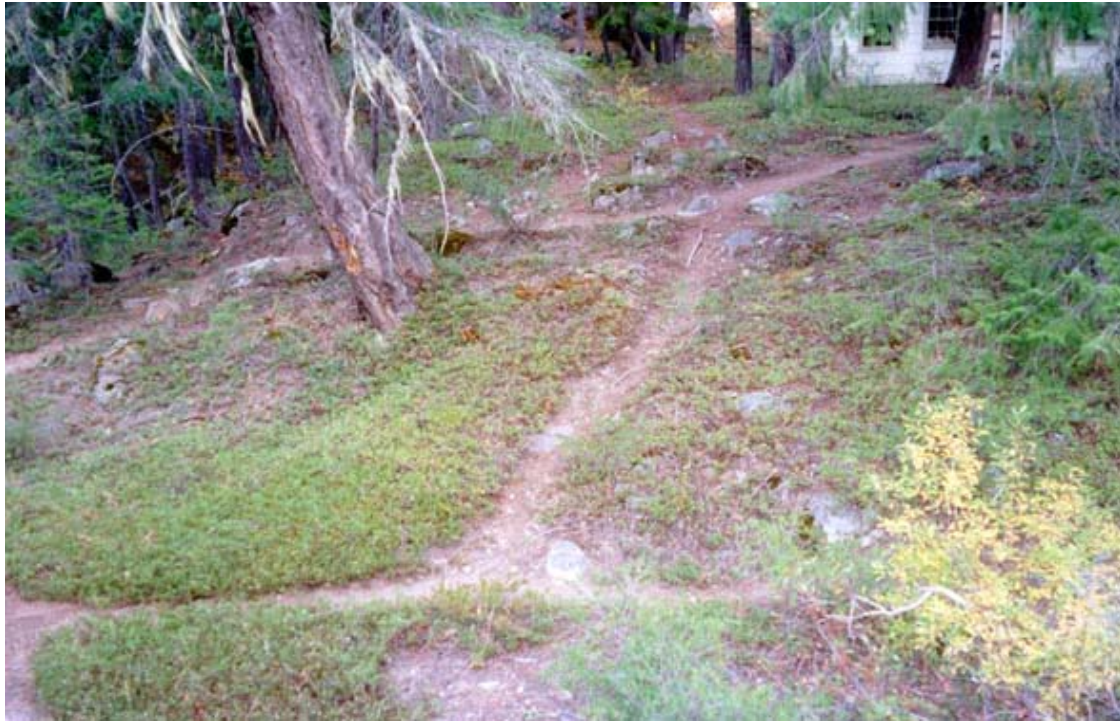
*Contemporary photograph showing social pathways through the understory vegetation at High Bridge Ranger Station (CCSO 2001).*

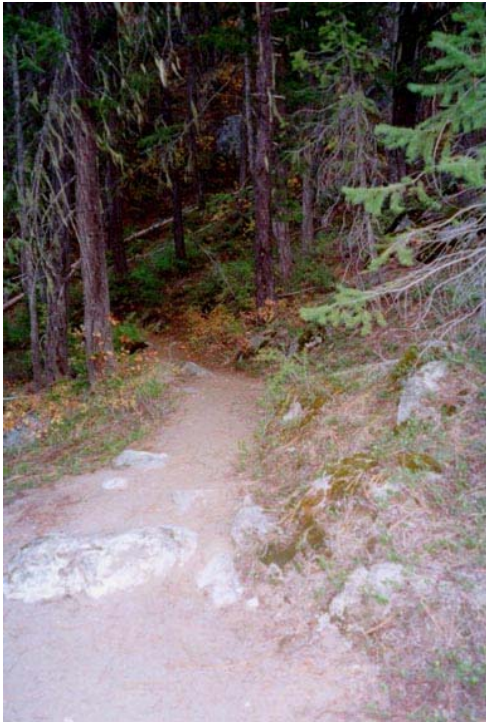
*Contemporary photograph showing trail that leads from High Bridge Ranger Station down to the Stehekin River (CCSO, 2001).*

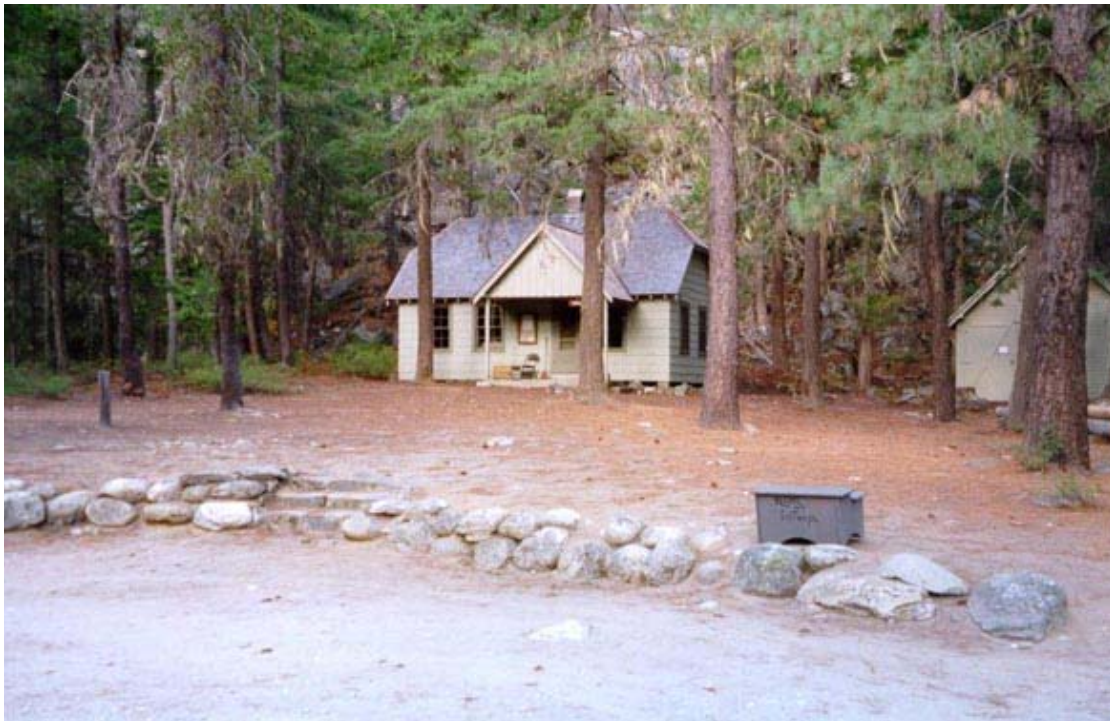
*Contemporary photograph showing stone steps and dry-stack retaining wall that delineates the vehicle turnout at High Bridge Ranger Station (CCSO, 2001).*

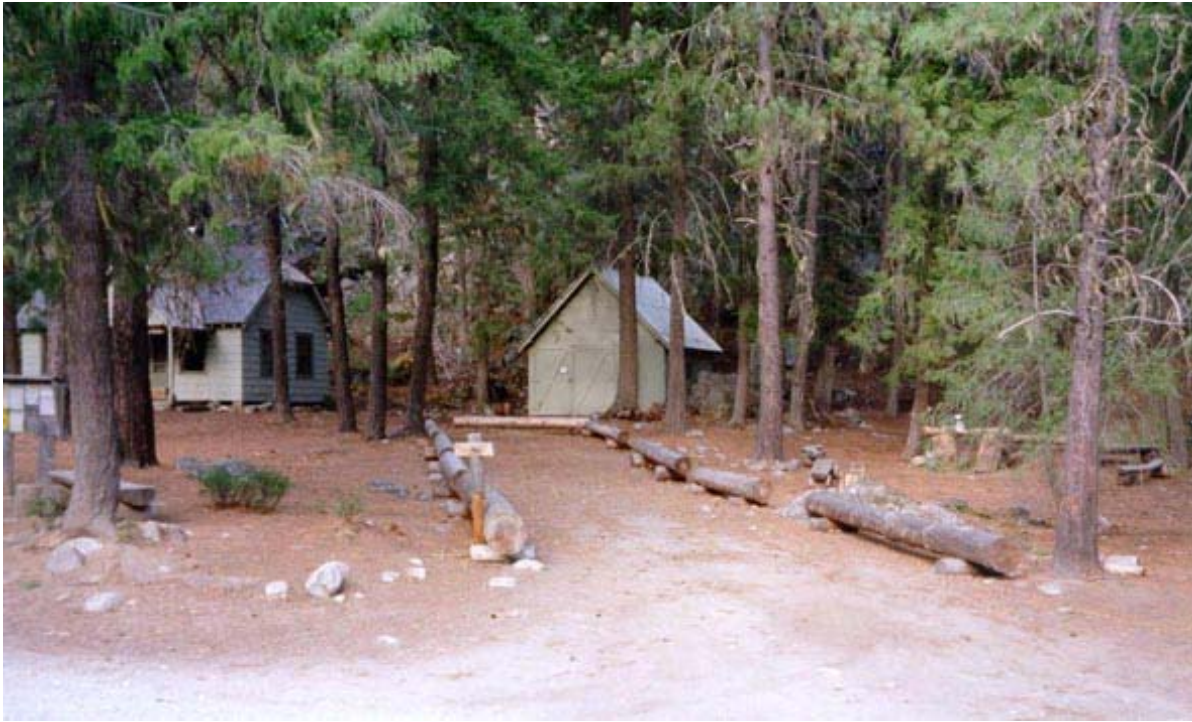
During the period of significance, the driveway may have been defined by gravel, according to the “Lands Handbook” which states, “It is desirable to gravel the driveways and service courts whenever funds may be made available” (USFS Lands Handbook 185). The horse ramp’s dry-stack retaining walls are currently overrun with vegetation, which is compromising the structural integrity of this feature.

*Contemporary photograph showing driveway at High Bridge Ranger Station (CCSO, 2001).*

3. Driveway
  - a. Remove logs currently delineating driveway. Replace logs with local stones using a combination of large and small stones.
4. Horse Ramp

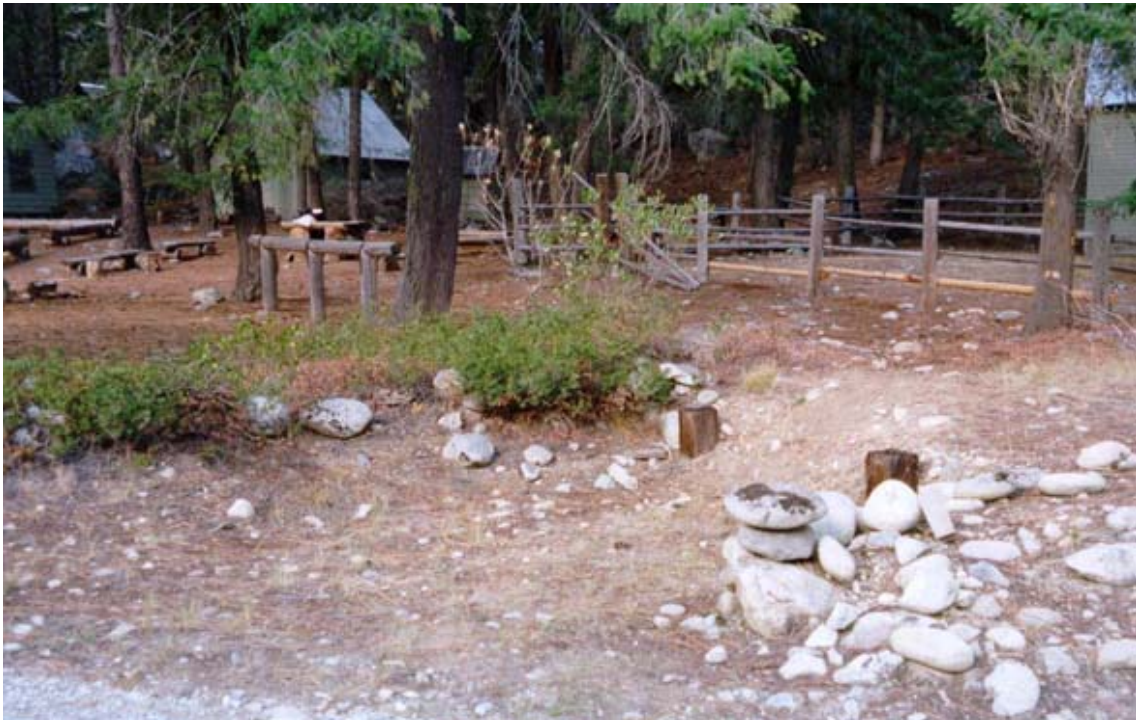
*Contemporary photograph showing the horse ramp connecting Stehekin Road with the horse corral (CCSO, 2001).*

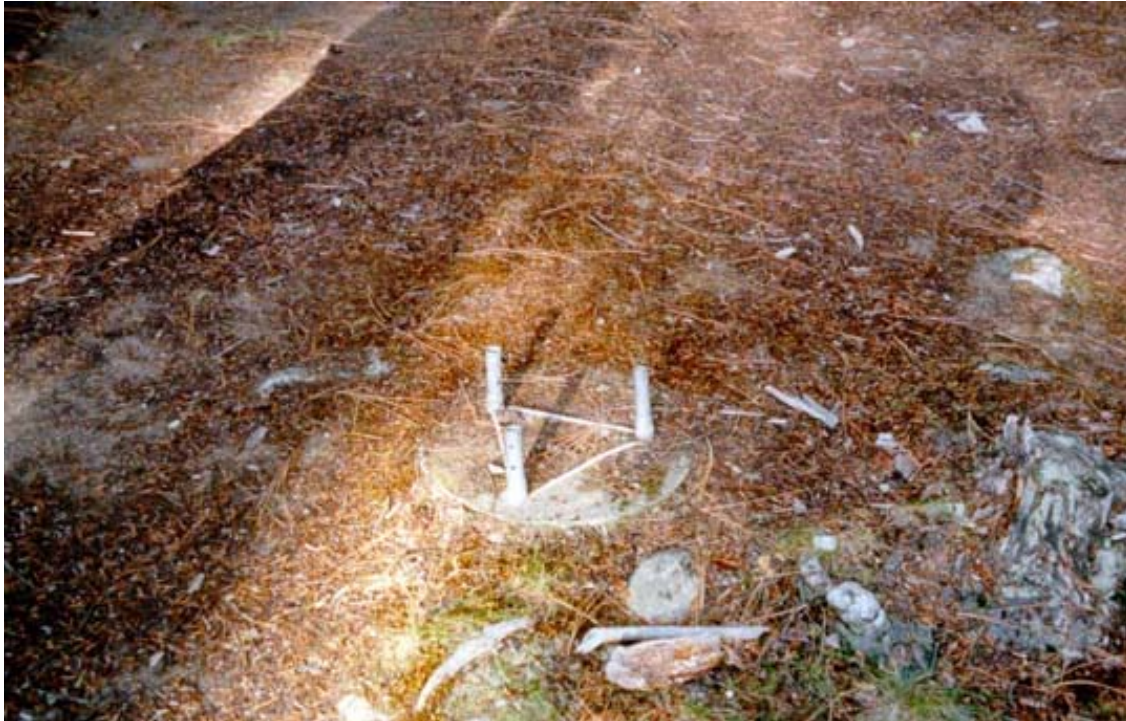
*Contemporary photograph showing historic radio mast at High Bridge Ranger Station (CCSO, 2001).*

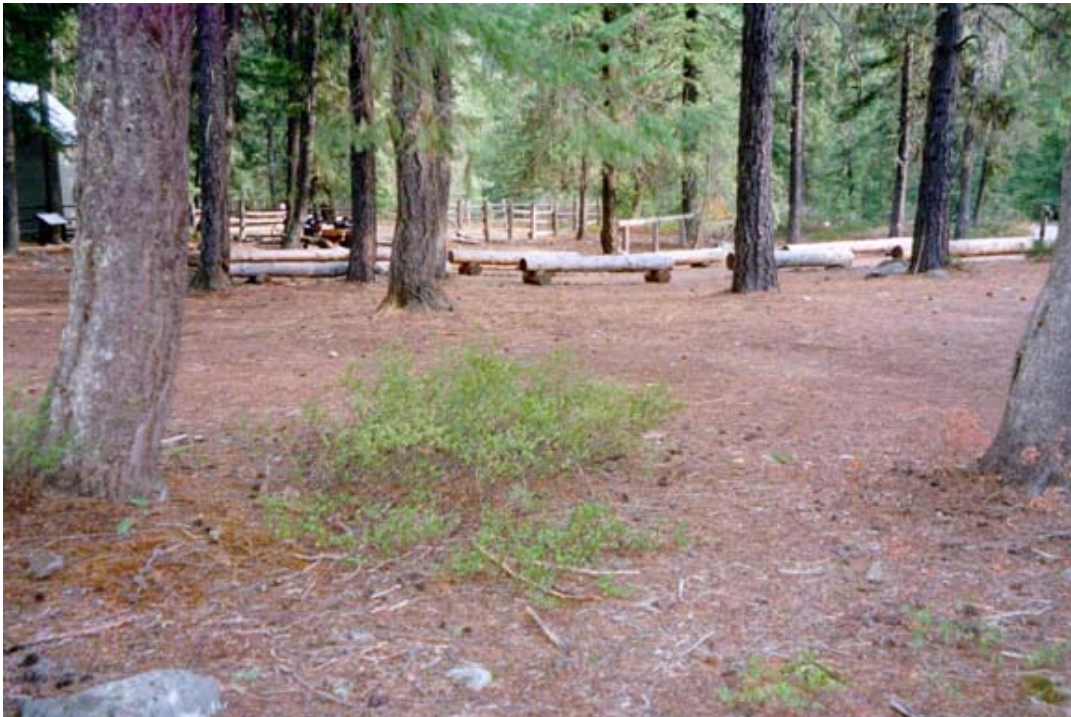
*Contemporary photograph showing driveway in the foreground and the hitching post in the background (CCSO, 2001).*

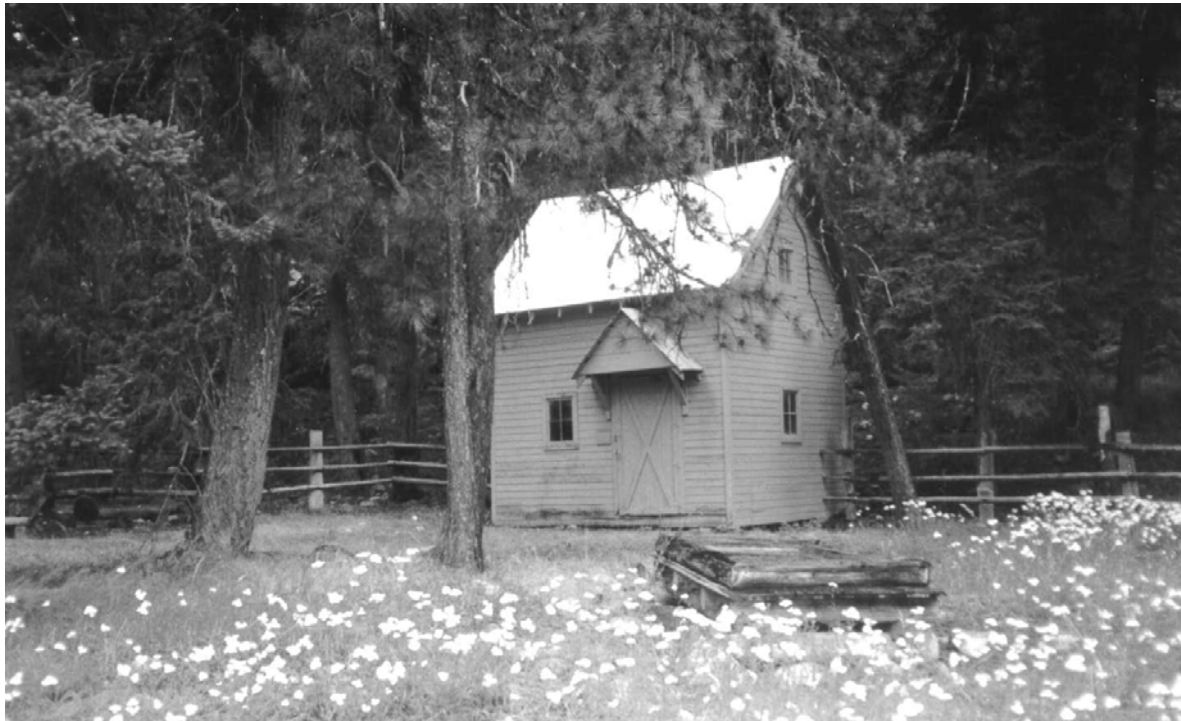
The barn measures 14'x 16', wood frame construction with shiplap siding, and is set on a rock and post foundation. The structure is two bays wide with a 1.5 story loft. In addition, the barn features a metal-covered gable roof with slightly extended eaves and exposed rafter ends; a narrow vertical wood slat door with cross-bracing and simple casing on the front façade, with a gabled-roof cantilevered porch. The ground floor is used as miscellaneous storage, plus a small horse stall on the lower level. Hay storage is located on the second level.

*Contemporary photograph of the barn at High Bridge Ranger Station (CCSO, 2001).*

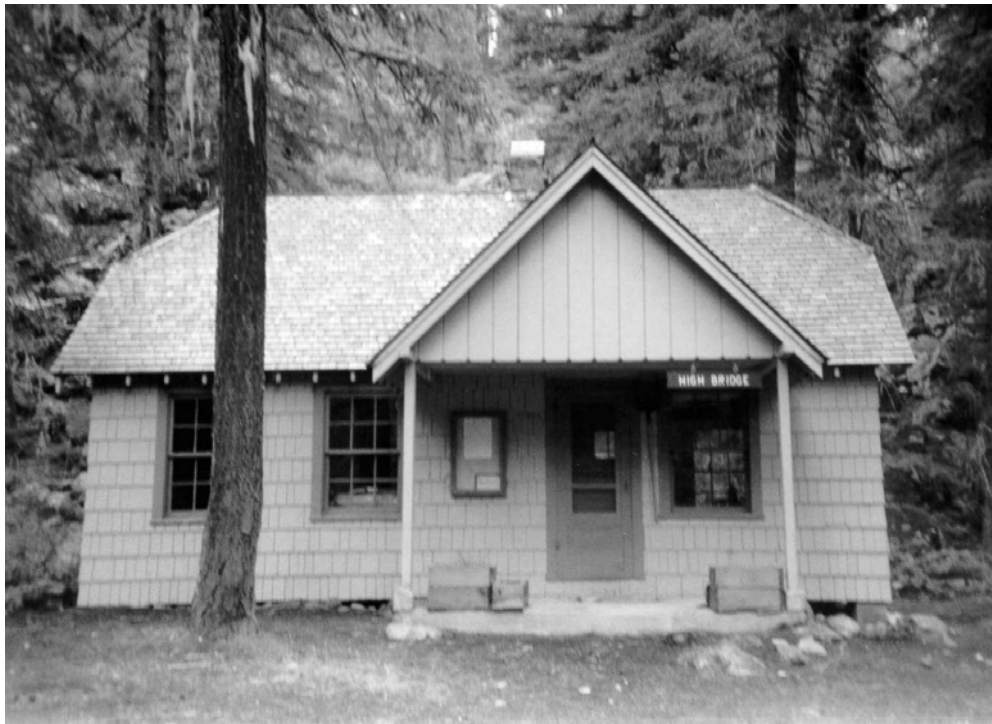
The ranger residence has a rectangular footprint and is 17'x 28'. This wood frame building is set on a concrete block foundation. It has a cedar-shingled jerkin-head gable roof with extended eaves and exposed rafter ends. The exterior shingle siding is painted in a light creamy green. Windows are double hung, six over six, and single glazed. The structure has two concrete slab porches: an oversized pediment entrance portico (gabled porch) on the south and north supported by squared posts with knee braces. A small utility closet has been added beside the rear porch.

*Contemporary photograph of the residence at High Bridge Ranger Station (CCSO, 2001).*
