National Park Service  
Cultural Landscapes Inventory

Marblemount Ranger Station Historic District  
North Cascades National Park

**Marblemount Ranger Station Historic District  
North Cascades National Park**

CONDITION ASSESSMENT: **Fair**

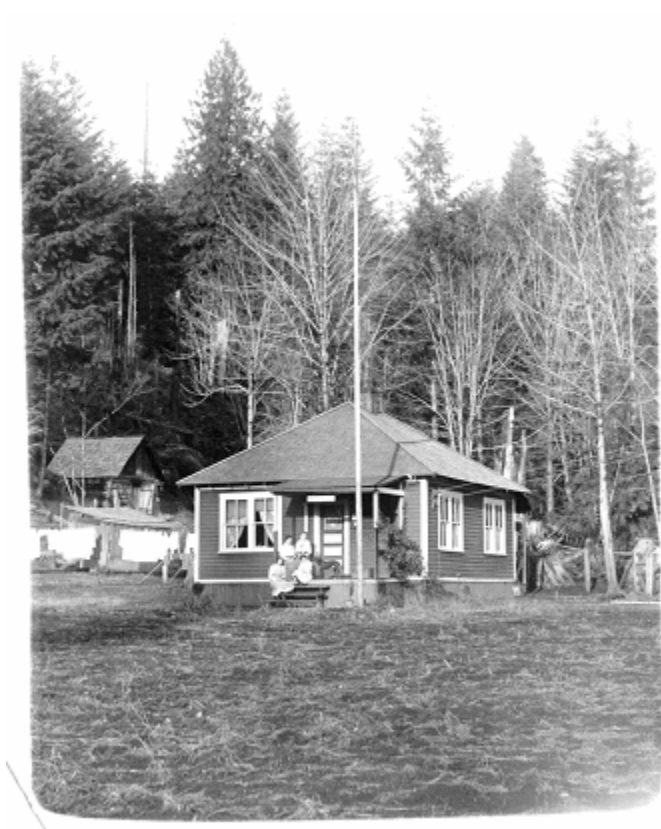
*The first district ranger's house at Marblemount (Backus) Ranger Station, ca. 1916. Note the flagpole in front of the house and the barn and chicken coop in the rear (NOCA 11589, ca. 1916). This house was removed during the period of significance.*

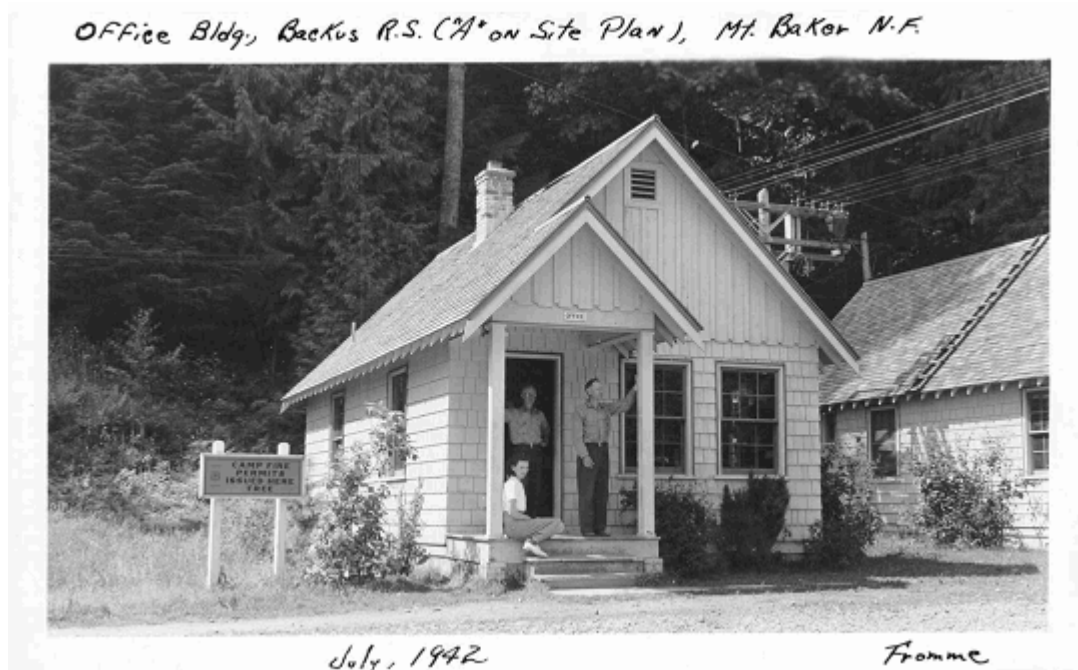
*The 1926 Marblemount (Backus) Ranger Station office building in 1942. Note the ornamental foundation plantings around the buildings and the sign for camp fire permits (NOCA 11287, 1942). This residence was removed in the late 1950s-early 1960s.*

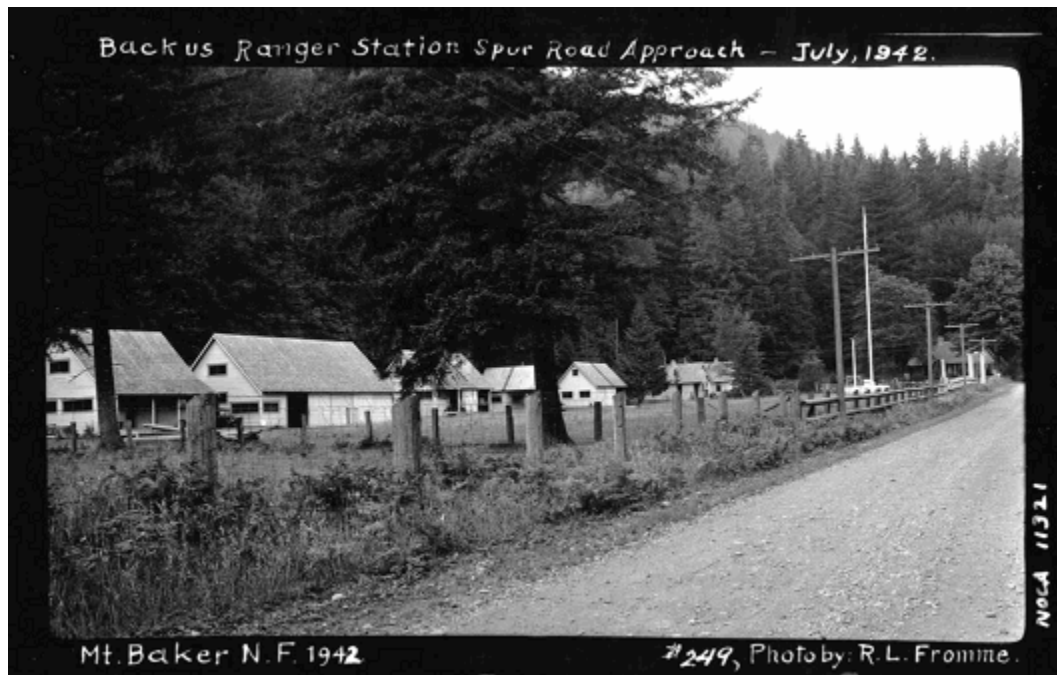
*Historic photograph of Marblemount (Backus) Ranger Station, viewed looking north and west from Ranger Station Road. Note the row of utilitarian buildings built by the CCC and the fenced pasture (NOCA 11321, 1942).*

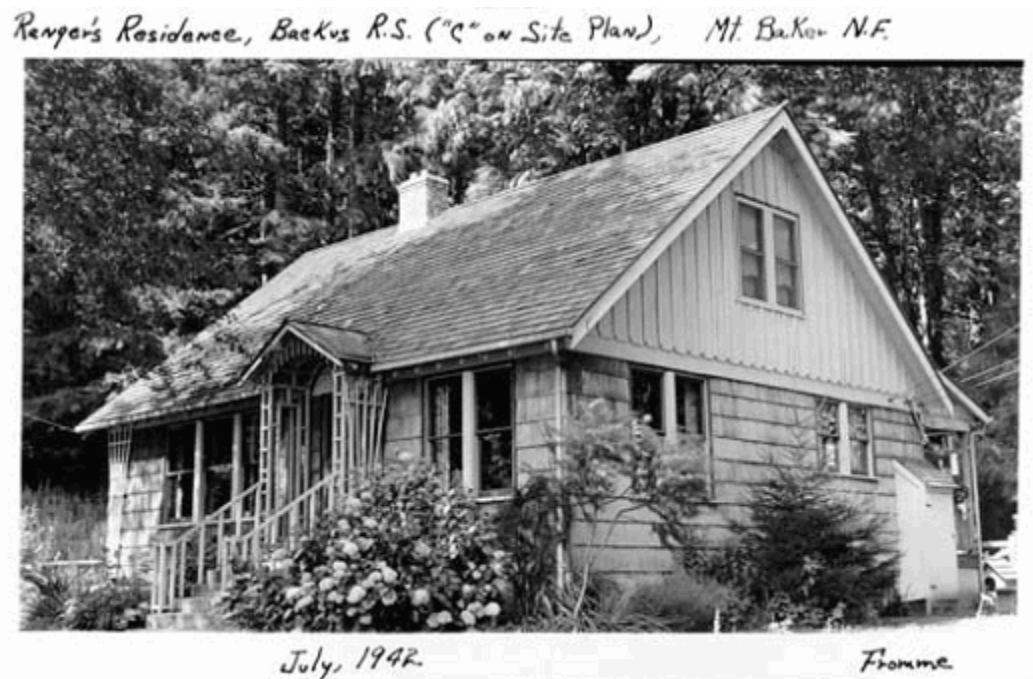
*The District Ranger's Residence (building 1010) at Marblemount (Backus) Ranger Station in the 1930s. Note the ornamental plants and the trellises on either side of the front porch (NOCA 11289, 1942).*

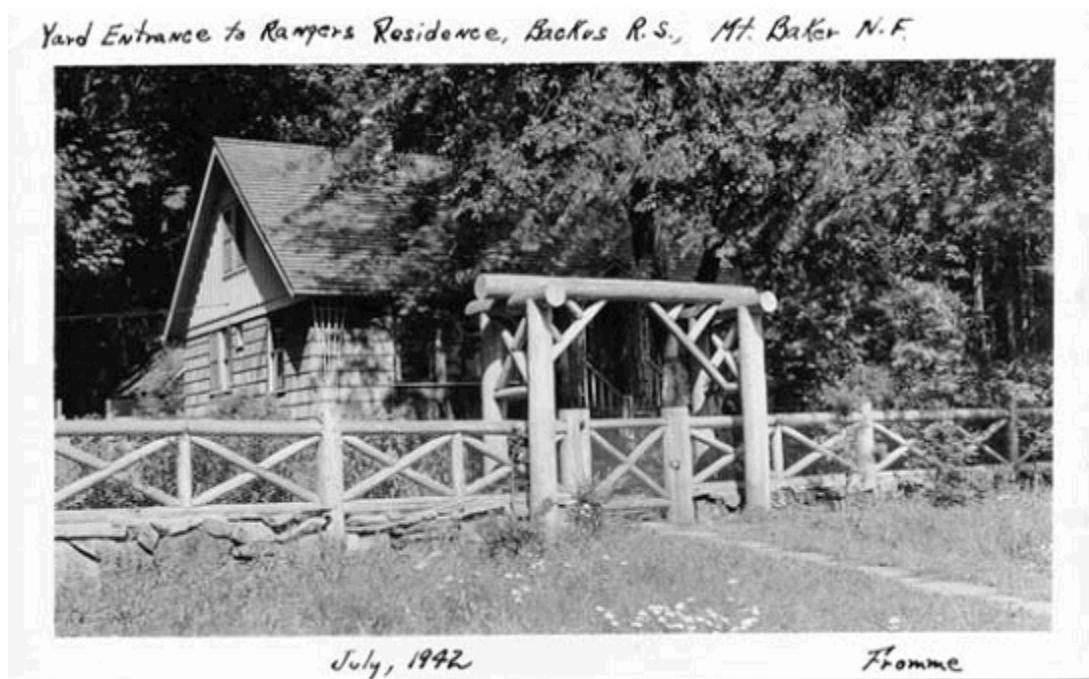
*Historic photograph of the district ranger's residence at Marblemount (Backus) Ranger Station, showing a peeled log and stone rustic fence and arbor-gate in the front yard (NOCA 11296, 1942).*

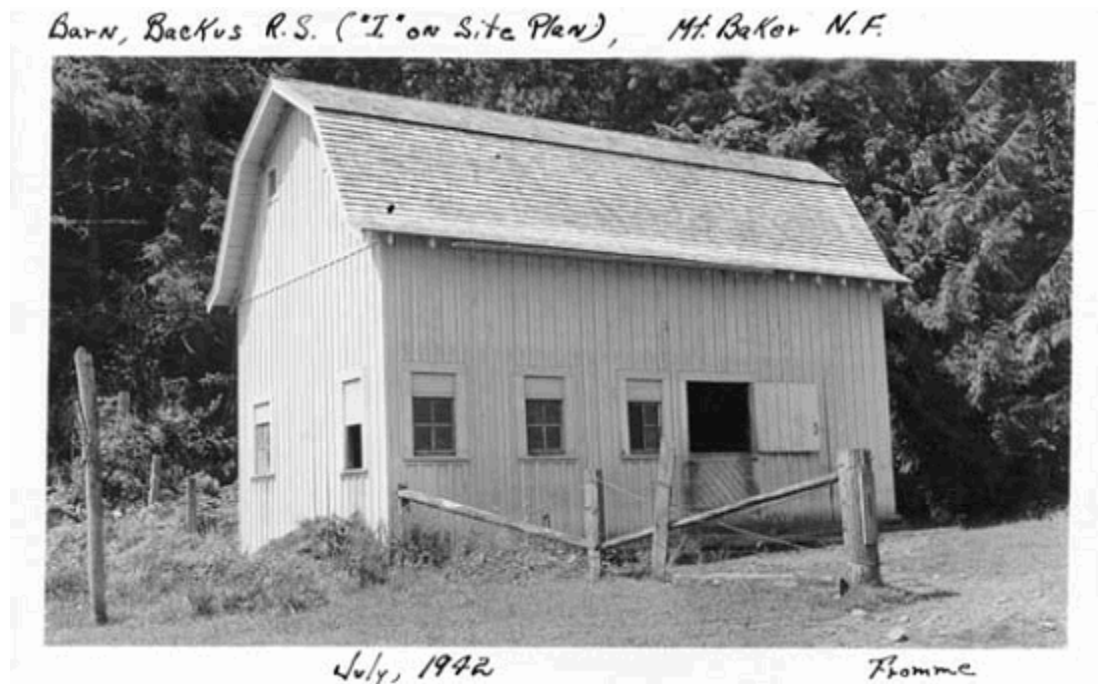
*The barn at Marblemount (Backus) Ranger Station, built by the CCC during the 1930s (NOCA 11295, 1942). This barn was removed in the 1960s.*

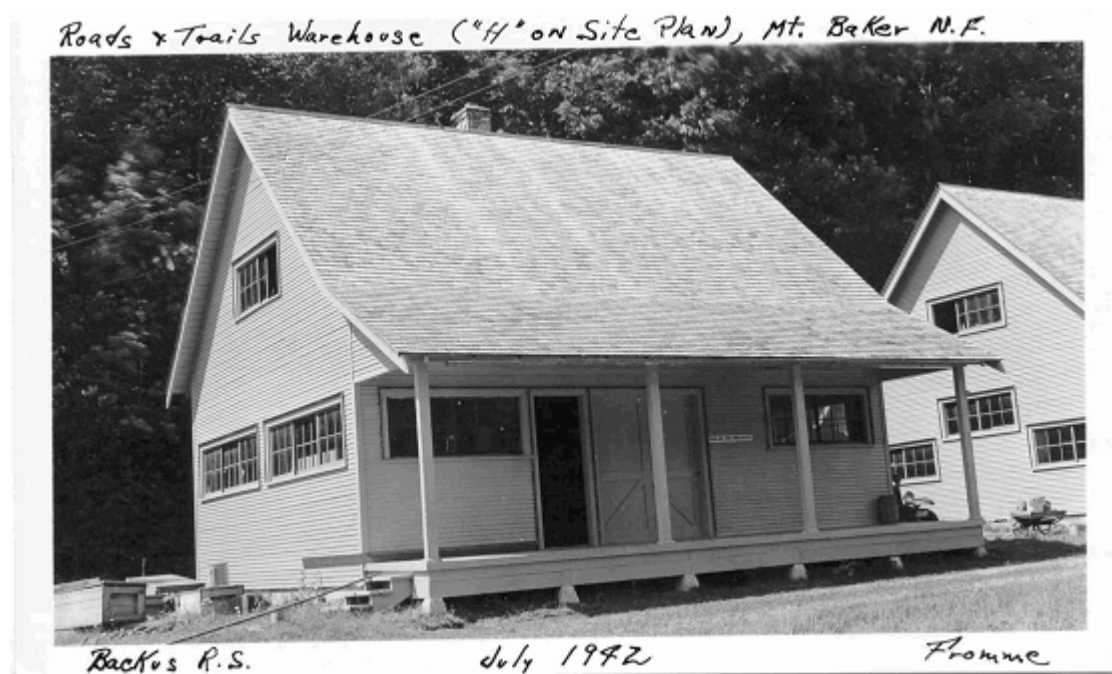
*Historic photograph of the R&T storage building at Marblemount (Backus) Ranger Station, built by the CCC during the 1930s (NOCA 11294, 1942).*

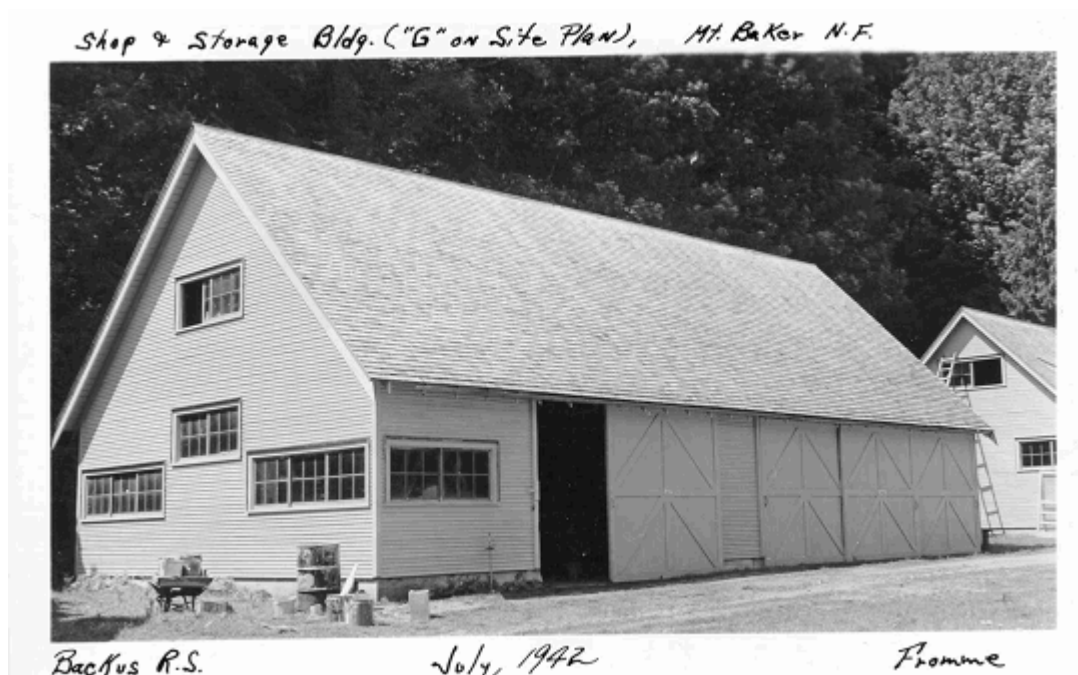
*Historic photograph of the warehouse building at Marblemount (Backus) Ranger Station, built by the CCC during the 1930s (NOCA 11293, 1942).*

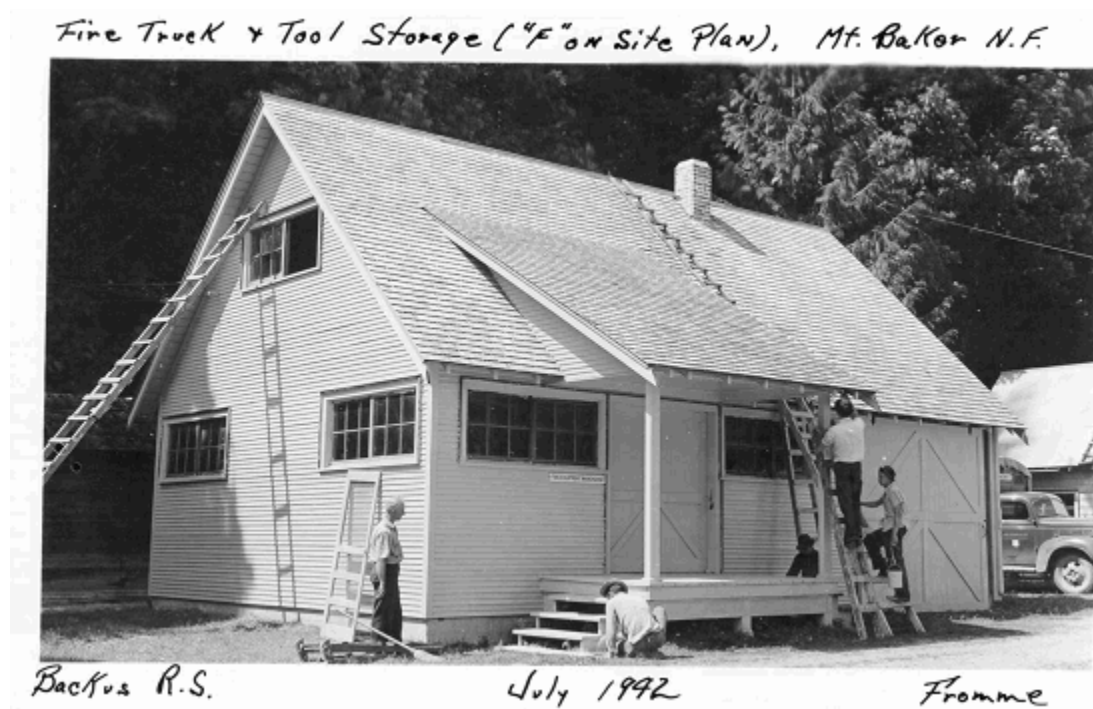
*The shop at Marblemount (Backus) Ranger Station, built by the CCC during the 1930s (NOCA 11292, 1942). The shop was removed by 1977.*

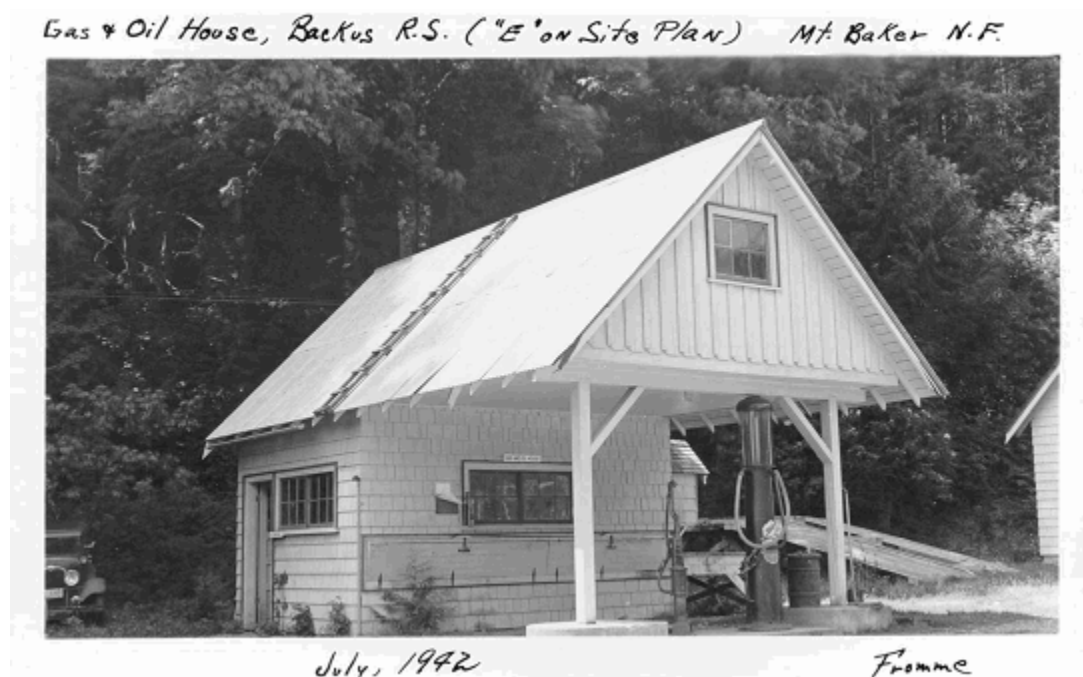
*The oil house at Marblemount (Backus) Ranger Station, built by the CCC during the 1930s (NOCA 11291, 1942). This building was replaced in 1977 with a gas house.*

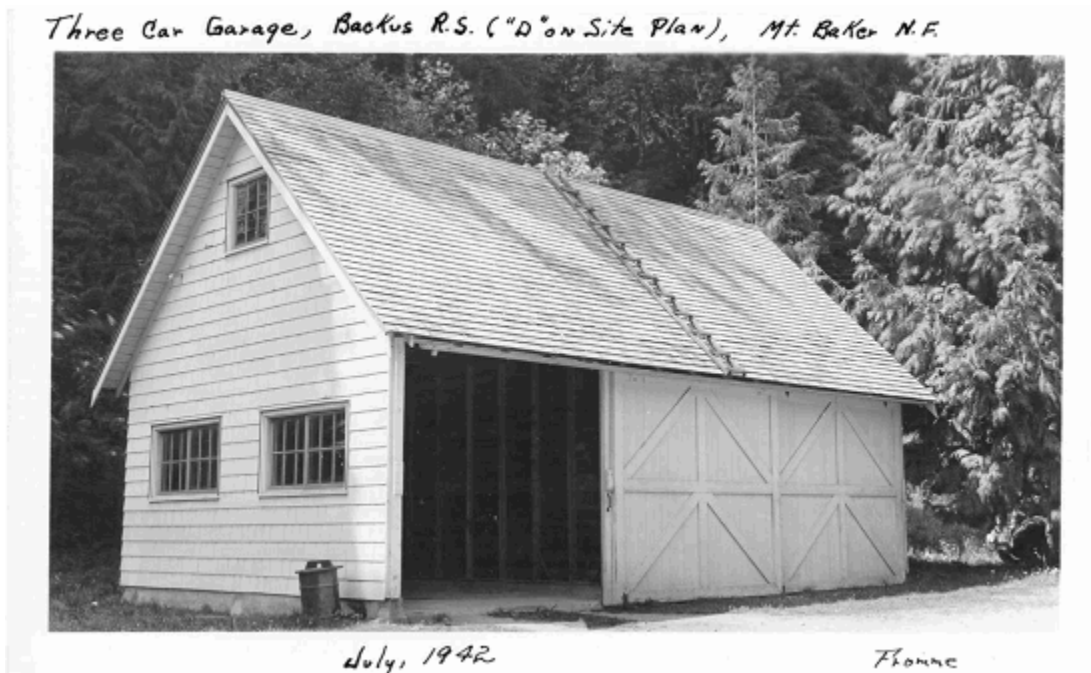
*The 3-car garage at Marblemount (Backus) Ranger Station, built by the CCC in the 1930s. Note the Western red cedar on the right that separated residences from the row of utilitarian buildings (NOCA 11290, 1942).*

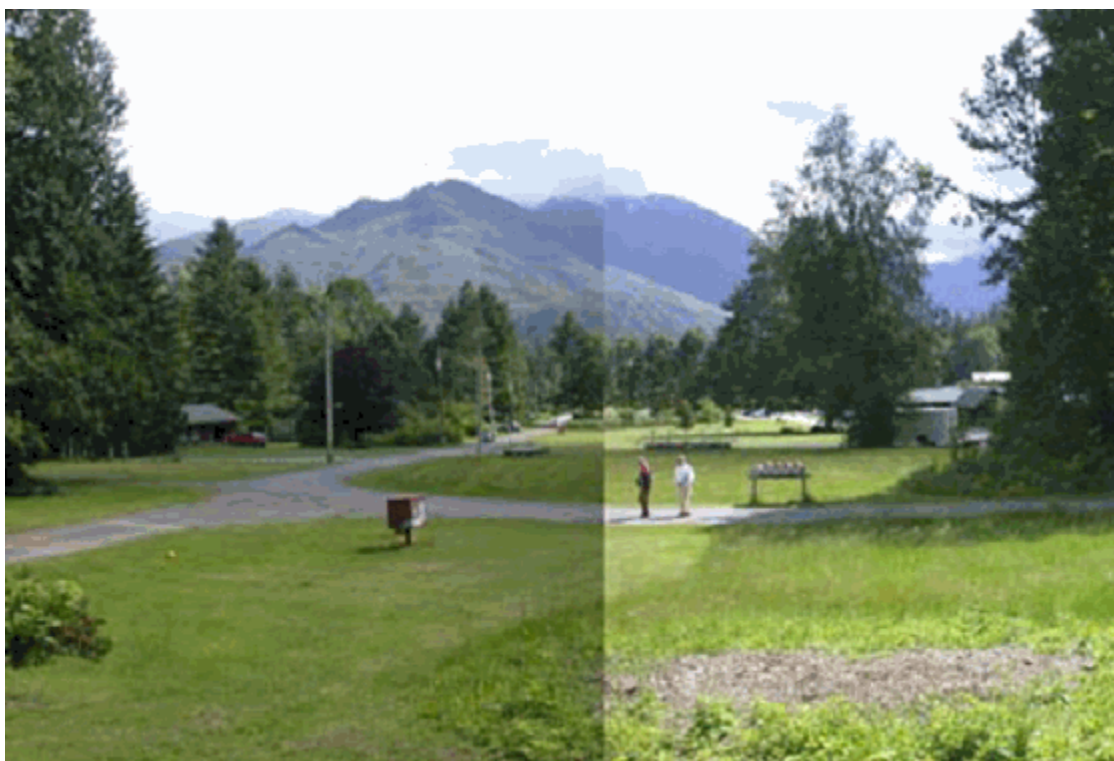
*Contemporary photograph of the Marblemount Ranger Station Historic District taken from the District Rangers Residence, looking south (PWRO-Seattle, 2004).*

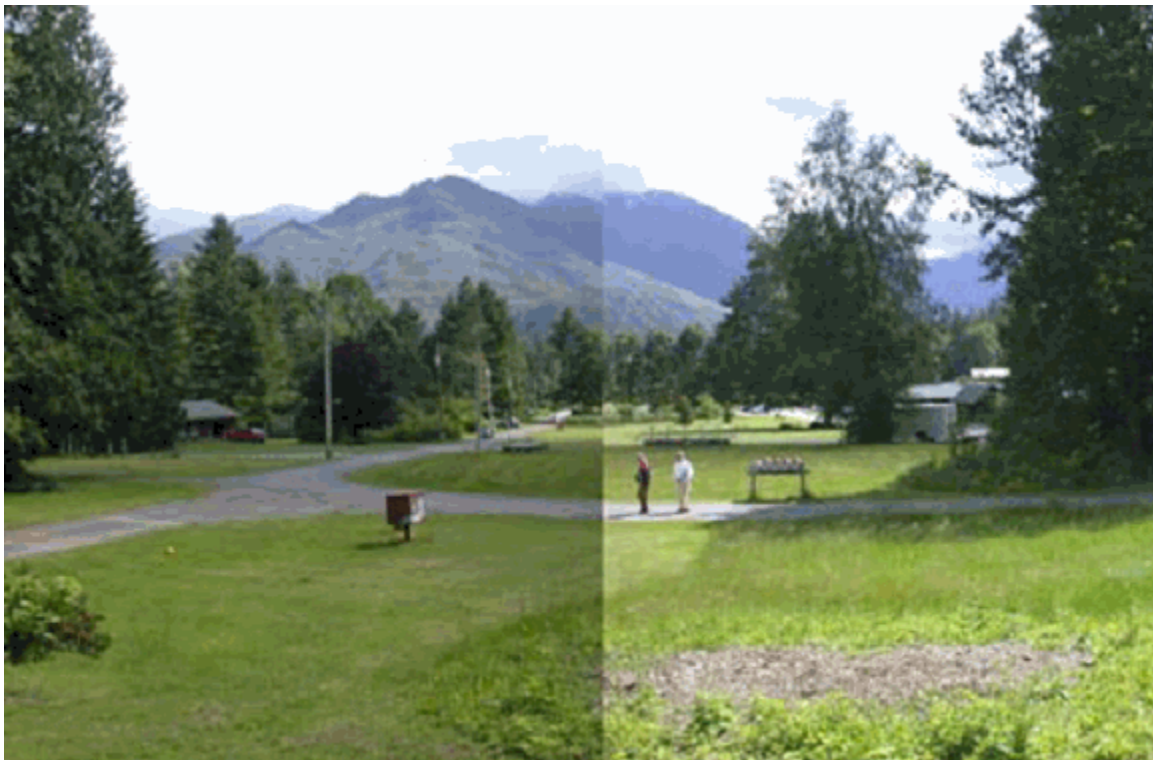
*This photo from the District Ranger's Residence porch reveals the commanding view created by careful siting of the house. The looped road, central open area, and maintenance area are all visible (PWRO-Seattle, 2004).*

This pattern of spatial organization still exists within the historic district today, despite alterations and additions that have occurred since 1942. The district is still organized around a central open space, with buildings located at the periphery and oriented towards the center. A loop road still delineates the central open space, and the cluster of residential buildings and row of utilitarian buildings remain separated. While some buildings and structures have been removed and others added, the new additions have not modified the historic pattern of spatial organization and have conformed to the USFS site planning principles in use in the 1930s. Therefore, Marblemount Ranger Station Historic District retains integrity of the landscape characteristic spatial organization.

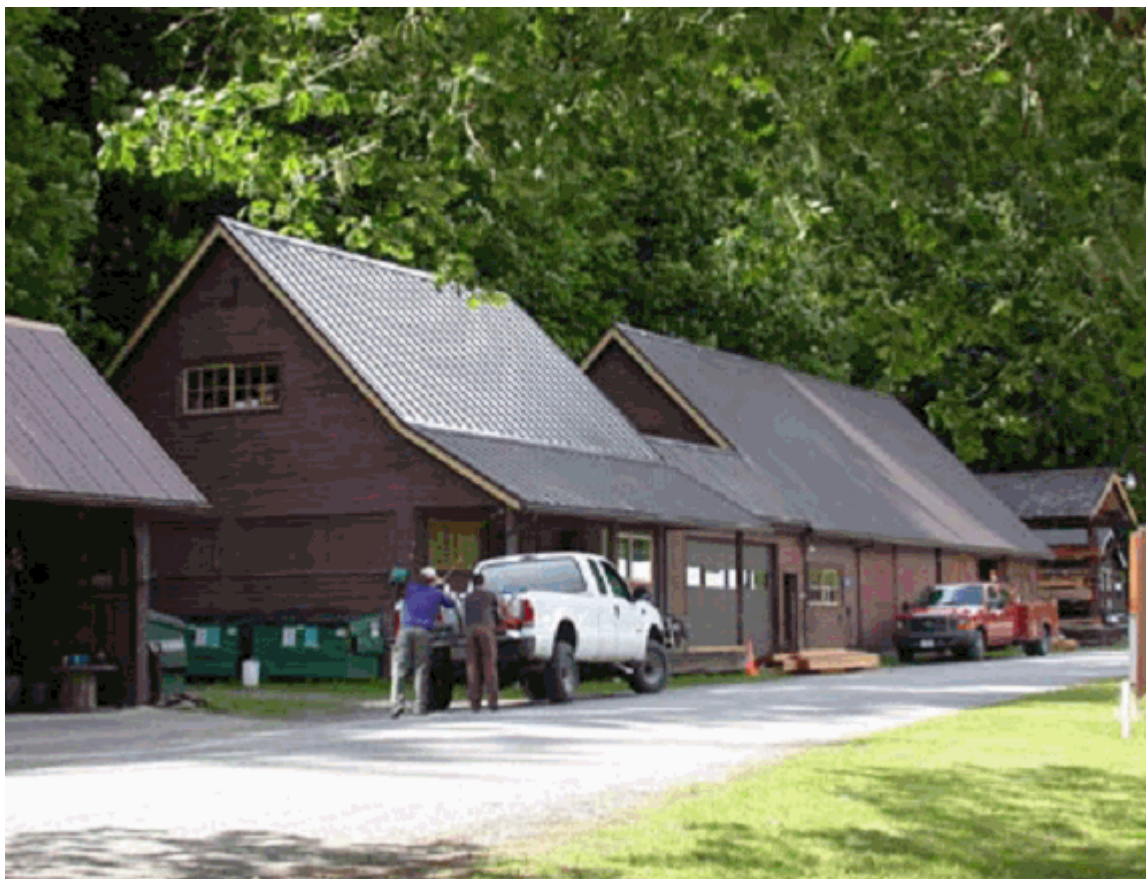
*The RT Storage building (left) and the warehouse (right) connected by a non-historic breezeway (PWRO-Seattle, 2004).*

| <b>Impact Description:</b> | Drainage problems behind the row of utilitarian buildings is causing pools of standing water around the building foundations -- the 1930s R&T storage building and the 1930s warehouse are among those affected by the drainage problems. Grading of a swale behind the buildings is needed, to intercept the stormwater that drains off the slope. |

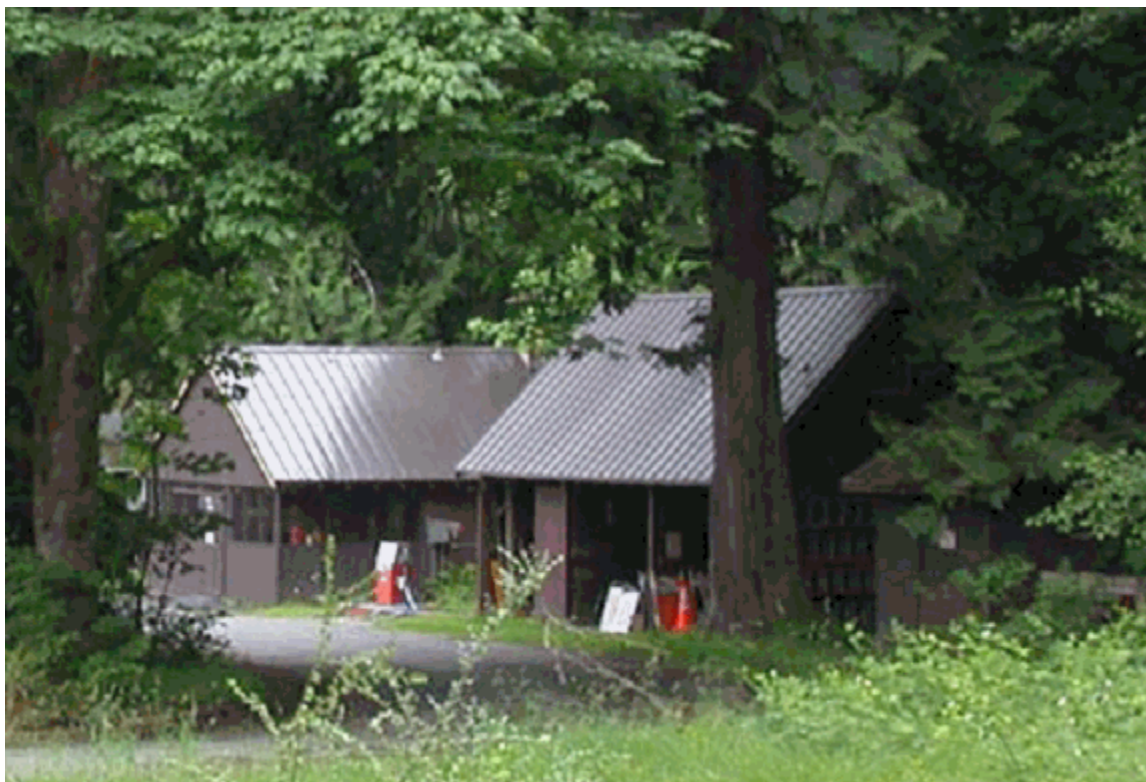
*The garage (right) has had the front doors removed (PWRO-Seattle, 2004).*

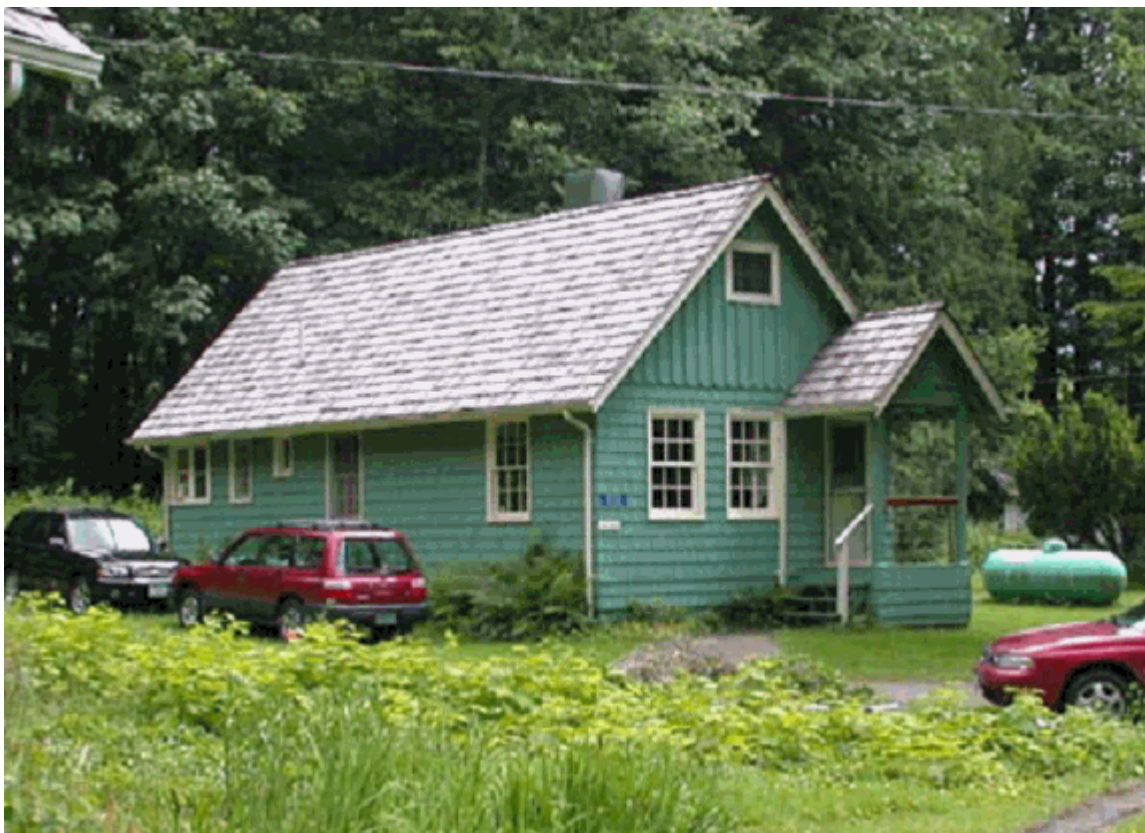
*This residence (building 1009), built in 1929, was moved to its current location after the period of significance (PWRO-Seattle, 2004). Its current location was originally the site of a different residence.*

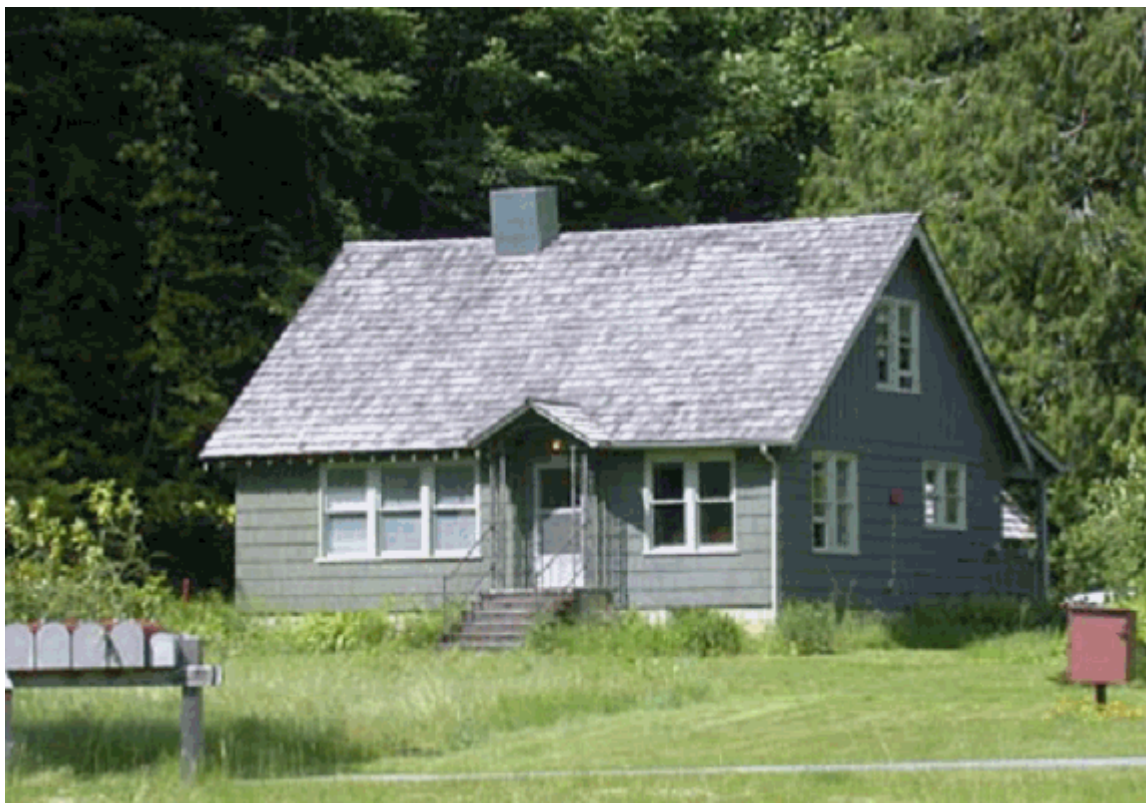
*The District Ranger's Residence (building 1010), constructed in the 1930s by the CCC (PWRO-Seattle, 2004).*

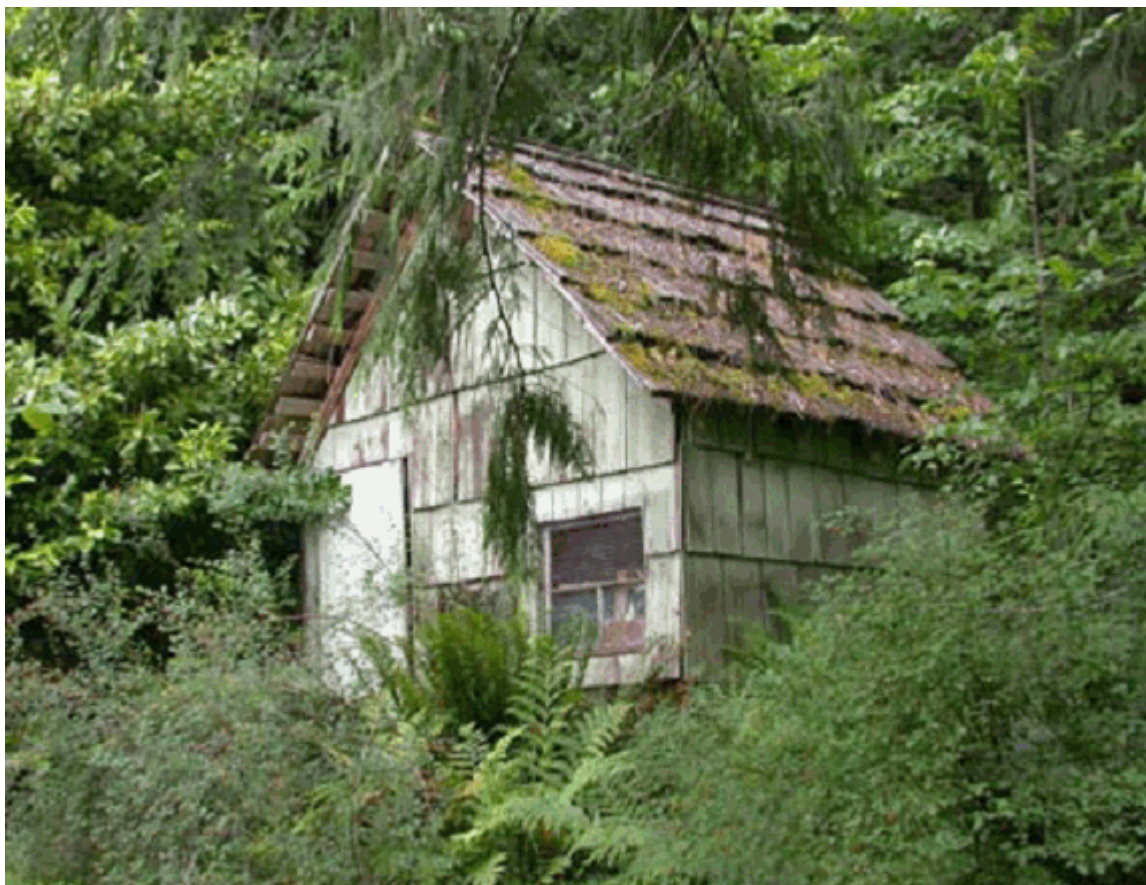
*Chicken coop located behind the District Ranger's Residence (PWRO-Seattle, 2004).*

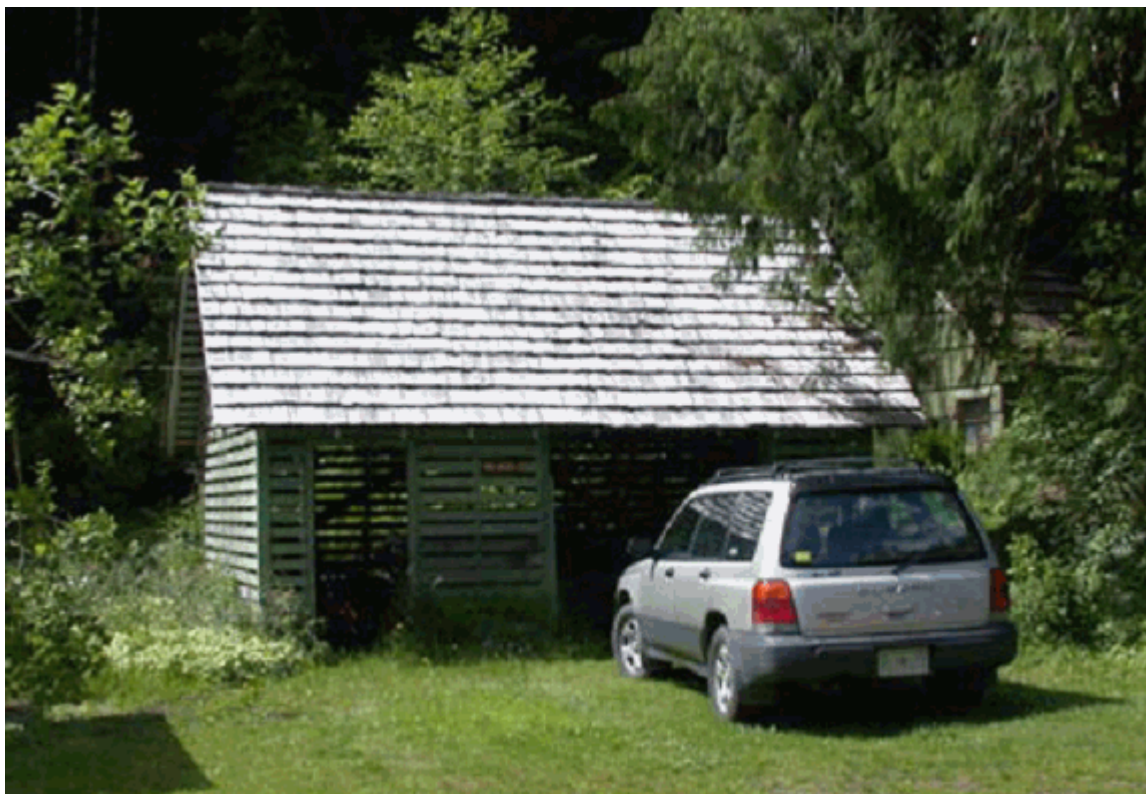
*The Woodshed located behind the District Ranger's Residence (PWRO-Seattle, 2004).*

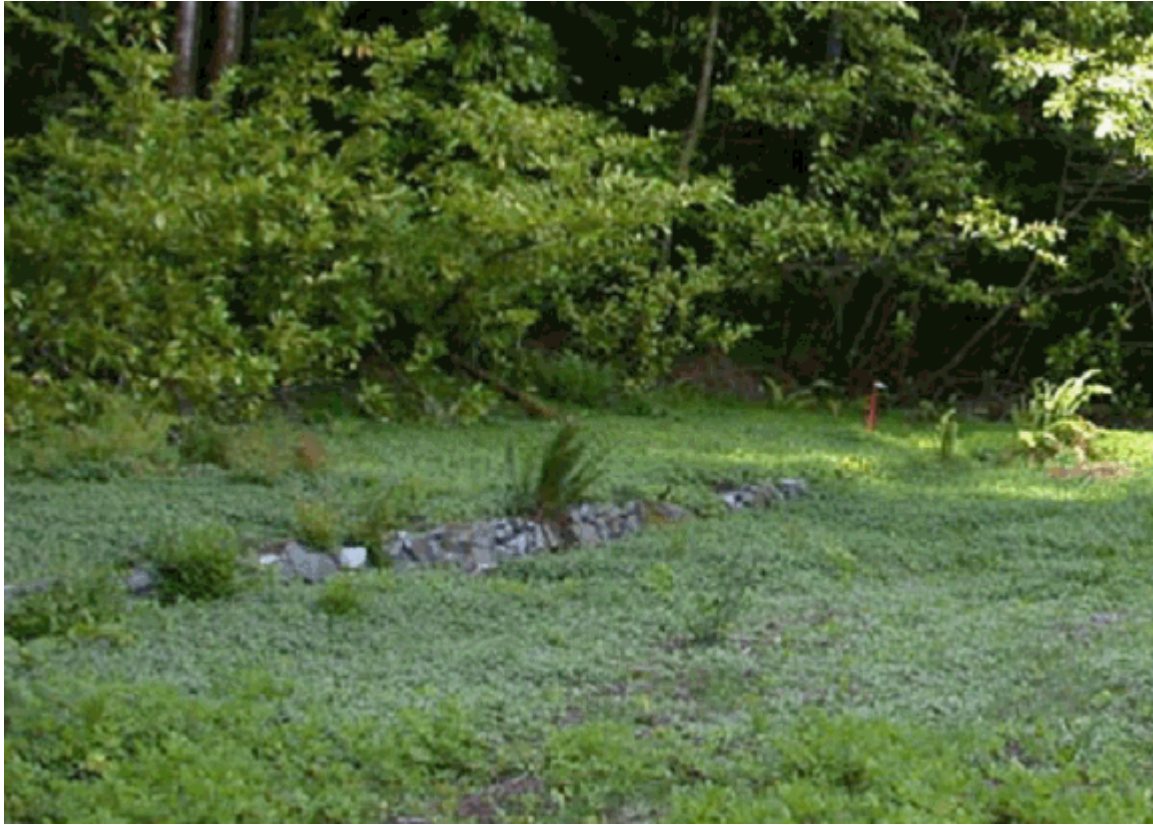
*Rock wall, located along the western edge of the District Ranger's Residence  
(PWRO-Seattle, 2004).*

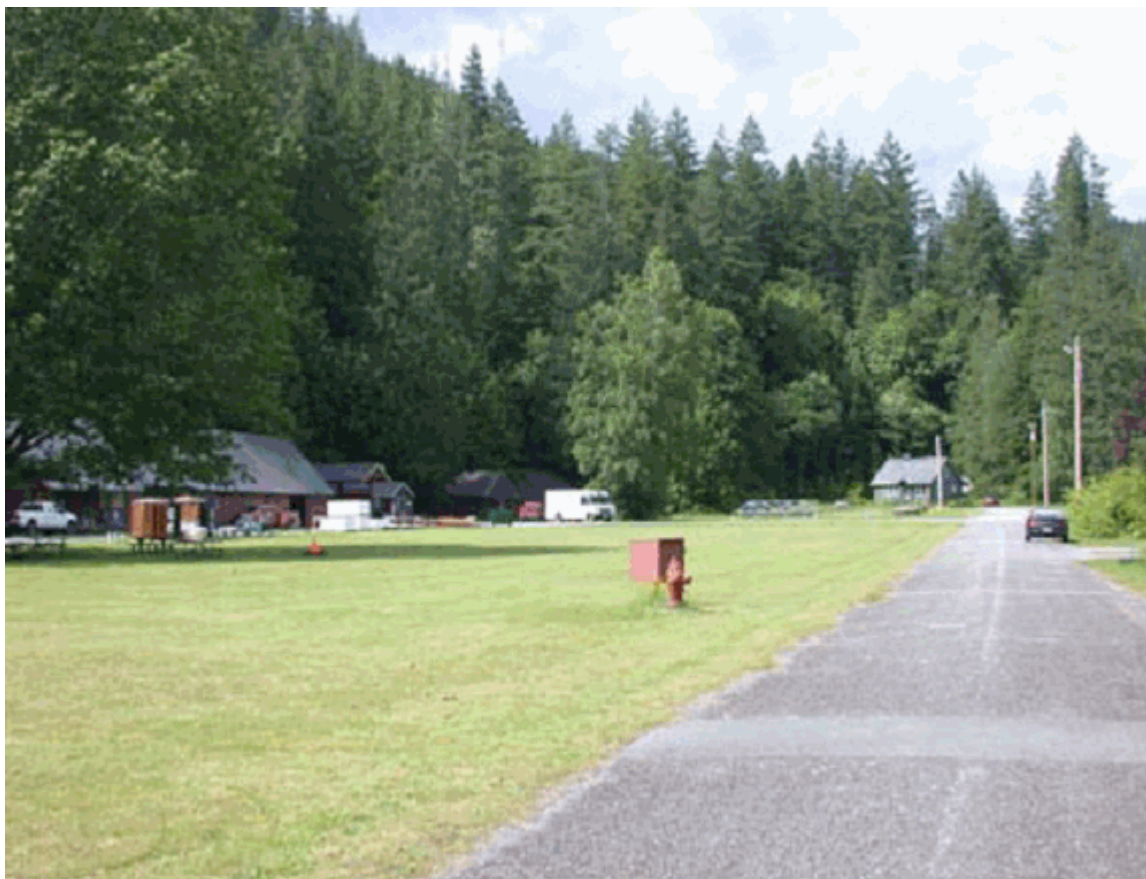
*The northern portion of Ranger Station Road appears much as it did historically in width and surface material (PWRO-Seattle, 2004).*

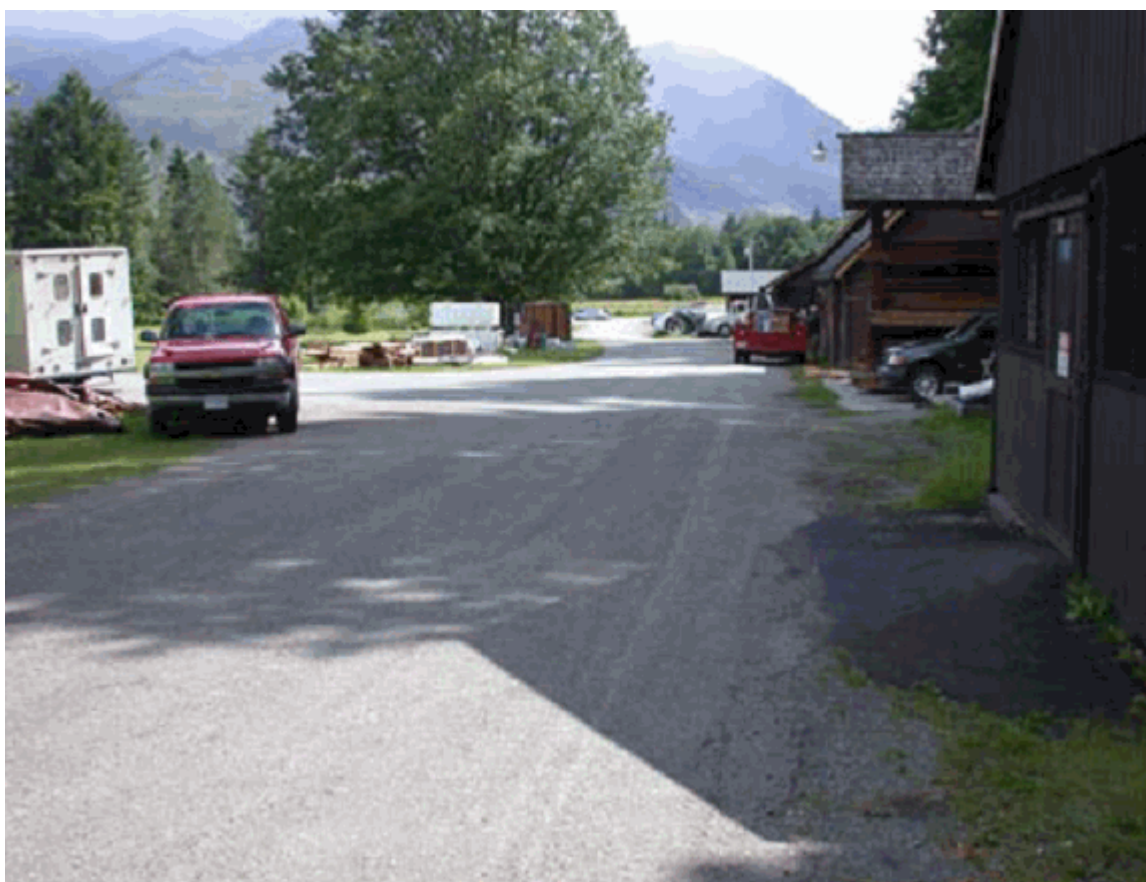
*A portion of the Loop Road in front of the Garage and non-historic Gas/Oil House still appears much as it did historically in width and surface material (PWRO-Seattle, 2004).*

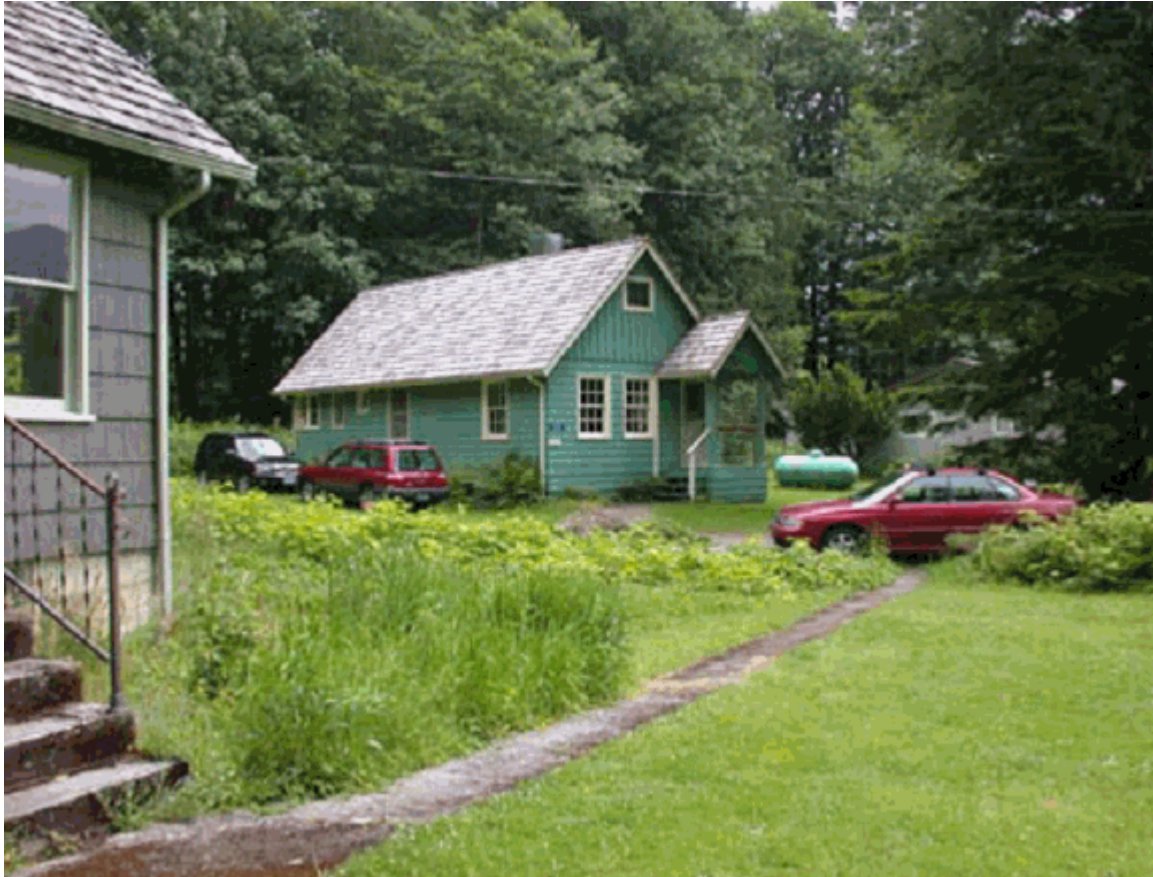
*Historic concrete pathways to both residences still remain. This shows one of the walkways at the District Rangers Residence (PWRO-Seattle, 2004).*
