National Park Service  
Cultural Landscapes Inventory

Marblemount Ranger Station Historic District  
North Cascades National Park

**Marblemount Ranger Station Historic District  
North Cascades National Park**

CONDITION ASSESSMENT: **Fair**

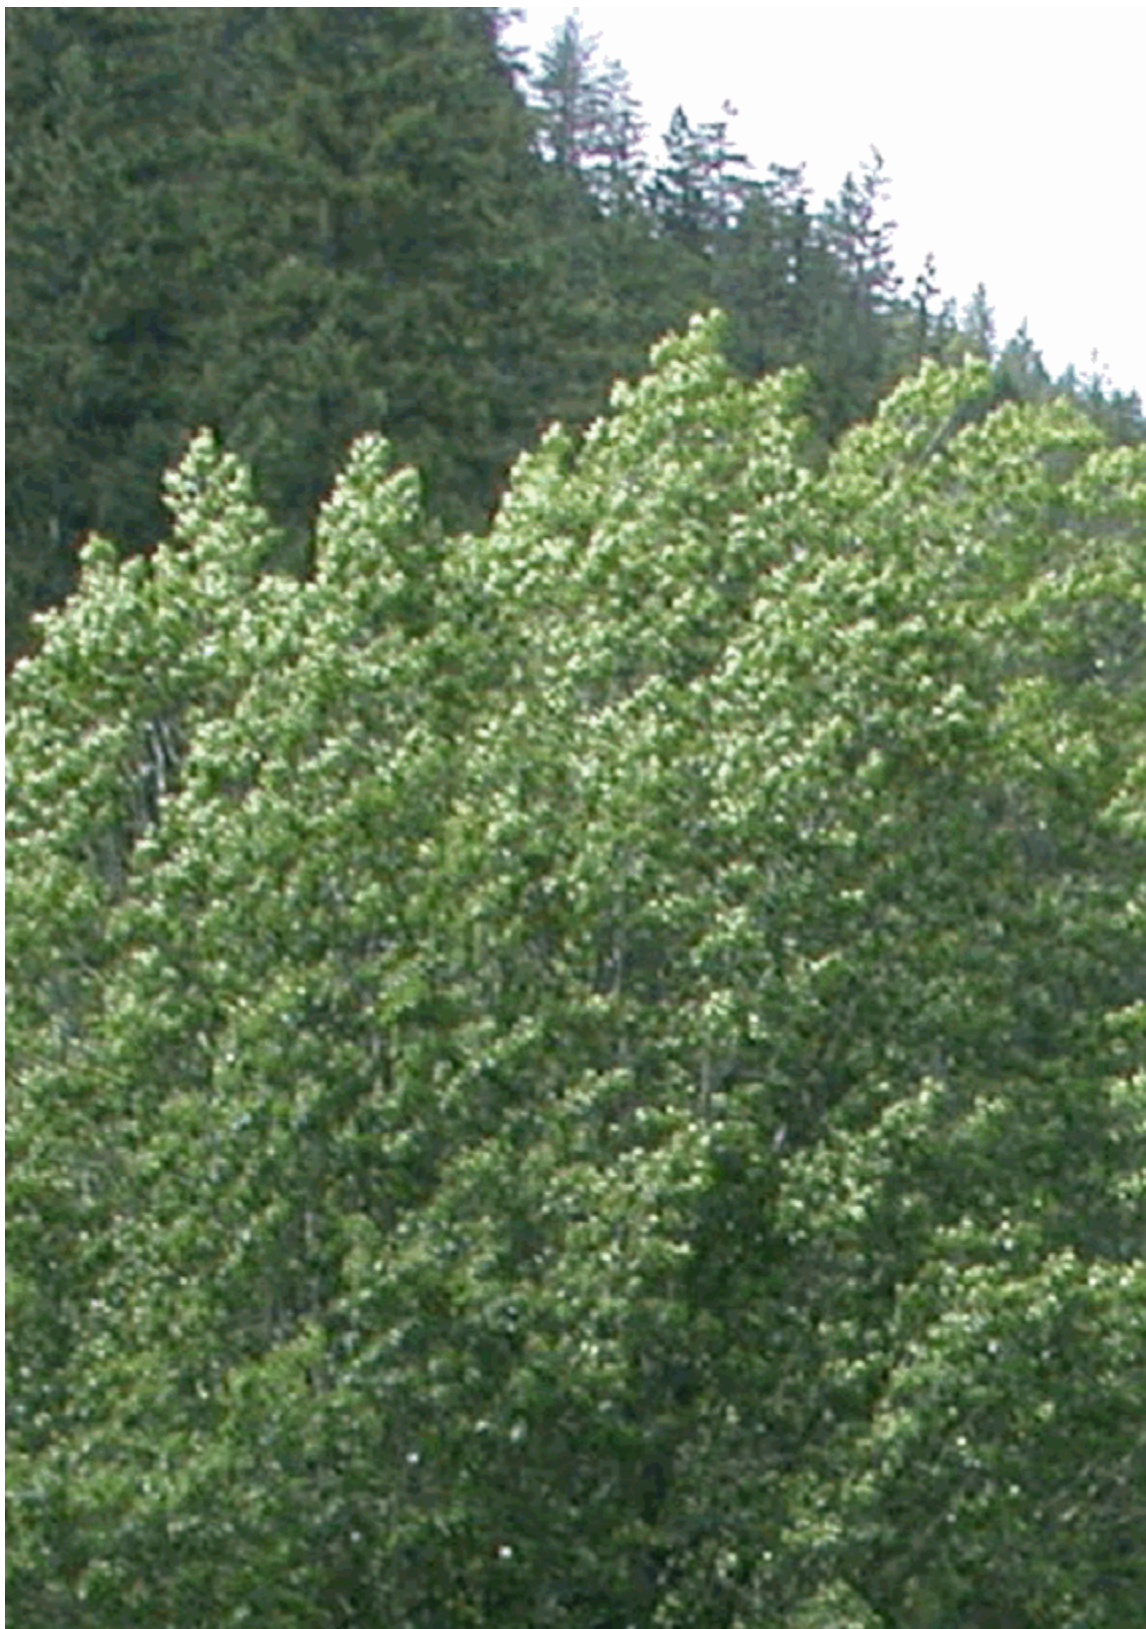
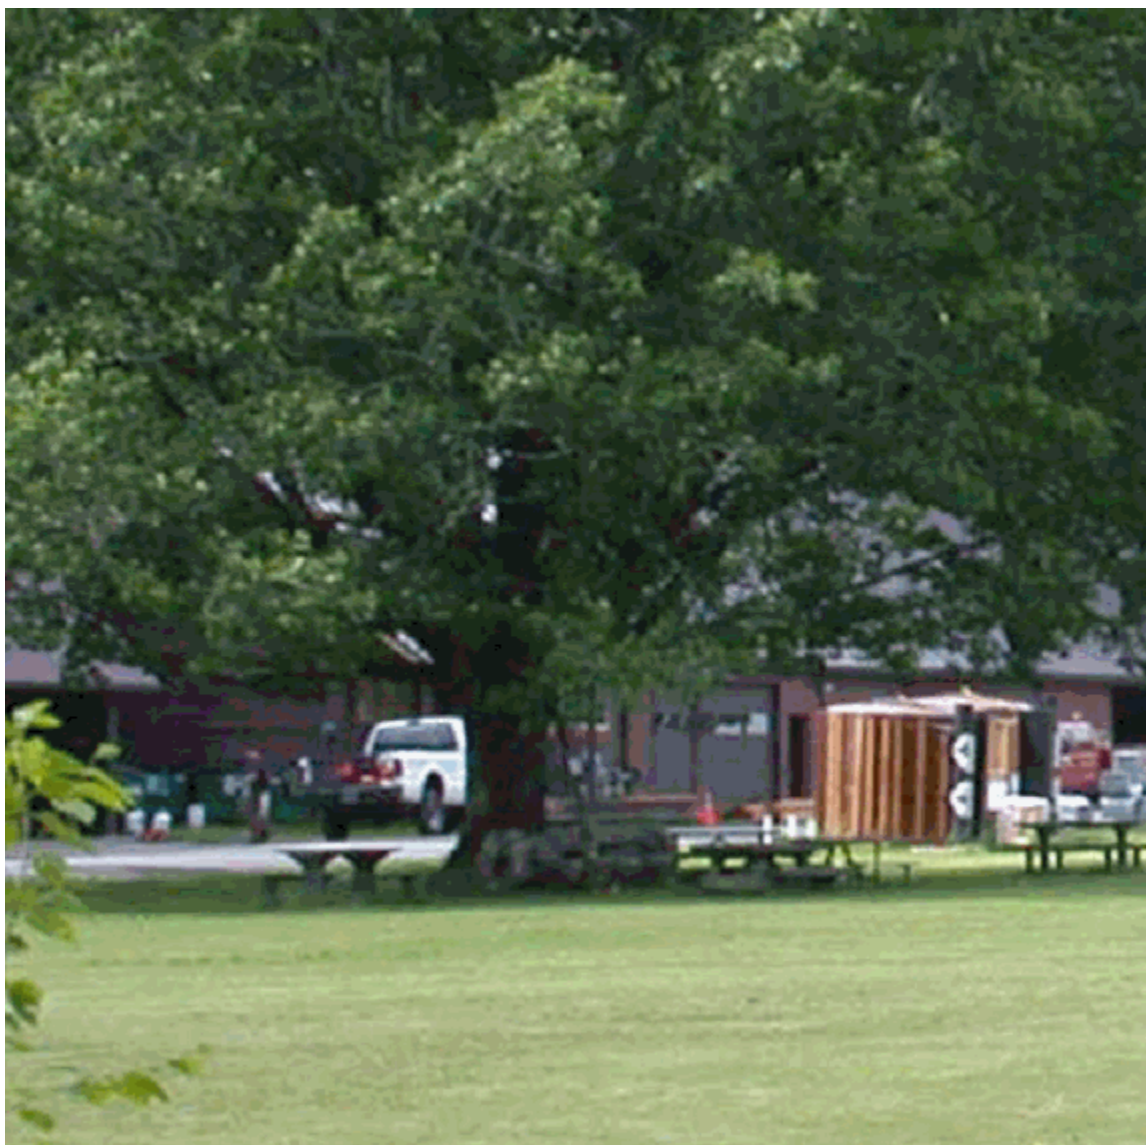
*Mature coniferous forest creates a buffer along the western and northern edges of the historic district. Lawn is maintained in the central area (PWRO-Seattle, 2004).*

| <b>Impact Description:</b> | Lack of vegetation management is an impact upon the condition of Marblemount Ranger Station Historic District. Currently, forest canopy is encroaching on the row of utilitarian structures, where it drops leaf and needle litter, causing moisture retention on building roofs and sheathing. The central meadow grasses are being compacted by vehicular parking, and is addressed above. Other woody vegetation planted around the historic structures and throughout the historic district is in need of remedial and rejuvenative pruning, or replacement. Ivy growing at the rear of the historic residences at the north end of the ranger station should be contained. It currently occupies a large area, and may suppress or kill the other remaining ornamental plants dating from the period of significance (such as periwinkle, boxwood, and rhododendron). |

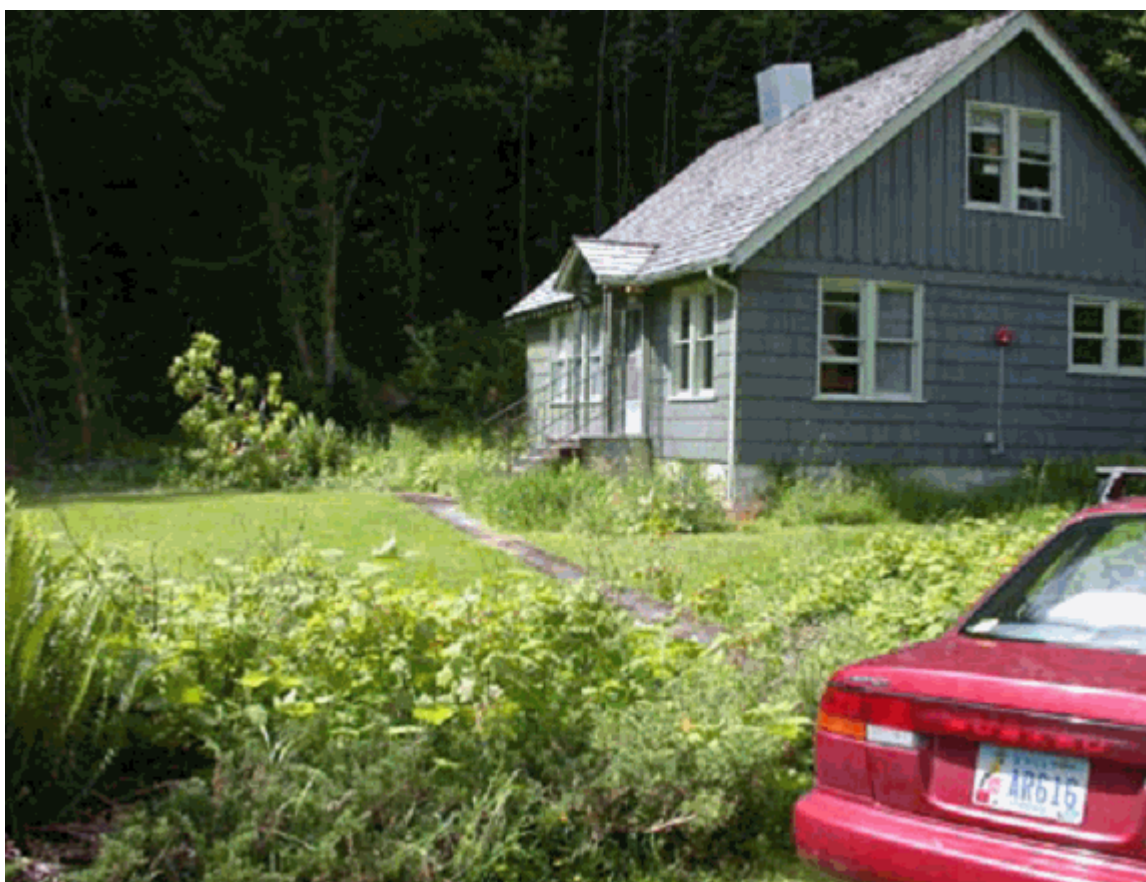
*Ornamental shrubs and perennials grow in historic plant beds around the District Rangers Residence (PWRO-Seattle, 2004).*
