NORTH CASCADES NATIONAL PARK

PNRO INVENTORY

| NAME(S) OF STRUCTURE/SITE<br>(Building) SOURDOUGH MOUNTAIN LOOKOUT | | DATE OF CONSTRUCTION<br><br>1933<br><br>ADDITION(S) | SITE ID. NO. | |

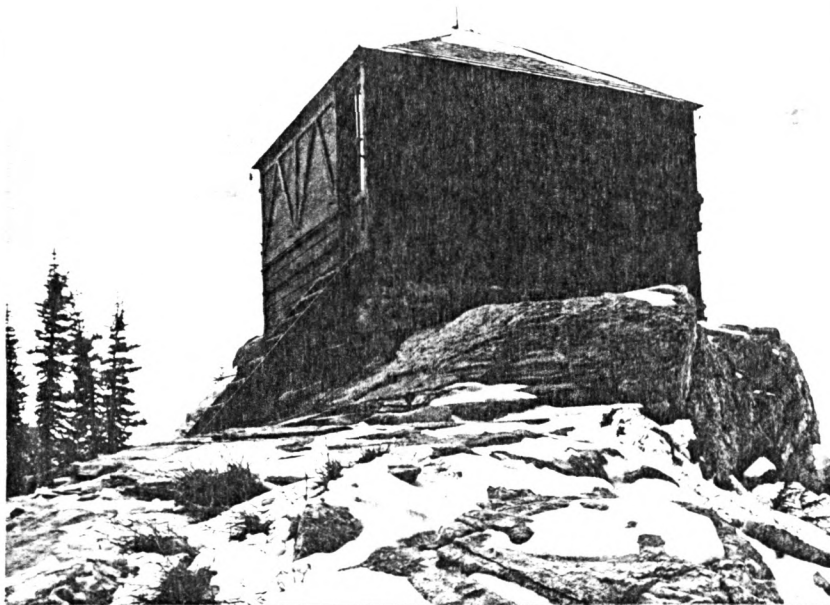
FROM N

| DESCRIPTION AND BACKGROUND HISTORY INCLUDING CONSTRUCTION DATE(S), PHYSICAL DIMENSIONS, MATERIALS, MAJOR ALTERATIONS, IMPORTANT BUILDERS, ARCHITECTS, ENGINEERS, ETC.<br>Cabin. Wood frame set on rock foundation; square (14'3"x14'3"); 5 bays wide; 1-story; shiplap siding; wood-shingled hip roof; off-center door on east with wood panel and glass door. Exterior features include 2/2 hinged sash on each facade; plywood hinged shutters with diagonal bracing.<br>The U.S. Forest Service erected fire lookouts as part of their fire protection system for the forests. Most of the lookouts were built between 1920-1935. W.W.II brought a perceived threat from across the Pacific and this led to the manning of some lookouts as part of the military's Aircraft Warning System. After the war, aerial surveillance and other technological advances rendered the old lookouts obsolete. Many were torn down in the 1960s. The first lookout on this mountain was erected in 1917 by Glee Davis (early upper Skagit Valley resident). He hand-split shakes and siding at his homestead at Cedar Bar and packed the materials up the mountain with horses. His father-in-law was the first lookout (Campbell). The structure was about 10' x 10' with a 6' x 6' cupola. The present lookout was erected by the CCC's in 1933, replacing Davis' building. This lookout is no longer used on a regular basis. It is a popular destination for day hikers. A new roof was installed in 1980. | | | DANGER OF DEMOLITION?<br>(SPECIFY THREAT)<br><input type="checkbox"/> YES<br><input type="checkbox"/> NO<br><input checked="" type="checkbox"/> UNKNOWN | |
