# NORTH CASCADES NATIONAL PARK

## INVENTORY

| <b>NAME(S) OF STRUCTURE/SITE</b><br><i>(Building)</i> <i>SWAMP CABIN/MEADOW CABIN (East)</i> | | <b>DATE OF CONSTRUCTION</b><br><br><i>c. 1912<br/>or earlier</i> | | <b>SITE ID. NO.</b><br><div style="border: 1px solid black; width: 100%; height: 20px; margin-top: 5px;"></div> | | | | | | | | | |

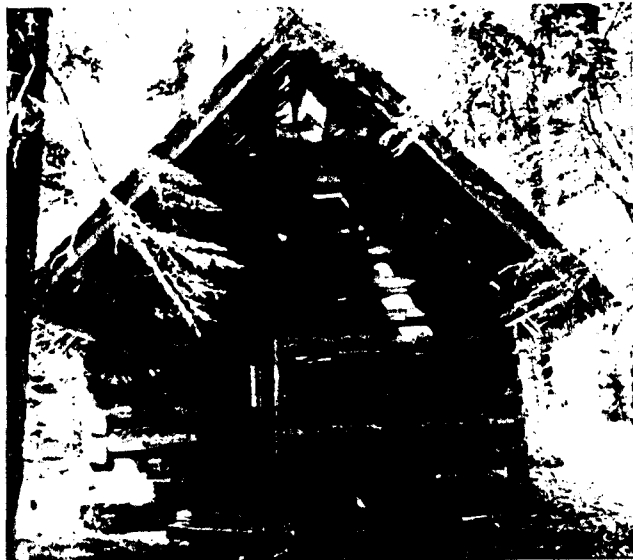
FROM E.

| <b>DESCRIPTION AND BACKGROUND HISTORY INCLUDING CONSTRUCTION DATE(S), PHYSICAL DIMENSIONS, MATERIALS, MAJOR ALTERATIONS, IMPORTANT BUILDERS, ARCHITECTS, ENGINEERS, ETC.</b><br><i>Cabin. Log construction set on log foundation; rectangle (15' x 18'); 1 bay wide; 1-story; round logs with round-hewn ends and square-notched corners; wood-shaked gable roof extended on south to form porch overhang; off-center entrance opening on south. Exterior features include rectangular window opening (sash missing) on north; round log purlins; plain fascia board on south; split wood used as chinking between logs.</i><br><br><i>The date of construction for this cabin is not known. It is associated with early mining operations in upper Thunder Creek but does not appear on a 1913 or 1922 Washington National Forest Map (first appears on Mt. Baker National Forest Map, 1936). It is believed that the North Coast Mining and Milling Company built this structure and one nearby and used them as headquarters for assaying, storage, etc. The company was large and financed by an English outfit. They hired a man from Marblemount for the axe work on both log buildings. Supplies to the cabins and mines were brought in by packtrain. The company had a substantial warehouse in Marblemount where they kept supplies and mules. The round-trip to the mines usually took five days. After mining subsided (c. 19-teens) the cabins were used as shelters by various people including Jack Durand (builder of Middle Cabin-razed) and John Dayo (trapper) in the 1920s.</i> | | | | <table border="1" style="width: 100%; border-collapse: collapse;"> <tr> <td style="width: 50%;"><b>CURRENT USE</b><br/><i>Vacant</i></td> <td style="width: 50%;"><b>ORIGINAL USE</b><br/><i>Storage</i></td> </tr> </table> | | <b>CURRENT USE</b><br><i>Vacant</i> | <b>ORIGINAL USE</b><br><i>Storage</i> | | | | | | |
| <b>CONDITION</b><br><input type="checkbox"/> EXCELLENT<br><input type="checkbox"/> GOOD | <input type="checkbox"/> FAIR<br><input checked="" type="checkbox"/> DETERIORATED<br><input type="checkbox"/> RUINS | | | | | | | | | | | | |

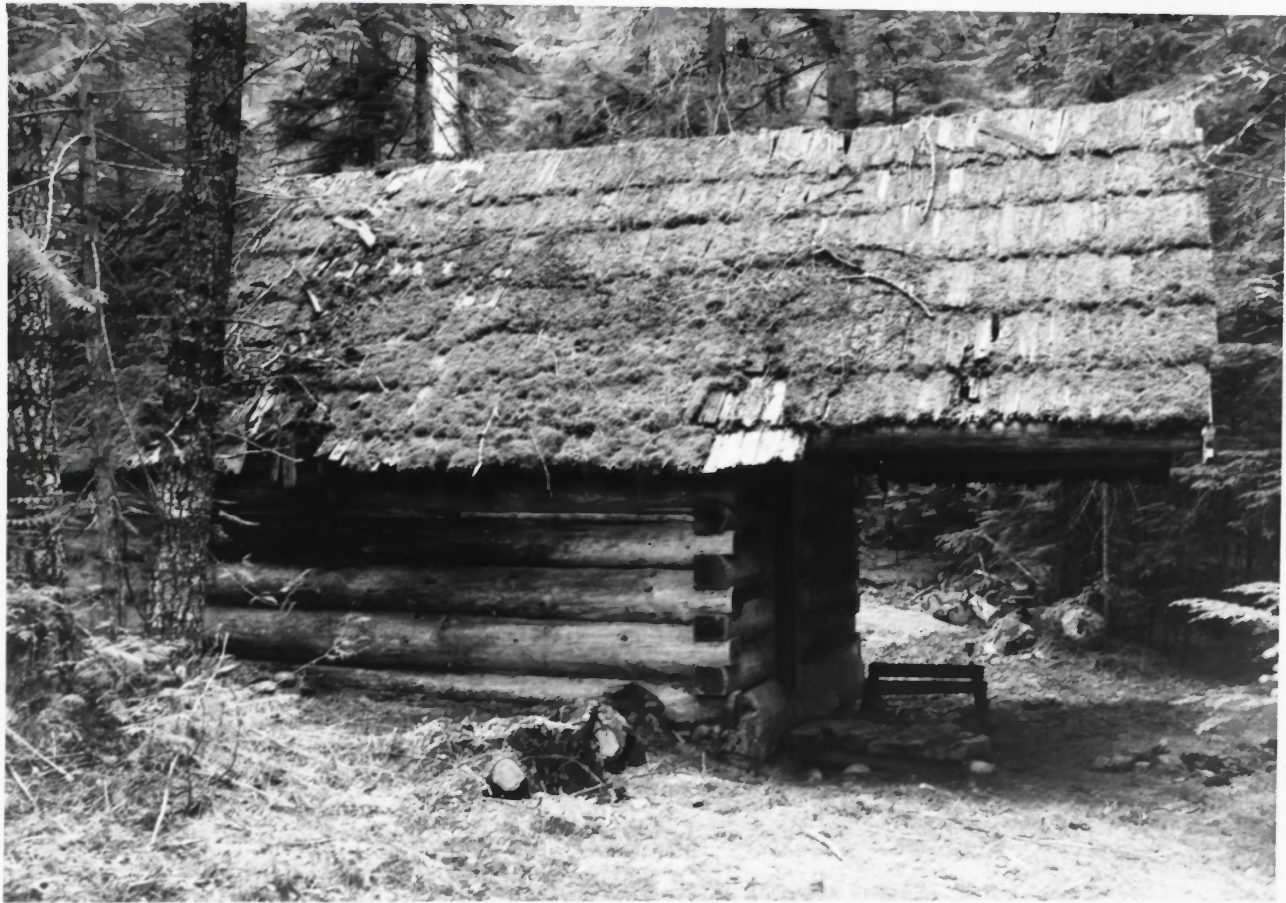
Meadow Cabin East  
#39

PNR #GL5-20
