Graves Creek Ranger Station  
Olympic National Park

CULTURAL LANDSCAPES INVENTORY (CLI) PROGRAM  
*2010 Condition Assessment Update for:*

**Graves Creek Ranger Station**  
**Olympic National Park**

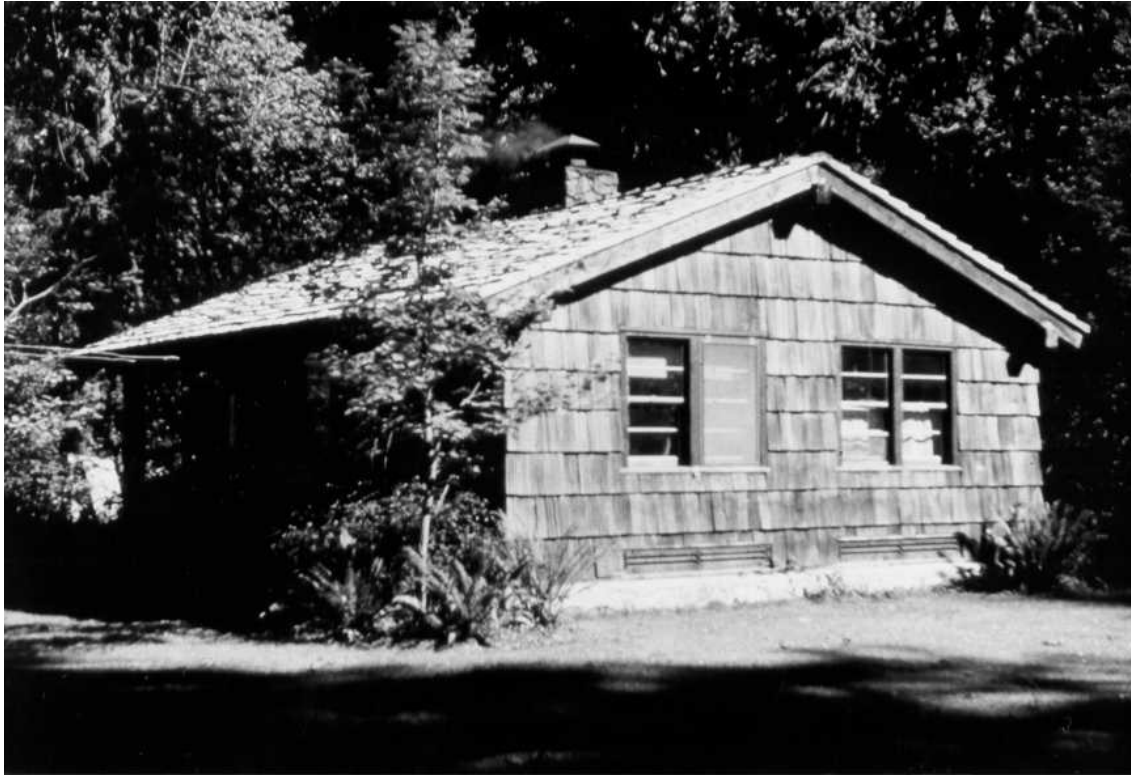
*Historic photograph of the Graves Creek Ranger Station. Note the use of Sword ferns as foundation plantings. (OLYM-4787/728.2, 1948.)*

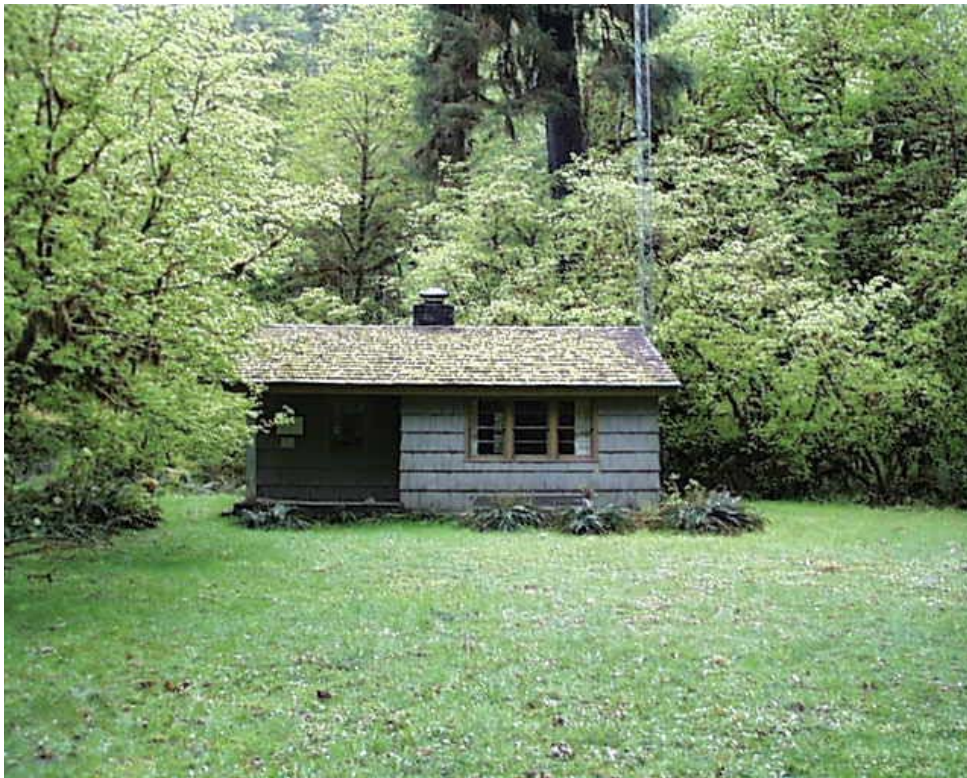
*Contemporary photograph of Graves Creek Ranger Station. (CCSO, 2000.)*

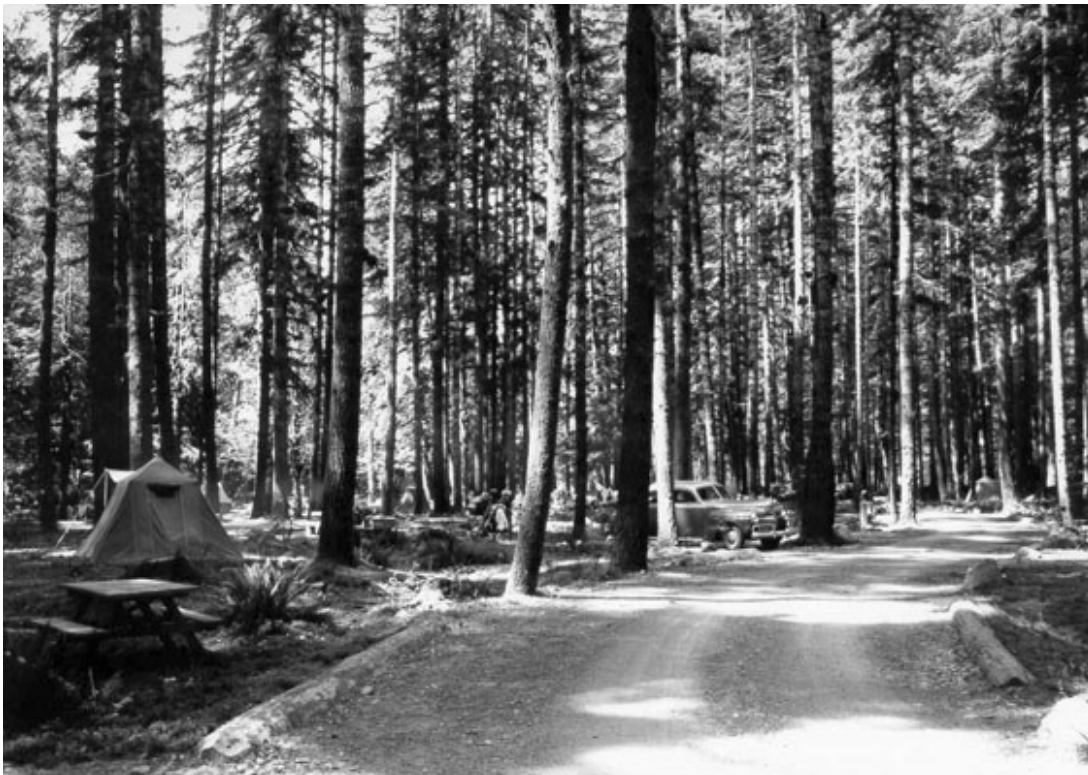
*Historic photograph of Graves Creek Campground, 1941. Note the curvature of the road, the log berm, and picnic tables. (OLYM-2474/728.993, Mortiboy, 7/5/41.)*

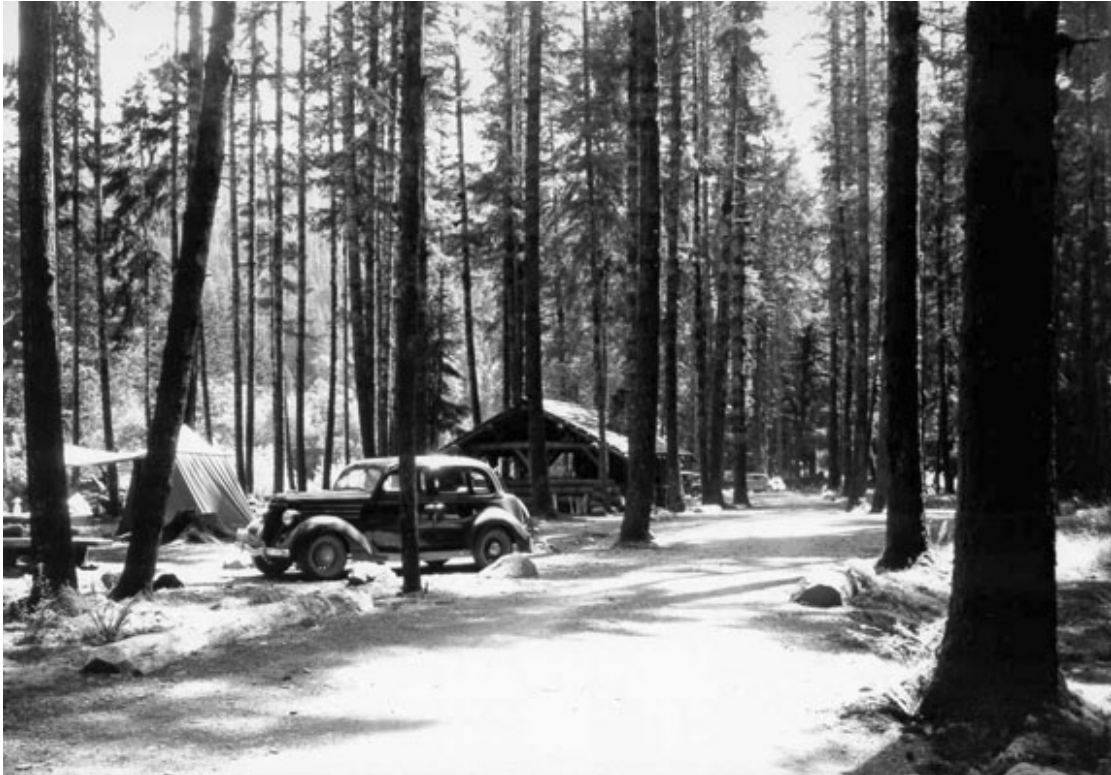
*Historic photograph of Graves Creek Campground, 1941. Note the community kitchen in the background. (OLYM-2473/728.993, Mortiboy, 7/5/41.)*

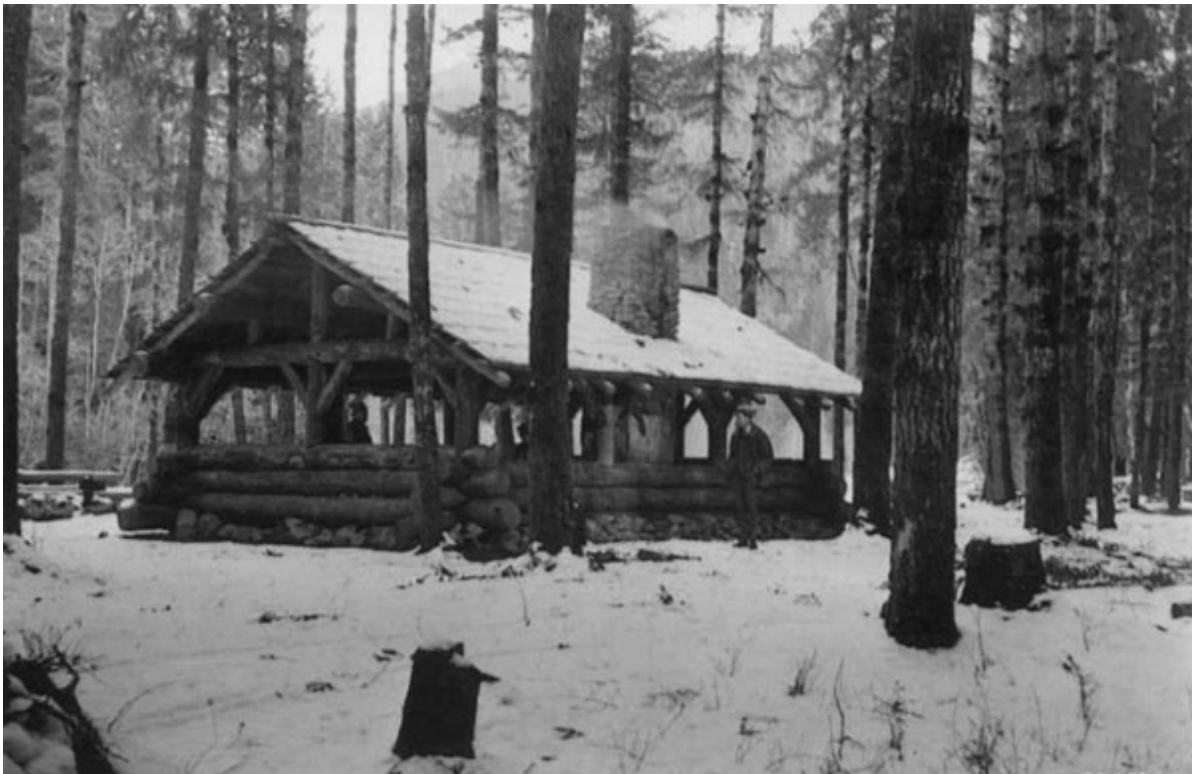
*Historic photograph of the community kitchen at Graves Creek Campground, 1936. (GCRS/OLYM-321493.)*

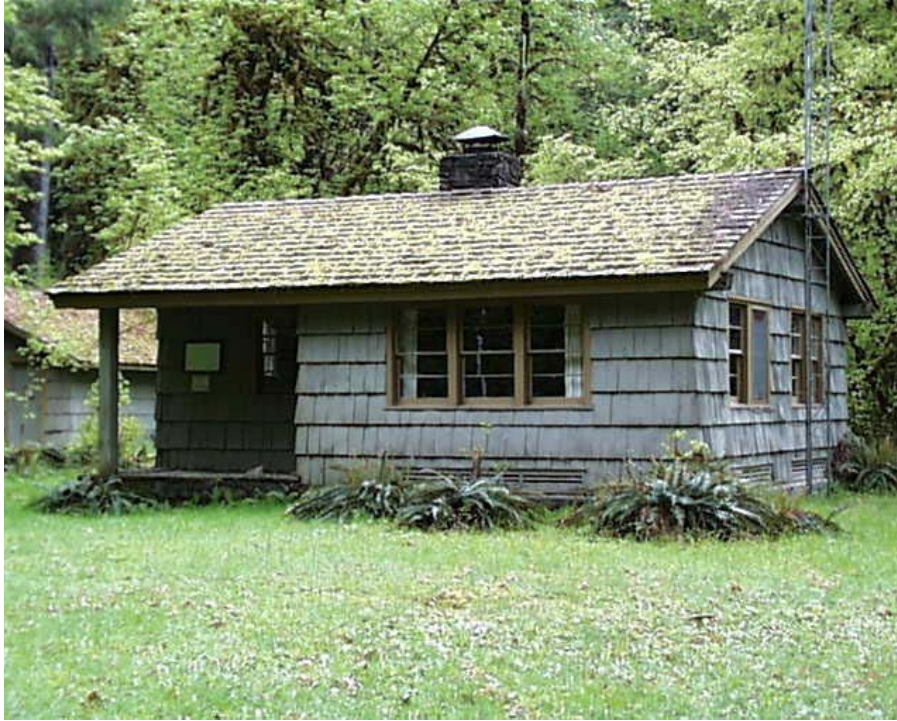
*Contemporary photograph of the Graves Creek Ranger Station. (CCSO, 2000.)*

The ranger station is in fair condition, although several areas need attention to prevent further deterioration. Several shingles near the foundation have been damaged by water and should be repaired, and where necessary, replaced. The mortar bond is failing in several areas on the two flagstone porches on the ranger station, and should be tuckpointed to prevent further deterioration. Vegetation that covers the flagstone walkway leading from the ranger station to the road should be removed, and the mortar joints repointed. The roof (and rafters) on the generator house are in poor condition and should be repaired to prevent further deterioration.

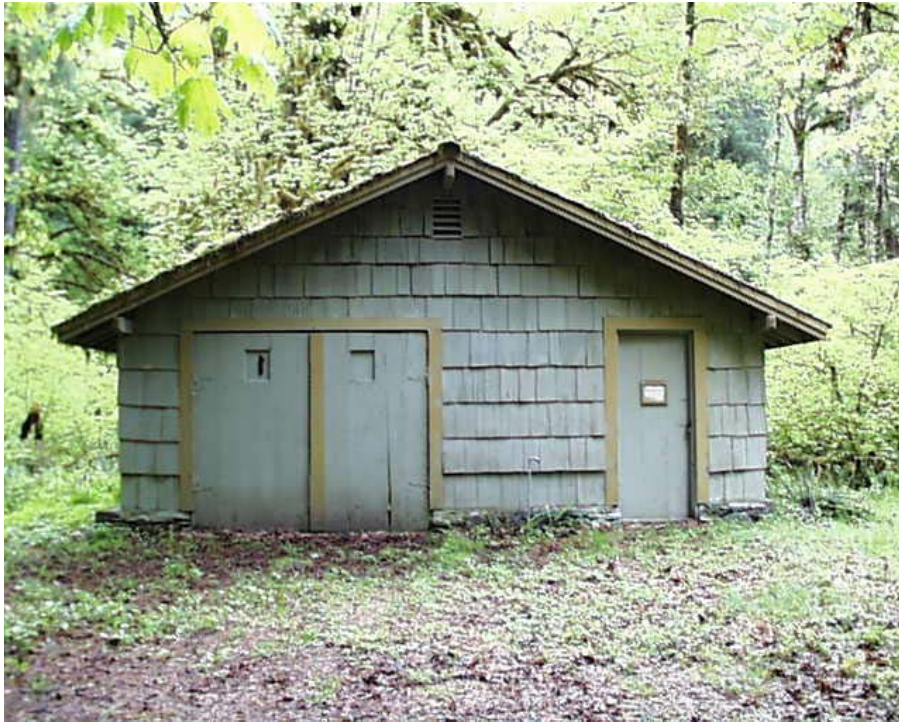
The garage/wood shed was built between 1941 and 1942, and is a one-story frame structure sheathed with cedar shingles. Rectangular in shape, it measures 22' x 24' and has a gable roof with exposed rafter tails. The roof is covered with cedar shakes. The building's foundation is stone and mortar, and a concrete slab exists in the garage portion. Windows in the building are one-over-one double-hung sash and multi-light fixed sash. There is a wide, wood garage door and a wood pedestrian door on the main façade. The form and materials of the garage/woodshed are similar to the ranger station/residence.

*Contemporary photograph of the garage/wood shed located in the Graves Creek Ranger Station Historic District. (CCSO, 2000.)*

*Between 2006 and 2009 the garage/woodshed received preservative maintenance. This work included: cleaning and repair of stone foundation, regarding the southwest corner where the foundation has been undermined, reroute propane and electrical piping, and re-glazing of some windows and doors.*

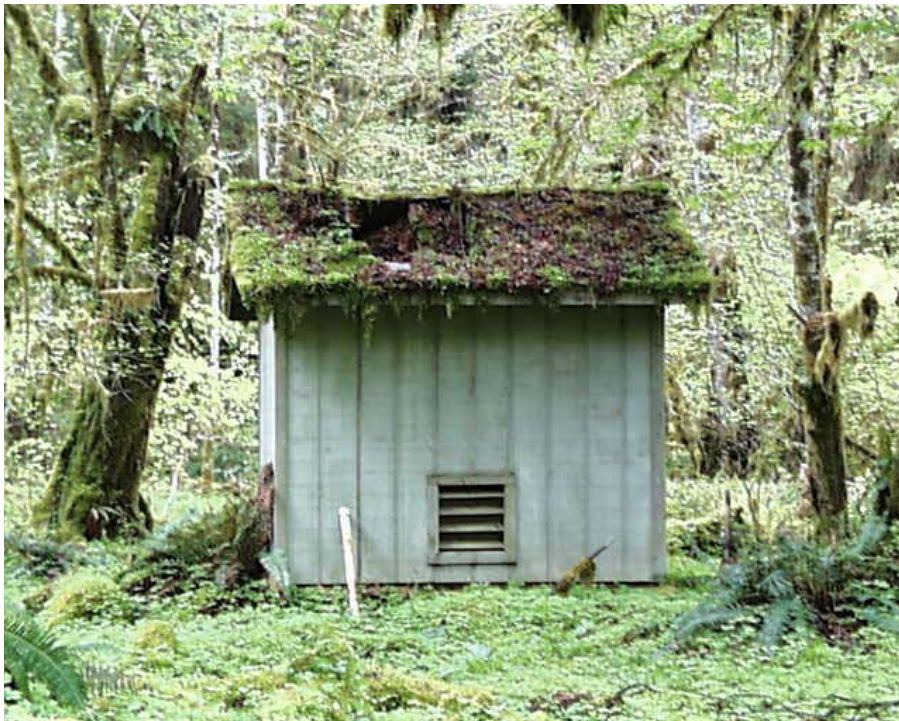
*Contemporary photograph of the generator house located in the Graves Creek Ranger Station Historic District. (CCSO, 2000.)*

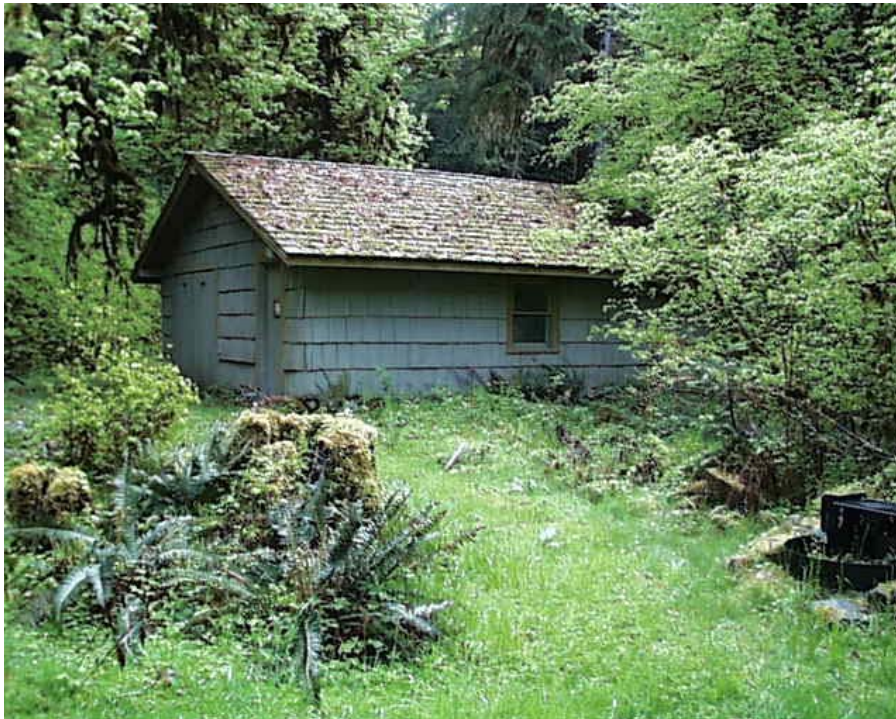
*Contemporary photograph showing a circulation path that leads from the back porch of the ranger station, past a fire ring (at the lower right corner of photo) to the garage/wood shed. (CCSO, 2000.)*

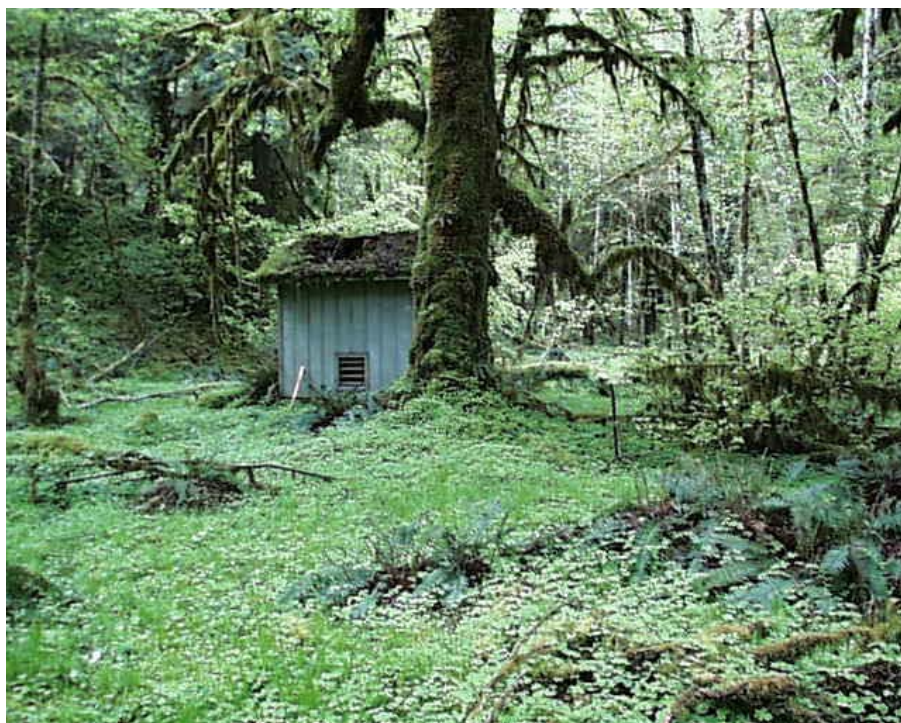
*Contemporary photograph showing the vegetative path that leads from the rear of the ranger station to the generator house. (CCSO, 2000.)*

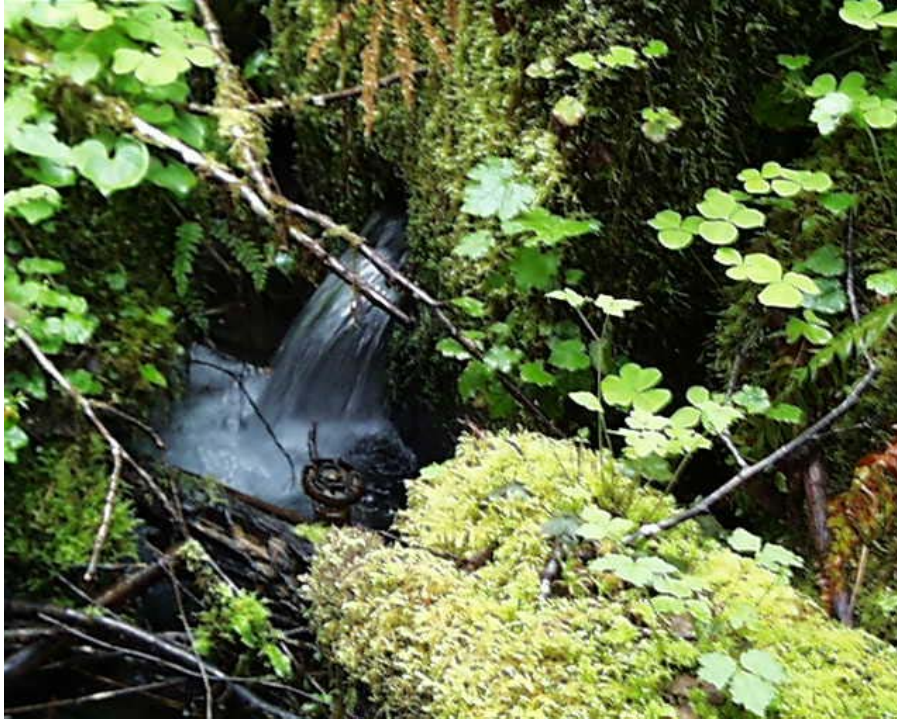
*Contemporary photograph showing a detail of the water intake system. Note the valve at the center left of the photograph. (CCSO, 2000.)*

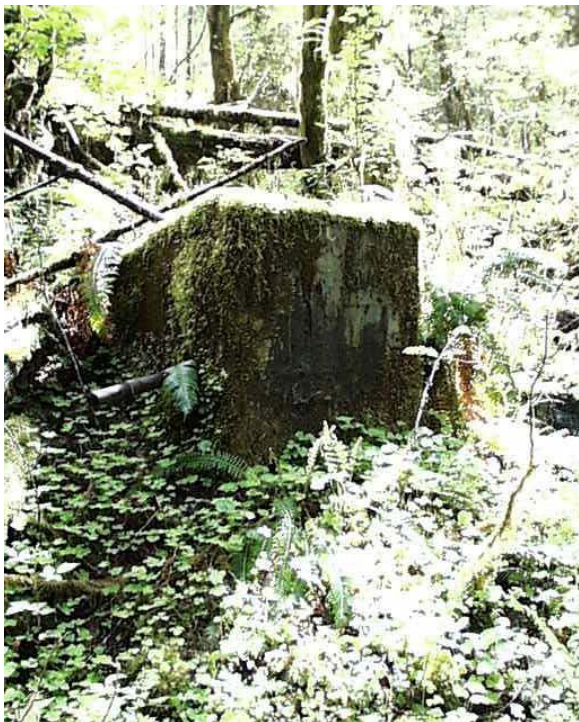
*Contemporary photograph showing one of the concrete basins that are part of the water intake system. (CCSO, 2000.)*

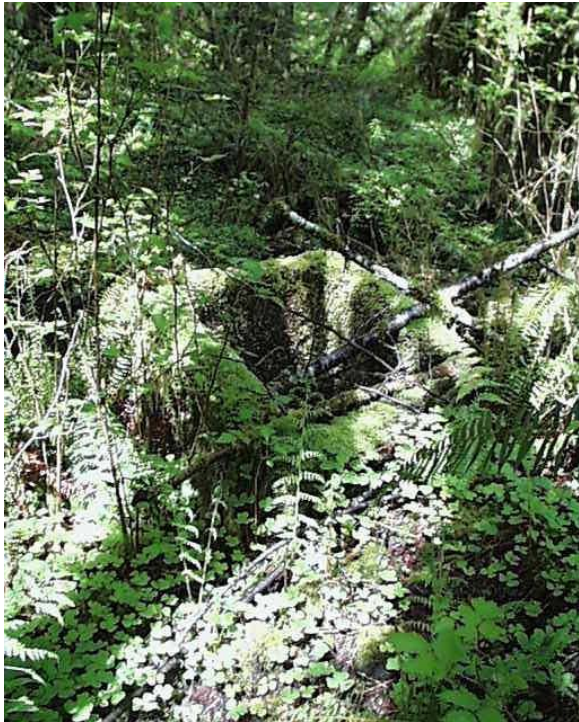
*Contemporary photograph of the second concrete basin that was part of the water intake system. (CCSO, 2000.)*

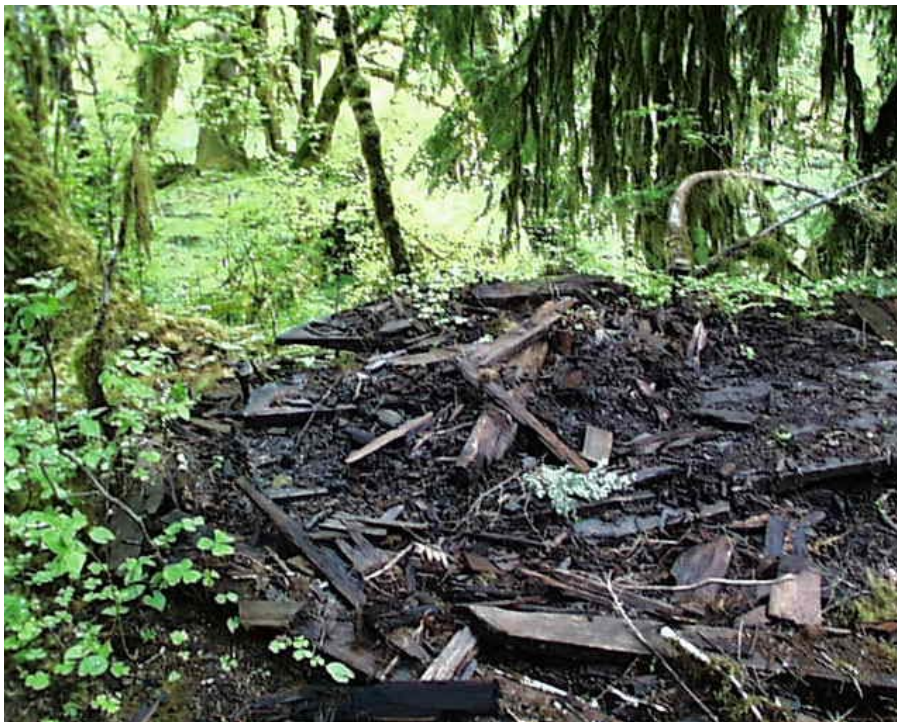
*Contemporary photograph of the ruin of the former redwood water tank, which was originally part of the water system for the ranger station. (CCSO, 2000.)*

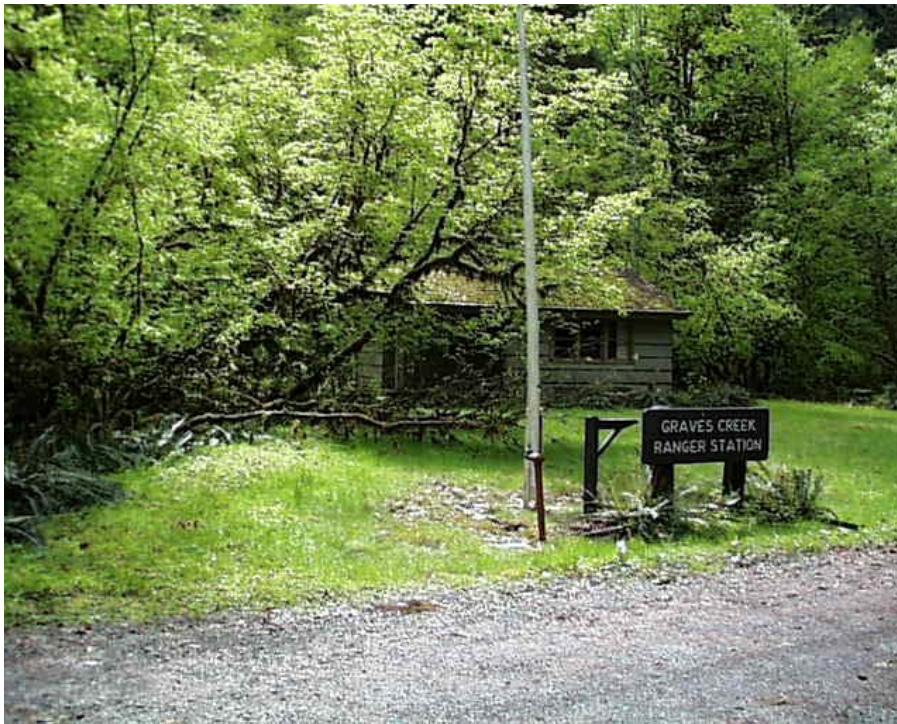
*Contemporary photograph of four small-scale features in the historic district: a flagpole, historic ranger sign post, current sign, and water spigot. (CCSO, 2000.)*

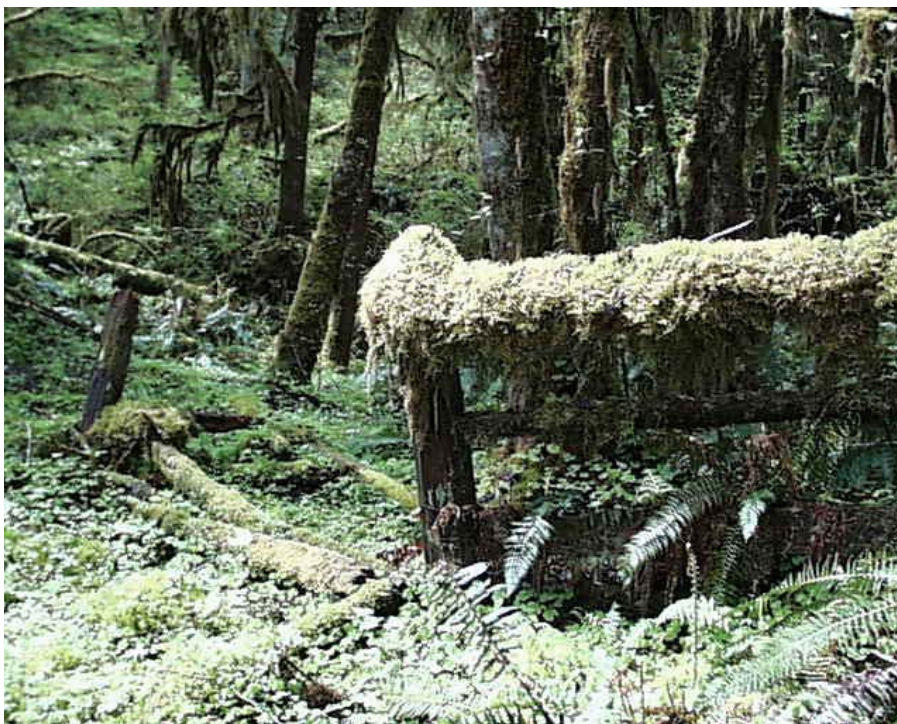
*Contemporary photograph of the fence ruin that historically contained the elk forage experimental plot. (CCSO, 2000.)*

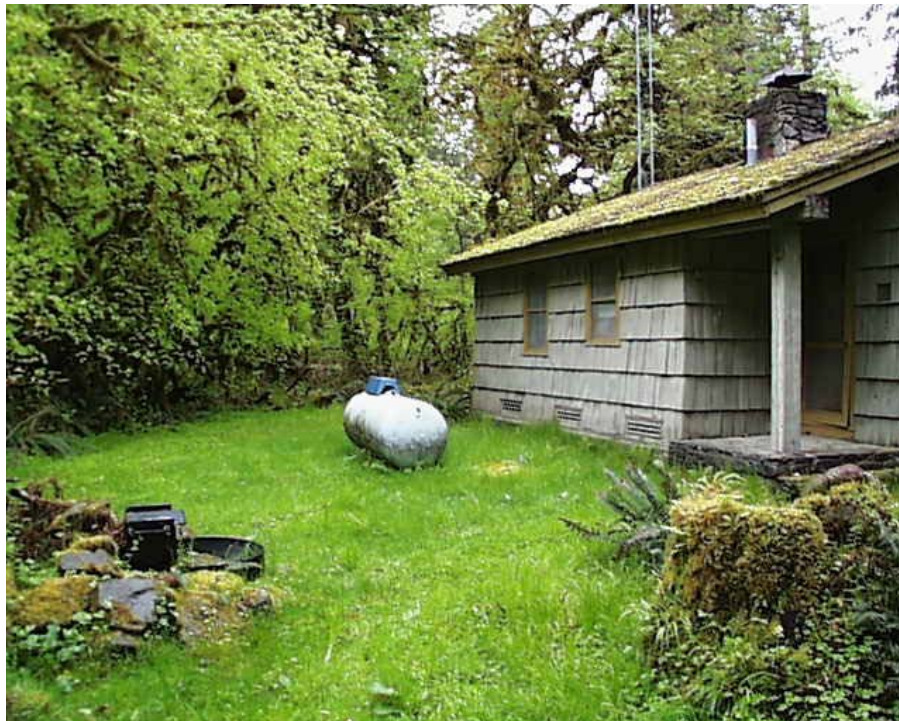
*Contemporary photograph showing the non-contributing propane tank and fire ring. (CCSO, 2000.)*

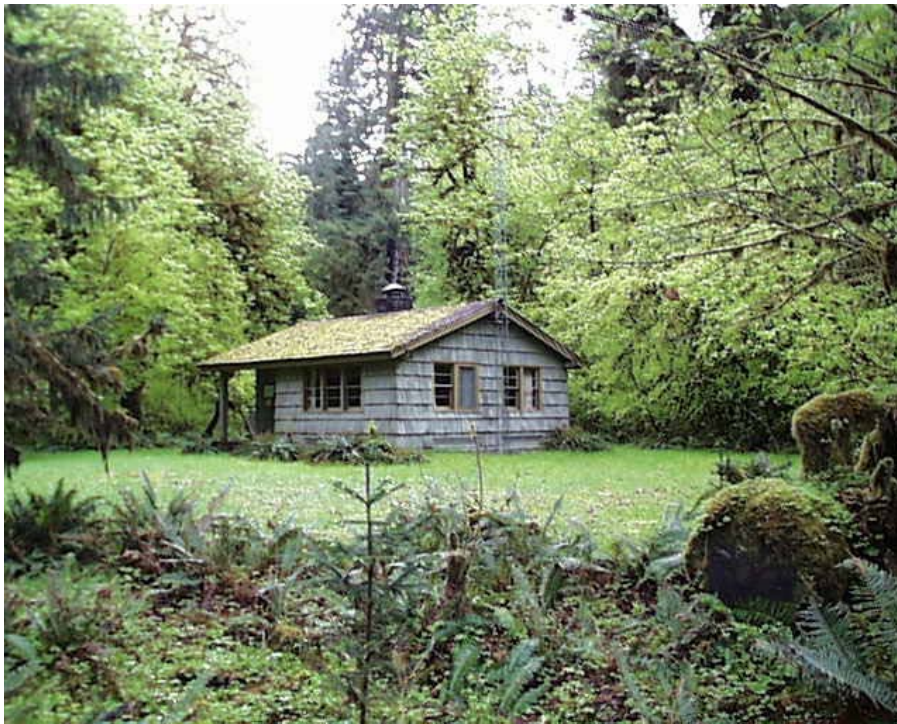
*Contemporary photograph of the residential space within the historic district. Note the expanse of lawn, and the vegetation that creates an edge to the space. (CCSO, 2000.)*

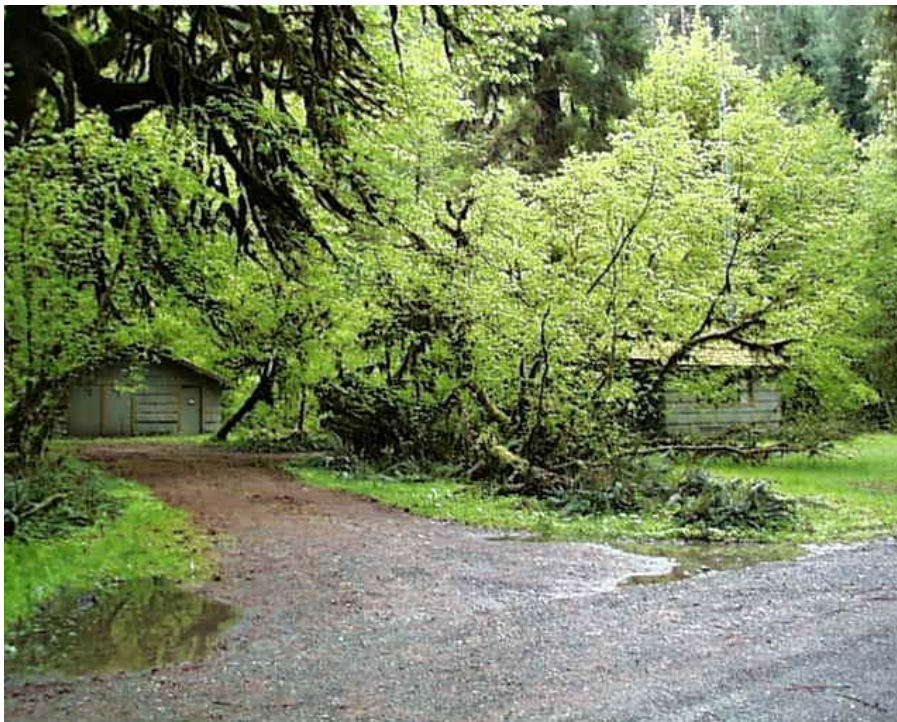
*Contemporary photograph showing the vehicle/service space. Note the vegetative screen that borders the driveway and separates this area from the residential space. (CCSO, 2000.)*

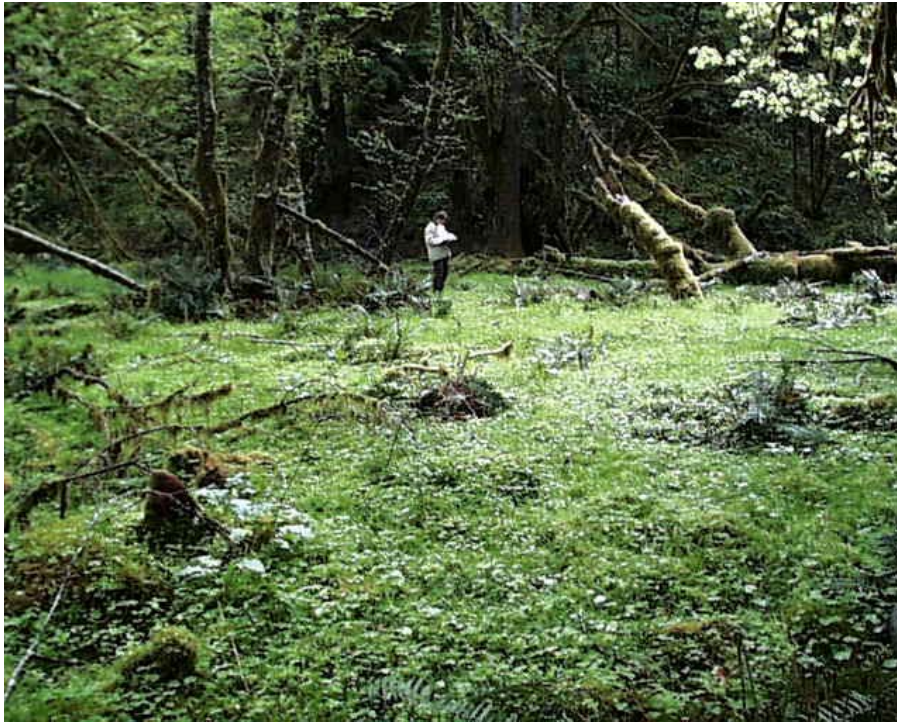
*Contemporary photograph showing the elk forage experimental space. Note the open characteristic of this space. (CCSO, 2000.)*

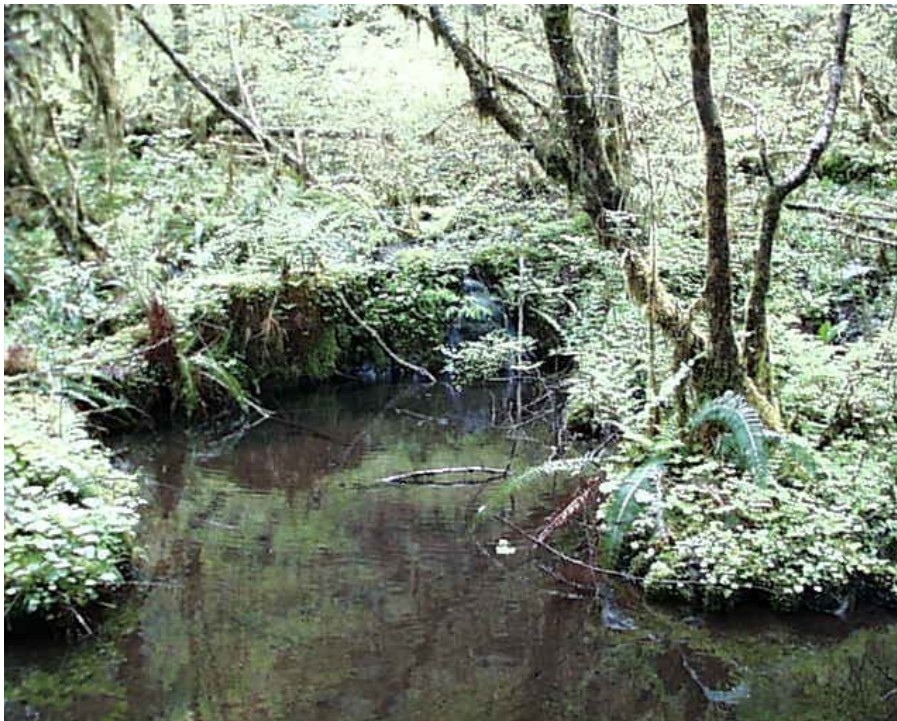
*Contemporary photograph showing the water system space, which is created by the water intake system and dam, and is enclosed by surrounding vegetation. (CCSO, 2000.)*

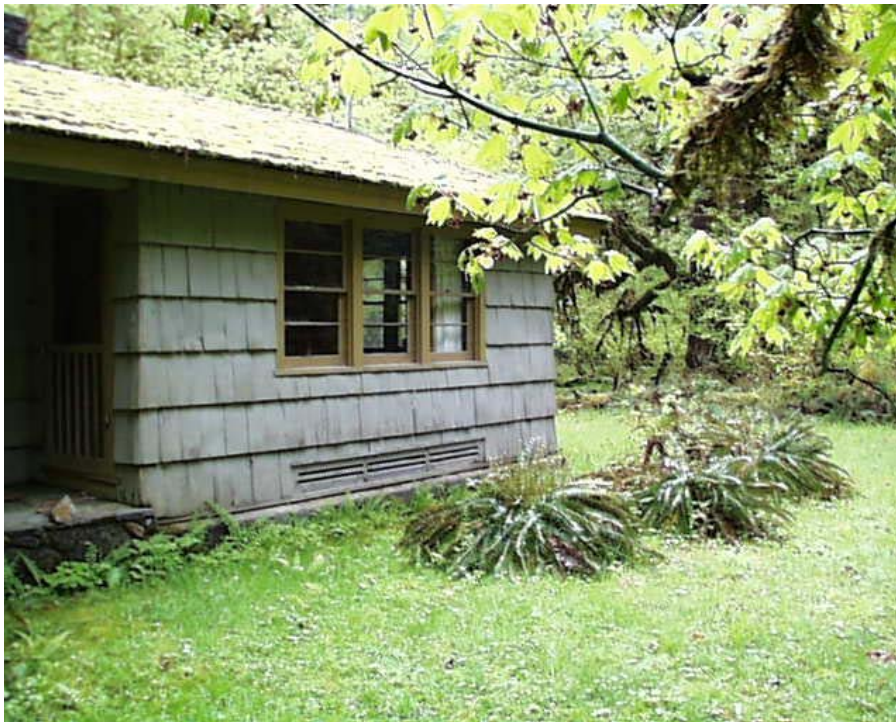
*Contemporary photograph showing the Sword ferns that were planted by CCC crews as ornamental plants. (CCSO, 2000.)*

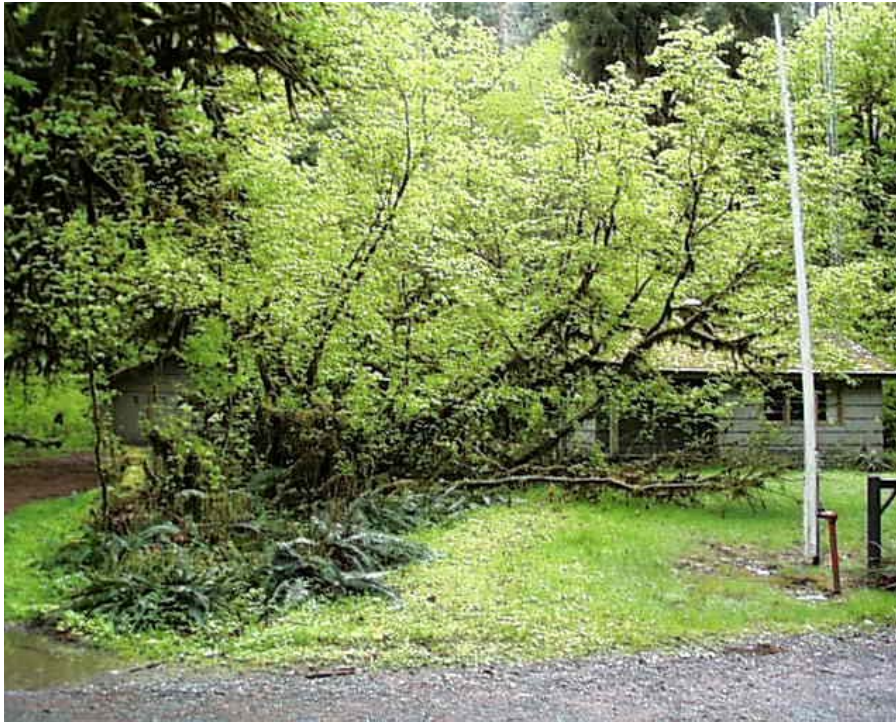
*Contemporary photograph showing the planting bed consisting of Vine maples and Sword ferns that separates the driveway from the lawn. Note the overgrown flagstone walk (the area of lighter green vegetation) that borders the planting bed. (CCSO, 2000.)*

Vegetation near the ranger station and the garage/wood shed should be thinned to provide adequate ventilation to protect the buildings from being damaged by rot. The vegetation strip that lines the driveway (next to the lawn) should also be thinned to provide ventilation. This area is currently overgrown, and limbs that overhang the flagstone walkway should be trimmed back, to allow use of the walkway.

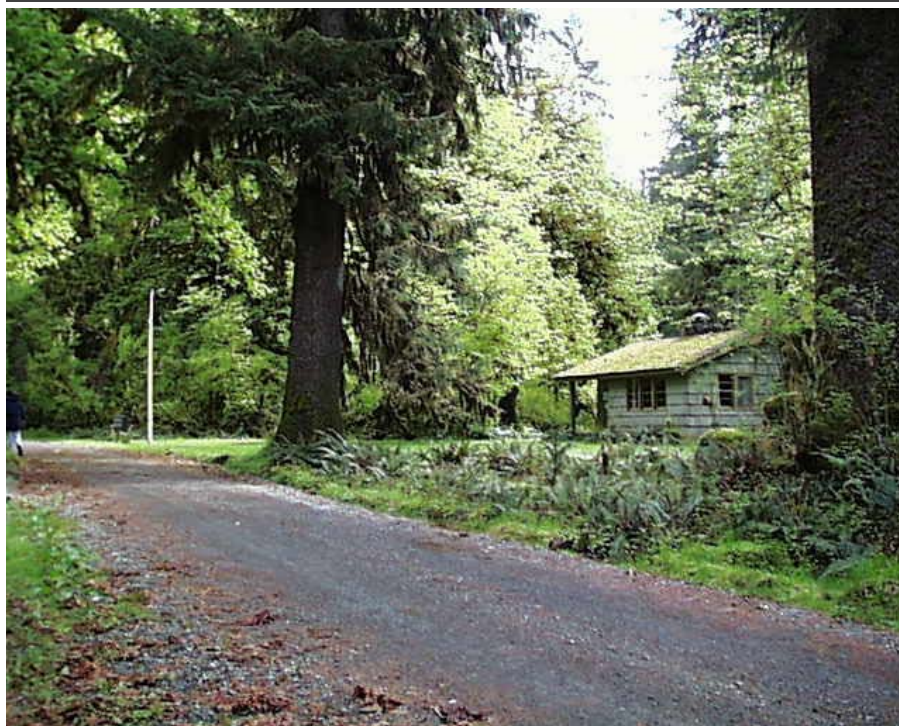
*Contemporary photograph showing the view of the ranger station from the road. (CCSO, 2000.)*

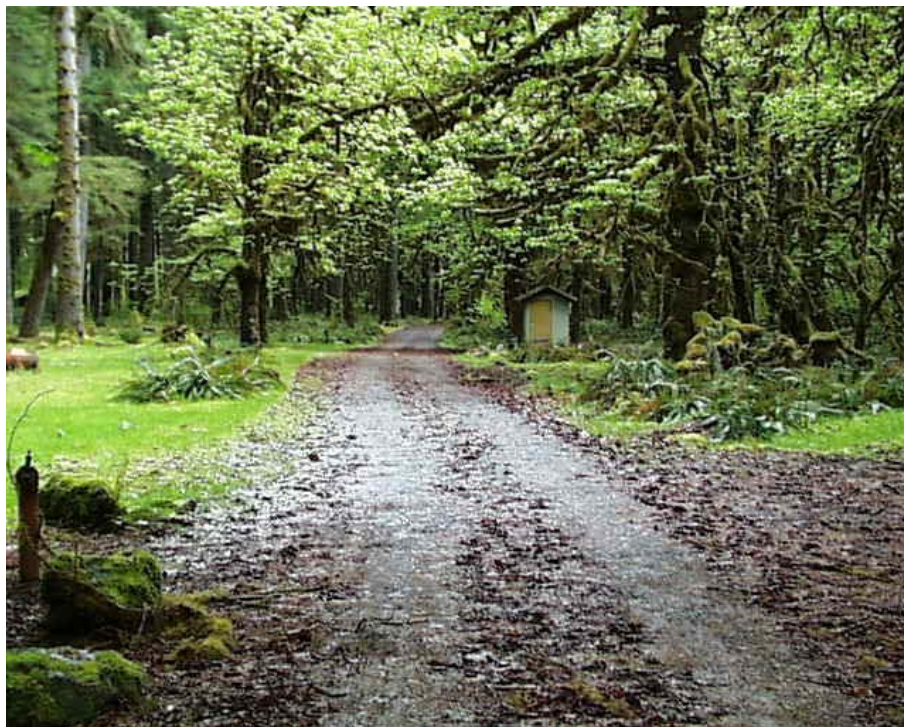
*Contemporary photograph showing the newer road within Graves Creek Campground. Note the linear character of the road, and the open lawn area to the left. (CCSO, 2000.)*

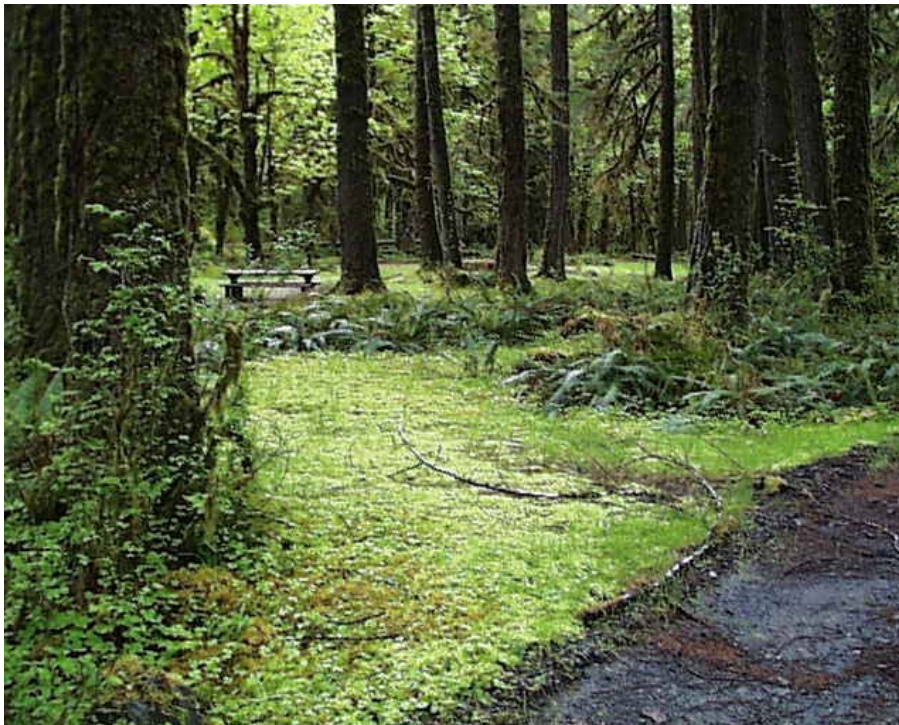
*Contemporary photograph of a historic parking spur at Graves Creek Campground. Note the mature Douglas fir trees that line the spur, and the growth of Oxalis that has emerged on the compacted soil. (CCSO, 2000.)*

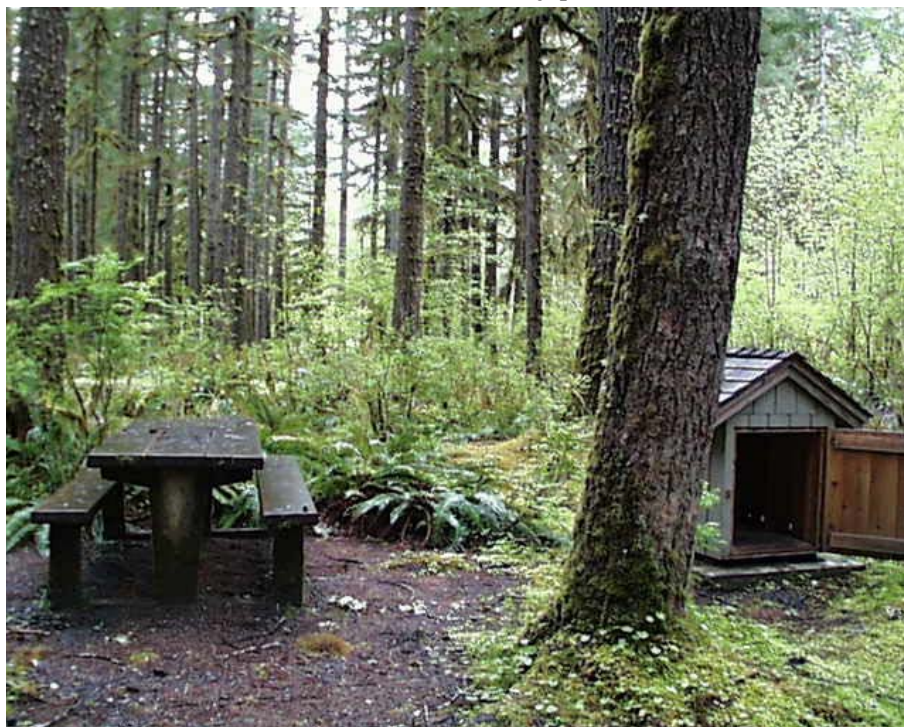
*Contemporary photograph showing the non-contributing small-scale features of the Graves Creek Campground. (CCSO, 2000.)*

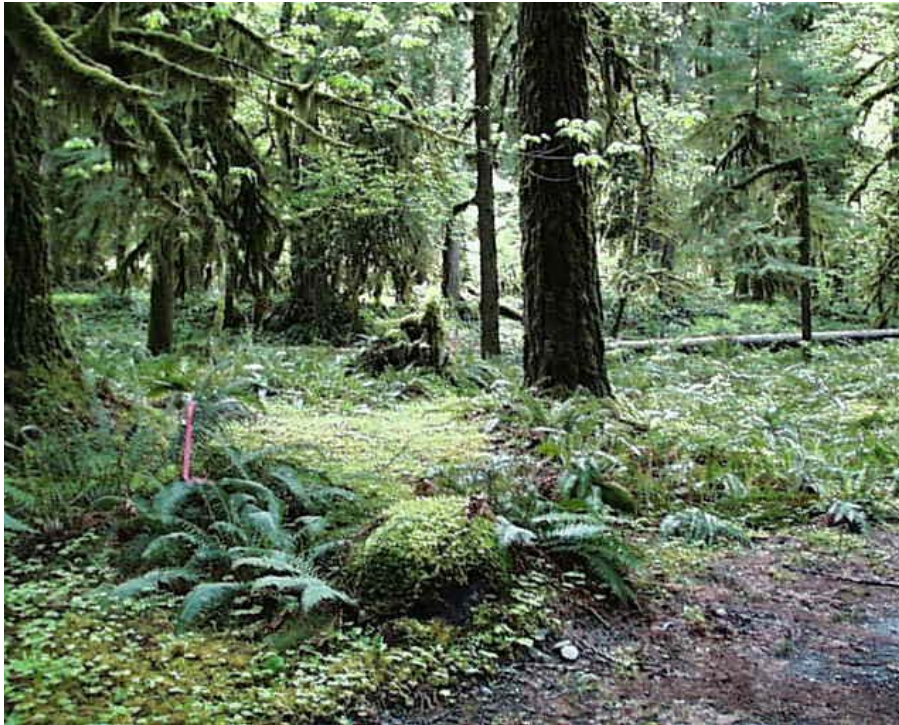
*Contemporary photograph showing the remnant small-scale features and vegetation characteristics of the campground. In the foreground, note the moss-covered boulders and Sword ferns that mark the entrance to a historic parking spur. (CCSO, 2000.)*

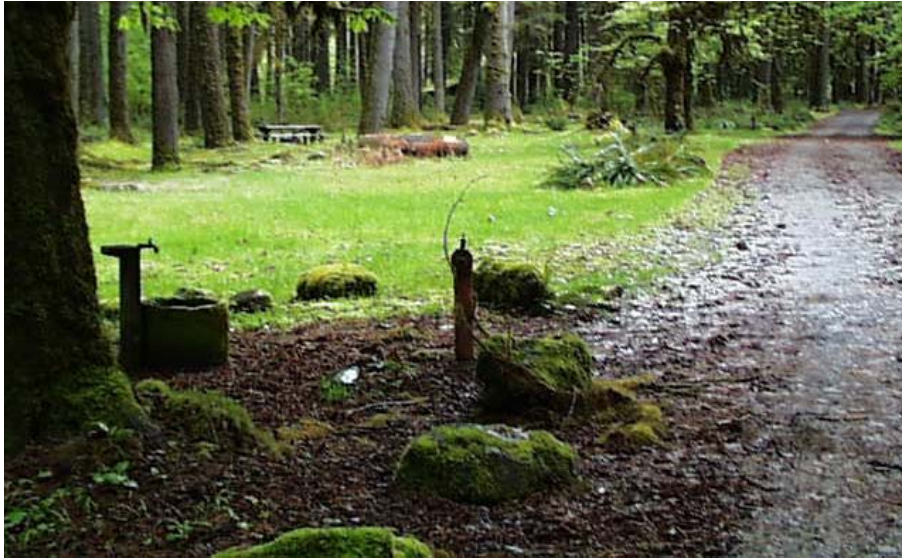
*Contemporary photograph showing the lawn area that was created in the center of the campground. This area was historically wooded. (CCSO, 2000.)*
