National Park Service  
Cultural Landscapes Inventory  
2000

Lake Crescent Lodge  
Olympic National Park

CULTURAL LANDSCAPES INVENTORY (CLI) PROGRAM  
*2010 Condition Assessment Update for:*

**Lake Crescent Lodge  
Olympic National Park**

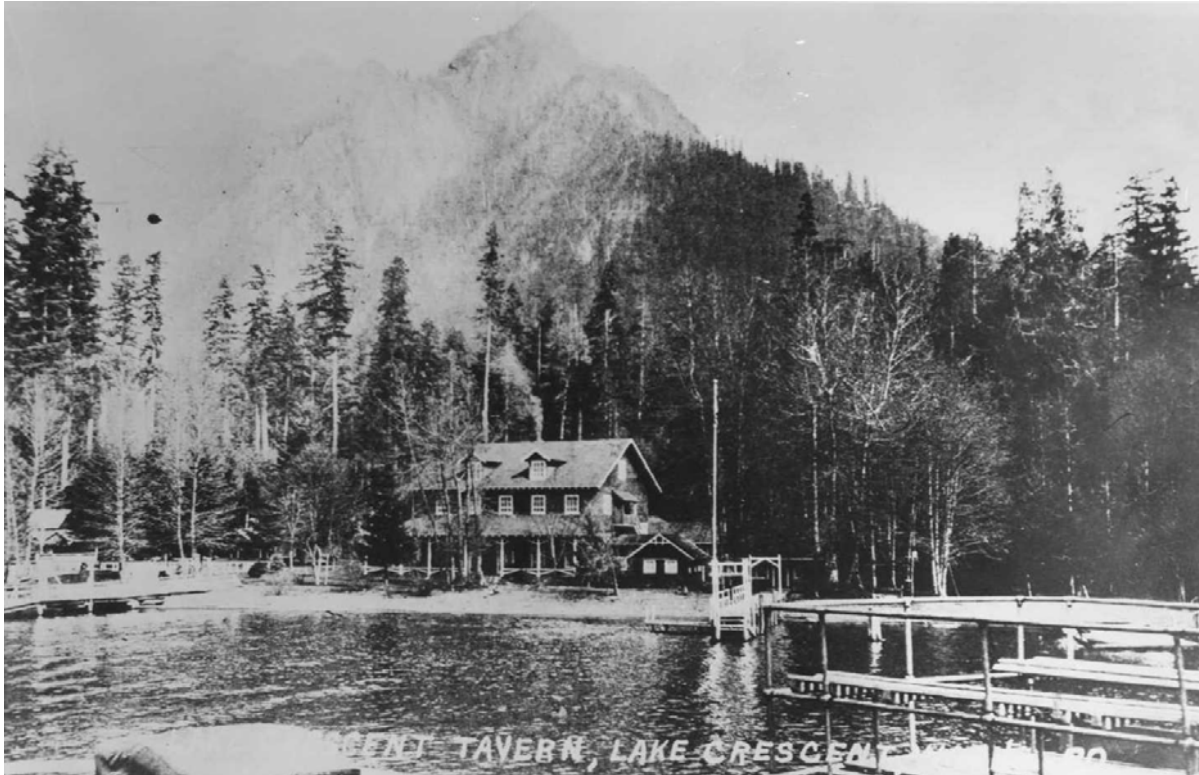
*Historic photograph of the lodge from the ferry boat in Lake Crescent. Note the large ferry dock and the small craft dock, and the mature trees along the beach. (OLYM / P.A.West/217, Bert Kellogg Collection, Clallam County Historical Society, n.d.)*

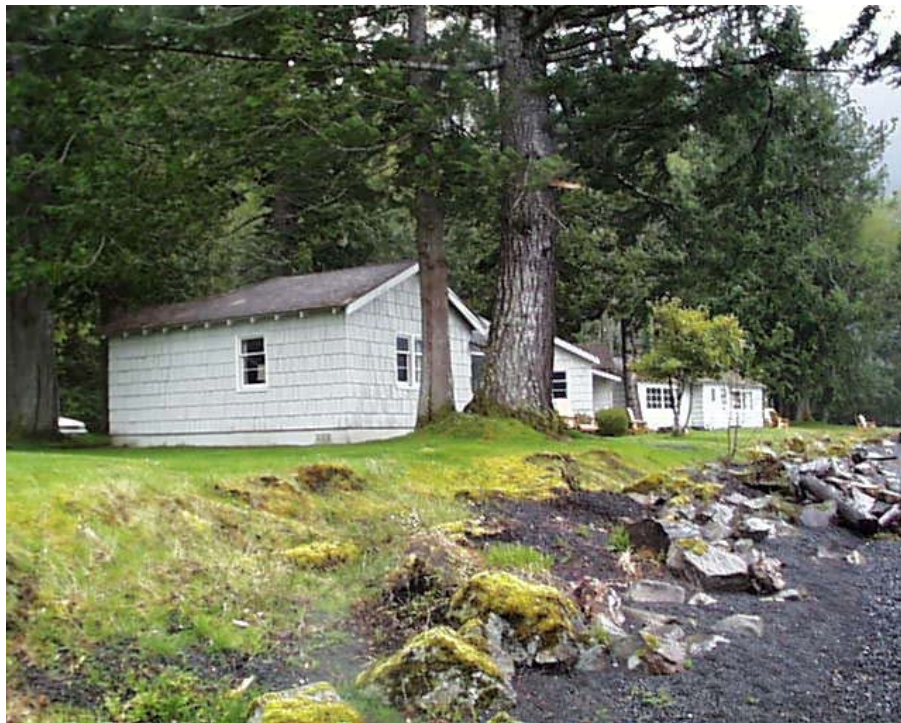
The three cabins built in 1947 are in fair condition and retain integrity. Called "fireplace cabins" because of their fireplaces with fieldstone chimneys, two of the cabins are single-family and one cabin is a duplex, accommodating two families. Vernacular in design and similar in scale to the earlier guest cabins, these three buildings exhibit several modern stylistic influences of the mid-1940s such as an emphasis on horizontal lines, low-pitched roofs, and large, fixed, multi-light windows.

*Contemporary photograph of the three 1947 cabins from the lake shore. Fireplace Cabin #1 is in the foreground. Note the non-linear orientation of the cabins to each other. (CCSO, 2000.)*

A palette of native shrubs and perennials could be planted in foundation beds around the three 1947 fireplace cabins to supplement or replace the existing plantings. The existing plantings are overly mature and sparse. A palette of shrubs and perennials similar to that of the new plantings around the reconstructed cabins is appropriate.

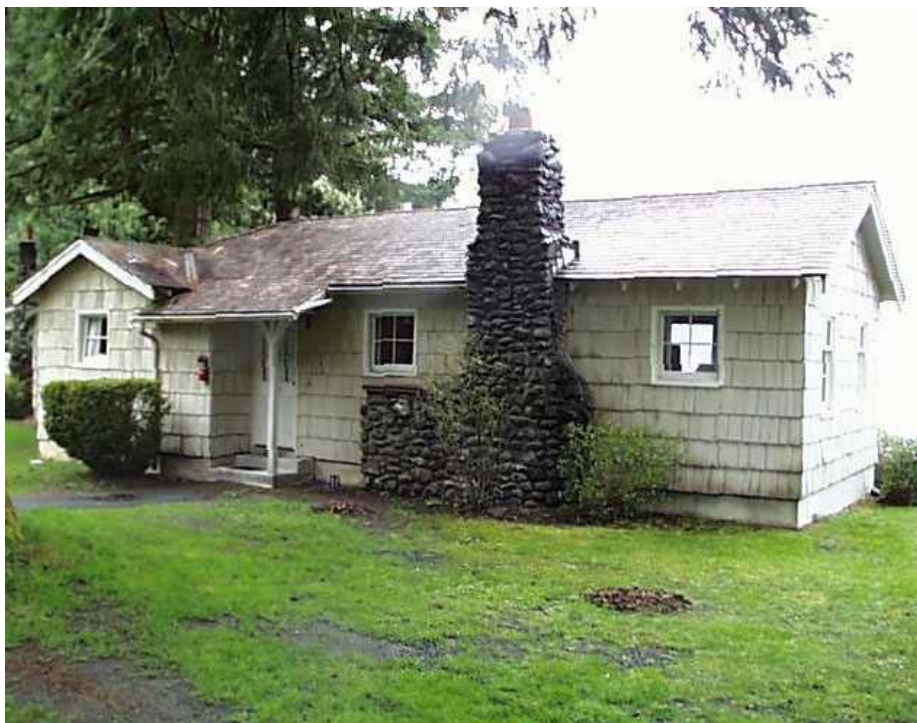
*Contemporary photograph of the center 1947 cabin (Fireplace Cabin #2). (CCSO, 2000.)*

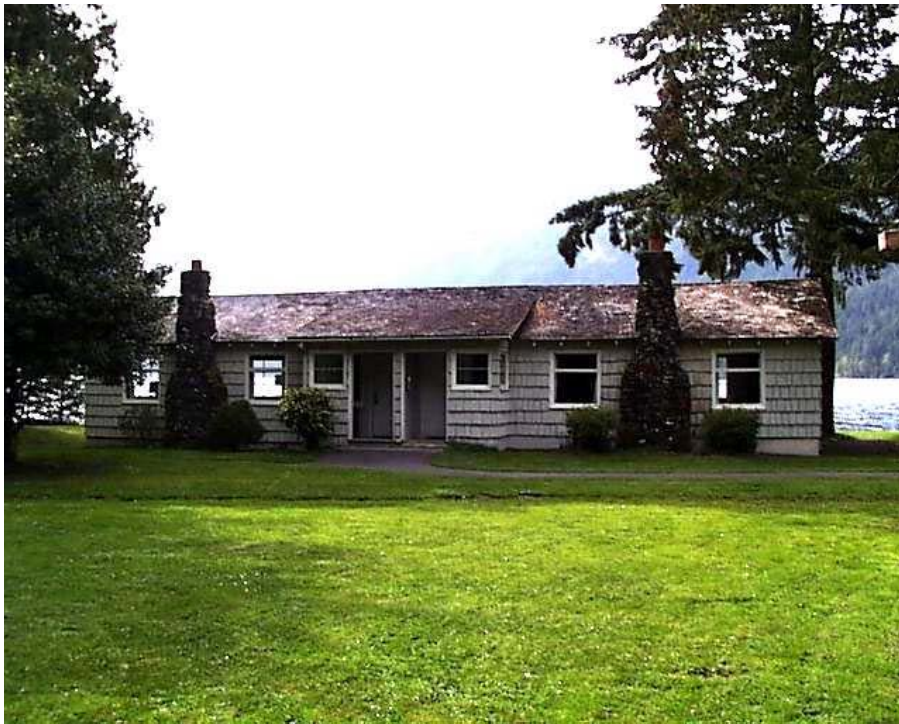
*Contemporary photograph of Fireplace Cabin #3. This cabin was built as a duplex; note the two chimneys flanking the two front doors. (CCSO, 2000.)*

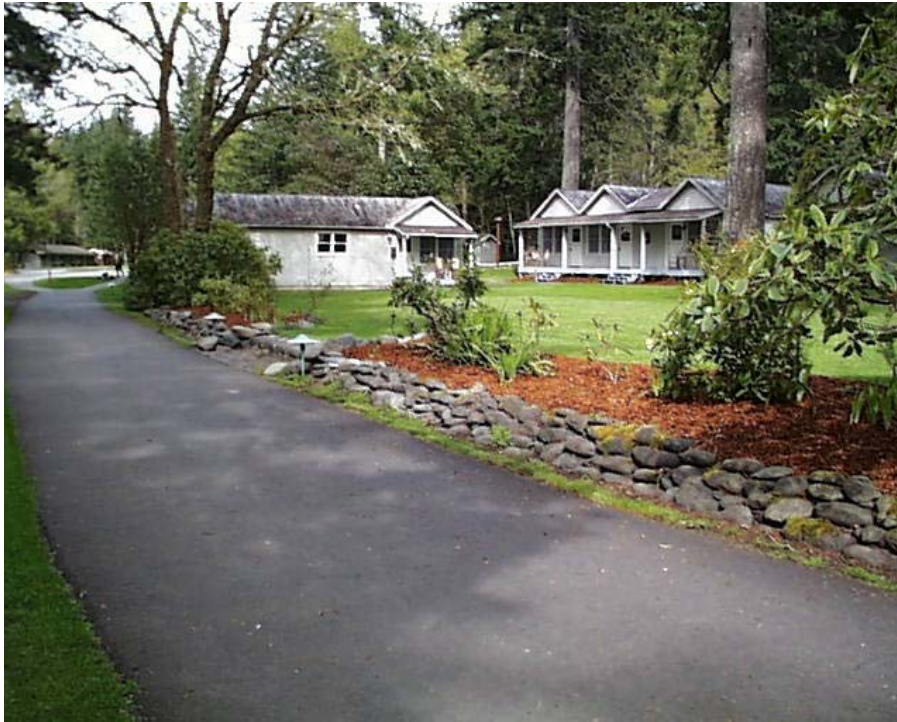
Two contributing structures that date from the historic period also remain. The first is a rubblestone wall that framed the horseshoe pit structure. This wall was rebuilt in the 1980s by park staff, is in good condition and currently borders a garden bed. The second structure is the tennis court pad in the

*Contemporary photograph of the rubblestone wall. Rebuilt in the 1980s, this wall originally bordered the horseshoe pit. The wall currently retains planting beds. (CCSO, 2000.)*

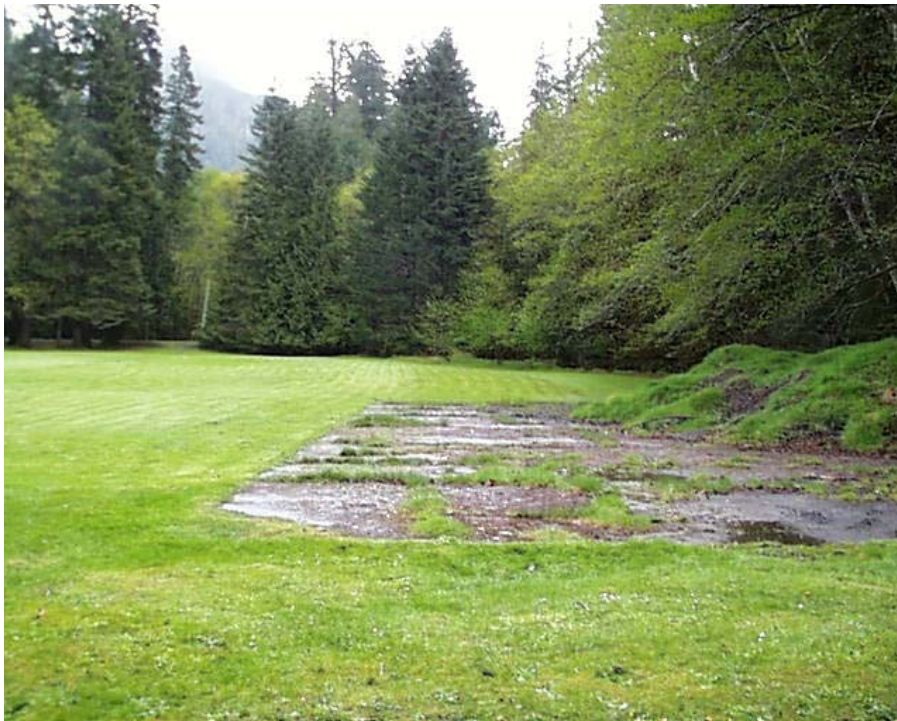
recreation field built in the 1940s. The concrete pad is in poor condition and is no longer used.

*Contemporary photo of the former tennis court pad, located in the recreational field. (CCSO, 2000.)*

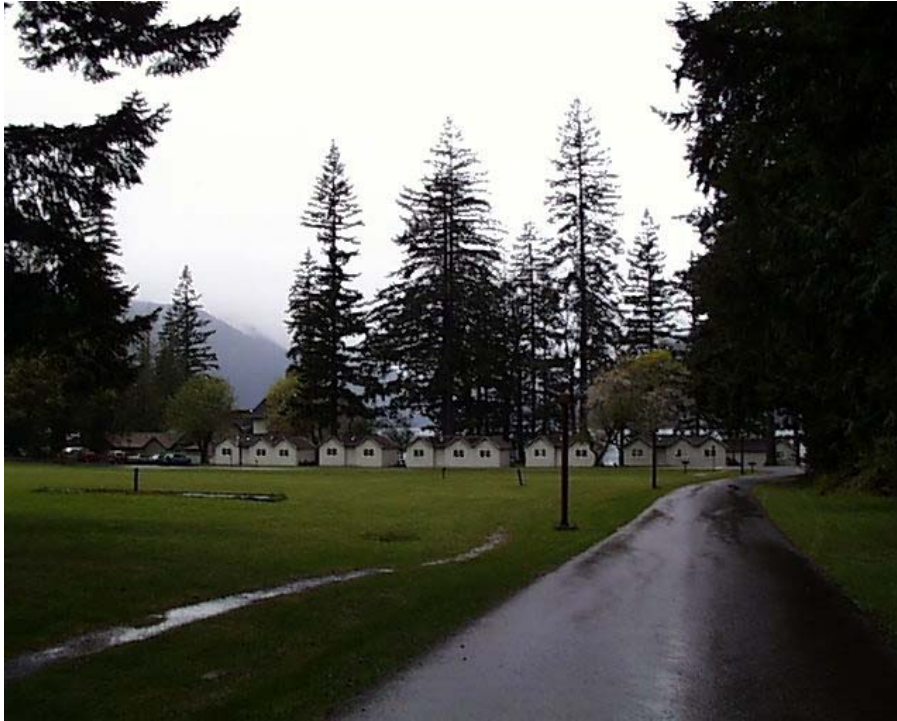
The former entrance road developed by the Singer's to accommodate vehicular traffic after the construction of Highway 101 retains integrity, although it no longer serves as the entrance to the resort. A new entry road was constructed outside the district boundaries and the former entrance road now serves as a one-way exit from the resort. As a result of this new use, the width and alignment of the historic entry has not changed and the original character of the road retains integrity.

*Contemporary photograph showing the original entry road to the resort. The road is currently used as a one-way exit for resort visitors. (CCSO, 2000.)*

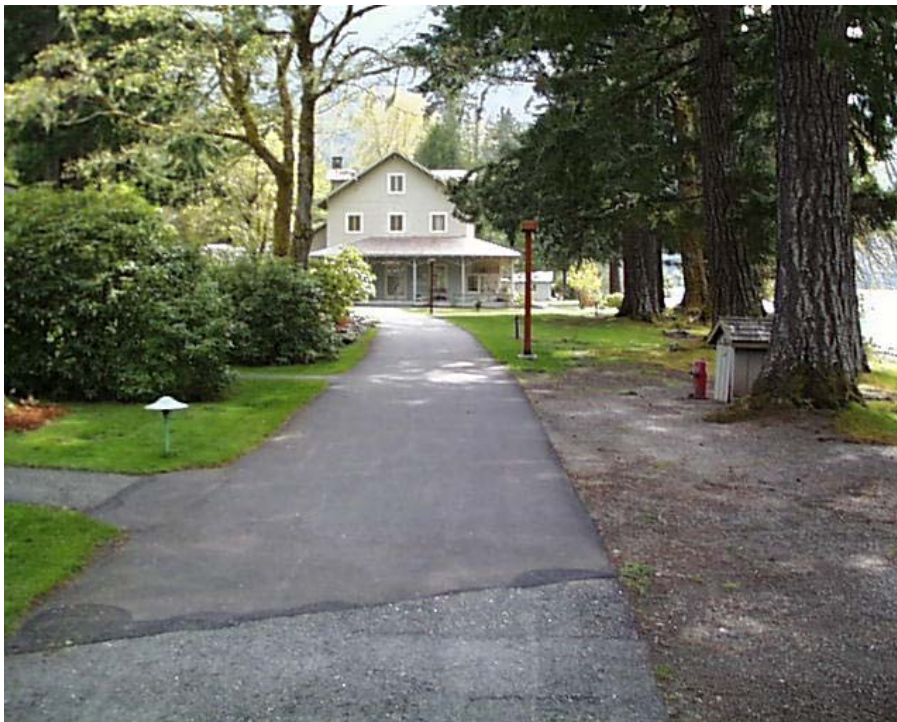
The circulation system relating to the 1947 cabins has also changed in use, from vehicular to pedestrian. Photographs from the late 1940s show a gravel road near the cabins. Currently, an asphalt path leads from the lodge to the three cabins, and a paved parking area exists east of this path to accommodate vehicles. The asphalt path was added in the late 1990s and corresponds with an older, linear gravel path that still remains and links the cabins to one another.

*Contemporary photograph showing the pedestrian path leading from the current parking lot to the lodge. This path was used for vehicles from the mid-1920s until the 1950s. A parking area was provided for guests near the lodge. (CCSO, 2000.)*

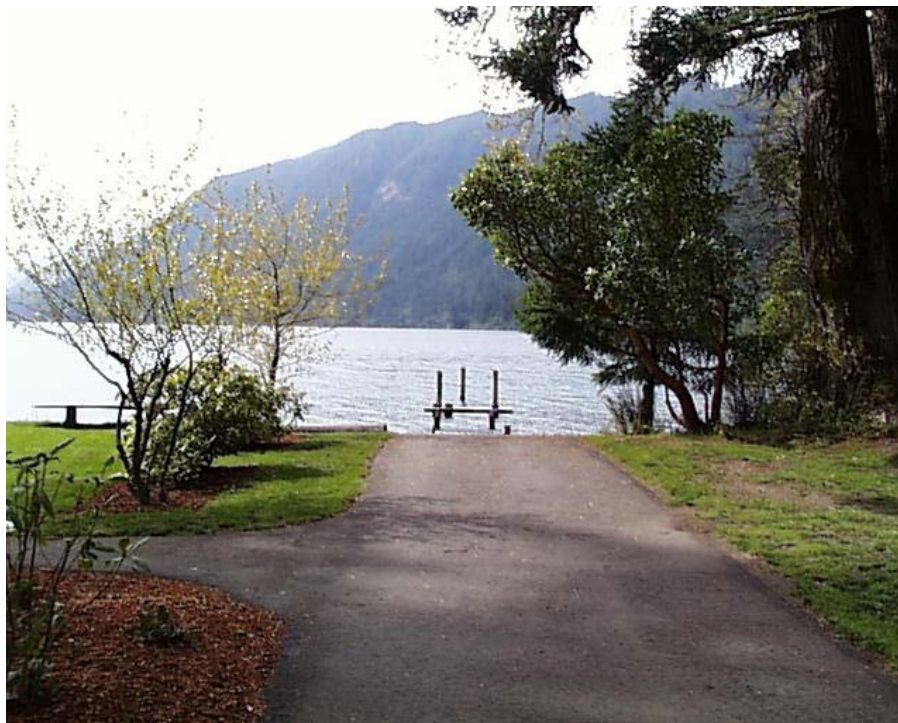
Circulation within the resort core was developed primarily as a pedestrian system, with the ferry providing transportation via Lake Crescent. The alignment of the earliest circulation from the original ferry dock to the lodge still remains. Although the historic dock has been removed, replacement piers and a path leading from the dock site to the lodge references its original location.

*Contemporary photograph showing the path leading from Lake Crescent to the lodge. The dock piers make reference to the original mode of transportation to the resort via ferry. (CCSO, 2000.)*

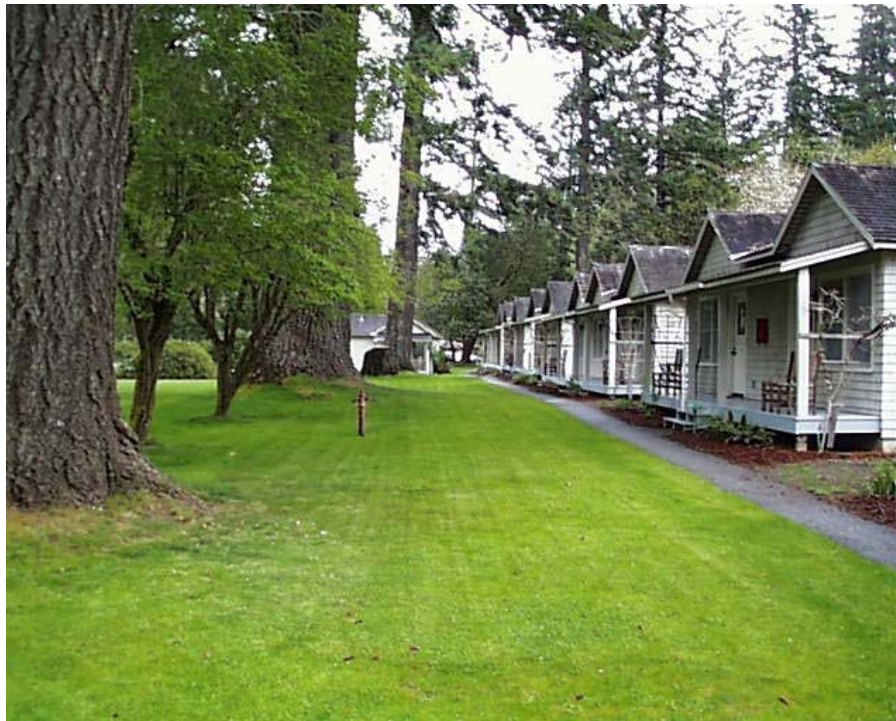
*Contemporary photograph showing the row of reconstructed cabins that provide a major edge to the central courtyard space. Note the two mature Hawthorn trees and the water hydrant. (CCSO, 2000.)*

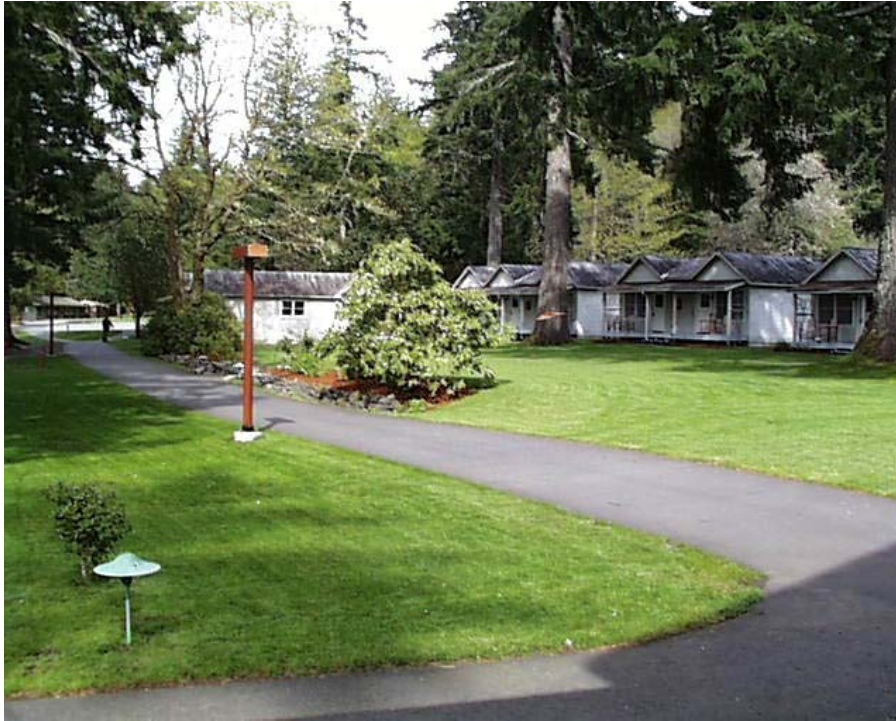
*Contemporary photograph showing historic plantings. Note the small Holly in the lower left hand corner, the large Rhododendron in the photo center, and the large Douglas firs in the background. (CCSO, 2000.)*

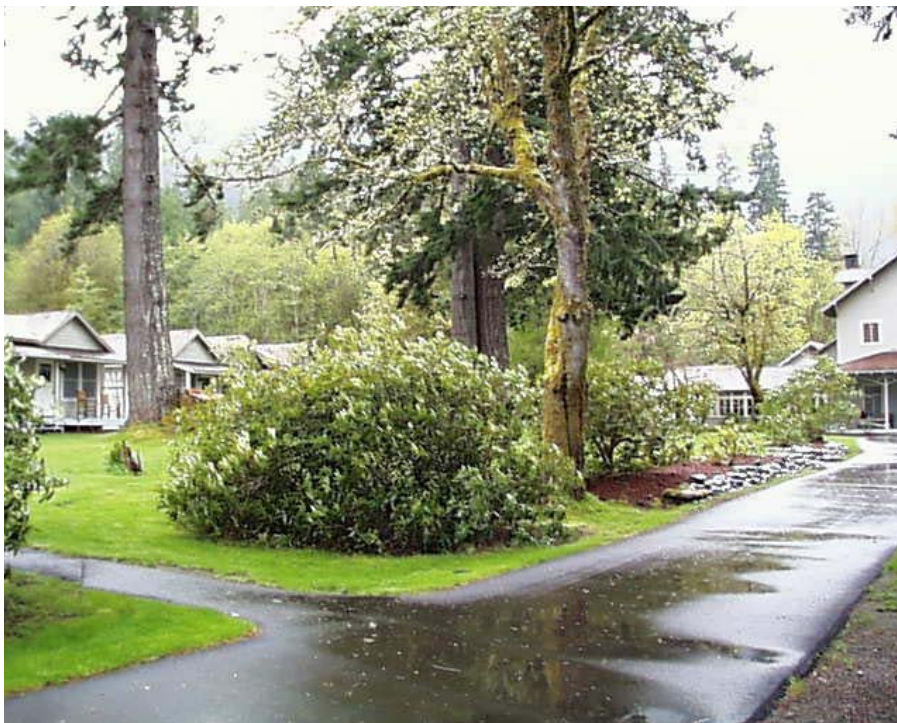
*Contemporary photograph showing mature Rhododendrons flanking the courtyard path. (CCSO, 2000.)*

Stabilization Measures *(This section was updated in 2010)*  
~~Because Lake Crescent Lodge is in good condition in 2000, and landscape characteristics and features are stable, no stabilization work is required.~~  
*The rhododendrons on the lakeside of the lodge are beginning to grow into the sightlines of the lodge windows. A small amount of pruning and regular pinching of the terminal leaf buds will increase the compactness of the growth form.*

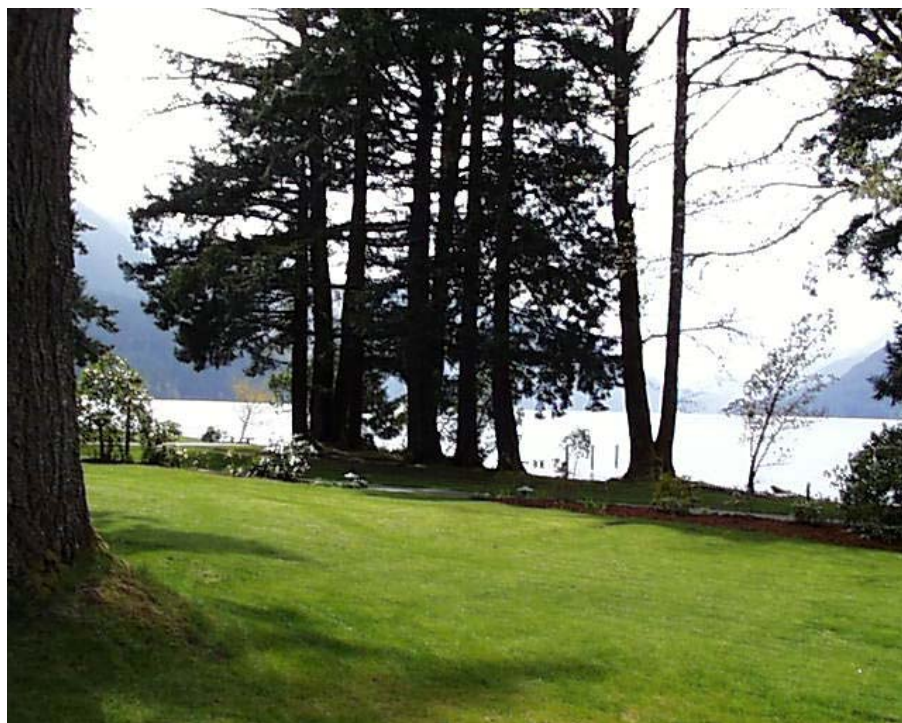
*Contemporary photograph showing a cluster of mature Douglas fir trees near the beach. (CCSO, 2000.)*

The fourth area within the district is the beach. This linear space is defined by the topography, which drops several feet towards the lakeshore, and by a row of mature trees growing along the beach's crest. The trees are predominantly coniferous and appear in early photographs of the resort. The lower limbs have been removed from the trunks of these trees to provide filtered views of the lake from the cabins.

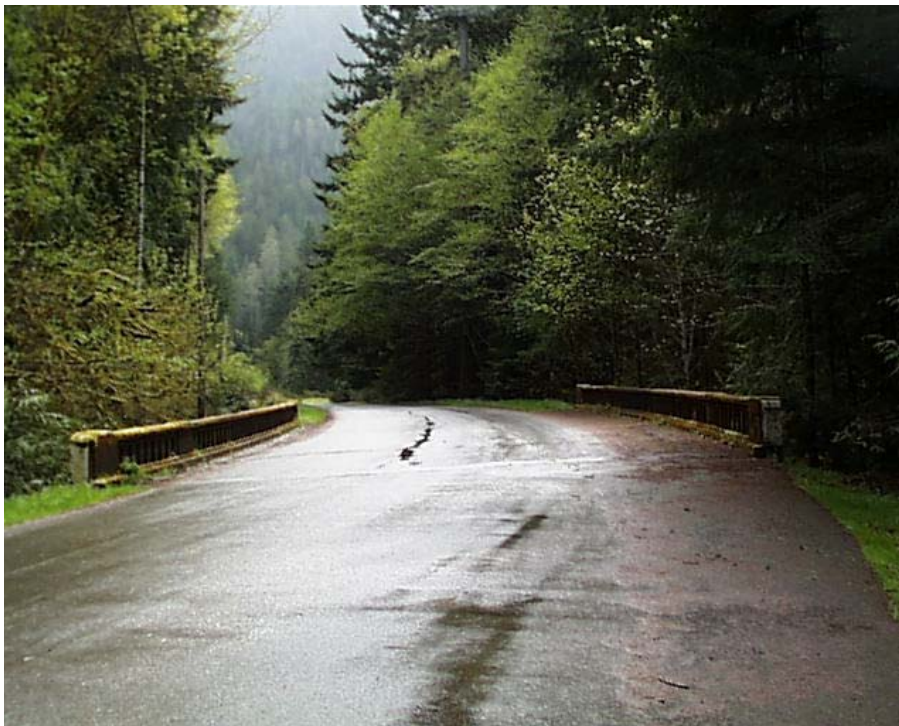
**Description:** Although the former Highway 101 (the stretch of road that connects Lake Crescent Lodge to the new Highway 101) was not included in the historic district, it retains integrity as a historic circulation network and adds to the historic setting of the resort. In 1987 Highway 101 was rerouted, and subsequently the section of old highway that led to Lake Crescent Lodge and Rosemary Inn was by-passed. Because of this the character, scale, and structures remain intact: the road retains its tight turn, its narrow width, and retains a 1945 two-lane concrete bridge that spans Barnes Creek. Although outside the historic district, this stretch of old Highway 101 augments the historic setting of Lake Crescent Lodge, and efforts should be made to retain the historic character of this highway.

*Contemporary photograph of Old Highway 101. Note the road's narrow width and the 1945 concrete bridge. (CCSO, 2000.)*
