National Park Service  
Cultural Landscapes Inventory  
1999

Rosemary Inn  
Olympic National Park

CULTURAL LANDSCAPES INVENTORY (CLI) PROGRAM  
*2010 Condition Assessment Update for:*

**Rosemary Inn**  
Olympic National Park

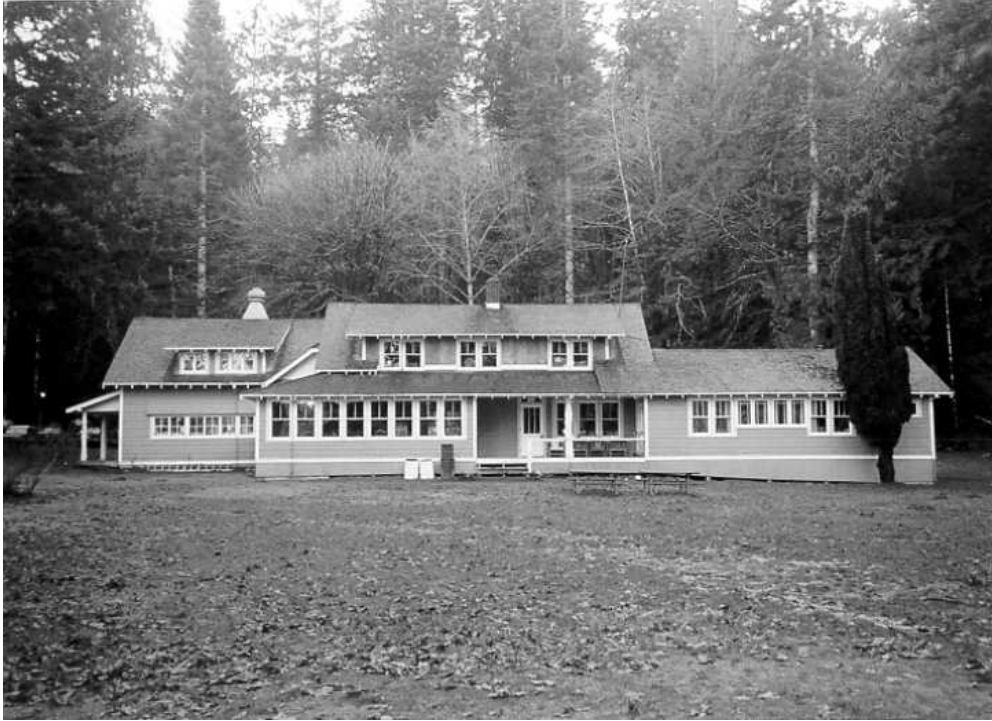
*Contemporary photograph of Rosemary Inn Lodge, historically used as the resort's dining room and lounge, and currently used as center for environmental education programs by the Olympic Park Institute. (CCSO, 1999.)*

*Stabilize the lodge by directing stormwater from the downspouts away from the post and pier foundation. Stabilize the cabins by removing grass clippings and organic debris from the perimeter of the cabins to prevent decomposition around the post and pier foundations.*

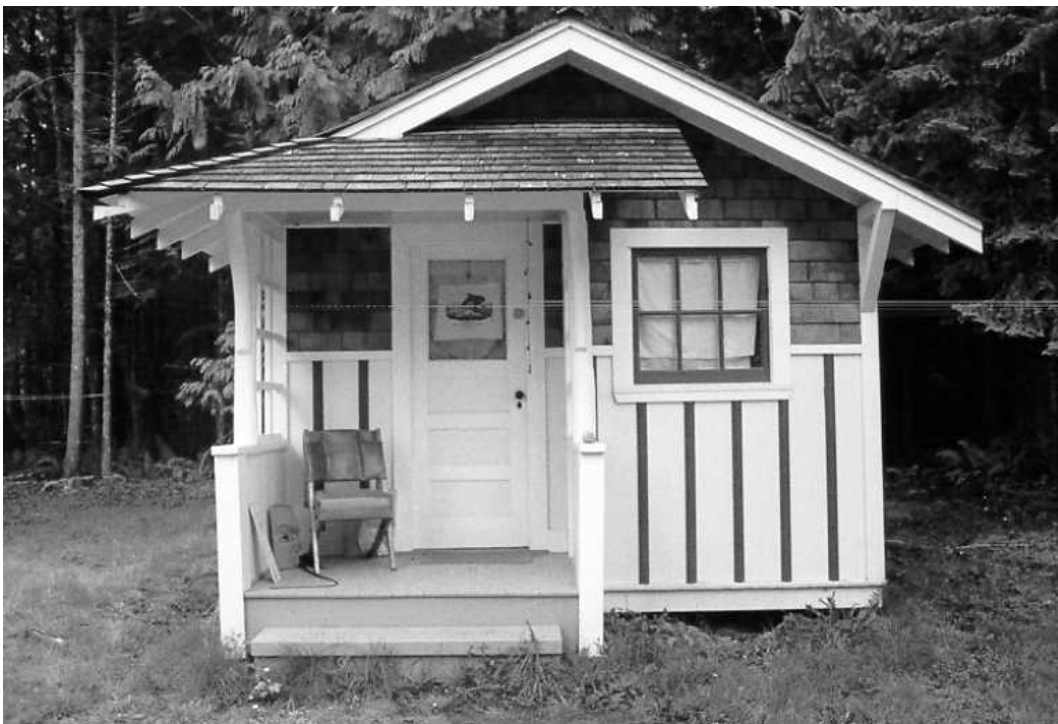
*Contemporary photograph of Cara Mia, one of the guest cabins at Rosemary Inn, built before 1926 and reconstructed in the 1990s. (CCSO, 1999.)*

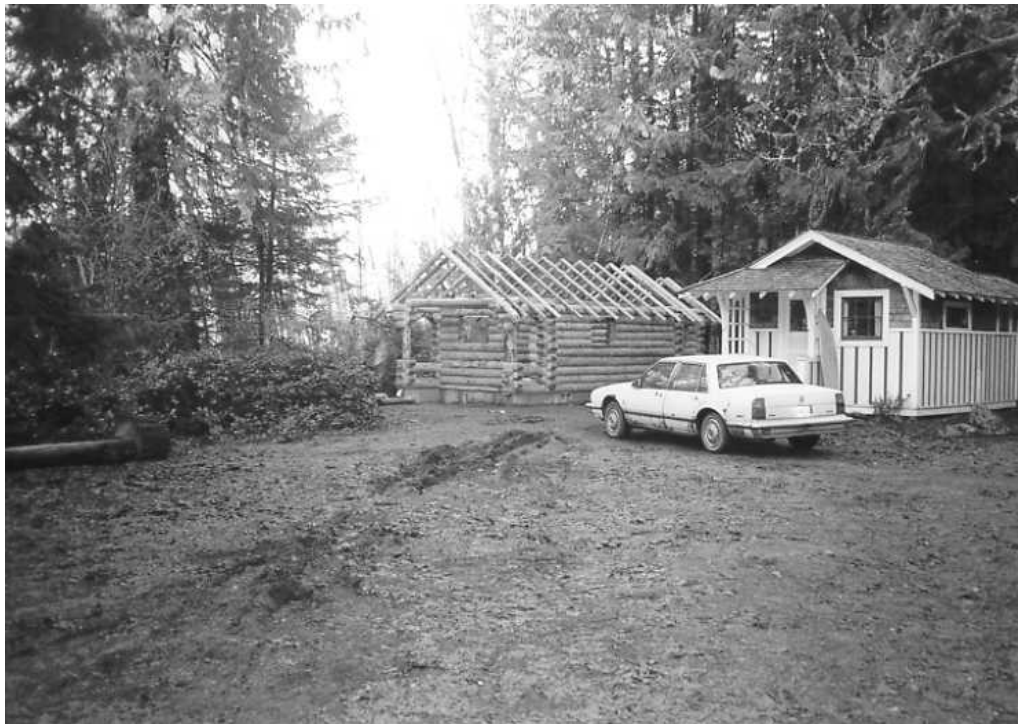
*Contemporary photograph of Dixie (center), one of the guest cabins at Rosemary Inn, built before 1926. Dixie was being reconstructed at the time of the photograph. (CCSO, 1999.)*

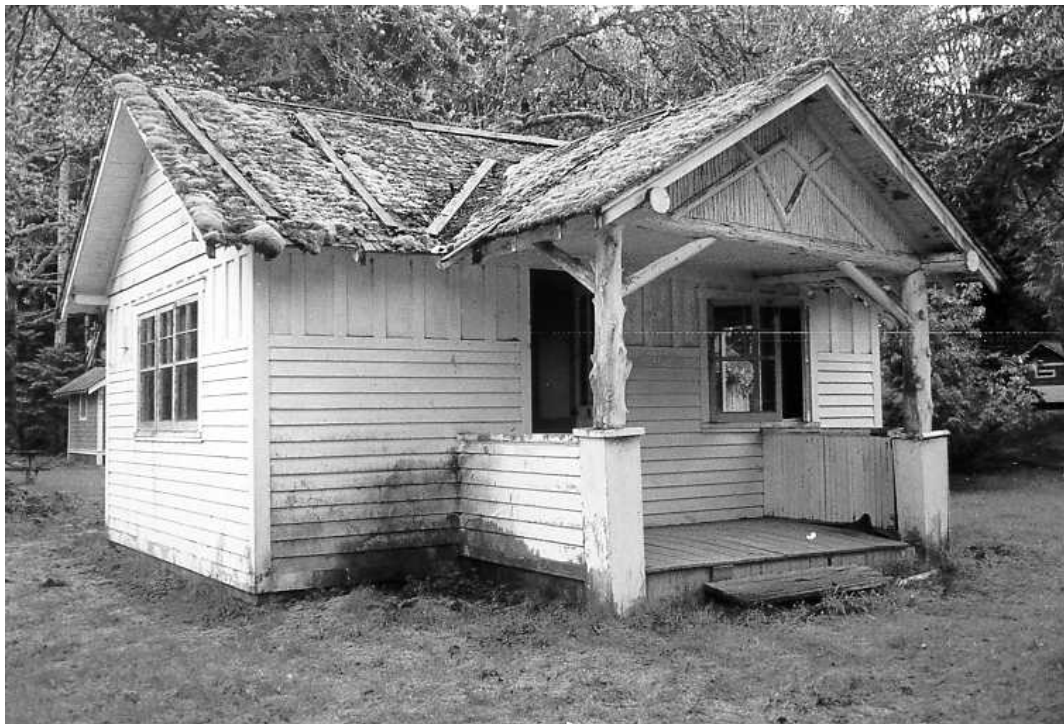
*Contemporary photograph of Summerie, a guest cabin at Rosemary Inn, built before 1926. Summerie had not been reconstructed at the time of the photograph and was in poor condition. (CCSO, 1999.)*

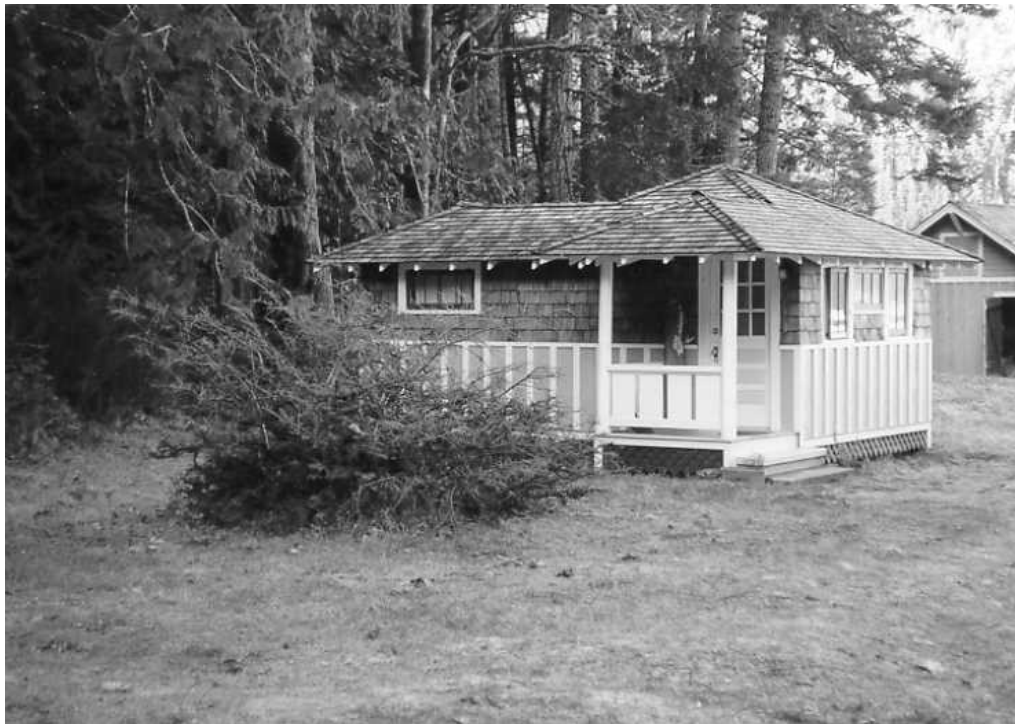
*Contemporary photograph of Rockaby, one of the guest cabins at Rosemary Inn, built before 1926 and reconstructed in the 1990s. Note the ornamental shrub in front of the cabin, Rockspray cotoneaster. (CCSO, 1999.)*

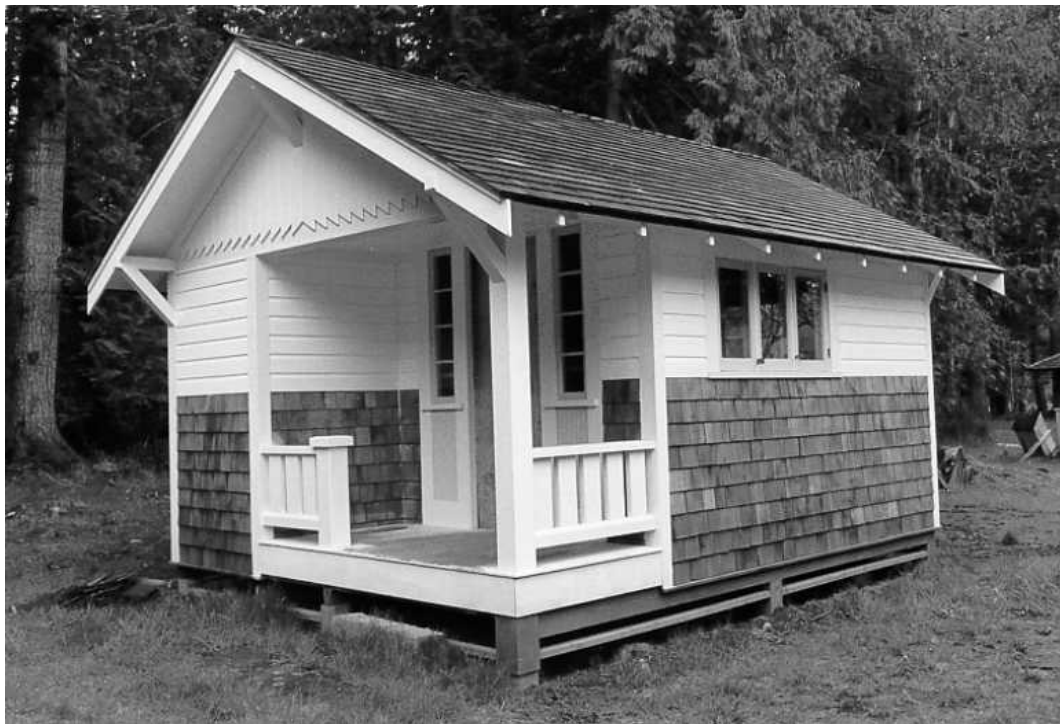
*Contemporary photograph of Dardanella, one of the guest cabins at Rosemary Inn, built before 1926 and reconstructed in the 1990s. (CCSO, 1999.)*

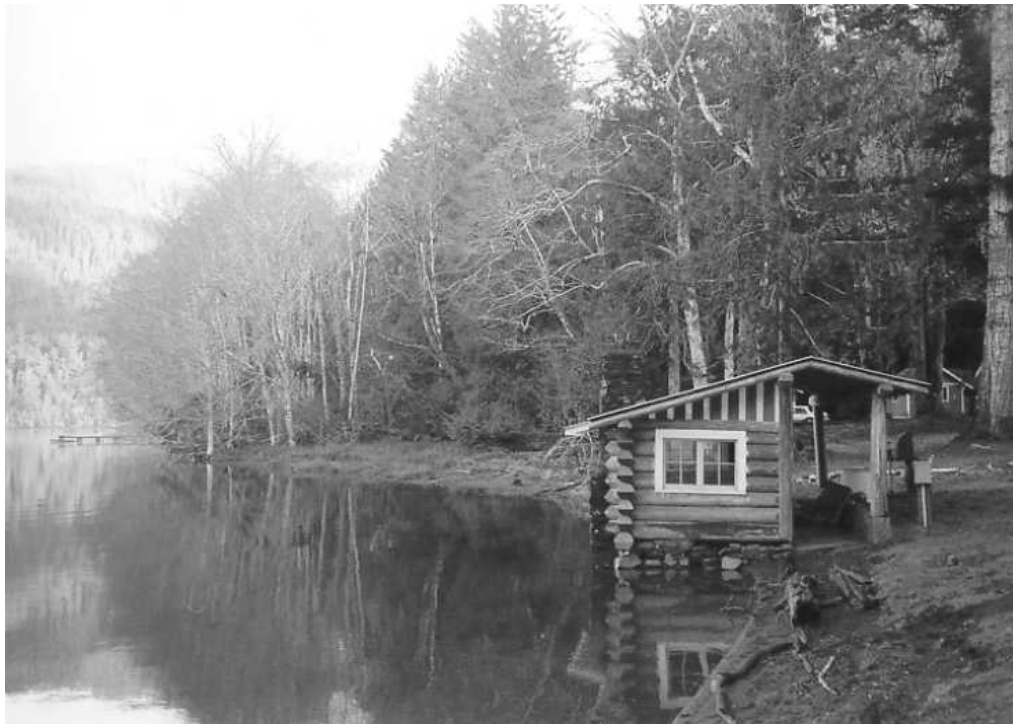
*Contemporary photograph of Inglenook, the Fireplace Shelter at Rosemary Inn, built in 1933. Note the inundation of the foundation, due to the erosion of the lake shore. (CCSO, 1999.)*

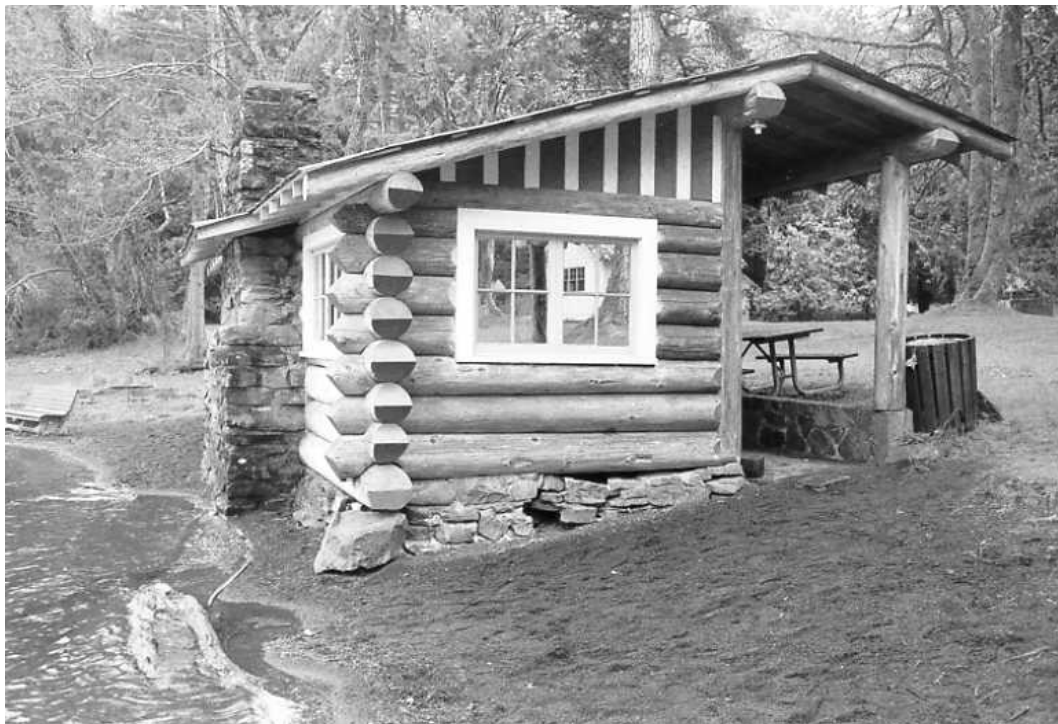
*Photograph of Inglenook, the Fireplace Shelter at Rosemary Inn, taken in 1993. A comparison with the previous photograph reveals the extent of lake shore erosion. (CCSO, 1993.)*

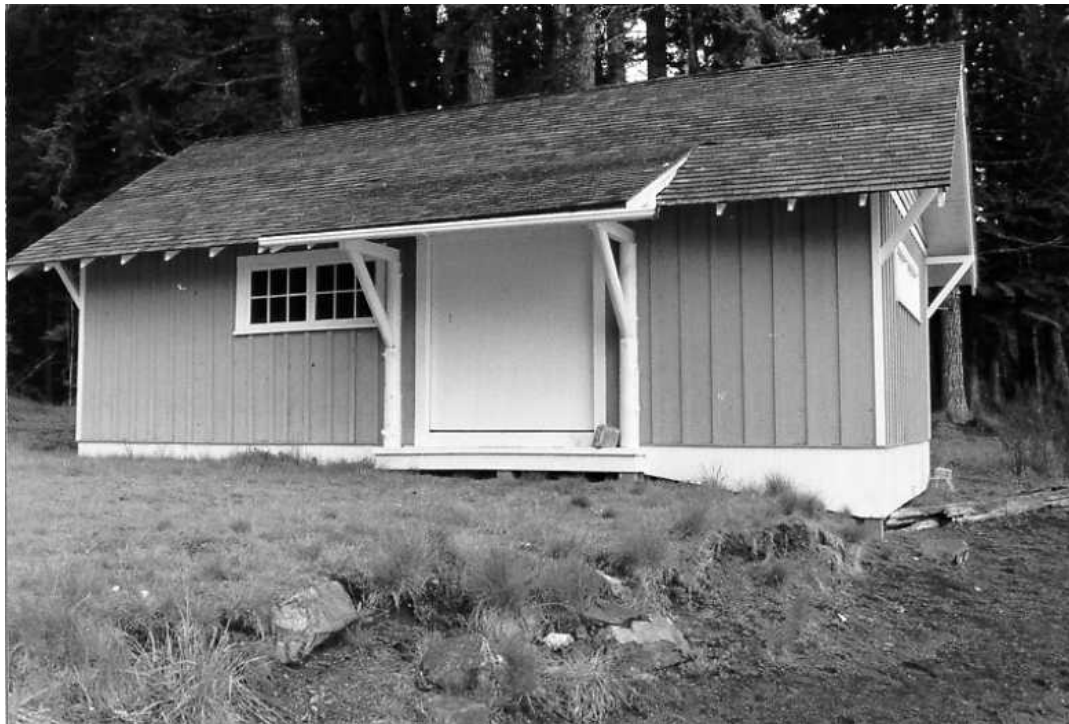
*Contemporary photograph of the Boathouse at Rosemary Inn, built in 1936. (CCSO, 1999.)*

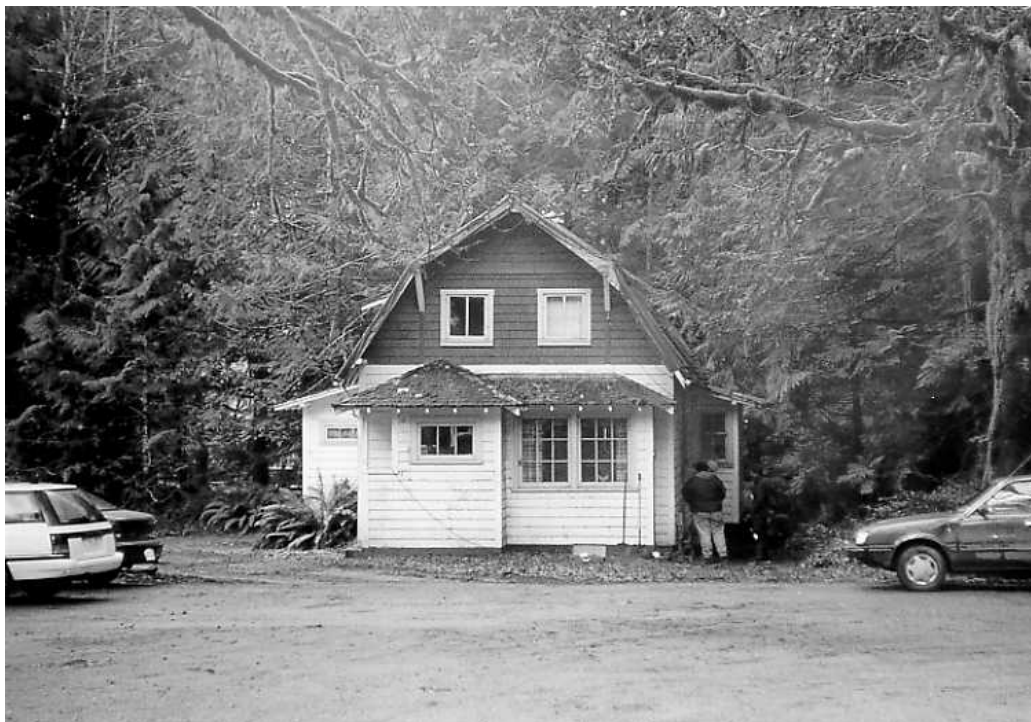
*Contemporary photograph of Tumble Inn, the Manager's Residence at Rosemary Inn. (CCSO, 1999.)*

Tumble Inn is located near the lodge, and served historically as Rose Littleton's, or the manager's residence. Tumble Inn is a one-and-a-half story gambrel roof frame cottage, with a shingle roof, and shingle siding. It is the second largest building at Rosemary, measuring 42 feet by 28 feet. Despite the building's dilapidated condition, the Olympic Park Institute (OPI) is currently using it as an office.

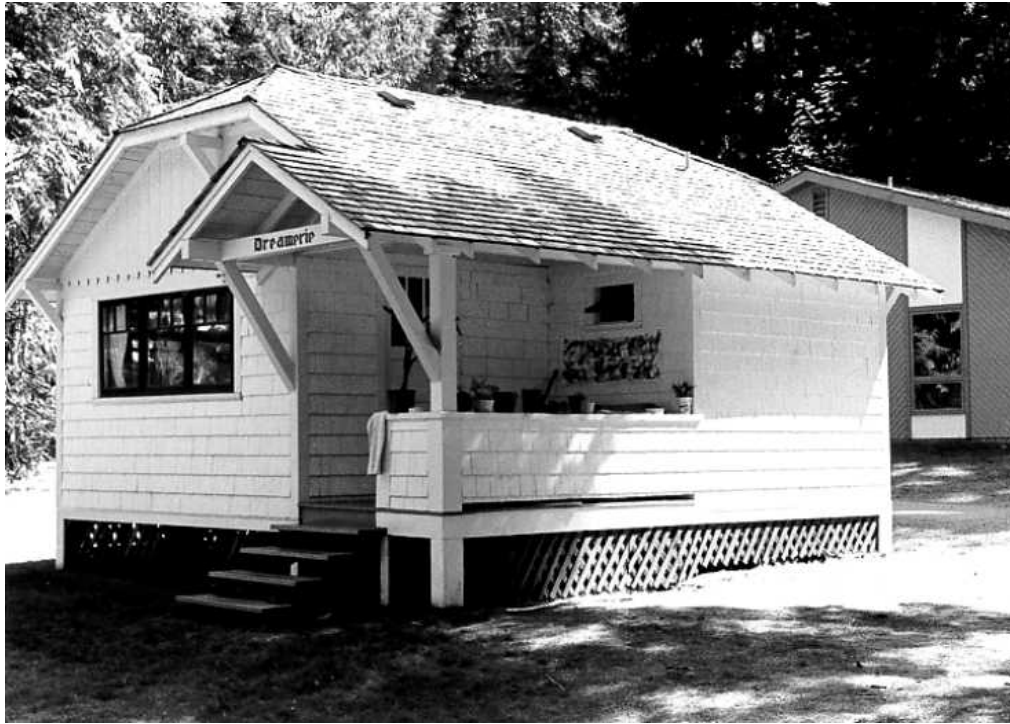
*Contemporary photograph of Dreamerie, one of the guest cabins at Rosemary Inn, built before 1926 and reconstructed in the 1990s. Note the intrusion of a 1970s water treatment building behind the cabin. (CCSO, 1999.)*

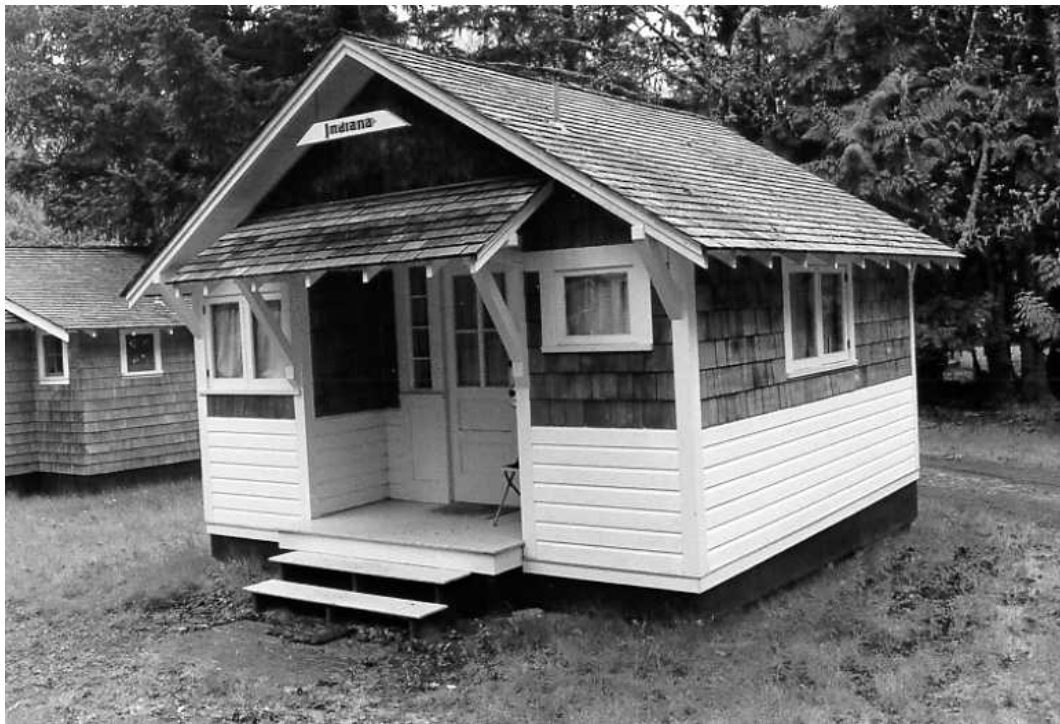
*Contemporary photograph of Indiana, one of the guest cabins at Rosemary Inn, built before 1926 and reconstructed in the 1990s. (CCSO, 1999.)*

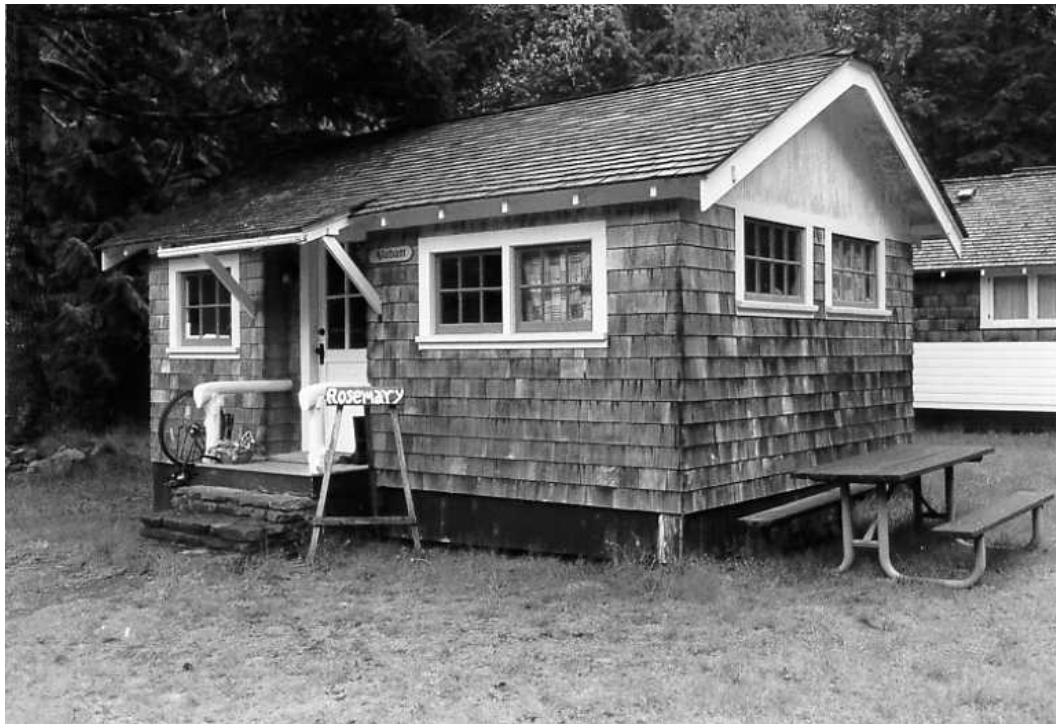
*Contemporary photograph of Alabama, one of the guest cabins at Rosemary Inn, built before 1926 and reconstructed in the 1990s. (CCSO, 1999.)*

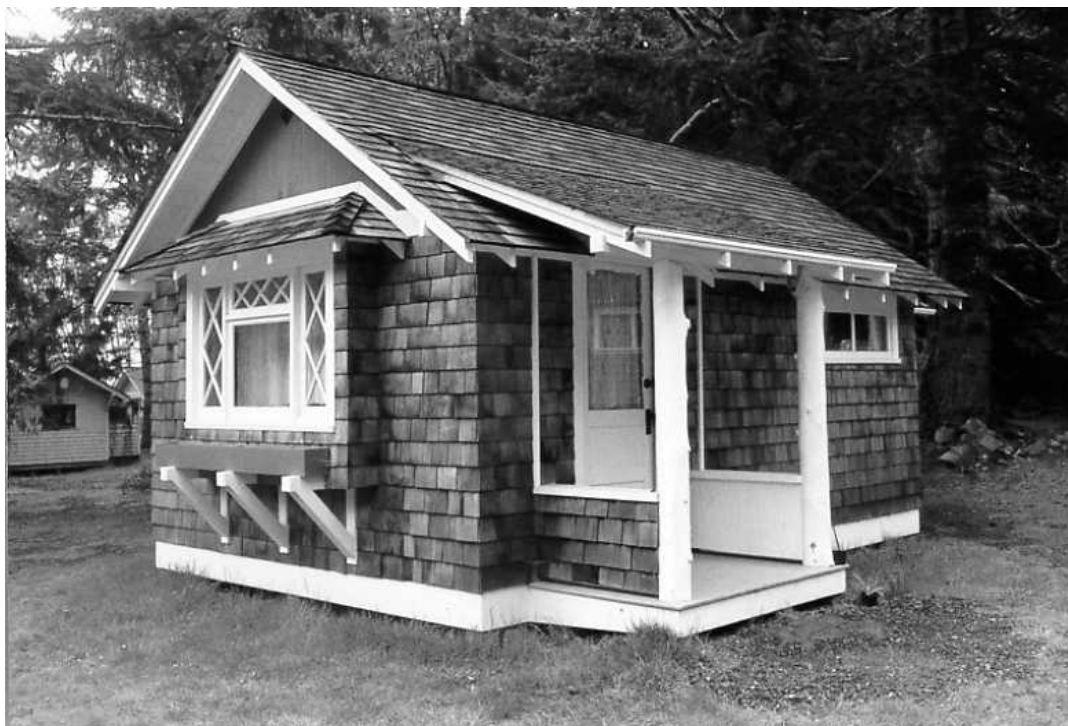
*Contemporary photograph of Honeysuckle, one of the guest cabins at Rosemary Inn, built before 1926, and reconstructed in the 1990s. (CCSO, 1999.)*

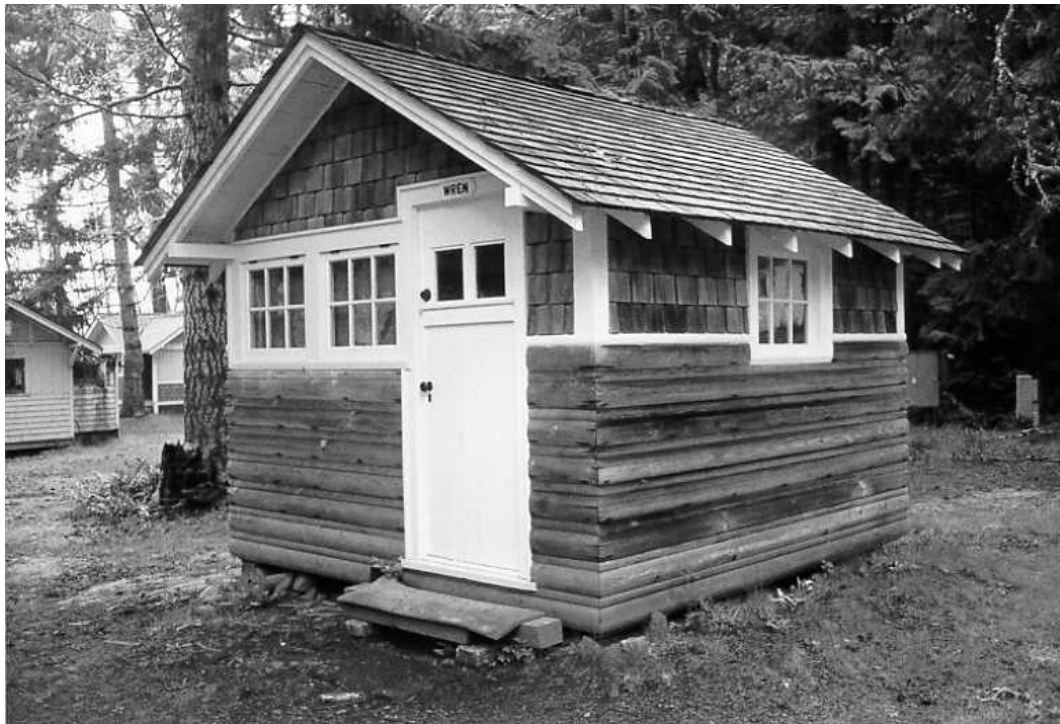
*Contemporary photograph of Wren, one of the guest cabins at Rosemary Inn, built before 1926 and reconstructed in the 1990s. (CCSO, 1999.)*

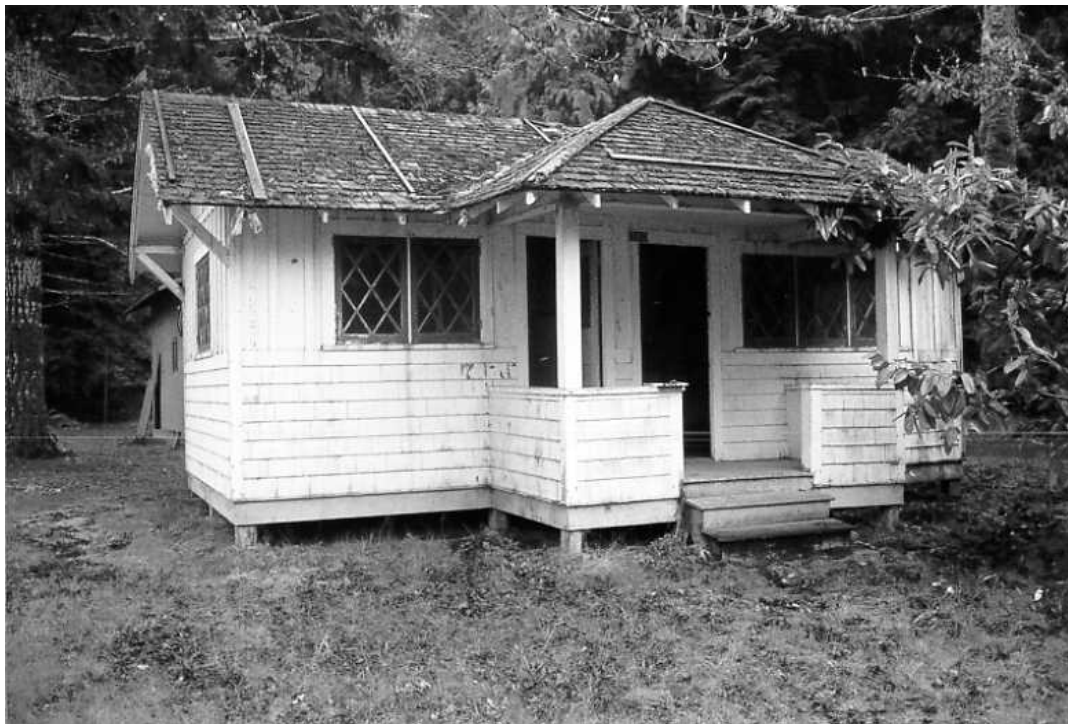
*Contemporary photograph of Red Wing, one of the guest cabins at Rosemary Inn, built before 1926. This cabin has not been reconstructed and is in poor condition. (CCSO, 1999.)*

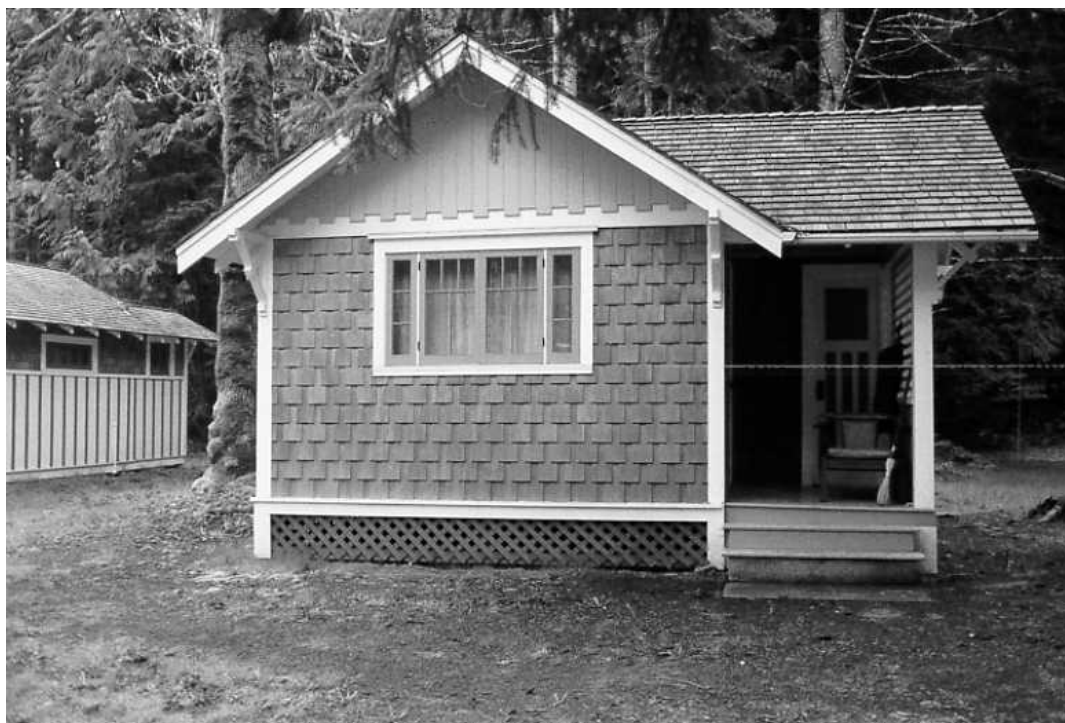
*Contemporary photograph of Silver Moon, one of the guest cabins at Rosemary Inn, built before 1926 and reconstructed in the 1990s. (CCSO, 1999.)*

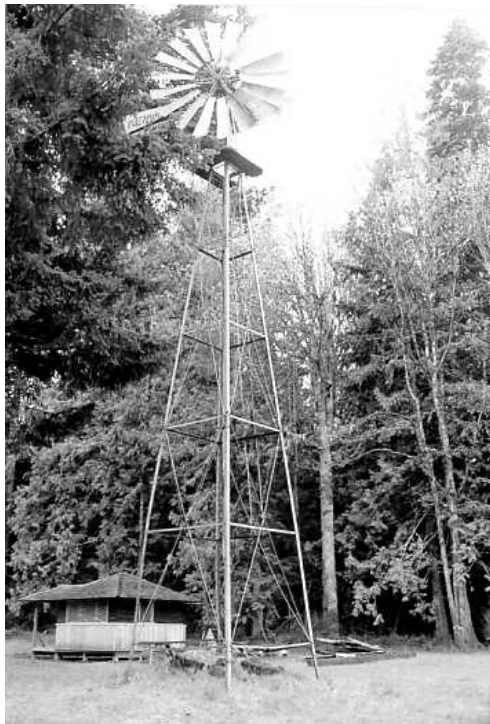
*LCS photograph of a small scale feature at Rosemary Inn: the windmill. This photograph was taken in the early 1990s before the reconstruction of the cabin Rockaby in the distance. (CCSO, 1990.)*

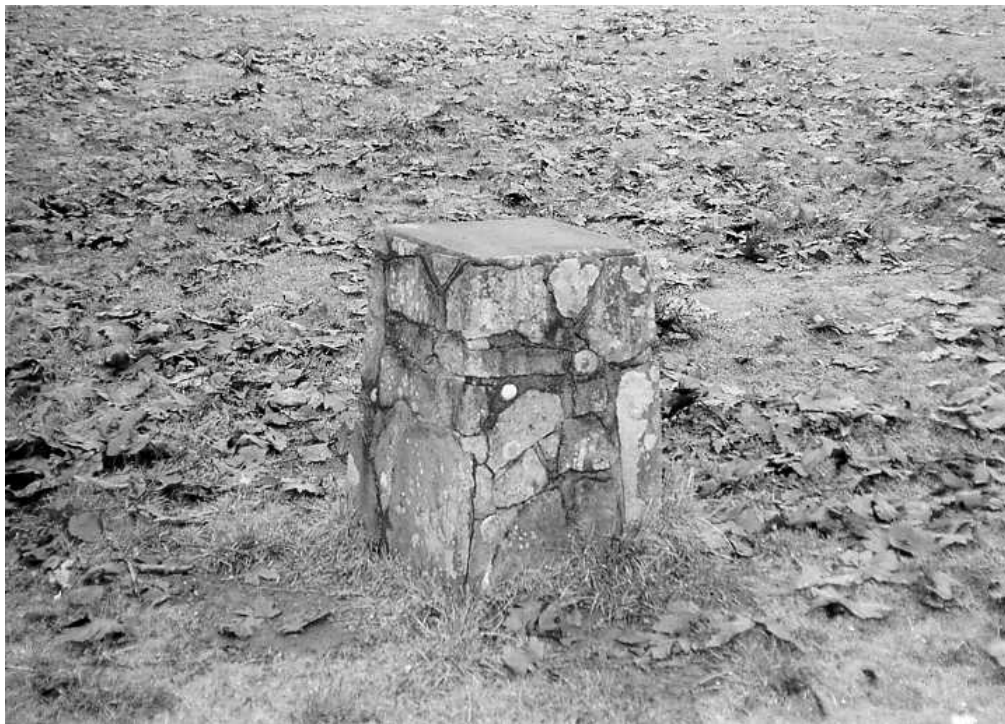
*Contemporary photograph of a small scale feature at Rosemary Inn: a sundial. The sundial was part of the stroll garden. (CCSO, 1999.)*

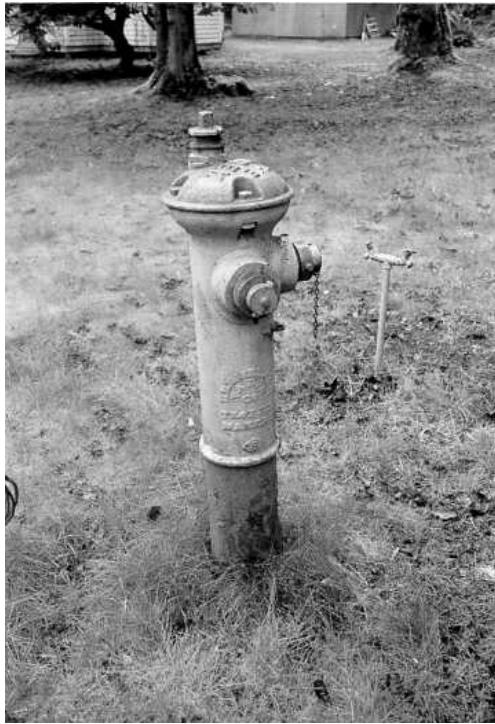
*LCS photograph of a small scale feature at Rosemary Inn: a fire hydrant. The fire hydrant is inscribed with "Rensselaer Valve Co, Troy NY, Makers" and "The Corey" and dates from the historic period. (CCSO, 1990.)*

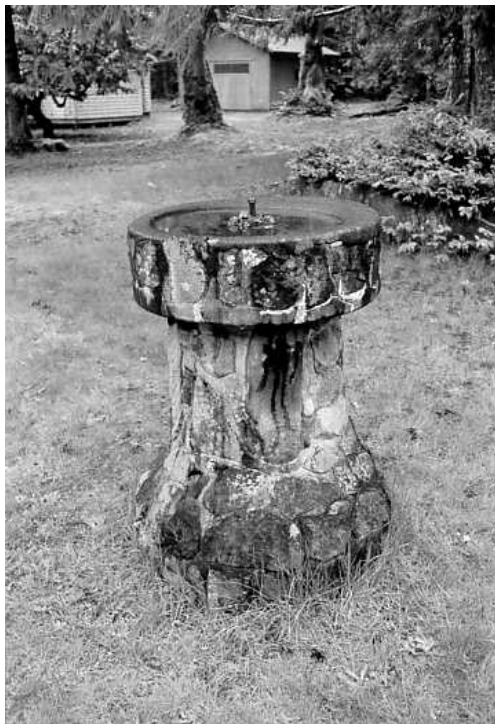
*LCS photograph of a small scale feature at Rosemary Inn: one of the two drinking fountains. The drinking fountains were part of the stroll garden. (CCSO, 1990.)*

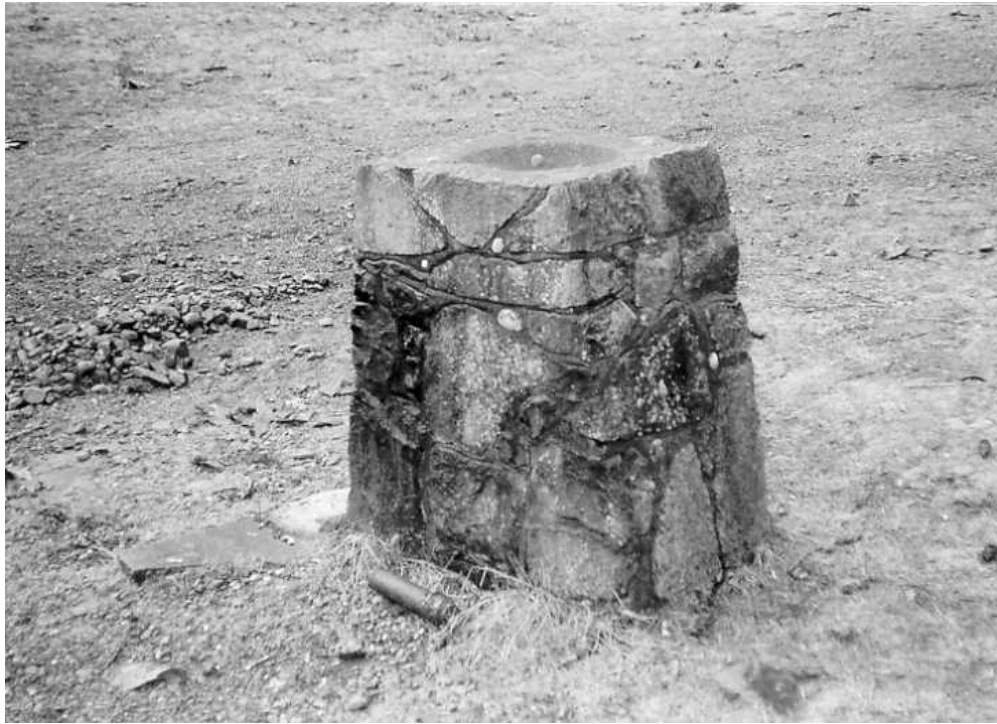
*Contemporary photograph of a small scale feature at Rosemary Inn: one of the two drinking fountains. This drinking fountain was historically covered by a wooden shelter. (CCSO, 1999.)*

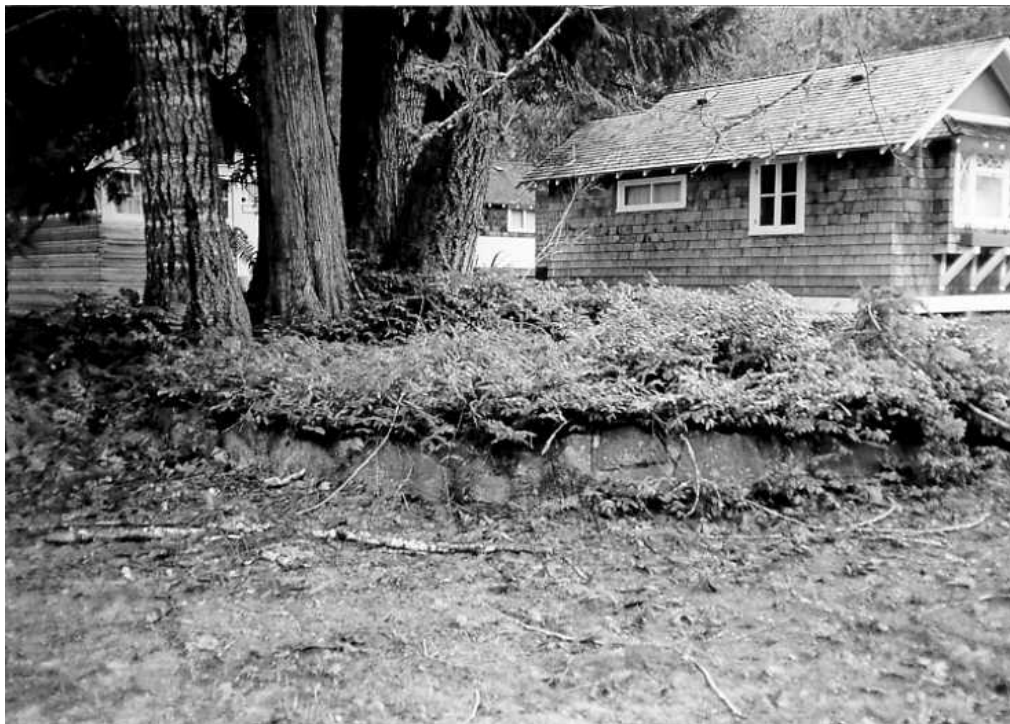
*Contemporary photograph of a small scale feature at Rosemary Inn: a rock planter wall retaining a plant bed of St. John's wort. (CCSO, 1999.)*

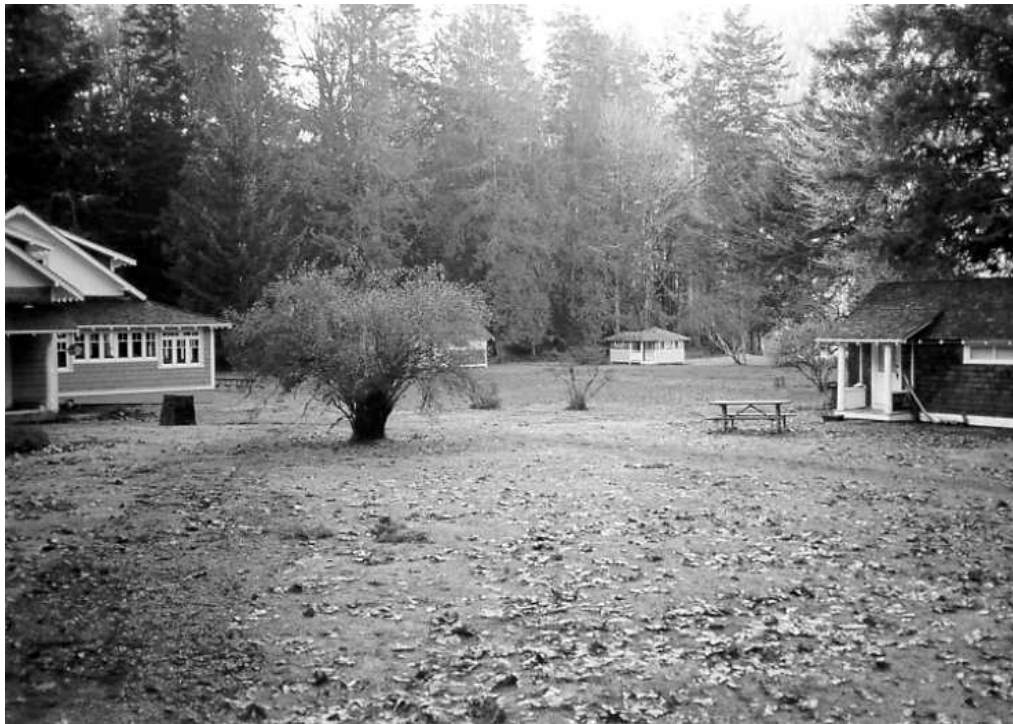
*Contemporary photograph of the Rosemary Inn, showing a view of the central clearing from the entry space near the lodge. (CCSO, 1999.)*

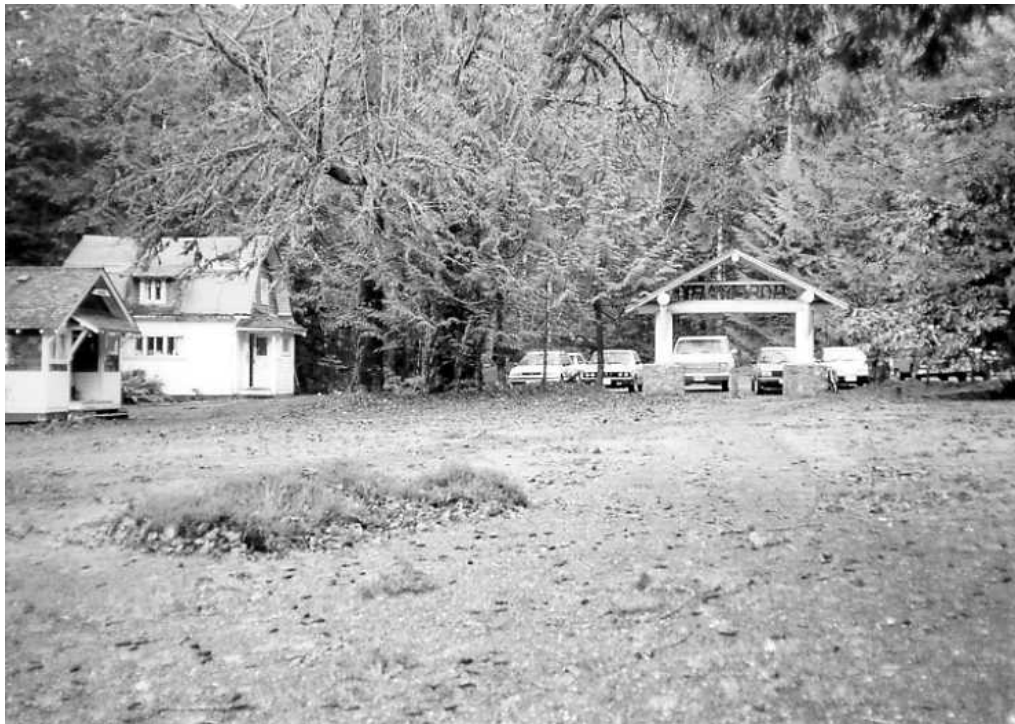
*Contemporary photograph of Rosemary Inn, showing one part of the spatial organization of the site, the entry space. (CCSO, 1999.)*

Another important space is at the southeast of the site, located between the Rosemary gate (a later replacement) and the lodge. This can be considered an entry space, and is framed by a view through the Rosemary gate as visitors enter from the guest parking area. A pathway leads from the gate towards the lodge through an open grassy area, defined at the edges by trees and buildings. As the visitor approaches the lodge, the orientation of the pathway turns and directs the visitor towards the central clearing, leading in to its oblique orientation. This space remains an authentic part of the organization of the site, and continues to function as the formal entry space to the site.

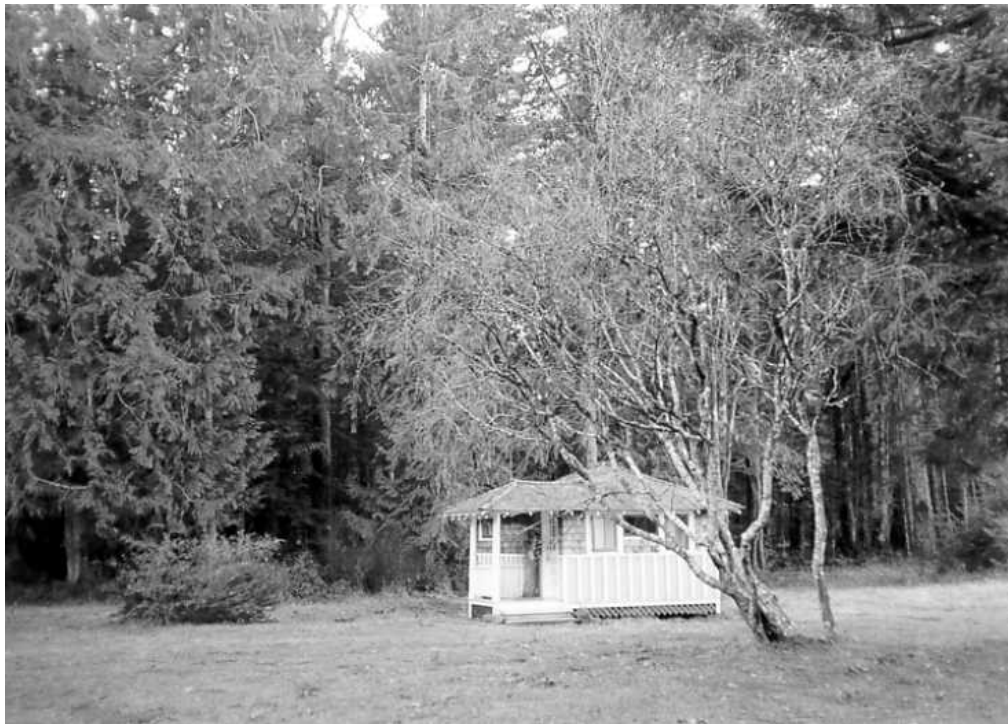
*Contemporary photograph of a vegetation feature at Rosemary Inn: a Goldenchain tree. This feature (foreground right) is shown in historic photographs of the 1915-1946 period. (CCSO, 1999.)*

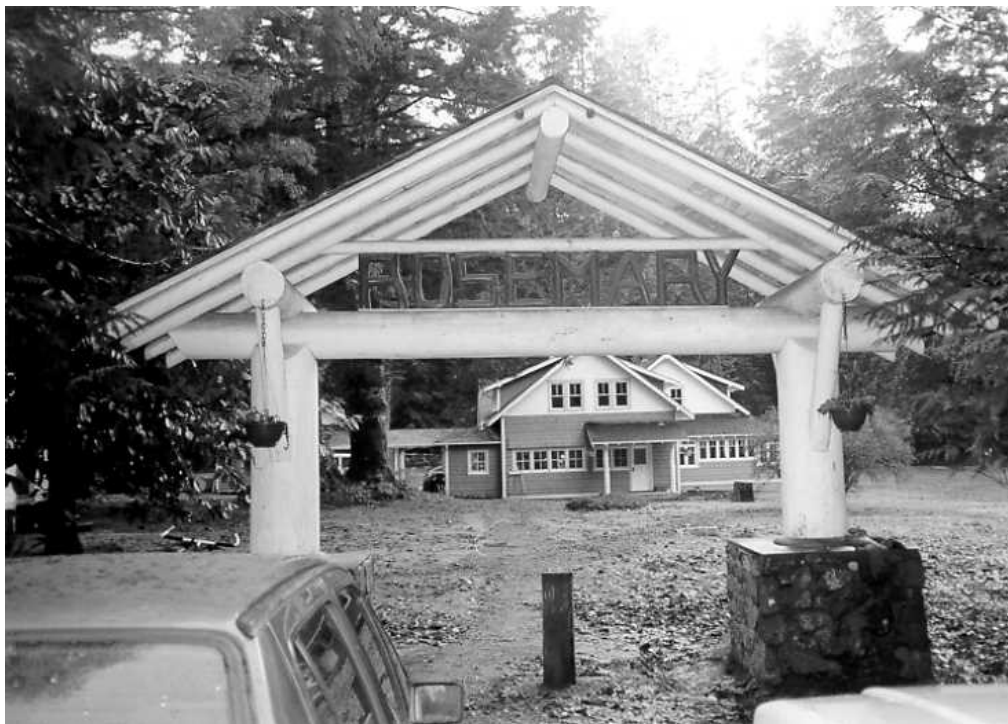
*Contemporary photograph of a vegetation feature at Rosemary Inn: English laurel (*Prunus laurocerasus*) (left of gate). This is one of two remaining English laurel shrubs. (CCSO, 1999.)*

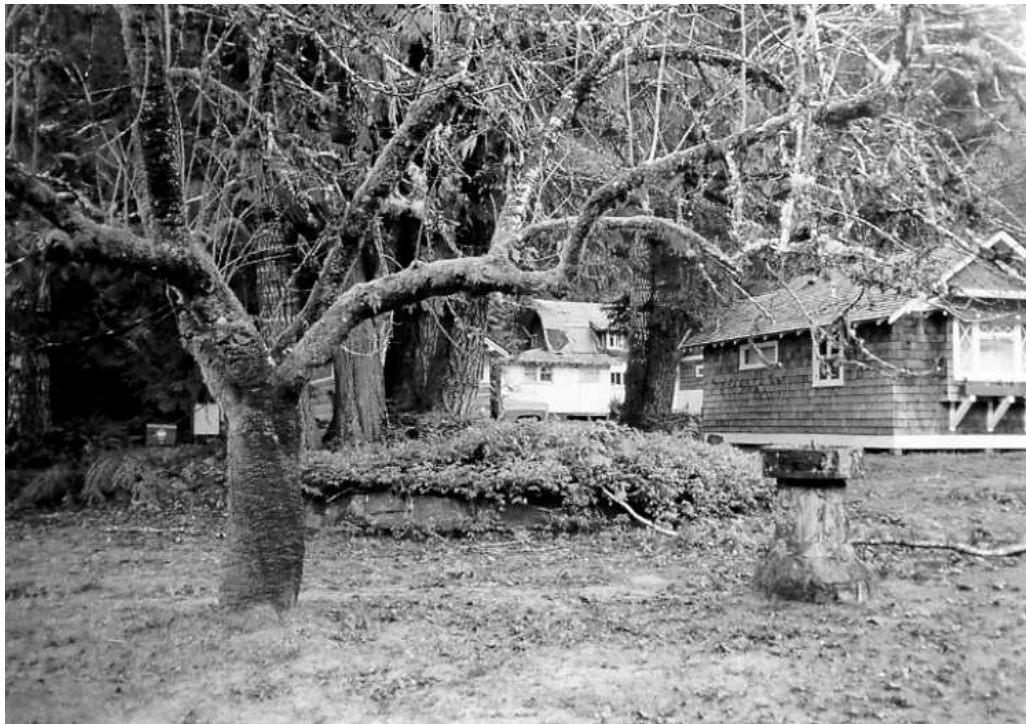
*Contemporary photograph of a vegetation feature at Rosemary Inn: a domestic apple tree (foreground left). This is one of three remaining apple trees. (CCSO, 1999.)*

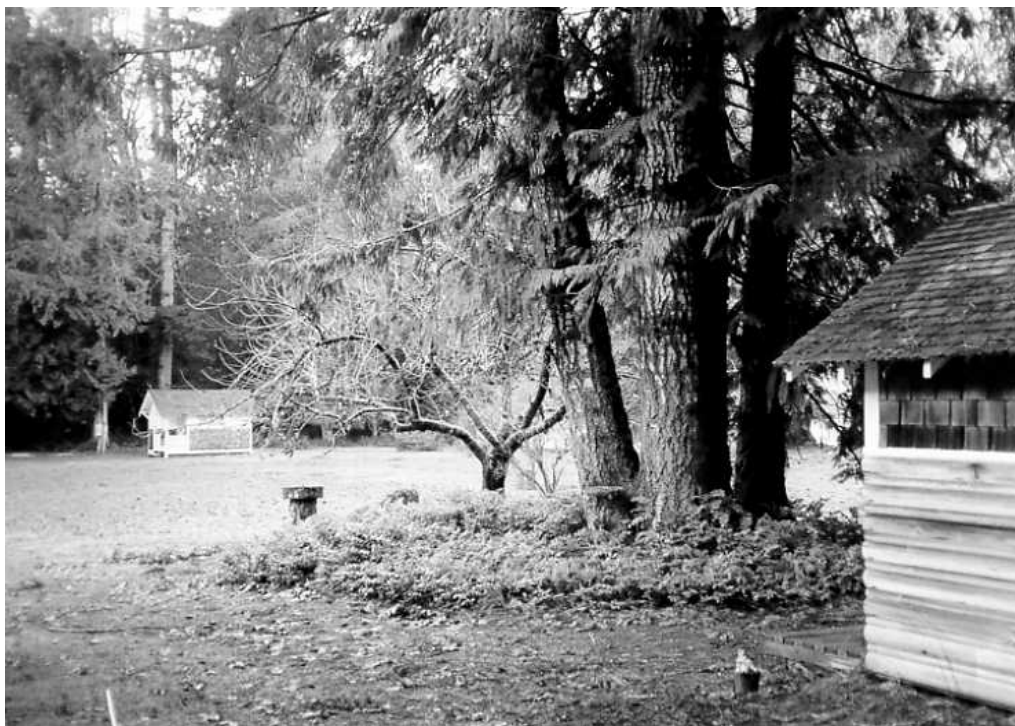
*Contemporary photograph of a vegetation feature at Rosemary Inn: St. John's Wort (beneath conifer in center). (CCSO, 1999.)*

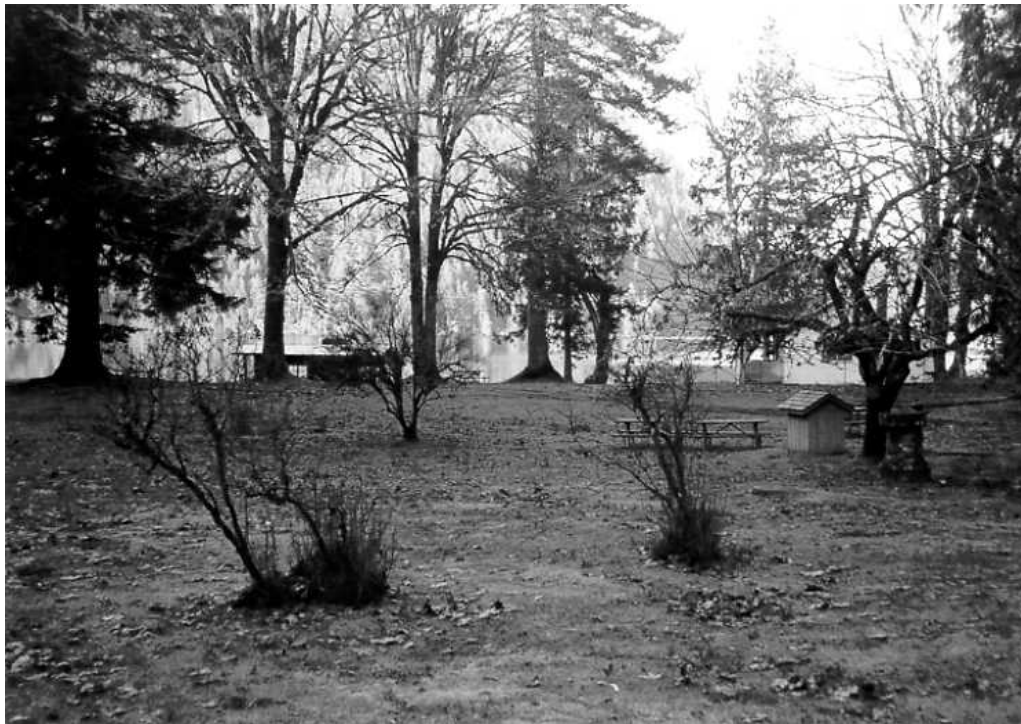
*Contemporary photograph of a vegetation feature at Rosemary Inn: two Lilacs (*Syringa vulgaris*) (left and right foreground). These shrubs are remnants of the stroll garden. (CCSO 1999.)*
