National Park Service  
Cultural Landscapes Inventory  
1999

Rosemary Inn  
Olympic National Park

CULTURAL LANDSCAPES INVENTORY (CLI) PROGRAM  
*2010 Condition Assessment Update for:*

**Rosemary Inn**  
Olympic National Park

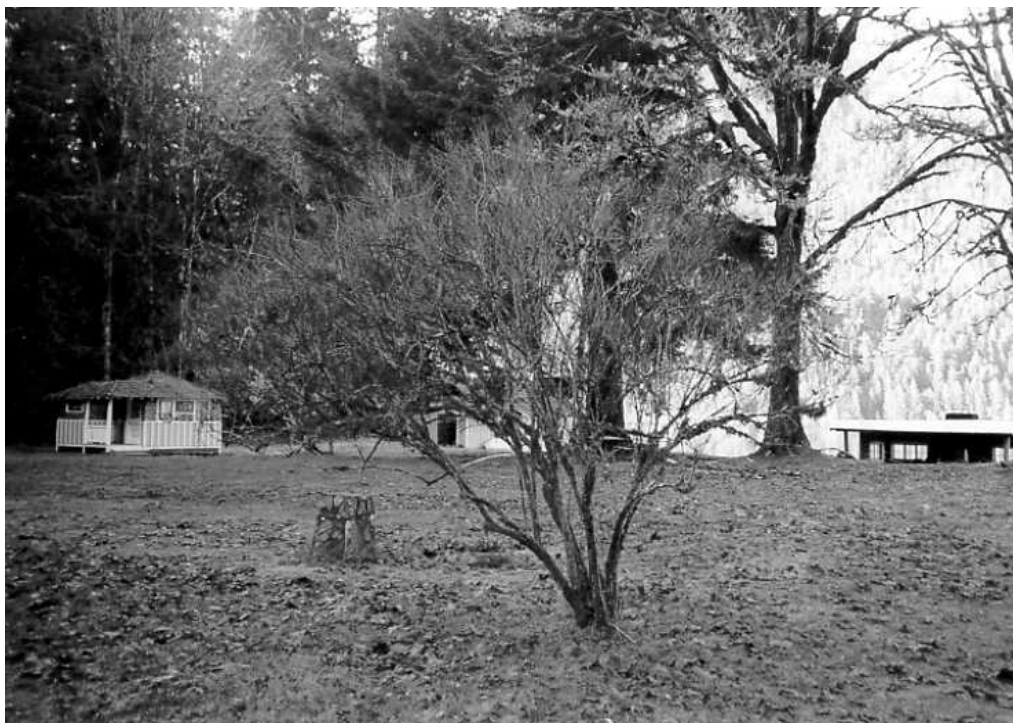
*Contemporary photograph of a vegetation feature at Rosemary Inn: a Mock orange shrub (*Philadelphus virginialis*). (CCSO, 1999.)*

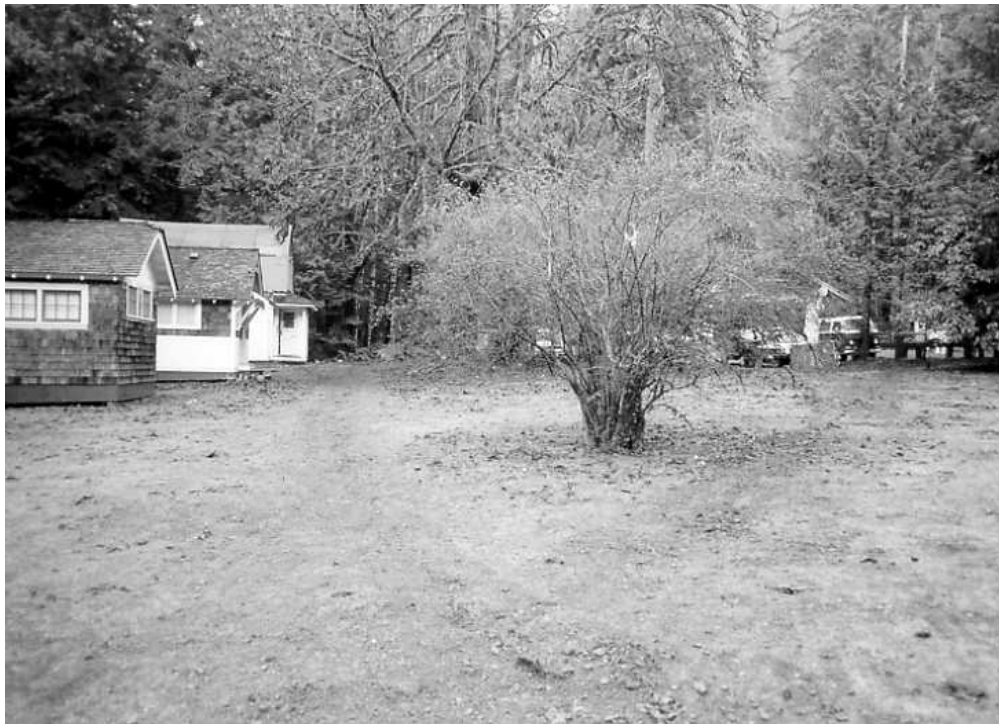
*Contemporary photograph of a vegetation feature at Rosemary Inn: a Beautybush shrub (Kolkwitzia amabilis). (CCSO, 1999.)*

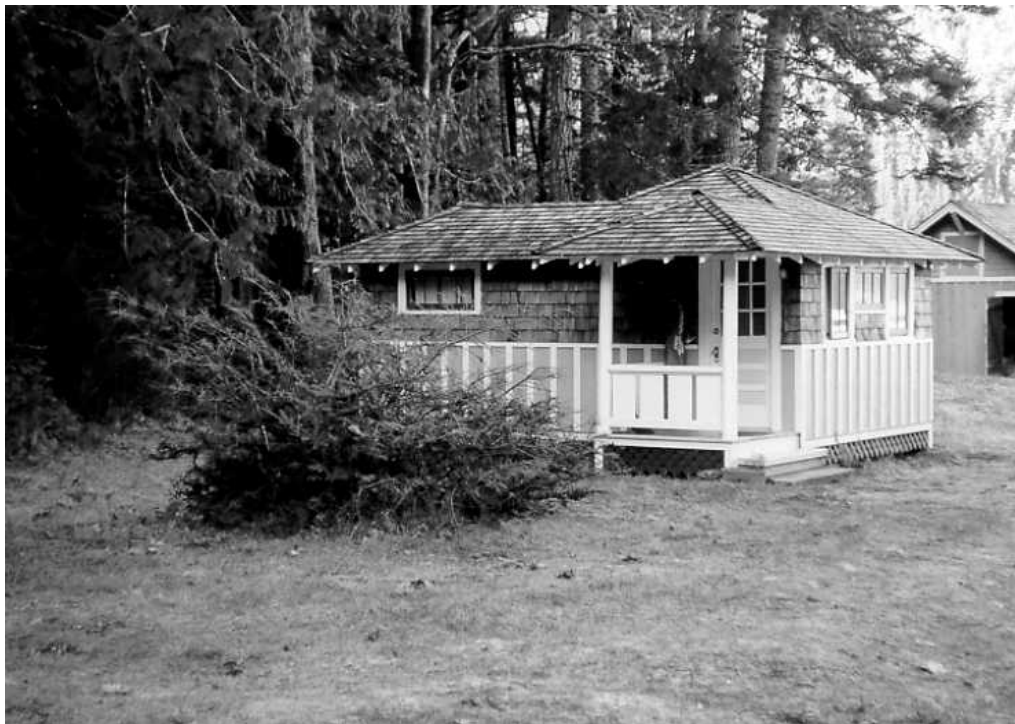
*Contemporary photograph of a vegetation feature at Rosemary Inn: a Rockspray cotoneaster shrub (Cotoneaster horizontalis). (CCSO, 1999.)*

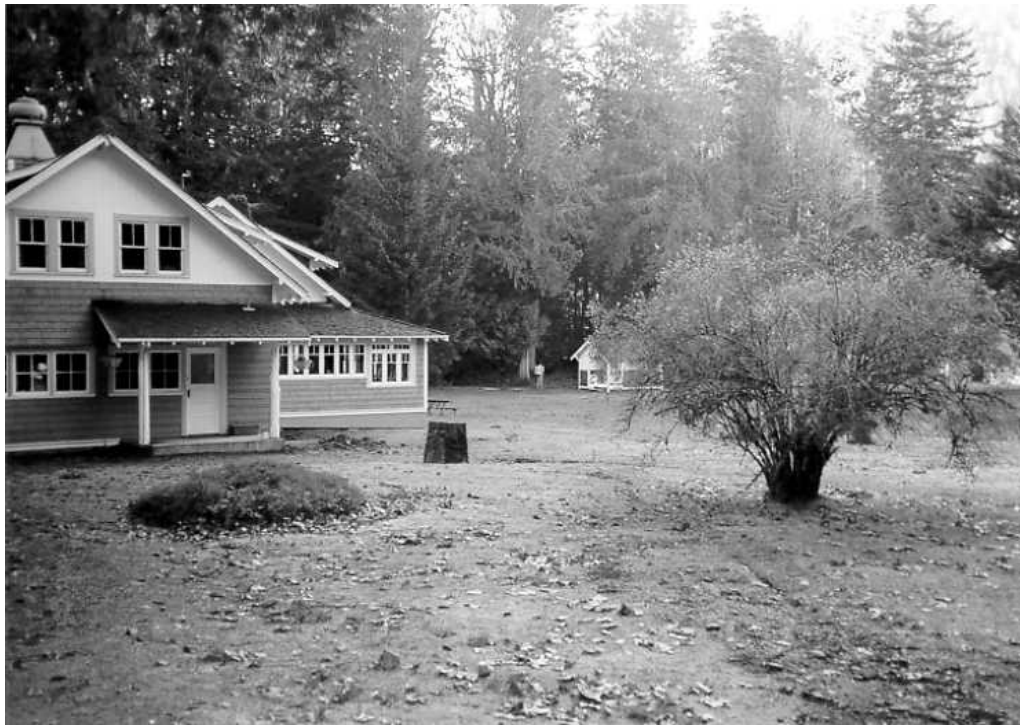
*Contemporary photograph of a vegetation feature at Rosemary Inn: Scots heather (*Calluna vulgaris*), (foreground left). (CCSO, 1999.)*

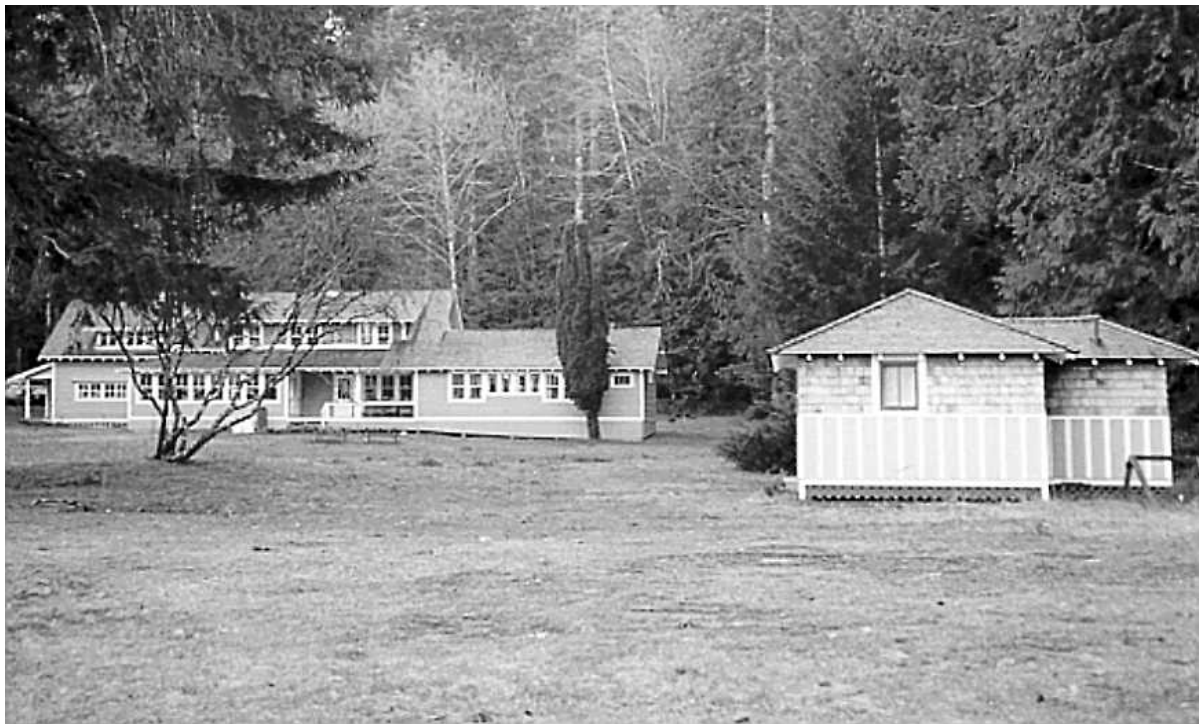
*Contemporary photograph of a vegetation feature at Rosemary Inn: an Irish yew shrub (*Taxus baccata*) (middle, in front of lodge). This shrub is shown in photographs near the end of the 1914-1946 period. (CCSO, 1999.)*
