Storm King Ranger Station  
Olympic National Park  
N. side of U.S. Highway 101 (near Barnes Pt.)  
Lake Crescent Vicinity  
Clallam County  
Washington

HABS No. WA-155

STORM KING RANGER STATION

# STORM KING RANGER STATION- OLYMPIC NATIONAL PARK

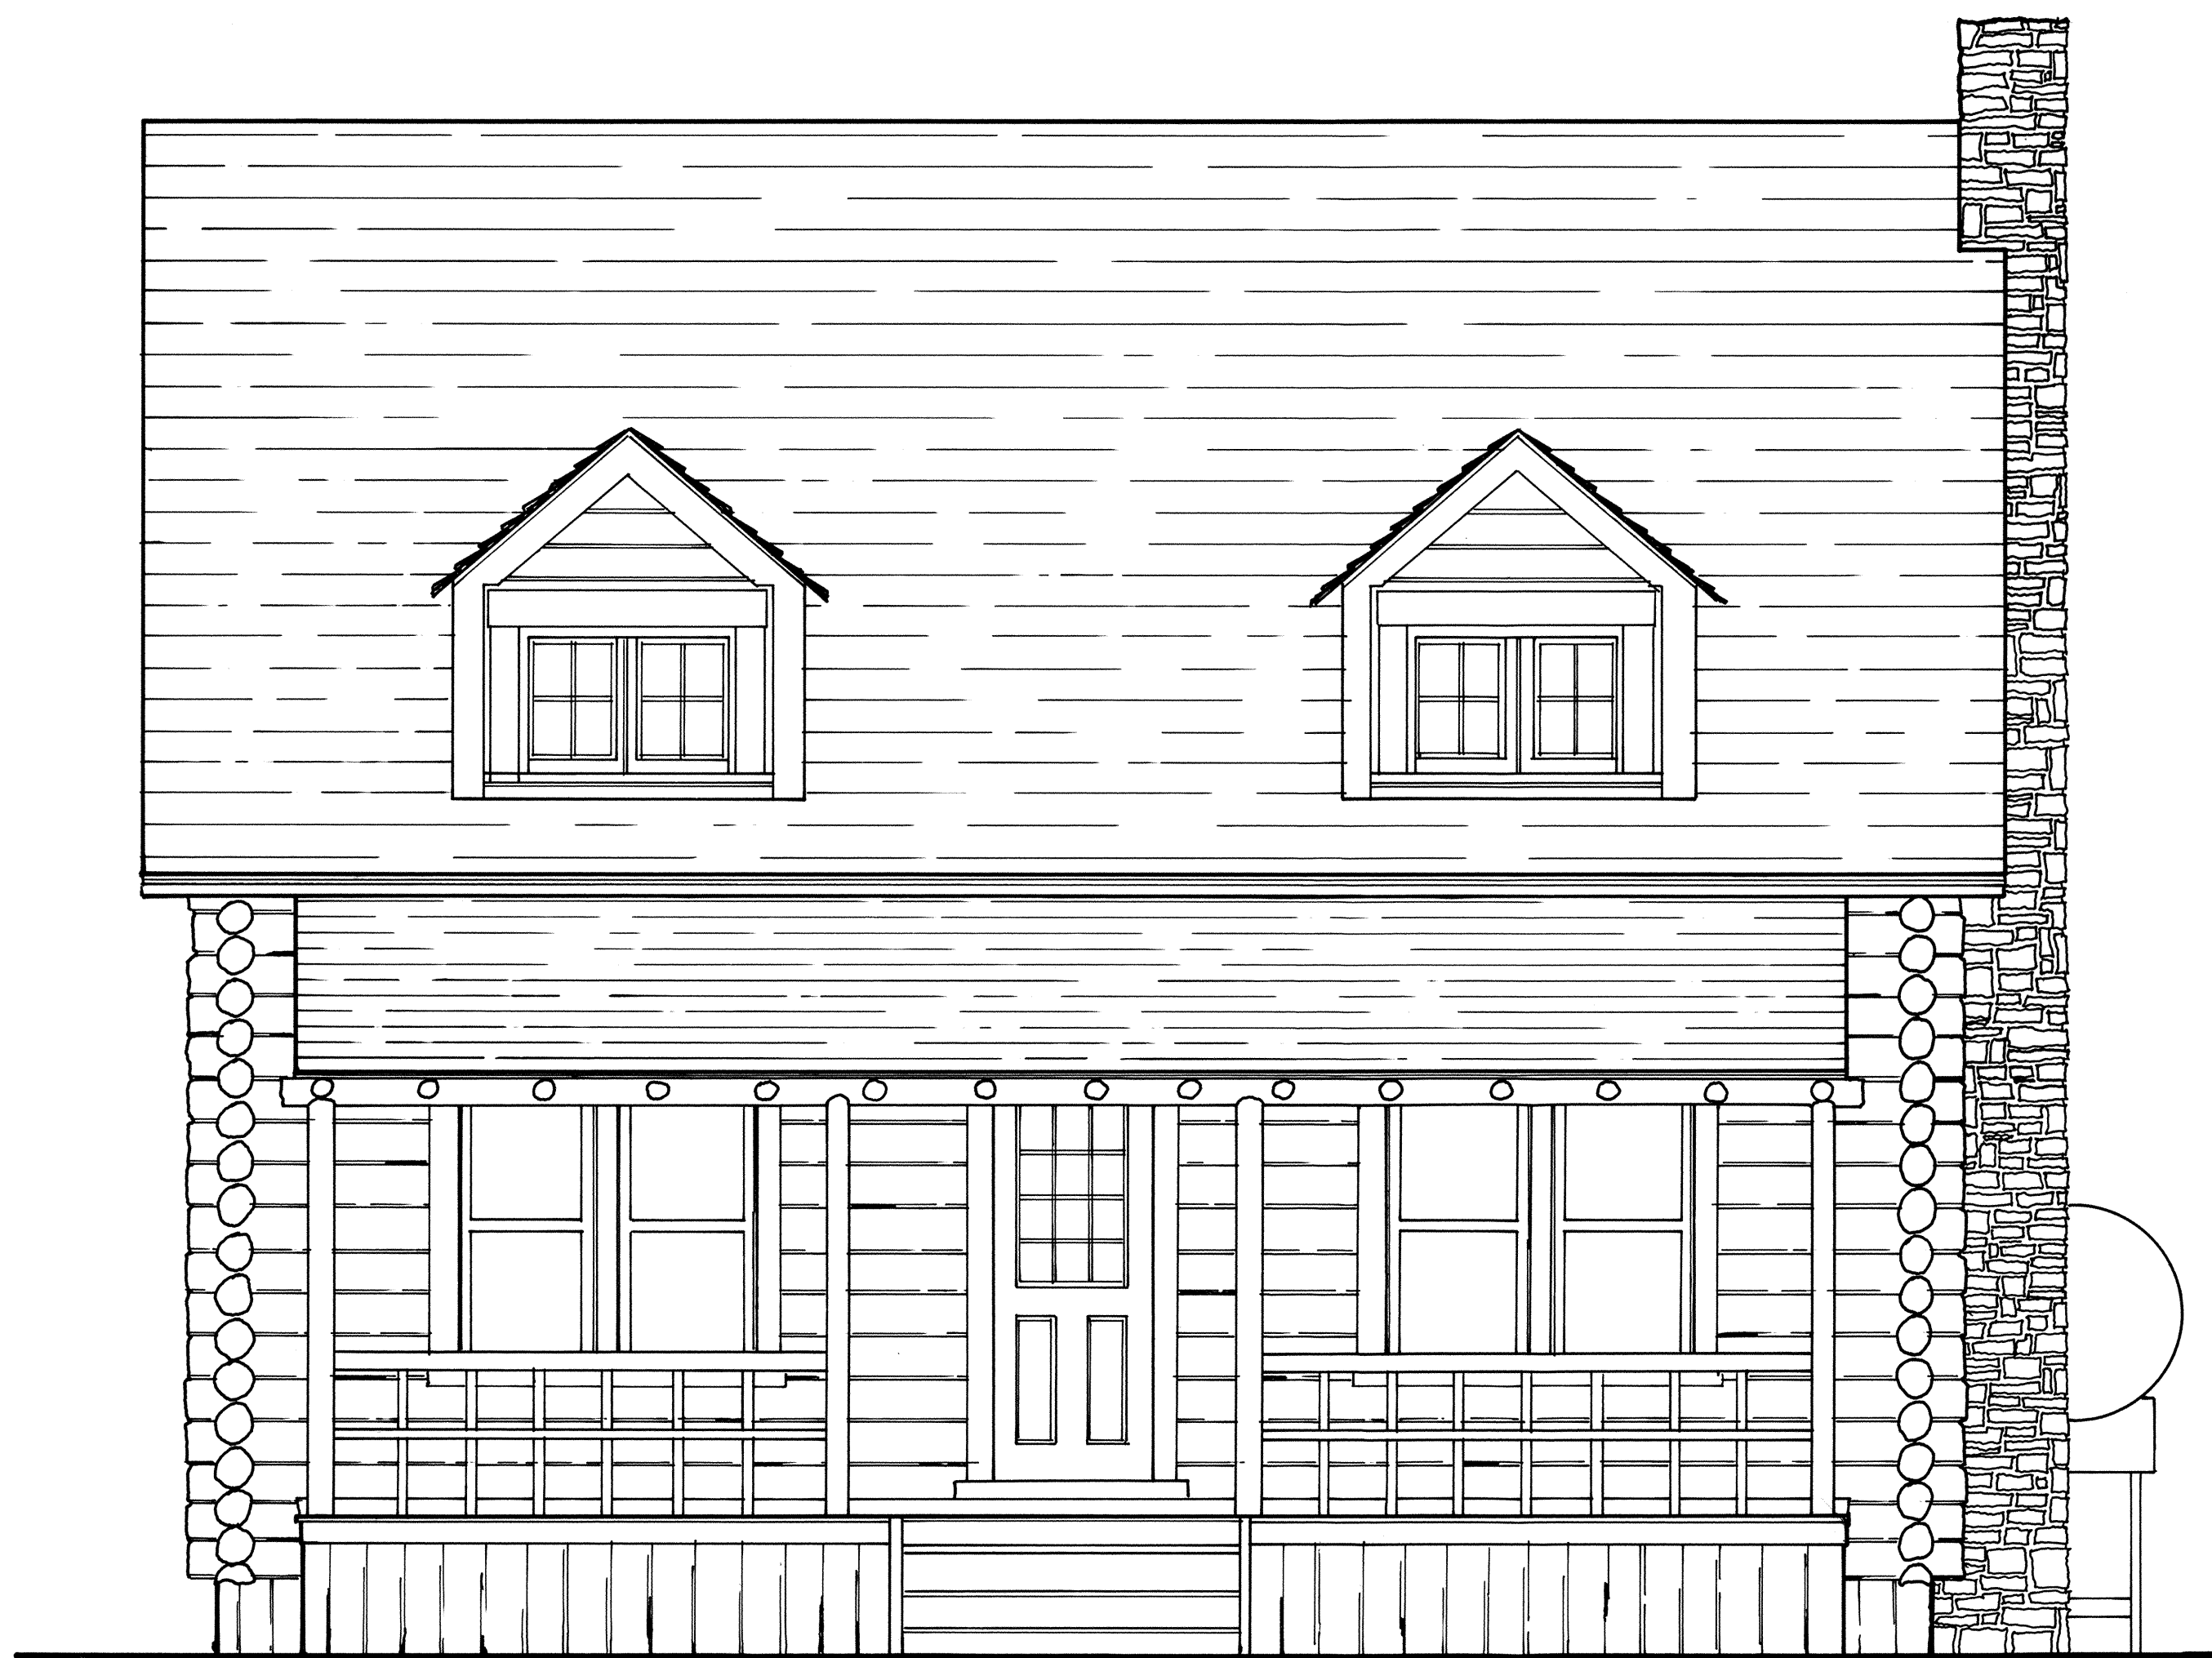
NORTH ELEVATION

Overall dimensions: The cabin is basically rectangular with an enclosed lean-to porch on the rear elevation and an open lean-to porch across the front. The building is approximately twenty-nine feet across and thirty-five feet deep, including both porches. The cabin is a story-and-one-half with two symmetrically placed gabled dormers on the front elevation.

Roof: The cabin has a cedar shingle gable roof with two north facing gabled dormers.

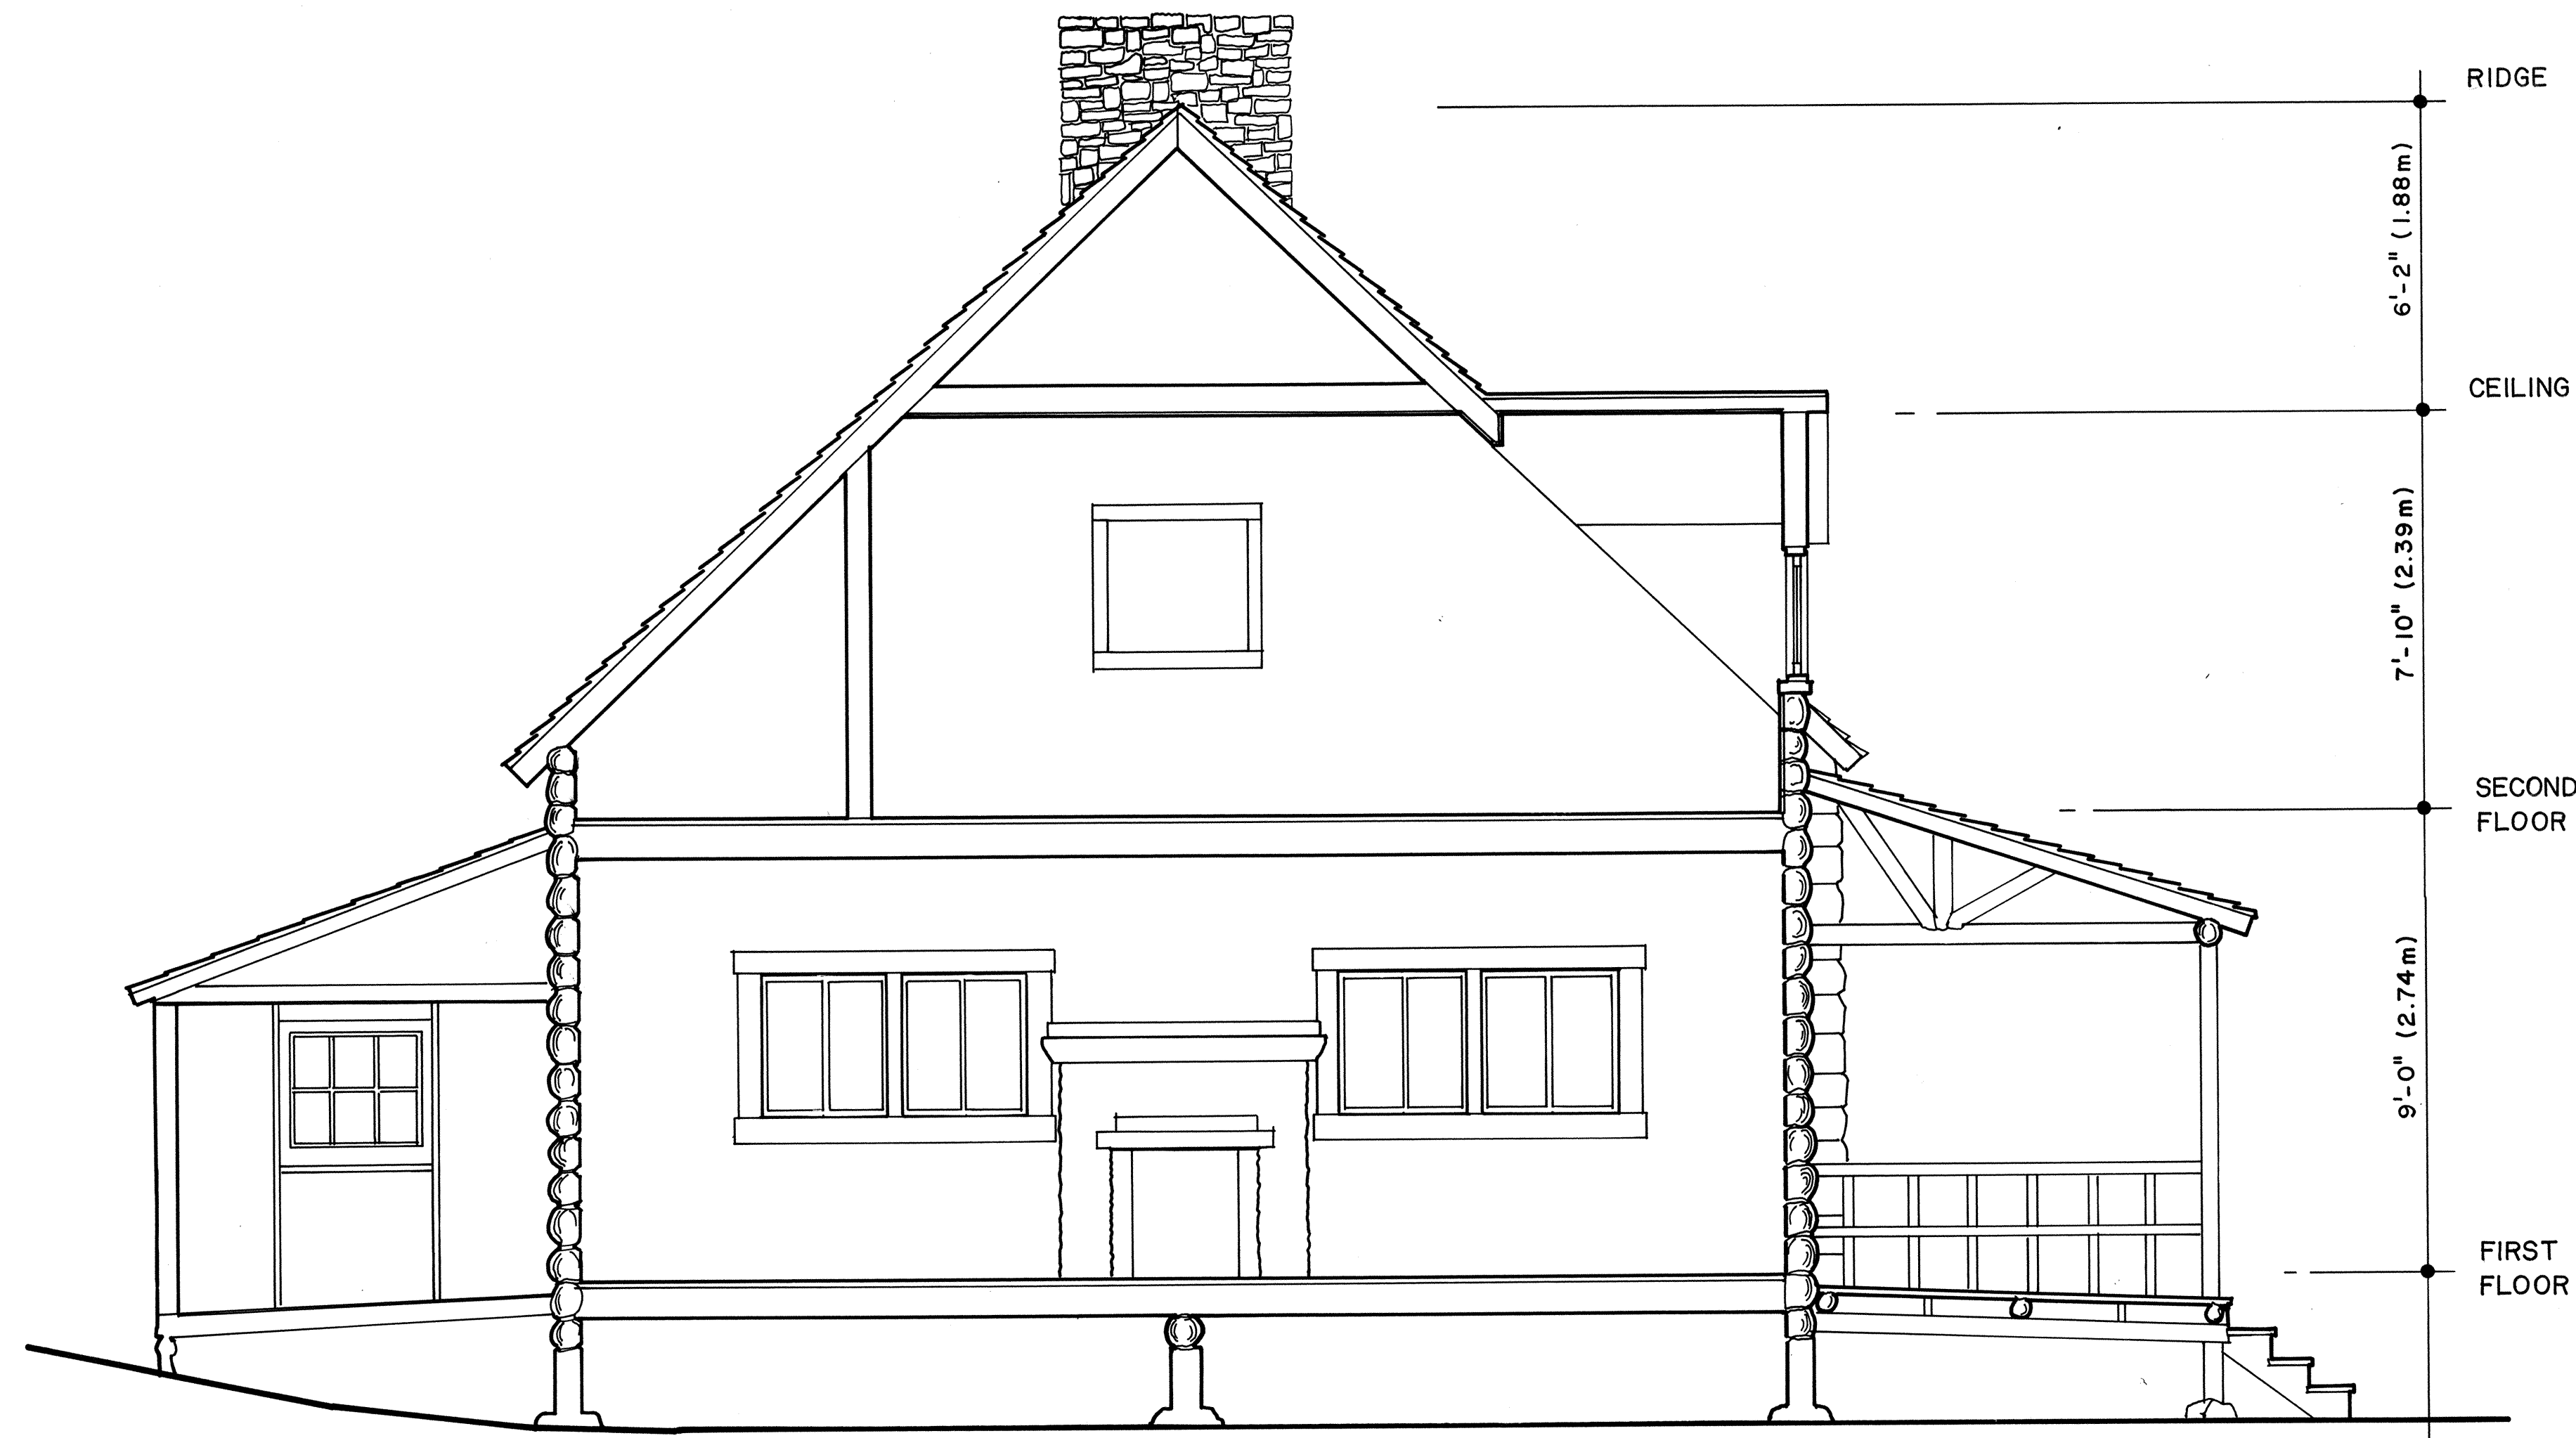
SECTION B - B

Structural System: Log floor joists are generally ten inches in diameter, approximately two feet on center, and are notched into the north and south sill log of the cabin. The exposed ceiling joists found throughout the structure are also notched into the north and south log walls. These joists are also about ten inches in diameter. Roof rafters are notched into the top wall log. There is no continuous ridge log, so the rafters on each side of the roof rest on each other and are blocked in between.

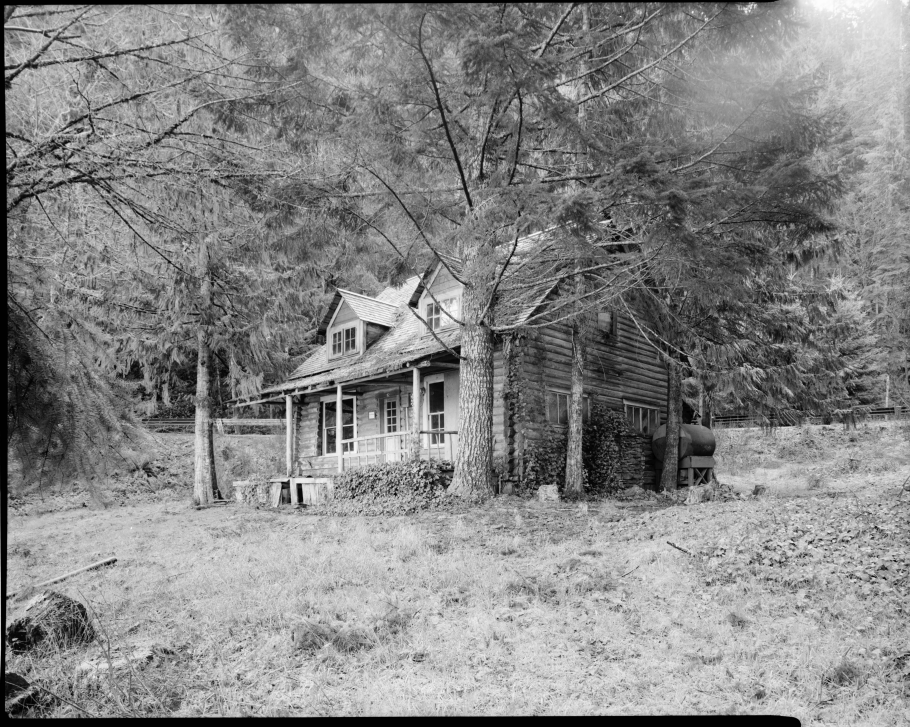
HABS No. 1115 - 100 - 7

- WA-155-5      EXTERIOR, SOUTHWEST CORNER
- WA-155-6      EAST SIDE, SHOWING ACCIDENT DAMAGE AND PROXIMITY  
TO U.S. HIGHWAY 101
- WA-155-7      EXTERIOR, NORTH FRONT AND EAST SIDE

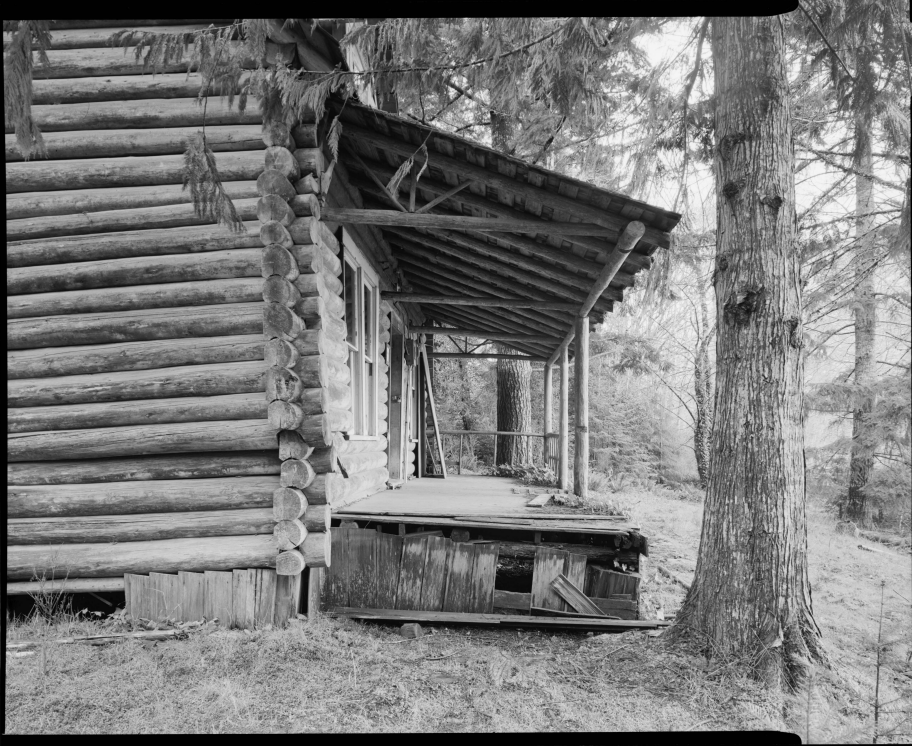
HABS No. 11A - 155 - 9

- WA-155-8      EXTERIOR, NORTHEAST CORNER, SHOWING NOTCHING, DEEP PORCH  
EAVE AND LAKE CRESCENT
- WA-155-9      EXTERIOR, PARTIAL VIEW OF EAST SIDE, SHOWING PROFILE OF  
FRONT PORCH

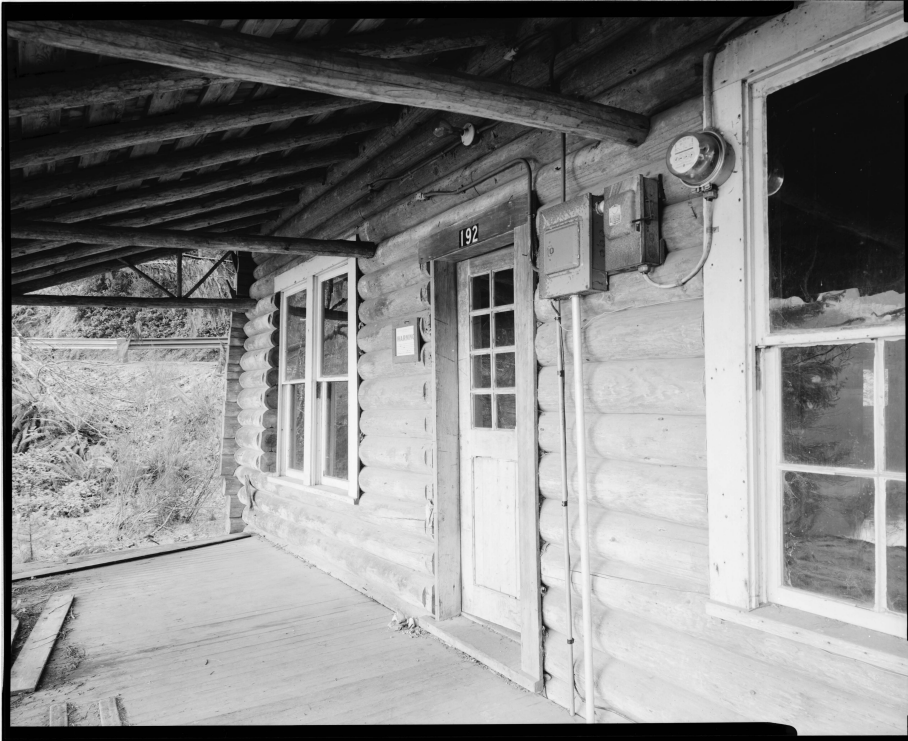
HABS No. WA. 105-10

- WA-155-10     EXTERIOR, NORTH FRONT, DETAIL OF NORTH WALL AND WINDOWS
- WA-155-11     EXTERIOR, DETAIL OF NORTH DOORWAY
- WA-155-12     EXTERIOR, NORTHWEST CORNER, NOTCH DETAIL

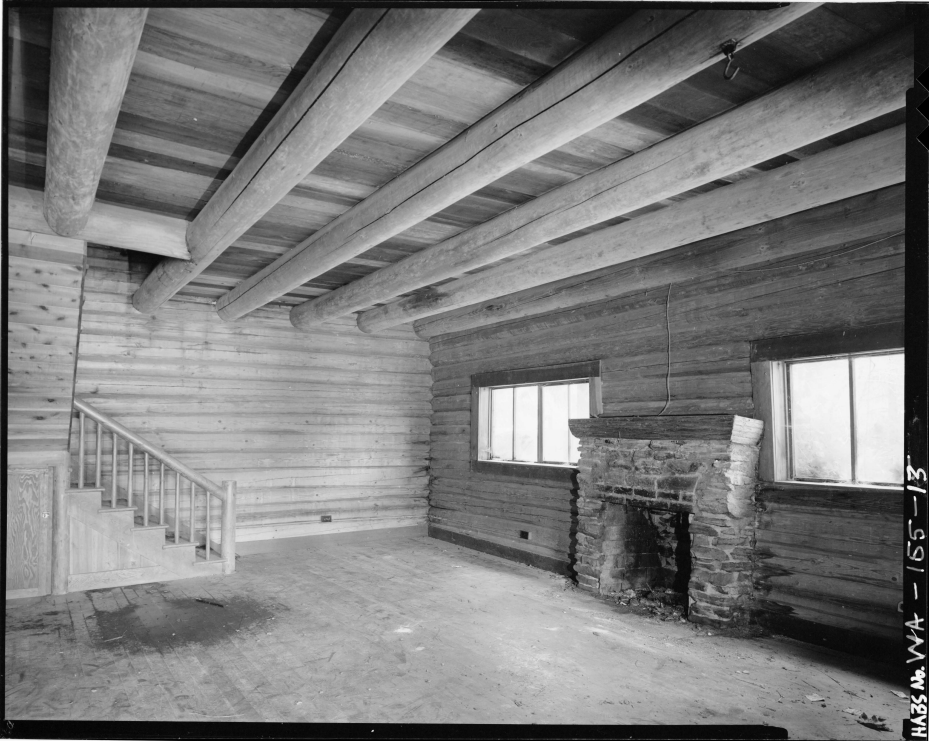
HABS No. WA-165-13

Fireplace: A masonry stone fireplace, with brick lintel and hearth was added to the cabin, probably in the 1930s. This fireplace is located between the two casement windows on the west living room wall and is topped with a rough sawn fir mantel.

- WA-155-13     INTERIOR, FIRST FLOOR, NORTHWEST ROOM, SHOWING FIREPLACE AND  
STAIRWAY
- WA-155-14     INTERIOR, FIRST FLOOR, NORTHWEST ROOM, WEST WALL WITH  
FIREPLACE

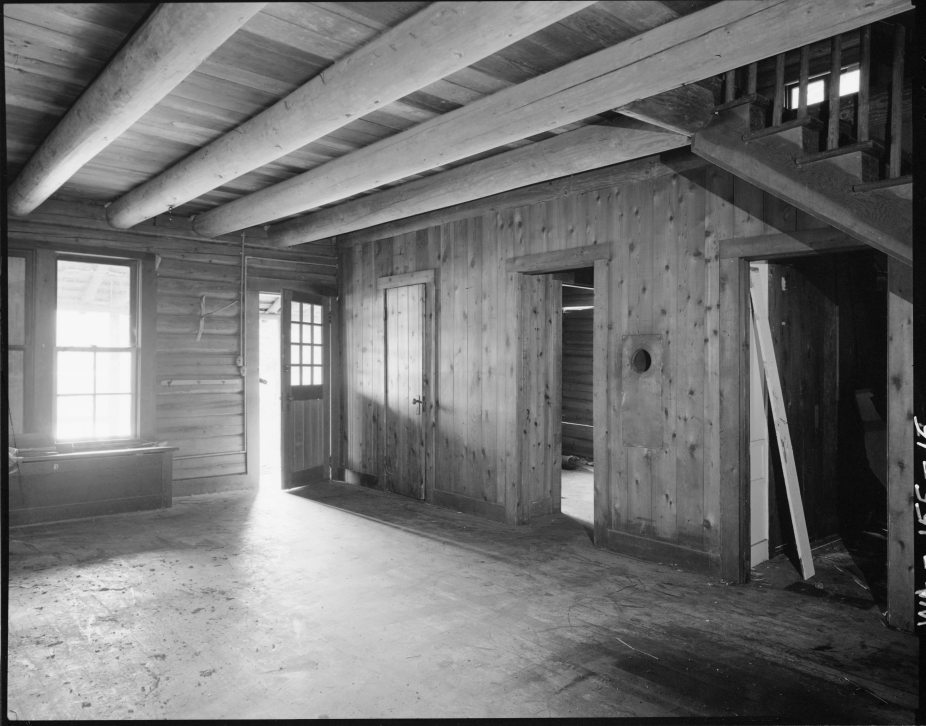
WA - 155 - 15

- WA-155-15     INTERIOR, FIRST FLOOR, NORTHWEST ROOM, SHOWING NORTH WALL  
WITH DOORWAY AND EAST WALL WITH UPPER STAIRWAY
- WA-155-16     INTERIOR, FIRST FLOOR, NORTHWEST ROOM, FULL VIEW OF STAIRWAY

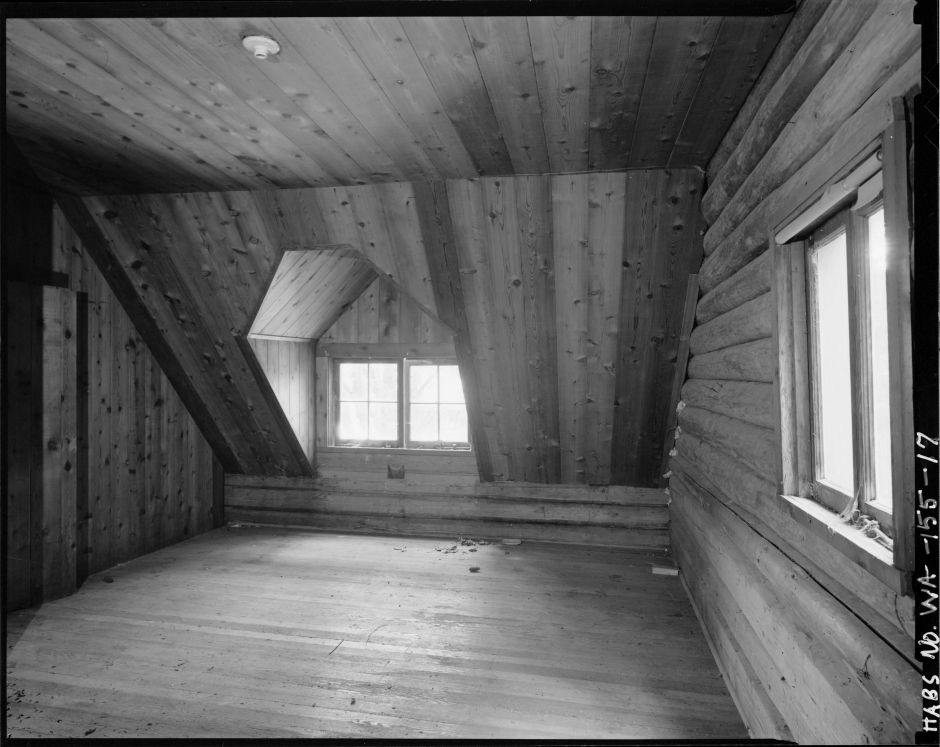
HABS NO. WA-155-17

- WA-155-17     INTERIOR, SECOND FLOOR, NORTHEAST ROOM WITH DORMER
