Rosemary Inn, Lodge (Bldg. No. 372)  
Olympic National Park  
Barnes Point, Lake Crescent  
Port Angeles Vicinity  
Clallam County  
Washington

HABS No. WA-185-A

WRITTEN HISTORICAL AND DESCRIPTIVE DATA

HISTORIC AMERICAN BUILDING SURVEY  
ARCHITECTURAL DATA FORM

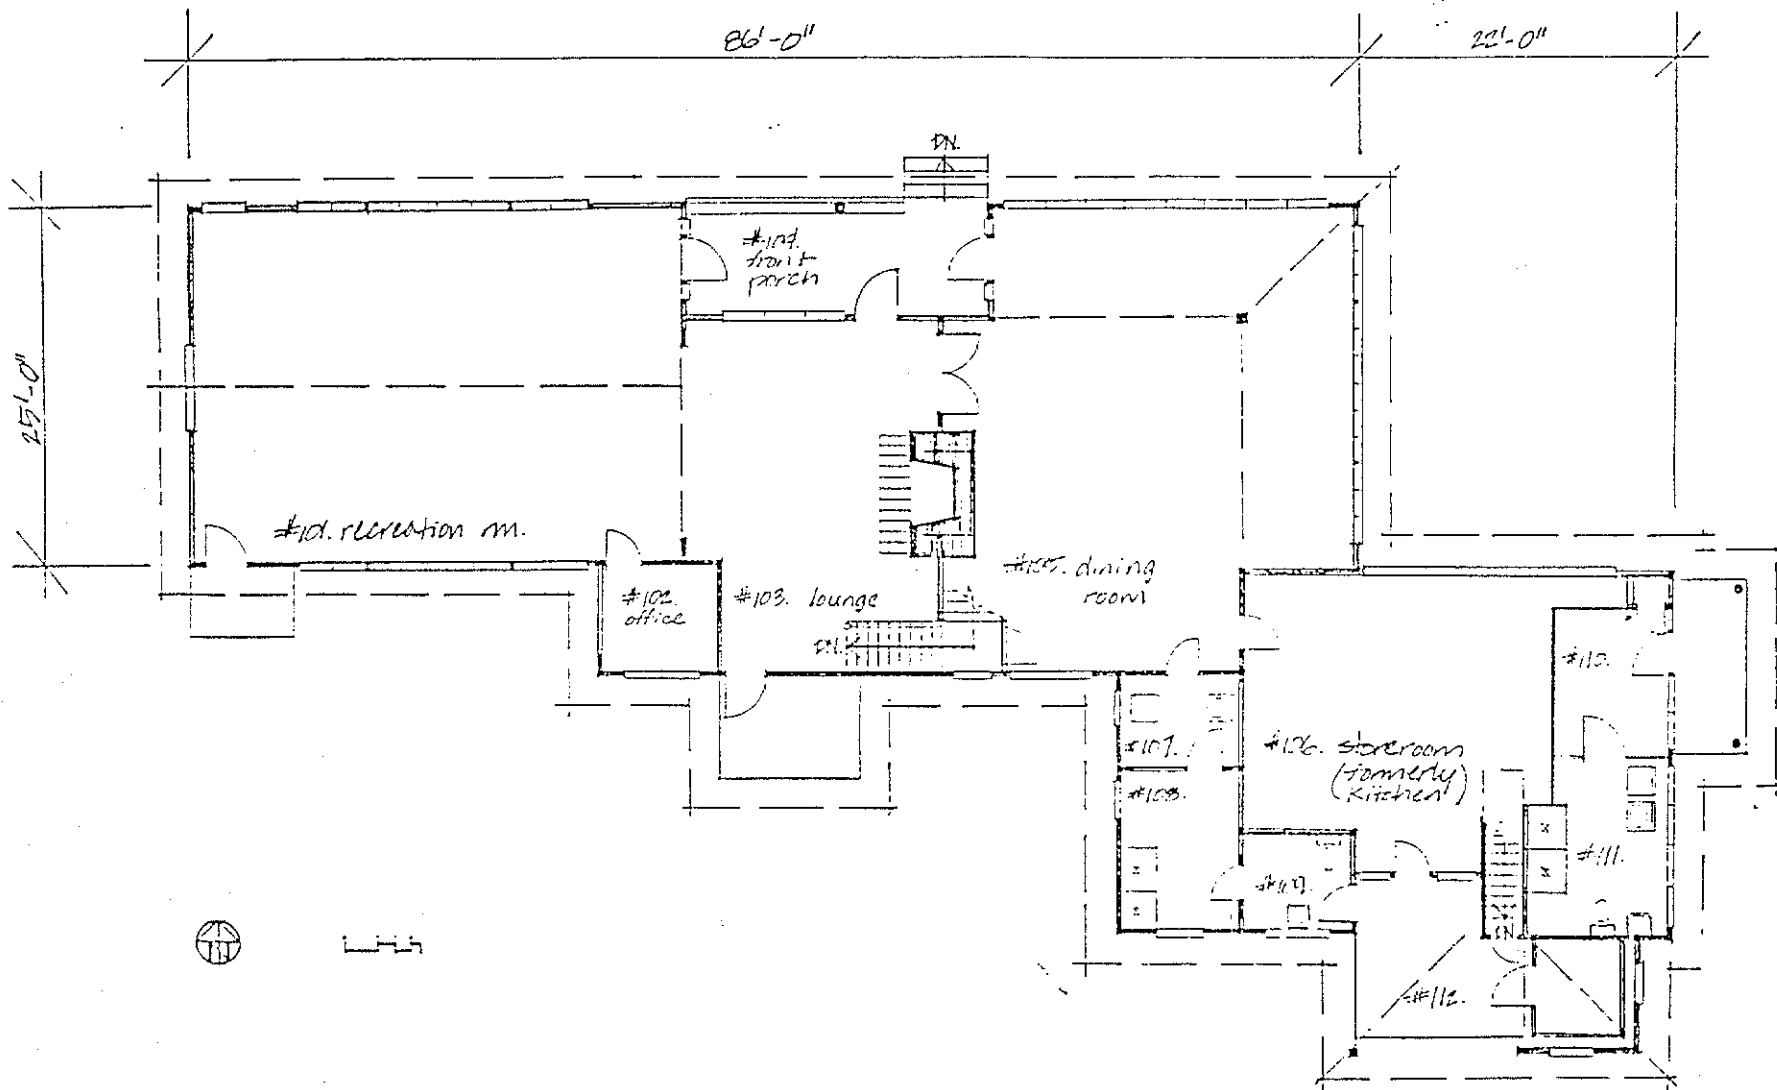
Rosemary Lodge Building #372 - First Floor

| SHAPE AND DIMENSIONS OF STRUCTURE (sketched floor plans on separate sheet acceptable)<br>Irregular shape: overall dimensions 86' x 34' with 41' x 38' extension on SE corner. | | |
| INTERIOR FEATURES OF NOTE (describe floor plans if not sketched)<br>Massive stone and mortar fireplace in lobby; hand-crafted twisted madrona baluster on first floor stairway; hardwood floors; wood wainscoting along walls in lobby with horizontal knotty pine boards above windows; wood ceiling on 1st floor. | | |
