Rosemary Inn, Wren Cabin (Bldg. No. 373)  
Olympic National Park  
Barnes Point, Lake Crescent  
Port Angeles Vicinity  
Clallam County  
Washington

HABS No. WA-185-G

HISTORIC AMERICAN BUILDING SURVEY  
ARCHITECTURAL DATA FORM

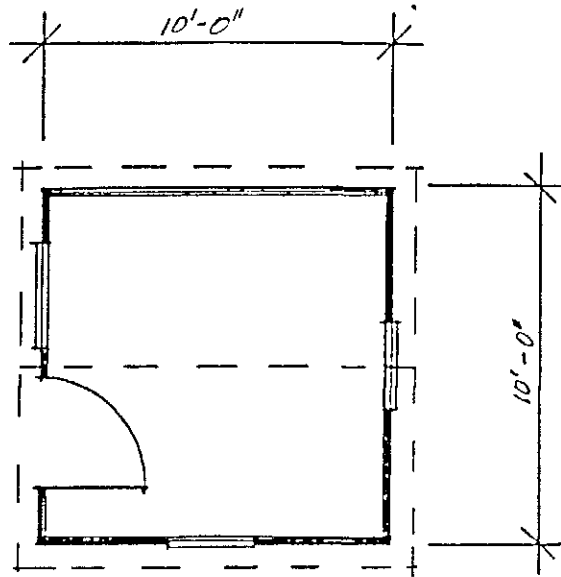
Wren Building #378

| SHAPE AND DIMENSIONS OF STRUCTURE (sketched floor plans on separate sheet acceptable)<br>Square: 10' x 10' | | |
