Edgewater Inn, Summerie Cabin (Building No. 334)  
Olympic National Park  
Barnes Point, Lake Crescent  
Port Angeles Vicinity  
Clallam County  
Washington

HABS No. WA-185-L

HISTORIC AMERICAN BUILDING SURVEY  
ARCHITECTURAL DATA FORM

ROSEMARY INN, SUMMERIE CABIN (Bldg. No. 384)  
HABS No. WA-185-L (page 2)

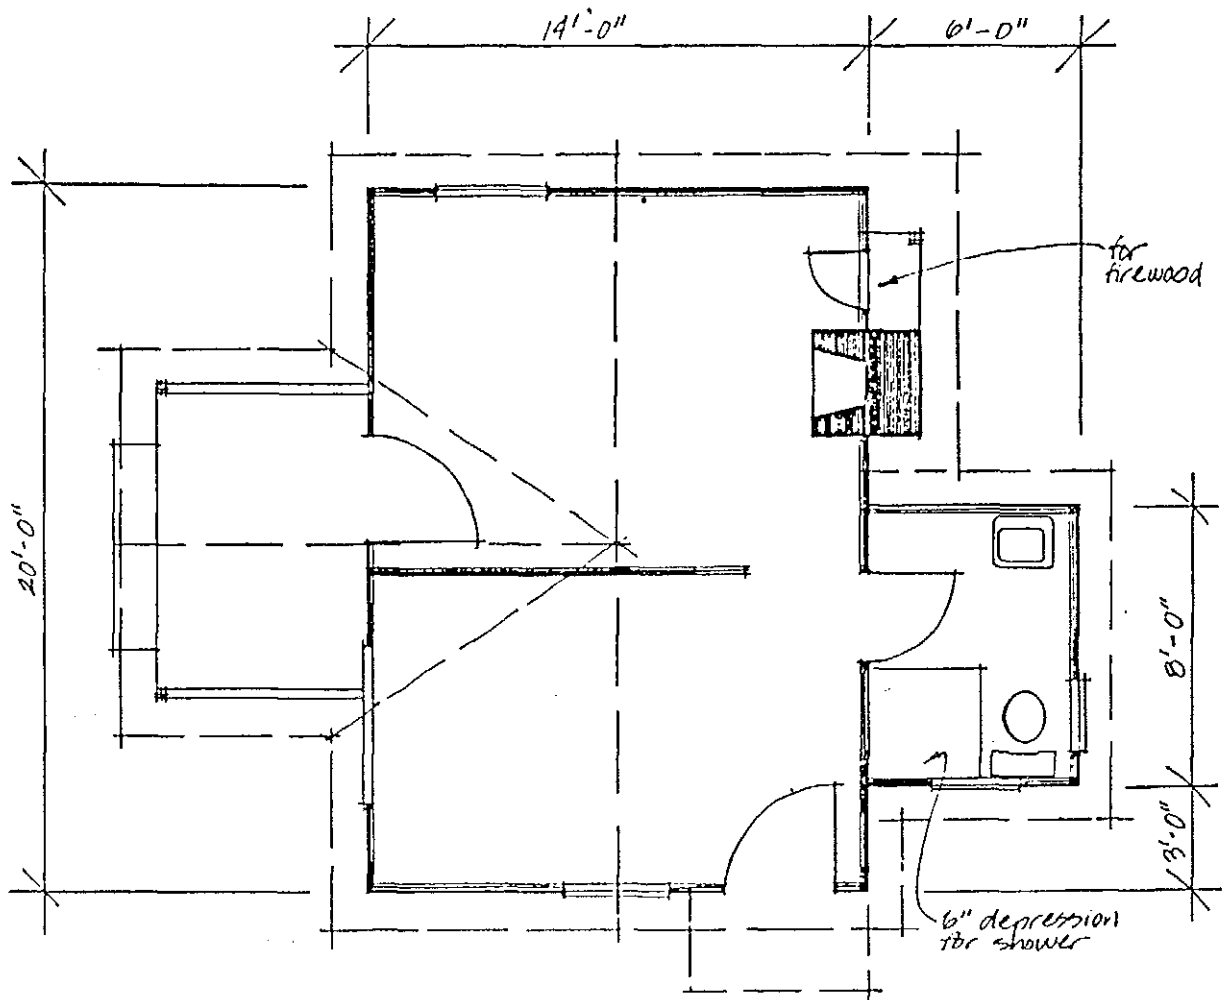
Summerie Building #384

| SHAPE AND DIMENSIONS OF STRUCTURE (sketched floor plans on separate sheet acceptable)<br>Irregular: 14' x 20' with a 6' x 8' extension on east | | |
| INTERIOR FEATURES OF NOTE (describe floor plans if not sketched)<br>Painted floor boards; painted vertical wood wainscoting on walls with painted horizontal wood boards above; original partition divides space into two sleeping rooms with separate entrys. | | |
