Singer's Lake Crescent Tavern (Lake Crescent Lodge),  
Cabins 3-21 (Bldg. Nos. 668-674)  
Barnes Point, Lake Crescent  
Olympic National Park  
Port Angeles Vicinity  
Clallam County  
Washington

HABS N. WA-186-E

HISTORIC AMERICAN BUILDINGS SURVEY  
NATIONAL PARK SERVICE  
PACIFIC NORTHWEST REGION  
DEPARTMENT OF INTERIOR  
SEATTLE, WASHINGTON

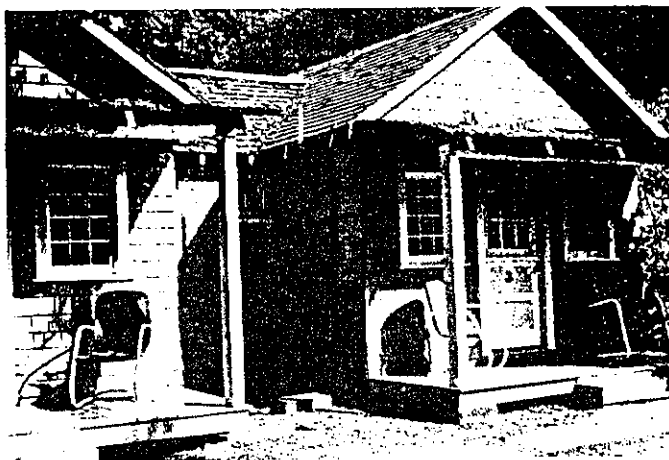
NEG. 2:11

Cabin 3 & 4 was erected in 1915, the first year of operation of Singer's Lake Crescent Tavern. This cabin and others adjoining it in a row to the east of the main lodge, was among the first twenty sleeping cabins built at the resort. Although little is known of the social history of the cabin, as part of the Singer's resort building ensemble it played a significant role in the early resort development of Lake Crescent and the north Olympic Peninsula. Even though several cabins in the row of eight have been remodeled on the interior and have received new foundation supports, new roofs, and new porches, the integrity of scale, design, materials, and setting of the entire row has remained largely intact.

U-shape in plan; each unit measures 12' x 14' with 4' wide porch extending across the main facade; 1 story; wood-frame wall construction with shingle siding; roof consists of two gables with connecting cross gable; wood shingle roof; post and pier foundation; multi-light single-leaf casement windows frame multi-pane glass and wood door on main (north) elevation; multi-light projected casement windows on south elevation; shed roof over front porch supported by posts supporting plate. Alterations: none apparent. Siting: in row arrangement with other cabins; approx. 25 yards from Lake Crescent in a grove of trees; part of the Singer's Tavern building group.

| <input type="checkbox"/> EXCELLENT | <input type="checkbox"/> GOOD | <input checked="" type="checkbox"/> FAIR | <input type="checkbox"/> DETERIORATED | <input type="checkbox"/> RUINS | <input checked="" type="checkbox"/> YES | <input type="checkbox"/> NO | <input type="checkbox"/> UNKNOWN |

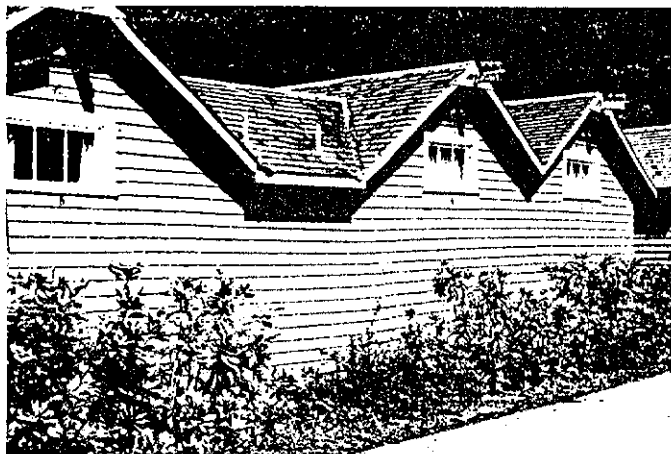
NEG. 2-23 (Also see Building No. 668)

Cabin 5, 6 & 7 was erected in 1915, the first year of operation of Singer's Lake Crescent Tavern. This cabin, and others adjoining it in a row to the east of the main lodge, was among the first twenty sleeping cabins built at the resort. Although little is known of the social history of the cabin, as part of the Singer's resort building ensemble, it played a significant role in the early resort development of Lake Crescent and the north Olympic Peninsula. Even though several cabins in the row of eight have been remodeled on the interior and have received new foundation supports, new roofs, and new porches, the integrity of scale, design, materials, and setting of the entire row has remained largely intact.

Irregular in shape; overall measurement 58' x 14' with 4' wide porch on north elevation; 1 story; wood-frame wall construction; shingle siding; 3 gables with 1 cross gable; shingle roofing material; post and pier foundation; multi-light casement windows frame multi-light glass and wood doors on main facade; projected casement windows on south elevation; shed roof porch supported by square posts under plate. Alterations: none apparent. Siting: approx. 25 yards from Lake Crescent in row arrangement with other cabins; part of the Singer's Tavern building group.

| 14. CONDITION | <input type="checkbox"/> EXCELLENT | <input type="checkbox"/> GOOD | <input checked="" type="checkbox"/> FAIR | <input type="checkbox"/> DETERIORATED | <input type="checkbox"/> RUINS | 15. DANGER OF DEMOLITION?<br>(SPECIFY THREAT) | <input checked="" type="checkbox"/> YES | <input type="checkbox"/> NO | <input type="checkbox"/> UNKNOWN |

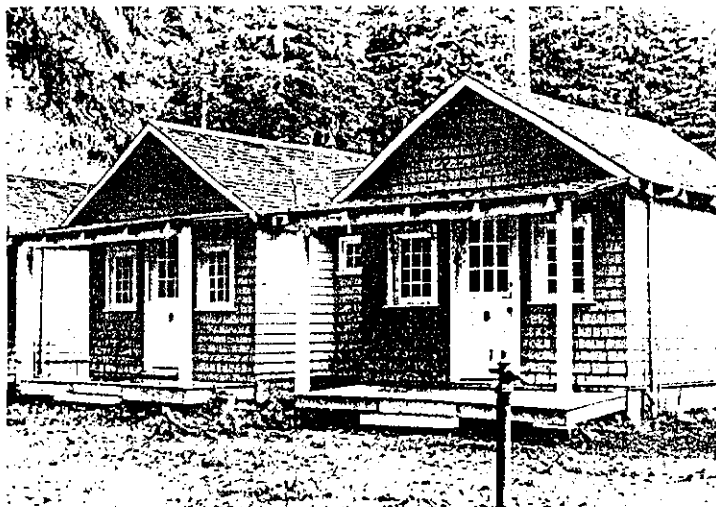
NEG. 37:7

Cabin 8 & 9 was erected in 1915, the first year of operation of Singer's Lake Crescent Tavern. This cabin, and others adjoining it in a row to the east of the main lodge, was among the first twenty sleeping cabins built at the resort. Although little is known of the social history of the cabin, as part of the Singer's resort building ensemble, it played a significant role in the early resort development of Lake Crescent and the north Olympic Peninsula. Even though several cabins in the row of eight have been remodeled on the interior and have received new foundation supports, new roofs, and new porches, the integrity of scale, design, materials, and setting of the entire row has remained largely intact.

U-shape in plan; each unit measures 12' x 14' with 4' wide porch extending across the main facade; 1 story; wood-frame wall construction with shingle siding; roof consists of two gables with connecting cross gable; wood shingle roof; post and pier foundation; multi-light, single-leaf casement windows frame multi-pane glass and wood door on main (north) elevation; multi-light projected casement windows on south elevation; shed roof over front porch supported by posts supporting plate. Alterations: none apparent. Siting: in row arrangement with other cabins, approx. 25 yards from Lake Crescent in a grove of trees; part of the Singer's Tavern building group.

| 14. CONDITION | <input type="checkbox"/> EXCELLENT | <input type="checkbox"/> GOOD | <input checked="" type="checkbox"/> FAIR | <input type="checkbox"/> DETERIORATED | <input type="checkbox"/> RUINS | 15. DANGER OF DEMOLITION?<br>(SPECIFY THREAT) | <input checked="" type="checkbox"/> YES | <input type="checkbox"/> NO | <input type="checkbox"/> UNKNOWN |

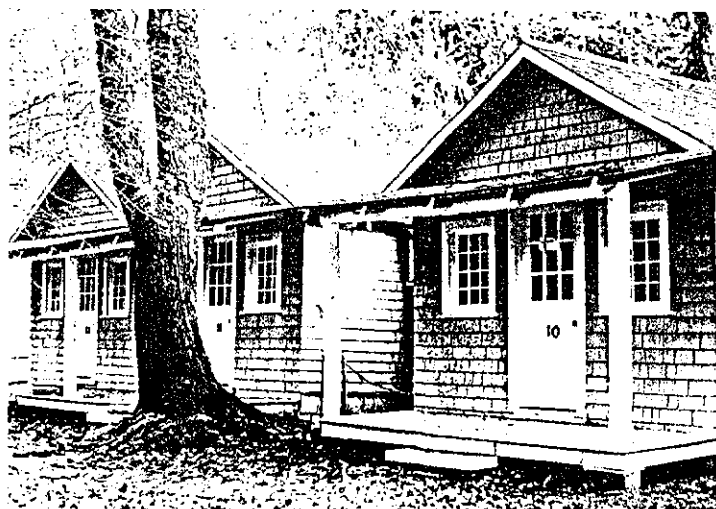
NEG. 37:9

Cabin 10, 11 & 12 was erected in 1915, the first year of operation of Singer's Lake Crescent Tavern. This cabin, and others adjoining it in a row to the east of the main lodge, was among the first twenty sleeping cabins built at the resort. Although little is known of the social history of the cabin, as part of the Singer's resort building ensemble, it played a significant role in the early resort development of Lake Crescent and the north Olympic Peninsula. Even though several cabins in the row of eight have been remodeled on the interior and have received new foundation supports, new roofs, and new porches, the integrity of scale, design, materials, and setting of the entire row has remained largely intact.

Irregular in shape; overall measurement 58' x 14' with 4' wide porch on north elevation; 1 story; wood-frame wall construction; shingle siding; 3 gables with 1 cross gable; shingle roofing material; post and pier foundation; multi-light casement windows frame multi-light glass and wood doors on main facade; projected casement windows on south elevation; shed roof porch supported by square posts under plate. Alterations: none apparent. Siting: approx. 25 yards from Lake Crescent in row arrangement with other cabins: part of the Singer's Tavern building group.

| <input type="checkbox"/> EXCELLENT | <input type="checkbox"/> GOOD | <input checked="" type="checkbox"/> FAIR | <input type="checkbox"/> DETERIORATED | <input type="checkbox"/> RUINS | <input checked="" type="checkbox"/> YES | <input type="checkbox"/> NO | <input type="checkbox"/> UNKNOWN | | |

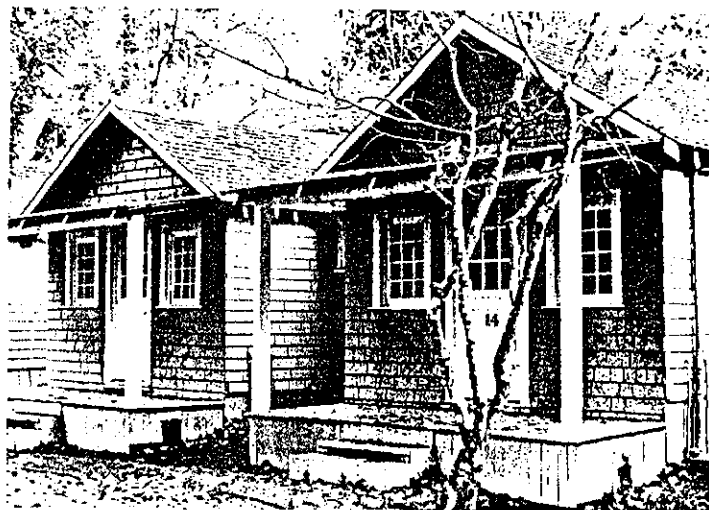
NEG. 37:10

| 12. OWNER/ADMIN ADDRESS<br>Department of the Interior, National Park Service, Olympic National Park, 600 East Park Ave., Port Angeles, WA 98362 | | 13. DESCRIPTION AND BACKGROUND HISTORY INCLUDING CONSTRUCTION DATE(S), PHYSICAL DIMENSIONS, MATERIALS, MAJOR ALTERATIONS, EXTANT EQUIPMENT, AND IMPORTANT BUILDERS, ARCHITECTS, ENGINEERS, ETC.<br><br>Cabin 14 & 15 was erected in 1915, the first year of operation of Singer's Lake Crescent Tavern. This cabin, and others adjoining it in a row to the east of the main lodge, was among the first twenty sleeping cabins built at the resort. Although little is known of the social history of the cabin, as part of the Singer's resort building ensemble, it played a significant role in the early resort development of Lake Crescent and the north Olympic Peninsula. Even though several cabins in the row of eight have been remodeled on the interior and have received new foundation supports, new roofs, and new porches, the integrity of scale, design, materials, and setting of the entire row has remained largely intact.<br><br>U-shape in plan; each unit measures 12' x 14' with 4' wide porch extending across the main facade; 1 story; wood-frame wall construction with shingle siding; roof consists of two gables with connecting cross gable; wood shingle roof; post and pier foundation; multi-light, single leaf casement windows frame multi-pane glass and wood door on main (north) elevation; multi-light projected casement windows on south elevation; shed roof over front porch supported by posts supporting plate. Alterations: none apparent. Siting: in row arrangement with other cabins, approx. 25 yards from Lake Crescent in a grove of trees; part of the Singer's Tavern building group. | | 11. REGION<br>PNR | | |
| 14. CONDITION<br><input type="checkbox"/> EXCELLENT <input type="checkbox"/> GOOD <input checked="" type="checkbox"/> FAIR <input type="checkbox"/> DETERIORATED <input type="checkbox"/> RUINS | | 15. DANGER OF DEMOLITION?<br>(SPECIFY THREAT) | | 16. SIGNIFICANCE<br>This building contributes to the integrity of design, workmanship, setting, and sense of time and place of Singer's Tavern Group. | | |

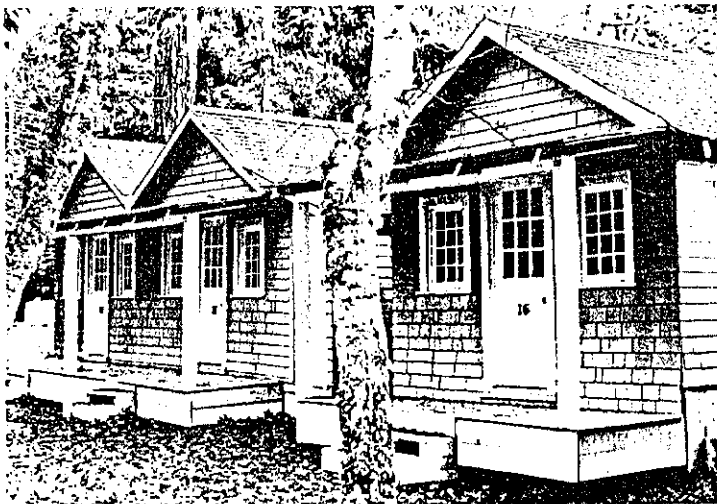
NEG. 37:11

Cabin 16, 17 & 18 was erected in 1915, the first year of operation of Singer's Lake Crescent Tavern. This cabin, and others adjoining it in a row to the east of the main lodge, was among the first twenty sleeping cabins built at the resort. Although little is known of the social history of the cabin, as part of the Singer's resort building ensemble, it played a significant role in the early resort development of Lake Crescent and the north Olympic Peninsula. Even though several cabins in the row of eight have been remodeled on the interior and have received new foundation supports, new roofs, and new porches, the integrity of scale, design, materials, and setting of the entire row has remained largely intact.

Irregular in shape; overall measurement 58' x 14' with 4' wide porch on north elevation; 1 story; wood-frame wall construction; shingle siding; 3 gables with 1 cross gable; shingle roofing material; post and pier foundation; multi-light casement windows frame multi-light glass and wood doors on main facade; projected casement windows on south elevation; shed roof porch supported by square posts under plate. Alterations: none apparent. Siting: approx. 25 yards from Lake Crescent in row arrangement with other cabins; part of the Singer's Tavern building group.

| 14. CONDITION | <input type="checkbox"/> EXCELLENT | <input type="checkbox"/> GOOD | <input checked="" type="checkbox"/> FAIR | <input type="checkbox"/> DETERIORATED | <input type="checkbox"/> RUINS | 15. DANGER OF DEMOLITION?<br>(SPECIFY THREAT) | <input checked="" type="checkbox"/> YES | <input type="checkbox"/> NO | <input type="checkbox"/> UNKNOWN |

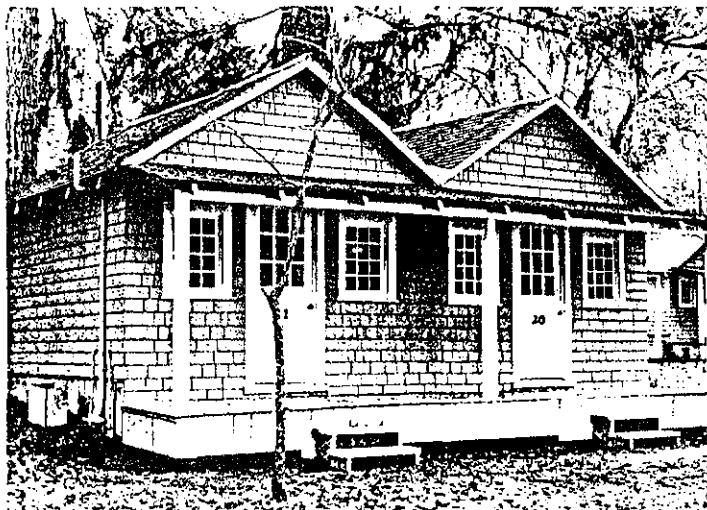
NEG. 37:13

Cabin 20 and 21 was erected in 1915, the first year of operation of Singer's Lake Crescent Tavern. This cabin, and others adjoining it in a row to the east of the main lodge, was among the first twenty sleeping cabins built at the resort. Although little is known of the social history of the cabin, as part of the Singer's resort building ensemble, it played a significant role in the early resort development of Lake Crescent and the north Olympic Peninsula. Even though several cabins in the row of eight have been remodeled on the interior and have received new foundation supports, new roofs, and new porches, the integrity of scale, design, materials, and setting of the entire row has remained largely intact.

Rectangular in shape; measures 14' x 23'6" with 4' wide porch; 1 story; wood-frame wall construction; shingle siding; 2 adjoining gable roofs with wood shingle roofing material; multi-light projected casement windows frame doorway on north elevation; small light windows on upper portion of door; post and pier foundation; shed roof over porch supported by square posts under horizontal plate. Alterations: removal of cabin unit attached to south wall of building since 1952 (?). Siting: approx. 20 yards from Lake Crescent shoreline in partially shaded area; part of Singer's Tavern building ensemble.

| <input type="checkbox"/> EXCELLENT | <input type="checkbox"/> GOOD | <input checked="" type="checkbox"/> FAIR | <input type="checkbox"/> DETERIORATED | <input type="checkbox"/> RUINS | <input checked="" type="checkbox"/> YES | <input type="checkbox"/> NO | <input type="checkbox"/> UNKNOWN | | |
