Singer's Lake Crescent Tavern (Lake Crescent Lodge),  
Outdoor Recreation Building (Shop, Bldg. No. 656)  
Barnes Point, Lake Crescent  
Olympic National Park  
Port Angeles Vicinity  
Clallam County  
Washington

HABS No. WA-186-F

# PNRO INVENTORY

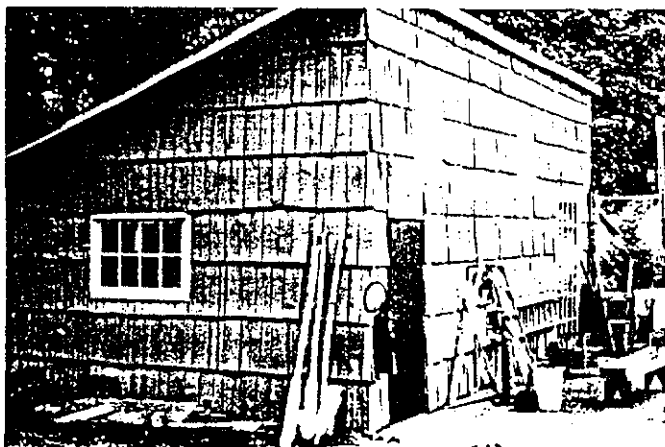
NEG. 2:10

Square in shape; measures 30' x 30'; 1 story; wood-frame wall construction sided with wood shingles; shed roof with composition rolled roofed material; post and pier foundation; original windows have been boarded over; door on south elevation not original; wide garage door on east elevation. Alterations: addition on north elevation for lumber storage; covering of some windows; possible resheathing of exterior walls. Siting: across service road from main lodge building in open grassy area; part of the Singer's Tavern building ensemble.

| 14. CONDITION | <input type="checkbox"/> EXCELLENT | <input type="checkbox"/> GOOD | <input checked="" type="checkbox"/> FAIR | <input type="checkbox"/> DETERIORATED | <input type="checkbox"/> RUINS | 15. DANGER OF DEMOLITION? (SPECIFY THREAT) | <input type="checkbox"/> YES | <input type="checkbox"/> NO | <input checked="" type="checkbox"/> UNKNOWN |

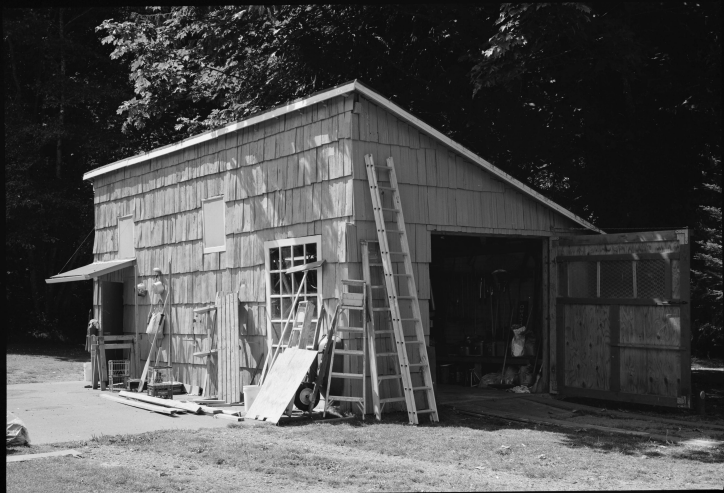
HABS No. WA-186-F-1

WA-186-F-1 NORTHEAST FACADE, LOOKING WEST
