Singer's Lake Crescent Tavern (Lake Crescent Lodge),  
Cabins 22-31 (Bldg. Nos. 675-680)  
Barnes Point, Lake Crescent  
Olympic National Park  
Port Angeles Vicinity  
Clallam County  
Washington

HABS No. WA-186-J

WRITTEN HISTORICAL AND DESCRIPTIVE DATA

HISTORIC AMERICAN BUILDINGS SURVEY  
NATIONAL PARK SERVICE  
PACIFIC NORTHWEST REGION  
DEPARTMENT OF INTERIOR  
SEATTLE, WASHINGTON

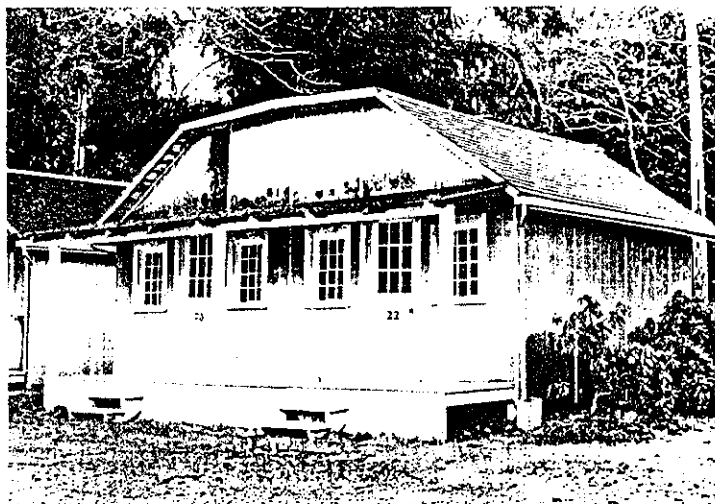
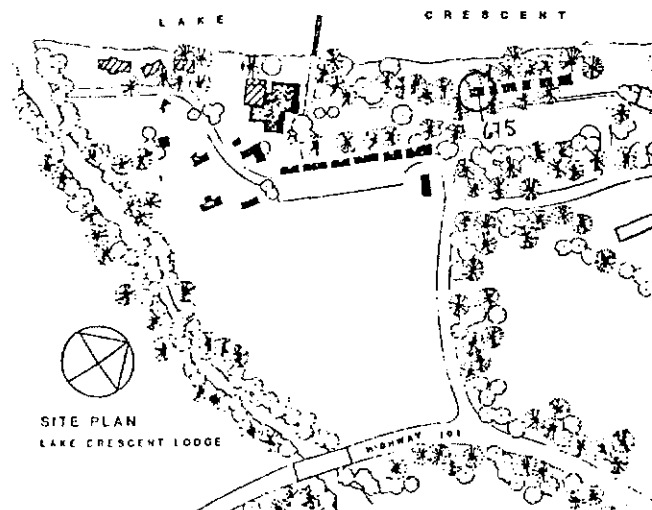
NEG. 37:15

Cabin 22 and 23 is one of six sleeping cabins standing in a row north of the Singer's Lake Crescent Tavern main lodge and approximately 75 feet from the Lake Crescent shoreline. These cabins stand on the site of an earlier row of wood frame canvas tent cabins, erected soon after the establishment of Singer's resort. This cabin and its adjacent neighboring cabins were probably constructed around 1919. Unlike the row of six cabins directly east of the main lodge, these cabins have received more extensive alterations since their construction. Possibly in the 1940s the owner joined several cabins by constructing gambrel roofs over adjoining pairs. In the late 1960s or early 1970s, the existing wood board and batten siding was replaced with simulated board and batten paneling. Porches and interiors have also been replaced or remodeled over the years. In terms of scale, overall design, siting and landscaping, the entire row of cabins has maintained much of its original integrity. More importantly, Cabin 22 and 23, and its adjacent cabins, contribute to the overall feeling and ambience of Singer's Lake Crescent resort. Little is known of the social history of this cabin.

Rectangular in shape; measures 14' x 24' with 4' wide porch; 1 story; wood-frame wall construction; pressboard siding; gambrel roof with wood shingles; shed roof porch across main facade; single leaf, multi-light casement windows frame the two doors on the north elevation. Alterations: shed roof addition which cuts into existing window on rear

| 14. CONDITION | <input type="checkbox"/> EXCELLENT | <input type="checkbox"/> GOOD | <input checked="" type="checkbox"/> FAIR | <input type="checkbox"/> DETERIORATED | <input type="checkbox"/> RUINS | 15. DANGER OF DEMOLITION? (SPECIFY THREAT) | <input checked="" type="checkbox"/> YES | <input type="checkbox"/> NO | <input type="checkbox"/> UNKNOWN |

south elevation; probable joining of two gable roofs under existing gambrel roof. Siting: approx. five yards from Lake Crescent in row arrangement with other cabins; part of the Singer's Tavern building group.

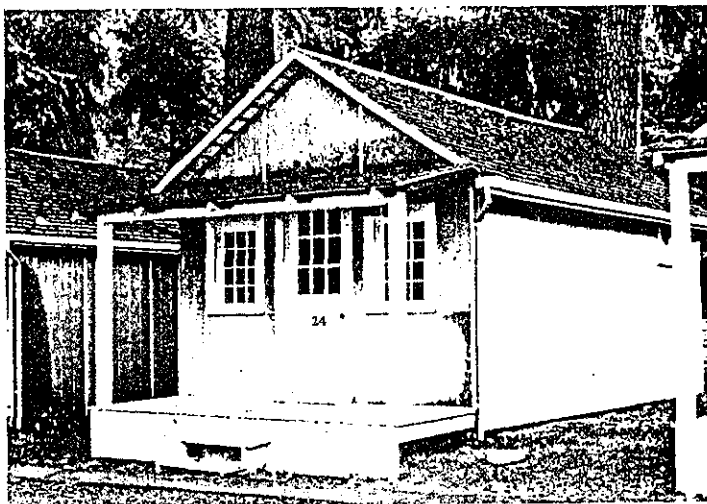
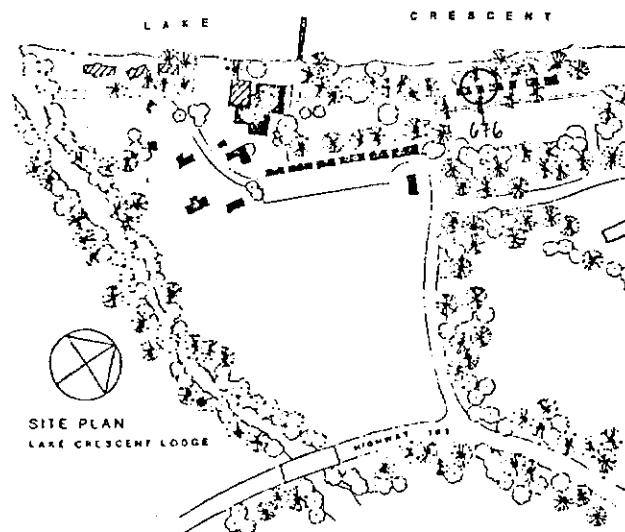
NEG. 37:17

Cabin 24 is one of six sleeping cabins standing in a row north of the Singer's Lake Crescent Tavern main lodge and approximately 75 feet from the Lake Crescent shoreline. These cabins stand on the site of an earlier row of wood-frame canvas tent cabins, erected soon after the establishment of Singer's resort. This cabin and its adjacent neighboring cabins were probably constructed around 1919. Unlike the row of six cabins directly east of the main lodge, these cabins have received more extensive alterations since their construction. Possibly in the 1940s the owner joined several cabins by constructing gambrel roofs over adjoining pairs. In the late 1960s, or early 1970s, the existing wood board and batten siding was replaced with simulated board and batten paneling. Porches and interiors have also been replaced or remodeled over the years. In terms of scale, overall design, siting, and landscaping, the entire row of cabins has maintained much of its original integrity. More importantly, Cabin 24 and its adjacent cabins, contribute to the overall feeling and ambience of Singer's Lake Crescent resort. Little is known of the social history of this cabin.

Rectangular in shape; measures 20' x 12' with 4' wide shed roof across main facade; 1 story; wood-frame wall construction pressboard siding; multi-light casement windows; small fixed-light windows on upper portion of door on north elevation. Alterations: none known. Siting: approx. 5 yds. from Lake Crescent shoreline in a row with other

| 14. CONDITION | <input type="checkbox"/> EXCELLENT | <input type="checkbox"/> GOOD | <input checked="" type="checkbox"/> FAIR | <input type="checkbox"/> DETERIORATED | <input type="checkbox"/> RUINS | 15. DANGER OF DEMOLITION? (SPECIFY THREAT) | <input checked="" type="checkbox"/> YES | <input type="checkbox"/> NO | <input type="checkbox"/> UNKNOWN |

~~XXXXXXXX~~ (Item No. 13 continued)  
cabins; part of Singer's Tavern building ensemble.

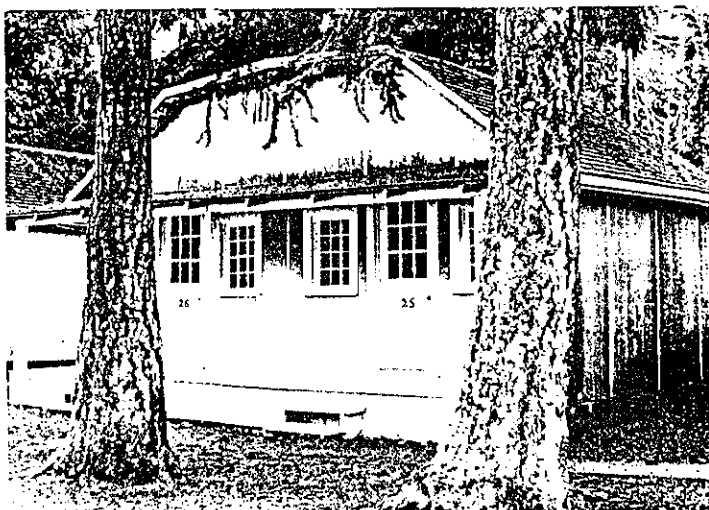
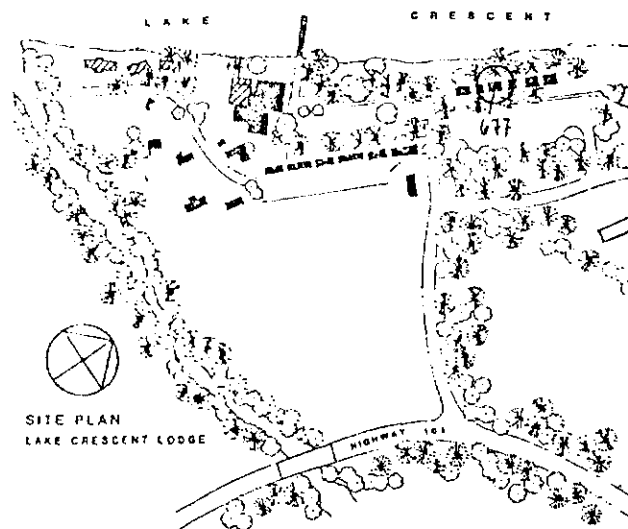
NEG. 37:18

Cabin 25 and 26 is one of six sleeping cabins standing in a row north of the Singer's Lake Crescent Tavern main lodge and approximately 75 feet from the Lake Crescent shoreline. These cabins stand on the site of an earlier row of wood frame canvas tent cabins, erected soon after the establishment of Singer's resort. This cabin and its adjacent neighboring cabins were probably constructed around 1919. Unlike the row of six cabins directly east of the main lodge, these cabins have received more extensive alterations since their construction. Possibly in the 1940s the owner joined several cabins by constructing gambrel roofs over adjoining pairs. In the late 1960s, or early 1970s, the existing wood board and batten siding was replaced with simulated board and batten paneling. Porches and interiors have also been replaced or remodeled over the years. In terms of scale, overall design, siting, and landscaping, the entire row of cabins has maintained much of its original integrity. More importantly, Cabin 25 and 26 and its adjacent cabins, contribute to the overall feeling and ambience of Singer's Lake Crescent resort. Little is known of the social history of this cabin.

Rectangular in shape; measures 14' x 24' with 4' wide porch; 1 story; wood-frame wall construction; pressboard siding; gambrel roof with wood shingles; shed roof porch across main facade; single leaf, multi-light casement windows frame the two doors on the north elevation. Alterations: shed roof addition which cuts into existing

| 14. CONDITION | <input type="checkbox"/> EXCELLENT | <input type="checkbox"/> GOOD | <input checked="" type="checkbox"/> FAIR | <input type="checkbox"/> DETERIORATED | <input type="checkbox"/> RUINS | 15. DANGER OF DEMOLITION?<br>(SPECIFY THREAT) | <input checked="" type="checkbox"/> YES | <input type="checkbox"/> NO | <input type="checkbox"/> UNKNOWN |

gambrel roof. Siting: approx. 5 yards from Lake Crescent in row arrangement with other cabins; part of the Singer's Tavern building group.

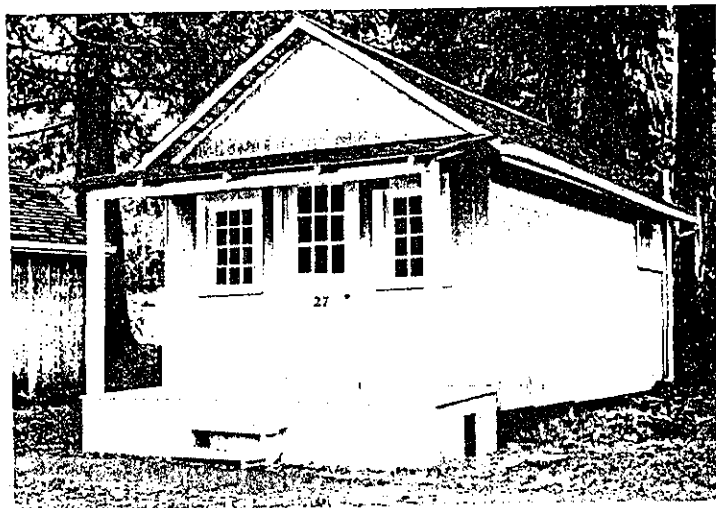
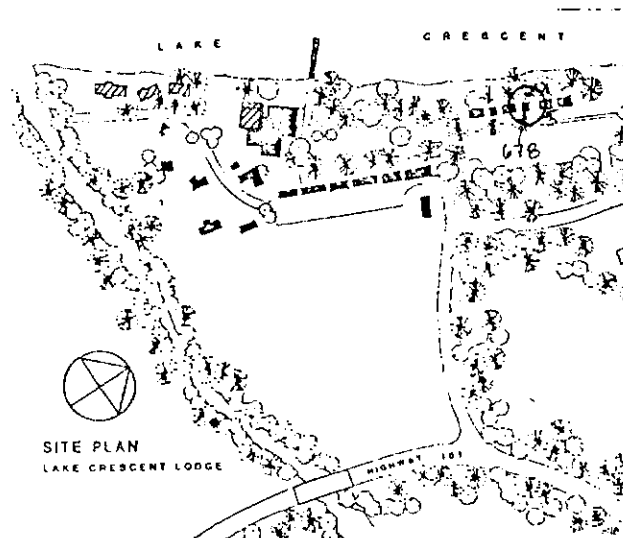
NEG. 37:19

Cabin 27 is one six sleeping cabins standing in a row north of the Singer's Lake Crescent Tavern main lodge and approximately 75 feet from the Lake Crescent shoreline. These cabins stand on the site of an earlier row of wood frame canvas tent cabins, erected soon after the establishment of Singer's resort. This cabin and its adjacent neighboring cabins were probably constructed around 1919. Unlike the row of six cabins directly east of the main lodge, these cabins have received more extensive alterations since their construction. Possibly in the 1940s the owner joined several cabins by constructing gambrel roofs over adjoining pairs. In the late 1960s, or early 1970s, the existing wood board and batten siding was replaced with simulated board and batten paneling. Porches and interiors have also been replaced or remodeled over the years. In terms of scale, overall design, siting, and landscaping, the entire row of cabins has maintained much of its original integrity. More importantly, Cabin 27 and its adjacent cabins, contributes to the overall feeling and ambience of Singer's Lake Crescent resort. Little is known of the social history of this cabin.

Rectangular in shape; measures 20' x 12' with 4' wide shed roof across main facade; 1 story; wood-frame wall construction with pressboard siding; multi-light casement windows; small fixed-light windows on upper portion of door on north elevation. Alterations: none known. Siting: approx. 5 yards from Lake Crescent shoreline in a row with

| 14. CONDITION | <input type="checkbox"/> EXCELLENT | <input type="checkbox"/> GOOD | <input checked="" type="checkbox"/> FAIR | <input type="checkbox"/> DETERIORATED | <input type="checkbox"/> RUINS | 15. DANGER OF DEMOLITION? (SPECIFY THREAT) | <input checked="" type="checkbox"/> YES | <input type="checkbox"/> NO | <input type="checkbox"/> UNKNOWN |

other cabins; part of Singer's Tavern building ensemble.

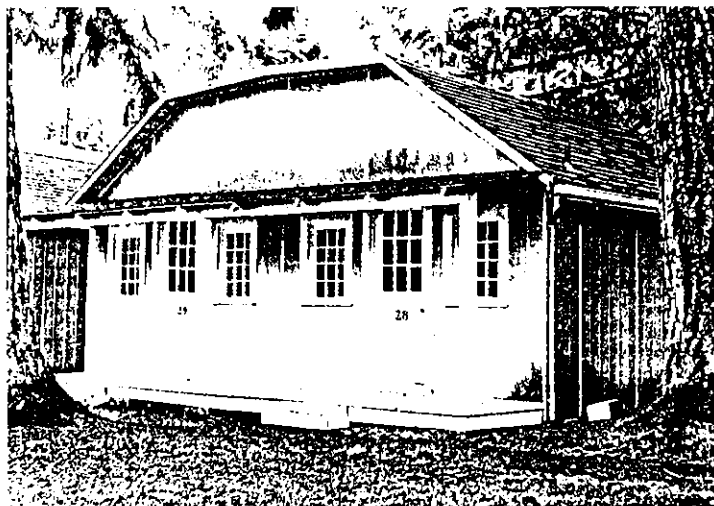
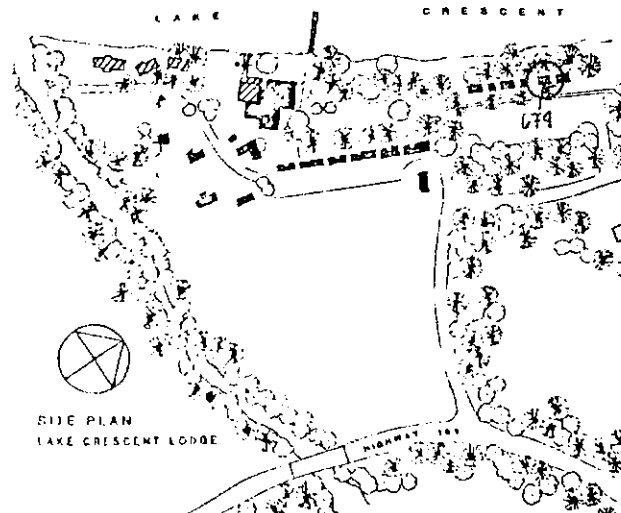
NEG. 37:20

| 13. DESCRIPTION AND BACKGROUND HISTORY INCLUDING CONSTRUCTION DATE(S), PHYSICAL DIMENSIONS, MATERIALS, MAJOR ALTERATIONS, EXISTANT EQUIPMENT, AND IMPORTANT BUILDERS, ARCHITECTS, ENGINEERS, ETC.<br><br>Cabin 28 & 29 is one of six sleeping cabins standing in a row north of the Singer's Lake Crescent Tavern main lodge and approximately 75 feet from the Lake Crescent shoreline. These cabins stand on the site of an earlier row of wood-frame canvas tent cabins, erected soon after the establishment of Singer's resort. This cabin and its adjacent neighboring cabins were probably constructed around 1919. Unlike the row of six cabins directly east of the main lodge, these cabins have received more extensive alterations since their construction. Possibly in the 1940s the owner joined several cabins by constructing gambrel roofs over adjoining pairs. In the late 1960s, or early 1970s, the existing wood board and batten siding was replaced with simulated board and batten paneling. Porches and interiors have also been replaced or remodeled over the years. In terms of scale, overall design, siting, and landscaping, the entire row of cabins has maintained much of its original integrity. More importantly, Cabin 28 & 29 and its adjacent cabins, contribute to the overall feeling and ambience of Singer's Lake Crescent resort. Little is known of the social history of this cabin.<br><br>Rectangular in shape; measures 14' x 24' with 4' wide porch; 1 story; wood-frame wall construction; pressboard siding; gambrel roof with wood shingles; shed roof porch across main facade; single leaf, multi-light casement windows frame the two doors on the north elevation. Alterations: shed roof addition which cuts into existing window | | | | | | | |
| 14. CONDITION<br><input type="checkbox"/> EXCELLENT <input type="checkbox"/> GOOD <input checked="" type="checkbox"/> FAIR <input type="checkbox"/> DETERIORATED <input type="checkbox"/> RUINS | | | | 15. DANGER OF DEMOLITION? (SPECIFY THREAT)<br><input checked="" type="checkbox"/> YES <input type="checkbox"/> NO <input type="checkbox"/> UNKNOWN | | | |

on rear south elevation; probable joining of 2 gable roofs under existing gambrel roof. Siting: approx. 5 yards from Lake Crescent in row arrangement with other cabins; part of the Singer's Tavern building group.

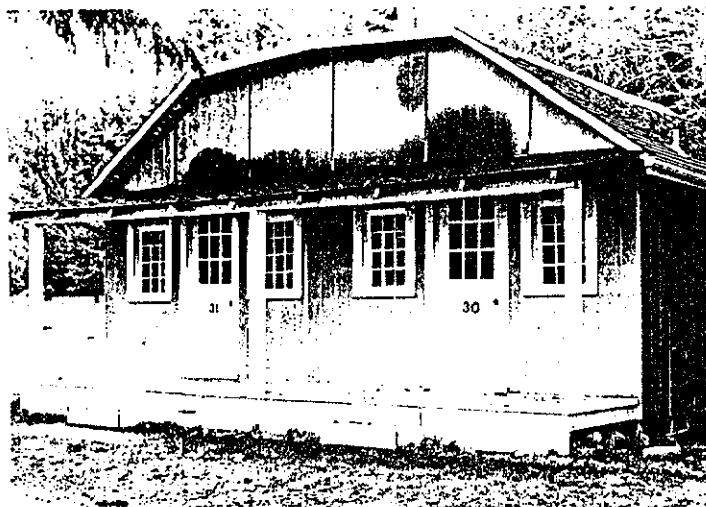
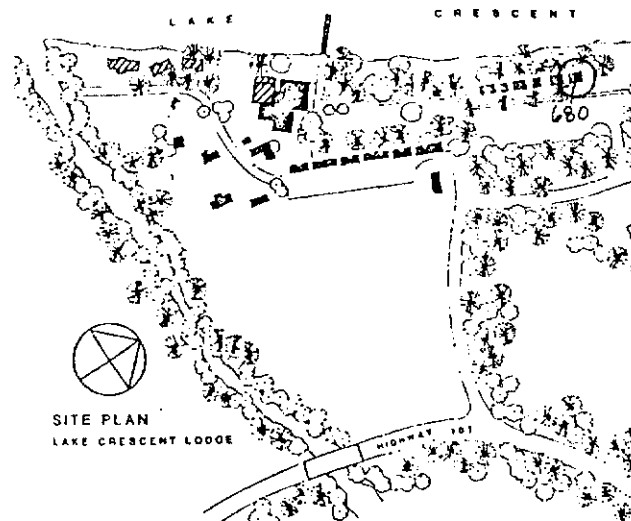
NFG. 37:21

Cabin 30 and 31 is one of six sleeping cabins standing in a row north of the Singer's Lake Crescent Tavern main lodge and approximately 75 feet from the Lake Crescent shoreline. These cabins stand on the site of an earlier row of wood frame canvas tent cabins, erected soon after the establishment of Singer's resort. This cabin and its adjacent neighboring cabins were probably constructed around 1919. Unlike the row of six cabins directly east of the main lodge, these cabins have received more extensive alterations since their construction. Possibly in the 1940s the owner joined several cabins by constructing gambrel roofs over adjoining pairs. In the late 1960s or early 1970s the existing wood board and batten siding was replaced with simulated board and batten paneling. Porches and interiors have also been replaced or remodeled over the years. In terms of scale, overall design, siting and landscaping, the entire row of cabins has maintained much of its original integrity. More importantly, Cabin 30 and 31, and its adjacent cabins, contribute to the overall feeling and ambience of Singer's Lake Crescent resort. Little is known of the social history of this cabin.

Rectangular in shape; measures 14' x 24' with 4' wide porch; 1 story; wood-frame wall construction; pressboard siding; gambrel roof with wood shingles; shed roof porch across main facade; single-leaf, multi-light casement windows from the two doors on the north elevation. Alterations: shed roof addition which cuts into existing window on rear

| 14. CONDITION | <input type="checkbox"/> EXCELLENT | <input type="checkbox"/> GOOD | <input checked="" type="checkbox"/> FAIR | <input type="checkbox"/> DETERIORATED | <input type="checkbox"/> RUINS | 15. DANGER OF DEMOLITION?<br>(SPECIFY THREAT) | <input checked="" type="checkbox"/> YES | <input type="checkbox"/> NO | <input type="checkbox"/> UNKNOWN |

south elevation; probable joining of 2 gable roofs under existing gambrel roof. Siting: approx. 5 yards from Lake Crescent in row arrangement with other cabins; part of the Singer's Tavern building group.

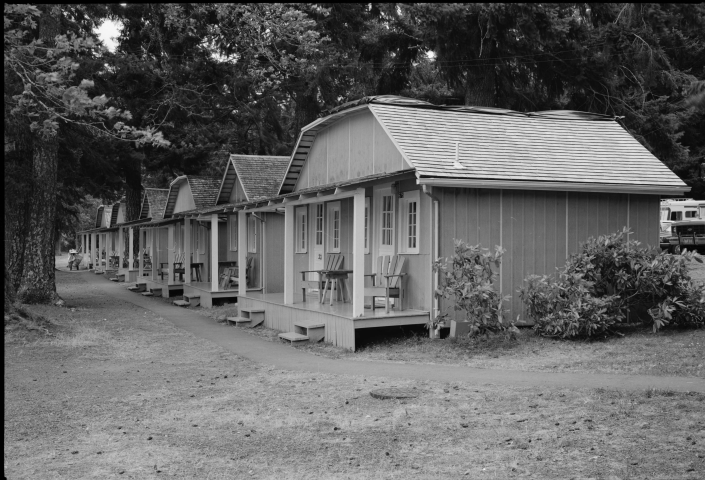
HABS NO. WA-186-J-1

- WA-186-J-1 GENERAL VIEW OF CABIN GROUP, LOOKING NORTH
- WA-186-J-2 LAKE CRESCENT LODGE GABIN 675, WEST ELEVATION, LOOKING EAST
- WA-186-J-3 LAKE CRESCENT LODGE GABIN 675, EAST ELEVATION, LOOKING WEST
- WA-186-J-4 LAKE CRESCENT LODGE CABIN 676, SOUTHWEST FACADE, LOOKING NORTHEAST
- WA-186-J-5 LAKE CRESCENT LODGE GABIN 677, WEST ELEVATION, LOOKING EAST
- WA-186-J-6 LAKE CRESCENT LODGE GABIN 678, WEST ELEVATION, LOOKING EAST
- WA-186-J-7 LAKE CRESCENT LODGE CABIN 679, WEST FACADE, LOOKING SOUTHEAST
- WA-186-J-8 LAKE CRESCENT LODGE CABIN 680, WEST ELEVATION, LOOKING EAST
