Singer's Lake Crescent Tavern (Lake Crescent Lodge),  
Sleeping Quarters (Workshop/Paint Shop, Bldg. No. 666)  
Barnes Point, Lake Crescent  
Olympic National Park  
Port Angeles Vicinity  
Clallam County  
Washington

HABS No. WA-186-K

WRITTEN HISTORICAL AND DESCRIPTIVE DATA

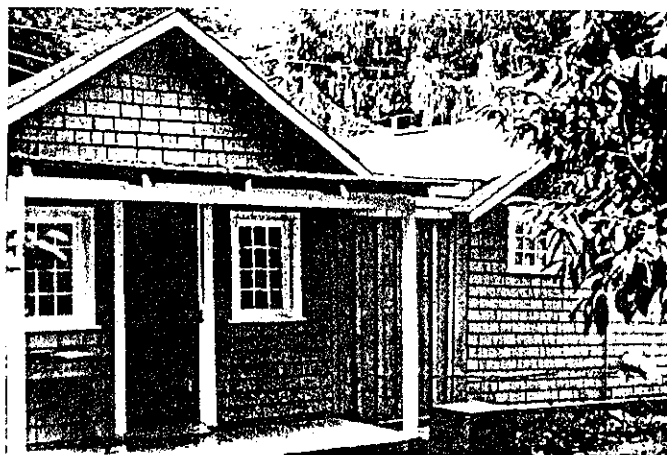
NEG. 2:25

L-plan in shape; originally two separate bldgs.; one rectangle connected to smaller square structure; measures 14' x 30' and 12' x 17'; 1 story; wood-frame wall construction; shingle siding; post and pier foundation combined with concrete foundation beneath one section of structure; small fixed-light windows on front elevation; small-light windows in upper portion of door. Porch with shed roof; exposed rafters project to edge of roof; porch roof supported by square posts; pipes associated with laundry functions located on north elevation. Alterations: possible relocation of one section of building. Siting: on edge of wooded area; part of the Singer's Tavern building group.

| 14. CONDITION | <input type="checkbox"/> EXCELLENT | <input type="checkbox"/> GOOD | <input checked="" type="checkbox"/> FAIR | <input type="checkbox"/> DETERIORATED | <input type="checkbox"/> RUINS | 15. DANGER OF DEMOLITION? (SPECIFY THREAT) | <input type="checkbox"/> YES | <input type="checkbox"/> NO | <input checked="" type="checkbox"/> UNKNOWN |

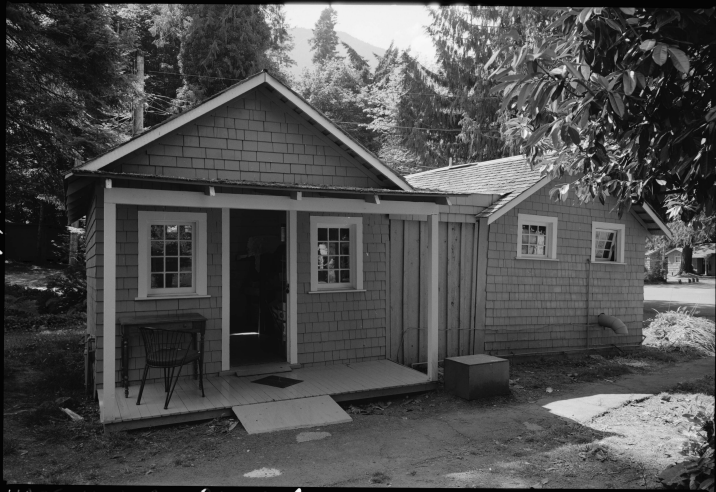
HABS NO. WA-136-K-1

WA-186-K-1 NORTH FACADE, LOOKING SOUTH
