Singer's Lake Crescent Tavern (Lake Crescent Lodge),  
Storage Building (Generator/Tool Shed, Bldg. No., 682)  
Barnes Point, Lake Crescent  
Olympic National Park  
Port Angeles Vicinity  
Clallam County  
Washington

HABS No. WA-186-L

WRITTEN HISTORICAL AND DESCRIPTIVE DATA

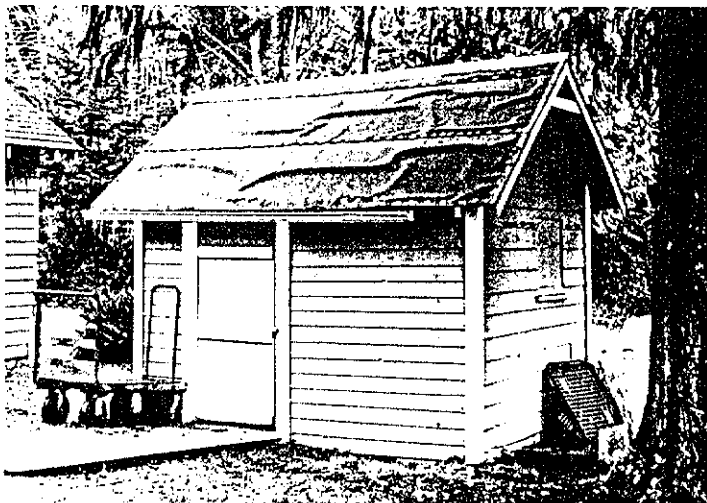
NEG. 37:6

Rectangular in shape; measures 8' x 10'; 1 story; wood-frame wall construction; horizontal rough sawn siding with corner boards. Gable roof with exposed rafters, sheathed with composition rolled roofing material; foundation not visible; 1 small, 4-light window with wide, plain board surrounds; small wood door with cross bracing. Altered: 1 window covered; possible resheathing of exterior walls. Siting: approx. 25' from the west end of the main lodge; near another storage building; part of the Singer's Tavern Group.

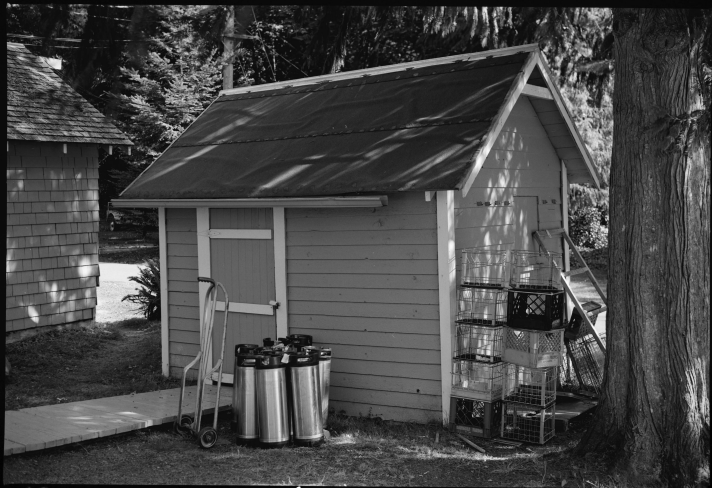
HABS No. WA-186-L-1

WA-186-L-1 SOUTHEAST FACADE, LOOKING SOUTHWEST
