National Register of Historic Places  
Registration Form

historic name Dodger Point Fire Lookout

**Dodger Point Fire Lookout: Clallam County, WA**

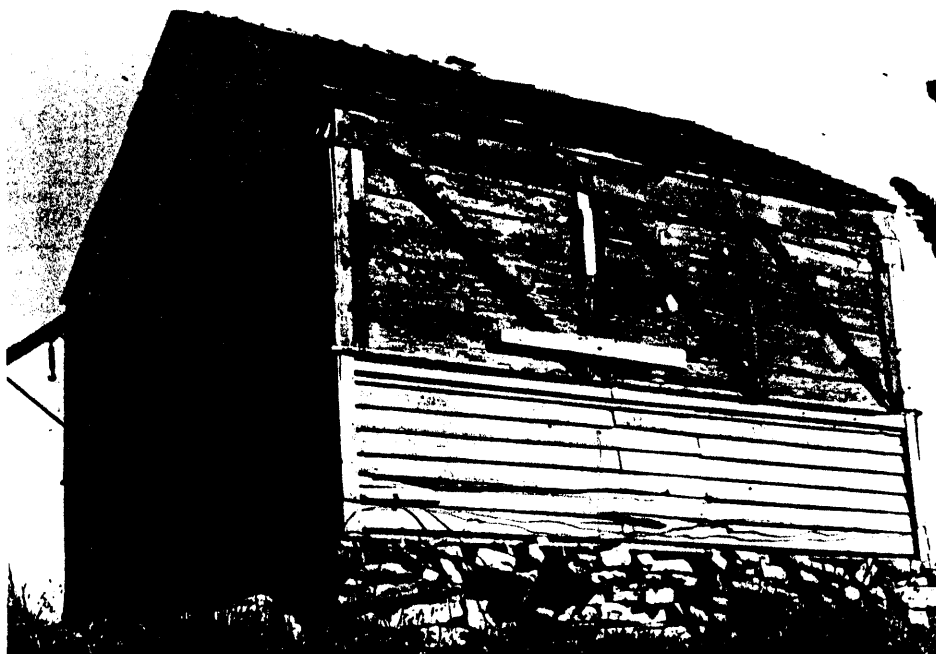
NEG. 8:6A

Square in shape; measures approx. 15' x 15'; 1 story; wood-frame wall construction, with horizontal clapboard siding; gable roof with shake roofing (no eaves); stone foundation; 5 windows on each elevation (except on N.W. elevation where door takes up 1 bay); windows begin 3 1/2' from foundation up to beginning of gable; they are multi-light; door, multi-light in upper portion, lower portion paneled. Alterations: none apparent. Siting: on peak of Dodger Point with 180 degree view, above timber line, alpine meadow. Other: substantial shutters in deteriorating condition have been placed over all windows. Therefore, every elevation has these "shutters" of horizontal boards with battens and cross brace, secured by heavy bolts and hinged at the top; the interior has wooden floor; interior wall paneling is

of narrow horizontal board up to windows and again on ceiling; windows (nonoperable) reach from 2' off floor to molding at ceiling. There is a small opening in ceiling to attic, covered. Simple built-in cupboard on N.E. wall, tables, bed, crank telephone, and other objects for previous function as lookout; maintenance equipment for cabin stored neatly.
