QUILEUTE RESERVATION NORTHERN BOUNDARY STUDY

A SURVEY OF THE MOUTH OF THE QUILLAYUTE RIVER CLALLAM COUNTY STATE OF WASHINGTON

A RETRACEMENT AND STUDY OF TWO OFFICIAL FEDERAL GOVERNMENT
SURVEYS, ONE PERFORMED IN 1881 AND APPROVED MAY 29, 1882,
AND ONE PERFORMED IN 1914 AND APPROVED OCTOBER 26, 1916,
COMPARED TO THE PRESENT LOCATION OF THE MOUTH OF THE
QUILLAYUTE RIVER, IN SECTION 21, TOWNSHIP 28 NORTH,
RANGE 15 WEST OF THE WILLAMETTE MERIDIAN.

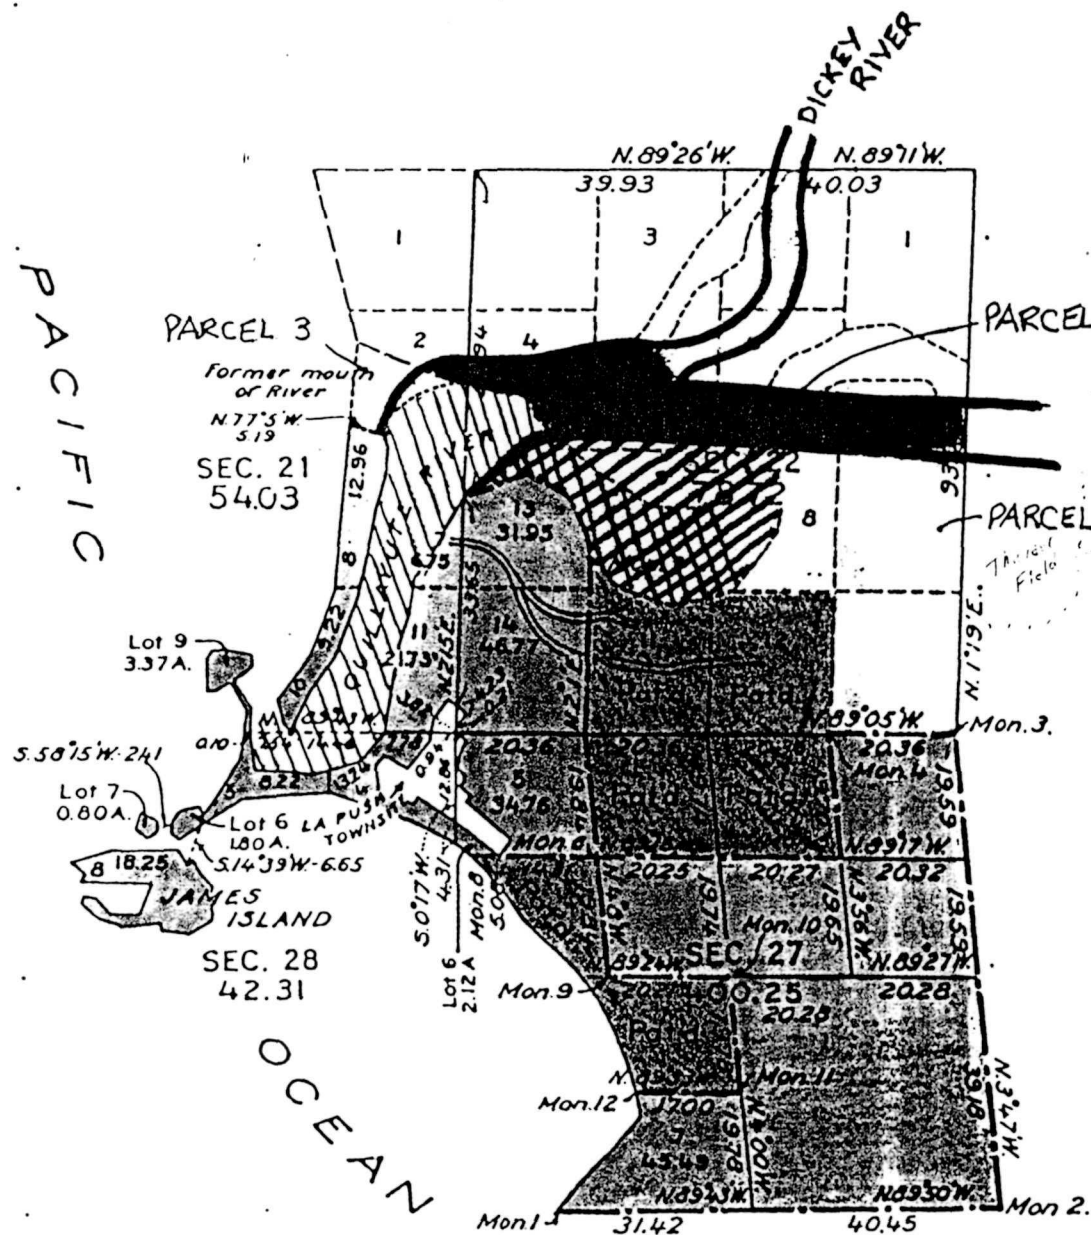
The result of this retracement is shown on the following map.
