National Park Service  
Cultural Landscapes Inventory  
2010

Painted Desert Inn  
Petrified Forest National Park

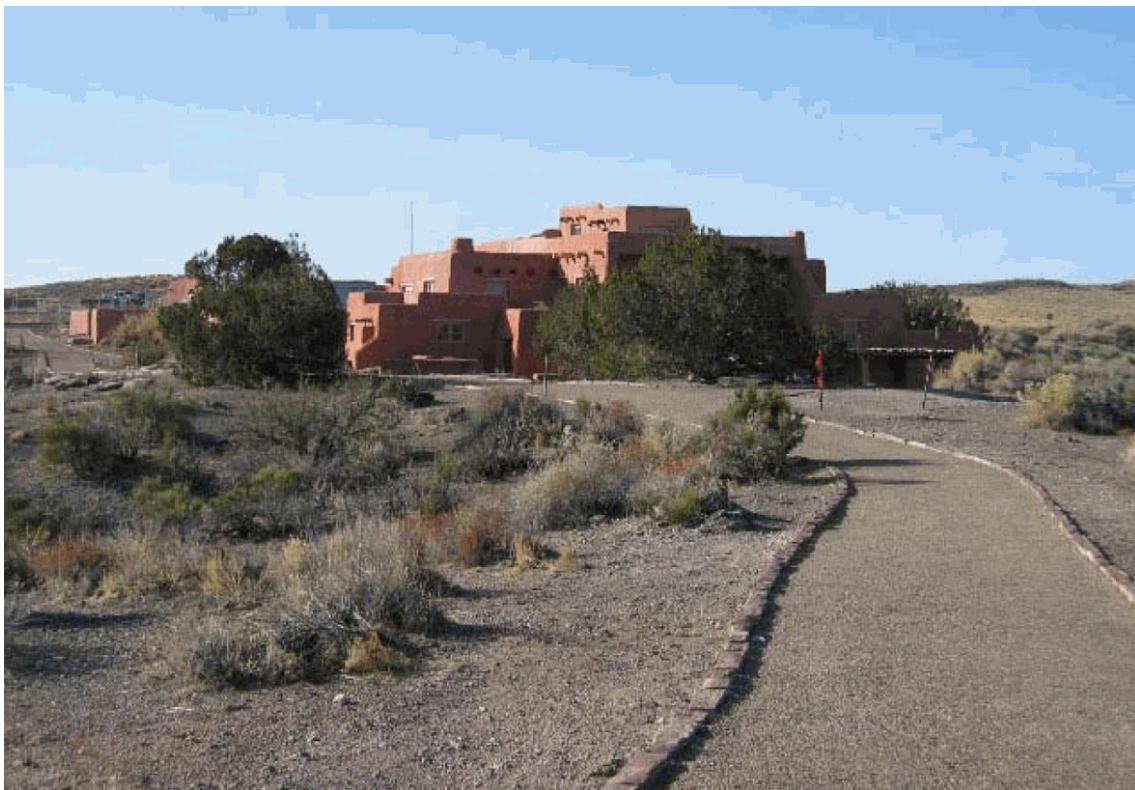
*Figure 4. East elevation of Painted Desert Inn, 2006. NPS photo.*

The Painted Desert Inn is a pueblo revival building sited along the rim at Kachina Point overlooking the Painted Desert. It is partially constructed of petrified stone found in the pre-existing Stone Tree House. The stone was incorporated into the walls of the new building and then stuccoed, as was the entire exterior of the building and its surrounding walls. This new form was radically different from the original Stone Tree House. Built with a combination of plastered masonry and wood, the Inn was designed to match its surroundings. Log beams project through plastered walls and the district features a variety of wall heights, roof lines, and floor levels. Around the perimeter of the building, a variety of architectural details including terraces, short narrow steps, broad sweeping stairs, porches, and buttresses can be seen (Figures 4-7).

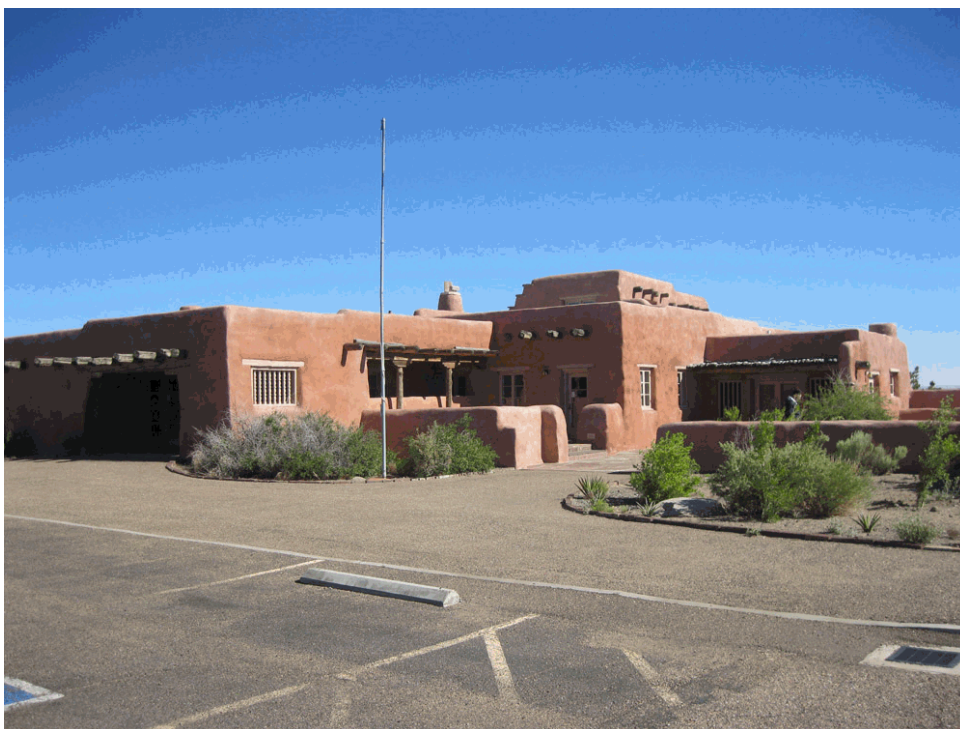
*Figure 5. Southeast elevation of Painted Desert Inn, 2011. NPS photo.*

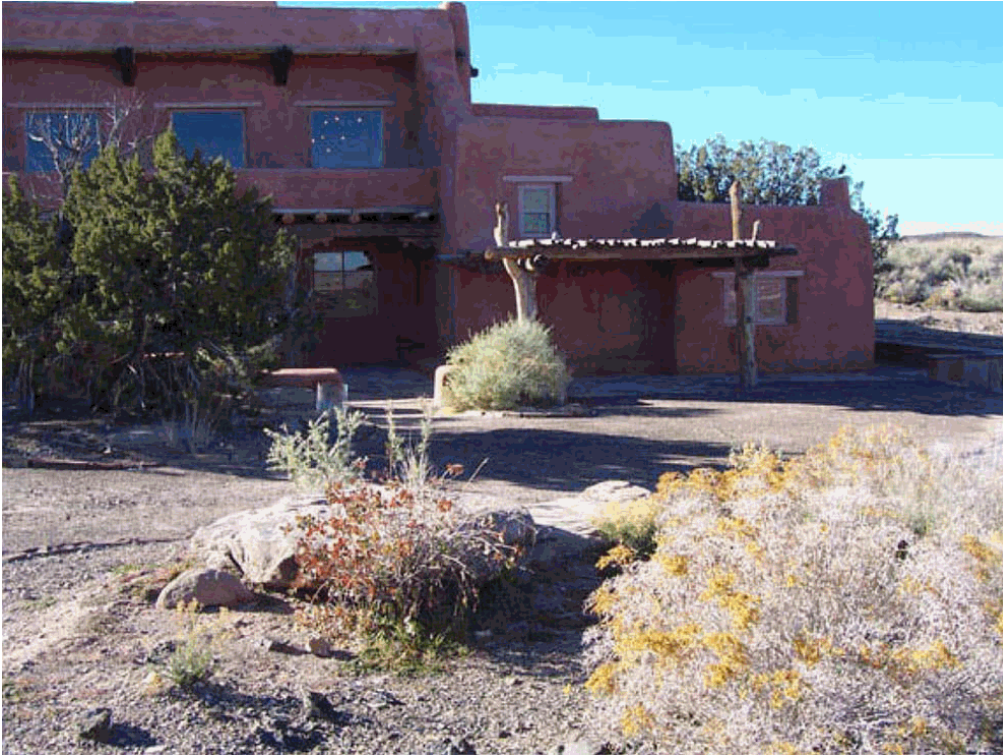
*Figure 6. Northwest side of Painted Desert Inn, 2006. NPS photo.*

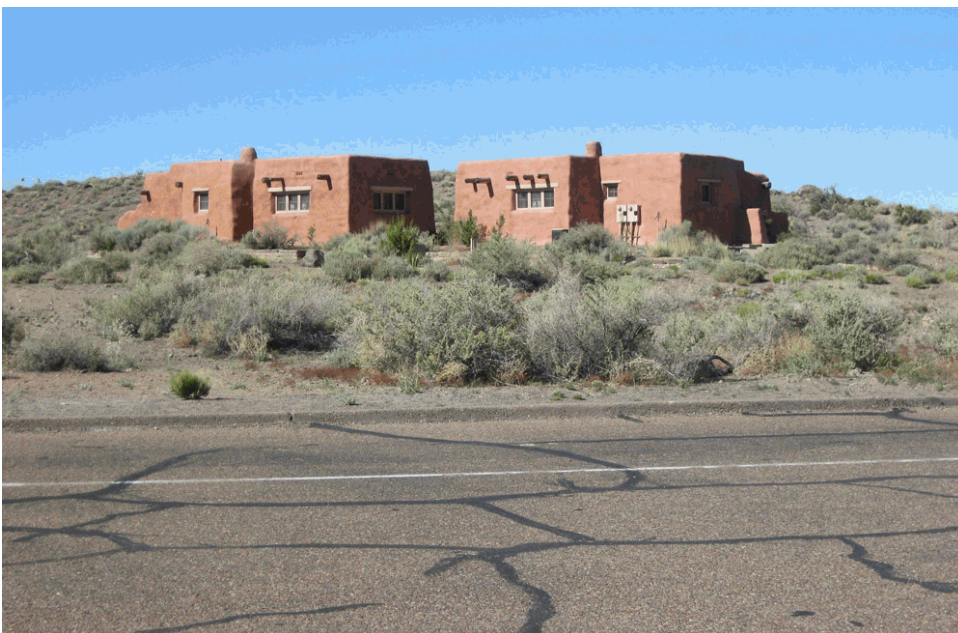
*Figure 7. Buildings within the Residence cluster, 2011. NPS photo.*

Originally included in Vint's 1937 master plan for the area, the residences were planned as part of a larger complex located south of the Inn. However, only two of the seven proposed residences were built. The two residences (originally designated as Buildings No. 1 and 2, now known as No. 76 and 77, respectively) were constructed in the pueblo revival style using Rustic principles. Like the Inn, the residences exhibit a non-intrusive design philosophy executed by architect Lyle Bennett. Use of color, mass, scale, texture, and stucco aid in blending the buildings within the surrounding landscape.

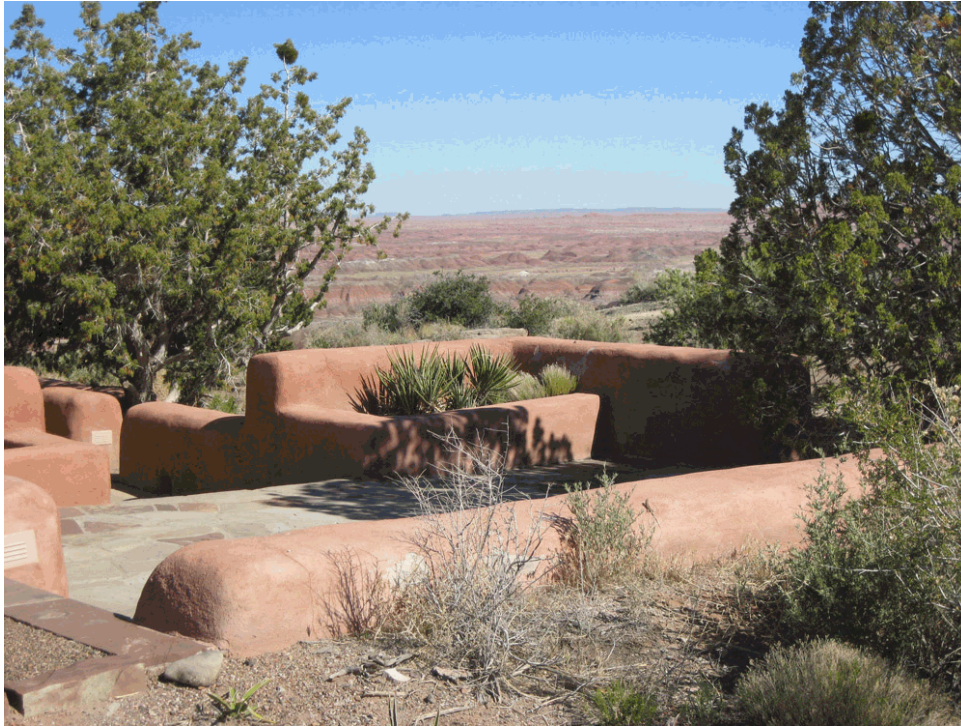
*Patio, terrace, and low adobe walls adjacent to the Painted Desert Inn, 2011. NPS Photo.*

While little information is known about the terraces and walls that existed during the Stone Tree House period, the remaining terraces and walls surrounding the Inn date to the period of significance. The Inn's courtyard, terraces, steps, and walls are based on architectural and landscape architectural Rustic principles in order to preserve the native landscape through sensitive site development and use of native materials, forms, and methods of construction. The courtyard and terraces, located to the east and north of the Inn, were constructed of flagstone in a 1:4 mortar bed over sand fill. The rustic steps and terrace over the museum room was flagstone set in a semi-irregular pattern. The existing flagstone terraces were reconstructed in 2005 to better reflect the colors of the original terrace. Exhibiting shades of red, purple, buff, and gray, these flagstones are now set in concrete.

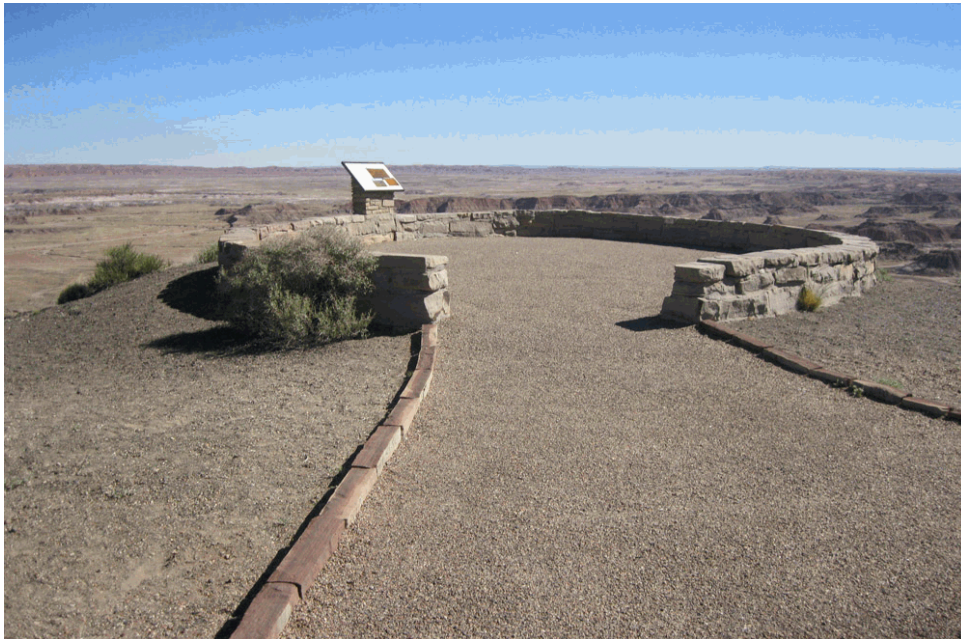
*Stone wall at Kachina Point, 2011. NPS Photo.*

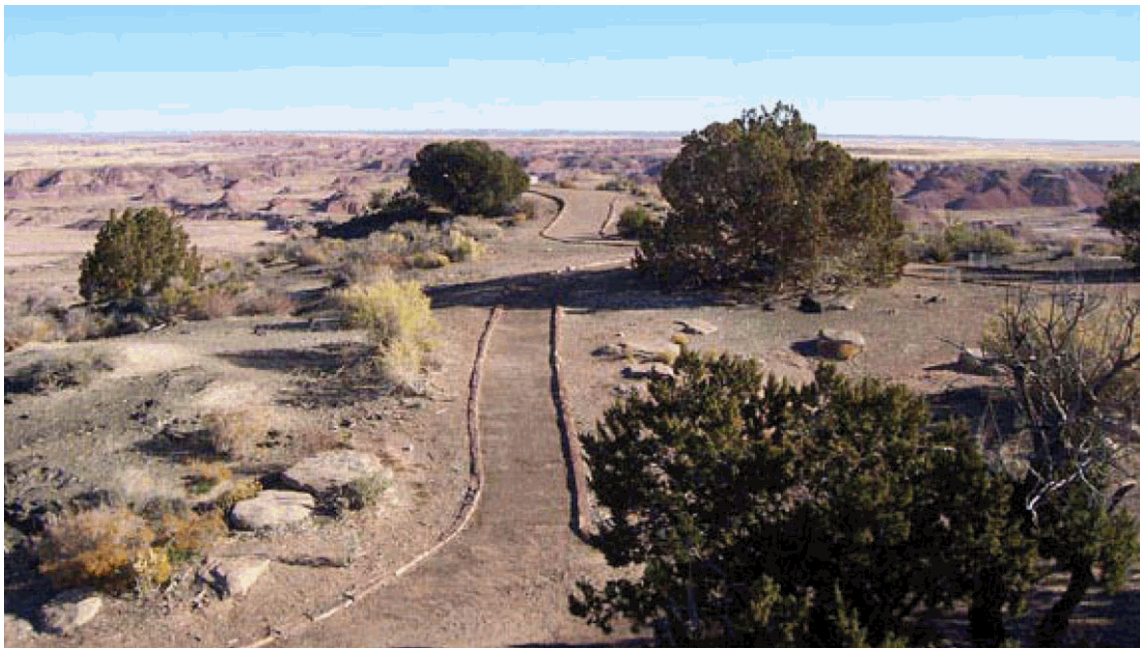
*Figure 8. View north to Kachina Trail and Overlook, 2006. NPS photo.*

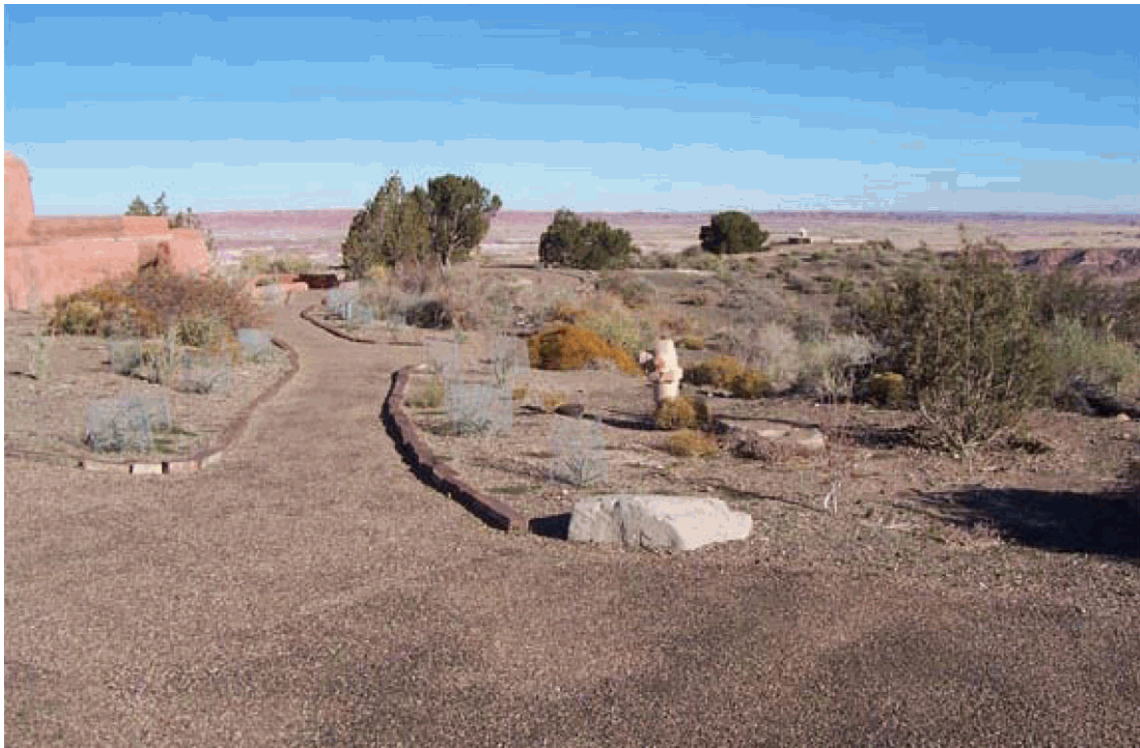
*Figure 9. Paths along east side of the Inn, 2006. NPS photo.*
