National Park Service  
Cultural Landscapes Inventory  
2020

Bear Valley School  
Pinnacles National Park

CULTURAL LANDSCAPES  
*2020 Condition Assessments for:*

**Pinnacles National Park**

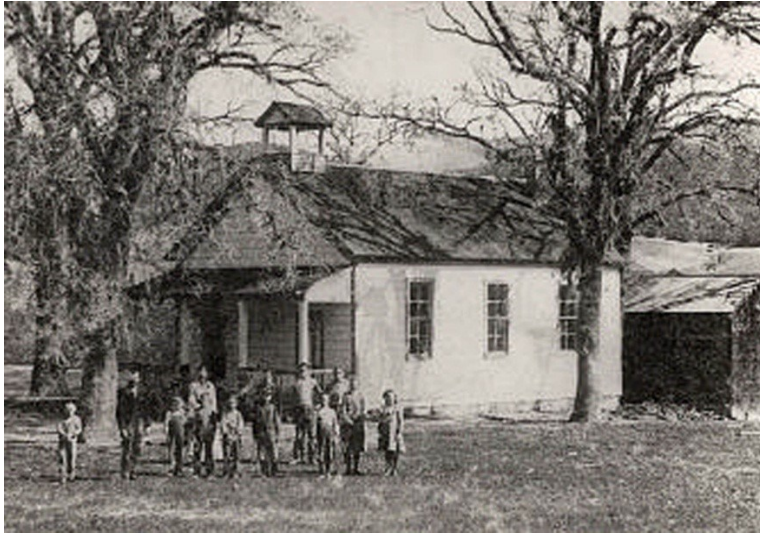
Physical History #3 View from southwest distance, ca. 1905 ["Aunt Grace Album," in Deborah Melendy Norman, ed., "South County Pioneers: Version 3.0," December 2008, p. 57]. Note the open porch. Separate outhouses were located in the field to the north of the schoolhouse. Note also that there were only three double-hung, four-over-four windows on the south wall. A similar pattern existed on north wall. The storage shed visible at the southeast corner was constructed of redwood lumber salvaged from the original 1873 schoolhouse.

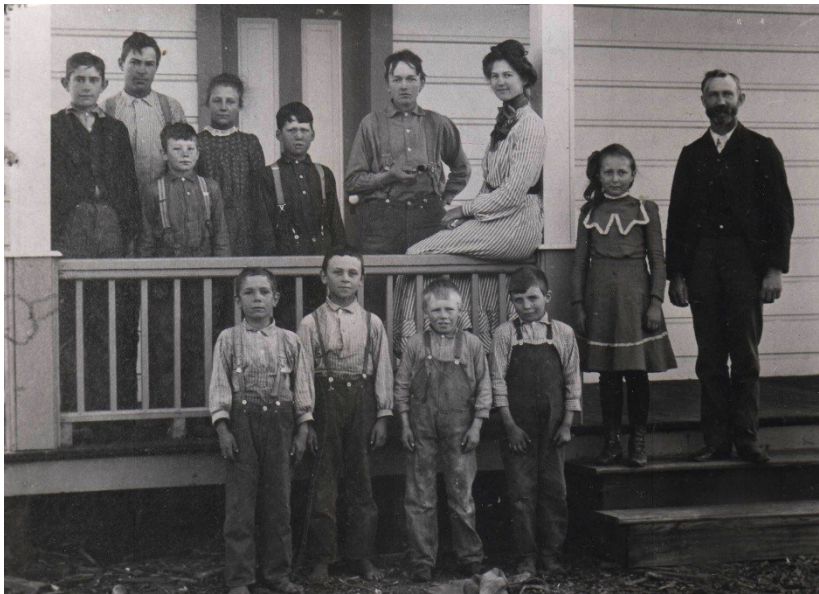
Physical History #4 View from west showing detail of front porch, ca. 1905. [Private collection of Jane Lausten.] Note open railing and square pillars. Horace G. Bacon is the older man standing at the far right.

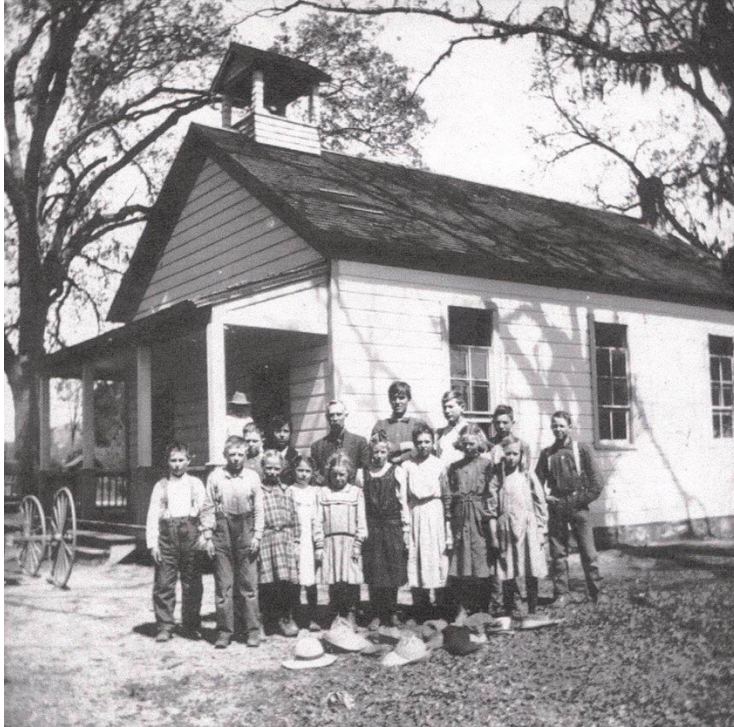
Physical History #5 View from southwest, ca. 1910. [Private collection of Nancy Lausten.] Note the gable roof of one of the vault toilets in the background, photo left.

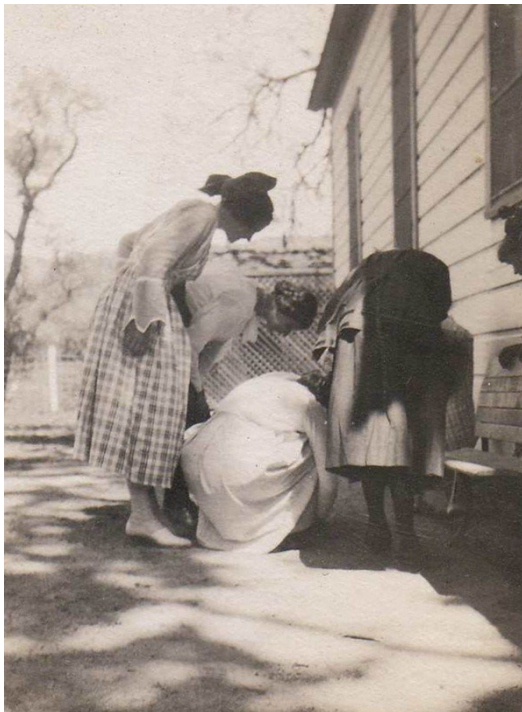
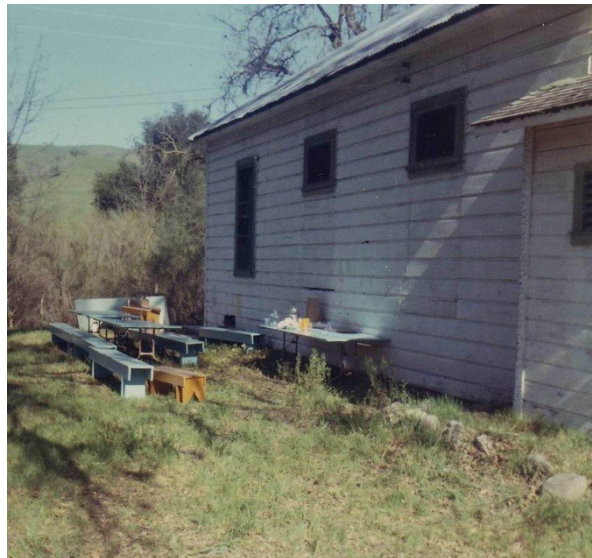
Physical History #6 Photo at left shows north wall of schoolhouse viewed from northwest corner, ca. 1915. Photo at right shows same wall, ca. 1960. Note that two of three original double-hung, four-over-four window have been shortened to accommodate blackboard inside. [Both photos from private collection of Jane Lausten.]

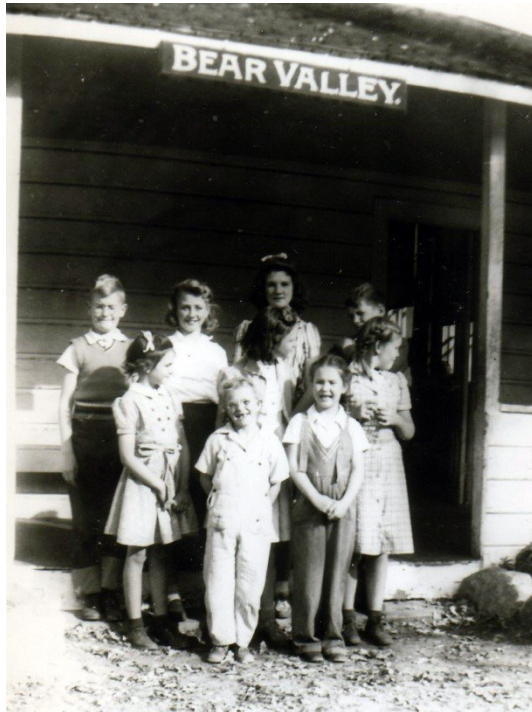
Physical History #7 View from northwest showing detail of front porch, 1942. Note that porch has been modified sometime between 1923 and this date. It is now lower, with only a single step, and has enclosed toilets on either side. The open railing has been replaced with a solid half-wall, and the boxed pillars with an unadorned four-by-four post. [Private collection of Bernice D'Arcy.]

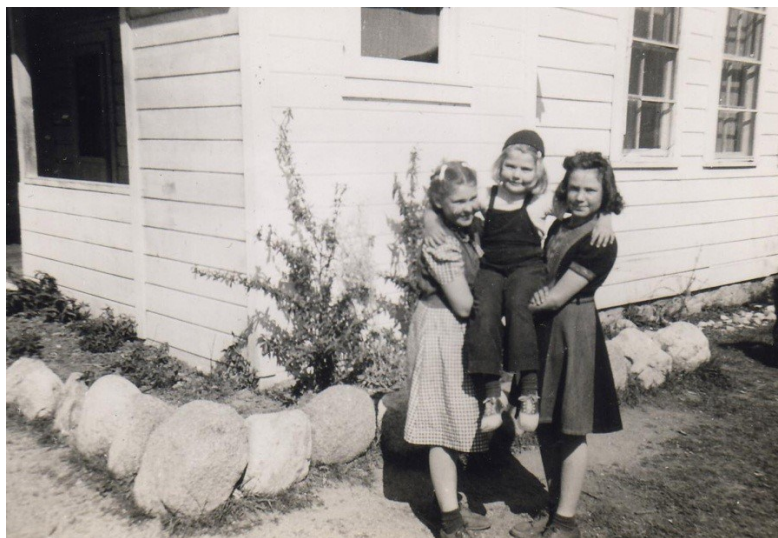
Physical History #8 View from southwest showing detail of porch and portion of south wall, 1942. Note enclosed toilet (girls on the south end, boys on the north). The window on the exterior wall of the toilet room will later be replaced with a louvered vent. Note also the foundation plantings and river stone border. The border is no longer present. [Private collection of Bernice D'Arcy.]

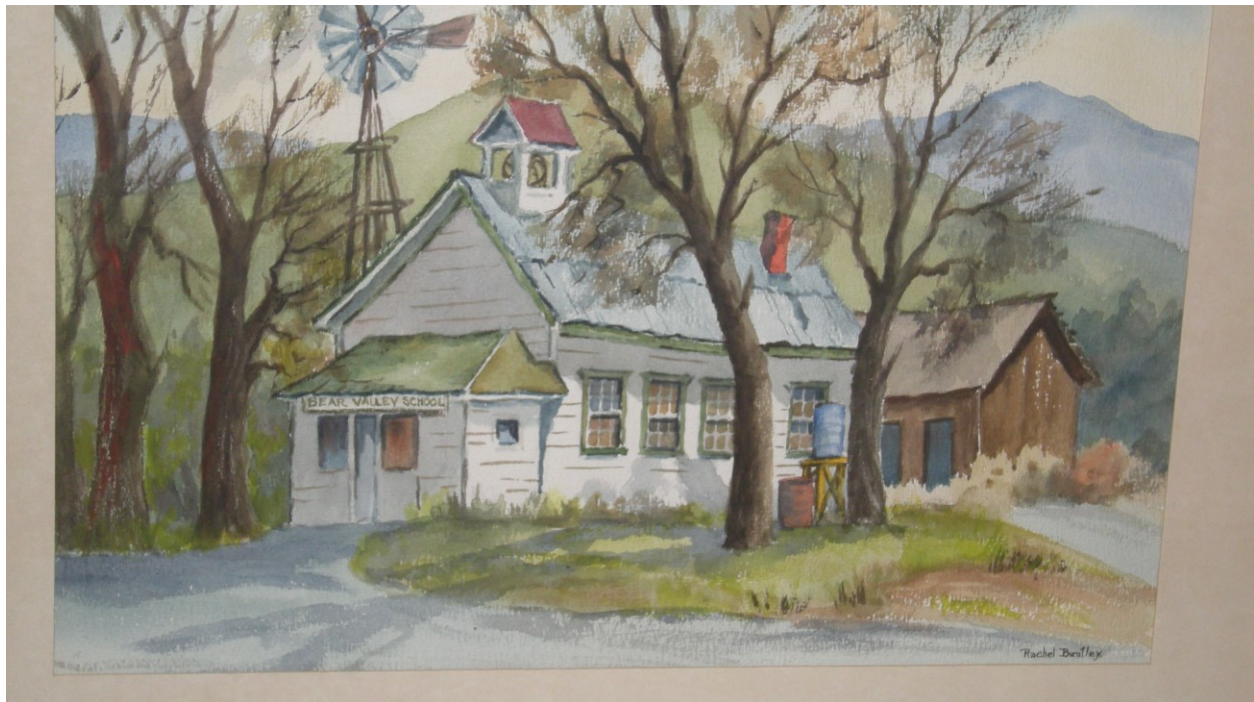
Physical History #10 Painting of the Bear Valley School by artist Rachel Bentley, 1950, as part of a series of watercolors representing all of California's schools, commissioned by the California Department of Education. Note the heating oil platform immediately to the south of the schoolhouse and the new flue on the roof. [Original painting owned by San Benito County.]

A number of changes occurred shortly after the Farm Bureau began managing the Bear Valley School. One of the first of these was installation of an oil-burning heater to replace the original wood-burning pot-bellied stove. The new heater had fans, and the venting pipe would become red hot when it was in use. Evidence of this excessive heat can still be seen in the blistered condition of the paint on the boxed casing on the back wall of the room just below the aperture where the original flue pipe entered the chimney. This problem was remedied by redirecting the flue straight up through the ceiling and out the roof rather than back to the chimney by means of an elbow. The new flue consisted entirely of metal pipe, and a new hole had to be cut into the roof to accommodate it a few feet west of the original chimney. The exterior masonry was subsequently removed and the original chimney passage blocked off at either end. (See Physical History 9)

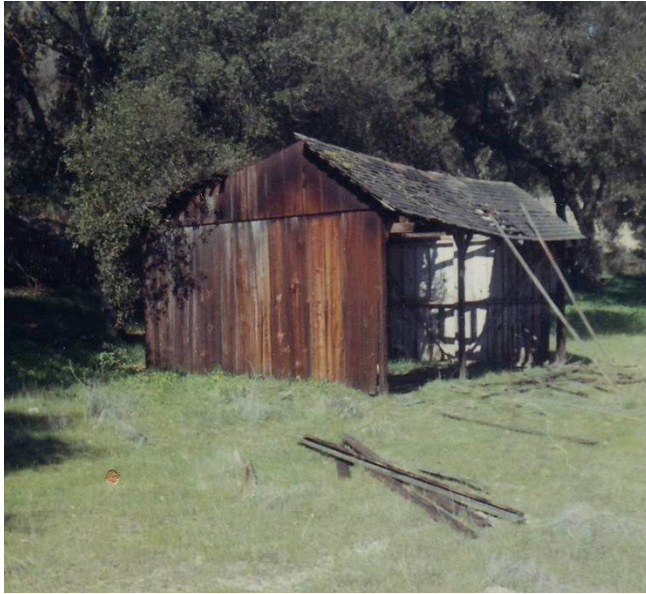
Physical History #11 Old storage shed seen from southeast (rear) corner of schoolhouse just prior to demolition, ca. 1960. This building was constructed during 1890s of redwood lumber salvaged from original 1873 schoolhouse. Demolition was carried out by local 4H volunteers as part of annual clean-up day. The debris was later burned. [Private collection of Jane Lausten.]

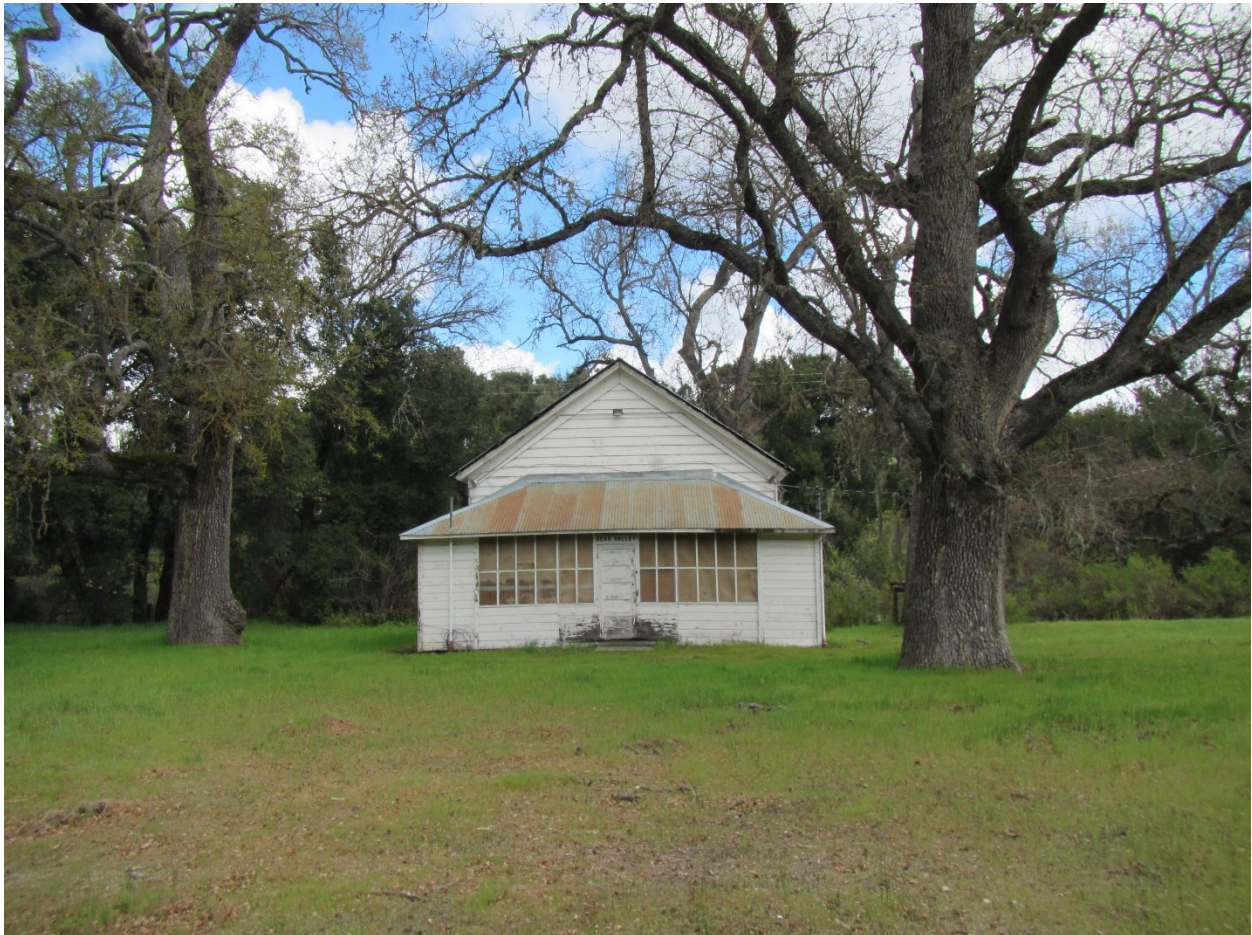
Natural Systems and Features #1 Bear Valley School within a small grove of valley oaks, view east-southeast. Note the open grassy landscape in the foreground and the dense riparian vegetation in the background. (NPS, March 2020)

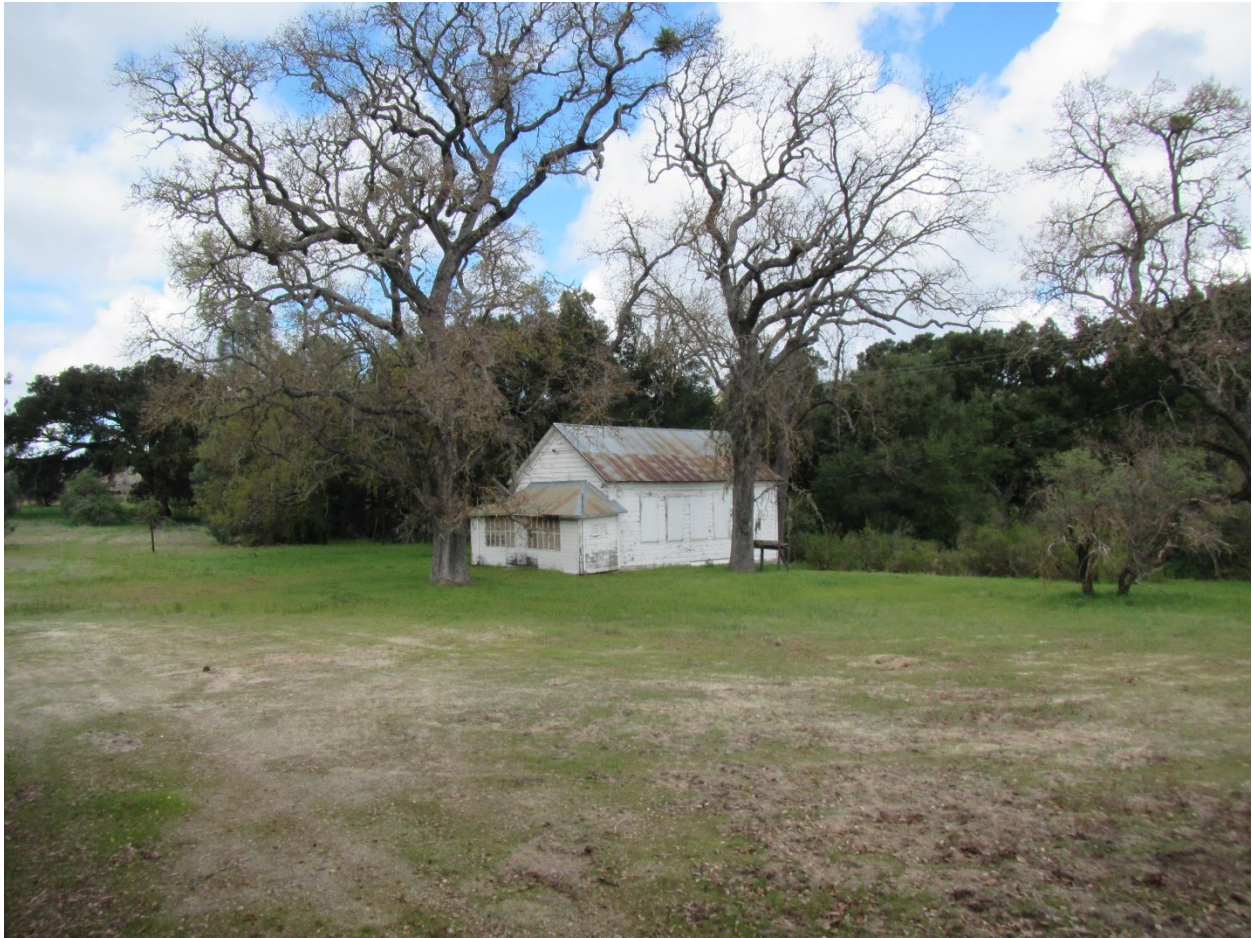
Spatial Organization #1 Bear Valley Schoolhouse and yard, view to north. (NPS, March 2020)

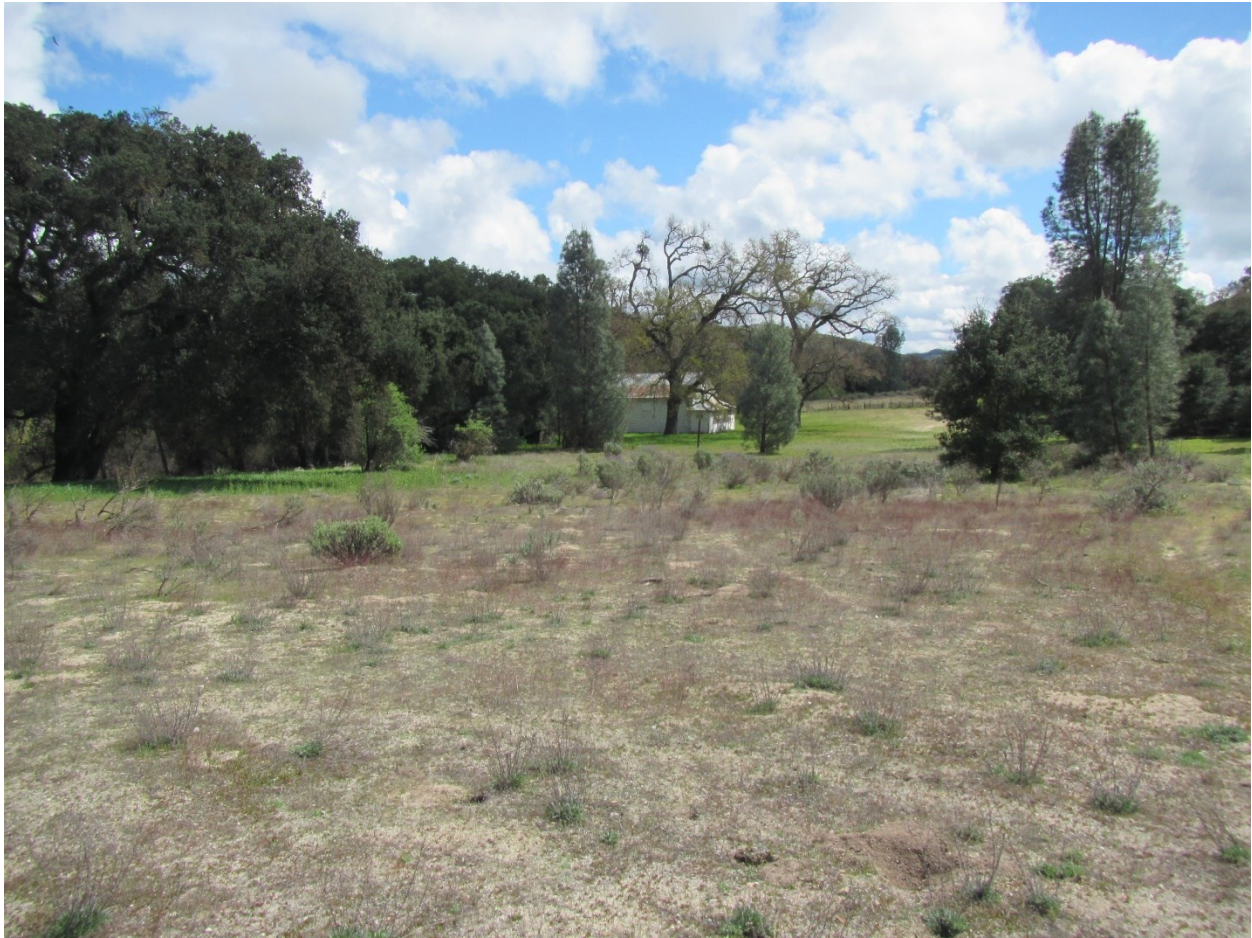
Spatial Organization #2 Bear Valley Schoolhouse and yard, view south-southeast from the north end of the schoolyard. (NPS, March 2020)

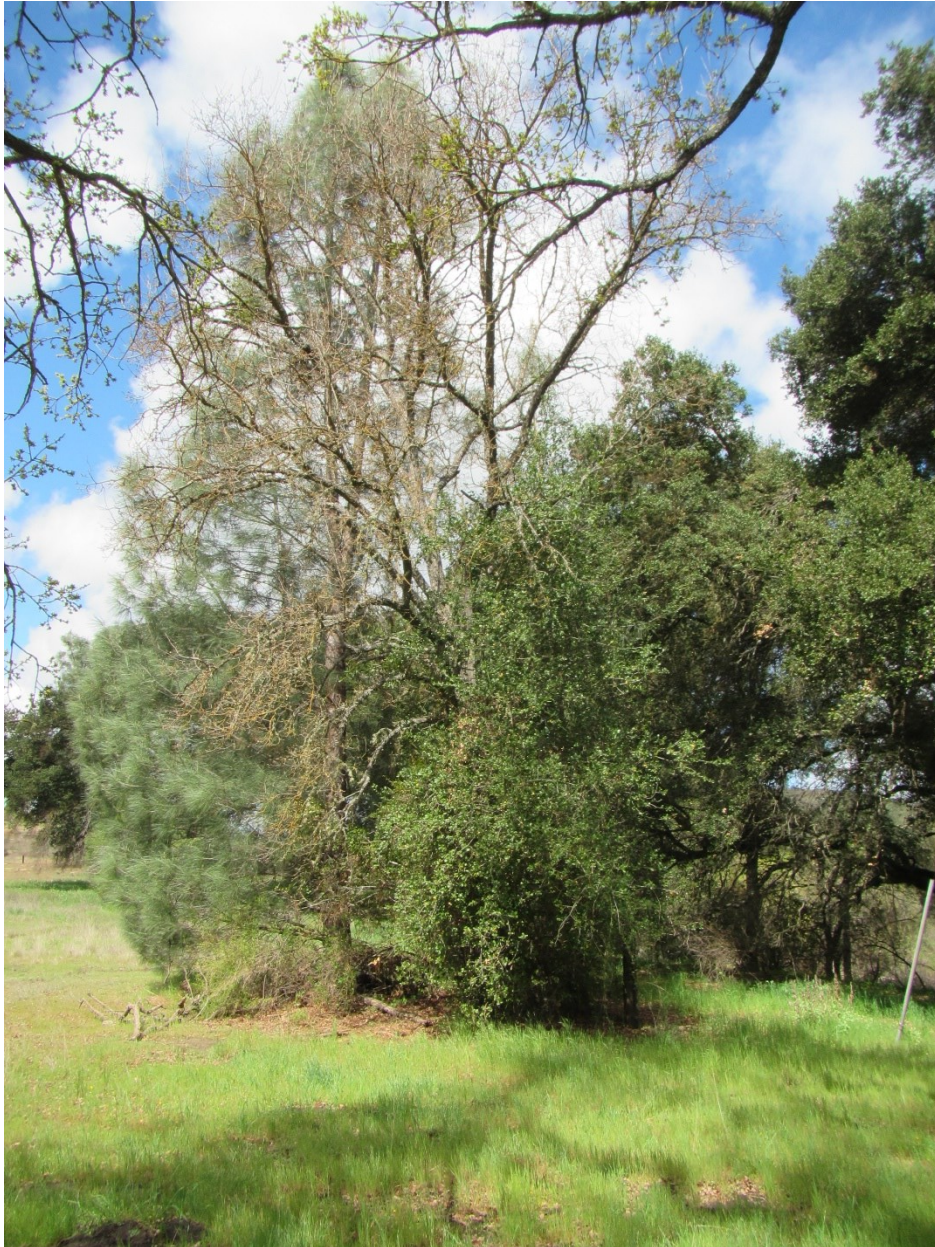
Vegetation #1 View of the Horace Bacon Commemorative Tree and exclosure, looking northwest (NPS, March 2020).

At least one native species present in the Bear Valley School site is identified to have been purposely planted. This is the Valley Oak (*Quercus lobata*), located north-northwest of the schoolhouse, which was planted in 1923 to honor Horace Bacon for his service to the school. This commemoration is a testament to the importance of Bear Valley School to the surrounding homestead community. The oak is differentiated from the other four Valley Oaks in that it is enclosed by a wooden enclosure, which may have once protected it as a seedling. Currently, the fence appears to foster the growth of vegetation inside the enclosed area that is encroaching on the specimen tree.

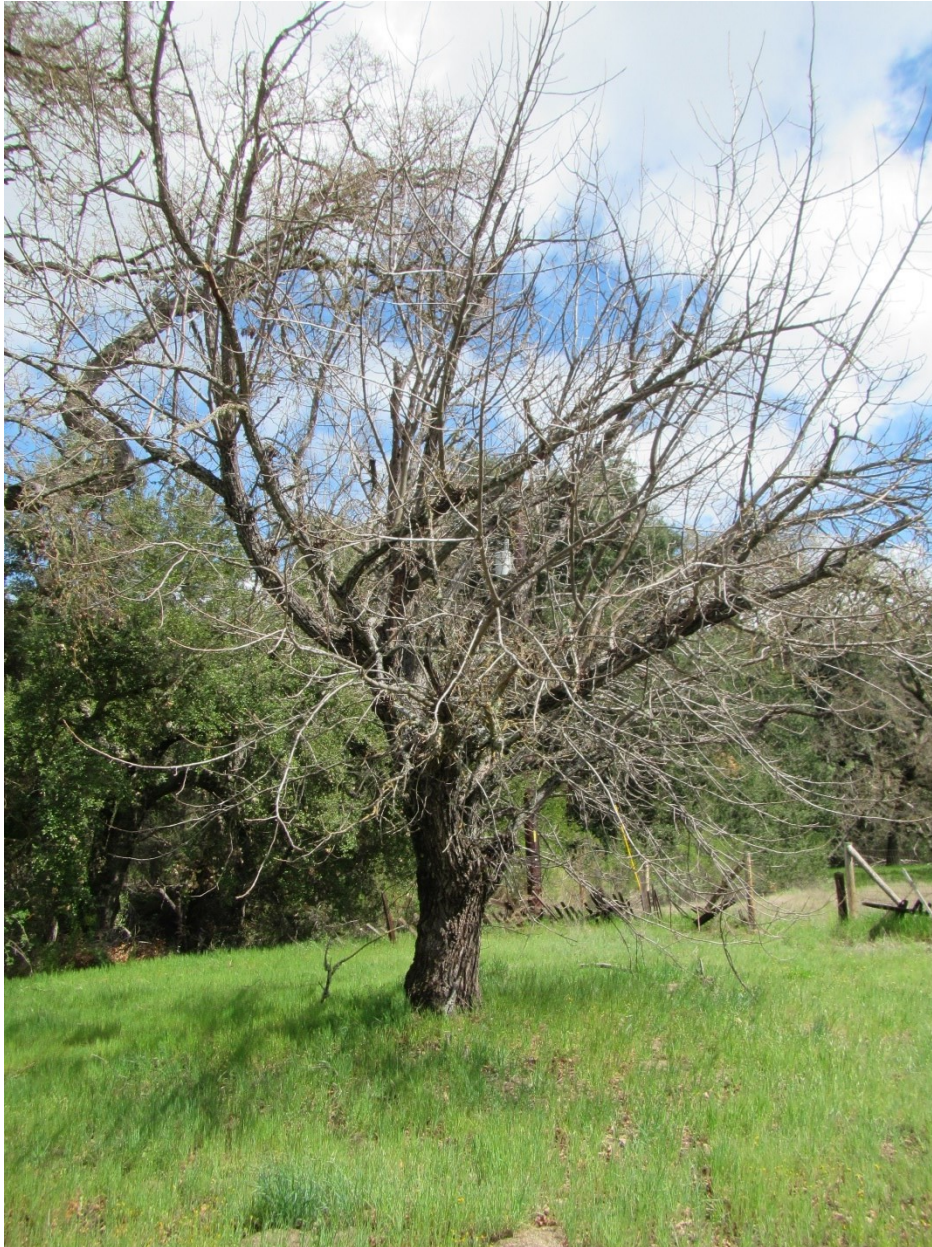
Vegetation #2 View of the California black walnut located at the eastern corner of the schoolyard, looking west (NPS, March 2020).

Two other native trees present at the site are the mature California black walnut (*Juglans californica*) and the blue elderberry (*Sambucus mexicana*), located to the southeast of the schoolhouse near the 1895 perimeter fence. Both species are commonly found within the local area, especially along riparian corridors where there is plenty of water. As their location is at the periphery of a riparian area, it is unlikely, though possible, they were planted.

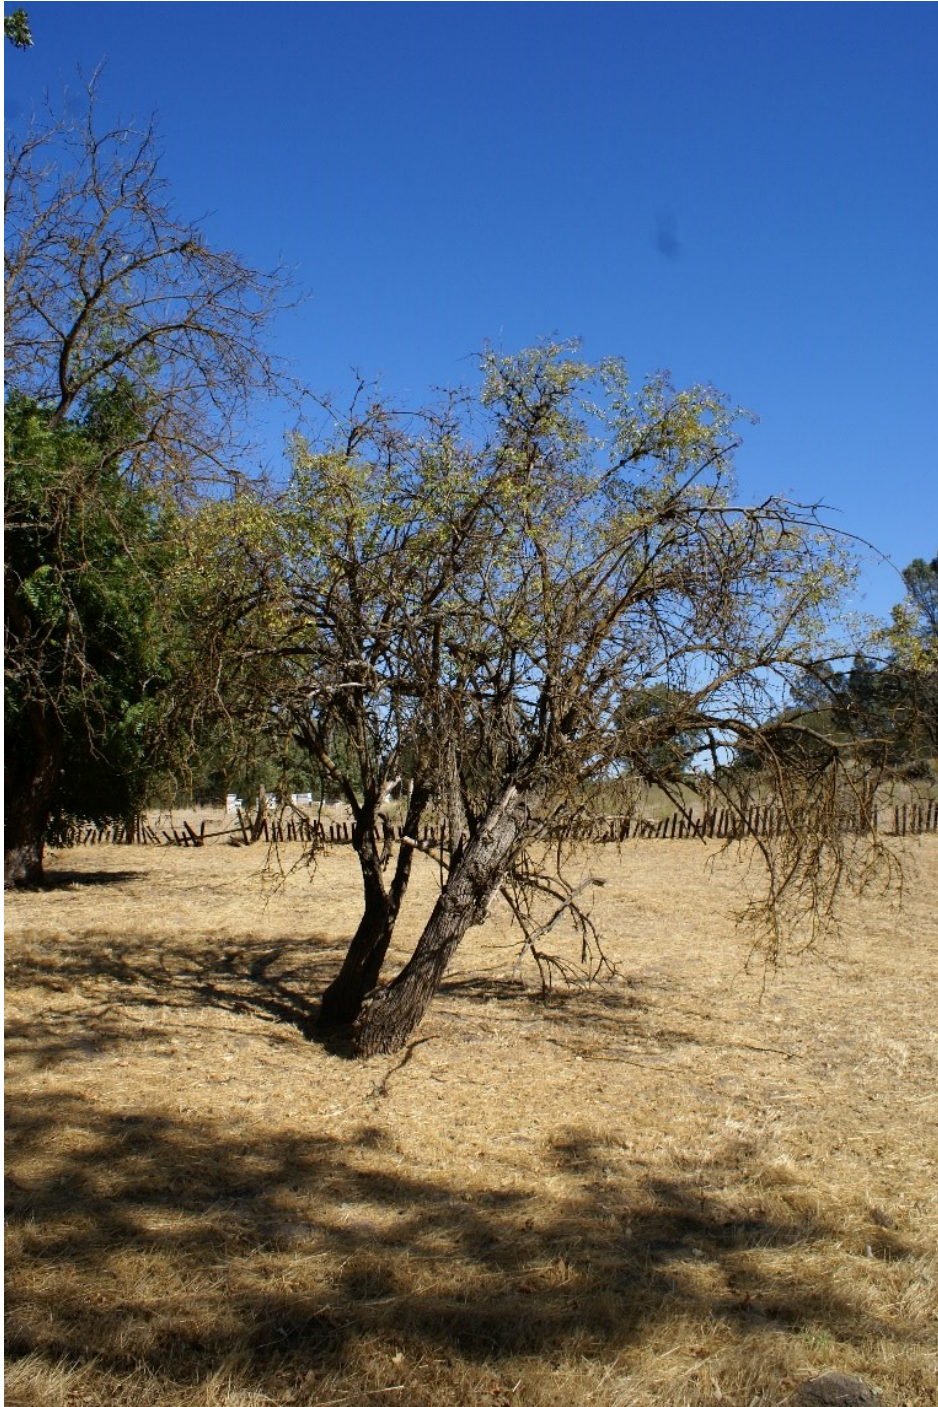
Vegetation #3 View of the blue elderberry located near the walnut tree in the eastern corner of the schoolyard, looking southwest (NPS, March 2020).

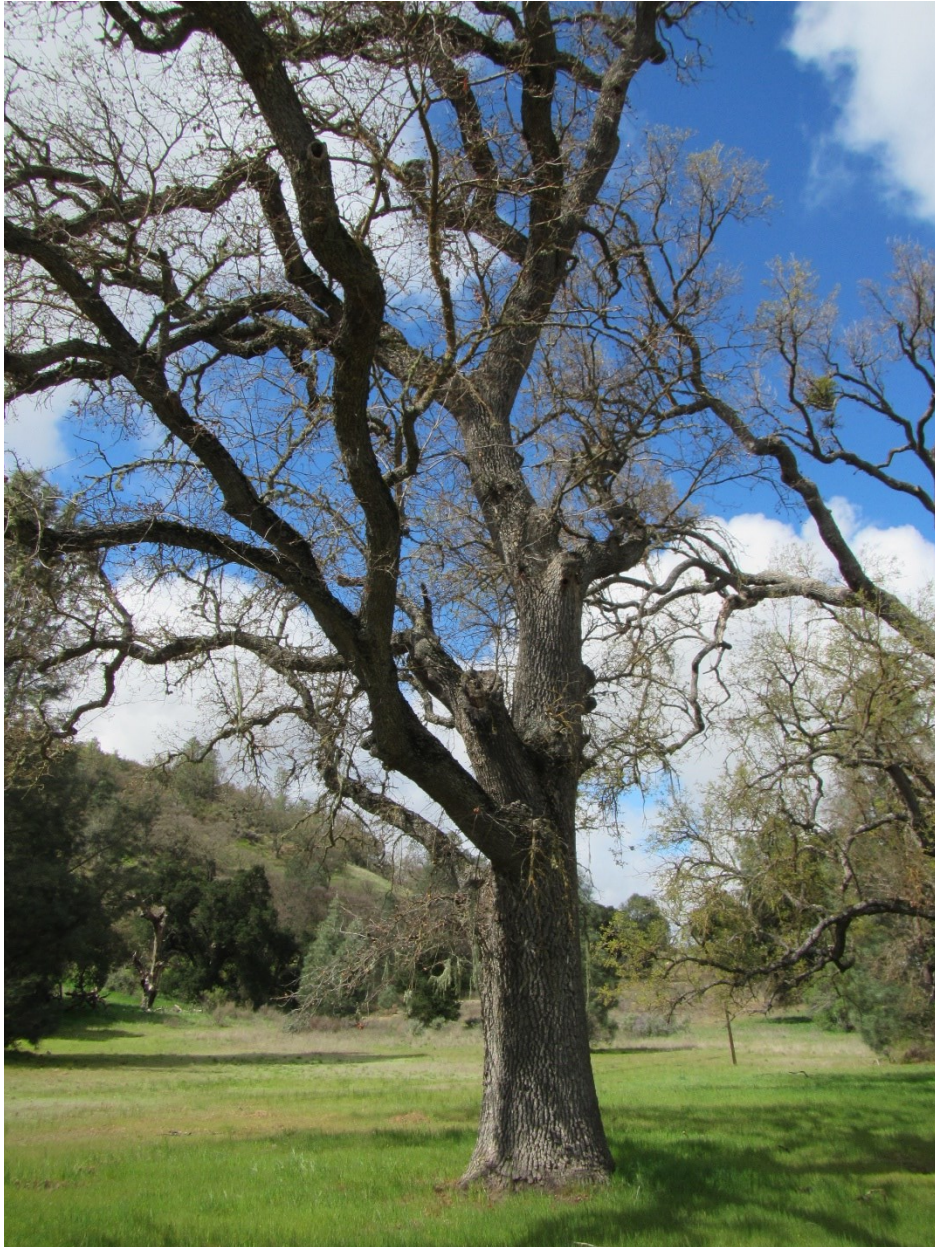
Vegetation #4 View of the southwestern most Valley Oak, looking west (NPS, March 2020).

**Impact Description:** The historic oak trees under which the Bear Valley Schoolhouse is located display hanging limbs and deadwood. These should be removed to reduce risk of carrying fire onto the historic building and to eliminate a falling hazard for visitors.

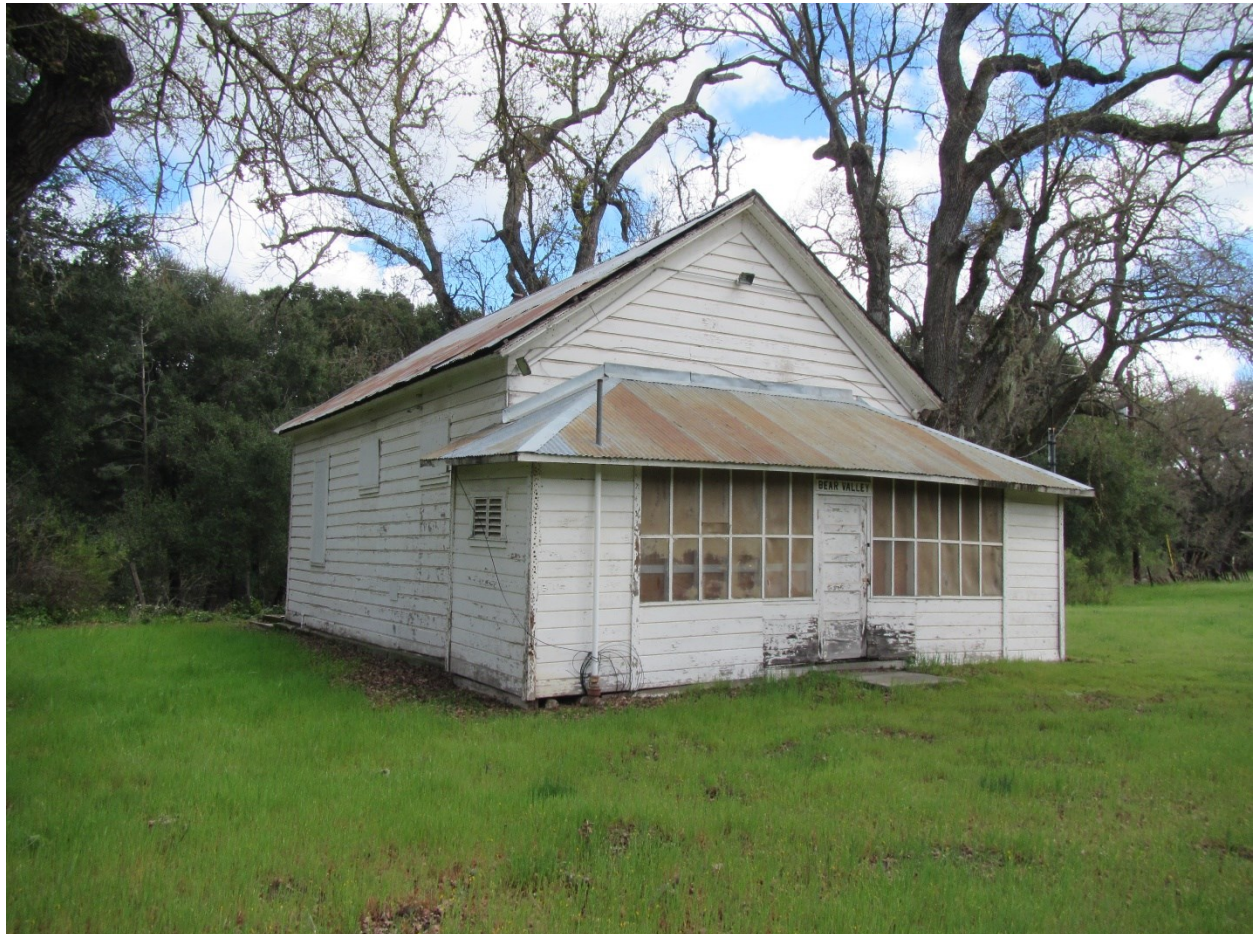
Buildings and Structures #1 Bear Valley School, view east-southeast. (NPS, March 2020)

**Impact Description:** The deferral of regular, cyclical maintenance activities has had a negative impact on the condition of the Historic District and its associated features. The historic schoolhouse displays large patches of peeling paint which directly exposes the wood siding

and frame to the elements. Cyclical maintenance will prevent further deterioration in the future.

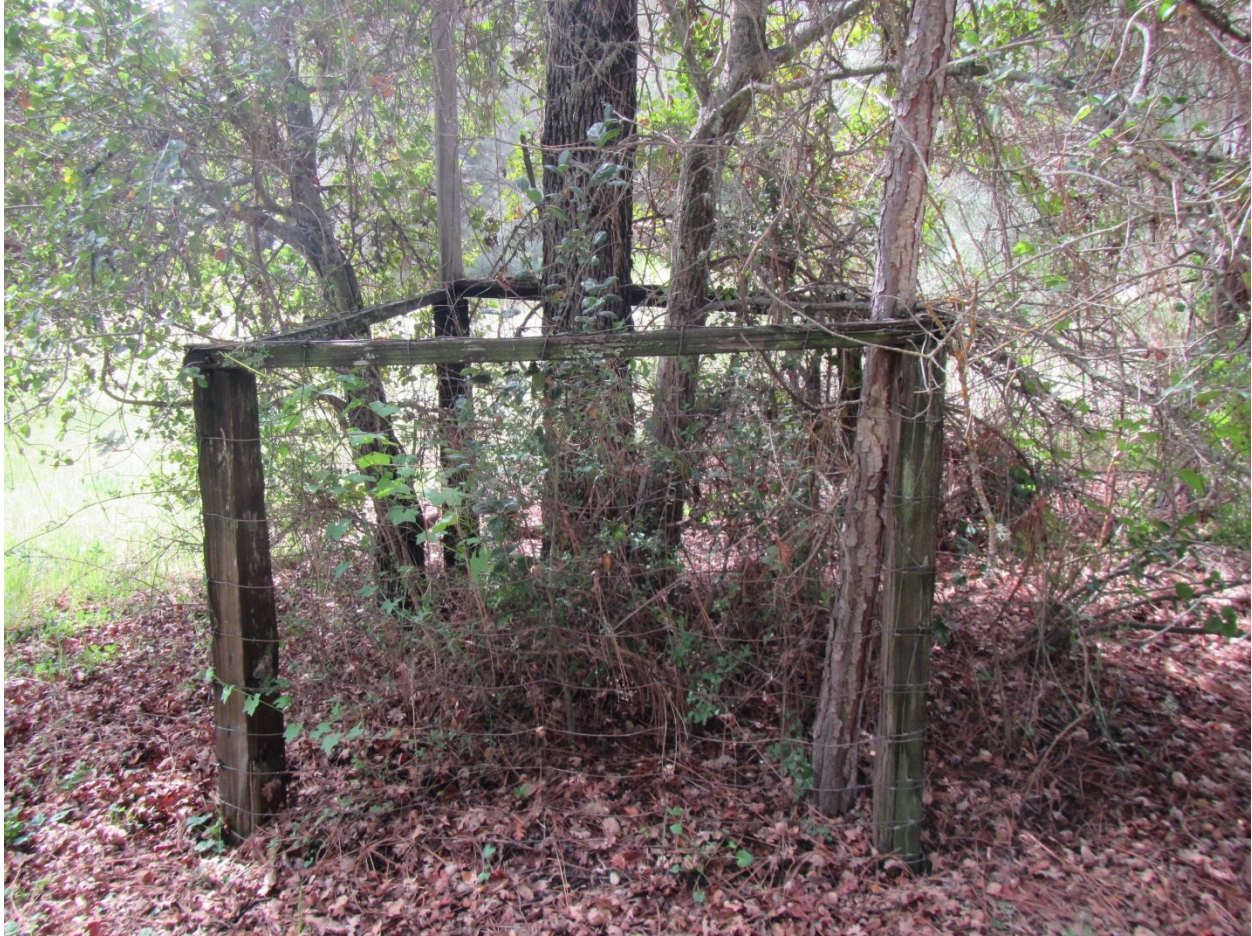
Buildings and Structures #2 Horace Bacon Commemorative Tree Exclosure, view southwest. (NPS, March 2020)

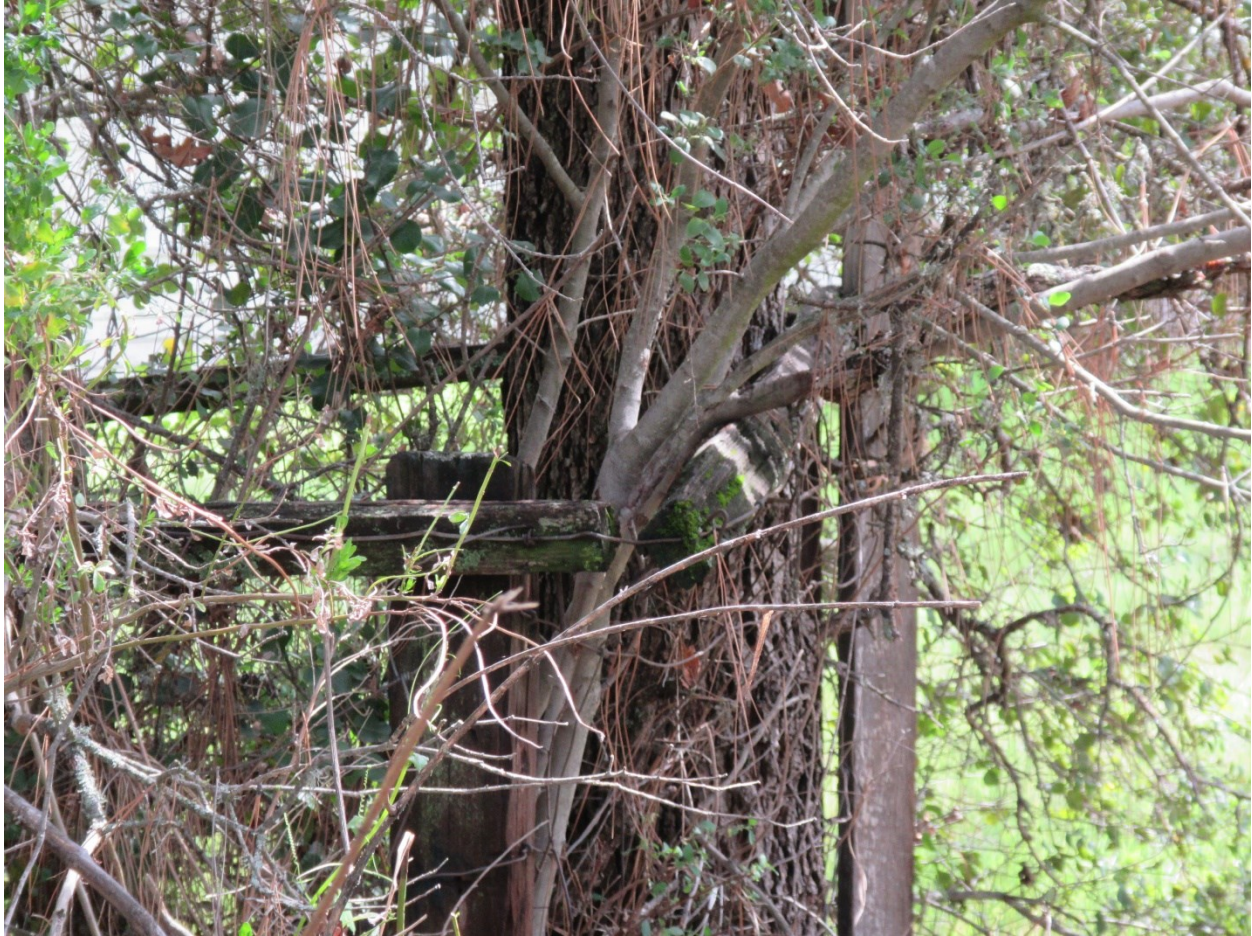
Buildings and Structures #3 Close-up of the damaged Horace Bacon Commemorative Tree Enclosure.  
(NPS, March 2020)

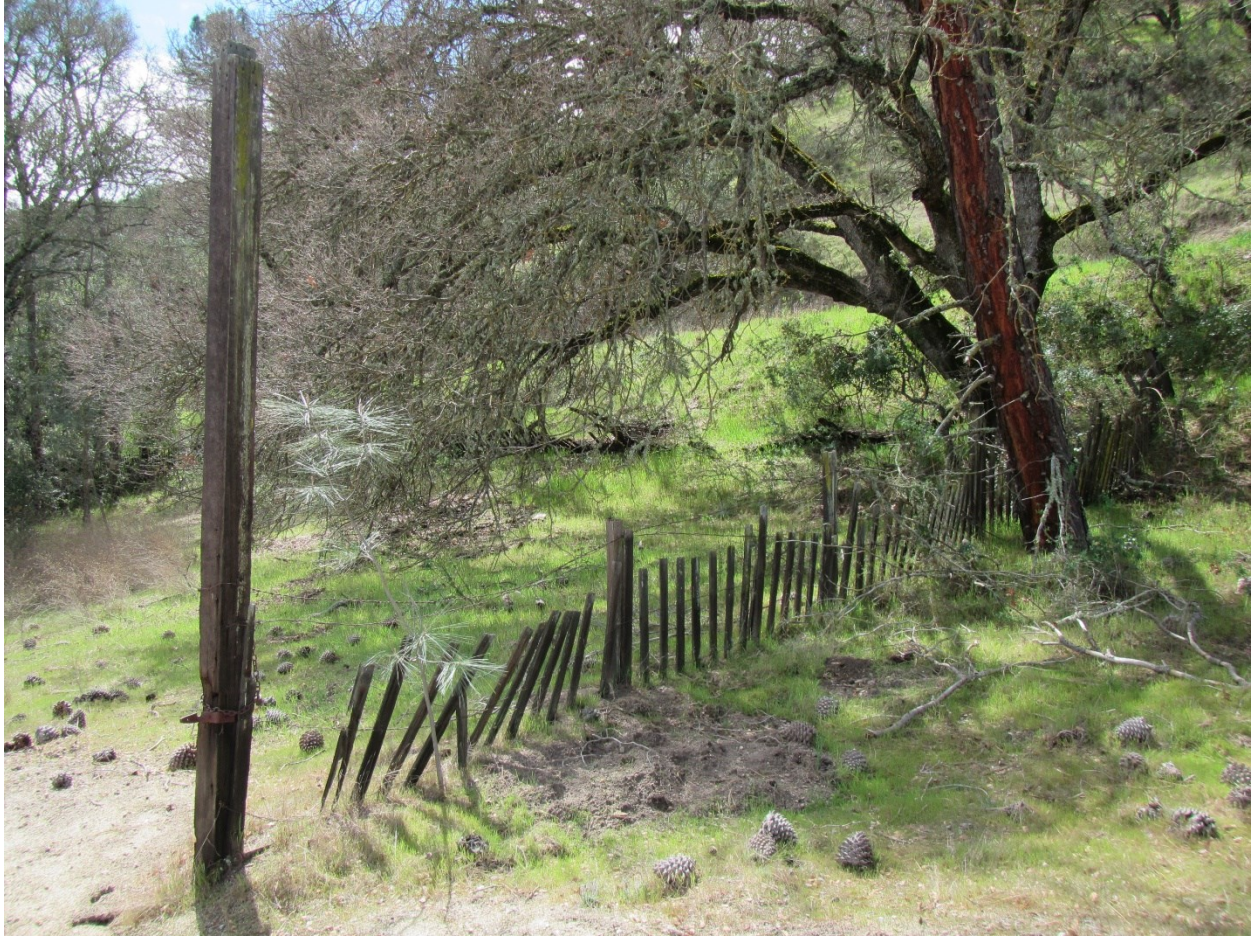
While the 1895 perimeter fence retains high integrity in material, workmanship, and design, a fire at the site in August of 2015 resulted in damage to sections of the resource. Some portions of the fence have also collapsed, but they have been left in place and continue to define the original perimeter of the historic schoolyard.

Buildings and Structures #4 1895 Redwood stave and wire perimeter fence, view north. (NPS, March 2020)

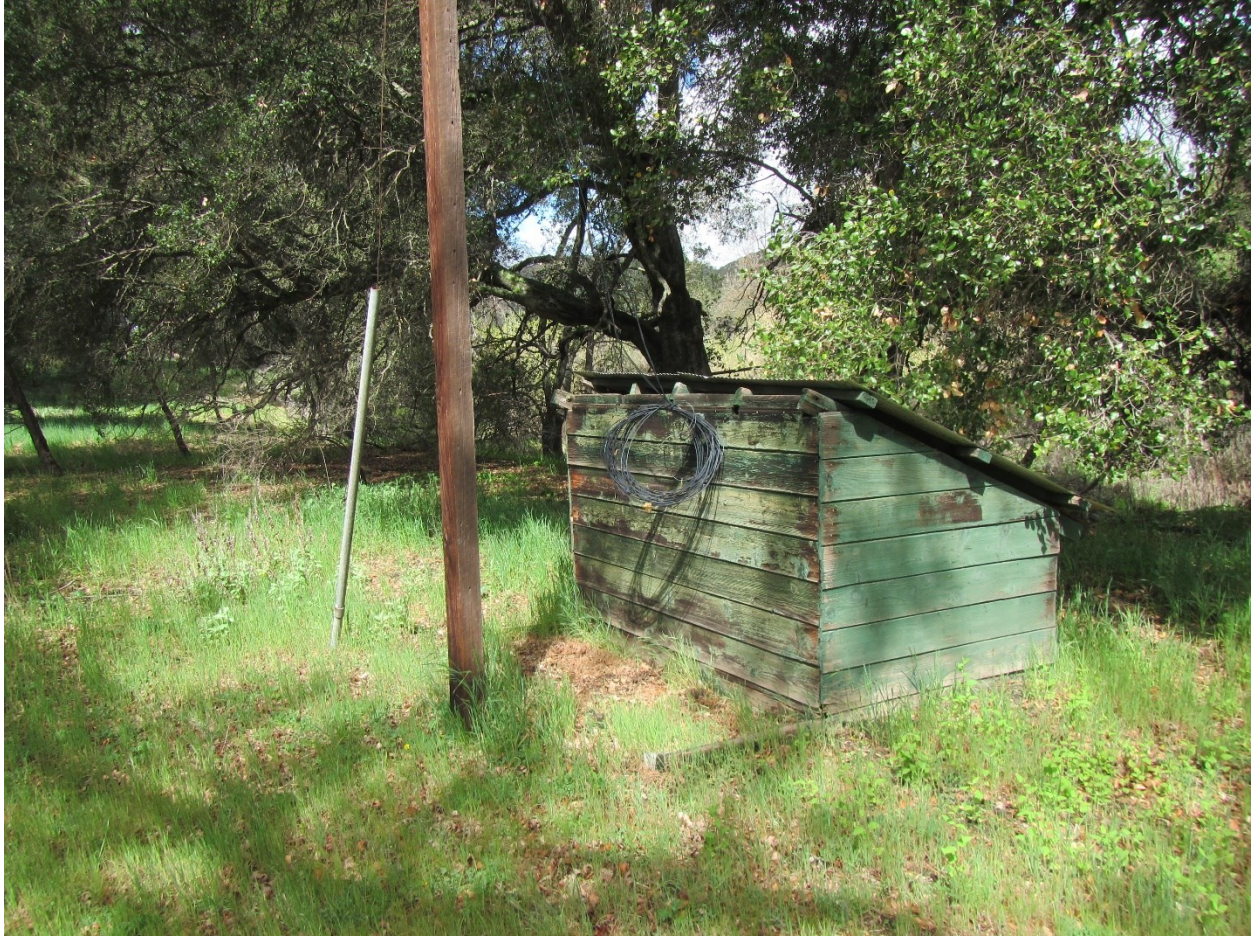
One notable alteration to the Bear Valley School landscape is associated with the historic well that was bored in 1902. An electric pump was installed and a lean-to pump house was constructed to replace an old windmill depicted in the 1950 watercolor painting of the school. However, these features do not disrupt the historic spatial organization or the overall integrity of the school site as these are minor in scale and enable the continued use of the historic water feature as well as sustain the historic function of the old windmill.

Buildings and Structures #5 Electric Pump/Wooden Shed-Style Pump House, view north. (NPS, March 2020)

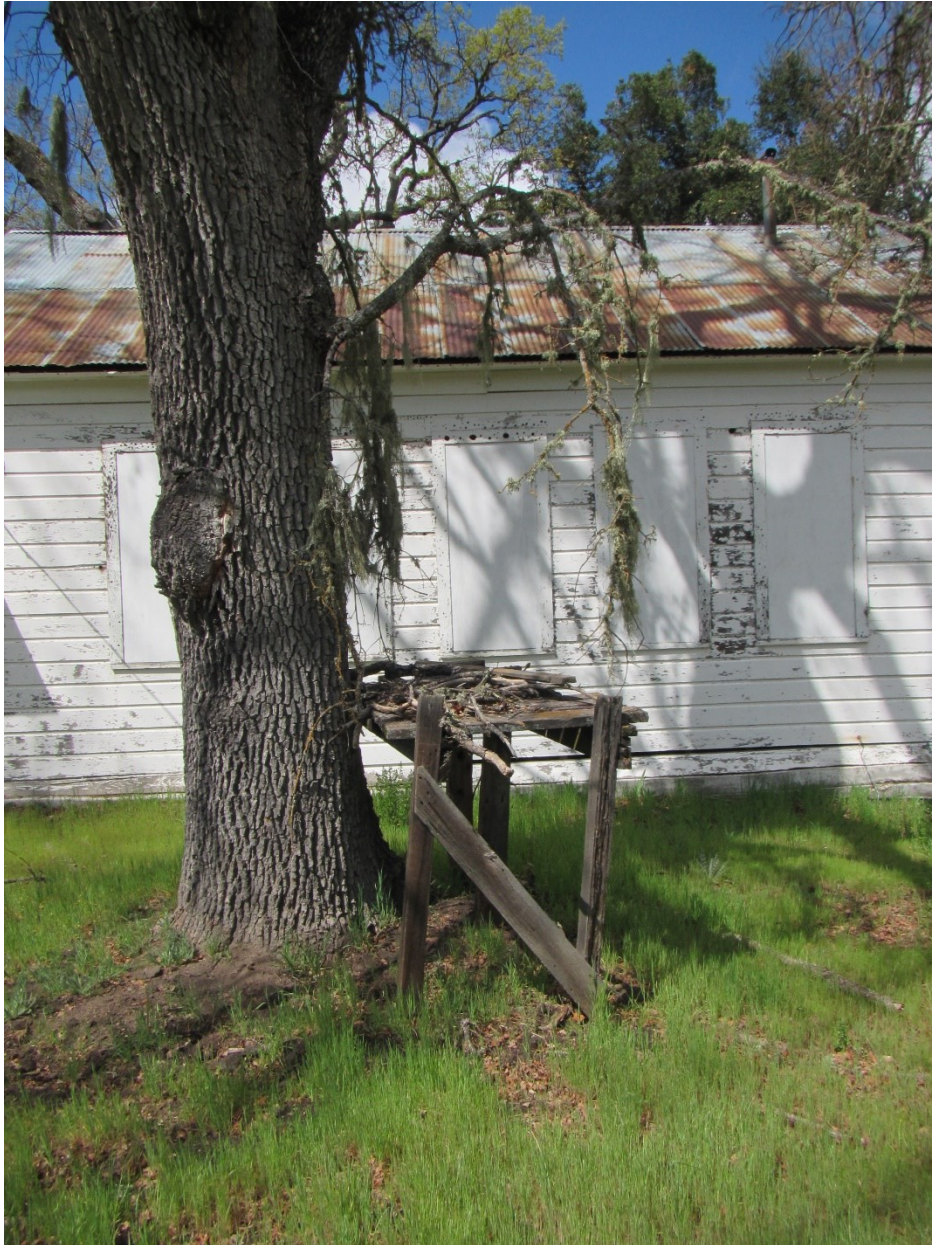
A small wooden structure stands in close proximity to the southeastern elevation of the Bear Valley schoolhouse, next to one of the original four valley oaks. The presence of a pipe/hose exposed from the exterior wall suggests that this structure served as a platform for metal tanks from which oil would be pumped into the schoolhouse to the oil-burning stove. Roughly 18 feet square and four feet tall, a similar structure is depicted supporting what appear to be oil tanks in the 1950 watercolor painting of the school. Though it is likely that the extant feature is the same structure depicted in the painting, this cannot be confirmed. The heating oil platform is therefore unknown in status.

Buildings and Structures #6 Heating oil platform, view north-northwest. (NPS, March 2020)
