National Park Service  
Cultural Landscapes Inventory  
2020

Bear Valley School  
Pinnacles National Park

CULTURAL LANDSCAPES  
*2020 Condition Assessments for:*

**Pinnacles National Park**

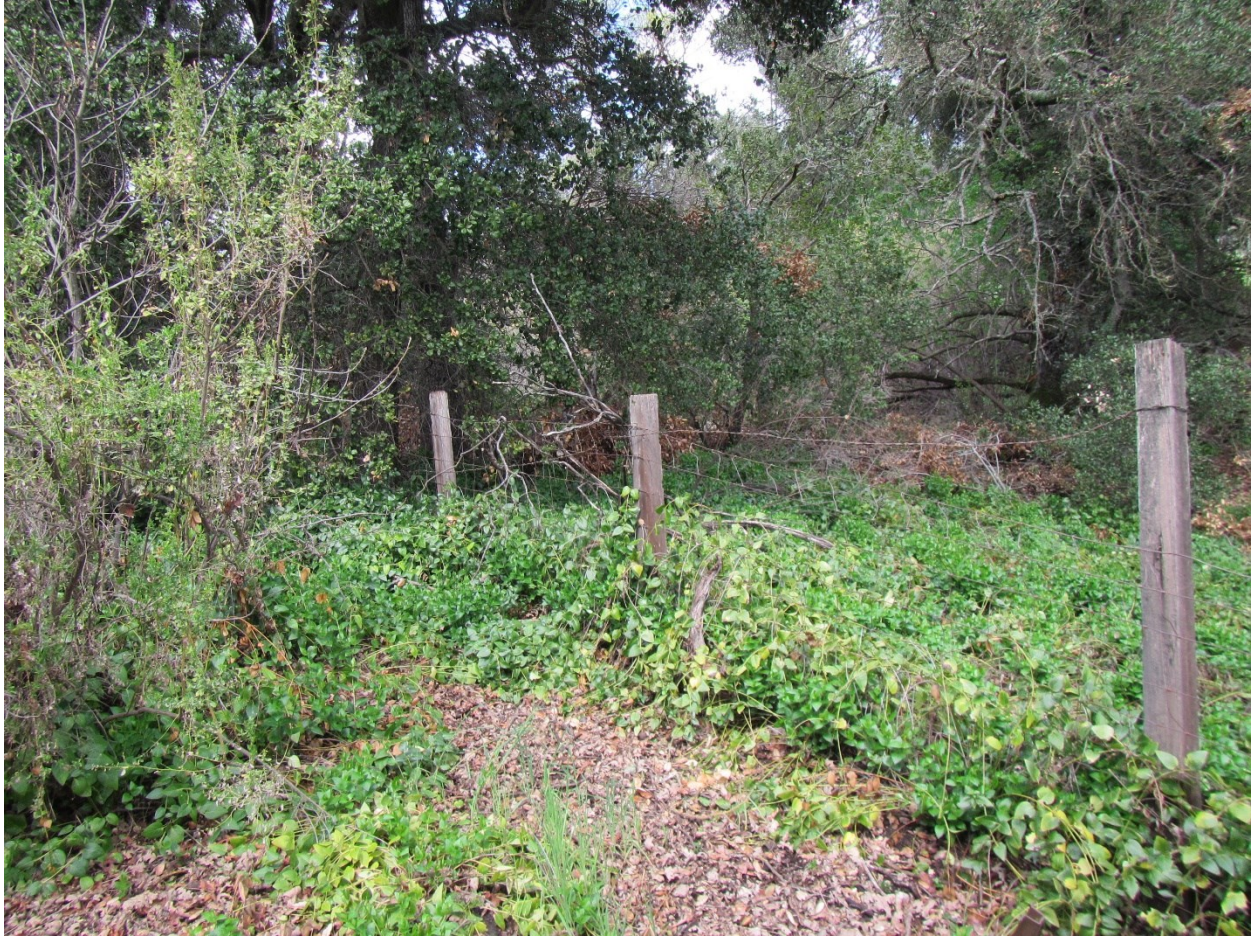
Another fence stands within the Bear Valley School parcel, enclosing an area similar to that of the 1895 historic perimeter fence. This fence follows the boundaries of the historic fence, standing just inside the property outlined by the latter. It retains a high level of integrity as the physical material of this structure can still be found, though collapsed, even in the downward slope toward the creek. The fence is comprised of three strands of barbed wire extended between wooden posts and can be seen in the background of historic photographs as early as 1915. However, as the exact date of and reason for its construction cannot be determined, its status is undetermined.

Buildings and Structures #7 Barbed wire fence to the rear of the schoolhouse. (NPS, March 2020)

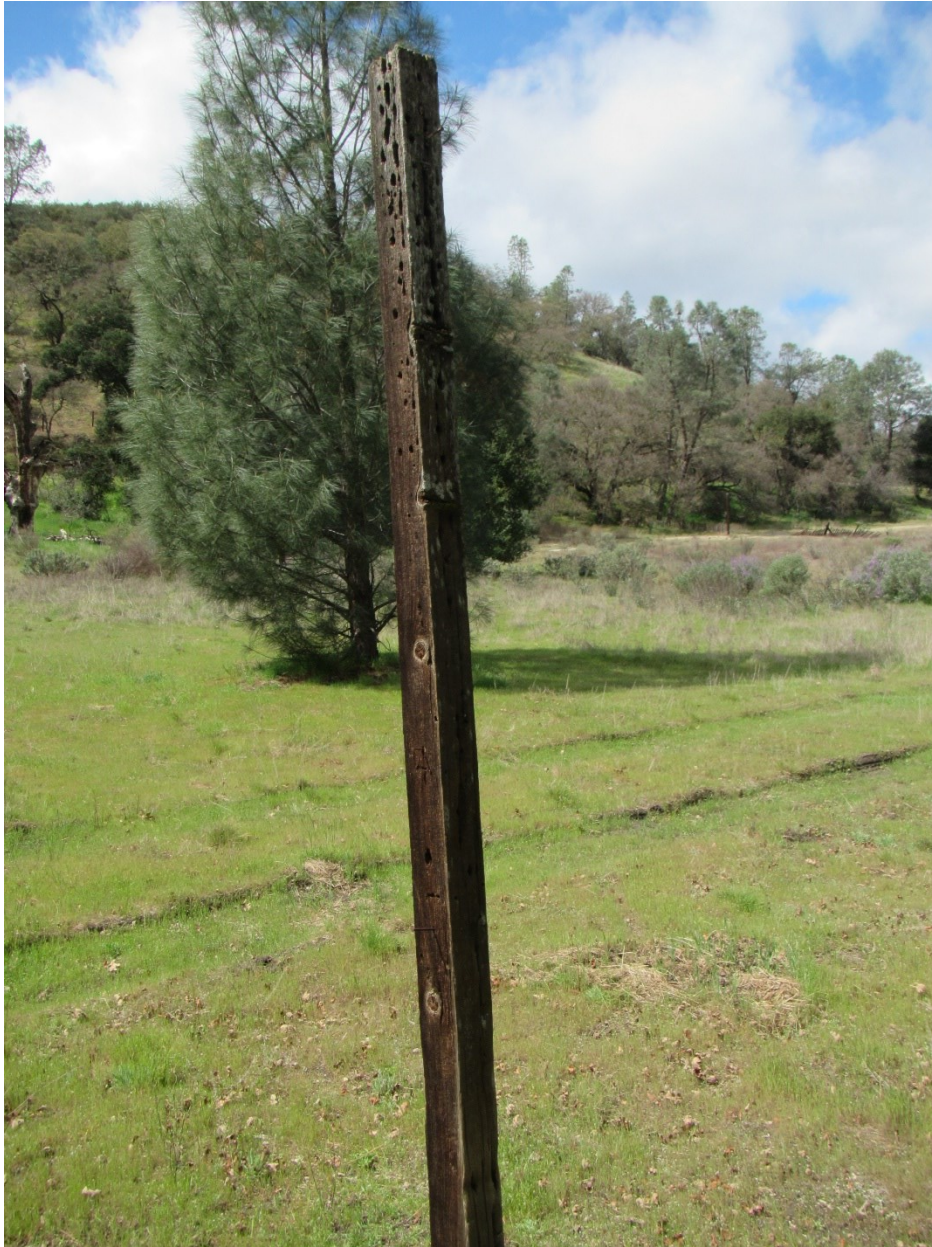
Buildings and Structures #8 Wood pole, view southeast. (NPS, March 2020)

Woodpecker damage is found across the wood features within the Bear Valley School site, including the Bear Valley Schoolhouse, fence posts, and the wooden pole. While woodpecker activity is common in the region, measure should be taken to either routinely repair damages or prevent/discourage woodpecker activities on the historic fabric. Not only do these pecking holes impact the structural integrity of the historic fabric but they also expose the wood members to the elements and further accelerate deterioration.

Animal/pest management: A historical architect, structural engineer, and pest management specialist should be consulted to develop a strategy to effectively repair and discourage woodpecker activities on the historic schoolhouse while maintaining sensitivity to the historic fabric.

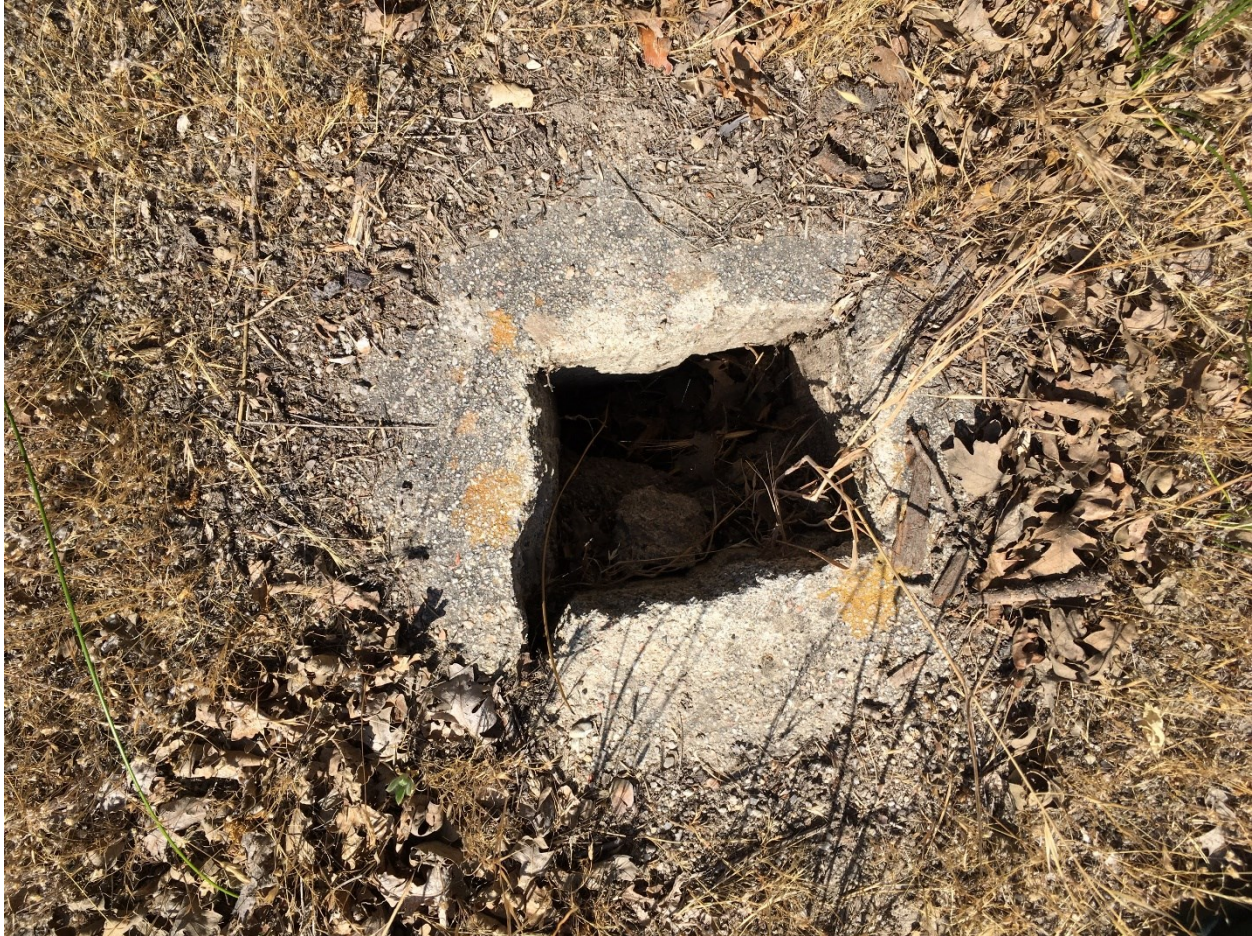
Buildings and Structures #9 Concrete socket of 1940s flagpole, located in front of the Bear Valley Schoolhouse. (NPS, June 2020)
