National Park Service  
Cultural Landscapes Inventory

Munising Range Lights Station  
Pictured Rocks National Lakeshore

**Inventory Unit Name:** Munising Range Lights Station

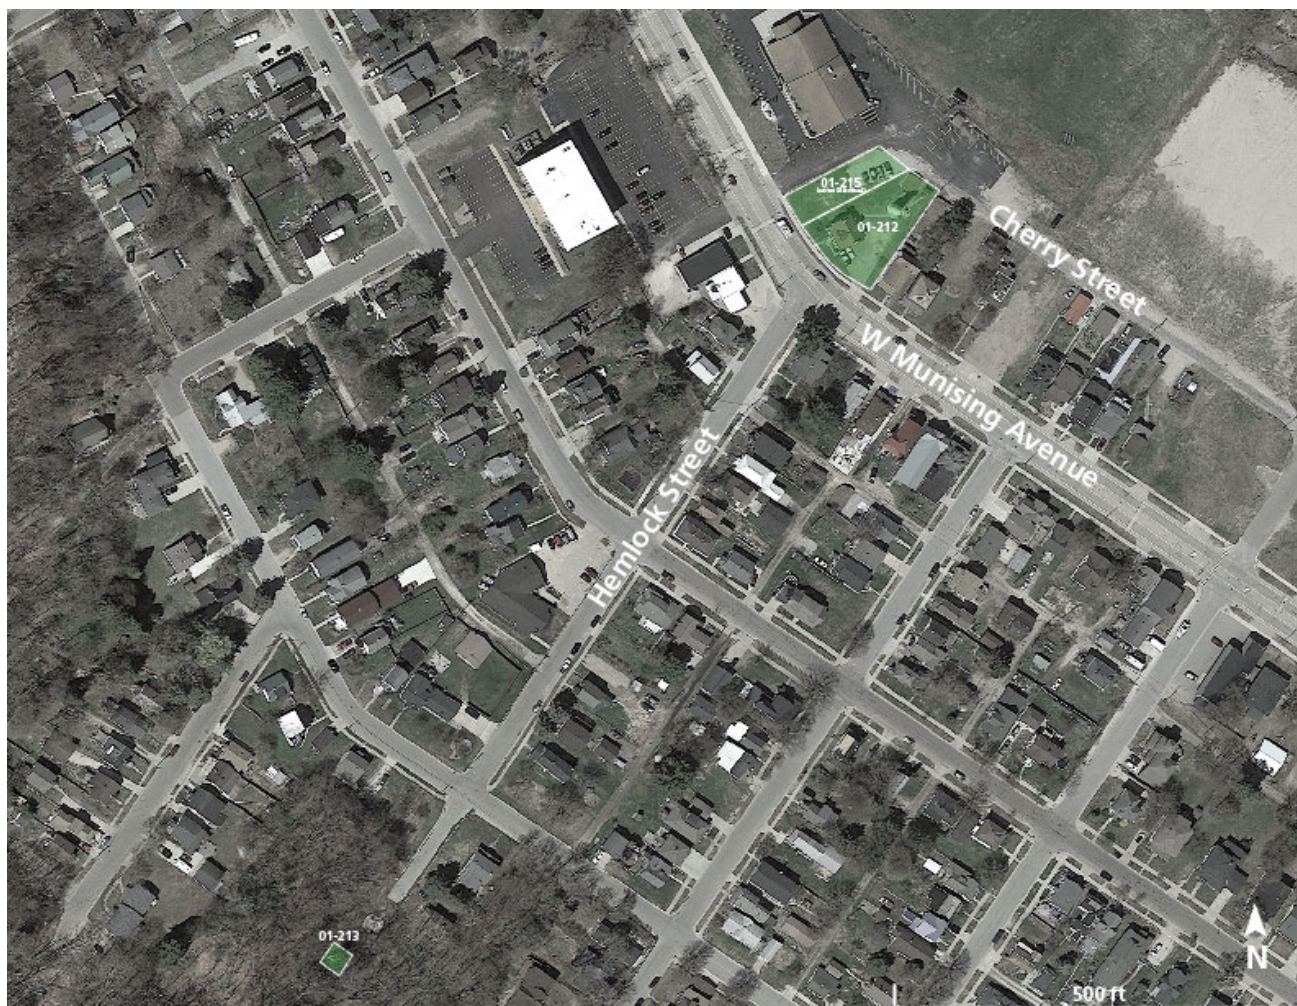
*Munising Range Lights Station cultural landscape - tract relationship (DOI Regions 3, 4, 5 Lands Division, edited by L. Edwards 2020)*

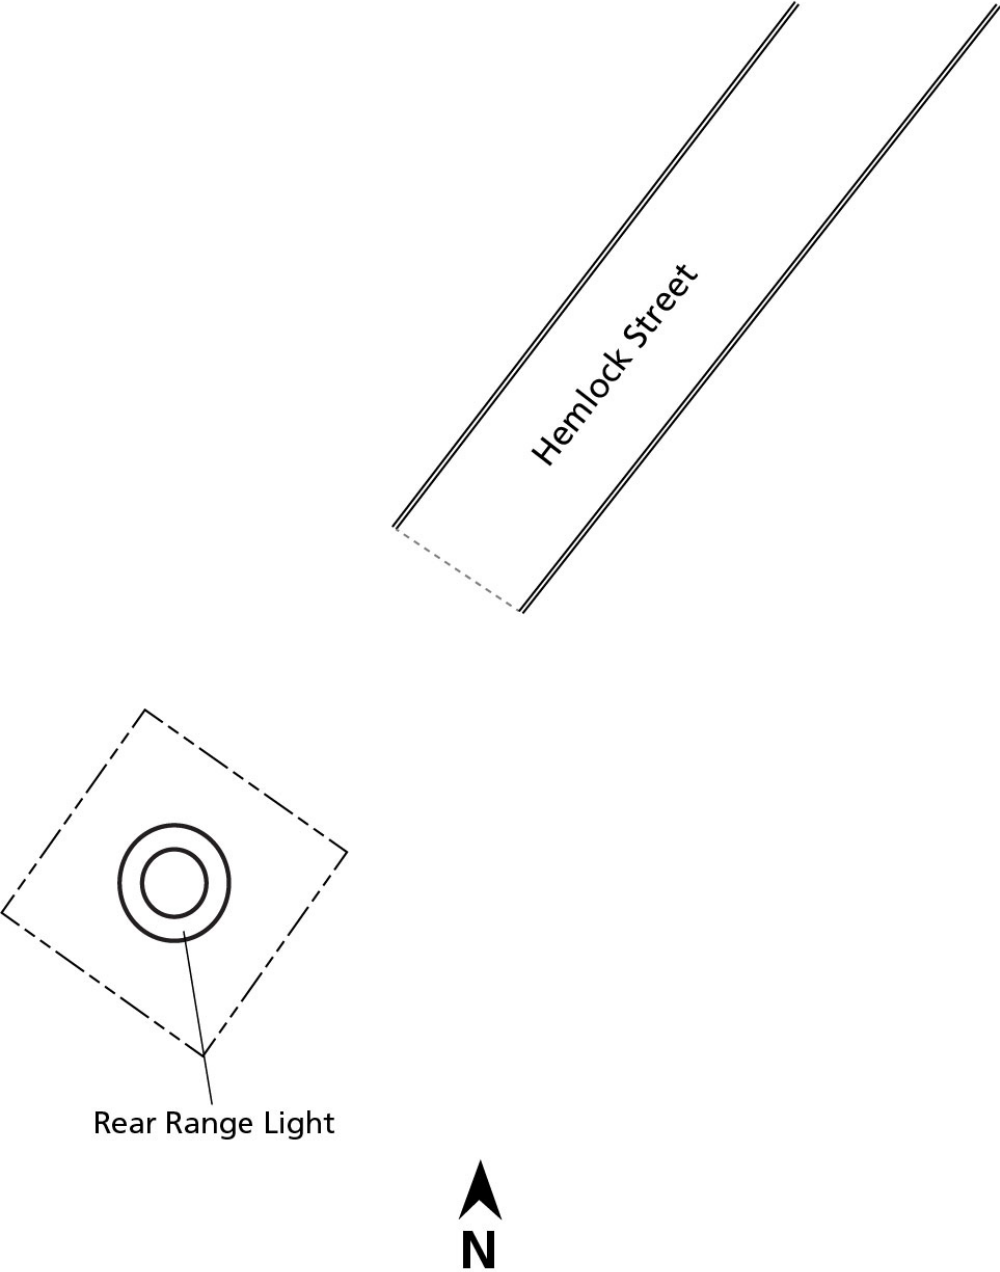
*Munising Range Lights Station cultural landscape - Rear Range Light Site Plan with 2020 conditions  
(NPS/Edwards 2020)*

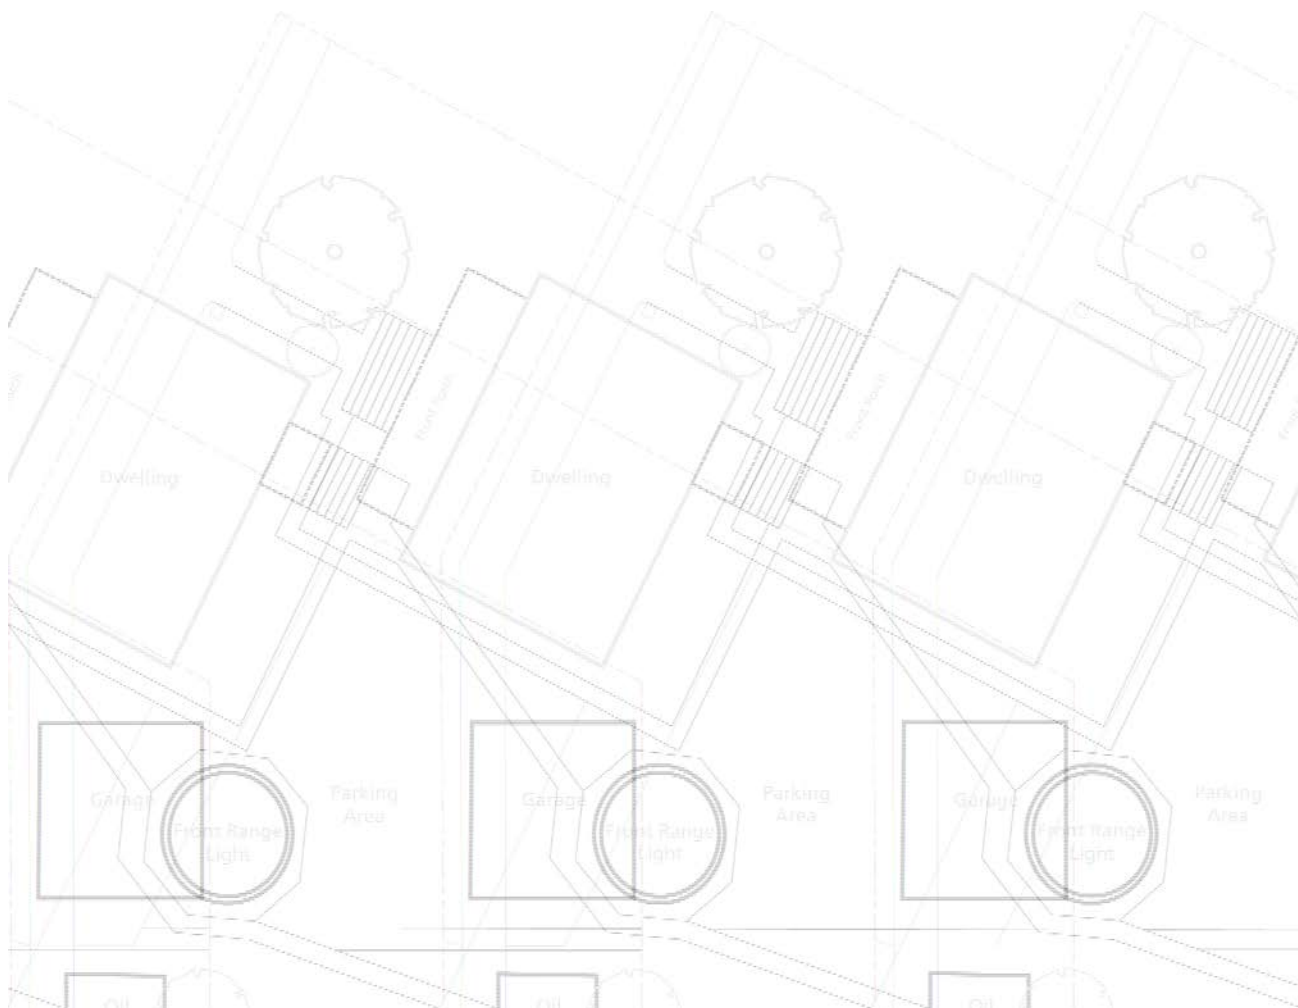
*Munising Range Lights Station cultural landscape - Front Range Light Site Plan with 2020 conditions  
(NPS/Edwards 2020)*

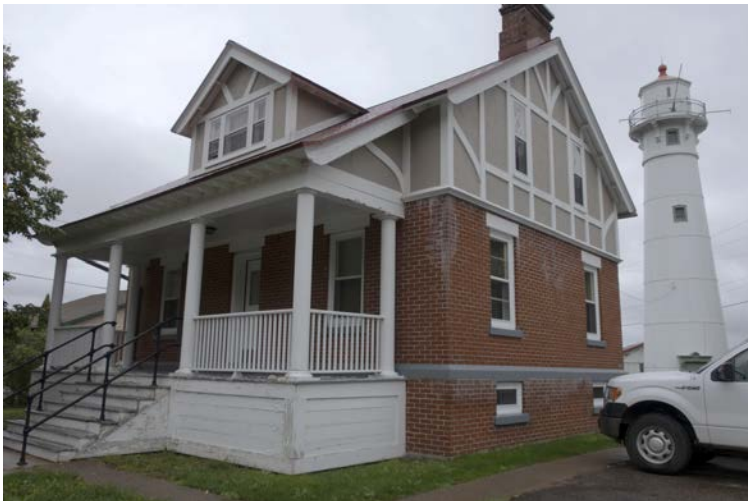
The historical integrity of the buildings are high. While repairs like repainting and replacing material is needed, especially on the dwelling and garage, overall the condition of the features is good.

*Dwelling (NPS/Edwards 2019)*

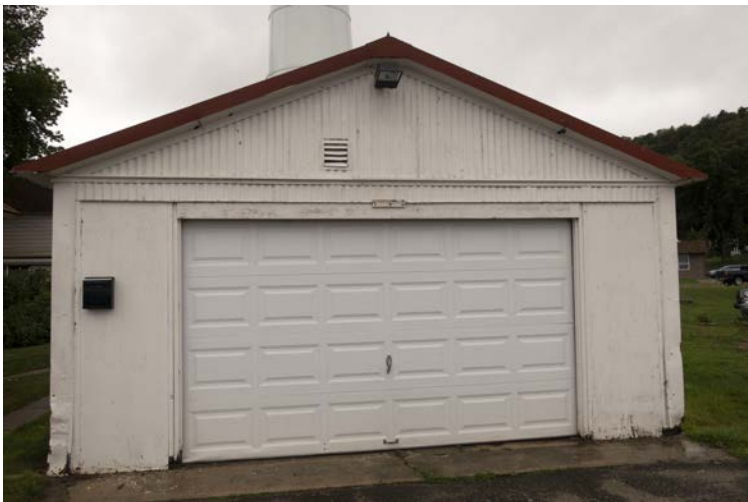
*Garage (NPS/Edwards 2019)*

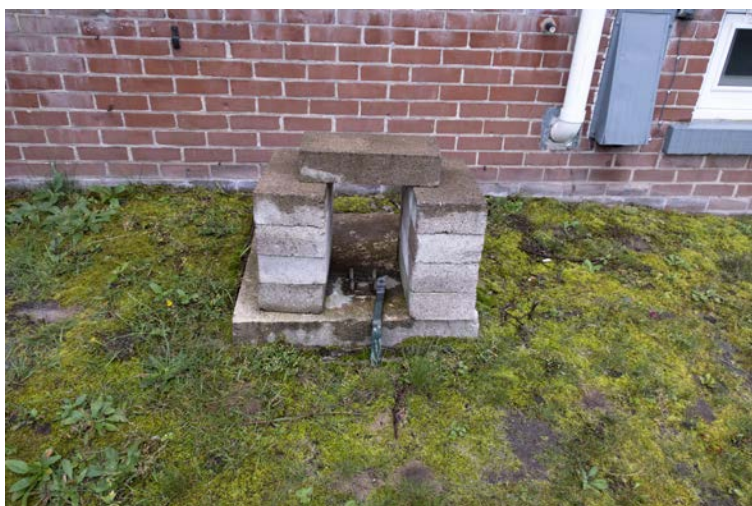
In site plans from 1966, there is an antenna and coupler on the west side of the dwelling. It is also depicted in plans from 1991. Presently there is not antenna on site. However, the concrete foundation for it remains on the west side of the dwelling.

*VHF antenna foundation remnants (NPS/Edwards 2019)*

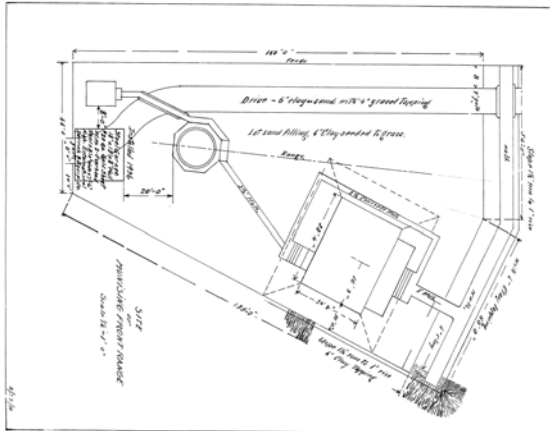
RHL 1015416

Site Plan of Front Munising Range Light - Drawn in 2010 (USCG Archives)

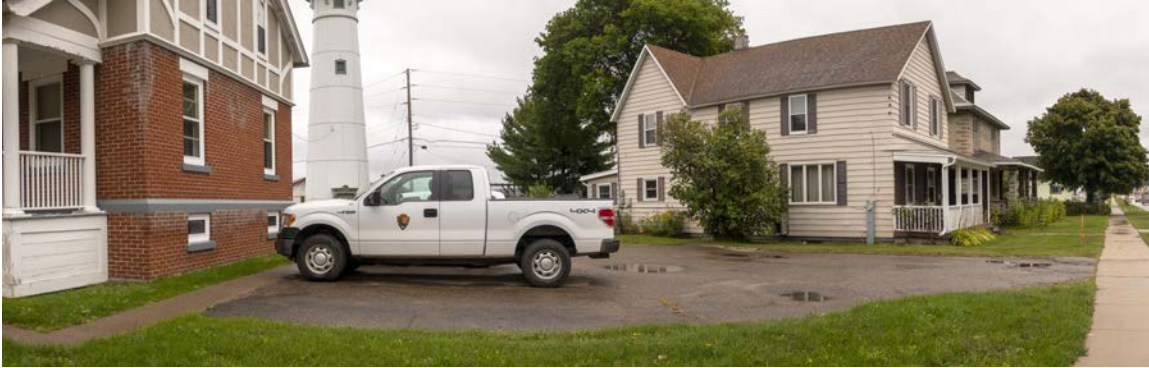
The historical integrity of the circulation features is moderate to high. Overall the walkways and parking area are in fair condition.

*Parking area east of dwelling (NPS/Edwards 2019)*

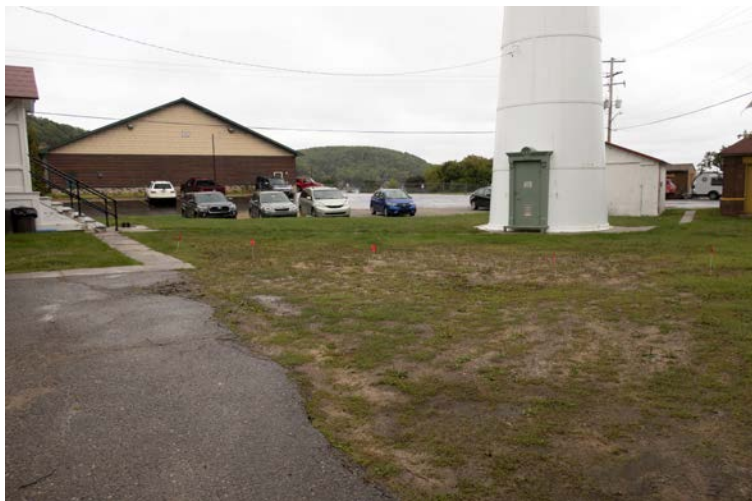
With such a long period of significance, and small amount of supporting documentation for the Station, the vegetation may have changed many times. Therefore, it is difficult to accurately assess historic integrity. The lawn and upland forest were consistent over time. Overall, the level of historic vegetation integrity is retained. The non-contributing features with the lawn and forest create a fair condition.

*Lawn with patchy sandy soil exposed (NPS/Edwards 2019)*
