National Park Service  
Cultural Landscapes Inventory  
2009

Point Reyes Lighthouse  
Point Reyes National Seashore

MANAGEMENT CATEGORY: **A: Must be Preserved and Maintained**

CONDITION ASSESSMENT: **Fair**

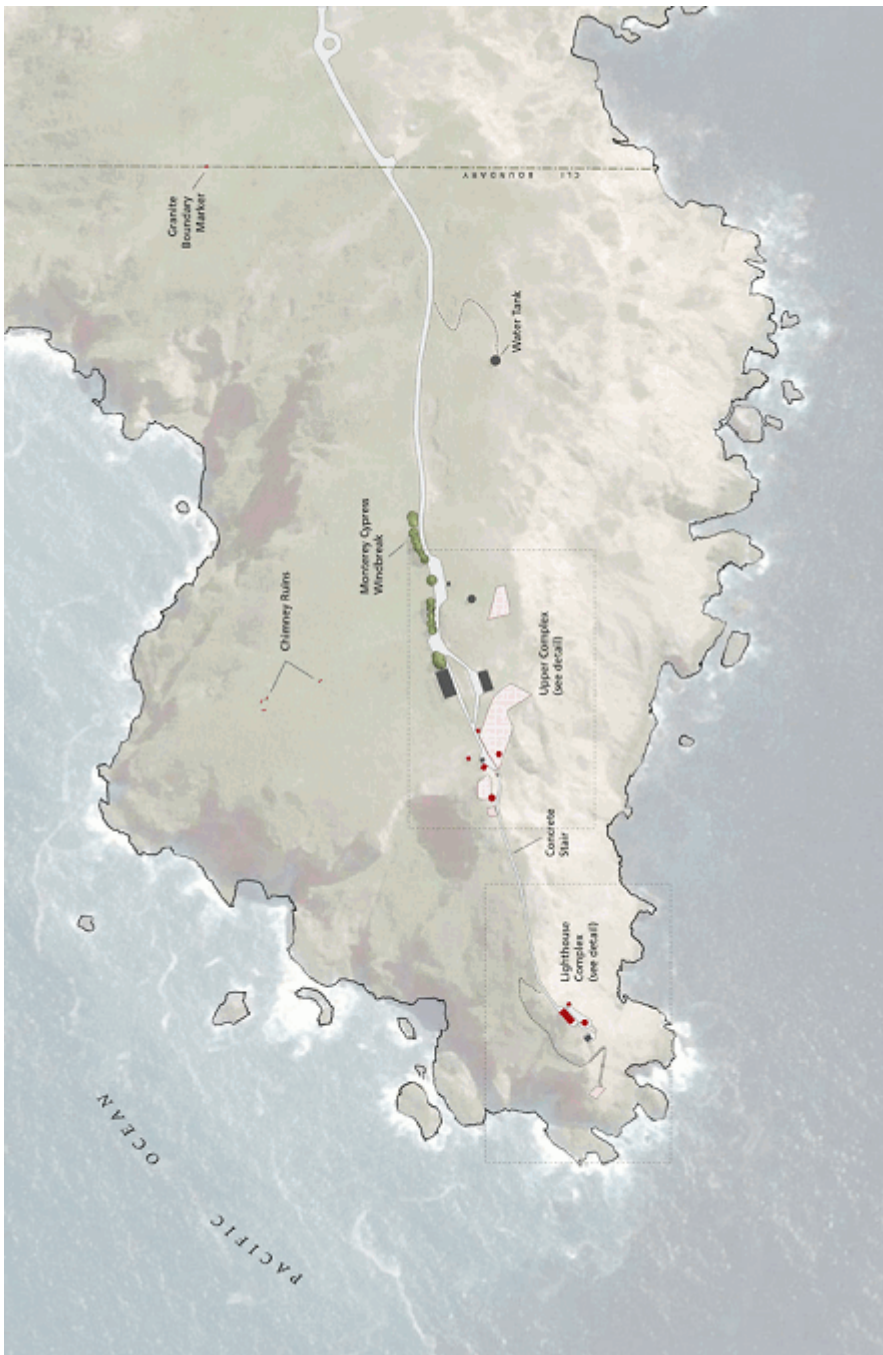
## Site Plan

*Point Reyes Light Station existing conditions map.*

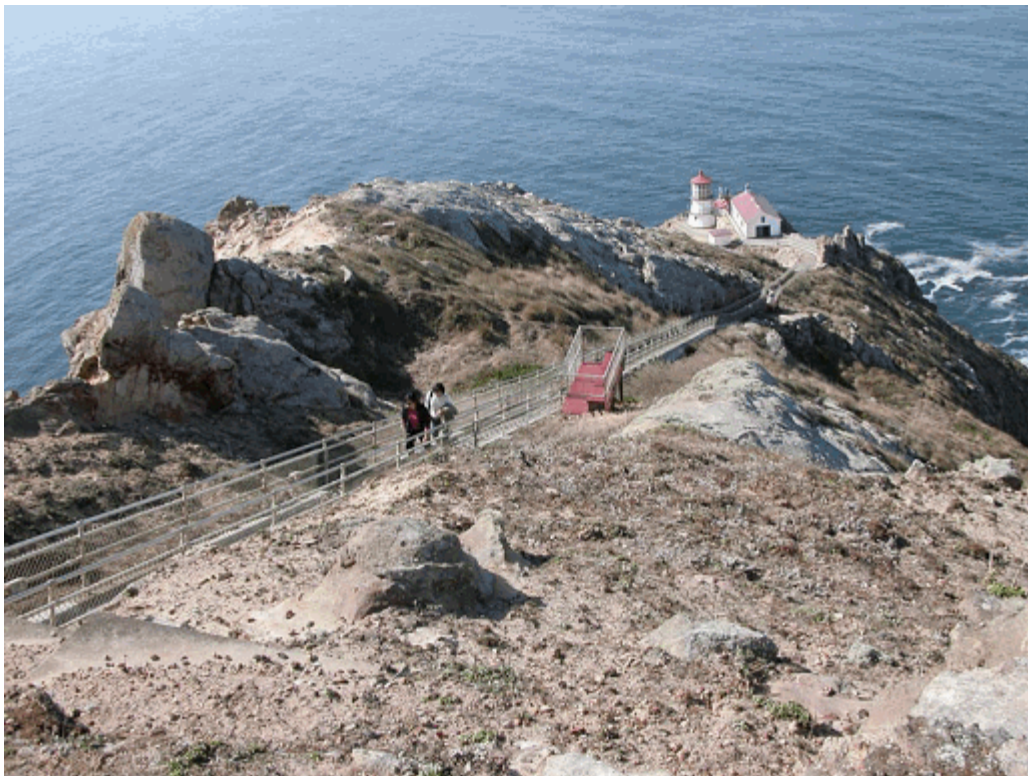
*Figure 1. View of linear path down to the Lighthouse, the Equipment Building and the Transformer Building also visible in the distance*

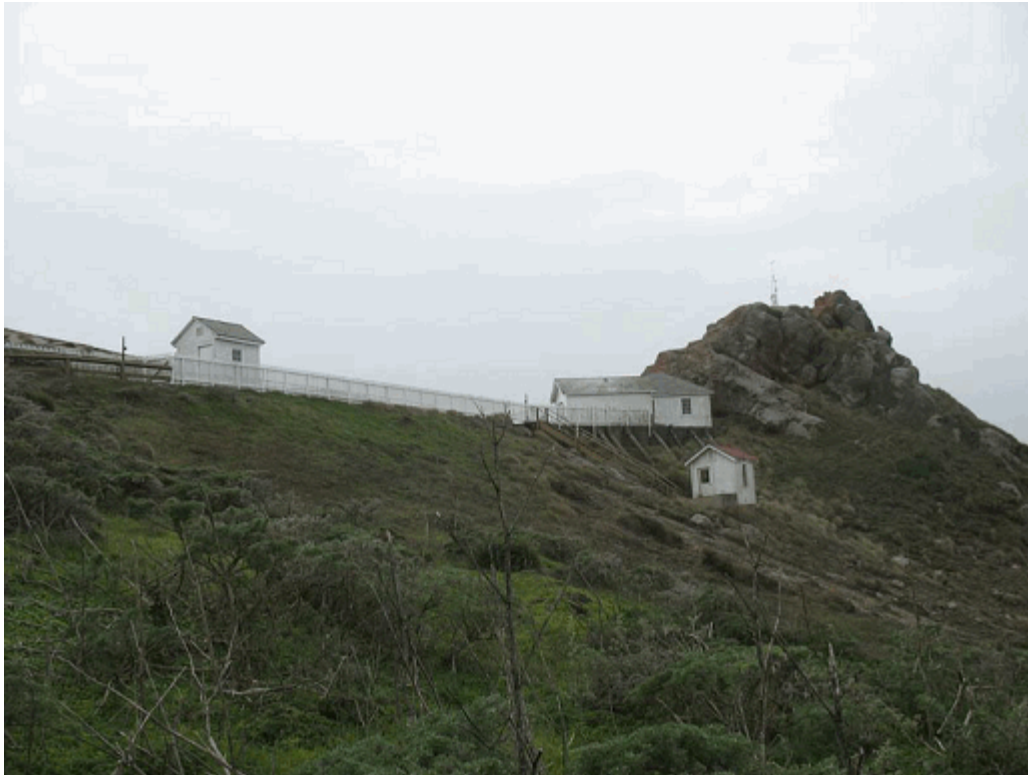
*Figure 2. View of linear development of the site, the Multi-Purpose Building (now the Visitor Center) visible in the center*

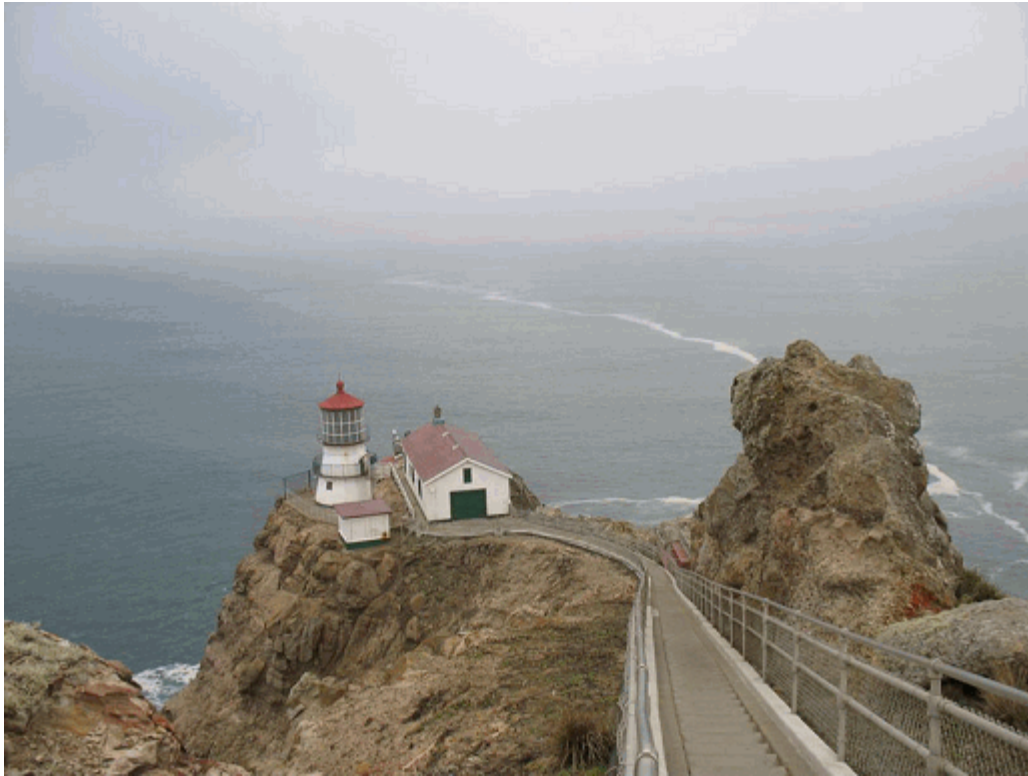
*Figure 3. View from the Overlook of the cluster of buildings at the Lighthouse, the rocky outcropping at right is a remnant resulting from intensive blasting at the site*

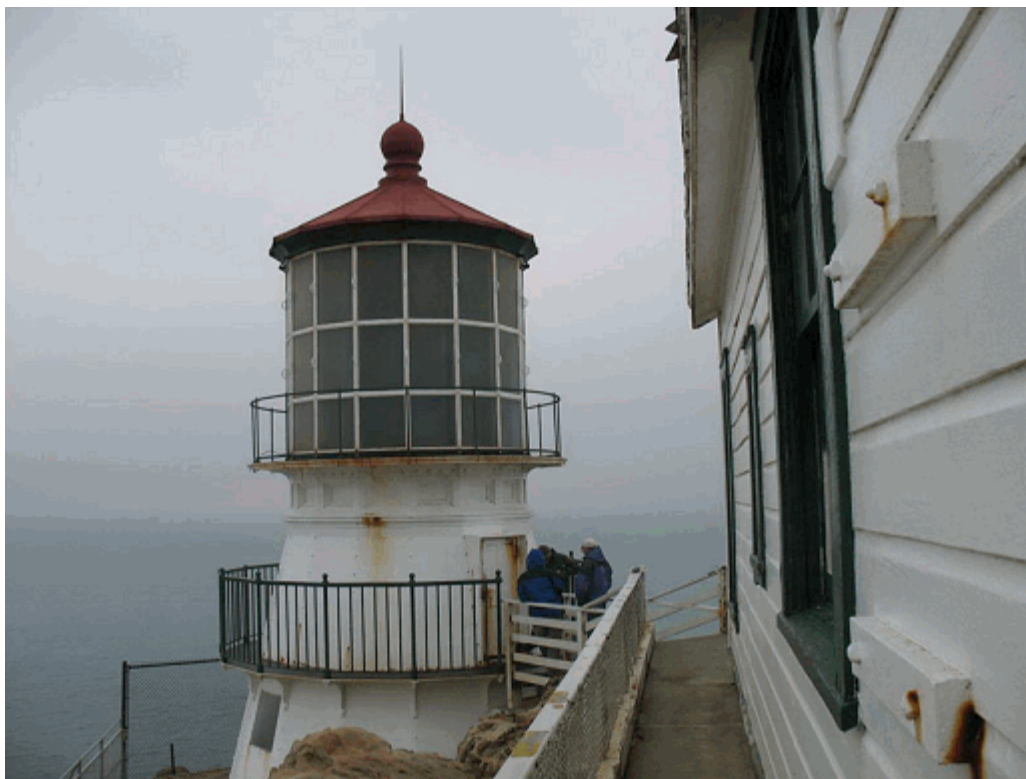
suited to California's rocky shoreline. The lantern, the glazing of which has been replaced with Plexiglas, is topped with an iron and copper roof. A pair of narrow balconies encircles the exterior of the tower at the first and second levels. Not only the centerpiece of the site, the lighthouse tower is the oldest remaining structure at the light station and retains a high level of architectural integrity. (No. 5, Historic Base Map, Toogood).

*Figure 4. View of the Lighthouse Tower, the side of the Equipment Building is visible at the right*

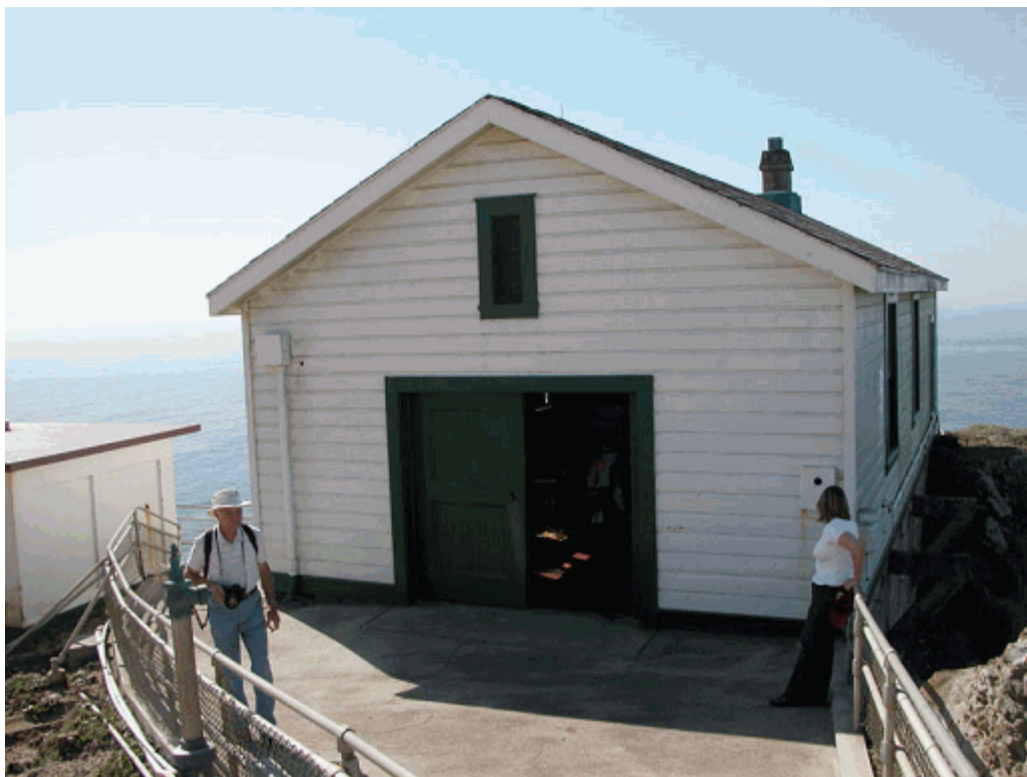
Also referred to in the National Register nomination as the Power House/Equipment Building/Fog Signal Building, the Equipment Building, a single-story, wood-frame structure, was the third building to occupy this site (Figure 5). The first structure, an equipment shed (1870), was replaced by a coal and oil storehouse built in 1889, which was in turn demolished in 1928. (HSR, p. 19). The Equipment Building was intended to house the machinery to operate the fog signal at the lower terrace of the site, 100 feet below. Though modified, it retains a high level of architectural integrity and contributes to the significance of the site. (No. 6, Historic Base Map, Toogood).

*Figure 5. View of the Equipment Building, the Transformer Building is visible at the left*

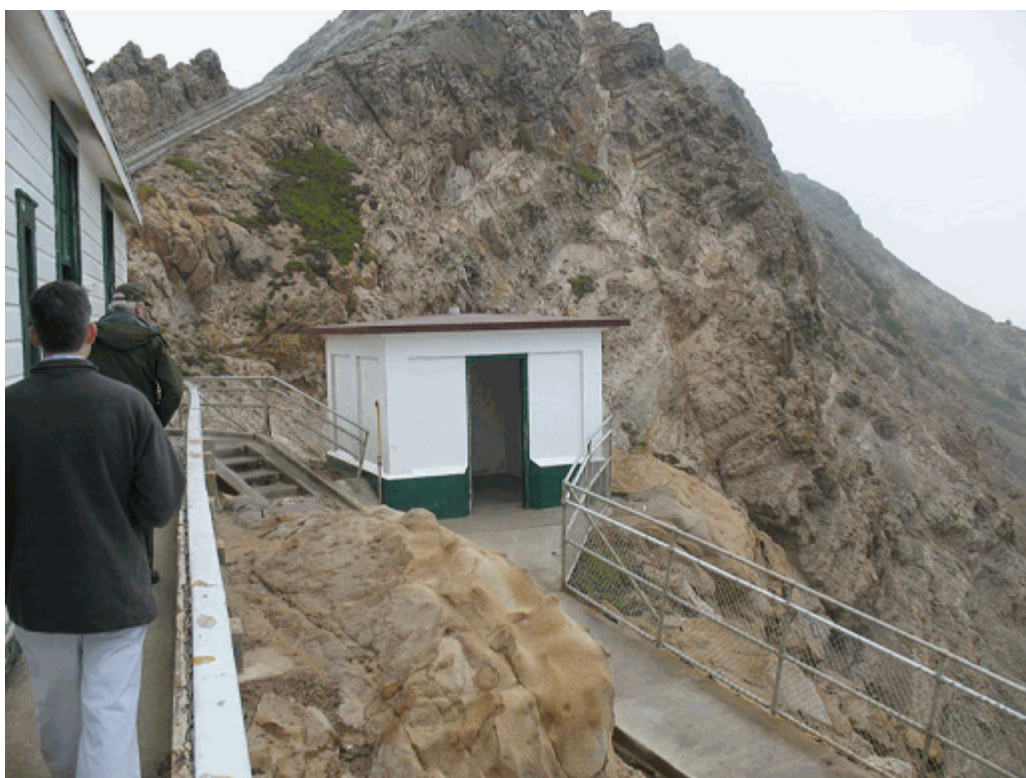
*Figure 6. View of the Transformer Building, the Equipment Building is visible at the left and the Concrete Stairway is in the background*

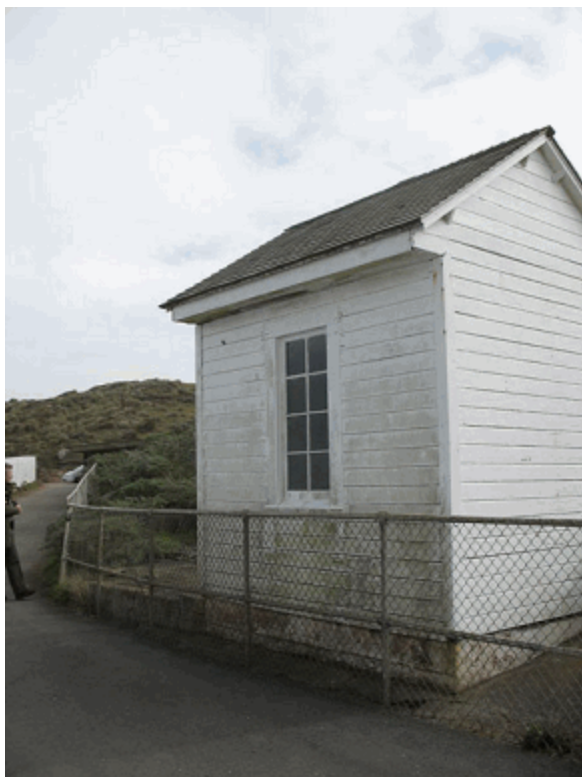
This small-scale, single-story, utilitarian building with a gabled roof is of wood-frame construction (Figure 7) and was intended as a storehouse for fuel and oil. Located immediately adjacent to the road, it has a brick and concrete foundation and measures 6 x 8 feet. It is presently surrounded by a non-contributing chain link fence. (No. 20, Historic Base Map, Toogood).

*Figure 7. View of Fuel and Paint Storage Building*

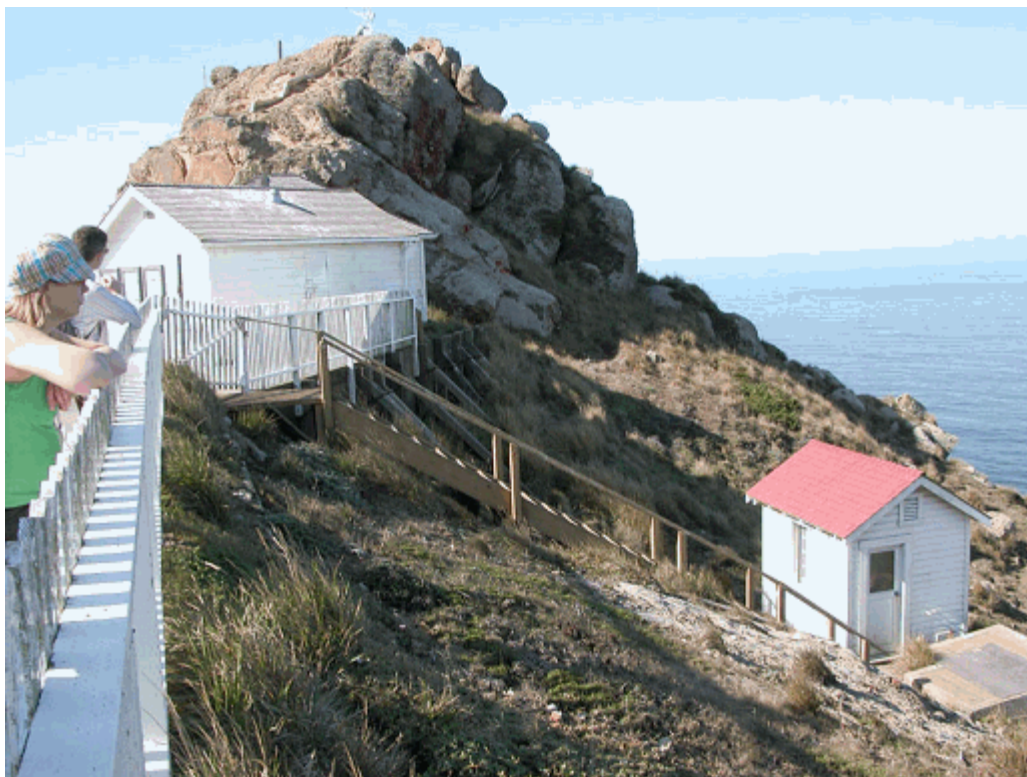
This small-scale, single-story, utilitarian building with a gabled roof is of wood-frame construction and measures 6 x 8 feet (Figure 8). Although the building appears to be in the same location as a pump house shown in historic documents, it is in very good condition and may be a replacement structure of a similar size. No documentation has been found that confirms this however. (No. 19, Historic Base Map, Toogood).

*Figure 8. View of the 1934 Pump House with Multi-Purpose Building visible to the left*

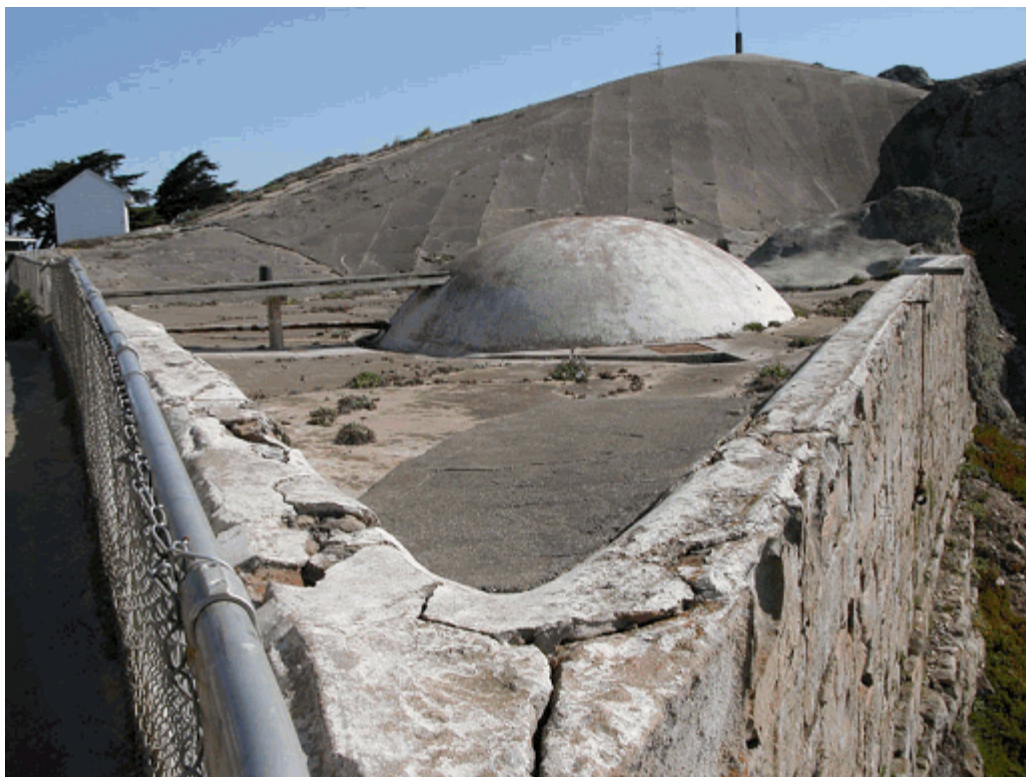
*Figure 9. View of 10,000 sf Watershed and Cistern with dome visible in the center*

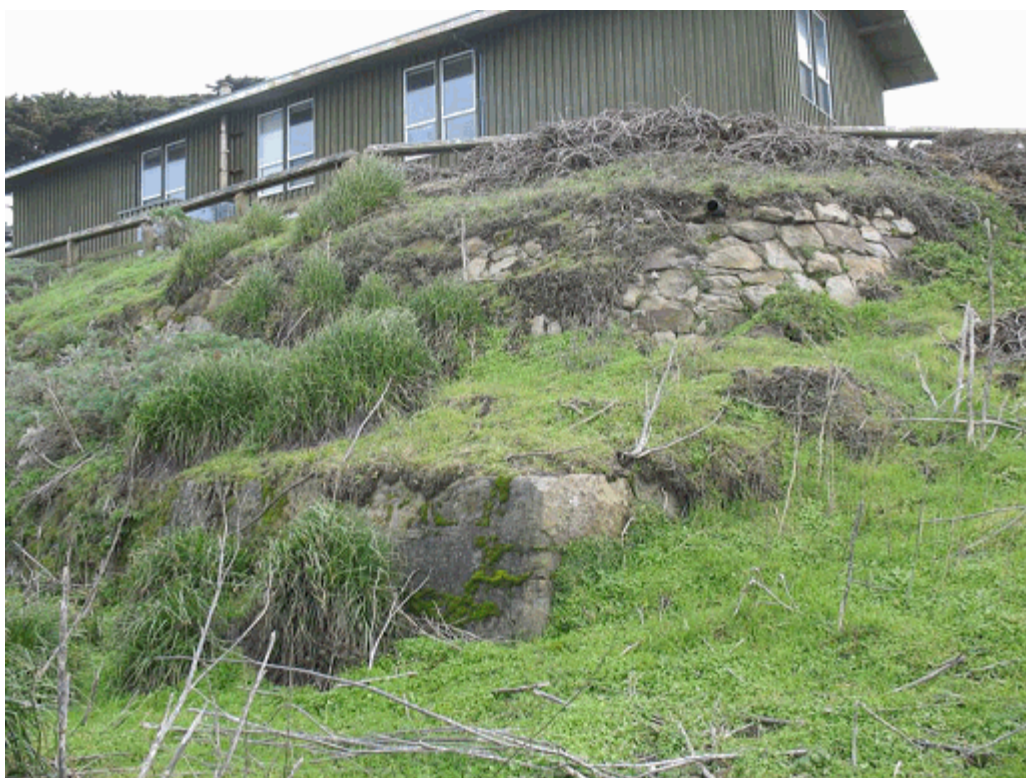
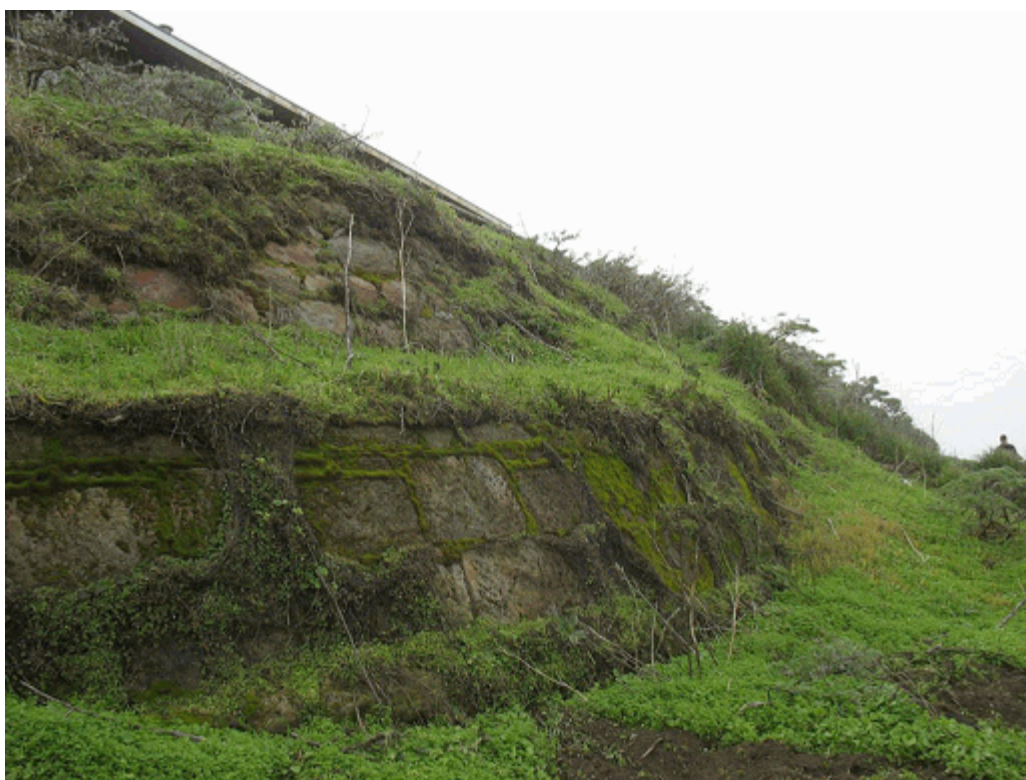
Constructed in 1870, the two-tiered retaining wall behind the site of the keepers' dwelling measures 217 feet in length (Figures 10 and 11). It was constructed of granite with concrete repairs that were scored to maintain the look of faced stone.

*Figure 10. View of two tier retaining wall below Multi-Unit Residence*

*Figure 11. View of two tier retaining wall below Multi-Unit Residence*

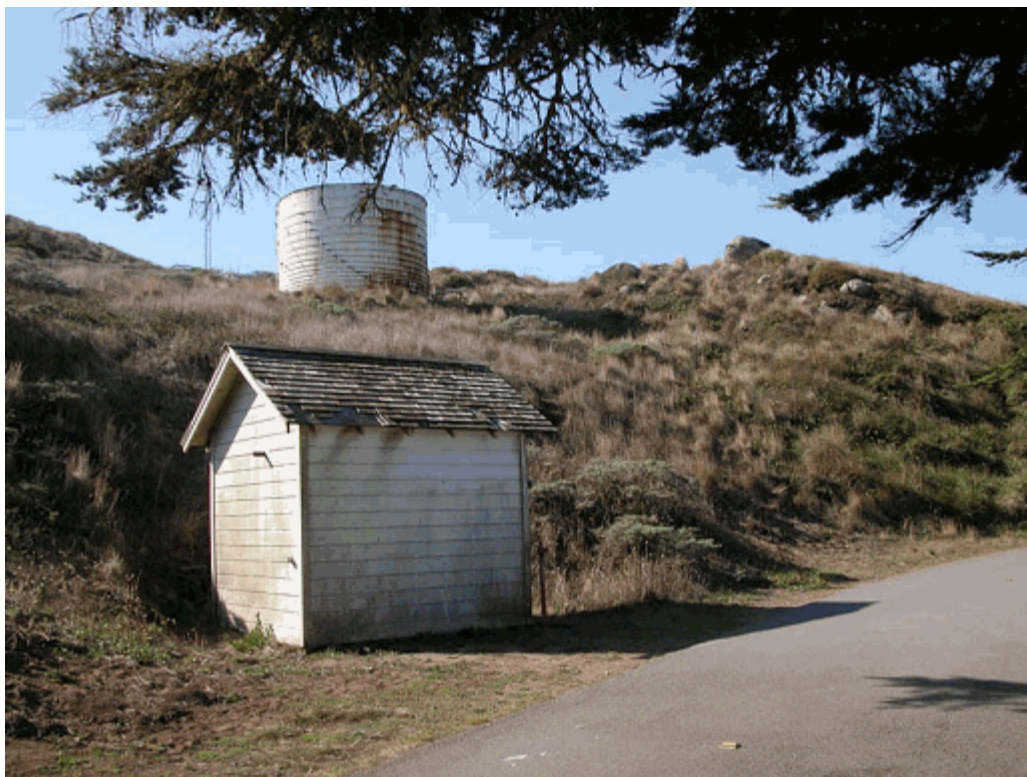
A wood water tank (Figure 12) is located on the east side of the road that divides the reservation site. Although the structure appears to be in the same location as a water tank shown in historic documents, it is in good condition and may be a replacement structure. No documentation has been found that confirms this however. (not shown, Historic Base Map, Toogood).

*Figure 12. View of wood Water Tank, with Pump House visible in the foreground*

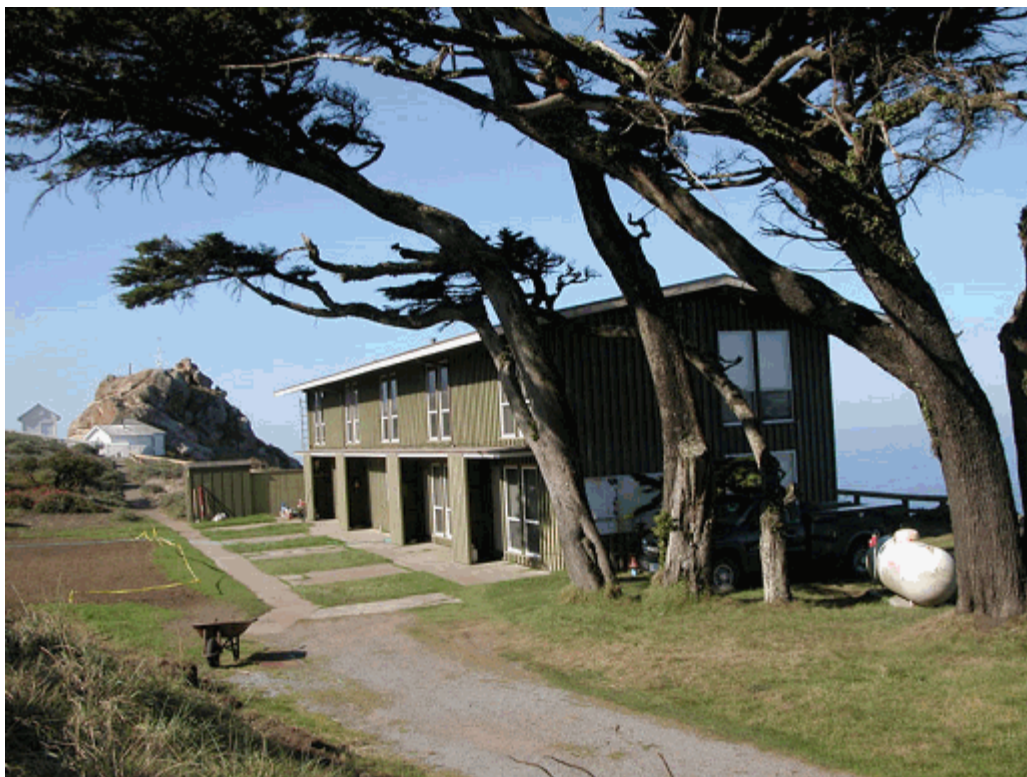
Designed by the San Francisco architectural firm of Wurster Bernardi and Emmons in 1960, this multi-unit, two-story residential apartment building (Figure 13) was erected on the site of the original keepers' dwelling. Of wood-frame construction, it was designed as family quarters for Point Reyes Light Station. Since an intensive survey or evaluation of any specific building was outside the scope of this project, it has not been fully evaluated. The building retains its original use and some level of architectural integrity, even though the windows were replaced in 1995. (No. 25, Historic Base Map, Toogood).

*Figure 13. View of the Multi-Unit Residence, the Multi-Purpose Building is visible in the background*

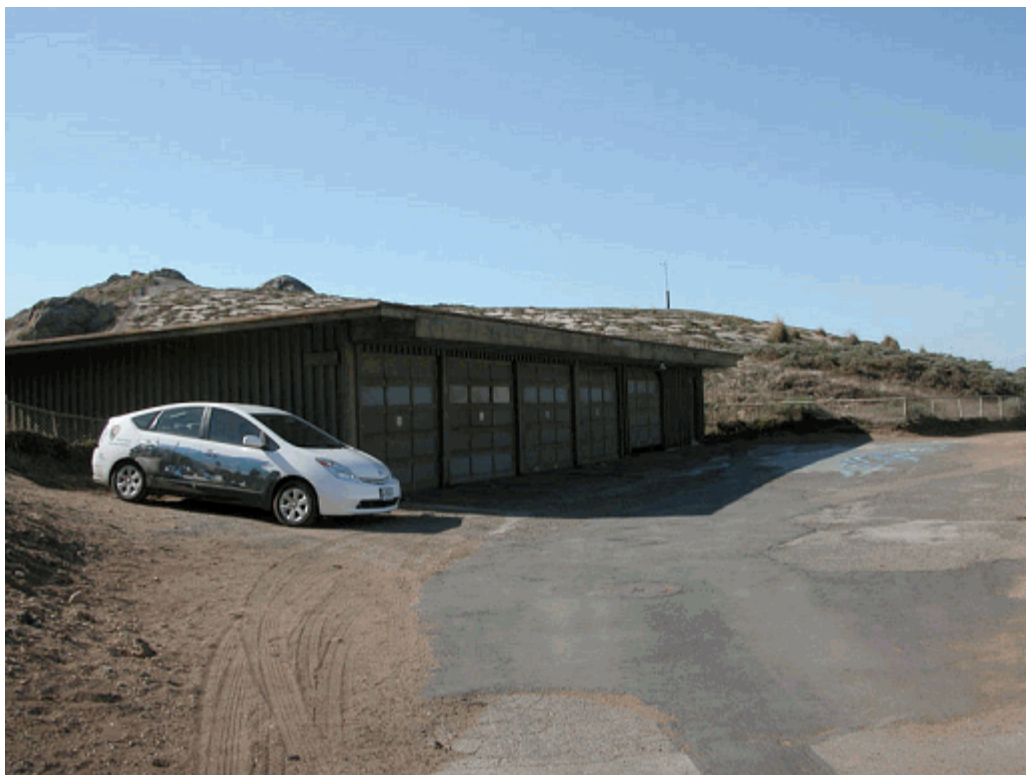
*Figure 14. View of the Garage / Shop Building*

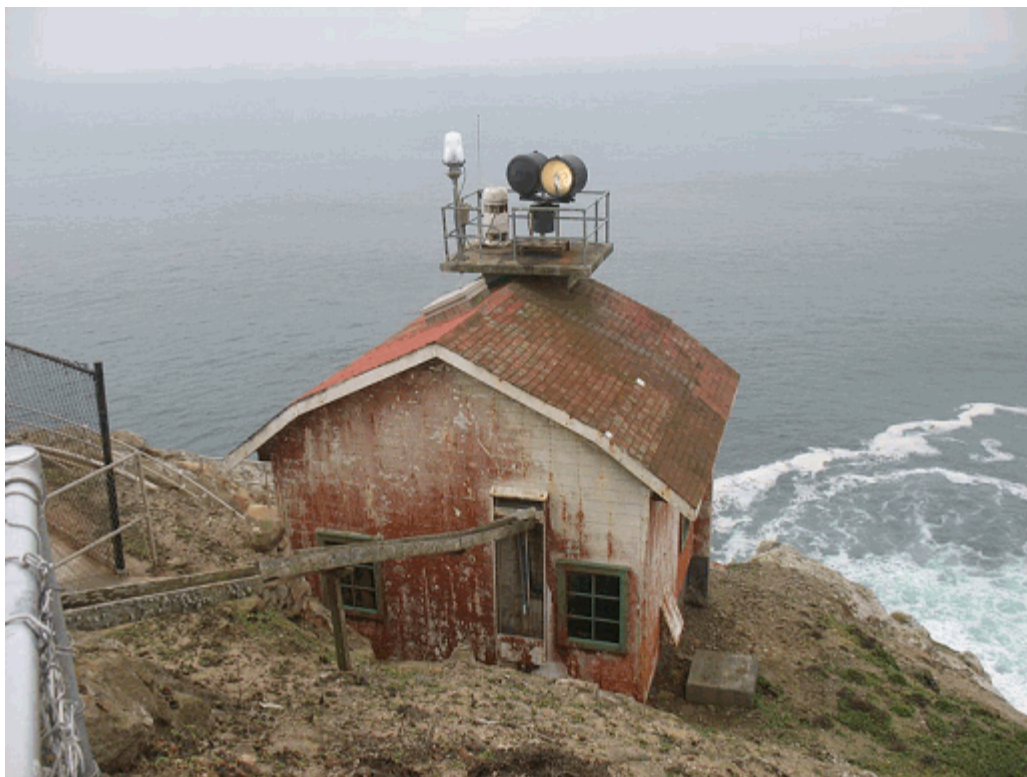
*Figure 15. View of the Navigational Aids Building*

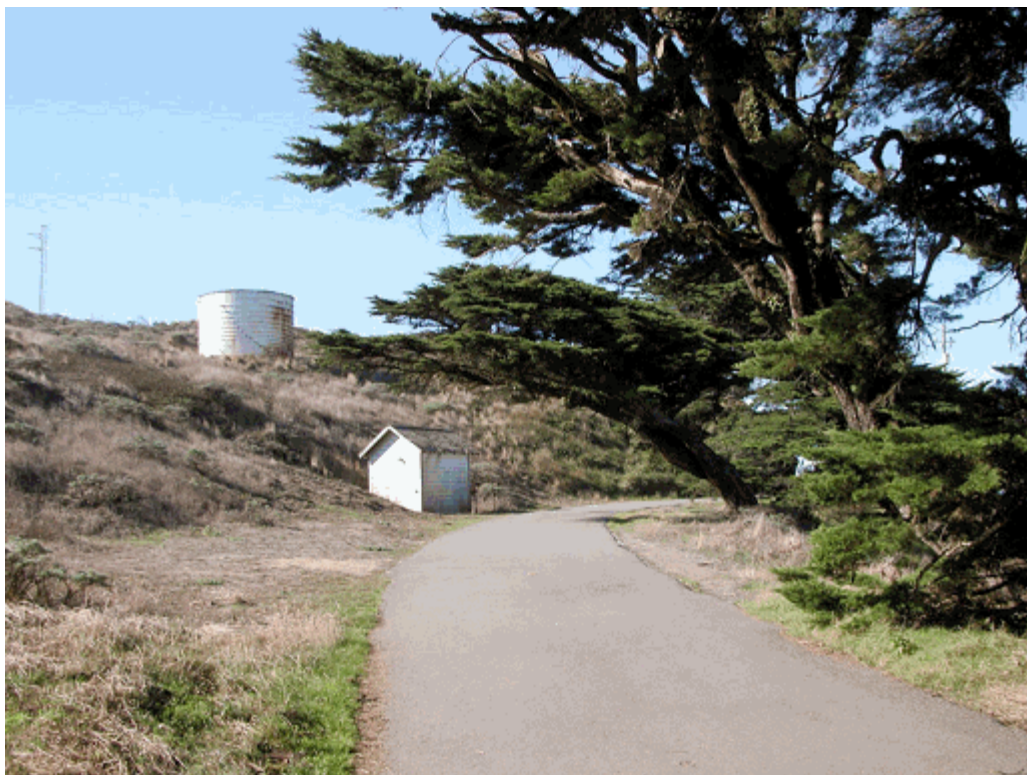
*Figure 16. View of easternmost Pump House, with wood Water Tank visible in background*

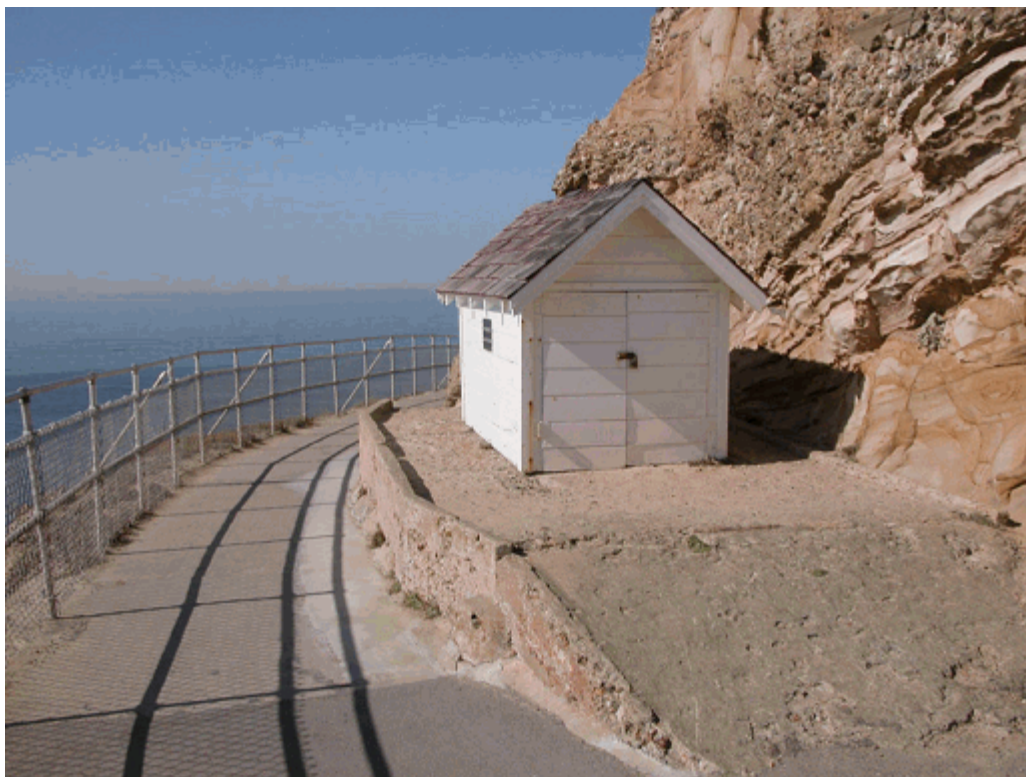
Located at the base of the rocky outcropping at the top of the concrete stairs, this small-scale wooden feature has a gable sloping roof (Figure 17). It is related to the National Park Service period. The pump house was constructed on the concrete foundation of the Weather Bureau garage. It is non-contributing due to its date of construction. (not shown, Historic Base Map, Toogood).

*Figure 17. View of westernmost Pump House, near top of Concrete Stairway*

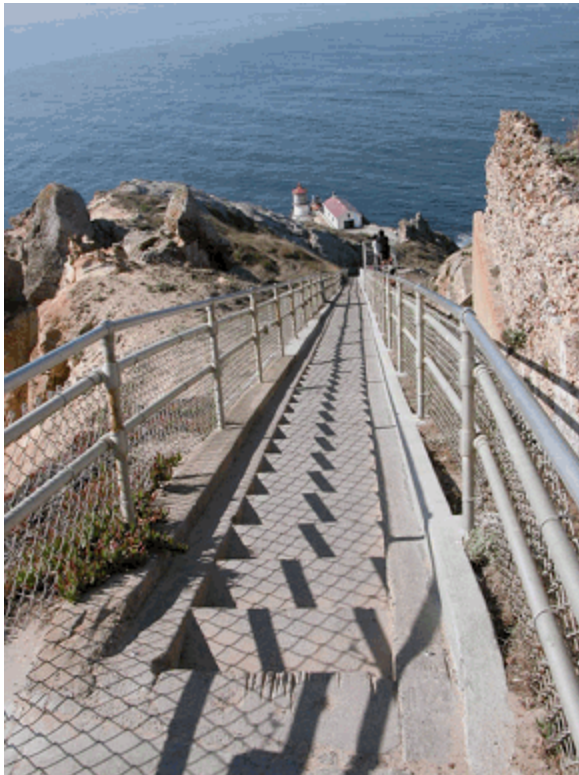
The original stairway to the lighthouse was a wooden structure. It remained in use with repairs until 1959 when it was removed and a new concrete stairway with ramps was installed (Figure 18). The new stairway follows the route of the original stair. (No. 11, Historic Base Map, Toogood).

*Figure 18. View of the Concrete Stairway from the top, the Lighthouse and the Equipment Building are visible in the distance.*

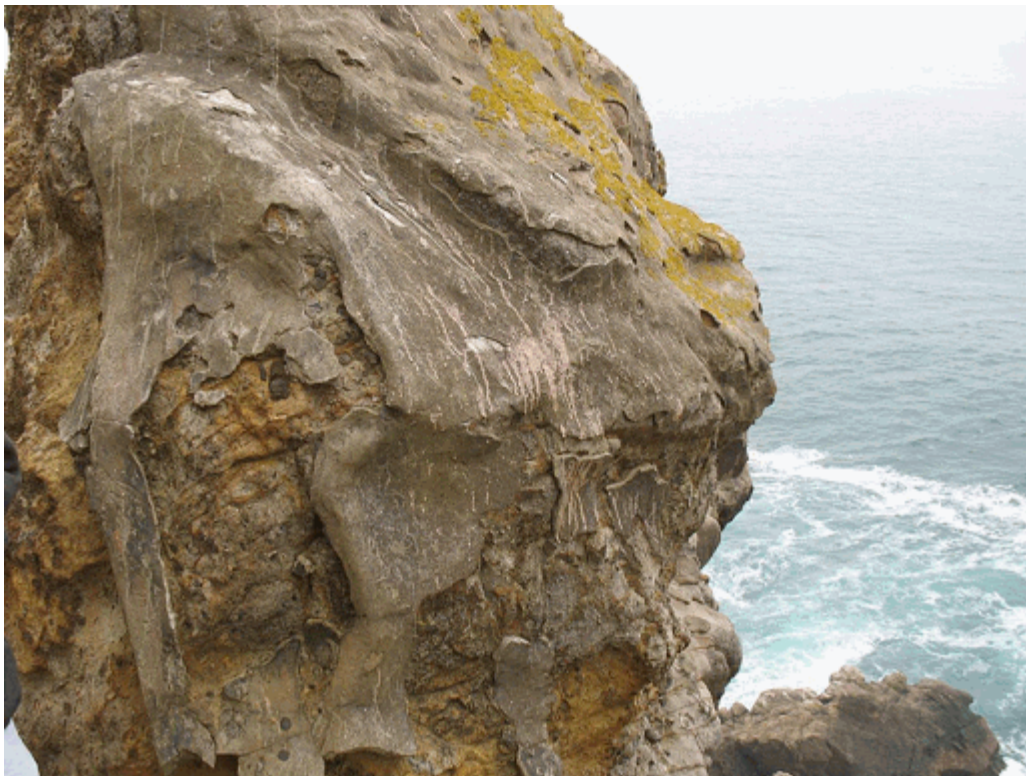
fog signal at the terrace below the lighthouse, unstable overhanging rocks required further blasting. Toogood notes that when the overhanging rocks were blasted away from the fog signal site in 1877, the face of the vertical rock was cemented as a safety measure. Further, in 1934, rockslides caused by intensely vibrating machinery required the slope to be stabilized with many tons of cement.

*Figure 19. View of cementitious coat used as erosion measure*

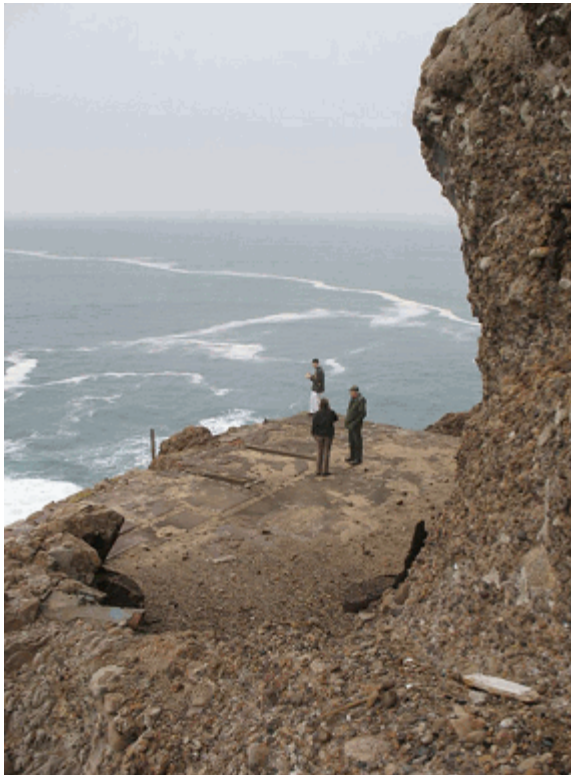
*Figure 22. View of the site of the Fog Signal Building*

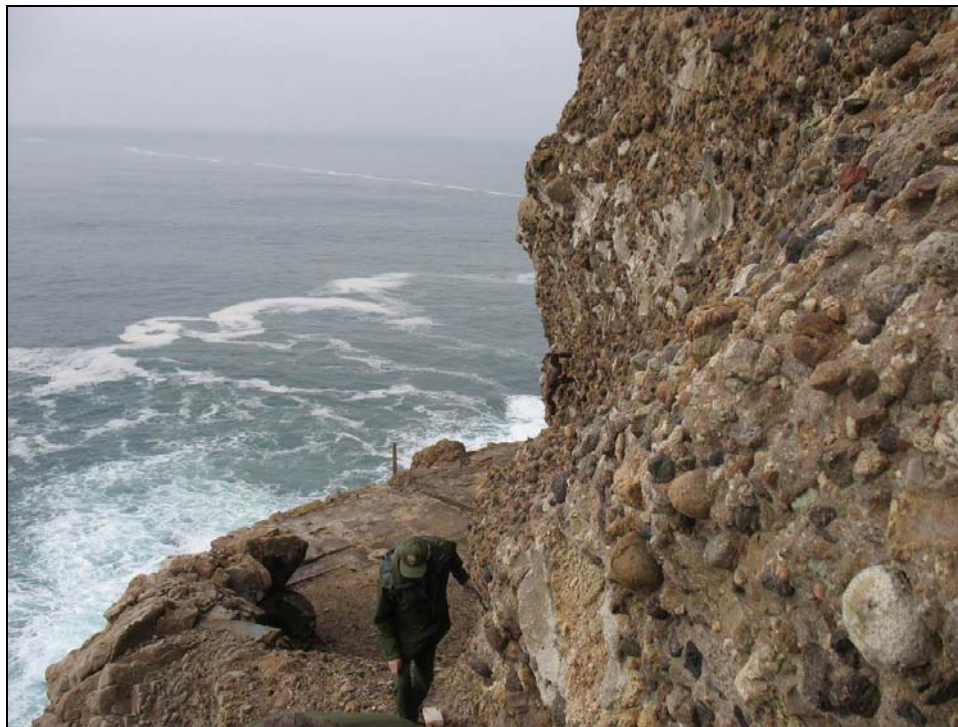
**Figure 1. View of the Fog Signal terrace formed by blasting at elevation below the Lighthouse**

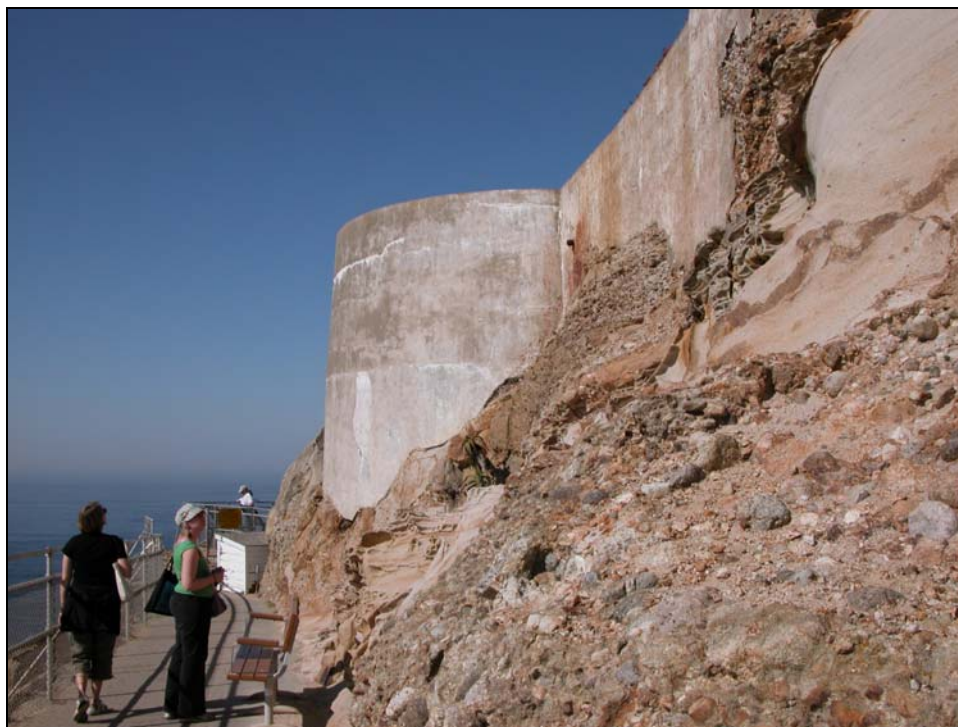
**Figure 2. View of Cistern and Watershed**

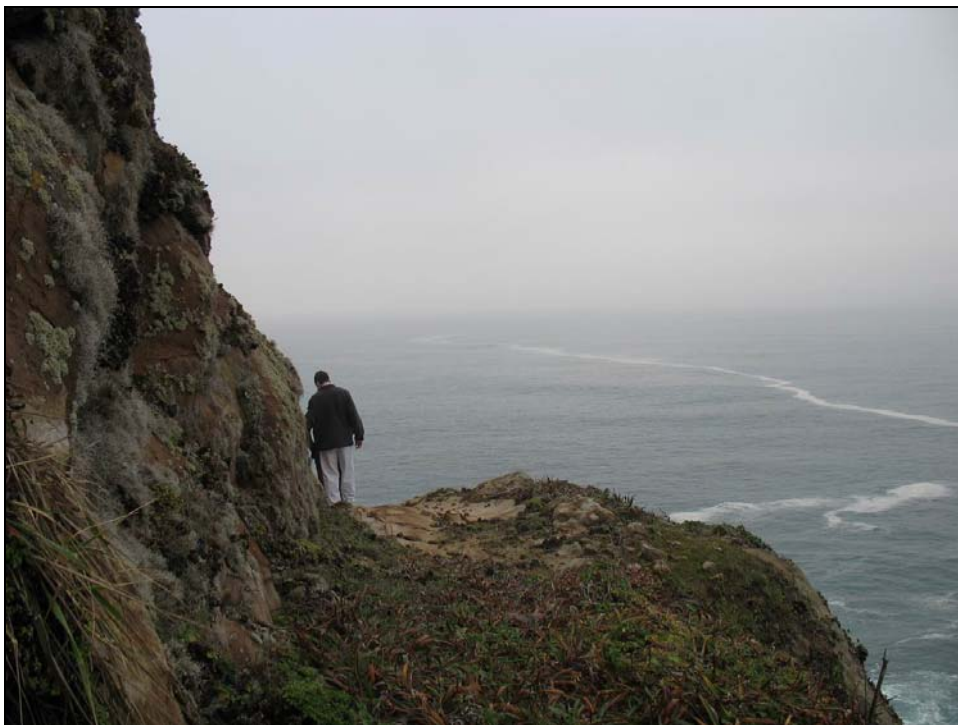
The trail that leads to the old fog signal site remains below the Lighthouse. The trail consists of a winding path that cuts through blasted rock north of the Lighthouse and makes a sharp southward cut down to the old fog signal site below. It is in poor condition, having been minimally used or maintained in recent years.

**Figure 4. View of the Trail to the Fog Signal site**

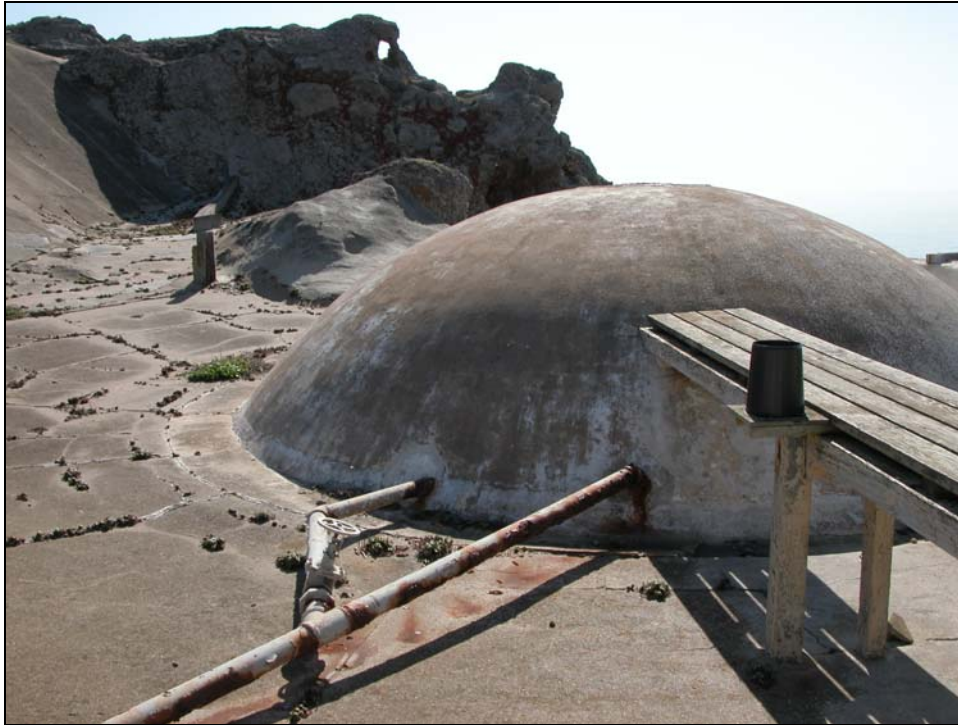
**Figure 5. View of the Water Catchment System**

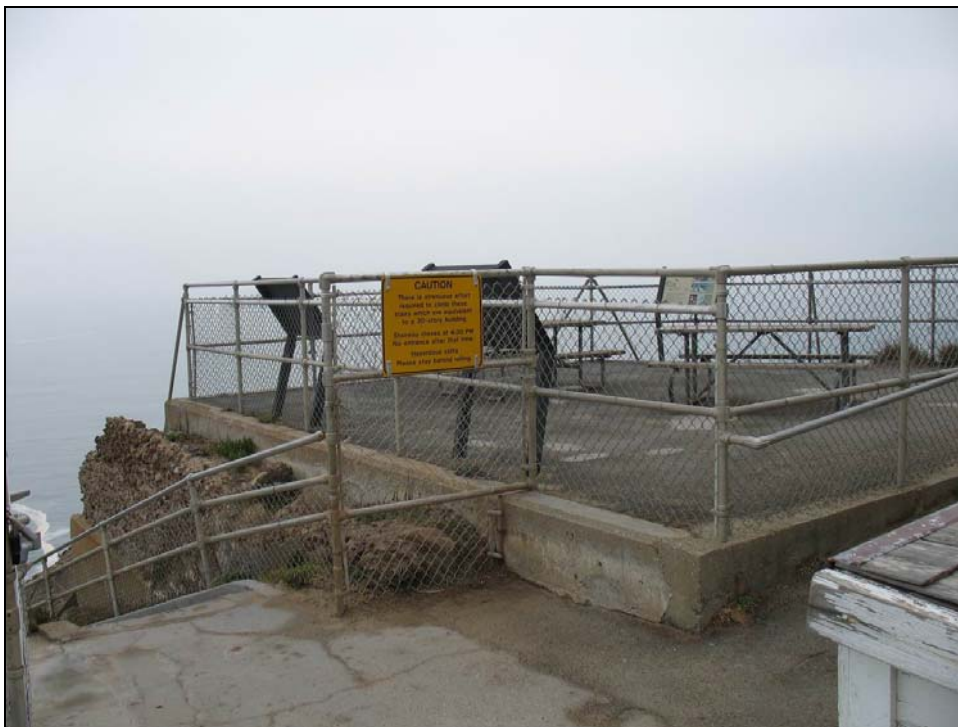
**Figure 6. View of the Overlook / Foundation of the Weather Bureau Building**

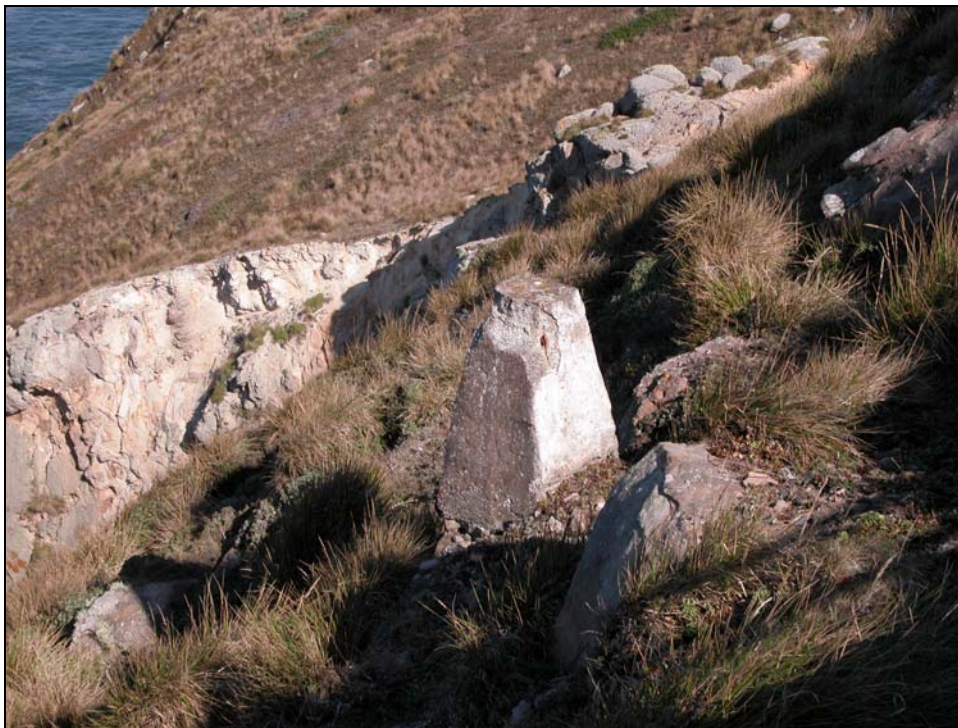
**Figure 14. View of concrete pier remnant**

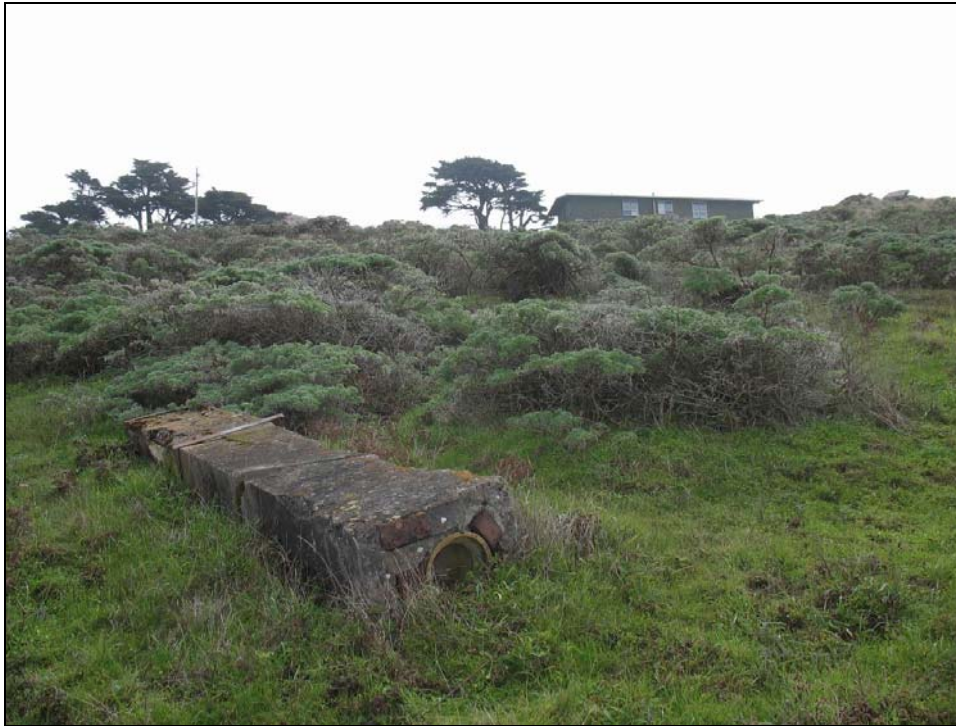
**Figure 15. View of chimney remnant, with Multi-Unit Residence in background**
