National Park Service  
Cultural Landscapes Inventory  
2009

Point Reyes Lighthouse  
Point Reyes National Seashore

MANAGEMENT CATEGORY: **A: Must be Preserved and Maintained**

CONDITION ASSESSMENT: **Fair**

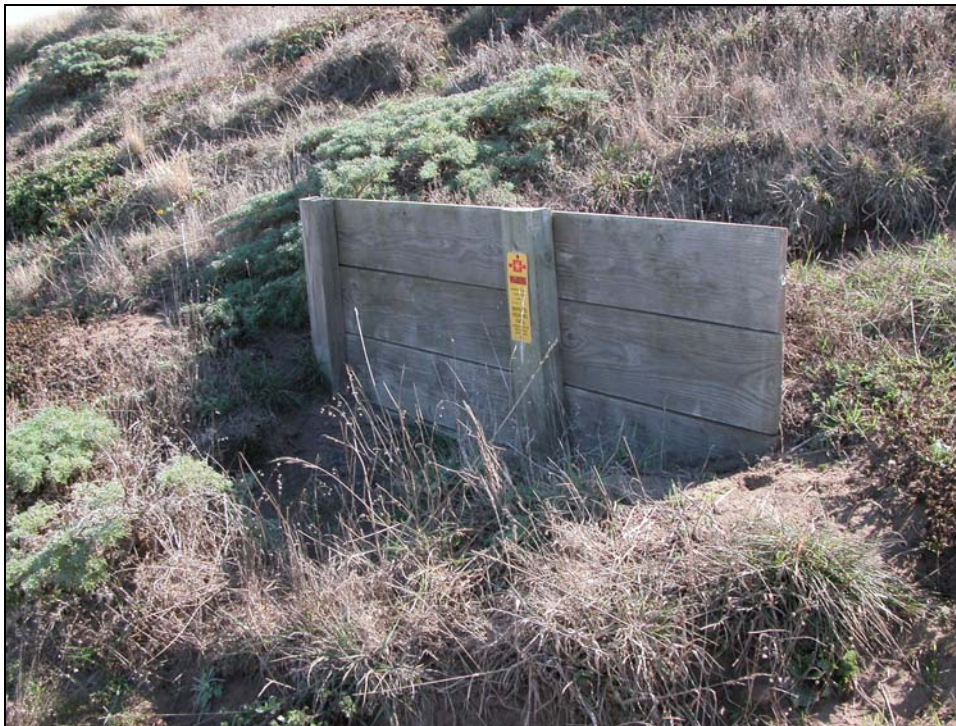
**Figure 16. View of modern erosion feature**

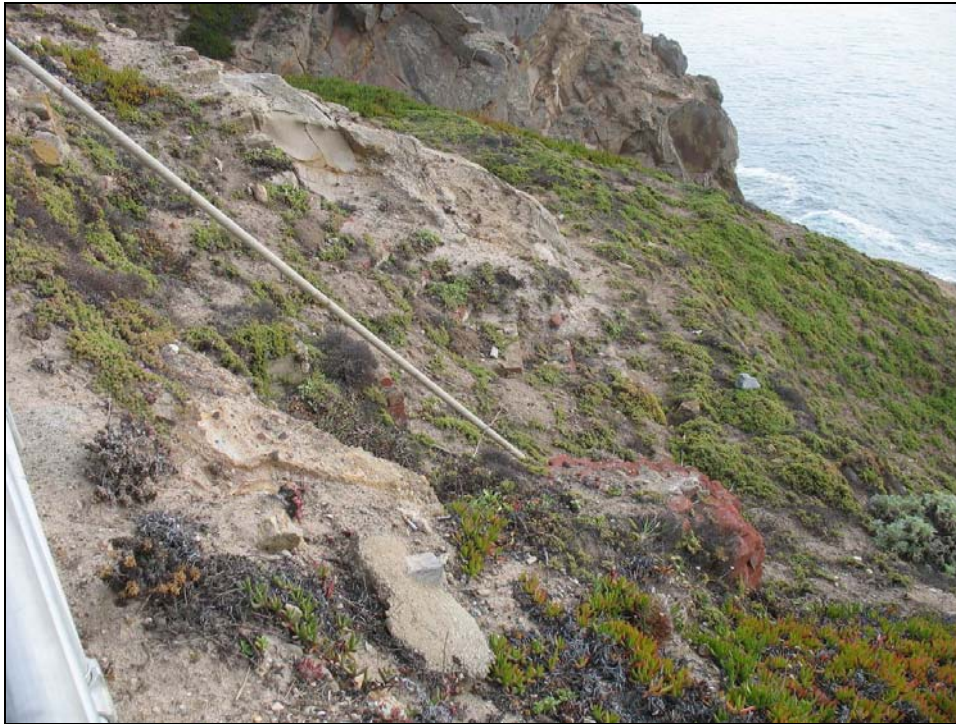
**Figure 17. View of brick steps at Wash House site**

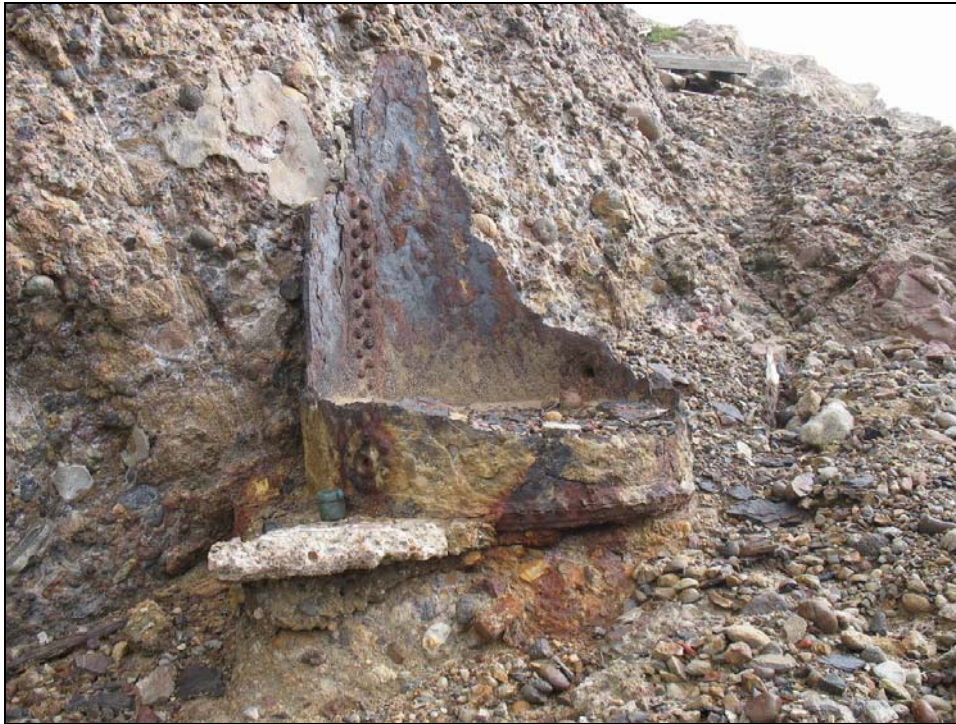
Also found throughout the site are foundations and concrete slabs, remnant brick and concrete stairs that relate information about the scale or orientation of demolished buildings. At the fog signal site, remnants of the cast iron boiler at the lower fog signal terrace and all the remnant ironwork that supported piping and chutes to get water and coal to the site illustrate the need for resources to power the fog signal, as do the pump houses and water tanks.

**Figure 19. View of cast iron boiler remnant at Fog Signal Building site**
