National Park Service  
Cultural Landscape Inventory  
2006

United States Coast Guard Point Reyes Lifeboat Station  
Historic District

Point Reyes National Seashore

**Point Reyes Lifeboat Station Historic District  
Point Reyes National Seashore**

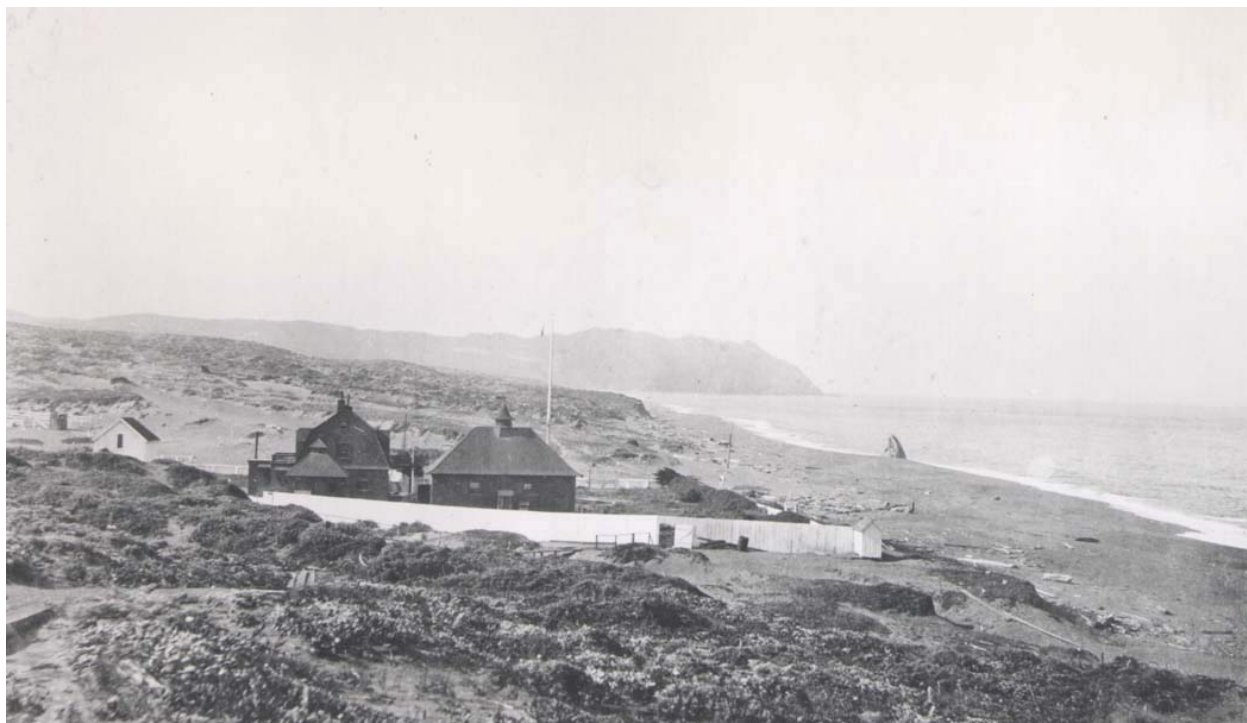
*History Figure No. 1. Original Point Reyes Life-Saving Station on Ten Mile Beach, ca. 1914 [NPS, Point Reyes National Seashore, Park Archives].*

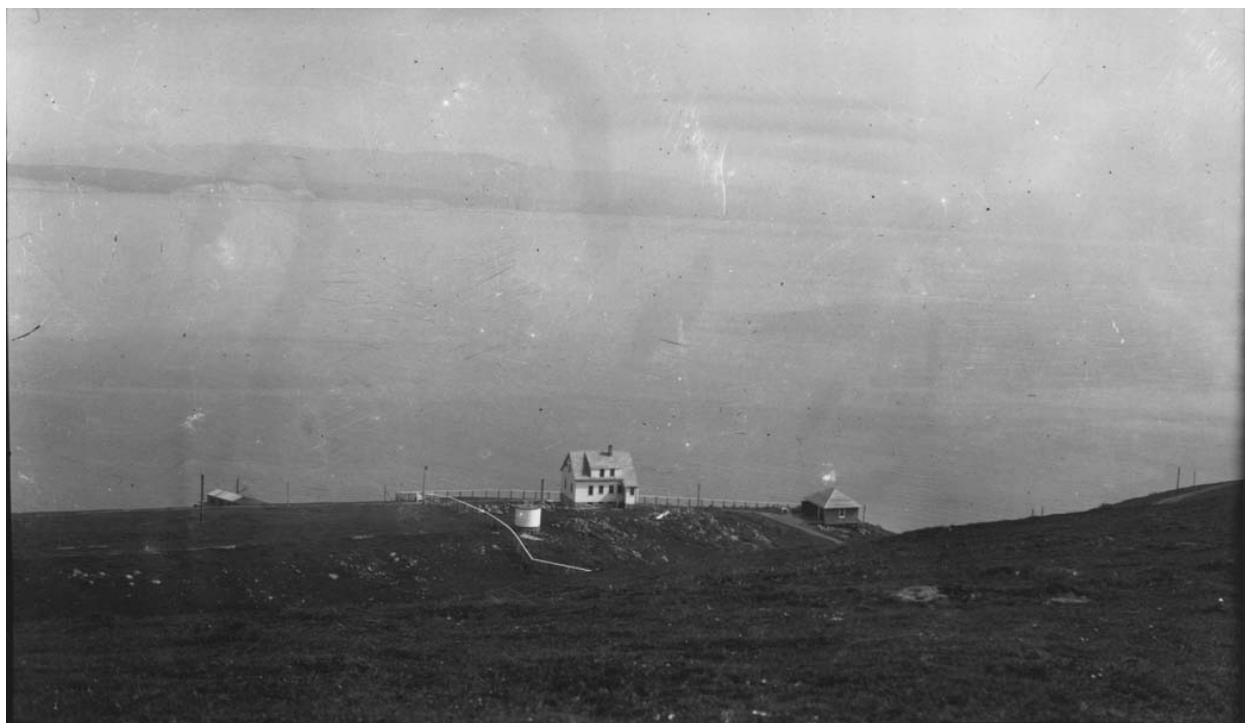
*History Figure No. 2. The Officer-in-Charge quarters on Drakes Bay seen from the west, ca. 1928 [NPS, Point Reyes National Seashore, Park Archives].*

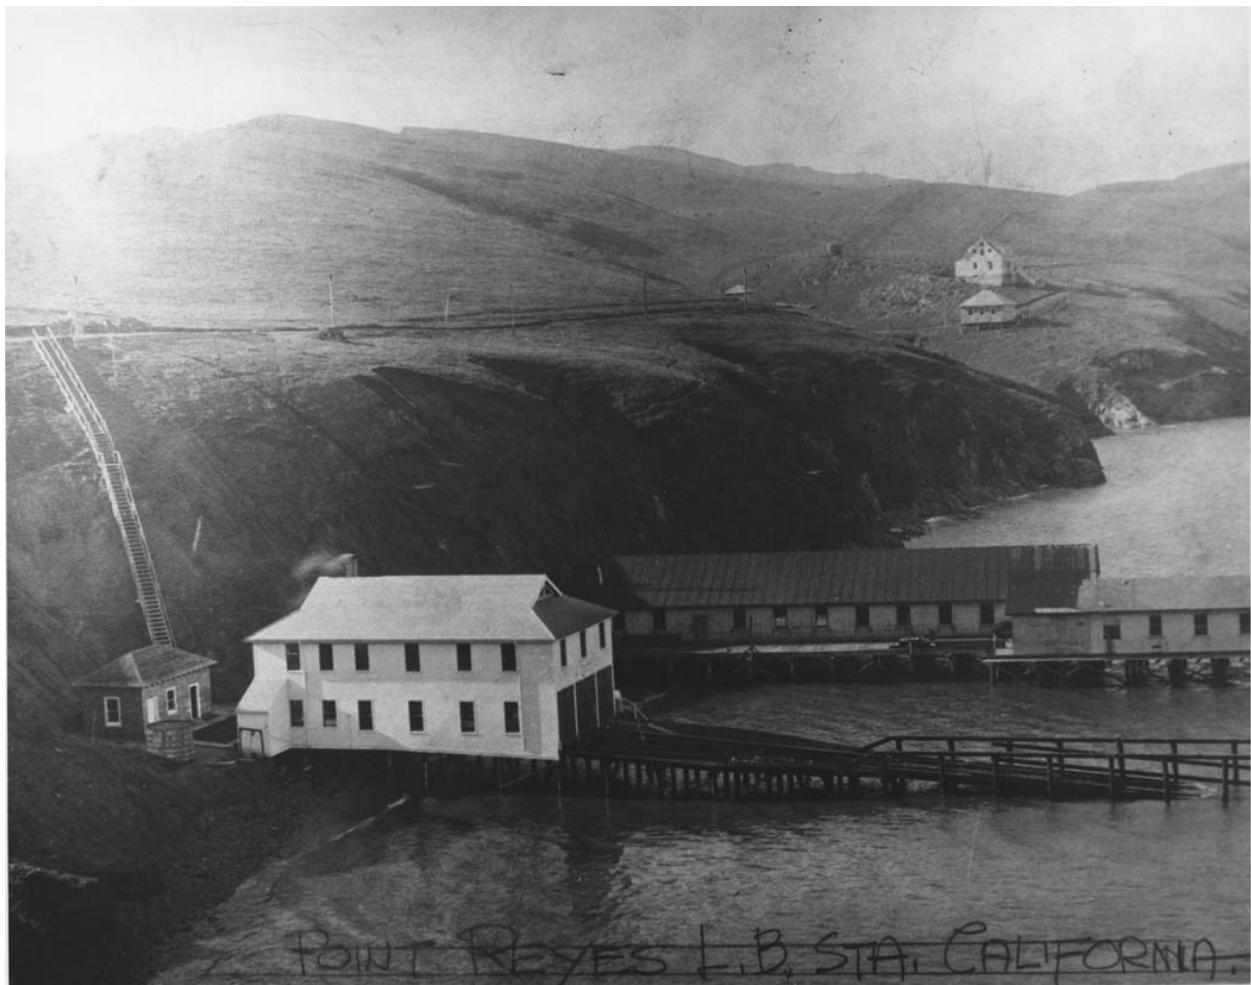
*History Figure No. 3. The lifeboat house on Drakes Bay with Paladini wharf in background, ca. 1928 [NPS, Point Reyes National Seashore, Park Archives].*

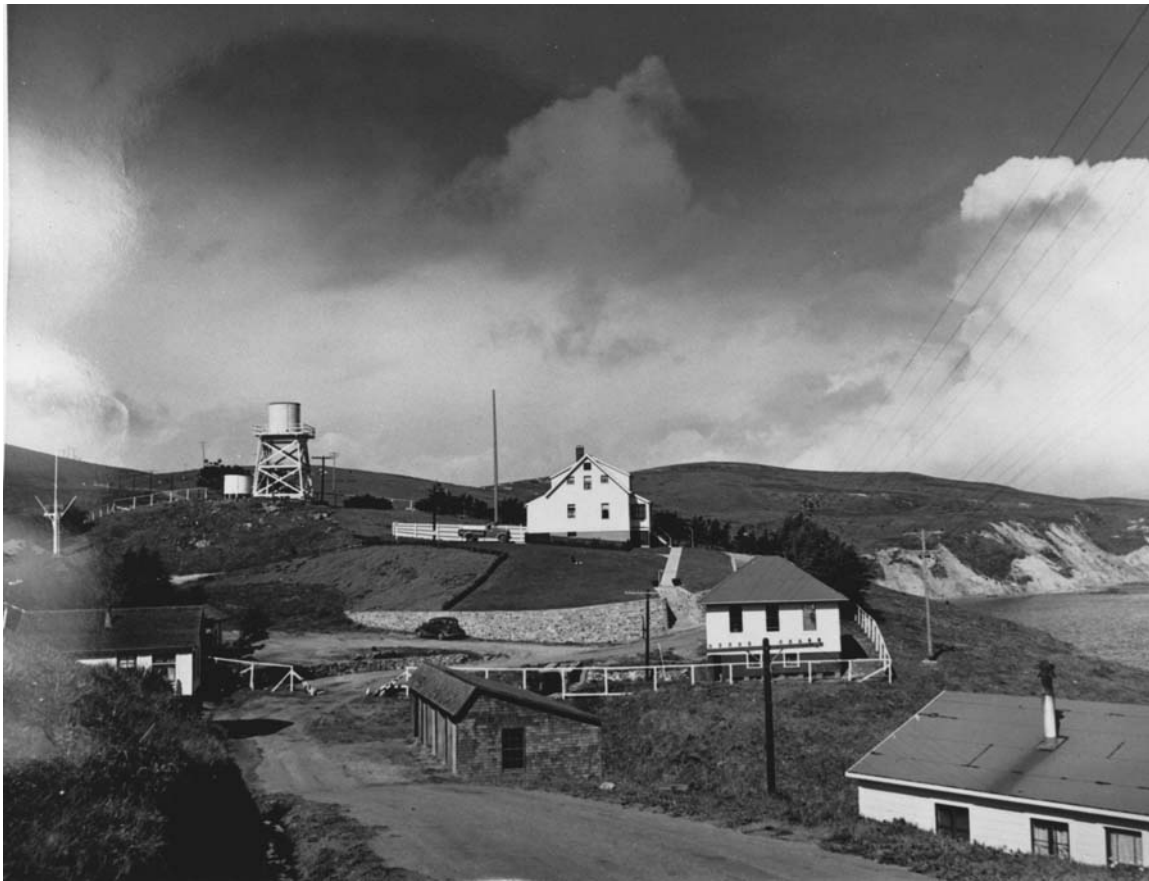
*History Figure No. 5. View of the Officer-in-Charge quarters shortly after completion of WPA work, ca. 1942. Private residences and 5-car garage in foreground. [NPS, Point Reyes National Seashore, Park Archives].*

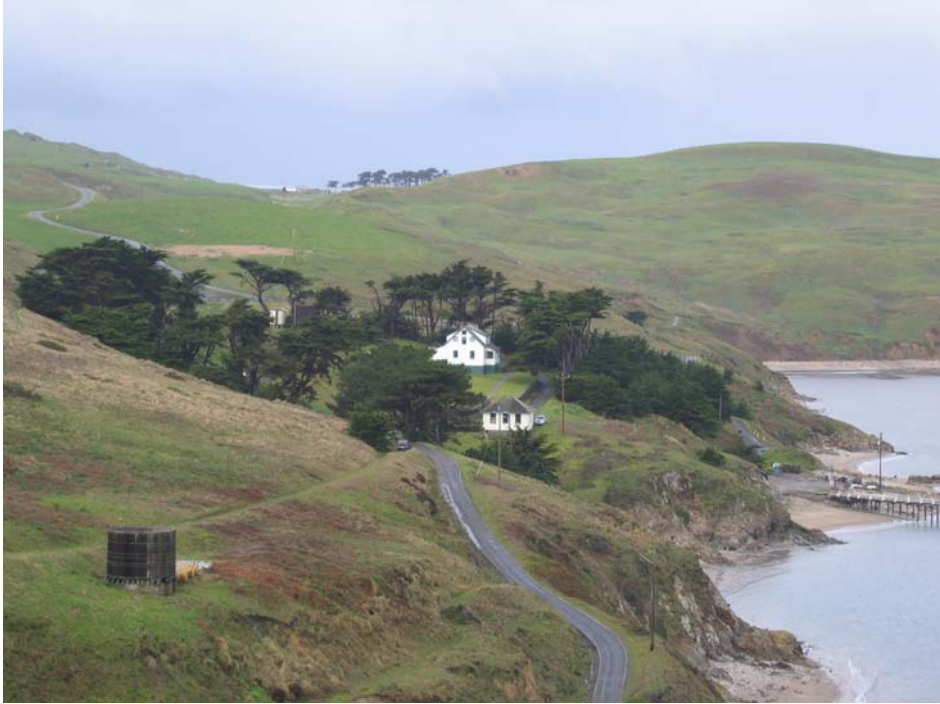
*Circulation No. 1. View of Boathouse Road, water tank road is located above water tank, and road ruin is located between the water tank road and Boathouse Road.*

This 10-foot-wide dirt surfaced road was built prior to 1942 and was altered in 1955 after a landslide damaged the slope below. The road is comprised of two distinct segments, neither of which is still used as a road. The first segment originates at the Lifeboat Station Road east of the Officer-in-Charge quarters. Analysis of historic photographs indicates that it veered off to the northeast, contoured along the steep slope and terminated into what appears to have been a parking area in the present day location of the water and fuel tanks. Photographs from 1955, taken after the landslide destroyed their previous site, show that the water tanks were moved to this parking location. At this point, the second segment of the road was built connecting the first segment with the lookout tower—approximately 1500-feet to the southwest.

The original segment of road including and adjacent to the water tanks still remains. The physical form of this section of the road (including the alignment and cut and fill) is still distinguishable. The dirt surface is covered in grass and other low coastal bluff vegetation. The second segment of the road starts above the fuel tanks, joins the Chimney Rock Trail and leads to the non-extant lookout tower. The portion that is actively used as the Chimney Rock Trail suffers from deep, braided erosion channels caused by water run-off and hikers. Once the road departs the Chimney Rock Trail and heads towards the lookout tower, the alignment is virtually indiscernible—although a faint trail, approximately 1- to 2-feet wide, still exists.

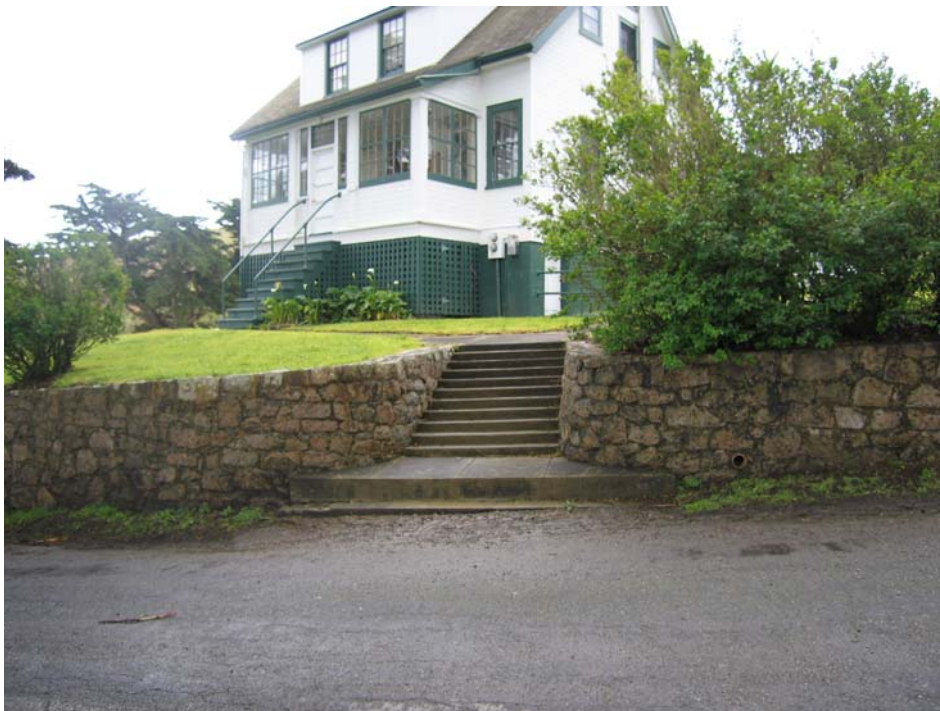
*Circulation No. 2: Concrete stairway leading from Boathouse Road to front of Officer-in-Charge quarters. (PWR Staff 2005).*

These 4-foot wide, linear concrete walks are located at the Officer-in-Charge quarters. They begin at each of the concrete stairways, lead to the front and back entrances to the Officer-in-Charge quarters, and completely surround the residence. Some cracking and erosion is apparent. Two concrete stairways connect the Boathouse Road with the front of the Officer-in-Charge quarters. These stairways taper from approximately 10-feet wide at the bottom to 4-feet wide at the top. They are bordered with the stone-faced wall (LCS ID: 16046) and were built at the same time, in 1940.

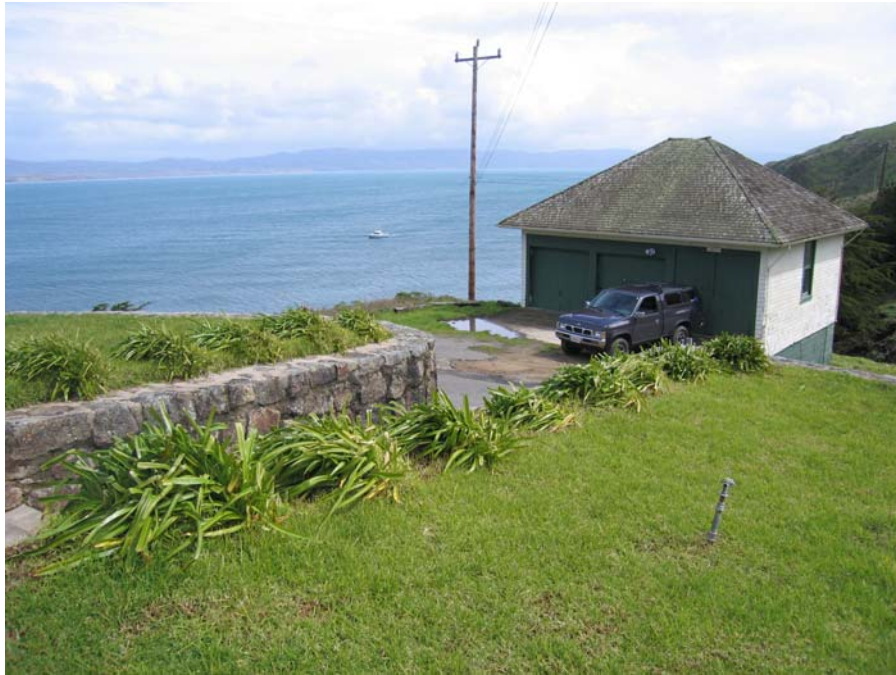
*Buildings and Structures No. 1. Front of three-stall garage. Officer-in-Charge quarters' lawn and stairway in foreground. Drake's Bay in background (PWR Staff 2006).*

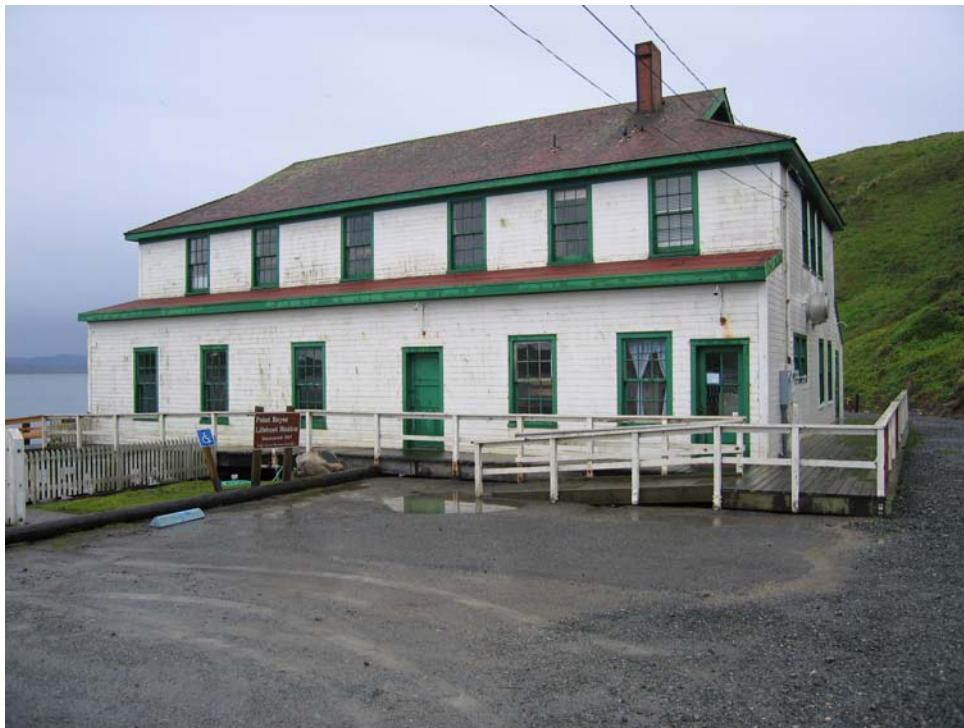
*Buildings and Structures No. 2. West elevation of boathouse (PWR Staff 2006).*

The boathouse was built in 1927 and was designed to house type "T" 36-foot motor lifeboats on the first floor and provide quarters for the station's crew on the second floor. The 60- by 40-foot boathouse rests on a concrete and wood piling foundation. It is a two-and-a-half story rectangular structure, of wood frame construction. Exterior walls are sheathed with horizontal wood siding with vertical wood trim at the corners and a horizontal frieze below the soffit. Most siding and trim appears to be original fabric. Except for the removal and replacement of some smaller windows on the south elevation (noticeable by seams in the siding), some indentations in the siding and trim caused from disk sanding and blistering paint.

The boathouse, simple in form, is punctuated heavily by windows and doors on all four elevations. The north elevation (facing Drake's Bay) consists primarily of three very large double doors, designed to be accessible for storage of the motor lifeboats. These doors are constructed like barn doors, with an upper and lower criss-cross structural frame on the inside. They are sheathed on the outside with beaded vertical and tongue and groove boards. The doors are in good condition and function properly. The large type T 36-foot motor lifeboat was stored in the center bay while the 26-foot rail-launched surfboats were stored in the end bays. Also on the north elevation are three double-hung windows on the second story of the building (above the boat doors) and three small windows in the attic gable of the roof.

The boathouse has a hip roof on the original portion of the building, and shed roofs on the 1946 west addition and east entry room. The hip roof, on the north and south ends of the structure, rises to a point where it dies into a windowed gable. Roofing material on the original building portion is wood shingles. The existing shingles were painted red when installed in 1976. Weathering during the intervening years has resulted in a worn and faded appearance. This roof portion shows years of wear with cupped and missing shingles. The shed addition on the west side was reroofed with red asphalt roll-roofing during the 1988-89 restoration.

The boathouse has a single red brick chimney originally used by the boiler. The chimney is located above the boiler room near the east end of the roof. Considerable deterioration of the mortar joints is evident.

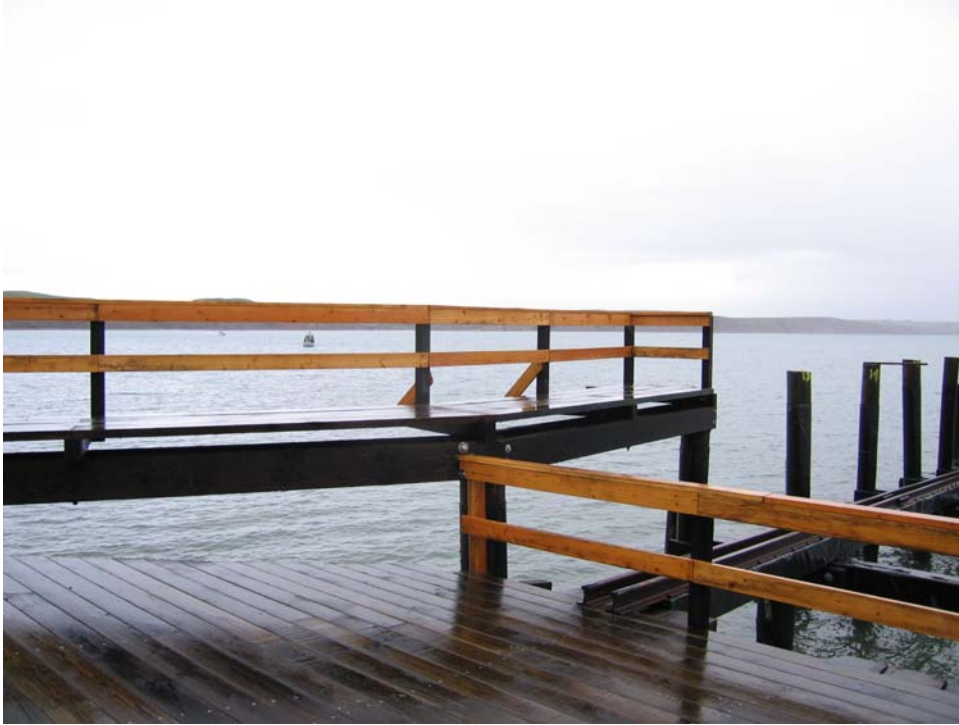
*Buildings and Structures No. 3. Marine railway undergoing restoration (PWR Staff 2006).*

Currently, the boathouse and marine railway are maintained and used by the National Park Service. The boathouse was recently restored and the marine railway is currently being restored. The Officer-in-Charge quarters and associated grounds are being maintained by its current residents, two NPS employees. Overall, the district is in good condition and exhibits all seven aspects of integrity as defined by the National Register of Historic Places. Because it is a National Historic Landmark, the district falls into Management Category A: Must Be Preserved and Maintained.

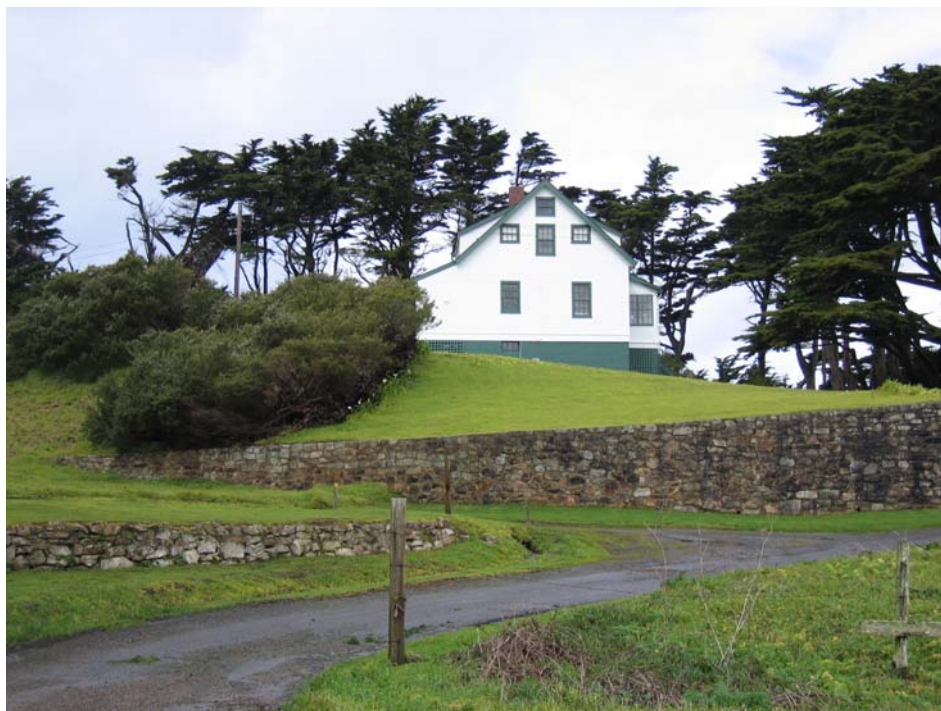
*Vegetation No. 1. Image shows the lawn, Monterey cypress windbreak, and Australian tea tree planted around the Officer-in-Charge quarters (PWR Staff 2006).*

Today, the ornamental vegetation at Point Reyes Lifeboat Station reflects the patterns and character it possessed during the period of significance. As a result, vegetation is considered a contributing landscape characteristic.
