**FAIRSTED**  
**Frederick Law Olmsted**  
**National Historic Site**  
**Brookline, Massachusetts**

**Tech Notes**

**NUMBER 1**

**Restoring Vine Coverage to  
Historic Buildings**

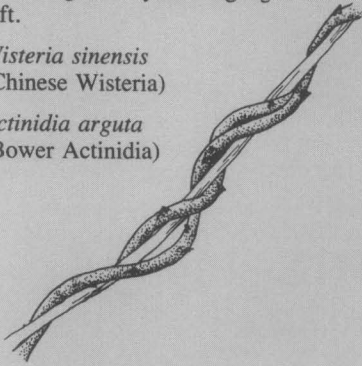
### Twining

Vines may climb by twining from left to right or by twining right to left.

growth habits. *Twining* vines climb by sending out shoots that wrap around objects and grow in both length and width. As the vine grows thicker, it can constrict these objects, causing features such as louver shutters to snap under the increasing pressure. Furthermore, the spreading shoots penetrate openings and crevices. In time, the growing vine can loosen and separate building materials.

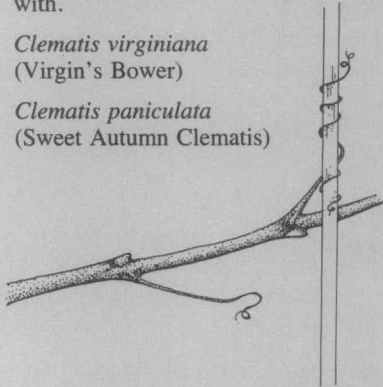
### Tendrils

The tendrils wrap themselves around anything that they come in contact with.

Like twining vines, *tendrils* wrap around objects for support. Because they are actually extended leaves, tendrils do not grow in width, only in length. Both twining and tendril vines, however, can break weather seals on wooden facades, separating wood shingles and siding, as well as fascia and soffit boards on porches. Other vine types include *Aerial* vines which grow small roots along the length of the stem. These rootlets cling to the wall and can force their way into crevices. The fineness and density of the rootlets makes

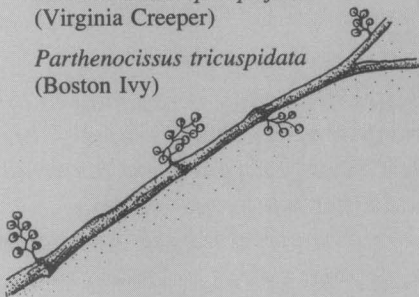
### Creeper

This vine clings by sending out small tendrils with adhesive discs that attach themselves to surfaces.

removal difficult. *Creeping* vines have tiny adhesive pads that cling to the building surface. Commonly found on masonry brick buildings, creeping vines do not generally cause extensive damage to structures while growing, although they may abrade softer mortar. However, they attach themselves so thoroughly to the building surface that paint, mortar, and brick are likely to be damaged when the vines are removed.

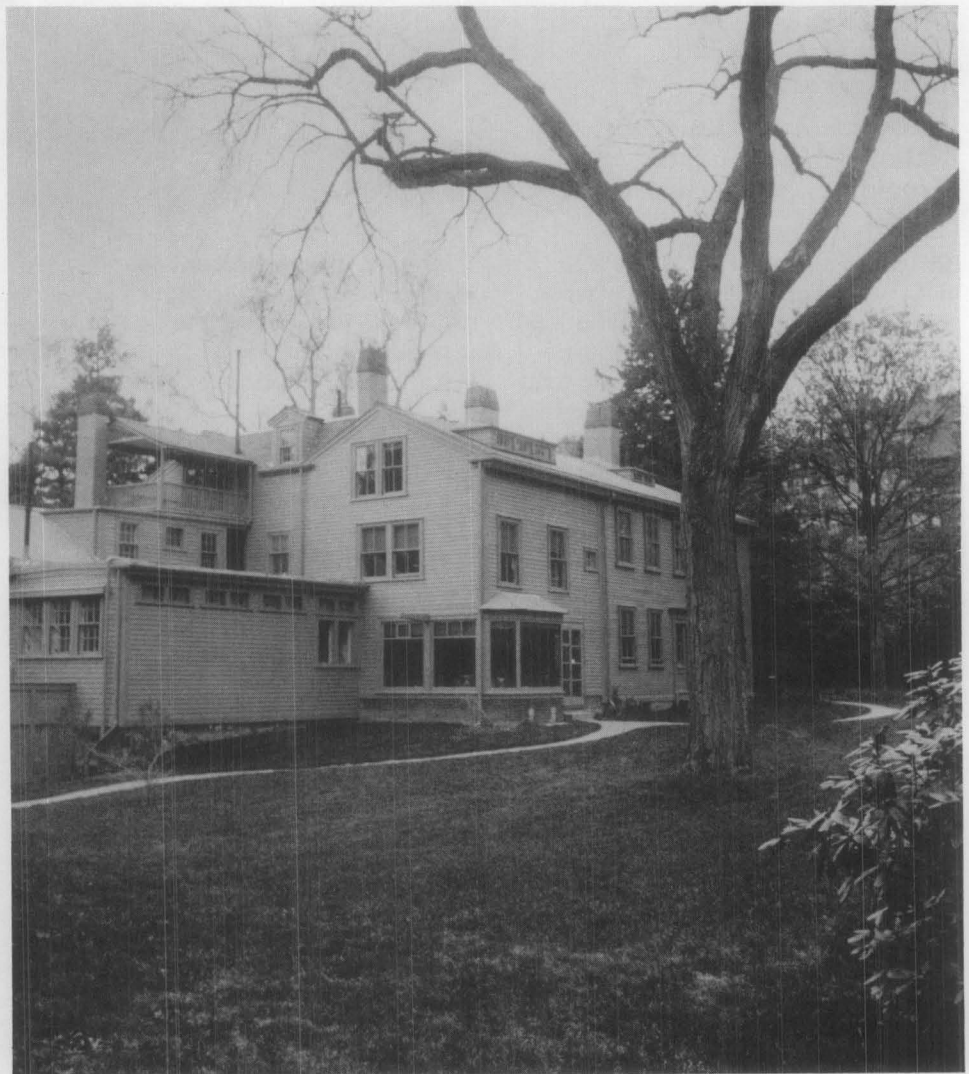
Figure 1. Historic plant materials can be retained while restoration of the historic structure is underway. The *Wisteria* and *Actinidia* vines that were historically used by Olmsted, were cut back during the restoration of Fairsted in 1988. Photo by Charles Pepper, courtesy of the Olmsted National Historic Site.

In 1980, The National Park Service began structural restoration of the house at Fairsted. To facilitate this work, the historic vines were removed from the facade and cut back to the ground. Since the vines were both historic plant material and an important feature of the property, complete removal was avoided. The vines were kept at ground level, but pruned frequently to prevent reattachment to the house. This situation resulted in weakened plant growth and an appearance quite different from

Olmsted's intention (*see figure 1*). Furthermore, long-term frequent pruning risked a higher incidence of pest-related problems to the plants and restricted their natural climbing habit. It was therefore important to the public site that a new trellis system be devised that would protect both the historic vegetation and the historic structure, while re-establishing the appearance of a "vine clad mansion."

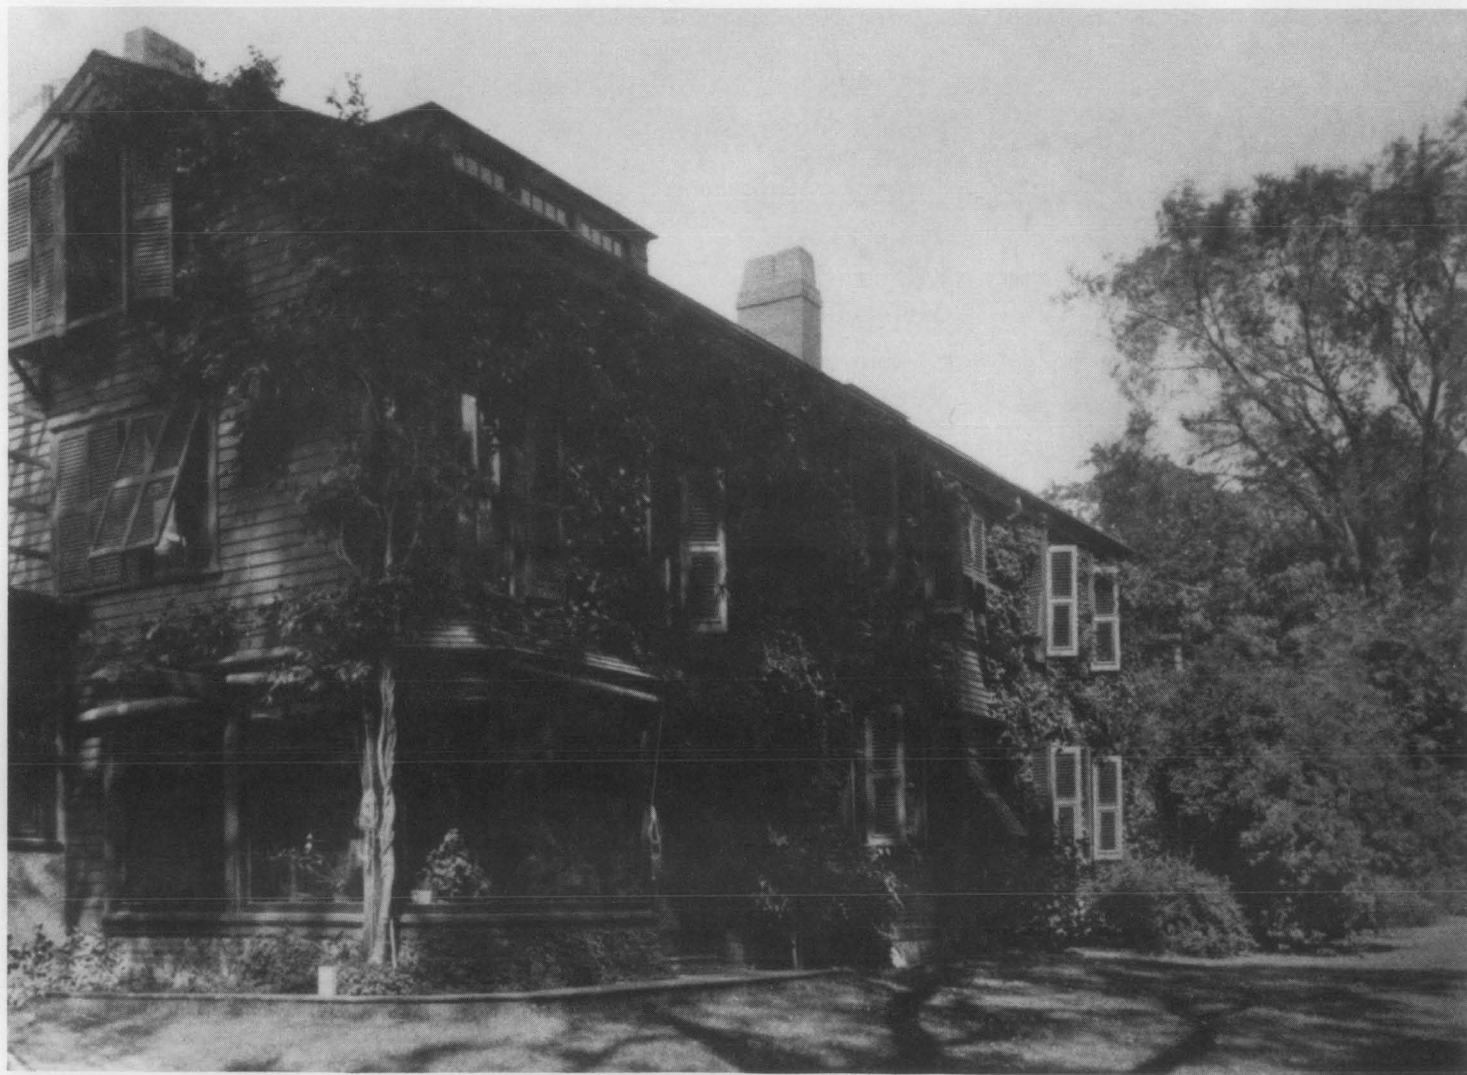
Figure 2. View of the west elevation at Fairsted which shows a steel strapping trellis system built as early as 1884. Photo courtesy of Olmsted National Historic Site.

Development of a new trellis system began with research into the materials, techniques and hardware used in New England between 1880 and 1930, as well as specific investigation into the various techniques used at Fairsted during those years. Historically, the east elevation of the house had two trellis structures supporting *Wisteria sinensis* (Chinese Wisteria). Photographs from as early as 1884 show a wooden trellis system at the entry porch and a spiraled steel strapping system along the house facade (*see figure 2*). Remnants of these

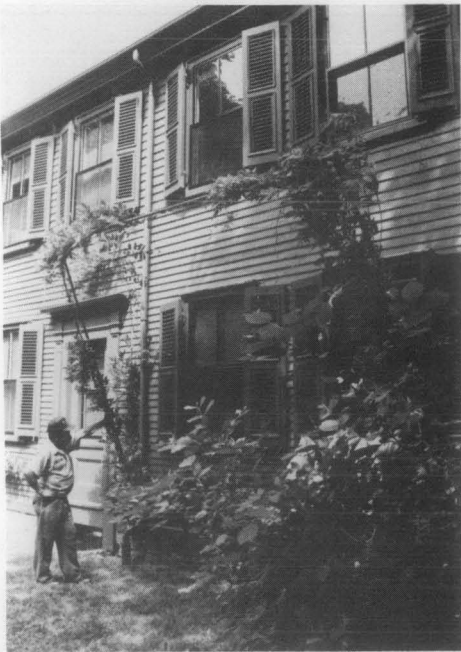
Figure 4. The pipe and strapping system, constructed with swivel sockets, allows the rigid support system to fold down away from the house. The strapping can also be removed from the pipe support for limited maintenance. Photo by Karen Day.

aged rapid rusting. The flexible aircraft cable (system 2), with the added weight of a mature vine will make removal and replacement difficult for one person. A temporary pulley system is recommended to aid in hoisting the vines back into place. The third design is a rigid modular pipe system (system 3). Although the rigidity of the system is advantageous to the stability of the vegetation, the weight of the vines may also be prohibitive for easy removal and replacement. The combination strapping and pipe system (system 4) does not recreate a historically accurate appearance. The system was designed in order to remove the vines on the strapping without removing the pipe supporting system. The vines growing on the strapping do not provide sufficient coverage to hide the pipe system behind. Furthermore, additional maintenance is required to keep the vines from growing on the pipe. After the multi-year test period is complete, one of the four systems will be selected, modified as needed, and installed to the east, south and west facades of the house (see figure 7).

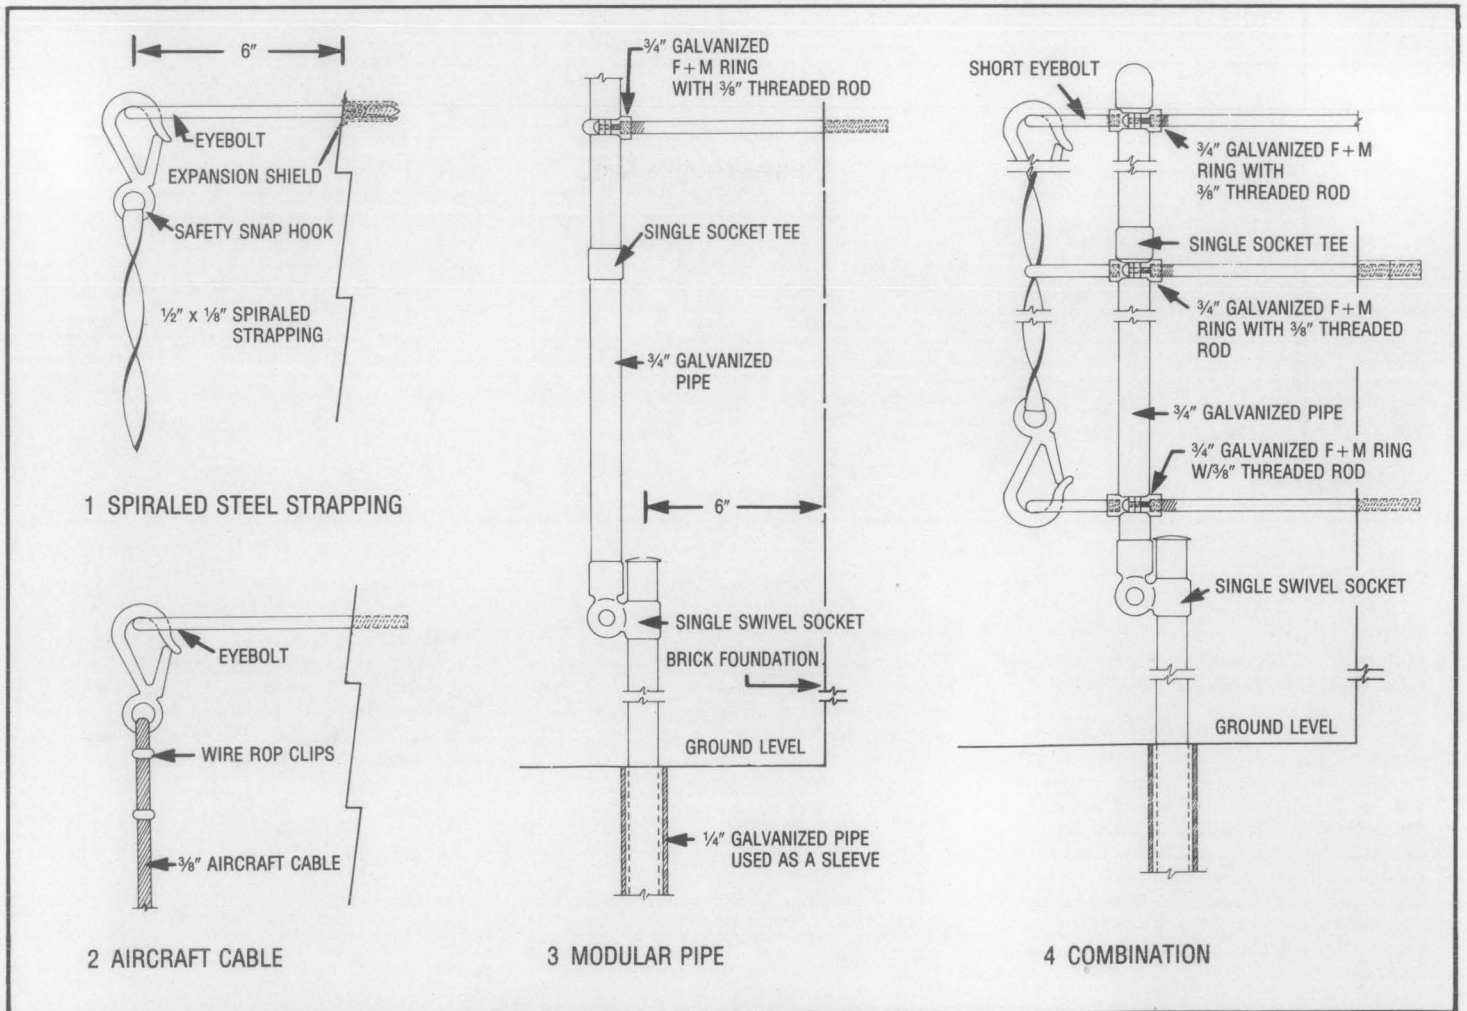
Figure 5. Details of the four experimental trellis systems. Drawings by Sharon Runner, National Park Service.

In order to meet both the above criteria and also to test alternative solutions, four different trellis systems were designed and installed for use in a two-year test phase (*see figure 3*). The first system used spiraled steel strapping; the second, aircraft cable; and the third modular pipe. The fourth system combined strapping and piping.

The steel strapping system (system 1), although painted, has shown a great amount of rust. The use of galvanized steel, painted with a zinc oxide primer and a finish coat would have discour-
