National Park Service  
Cultural Landscapes Inventory  
2014

Radar Station B-71  
Redwood National Park

## **Radar Station B-71**

### **Redwood National Park**

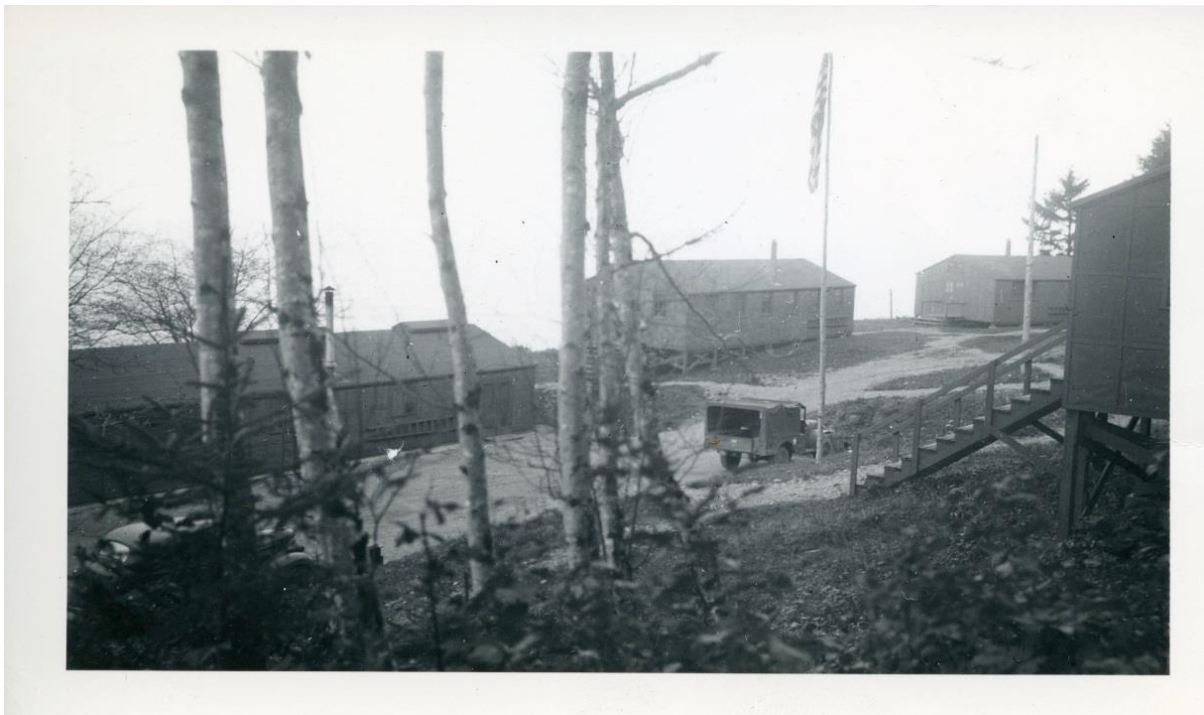
Historic photograph showing barracks located south of the radar station (Redwood National Park Museum Collection, Birdsall Collection Catalog Number REDW34248, Birdsall, 1944).

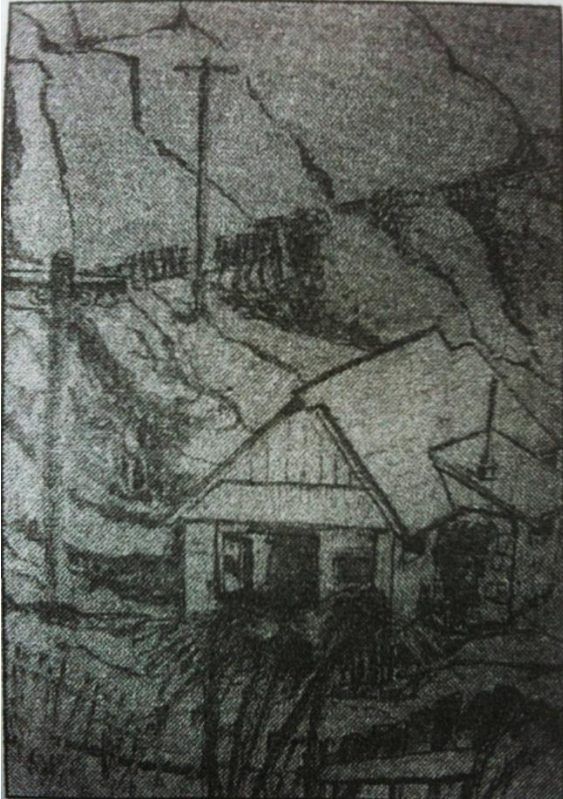
Sketch of the Operations Building, dated 1964 by John M. White (*The Daily Triplicate*, April 9, 2000).

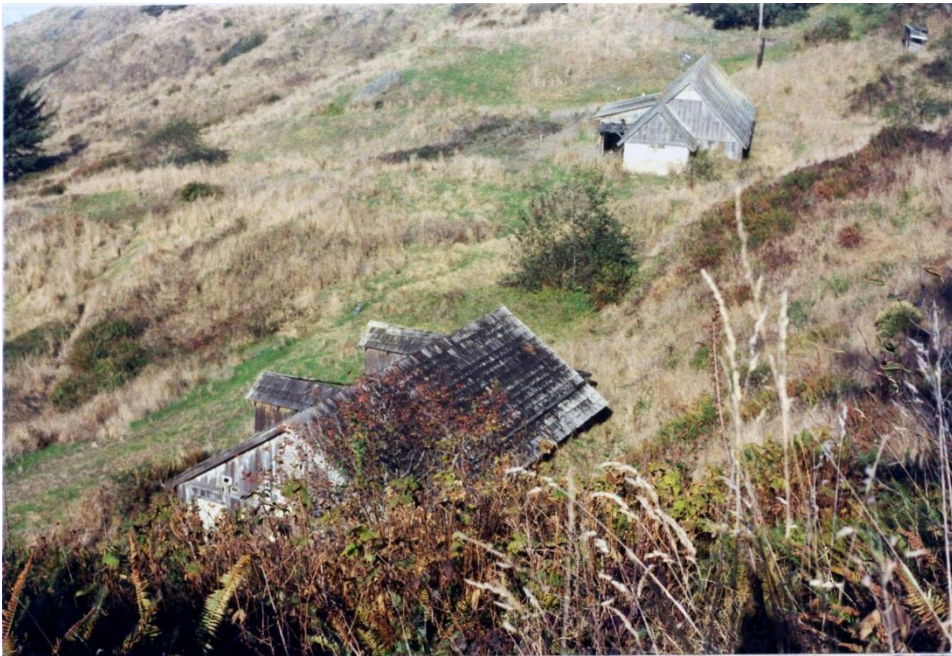
Radar Station, looking northwest from Coastal Drive. Note sparse vegetation throughout site and latrine located in upper right corner (REDW Museum Collection, Maintenance Division, Buildings and Utilities, Historic Preservation Files, Catalog No. REDW33659, November 1974, photo 3a).

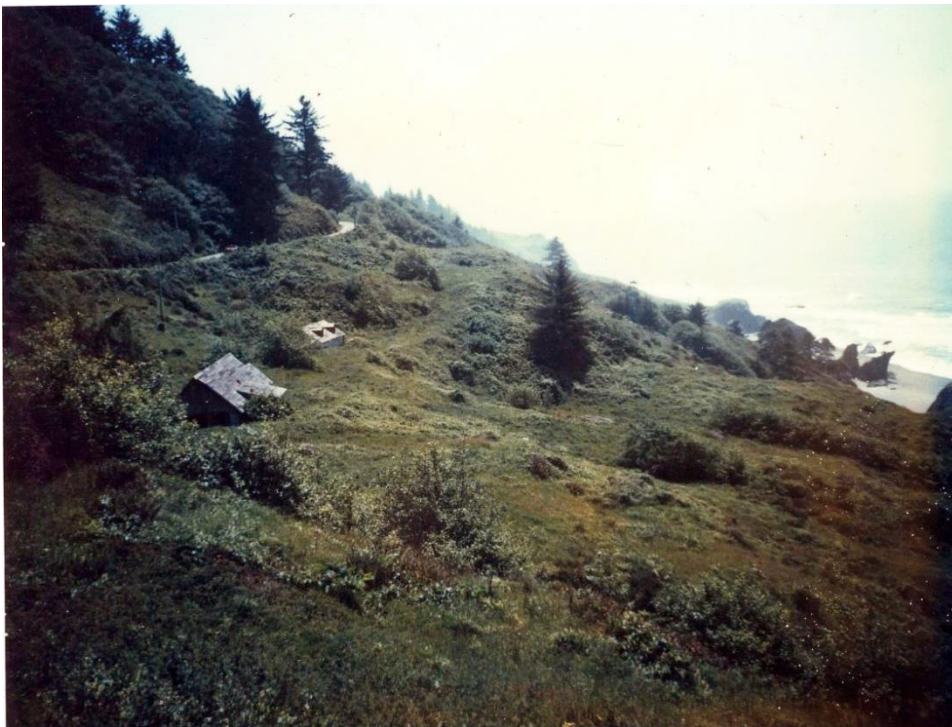
Radar Station, looking south. Note sparse vegetation along entire slope, and mud flow that encroached upon the Power Building, center (REDW Museum Collection, Maintenance Division, Buildings and Utilities, Historic Preservation Files, Catalog No. REDW33659 , May 18, 1978, photo 10a).

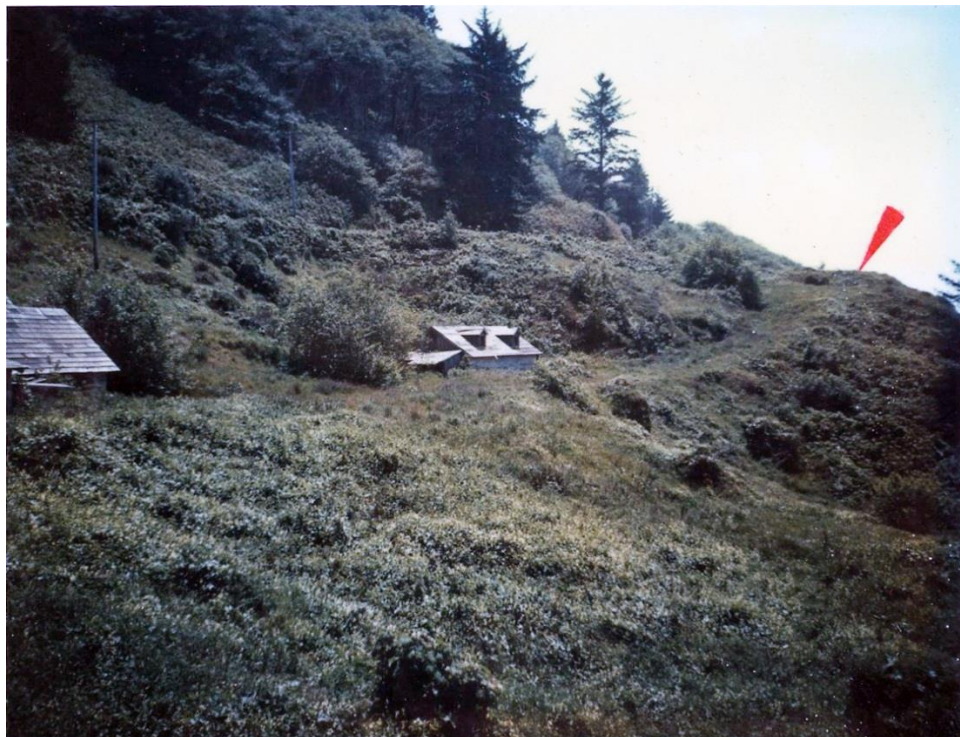
Photo of station, looking southeast, indicating location of a machine gun pit (REDW Museum Collection, Maintenance Division, Buildings and Utilities, Historic Preservation Files, Catalog No. REDW33659, May 18, 1978, photo 10b).

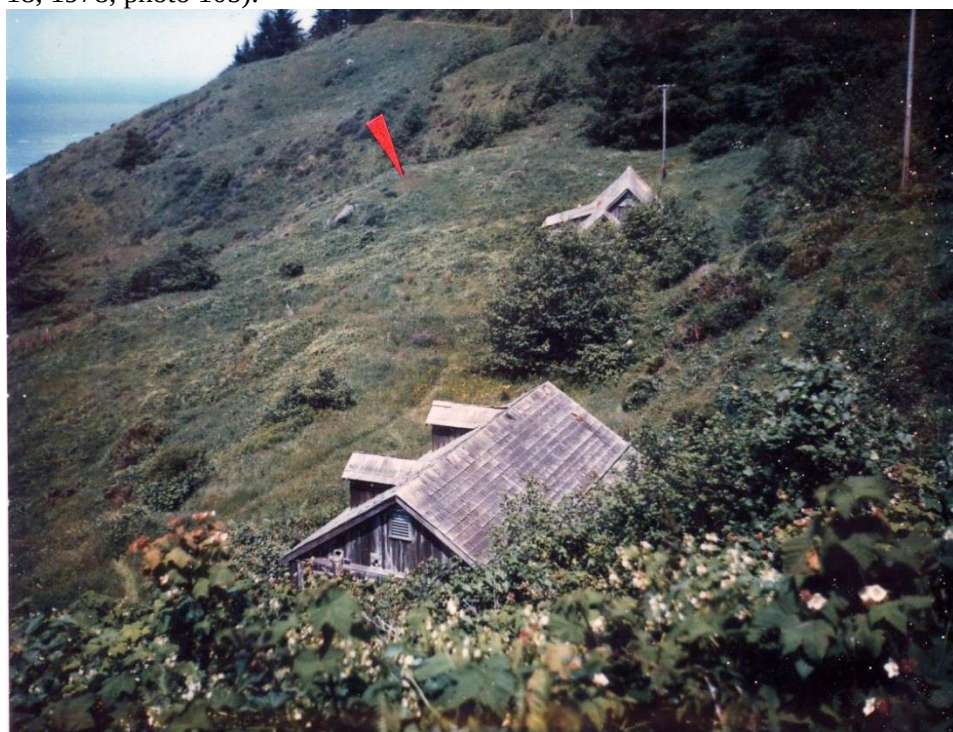
Photo of station, looking north, indicating location of a machine gun pit (REDW Museum Collection, Maintenance Division, Buildings and Utilities, Historic Preservation Files, Catalog No. REDW33659, May 18, 1978, photo 10c).

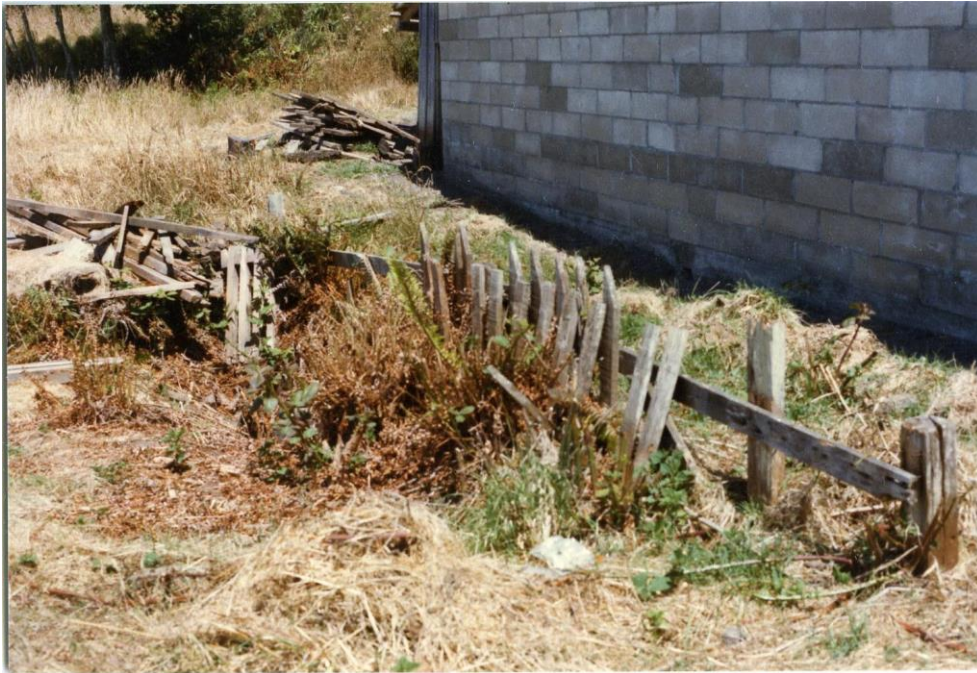
Photo showing remnant picket fencing on the radar station site. This section is to the west of the Power Building. (REDW Museum Collection, Maintenance Division, Buildings and Utilities, Historic Preservation Files, Catalog No. REDW33659, July 26, 1978, photo 34c1).

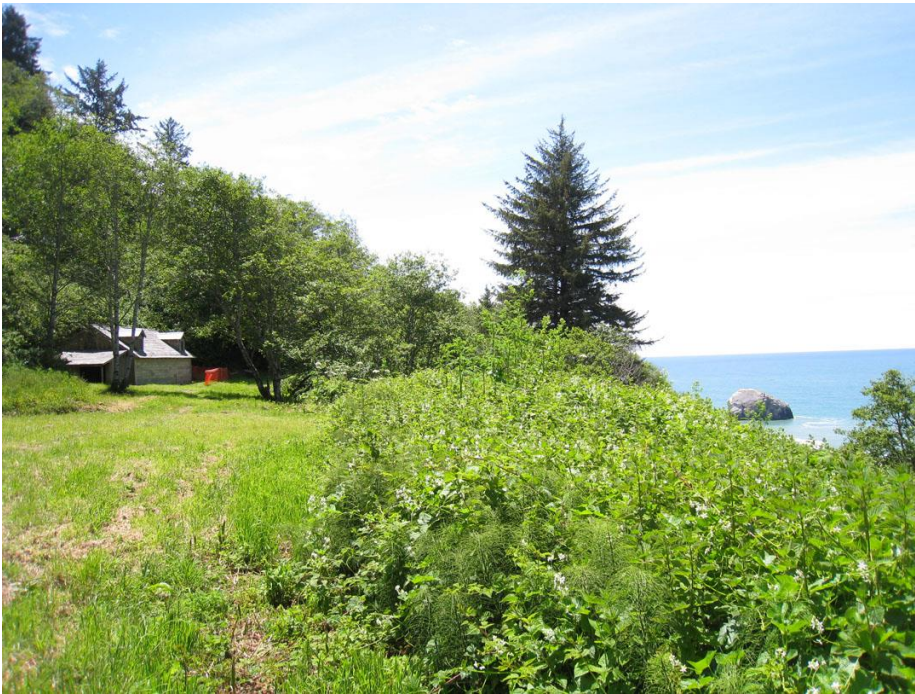
Natural Systems and Features #1: View looking south from north edge of antenna field, Power Building to the left and ocean to the right (PWR CL Program 2011).

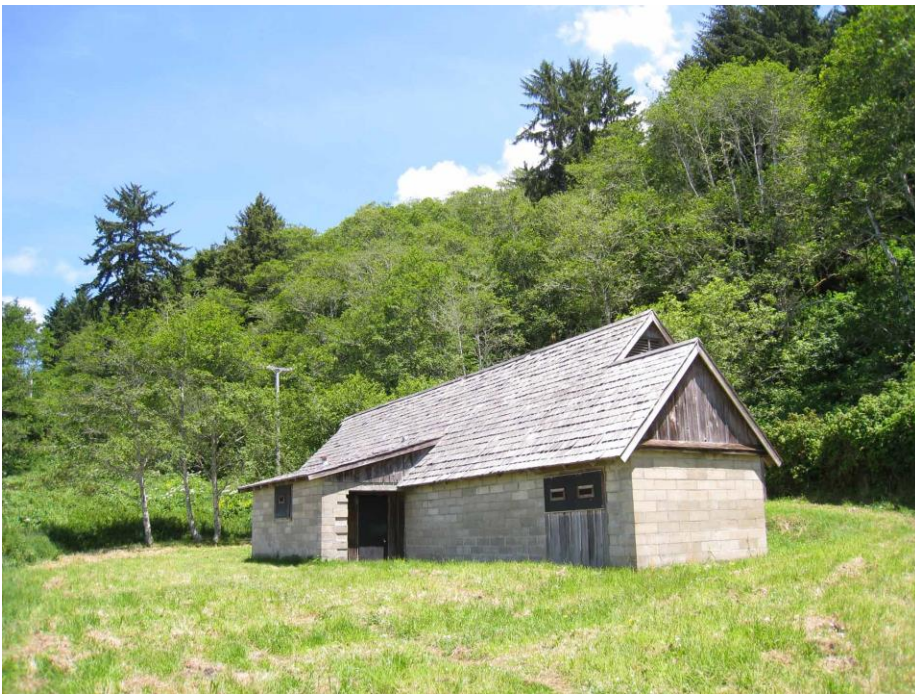
Natural Systems and Features #2: View looking north with the leveled bench used for the antenna field in the foreground, to the left of the Operations Building. The alder forest, located along the upper slopes of the hill, is visible in the background (PWR CL Program 2011).

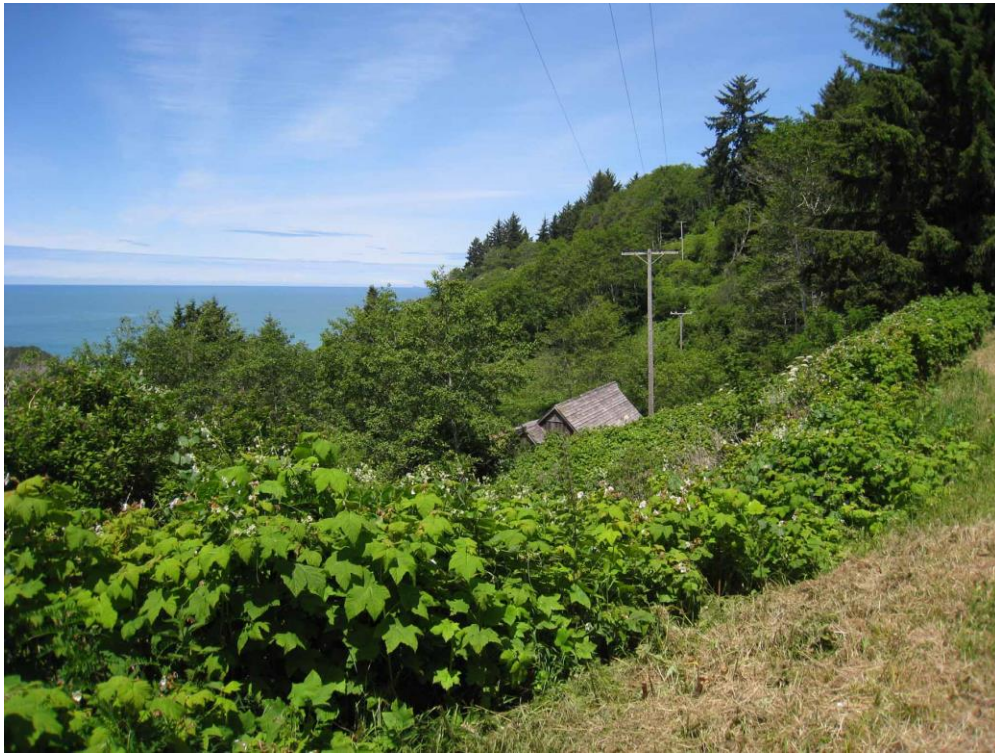
Spatial Organization #1: View to north from Coastal Drive located above the radar station. The top of the operation building is seen in the center, with the ocean in the horizon (PWR CL Program, 2011).

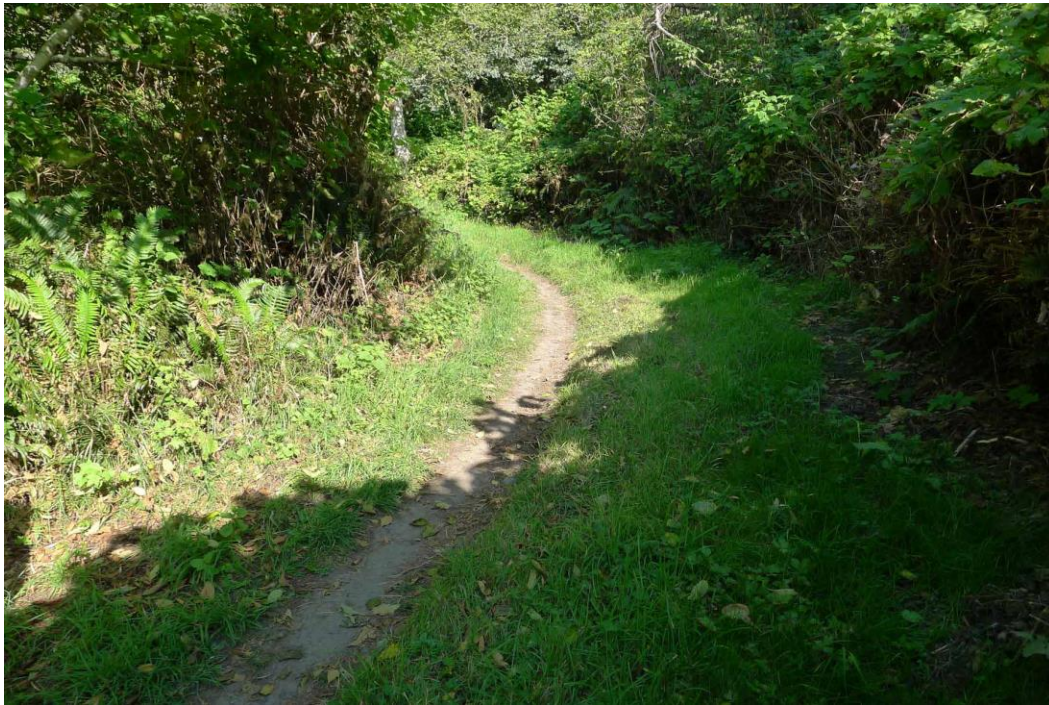
Contributing Radar Road looking south from half way up the road (PWR CL Program, 2012).

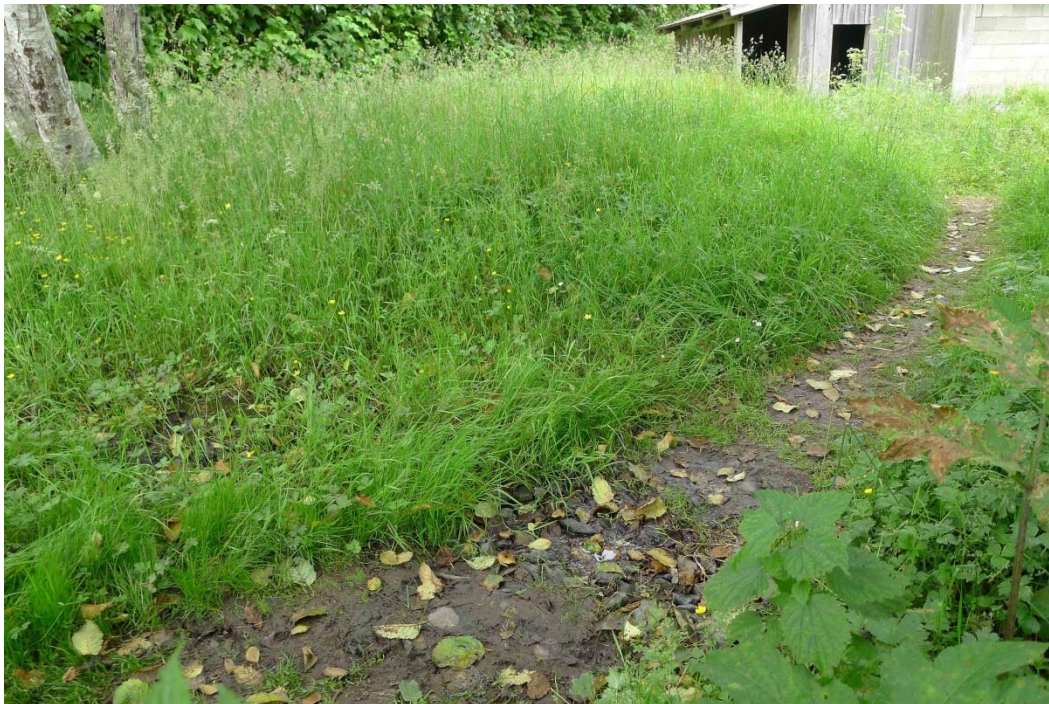
Non-contributing social trail connecting the radar road to the Power Building (PWR CL Program, 2012).

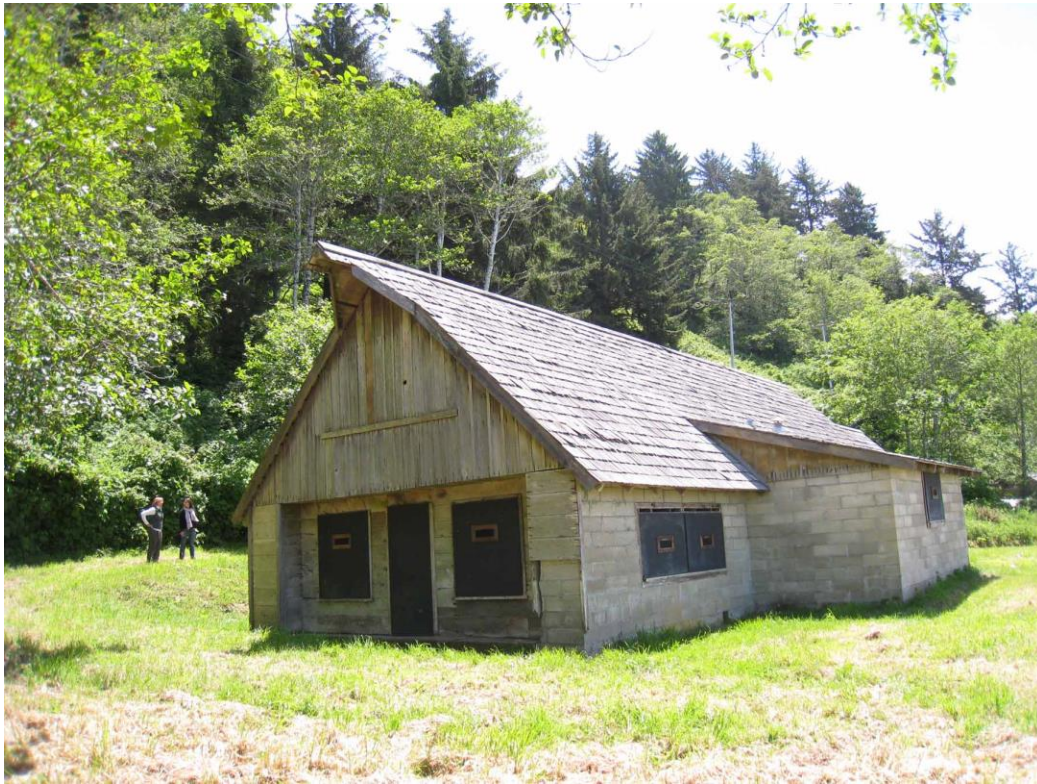
Both the Power Building and the Operations Building historically used board and batten siding to mask the concrete block construction. The front elevations of both buildings are missing their siding, leaving the concrete block construction exposed. The other walls have either reconstructed or original siding, which was attached to the concrete block by thick furring strips.

between the two, a horizontal board was placed at a 45-degree angle at the point of transition. The remnants of siding remaining on the east edge of the extension, south gable end of the main building, and the southern end of the rear (east) wall are deteriorating from moisture.

Operations Building, looking southeast (PWR, CL Program, 2012).

**Impact Description:** Due to damage from the elements, the exterior wood cladding remains on only a small portion of the buildings to indicate the way they were originally designed. Care should be taken to maintain this remaining cladding and ensuring it is repaired as needed.

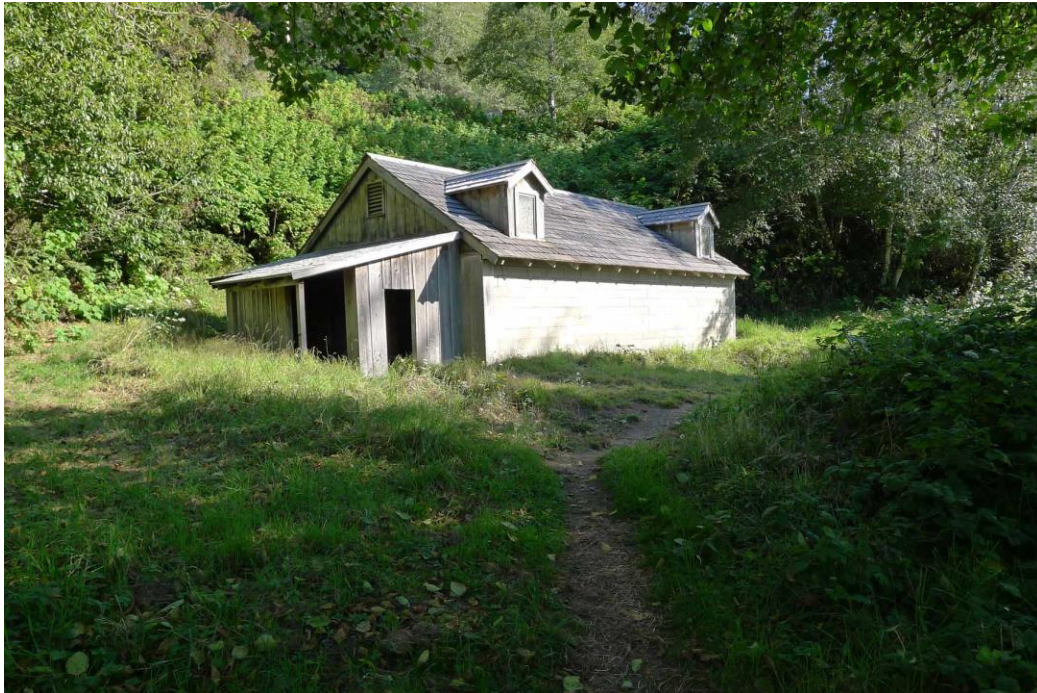
The Power Building is made of an unknown type (or types) concrete block with a wood façade that is used to camouflage the building as a farmhouse. The building measures 38 feet by 22 feet with no windows. The wood shingled gable roof has two false dormer windows. The walls are clad with vertical board and batten siding, and feature false windows. Much of this exterior treatment is missing.

On the south and north gable ends of the Power Building, the concrete block walls and siding do not extend to the gable. This is indicated by changes in the siding. The furring strips caused the siding to protrude several inches from the actual 1 foot, 9 inches thick concrete block wall, especially when compared with the siding on the gable ends, which was attached directly to the framing. In order to mask the resulting in a discrepancy between the two, a horizontal board was placed at a 45-degree angle at the point of transition.

The east wall features a doorway at the south end that Redwood National and State Parks personnel sealed with a plywood door painted black. A site plan for the Power Building indicates that in April 1983, park personnel decided not to reconstruct a shed roof over this door since it was probably an addition. Also along the east wall are three false windows trimmed in wood, like the rest of the false windows on the building. Since the east wall faces the slope that drops down from Coastal Drive, it has experienced both moisture and mud damage from rainy conditions, natural springs, and the natural flow of water across the site. Moisture damage can be seen near the doorway at the southeast corner where the siding has begun to rot. The north wall features an addition extending across nearly three-quarters of its length. The date of this addition is unknown, although the National Register nomination speculates it is post-war. The addition features a shed roof supported by two wood posts that extend beyond its walls, creating an overhang. As with the main structure, the addition's roof is wood shingled and the walls are of board and batten siding. Two doorways, one on the north wall and one on the east wall, provide access to the addition's interior. The remaining quarter of the north wall not covered by the addition has a false window. The north concrete block wall is cracked, which is possibly due to subsidence based on hydraulic action of site drainage.

Power Building, looking southeast (PWR, CL Program, 2012).

**Impact Description:** Both of the buildings have seen damage from slumping soil, which has caused cracking building foundations and damage to structural walls.

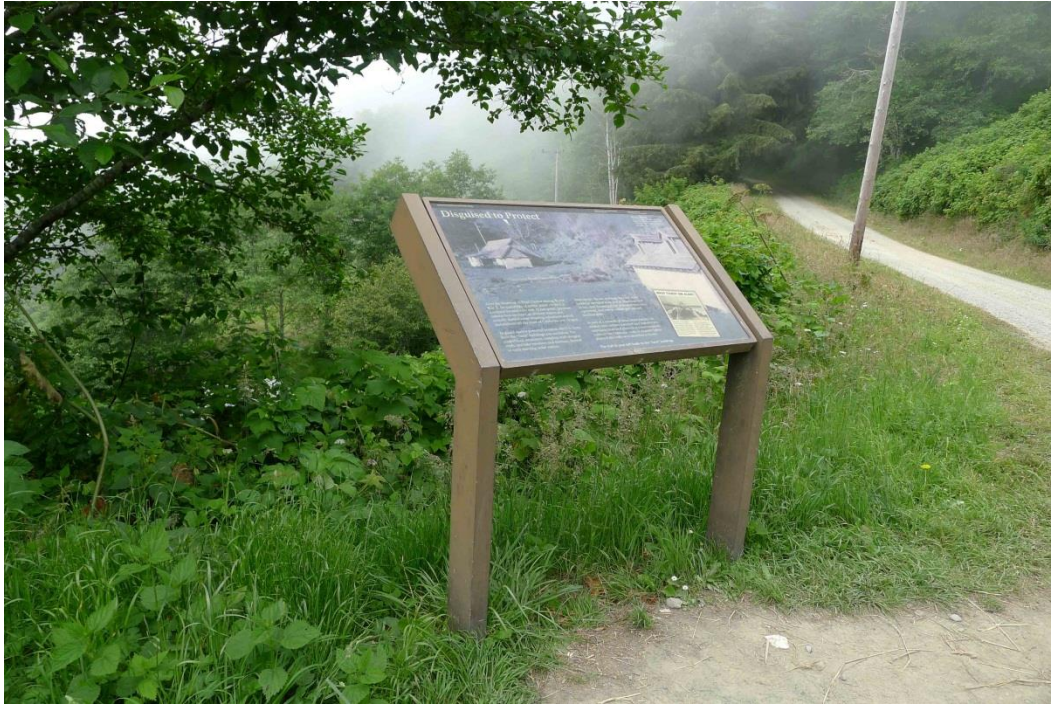
Non-contributing interpretive panel at site entrance. Coastal Drive pictured to the right (PWR, CL Program, 2012).

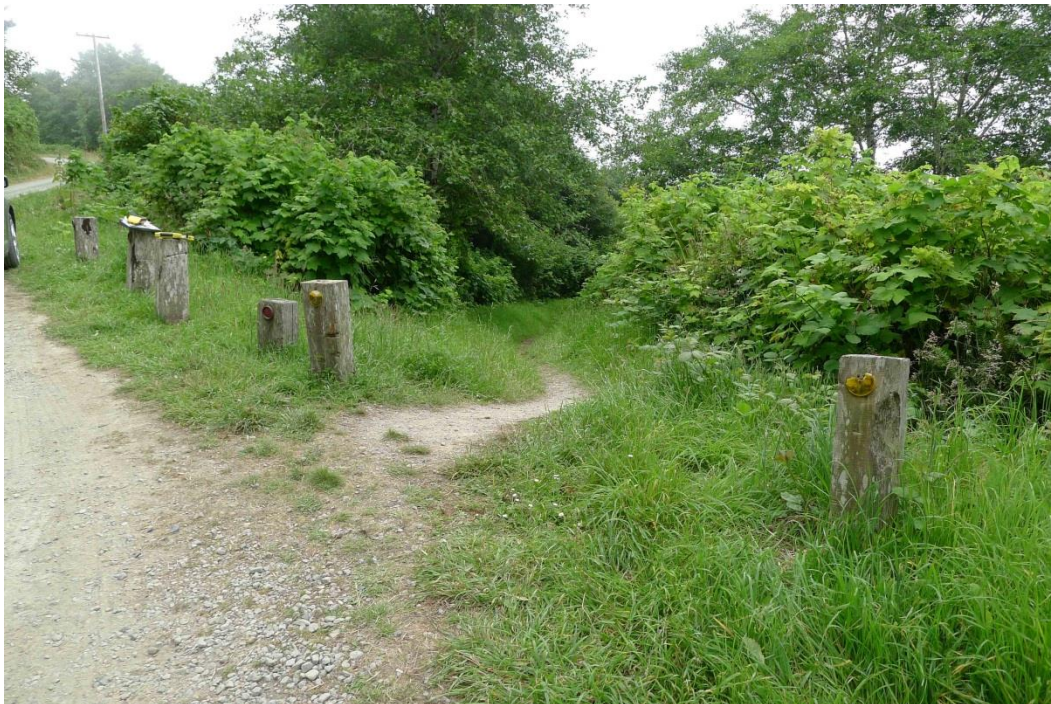
Non-contributing bollards located at entrance to site, looking southwest (PWR CL Program, 2012).
