WATERSHED REHABILITATION FOR EROSION CONTROL ON LOGGED LANDS  
IN REDWOOD NATIONAL PARK

Harvey M. Kelsey and William E. Weaver  
Redwood National Park, Orick, California 95555

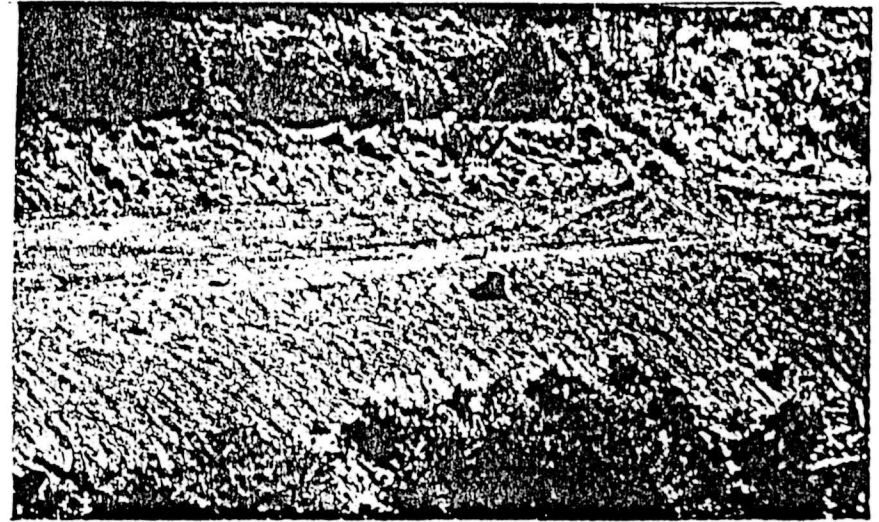
Photos 1 and 2 (August and October, 1978): Outsloping of a logging road in Redwood National Park, using heavy equipment--outside road fill removed and placed against the inside road cutbank. C-10 Road; Miller Creek drainage.

Redwood National Park pulled the terminal portions of two logging roads during August and September, 1978. The objective of rehabilitation on both roads was to remove the oversteepened sidecast fill on the outside of the roads and landings and place this fill against the cutslope (Photos 1-2). The heavy equipment also opened up first and second-order tributary channels that were formerly the sites of culvert wash-outs along the road (Photos 3-4). Where the logging roads cut into especially wet slopes where groundwater seepage from the cutbanks was prevalent, a backhoe excavated wide troughs, or cross road drains, that intermittently drained the cutbanks, so the soil fill placed against the cutslope would not become saturated (Photos 5-6). Along the oversteepened outside edge of the log landings, which are wide portions along the road, tons of woody debris is incorporated into the soil fill, and this fill is especially prone to failure as the woody debris rots. A crane pulled back the outer edge of these unstable landings to remove the perched woody debris and grade the slope back to a more stable configuration (Photos 7-8).

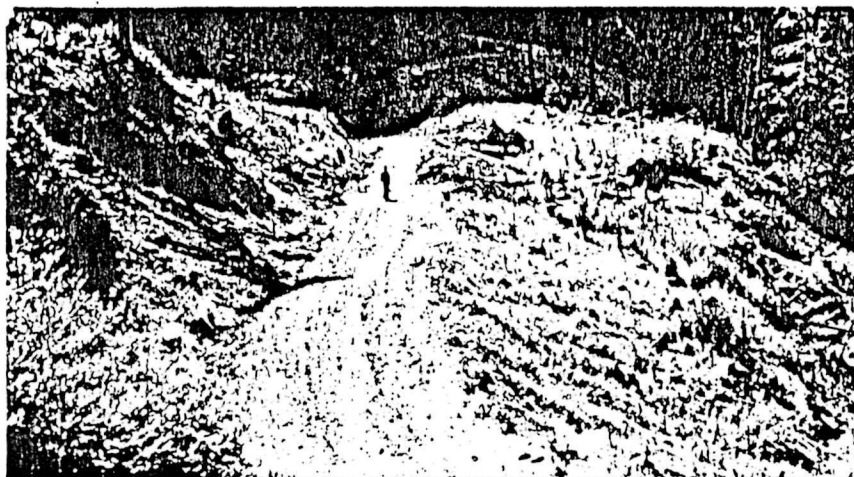
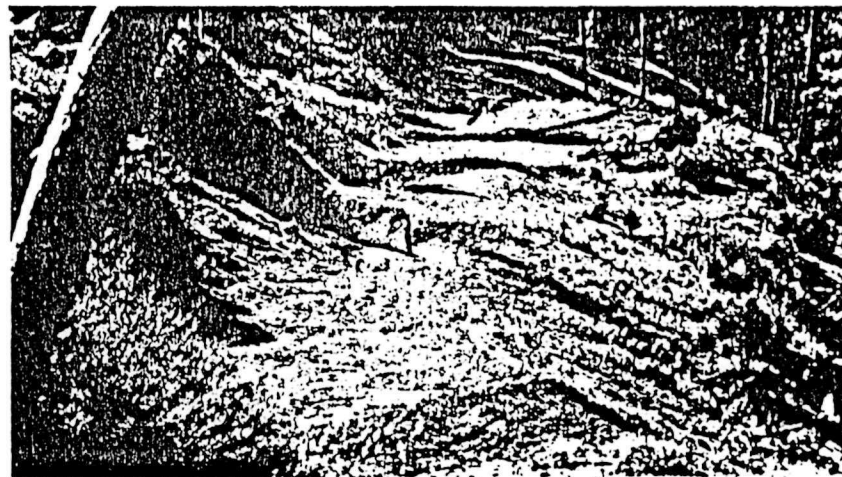
Photos 5 and 6 (August and October, 1978): Before and after views showing outsloping of road and installation of cross road troughs to drain the road cutbanks--note the elimination of the culvert and the inboard ditch in the October photo. C-90 Road, Harry Weir (Emerald) Creek.

Cross road drains are specialized ditches that drain the cutbanks of roads (Photos 5-6). These drains will in most instances be constructed by heavy equipment during outslowing, or pulling, of a road, though their final shaping may be done with shovels. The purpose of the drains is to prevent soaking, by groundwater seepage, of the fill placed against cutbanks, and to carry small drainages across the road prism. The drains should be placed, as best as possible, at the exact locations of major seepage areas and small drainages.

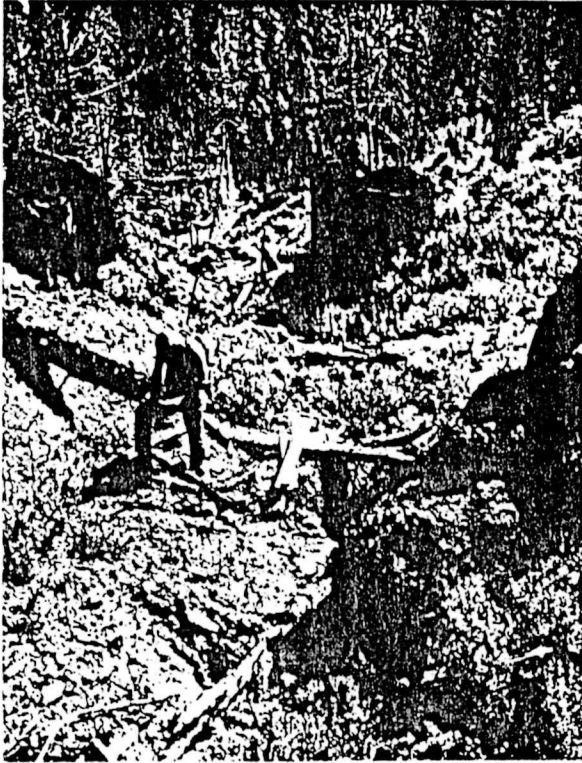
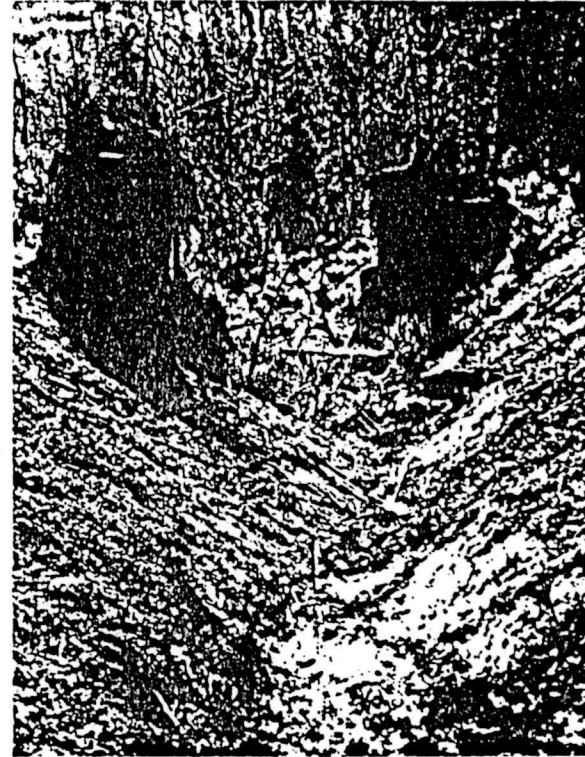
Photos 9-10 (August and October, 1978): To rehabilitate a reach of severely altered channel, a backhoe excavated a tractor-constructed fill crossing and redeposited the fill on adjacent skid roads. After removal of the fill crossing, manual labor crews will plant the slopes and install check dams in the channel to impede downcutting.

During September and October, 1978, a number of large fill crossings were excavated on two perennial stream channels in the park. The original, tractor-constructed approach trails were outsloped with material excavated from the prisms of fill deposited in the incised drainages (Photos 9-10). Gully and slope stabilization procedures (described below) were then utilized to revegetate and control erosion on the freshly exposed soils.

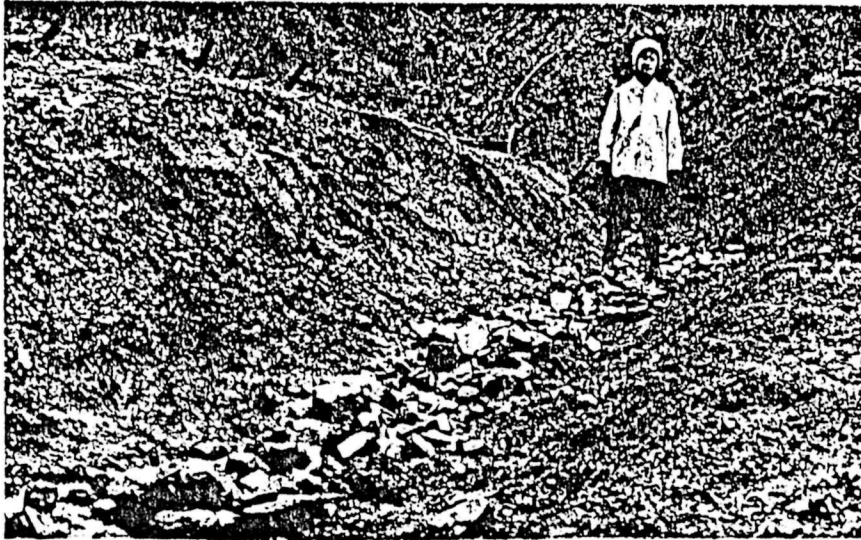
Photo 11: Cross road drain lined with coarse rock to prevent downcutting. C-90 Road, Harry Weir (Emerald) Creek.

When water is routed into the artificially constructed drains or troughs, erosion will likely occur in the excavated trough and directly downstream of the trough where concentrated runoff flows onto slopes of steeper gradient that do not already have stable channels. To try to prevent such erosion, waterbars, ditches, and cross road drains may be lined with rock (Photo 11). A device may then be installed on the slope directly below the rocked trough to dissipate the energy of the fast-flowing water. Rocking of drainage troughs only works if the rock is large enough to remain stationary during high runoff; in standard waterbars and cross road drains in the park (20'-30' long, 2%-6% grade), at least 25% of the rock should be ten inches or larger to assure a reasonable chance that the rock will remain in place and help armor the bed. Ideally, energy dissipation devices slow runoff and eventually become incorporated into the channel bed by trapping sediment and forming stable knickpoints in the channel profile. Energy dissipators take many forms--a sample list of techniques tried to date include: 1) strategically placed and

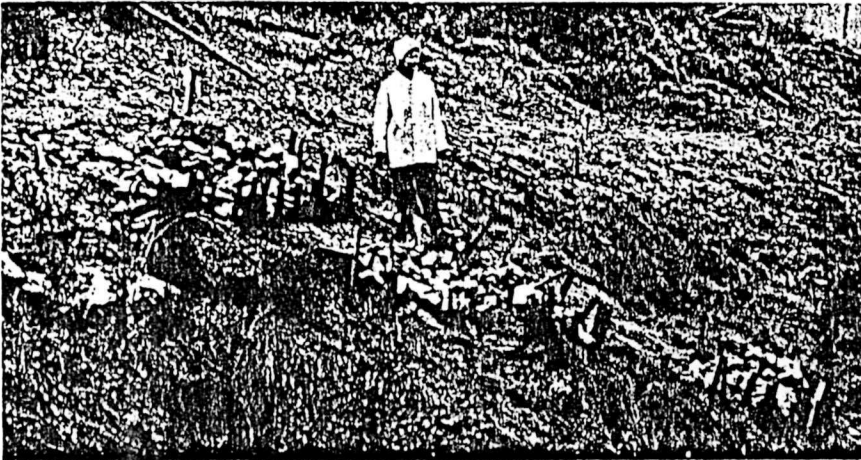
Photo 12: Piles of coarse rock held in place with wood stakes that serve as energy dissipation structures at the downslope end of a cross road drain. C-90 Road, Harry Weir (Emerald) Creek.

secured logging slash (branches, small trees); 2) split "ricochet" boards, anchored with stakes and rock, and placed diagonally into the slope to divert water back and forth in pinball fashion down a steep slope; 3) piles of rock that lean against stakes in a gully and slowly filter water through them (Photo 12); and 4) bundled conifer boughs staked diagonally in a drainage course in a herringbone pattern.

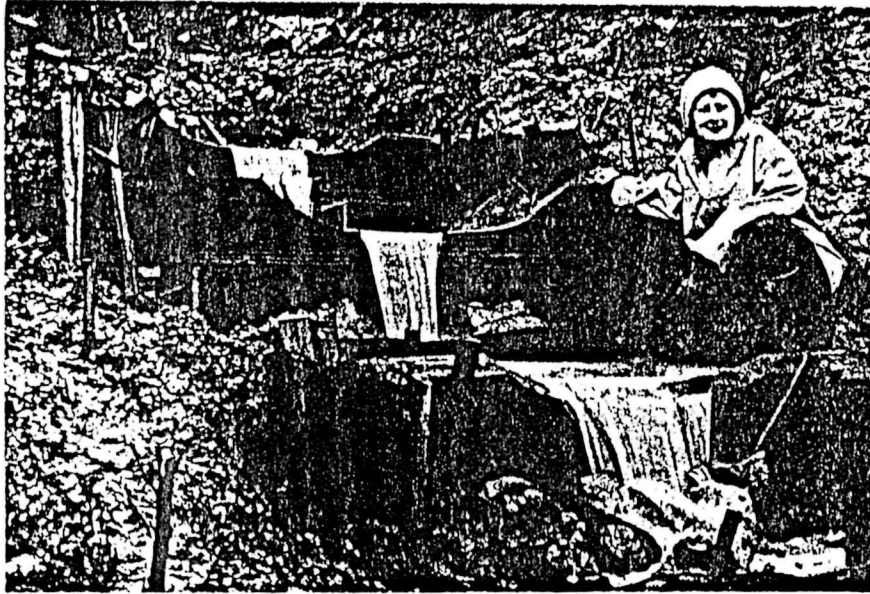
Photo 14 (December, 1978): Recently installed split-board check dams along an intermittent, second-order tributary in Redwood National Park. Each dam is ponding water, and sediment will settle out in the basin up to the height of the spillway. Note the close spacing of check dams, and the rock energy dissipation below the spillways; both measures protect the dams from gully downcutting. Note stem cuttings of willow (poles in gully bank) which are planted to accelerate revegetation. Drainage just below C-10 Road, Miller Creek.

Check dams can be an effective means of controlling gully erosion and stabilizing gully banks and bottoms so that vegetation can become established. During the past two summers, check dams were installed in four different locations in the park on first- and second-order perennial or intermittent drainages that were actively gullying. The three types of check dams, all constructed by hand and primarily using on-site or nearby materials, include split board dams (Photo 14), conifer bough dams, and rock dams reinforced with wire mesh. The check dams are typically 10-30 inches high and 2-6 feet wide, depending on gully width and gradient and type of construction.

Successful check dams are those which pond sediment in their basins while allowing free passage of water over the spillway. The ponded sediment prevents downcutting, stabilizes the adjacent gully banks by preventing lateral bank cutting, and provides a relatively permeable, fertile substrate for planting. The check dams must be well keyed into the bank, either by sufficient excavation or staking or both, so that water will not cut laterally around the end of the check dam. An adequately deep spillway that can accommodate high runoff further ensures that the dams will not be breached along the sides. Energy dissipa-

tion; in the form of branches, logs, boards, or large rock, must be placed in the channel below the spillway of each dam to deter plunge pool erosion and consequent undermining of the check dam. In actively downcutting gullies, a single check dam can easily be undermined from below as normal downcutting continues. Therefore, check dams are normally installed in a series so that undercutting cannot occur at the base of any one check dam. Ideally, the lowest check dam in a gully reach to be controlled should be constructed on a non-erodable base (bedrock, large boulders, etc.), and all check dams constructed upstream of this lowermost dam should be placed so that sediment fill behind the downstream dam (after the dam fills with sediment) abuts against the base of the next upstream check dam. Therefore, check dams and their trapped sediment totally cover the gully reach, and running water moves down the channel over the ponded sediment fill, over the check dam step, through the energy dissipation device, and onto the next lower level of ponded sediment.

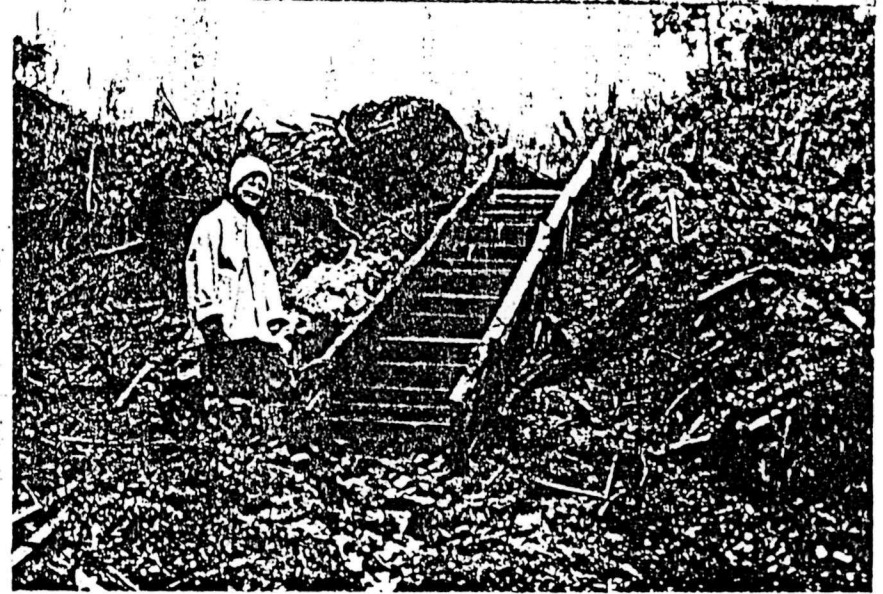
Photo 15 (December, 1978): Hand-constructed redwood board water ladder that is conveying stream runoff over a steep bank at the downstream end of a cross-road drain. The water ladder prevents gully cutting into the steep, bare bank and conducts the water downslope to less erodible, partially vegetated ground. Note rock energy dissipation at foot of water ladder. C-90 Road, Harry Weir (Emerald) Creek.

Water ladders are wooden structures, similar in appearance to stairs, that convey water over a steep slope without downcutting (Photo 15). In Redwood National Park, water ladders have been employed in the following situations: 1) in steep gully reaches where check dams are impractical; 2) in the lower section of a cross road drain where the drain drops off the edge of the former road bench and there is no other method, such as channel rocking, that could prevent downcutting; and 3) in disturbed drainages where tractor-constructed dirt crossings fill the channel and a water ladder may prevent further downcutting into the fill. In many localities, water ladders can serve the same purpose as half-round culverts that conduct culverted water over steep road fills and onto vegetated or slash-covered slopes.

Water ladders are placed so that they become a part of the stable channel bed. They must be well embedded into the drainage so that runoff does not go around or under the ladder during high flows. Vegetation planted adjacent to the ladder and between the rungs will further stabilize the channel.
