**NATIONAL REGISTER OF HISTORIC PLACES  
INVENTORY - NOMINATION FORM  
FOR FEDERAL PROPERTIES**

Pierce Springhouse and ~~Pierce~~ Barn (Art Barn)

Pierce Plantation

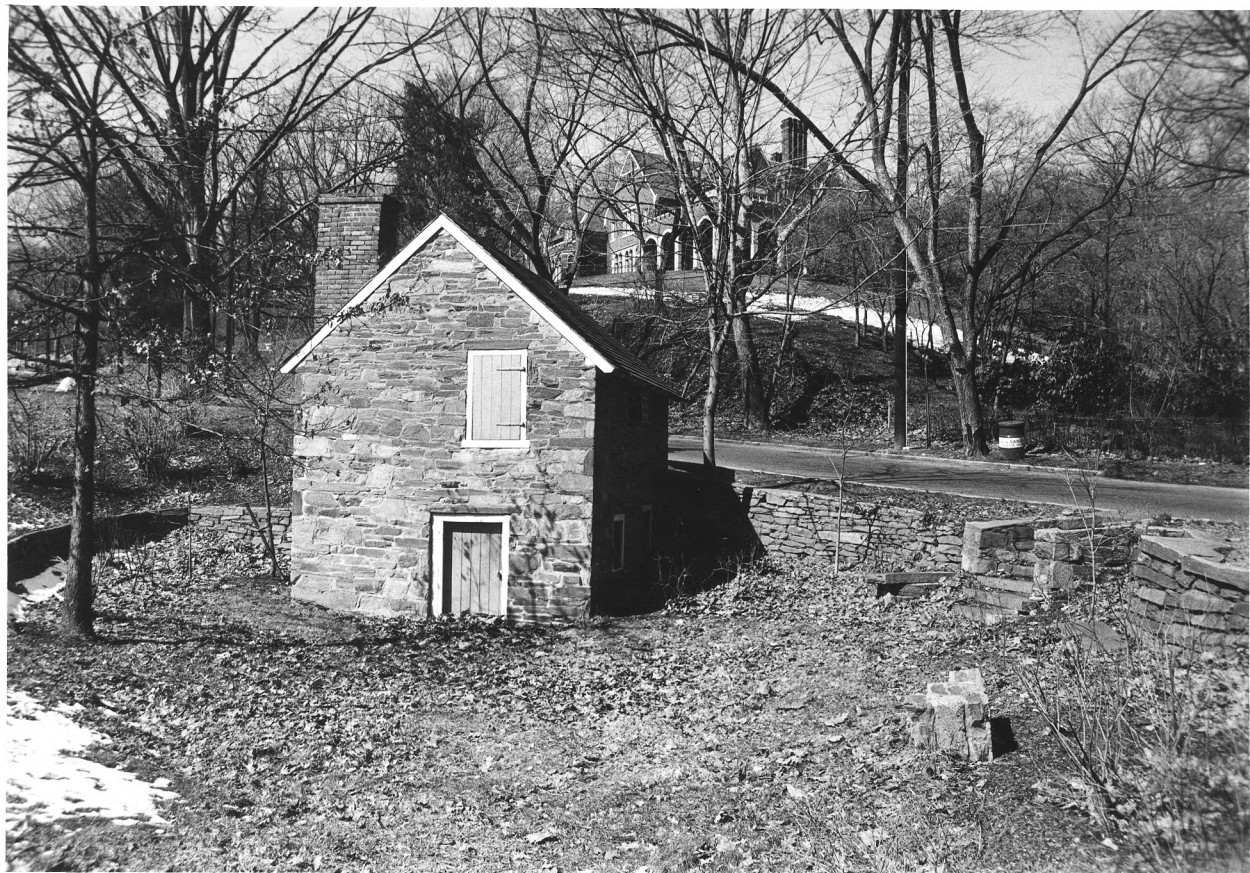
View showing the front entrance to the Springhouse and its setting in Rock Creek Park from the Southeast.

The Pierce Springhouse is located in Rock Creek Park on the green median strip between the dual lanes of heavily used Tilden Street, N.W. The Springhouse is constructed of blue granite that was quarried locally at a nearby Broad Branch Quarry. The structure has two stories, with a brick chimney and a gabled wood shingled roof. The ground floor has three windows; the upper level has one window at either end of the building. The front and rear sides of the Springhouse are 15'2" wide and the side walls are 19'1" wide. The building of the Springhouse predated the erection of any other existing buildings at the former Pierce Plantation site.

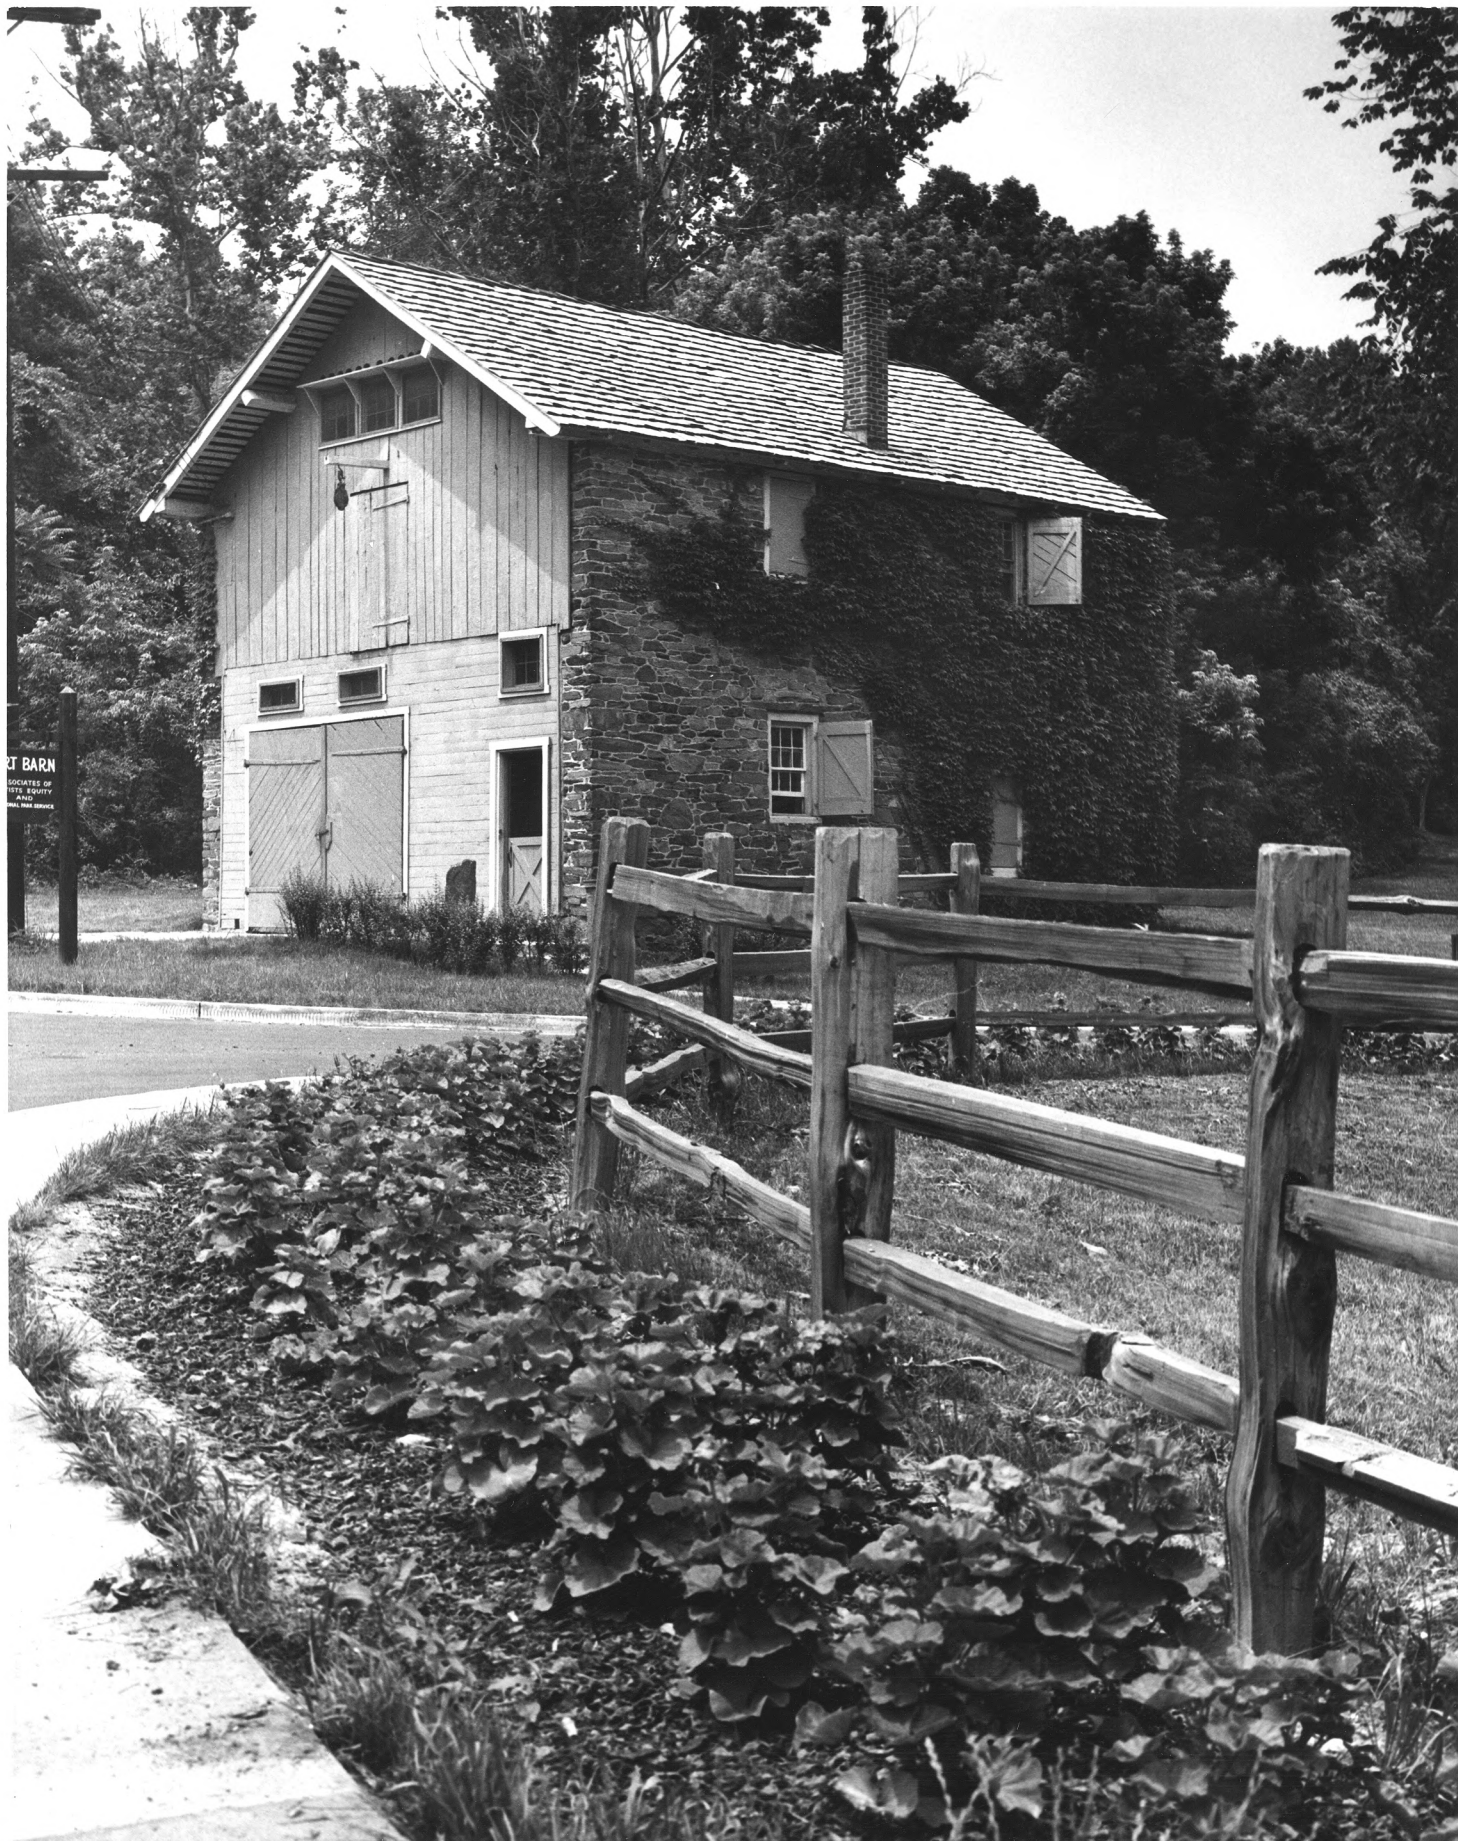
Principal southeast front and east side of Pierce Barn from the southeast

The Pierce Barn is located in the same area of Rock Creek Park as the Springhouse and the mill. The barn is approximately 26' wide and 35' in depth and is constructed of blue granite that was quarried locally at the Broad Branch Road Quarry. The front wall of the barn facing Tilden Street is made of woodboards. The rear wall contains a single window on each of the three levels. The side wall facing Rock Creek contains four irregularly spaced windows two on each of the first two floors. The other side walls contain a total of six irregularly sized windows, three small windows located above the double barn door and the nearby main entry door. Three windows are located at the third floor just below the gabled roof. The roof is of gabled wood shingles with a single brick chimney.
