National Park Service  
Cultural Landscapes Inventory  
2010

Moraine Park Museum and Amphitheater  
Rocky Mountain National Park

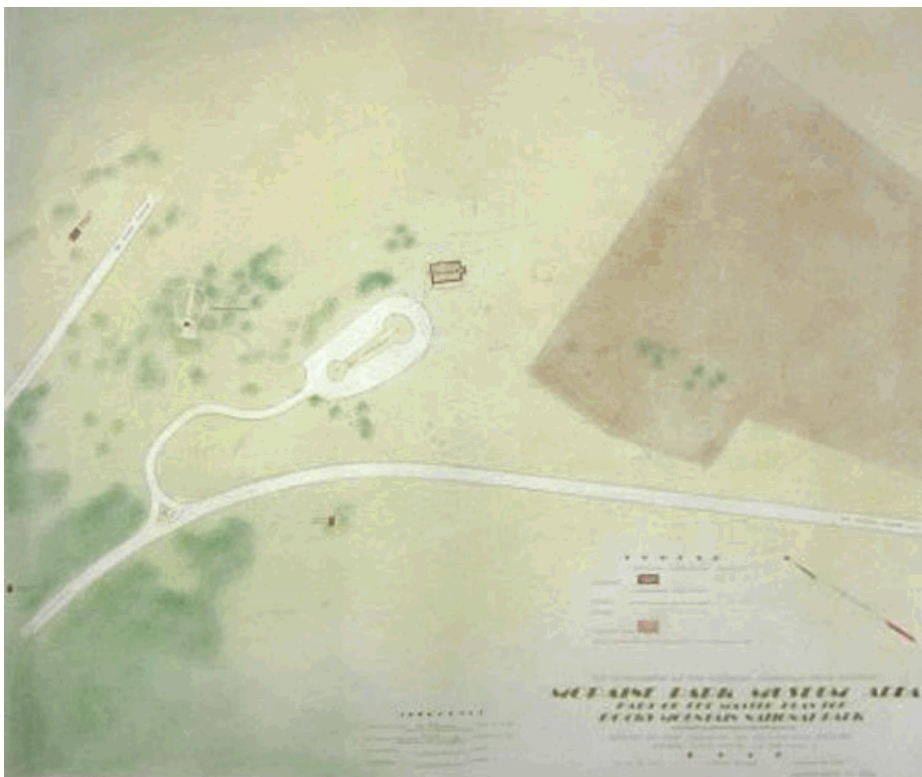
*Site plan showing proposed improvements from the 1936 Master Plan. Existing buildings are outlined in red; private land is shaded in brown. Source: ROMO Archives.*

| AD 1936 | Planned | March. The 1936 Master Plan outlines planning efforts for the Moraine Park area, including a site plan or proposed conditions and utility plan for the area (The Master Plan, Rocky Mountain National Park, Colorado 1936, 37). |

Master Plan was drafted that outlined the progress of the construction. It noted the existing entrance road, museum alterations, and amphitheater, thus implying those construction projects were completed first. Remaining improvements included the construction of the parking lot, trails, plantings, and entrance sign. More specifically, the document states,

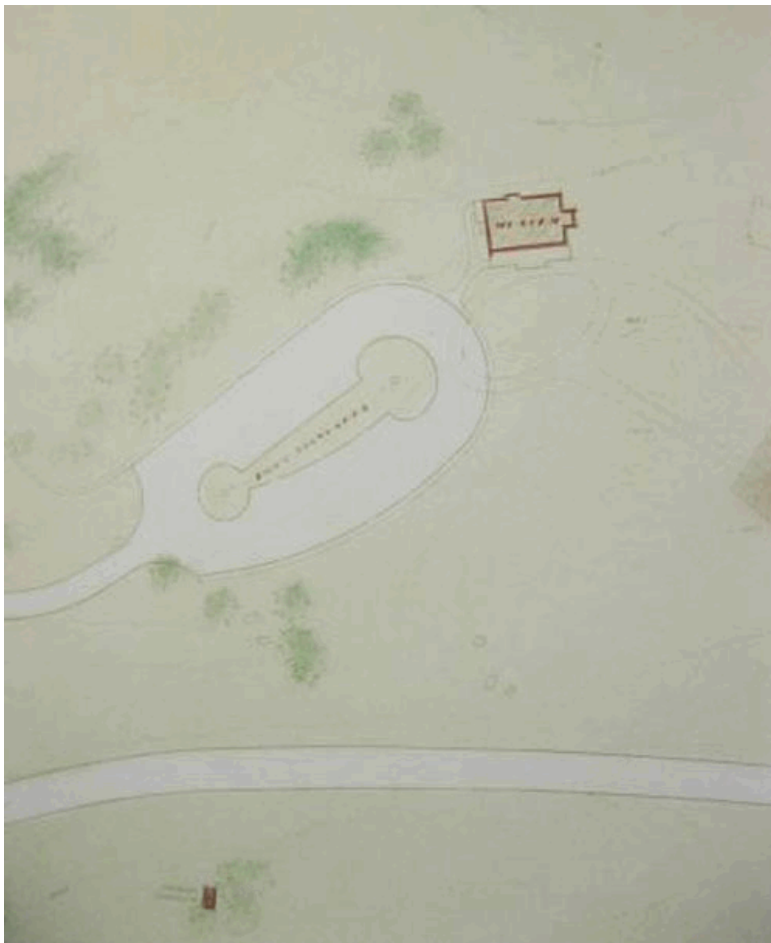
*Detail of museum area and parking lot from 1936 Master Plan. Existing buildings are outlined in red. Note the oval loop road south of the museum building. Source: ROMO Archives.*

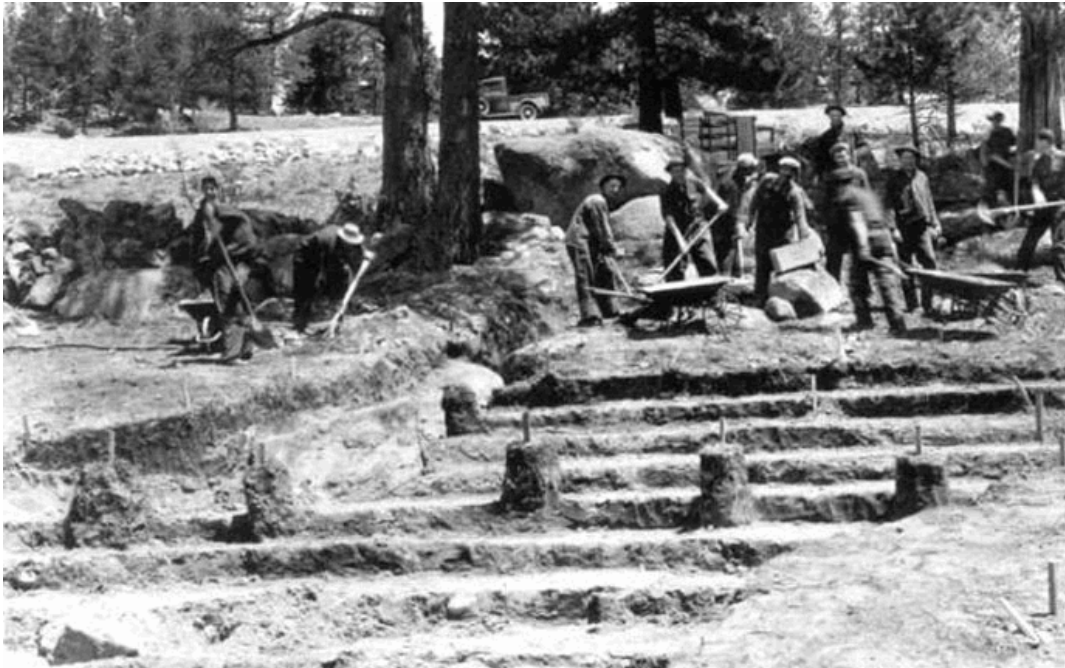
*Moraine Park Museum Amphitheater construction, May 29, 1936. Source: NPS-ROMO, 11—5, album 4008, neg 3132; NR nomination.*

The Moraine Park site represents one of the earliest, fully realized examples of this type of amphitheater design in the National Park Service. The Moraine Park Amphitheater's naturalistic design utilized the natural bowl site, retained and enhanced native plantings, used rustic materials such as wood and stone, included the fire circle, and focused the view across Moraine Park. In 1938, Rocky Mountain National Park built two, simpler lecture circles (Aspenglen Campground and Glacier Basin Campground both constructed in 1938) using cut logs for seats and the screen. Neither of these had the elaborate stone work found in the Moraine Park Museum Amphitheater's more formal design (NPS Drawing RM-5174, 8 July 1935; McClelland 1993, 147; HABS drawings, no date).

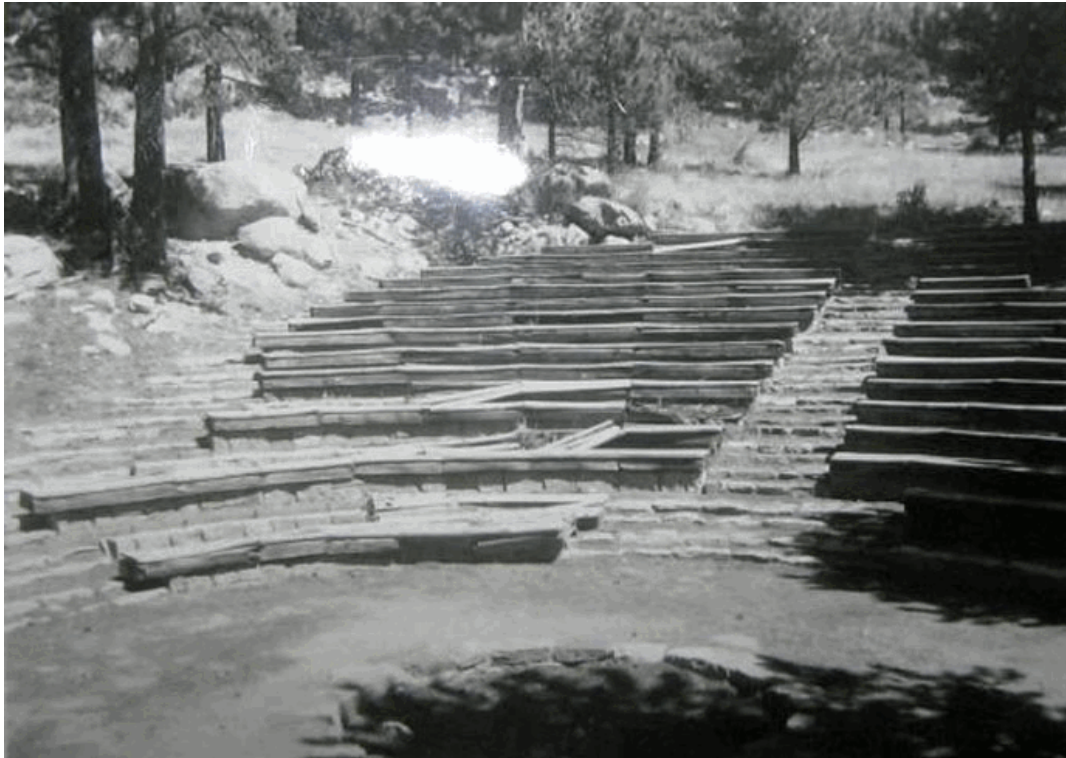
*View of the amphitheater, 1955. Note fire circle in foreground and deteriorated wood seats. Source: Urgently Needed Construction Projects, ROMO Archives.*

After the completion of the construction, the landscape of the Moraine Park Museum and Amphitheater changed little. The Museum was remodeled in 1941, with few exterior changes. However, by 1955, the amphitheater was in disrepair. In a report entitled, “Urgently Needed Construction Projects,” improvements were proposed to replace the seat tops and platform at the Moraine Park Amphitheater. (NPS Urgently Needed Construction Projects, 1955).

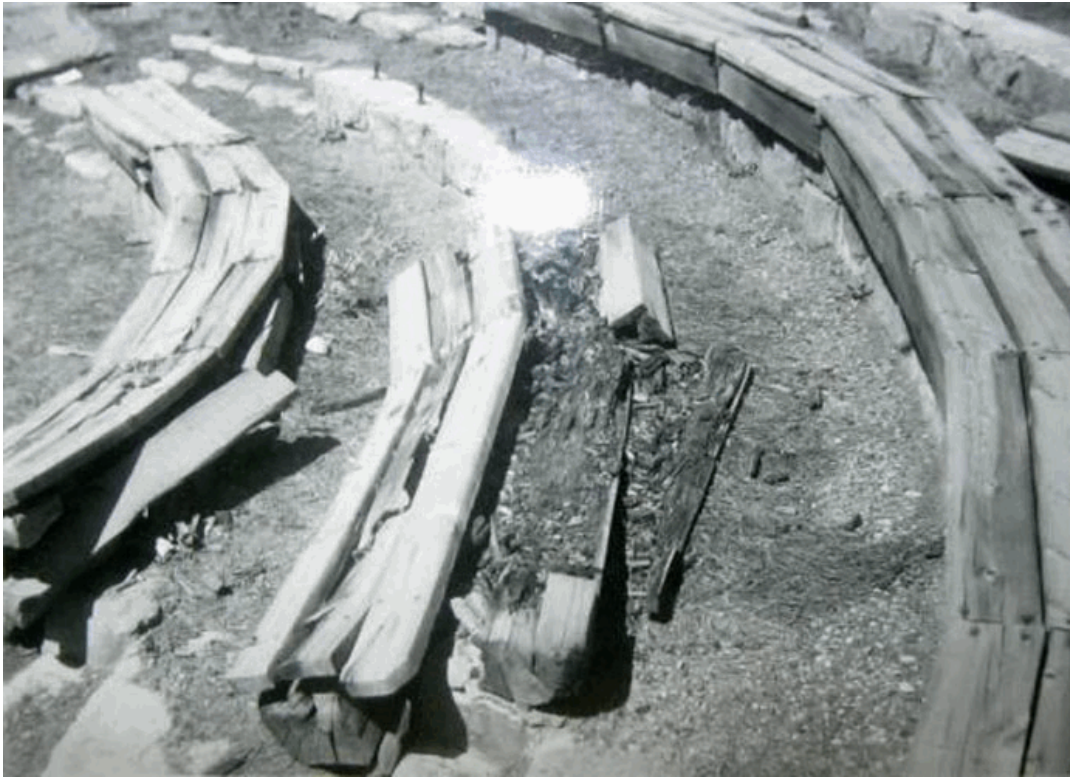
*View of the deteriorated wood seats in the amphitheater, 1955. Source: Urgently Needed Construction Projects, ROMO Archives.*

In 1958, the wood seats and wood stage were replaced by the National Park Service. It is also likely that the projection booth and screen were removed at this same time. No major alterations or demolitions have occurred since its construction.

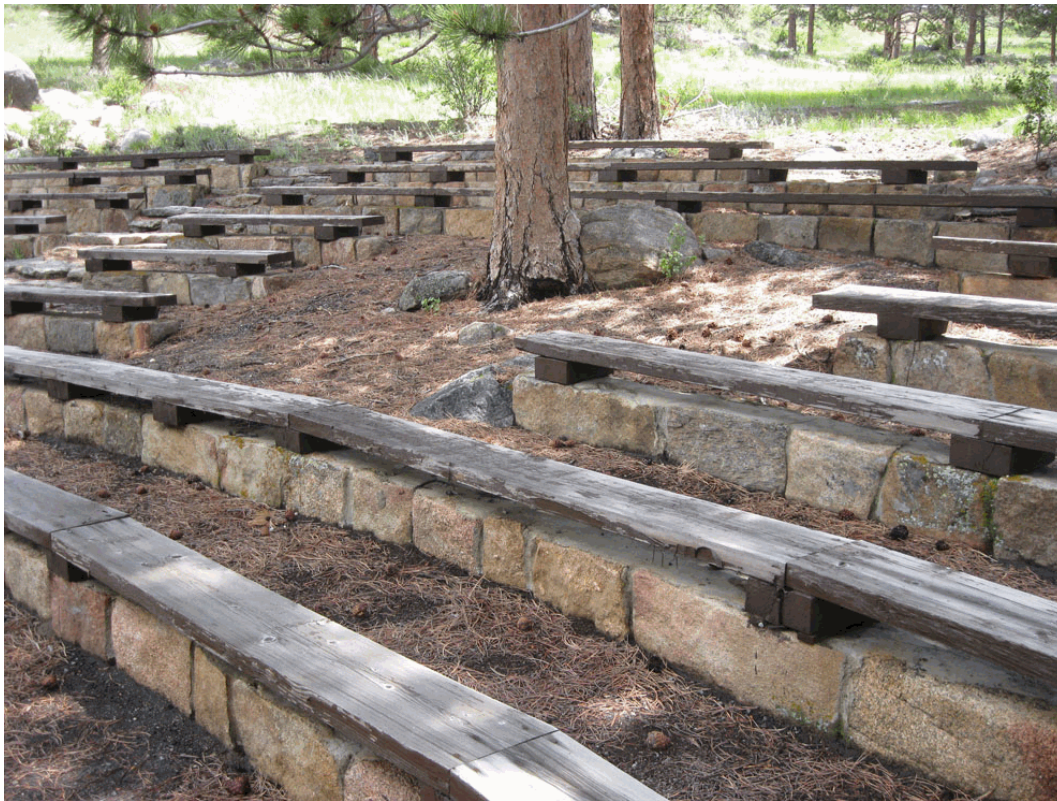
*Seats of the Moraine Park Amphitheater, July 2010. Source: C. Mardorf, NPS.*

Sixteen rows of seats in two arcs ascend from the stage area, arranged in an irregular fan shape, facing the stage and fire pit. The seats sit on somewhat regular stones some 10" high. Concrete mortar stabilizes the rocks holding the rectangular seating planks. Timber wedges (11" x 4") lie on these stone walls about 4-5 feet apart, with rectangular planks of milled lumber (2¼" x 11" x 4-6") nailed to the wedges. The joinery between the planks as well as the wedges use large unfinished nails. The planks are painted dark brown. The seating between rows 10 and 13 in the right arc is broken to accommodate an existing tree in a rectangular planting bed. Lighting fixtures installed under the seats remain but no longer function.

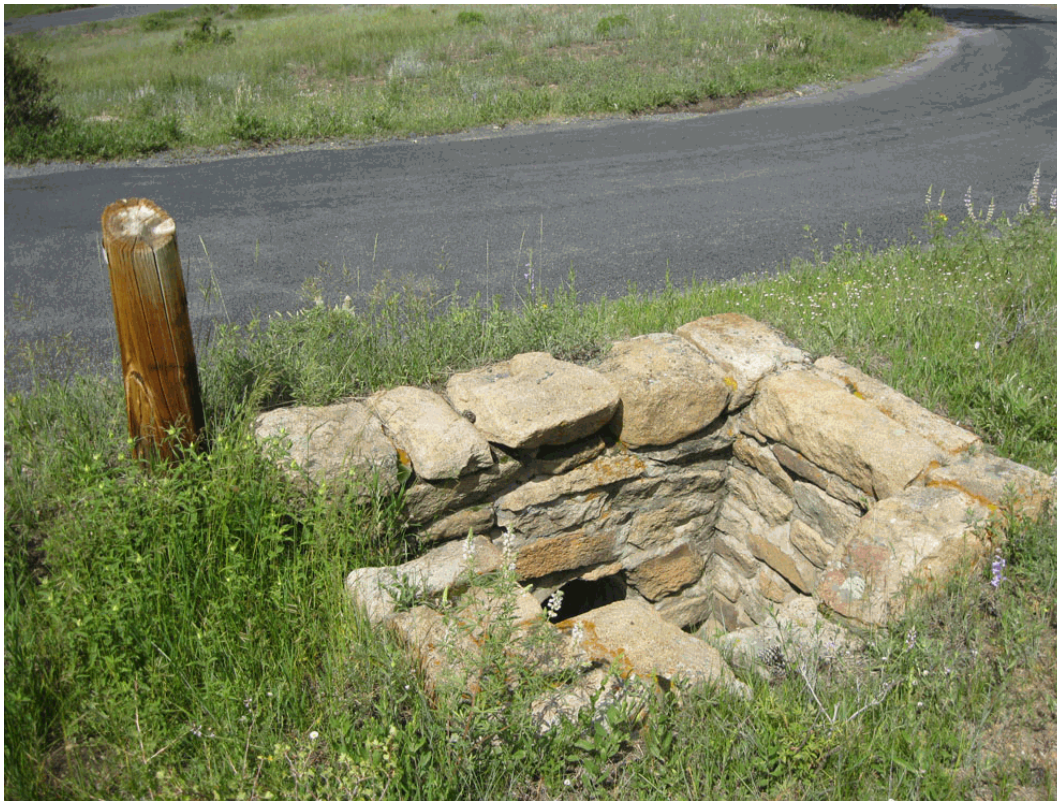
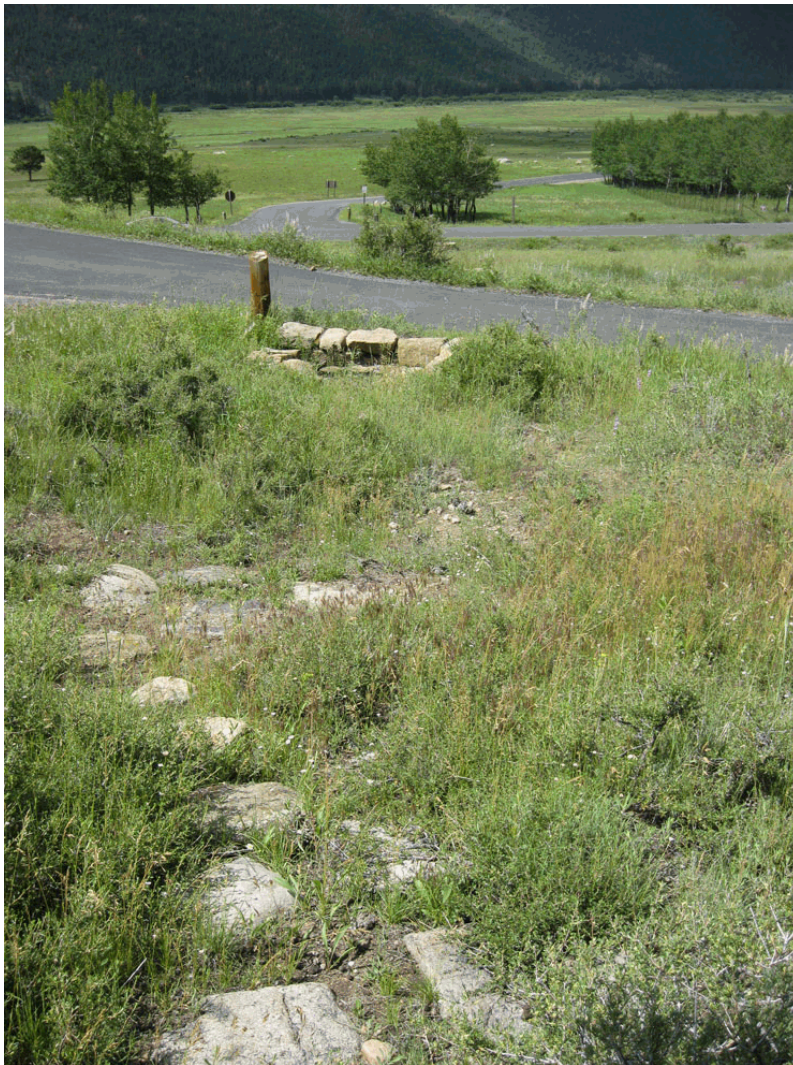
*Stone drainage structure along entrance road to Moraine Park Museum and Amphitheater, July 2010. Source: C. Mardorf, NPS.*

Numerous stone drainage structures move water through the site. Drainage features include a 60-foot-long stone gutter above the amphitheater, which channels water into a drain. A steel drain grate lies behind the screen foundation at the edge of the stage area. At the bottom of the slope below the stage area, a 24-inch steel culvert with stone and concrete battlements channels water under the entry road. Down the slope from this culvert, lies another stone battlement and culvert that carries water under Bear Lake Road. To the southeast, a second system of matching stone battlements and steel culverts moves water under the roads. This drainage pattern points to the elaborate construction techniques used in the creation of the site.

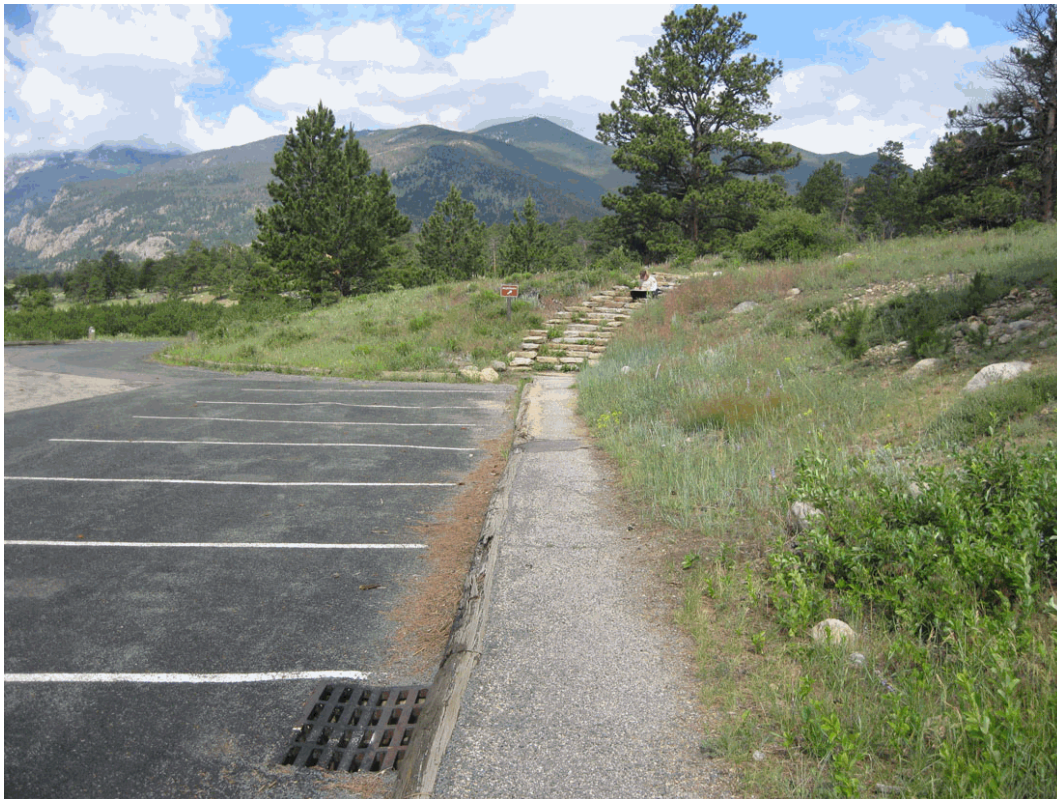
*Asphalt walk and stone steps leading to amphitheater, July 2010. Source: C. Mardorf, NPS.*

**Impact Description:** Deferred maintenance of the landscape has led to the deterioration of some features, such as the CCC era pedestrian path leading to the amphitheater and amphitheater seats. Lack of routine maintenance and substantial pine needle drop has also obscured some historic features in the amphitheater area.

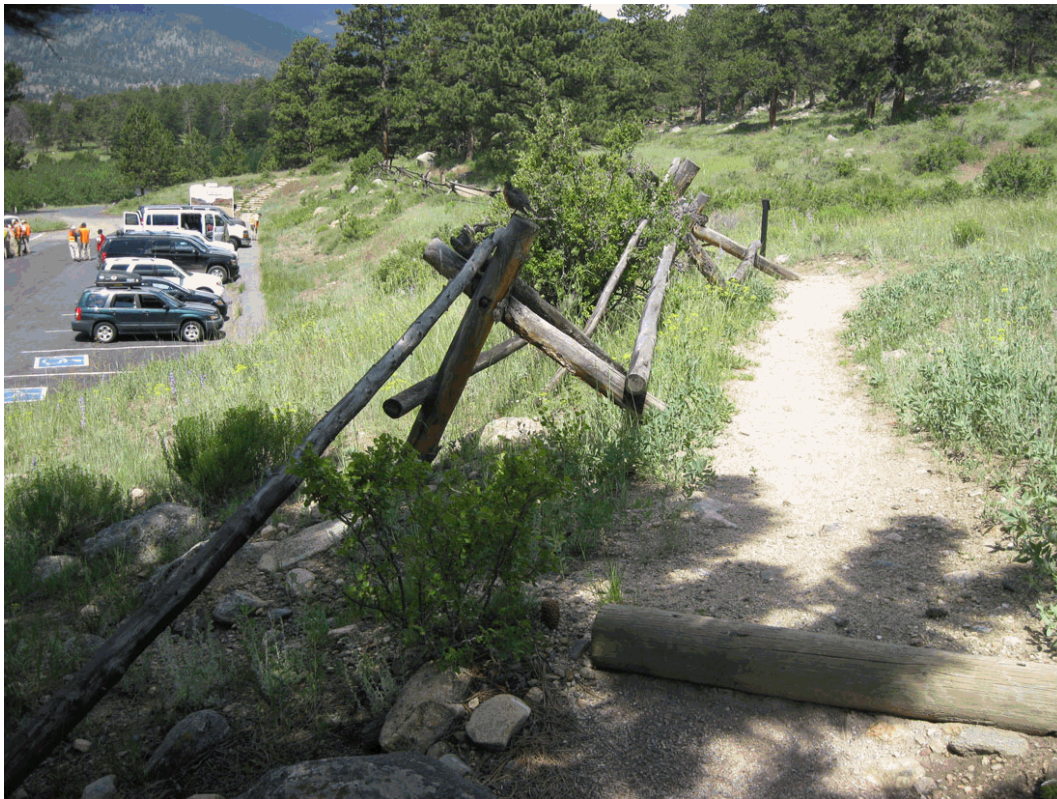
*Interpretive trail along the top of a steep slope with buck-and-rail fence, July 2010. Source: C. Mardorf, NPS.*

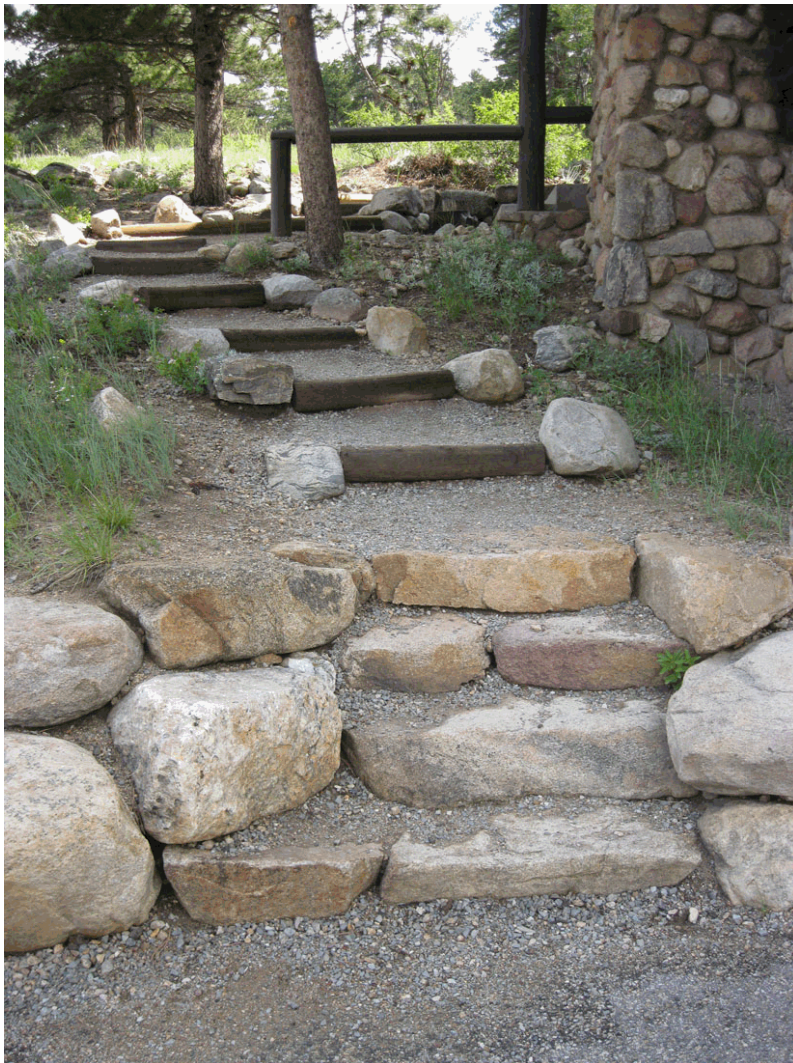
*Stone steps and stone wall west of the Museum, July 2010. Source: C. Mardorf, NPS.*

- Fire ring
- Stage (replaced)
- Wood seats (replaced)
- Stone steps west of museum
- Stone wall west of museum

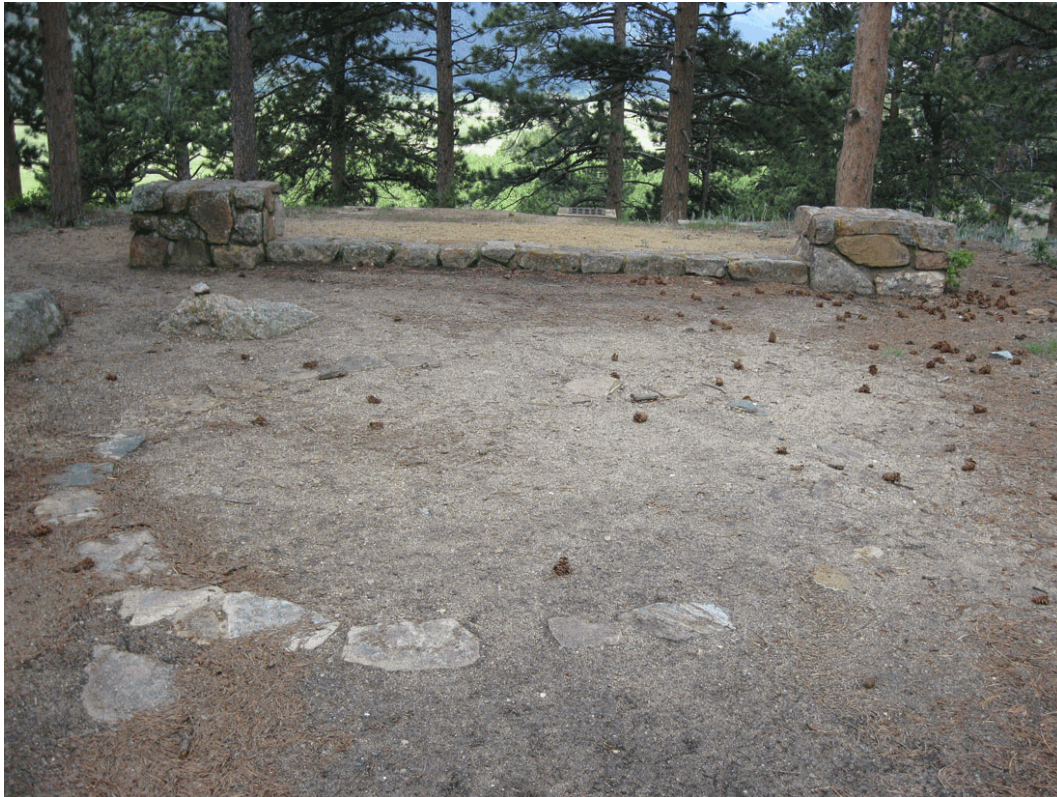
*Fire ring and stone stage at Amphitheater, July 2010. Source: C. Mardorf, NPS.*

foundation; a few large stones remain in situ, revealing their smooth surface on the floor of the stage. The stage is enclosed by a curtain wall of ponderosa pines.
