OMB NO. 1024-0018  
EXP. 12/31/04United States Department of the Interior  
National Park ServiceNational Register of Historic Places  
Inventory—Nomination FormSee instructions in *How to Complete National Register Forms*  
Type all entries—complete applicable sections

historic Rocky Mountain National Park Utility Area Historic District

and/or common Beaver Meadows Maintenance Area

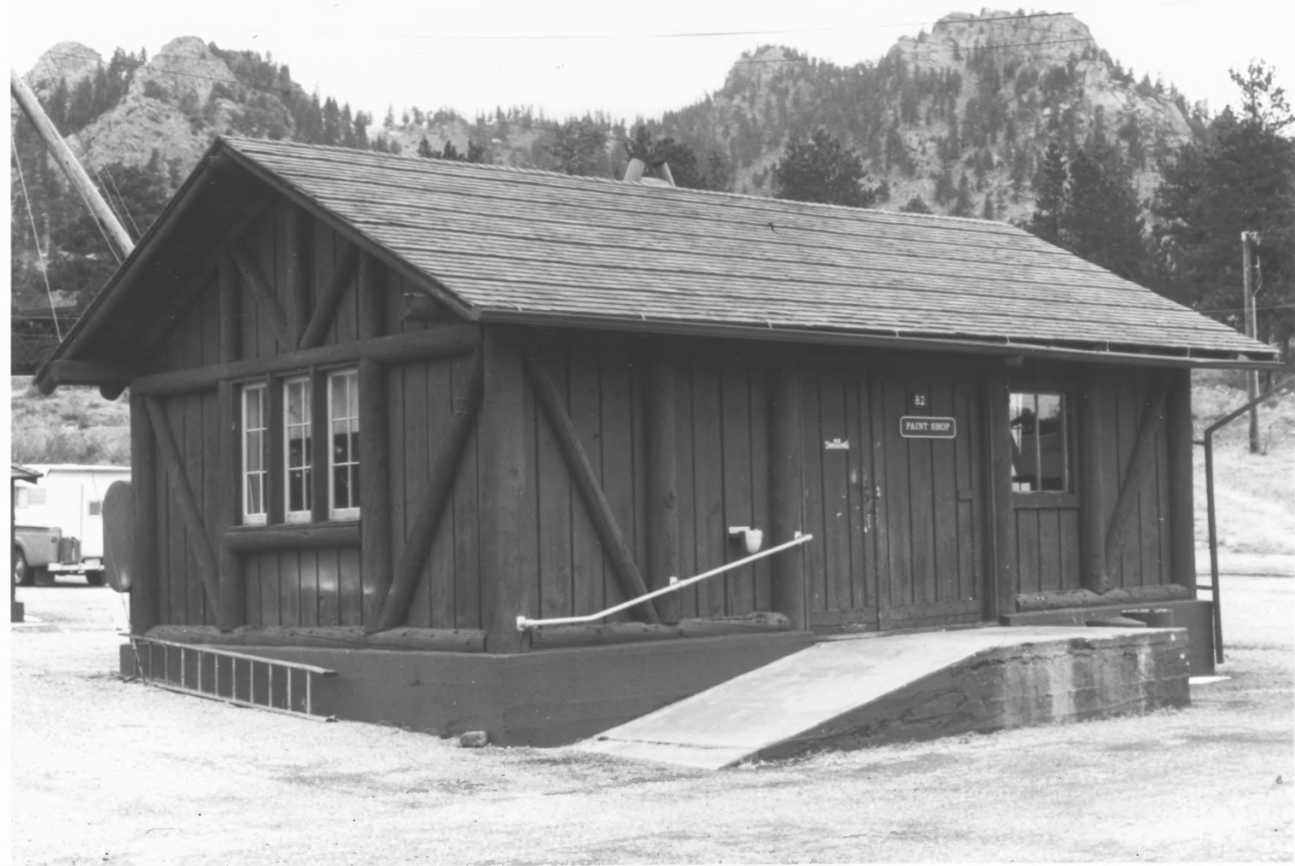
NAME: Blacksmith Shop (#82), Rocky Mountain  
National Park Utility Area Historic District  
LOCATION: Rocky Mountain National Park  
PHOTOGRAPHER: Rodd L. Wheaton  
DATE: March, 1976  
LOCATION OF NEGATIVE: Rocky Mountain Regional  
Office, Denver, CO  
VIEW: Looking west  
PHOTO NUMBER: 1

Building #82—Blacksmith Shop. Approximately 20' x 30', standard gabled roof, now paint shop, entrance ramp (Built 1931; moved to present site and lengthened 1936).

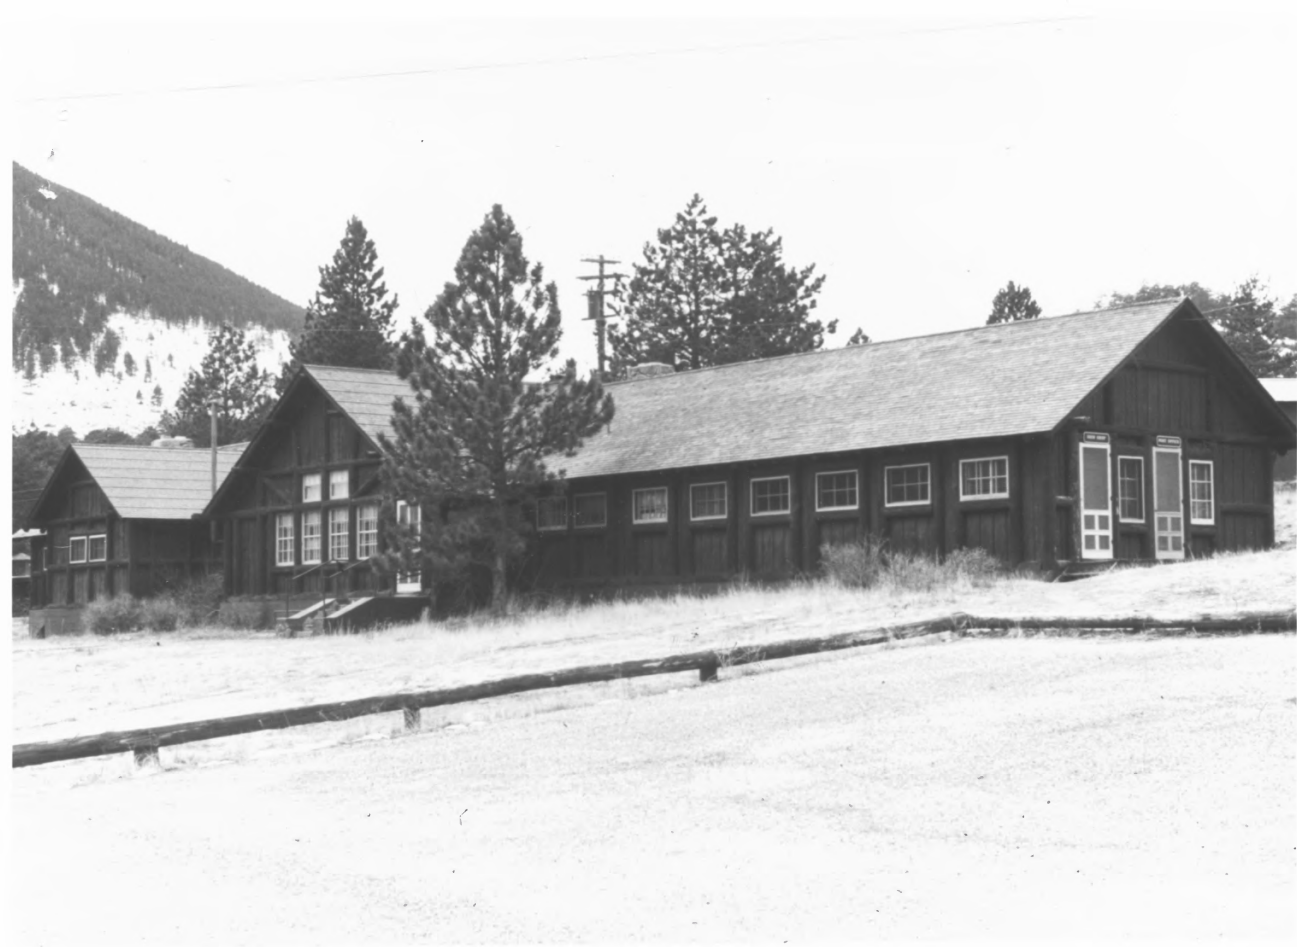
PHOTO NUMBER: 2

NAME: Annex-Mess Hall (#24), Rocky Mountain  
National Park Utility Area Historic  
District

VIEW: East elevation taken from north-east

Building #24-Mess Hall-Dormitory ("The Annex"). Approximately 27' x 190', cook's Kitchen adjoined to dining room with gabled pantry addition, lounge, toilet room, shower room and bedroom in bunkhouse wing, rear two bedroom/bath suite behind lounge; no diagonal corner bracing, standard gabled roof form used as administration building annex prior to 1965; currently used for storage, meeting rooms, and seasonal housing. (Built 1938)

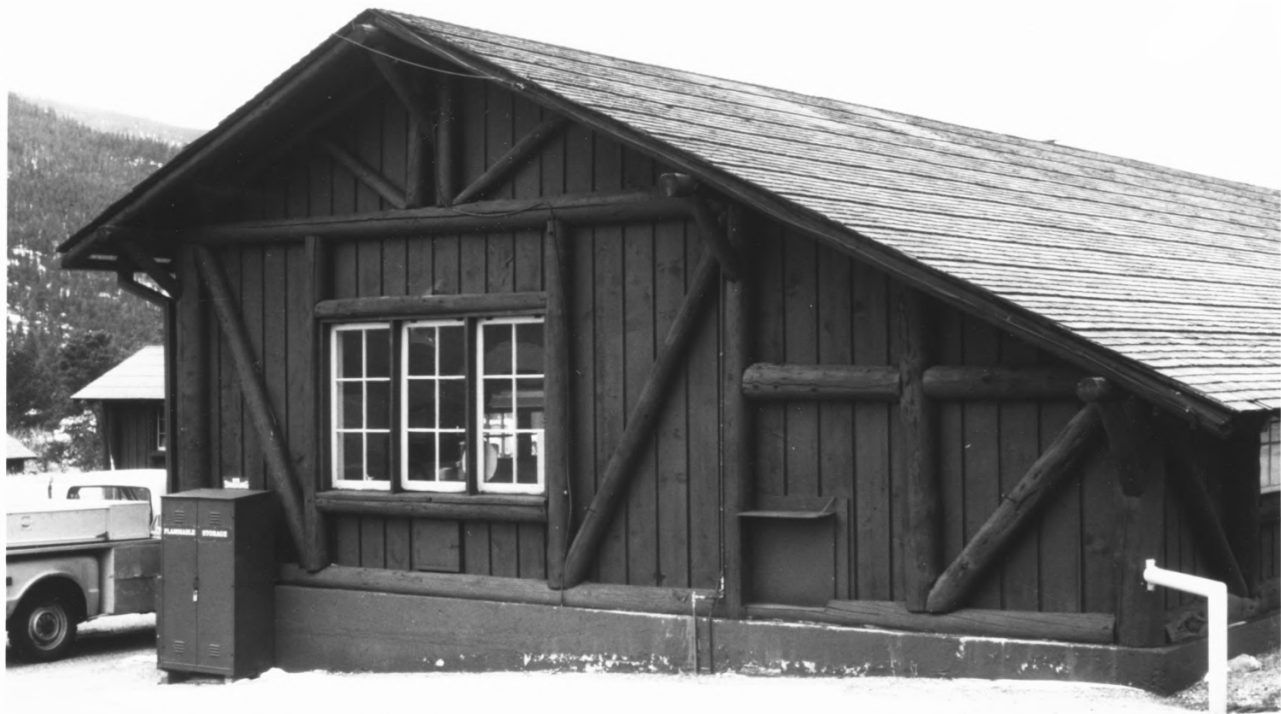
PHOTO NUMBER: 3

NAME: Equipment Building(#75), Rocky  
Mountain National Park Utility Area  
Historic District

VIEW: North elevation, look from south

Building #75-Equipment Storage Shed. Approximately 30' x 120', nine stalls, diagonal bracing of gabled end purlins (Built 1927; "Machine Shop," 1935; remodeled 1939, and 1954 with installation of wood floors over gravel in two stalls).

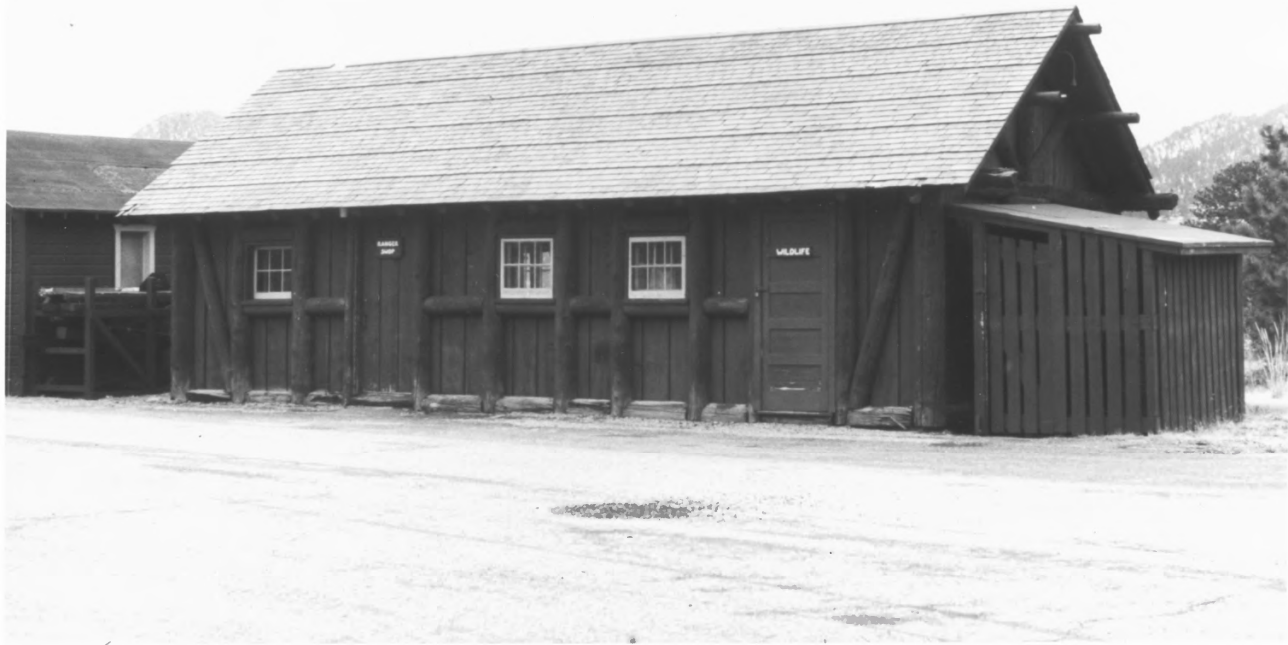
PHOTO NUMBER: 4

NAME: Fire Tool Cache Building (#87),  
Rocky Mountain National Park Utility  
Area Historic District

VIEW: West elevation looking east

Building #87—Fire Tool Cache Building. Approximately 17' x 32', standard gabled roof (Built 1929; moved 1938). Wood storage bin is on south end. Approximately 6' x 6'.

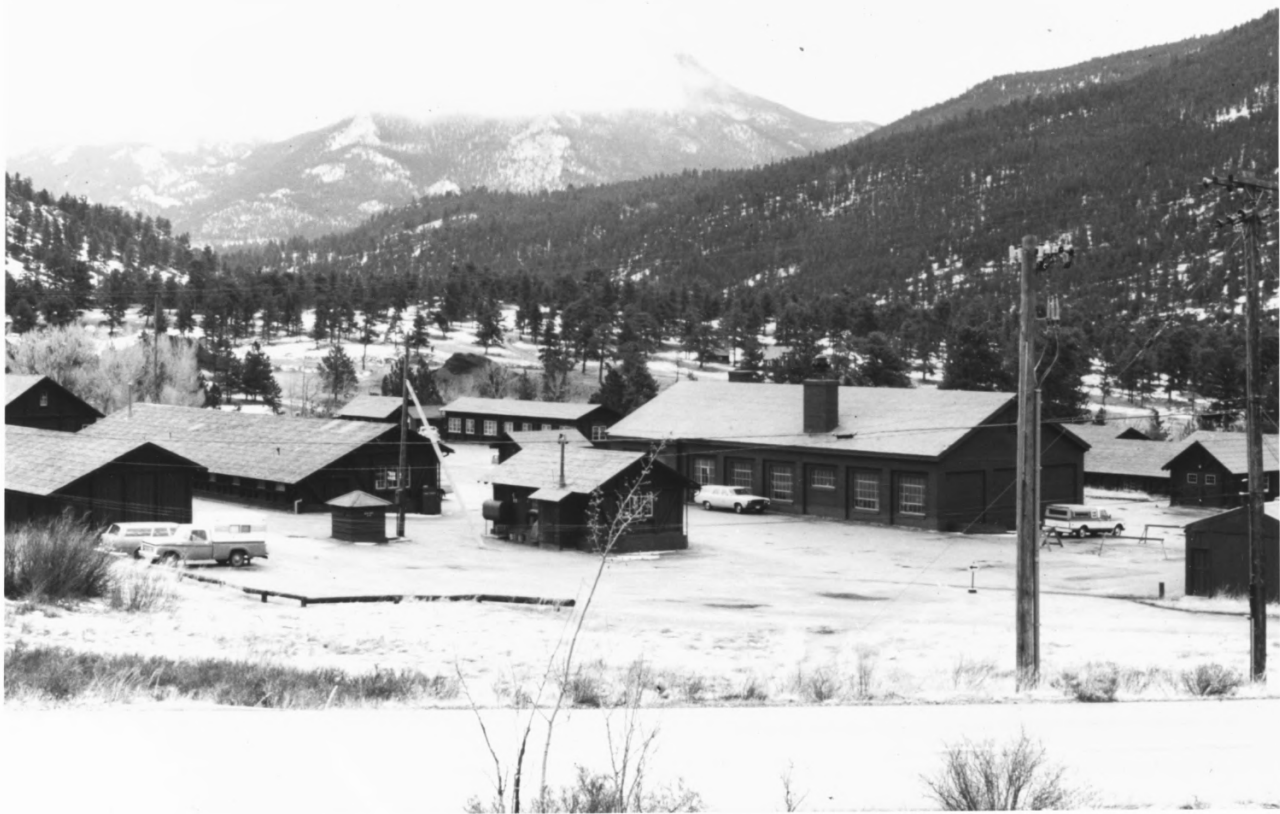
NAME: Maintenance Buildings Rocky Mountain  
National Park Utility Area Historic District  
LOCATION: Rocky Mountain National Park  
PHOTOGRAPHER: Rodd Wheaton  
DATE: March, 1976  
LOCATION OF NEGATIVE: Rocky Mountain Regional  
Office, Denver, CO  
VIEW: South  
PHOTO NUMBER: 5

Wood shingle roofs, with intervals of double shingled courses and stained green have extended rear eaves providing a "salt box" roof configuration. The roof structures typically are supported on log rafters, flattened on the upper surface, log ridge poles and wall plates. The log purlins supporting rear roof slope extensions are carried on log columns with diagonal bracing and are generally exposed in the unfinished interiors. Gravel and bituminous floors are common. In plan, the long rectangular shed structures typically have enclosed end bays, flanking the timber framed stall openings.

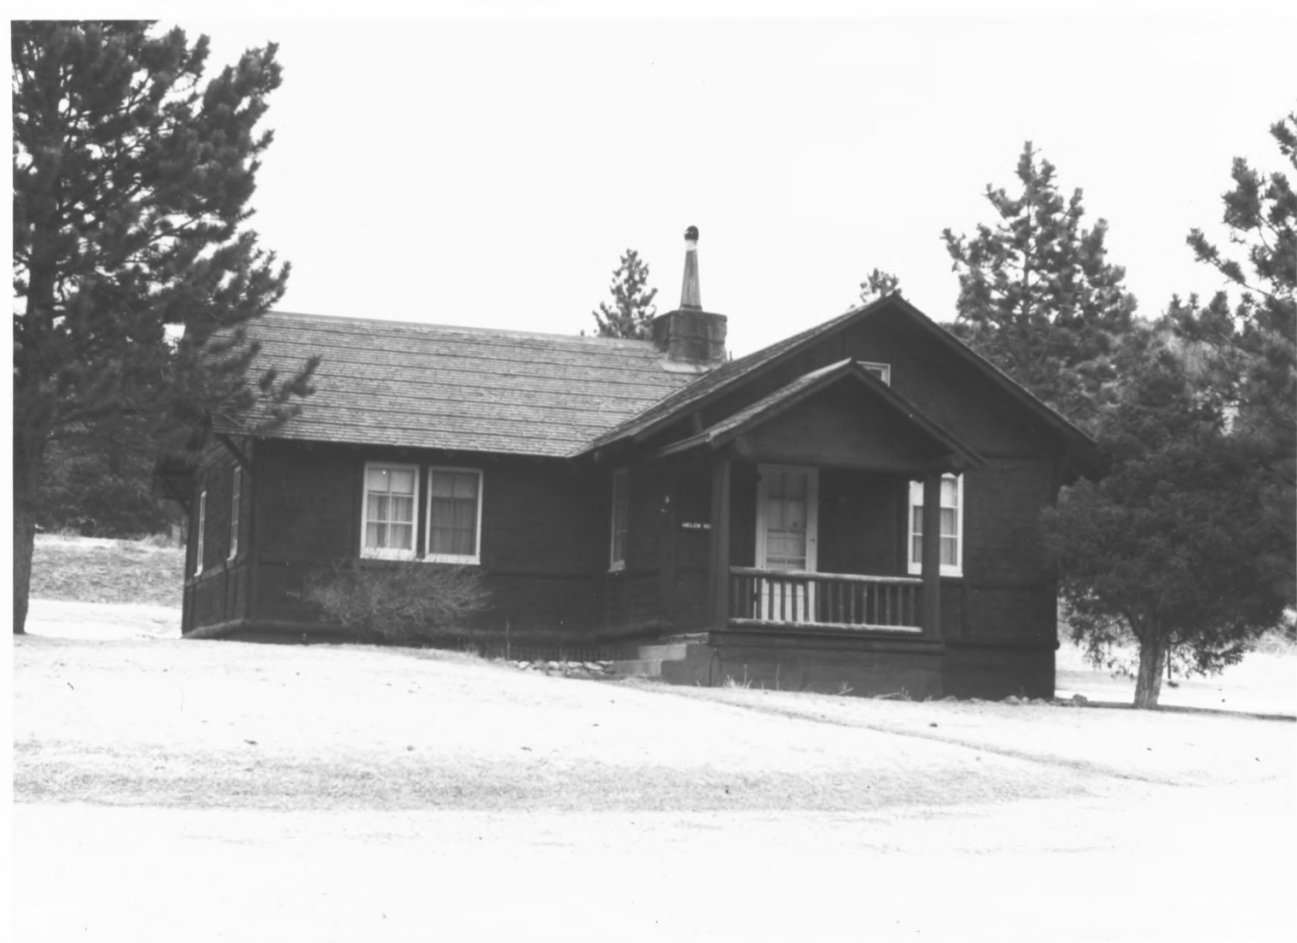
NAME: Residence (#5), Area B Rocky Mountain  
National Park Utility Area Historic District  
LOCATION: Rocky Mountain National Park  
PHOTOGRAPHER: Jim Muhn  
DATE: July, 1976  
LOCATION OF NEGATIVE: Rocky Mountain  
Regional Office, Denver, CO  
VIEW: Facing north  
PHOTO NUMBER: 6

Residential Area "B"; located northeast of the Utility Area and connected to it by two service roads which form a semi-circular drive, includes six individual residences which typify early Park Service-built houses. Typically the one-story, gabled roof structures on concrete foundations are of log frame construction infilled with shingled panels, and stained dark brown. Open gabled roof porches are supported on log columns. Extending beyond the gable ends, the log wall plates and ridge poles support green painted wood shingled roofs having doubled fifth courses. Single, double, and triple mullioned window openings have six-light casement sash and plain board trim, painted light green.

Residence #5. Approximately 30' x 40'; L-plan; two bedrooms (Built 1927; remodeled 1939).

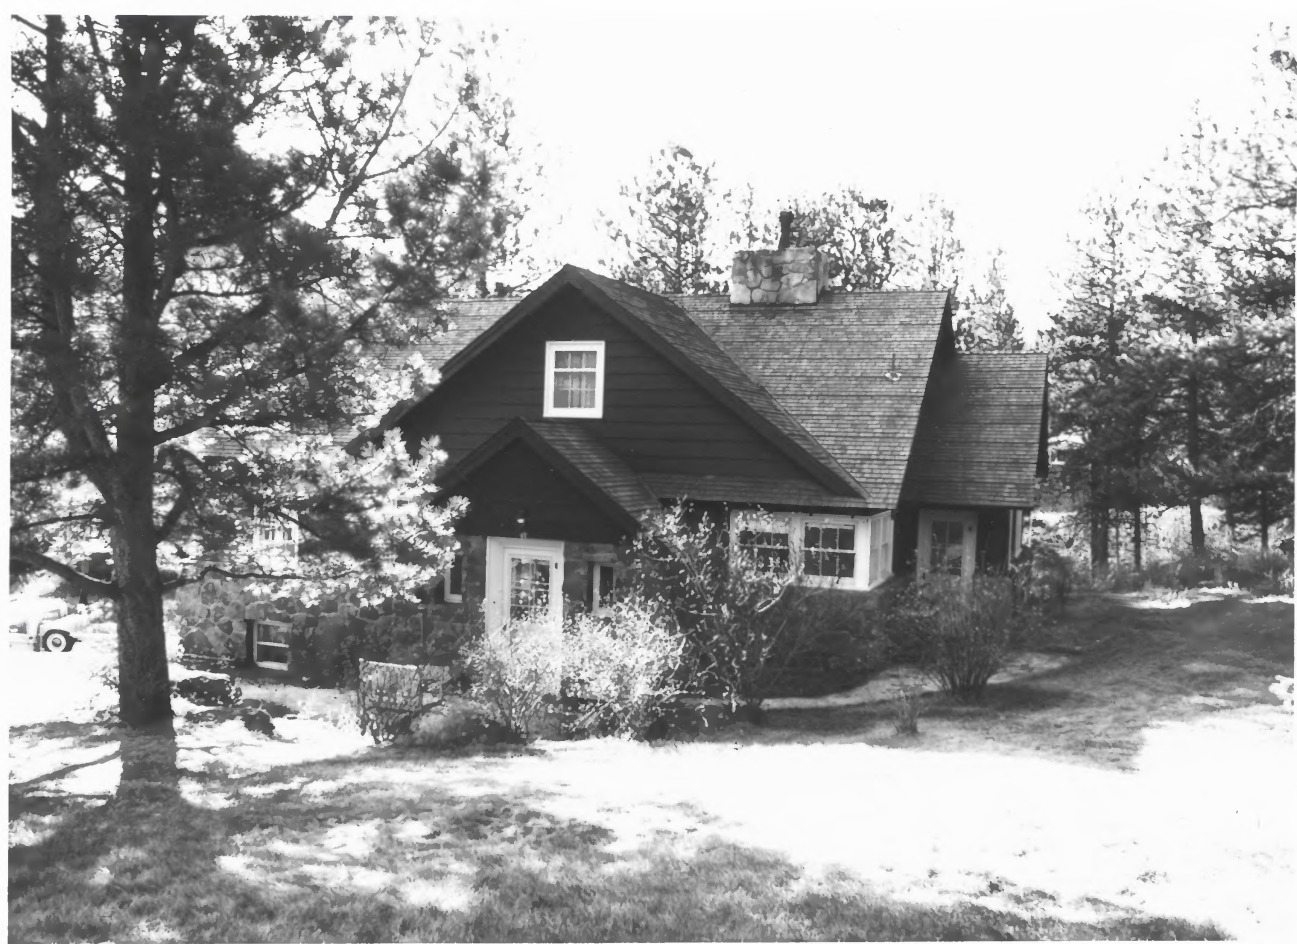
NAME: Residence (#47), Rocky Mountain National  
Park Utility Area Historic District  
LOCATION: Rocky Mountain National Park  
PHOTOGRAPHER: Jim Muhn  
DATE: July, 1976  
LOCATION OF NEGATIVE: Rocky Mountain  
Regional Office, Denver, CO  
VIEW: Looking south west  
PHOTO NUMBER: 7

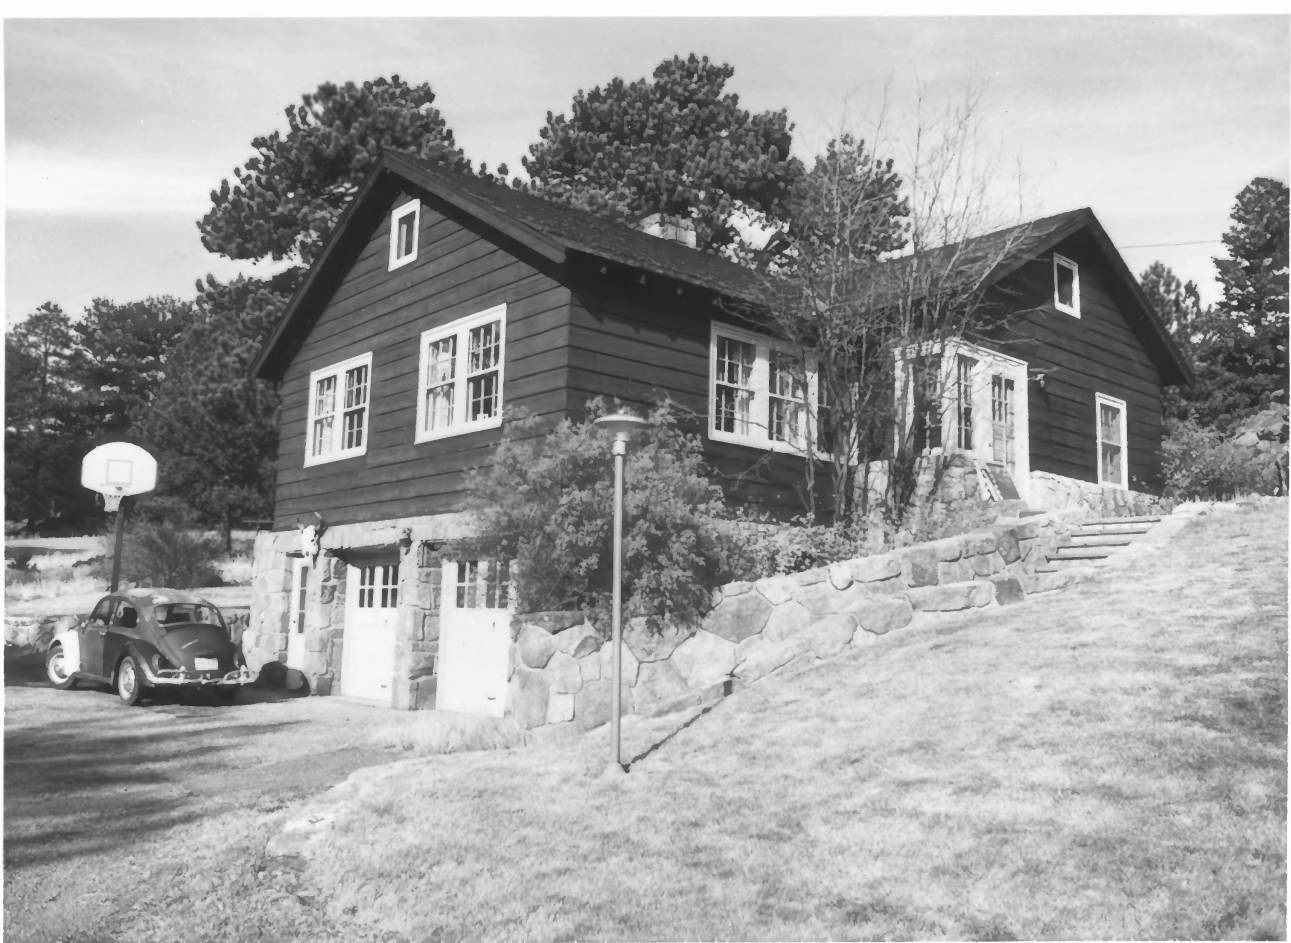
NAME: Residence (#46), Rocky Mountain  
National Park Utility Area Historic District  
LOCATION: Rocky Mountain National Park  
PHOTOGRAPHER: Jim Muhn  
DATE: July, 1976  
LOCATION OF NEGATIVE: Rocky Mountain Regional  
Office, Denver, CO  
VIEW: Looking west  
PHOTO NUMBER: 8

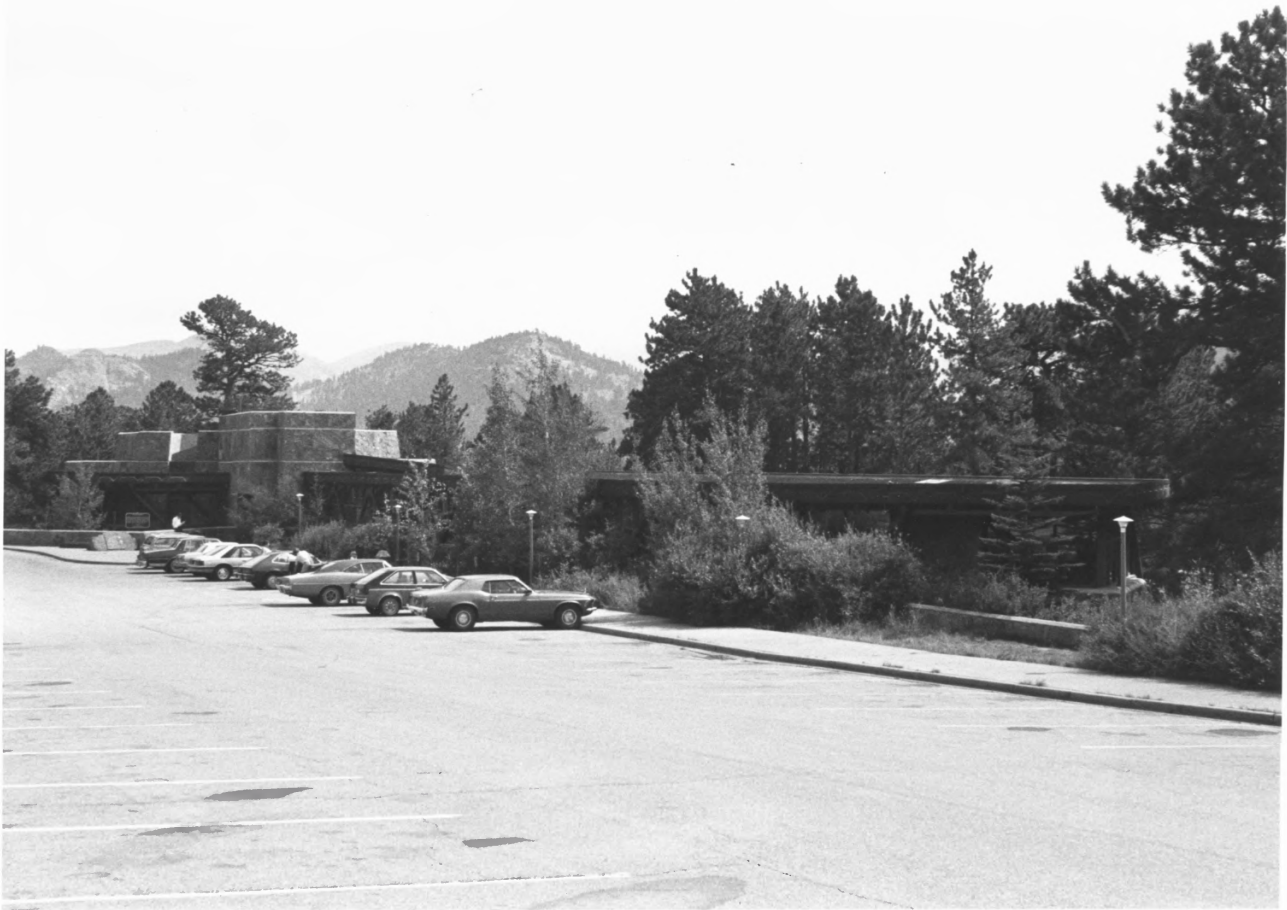
PHOTO NUMBER. 9

NAME: Beaver Meadows Visitor Center, Rocky  
Mountain National Park Utility Area  
Historic District

VIEW: Looking south-eastward--front elevation of  
building.

Also to be included as a contributing building is the Beaver Meadows Visitor Center north of the Maintenance area. The building, completed in October, 1966, was designed by Taliesin Associated Architects, LTD. The "Wrightian" design visitor center, 216' x 32', is a lineal plan, extending from a 29' square auditorium utilizing diagonal masonry walls. The two level building is set into the slope of the land with a daylight lower level. The exterior is characterized by Cor-ten steel using cast-in place stone masonry. The eaves of the low pitched built-up composition roof extends beyond the wall creating a definite "Wrightian" style with its cantilevered balcony on the upper floor and with the floor plan rotated 45° from the axis. Steel frame sliding and fixed sash windows extend the length of the lineal section.

The concern for blending the structure with a natural environment continued with the building of Beavers Meadows Visitor Center in 1966. The use of Cor-ten and native stone on the "Wrightian" design building was a deliberate attempt to accomplish the blending of the structure with its environment.

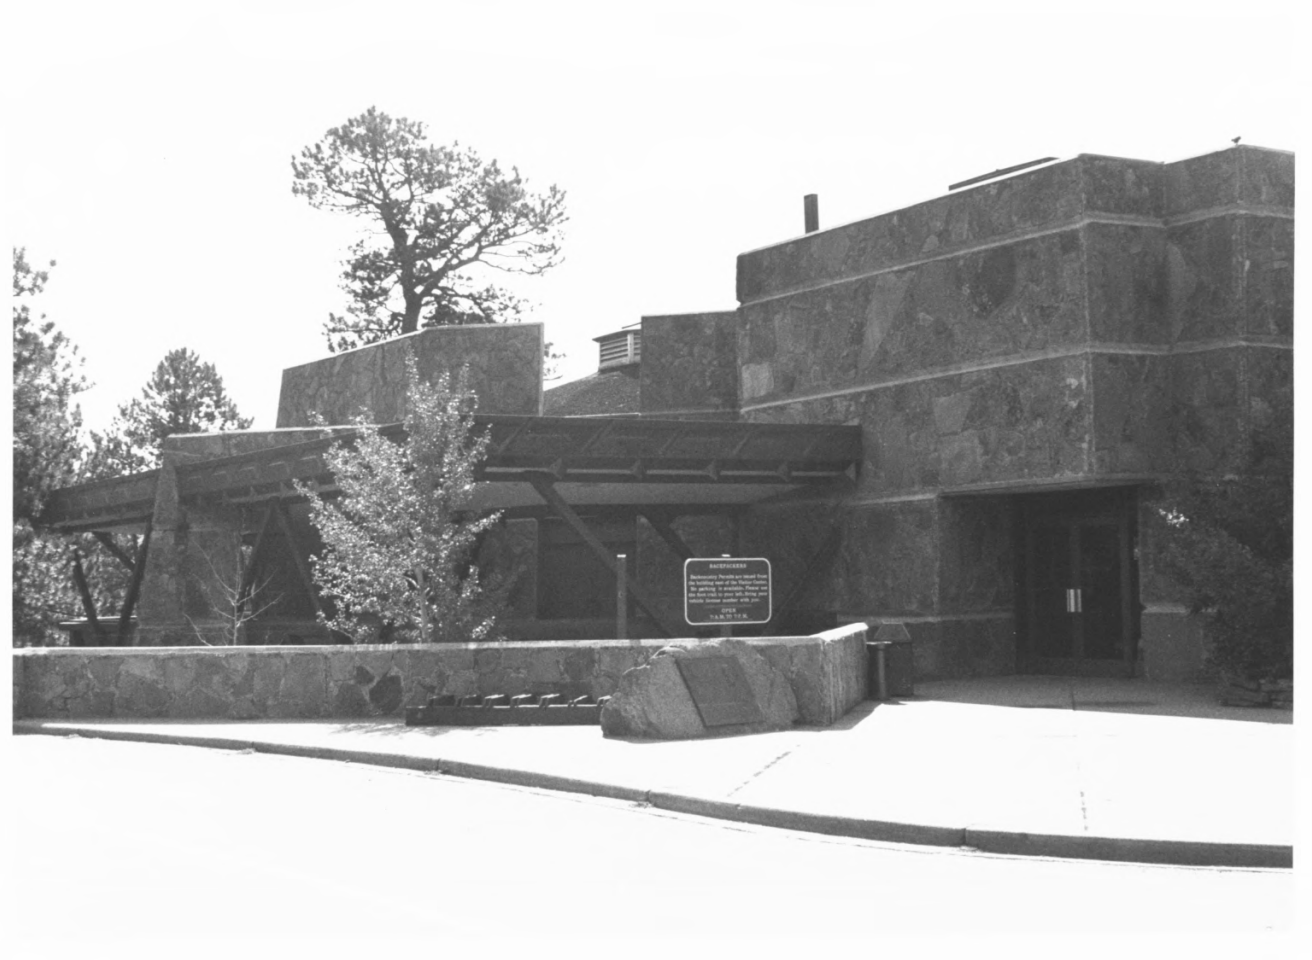
PHOTO NUMBER: 10

NAME: Beaver Meadows Visitor Center, Rocky  
Mountain National Park Utility Area  
Historic District

VIEW: Front entrance

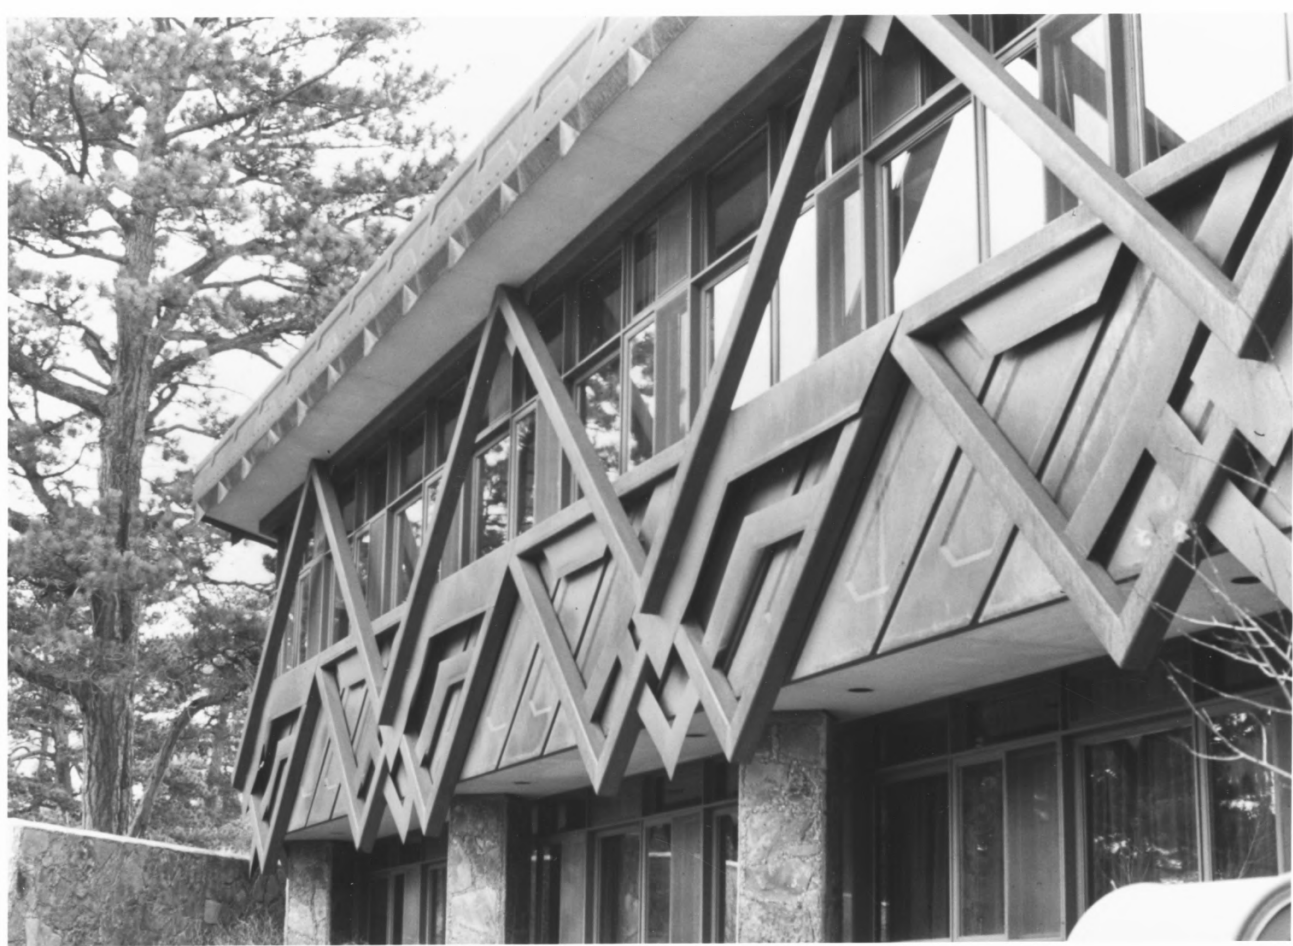
PHOTO NUMBER: 11

NAME: Beaver Meadows Visitor Center, Rocky  
Mountain National Park Utility Area  
Historic District

VIEW: Detailed view of front
