**HISTORIC LANDSCAPE
REPORT:
AMERICAN CAMP
& BRITISH CAMP
1987**

**SAN JUAN ISLAND
NATIONAL HISTORICAL PARK**

**HISTORIC LANDSCAPE REPORT :
AMERICAN CAMP AND BRITISH CAMP
SAN JUAN ISLAND NATIONAL HISTORICAL PARK
WASHINGTON**

**Cathy A. Gilbert
Historical Landscape Architect**

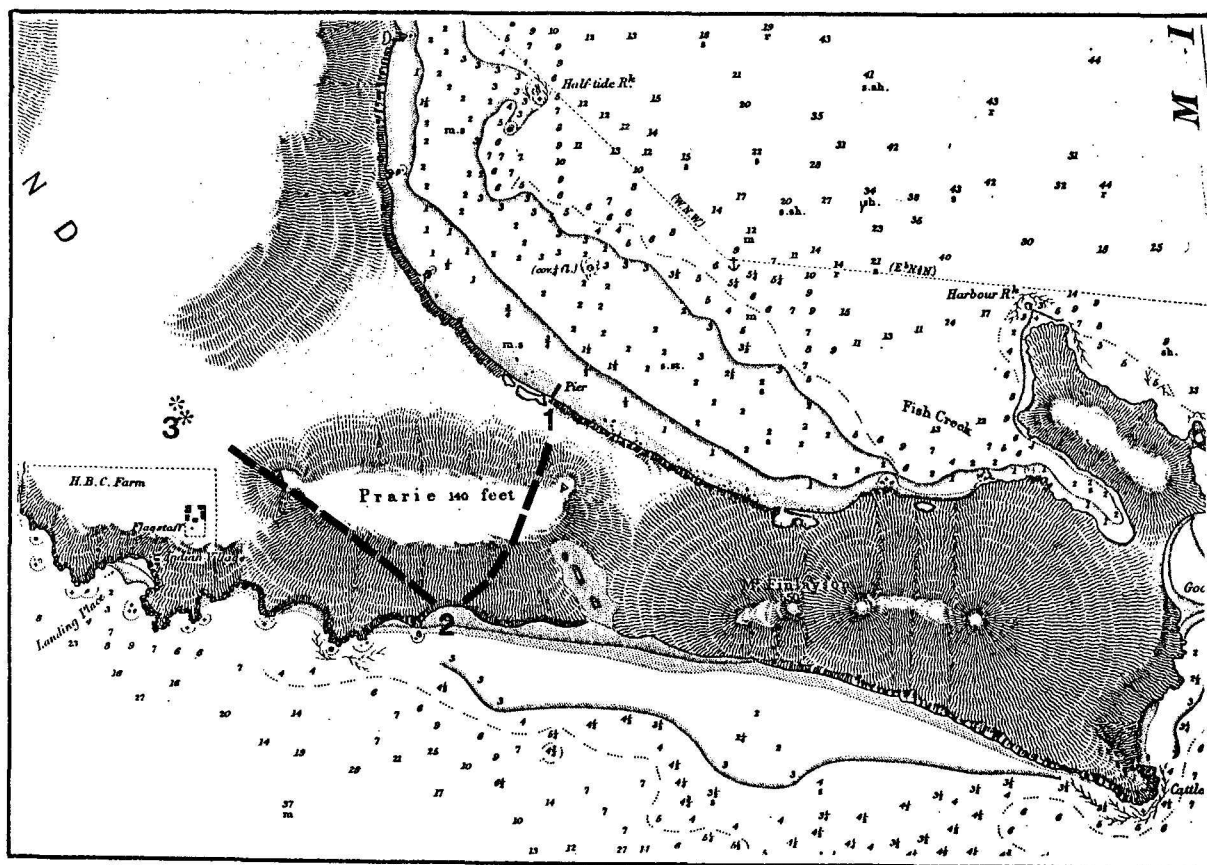
Superimposed on an 1858 navigational map of Griffin Bay are the three early American Camp sites: No.1--Pickett's first camp--near the Hudson's Bay Company wharf on Griffin Bay; No.2--known as the Spring Camp site-- on the south coast, near a natural spring; and No.3--the permanent camp site-- located on a ridge above Bellevue Farm.

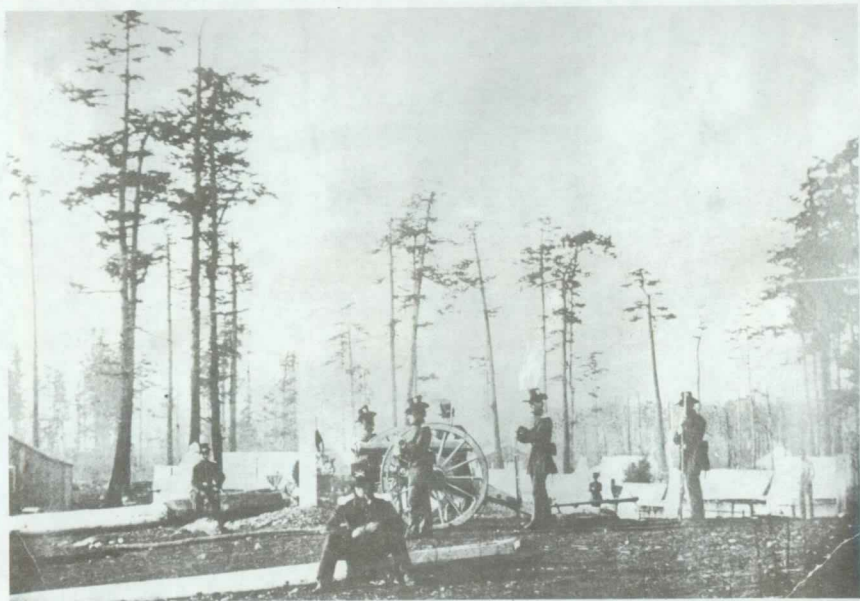
Early construction at American Camp ca.1859. Note frame buildings. (SAJH-photo file)

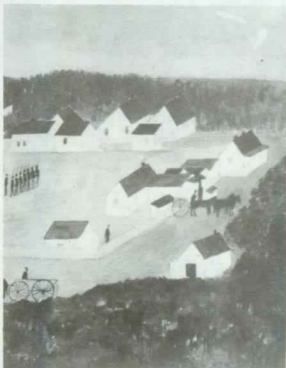
Detail from a watercolor of American Camp showing the newly constructed kitchen, messroom and bakehouse along the north edge of the encampment. Date and artist unknown. (Provincial Archives, Victoria, B.C.: SAJH photo file)

Although most new construction stopped when Hunt took command of American Camp, two other buildings were added to the camp in the early 1860s. A new, much-needed kitchen and messroom replaced the existing facilities in the barracks building. Sited north of the barracks, this log structure was large enough to accommodate sixty-four soldiers. The other new building -- a bakehouse -- was sited close to the kitchen and measured 20' X 12'.

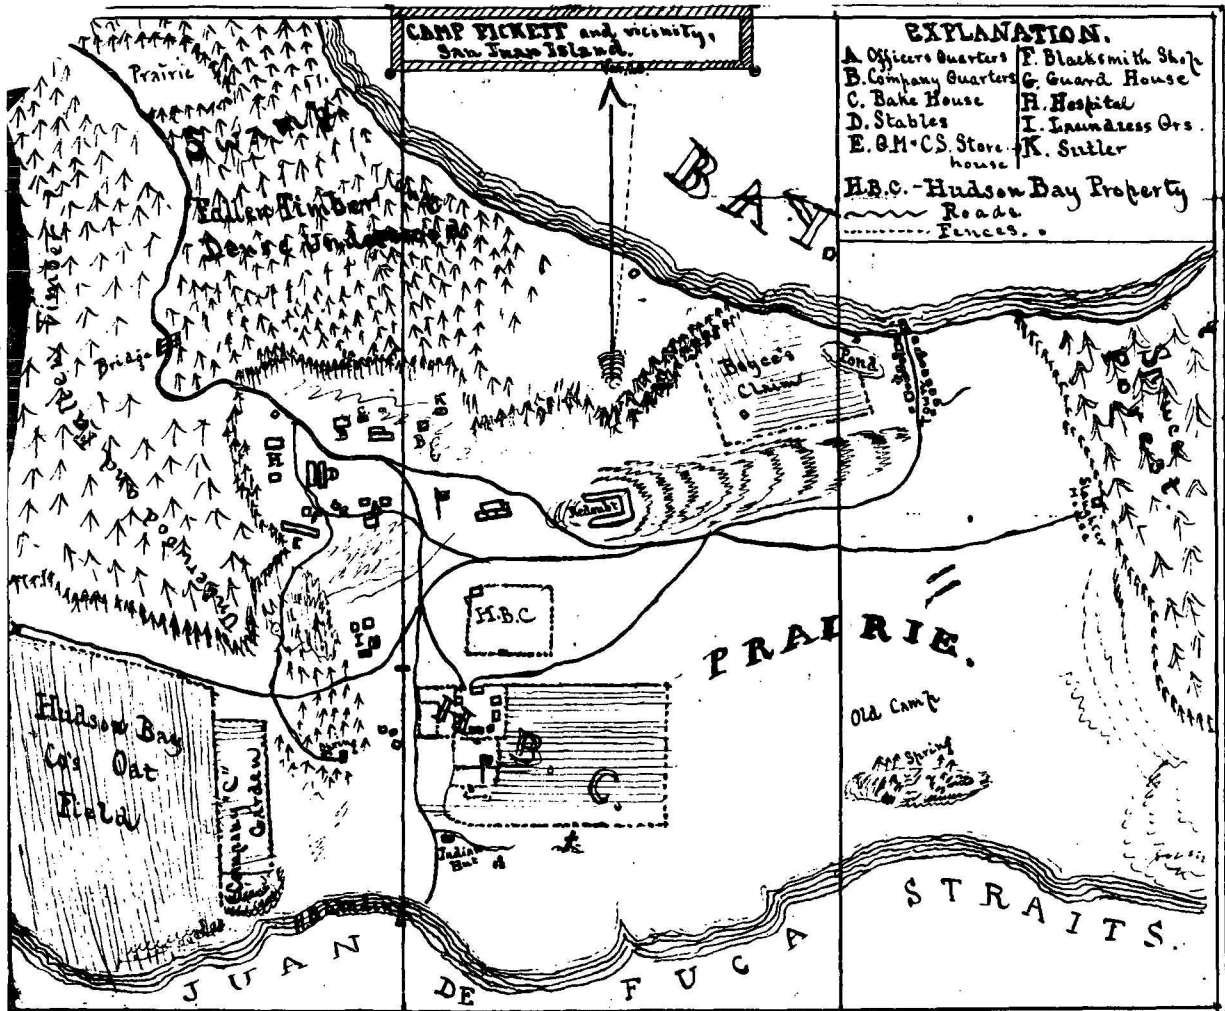
Early map illustrating the American encampment, Bellevue Farm, San Juan Town and significant landscape features in the early 1860s. (National Archives, Washington, D.C.: SAJH map file)

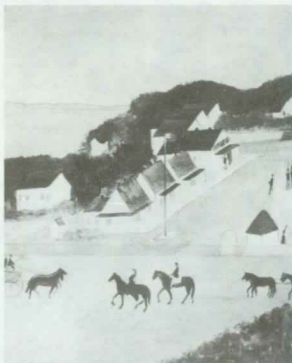
Detail from a watercolor of American Camp showing Officers' Row, the boardwalk, gardens and related outbuildings. Also note the blockhouse and gate along the northeast edge of the encampment. Date and artist unknown. (Provincial Archives, Victoria, B.C.: SAJH-photo file)

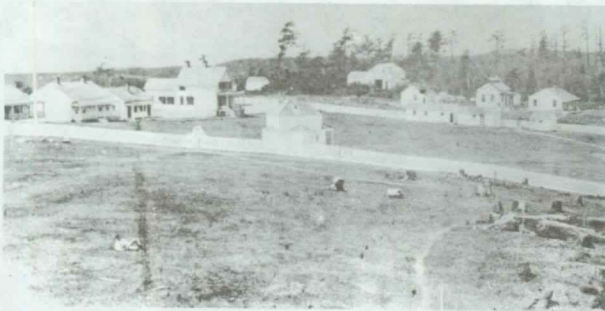
Photograph of American Camp ca. 1867 showing fenced encampment, Officers' Row to the left, the new hospital and the barn/stable in the background. View from the NE. (Provincial Archives, Victoria, B.C.: SAJH-photo file)

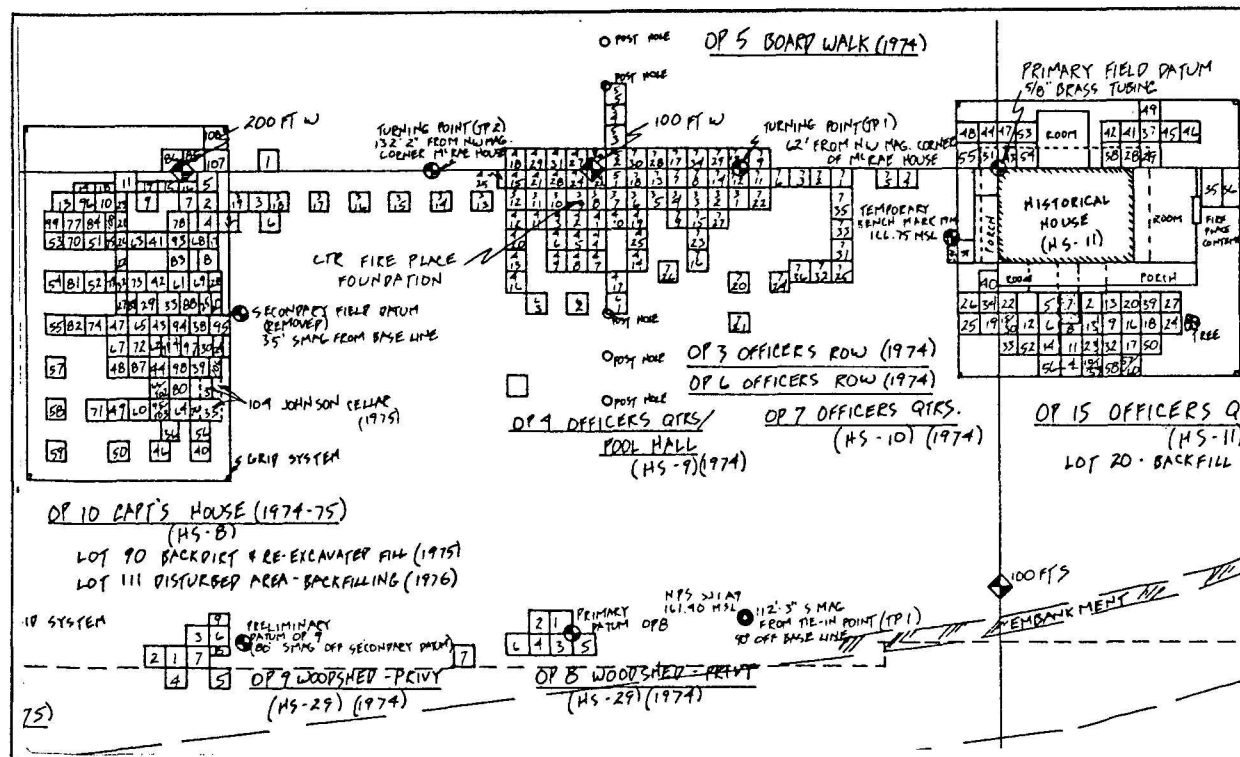
Detail from the archeological base map of American Camp depicting the investigations along a portion of Officers' Row. (On file-PNRO, Seattle, Washington)

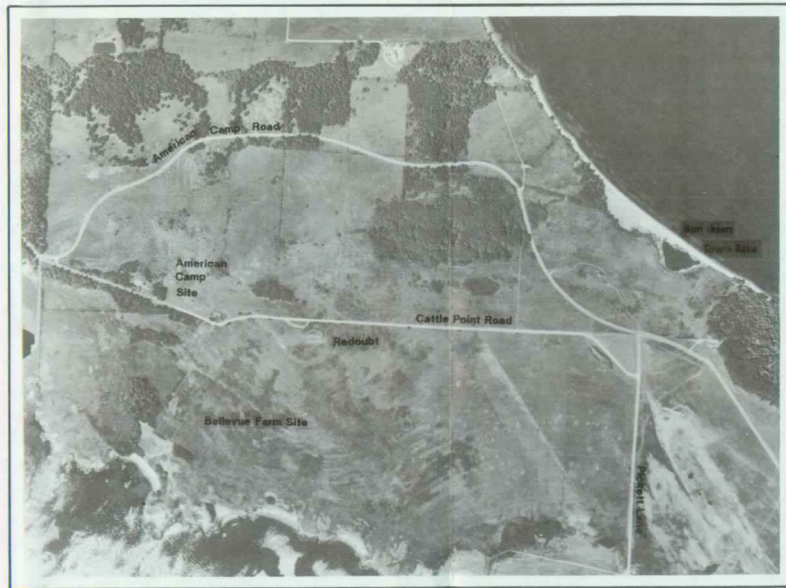
Historically, American Camp was located on the edge of a ridge above Bellevue Farm with coniferous forests north and west of the complex and grassland prairies extending east toward San Juan Town. Although much of the forest cover has changed, Existing landscape organization echoes these historic patterns. Access is from the west, off of Cattle Point Road. This road continues east through the site to the Redoubt and Pickett Lane with access to South Beach and Jakle's Lagoon. The land surrounding the camp site is open and gently sloping north to Griffin Bay and south to Haro Strait. Mt. Finlayson is the eastern edge of the site and the highest point on the south end of the island at 295'.

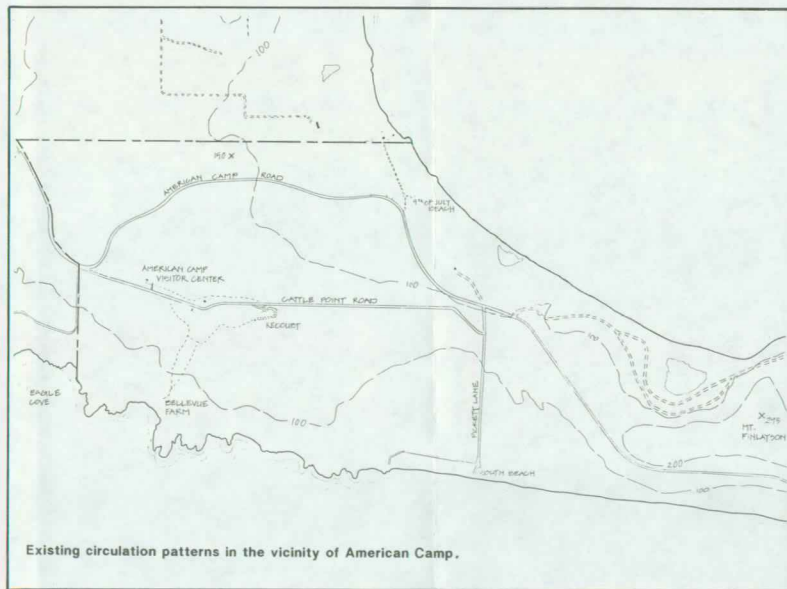
Historic roads in the vicinity of American Camp were relatively extensive, linking the north end of the island with the camp, San Juan Town and points east. These routes, established early by the Hudson's Bay Company and the American military, remained until 1900, when major land uses in the area changed. Current access to the site is off of Cattle Point Road, six miles south of Friday Harbor. The road leads to a small parking area next to the visitor center, and slices east through the site to the Redoubt. An interpretive trail from the visitor center leads to the camp site, the Redoubt and Bellevue Farm before circling back to the visitor center.

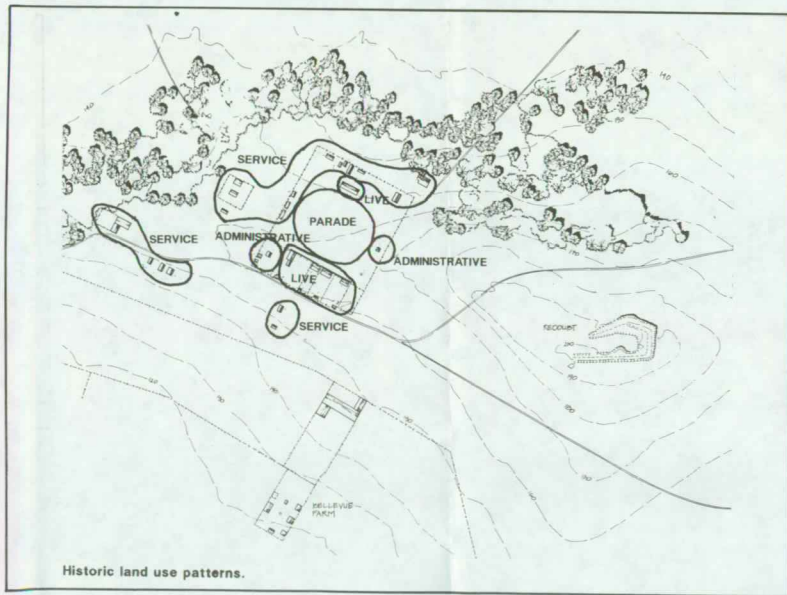
Historic land use patterns.

Land uses at American Camp during the historic period focussed on the area around the fenced complex. Officers and enlisted men lived within the enclosure and the majority of service facilities for the camp were close by. Off-site activities included target practice near the Spring Camp site, horseback riding and horse racing on the open prairie southeast of the camp, and various recreational activities in San Juan Town. Existing land uses at American Camp revolve around interpretation of the historic scene. Visitor services are located west of the site and an interpretive trail links the camp site, the Redoubt, Bellevue Farm and the visitor center.

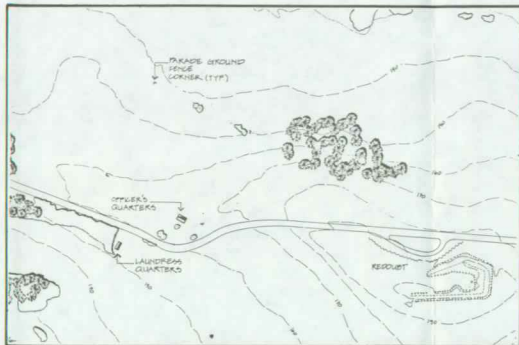
The officer's quarters and the laundresses quarters are the only buildings remaining from the historic period. View looking W from the Redoubt.

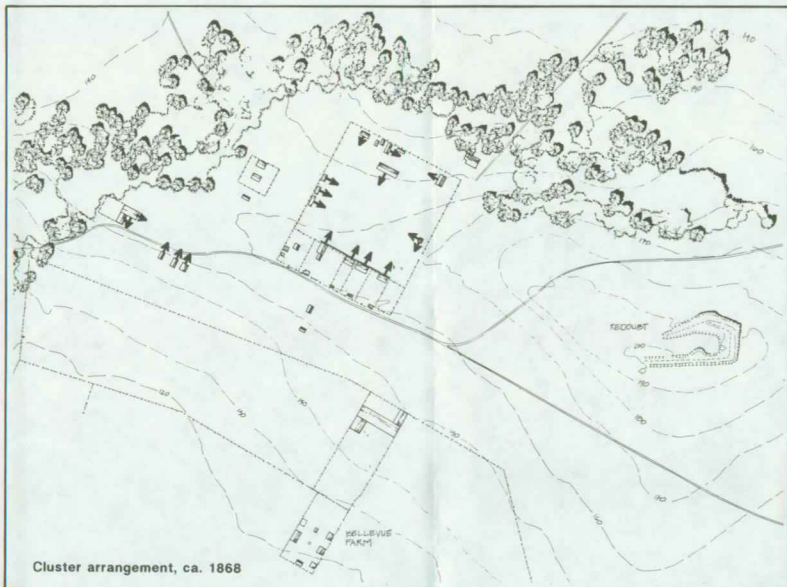
Historically the officers' quarters at American Camp were sited in a single row facing the parade ground with barracks for the enlisted men across the parade, facing officers' row. The messroom and the bakery were clustered behind the barracks with administrative offices for the camp located on the edges of the parade ground. All of these structures were enclosed by an extensive fence that defined the primary encampment. Other service related buildings were oriented along roads or as discrete complexes. Because only two buildings and the Redoubt remain at the site today, these structural relationships are not evident.

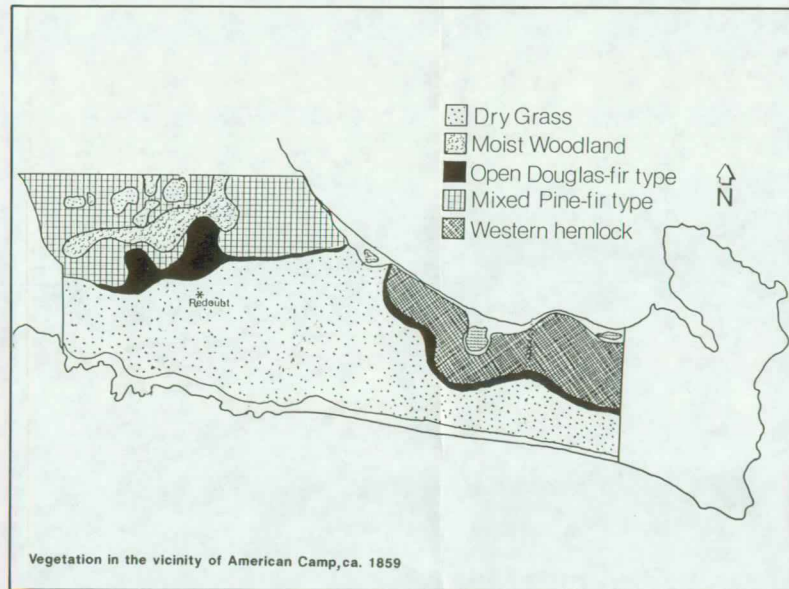
Historically American Camp was located on a ridgeline and vegetative ecotone, with grassland south of the ridge and forest to the north and west. Douglas fir, grand fir and lodgepole pine dominate the ridge, with hardwoods and grasses filling out depressions and lower areas north of the site. Between 1859 and 1870 portions of the forest immediately around the camp were harvested and used in the construction of the camp buildings. Subsequent to the American military occupation, agricultural land uses on the south end of the island favored an increase in the grassland cover at the site which remains today. Two remnant groves of fir trees next to the camp site and the Redoubt date from the historic period.

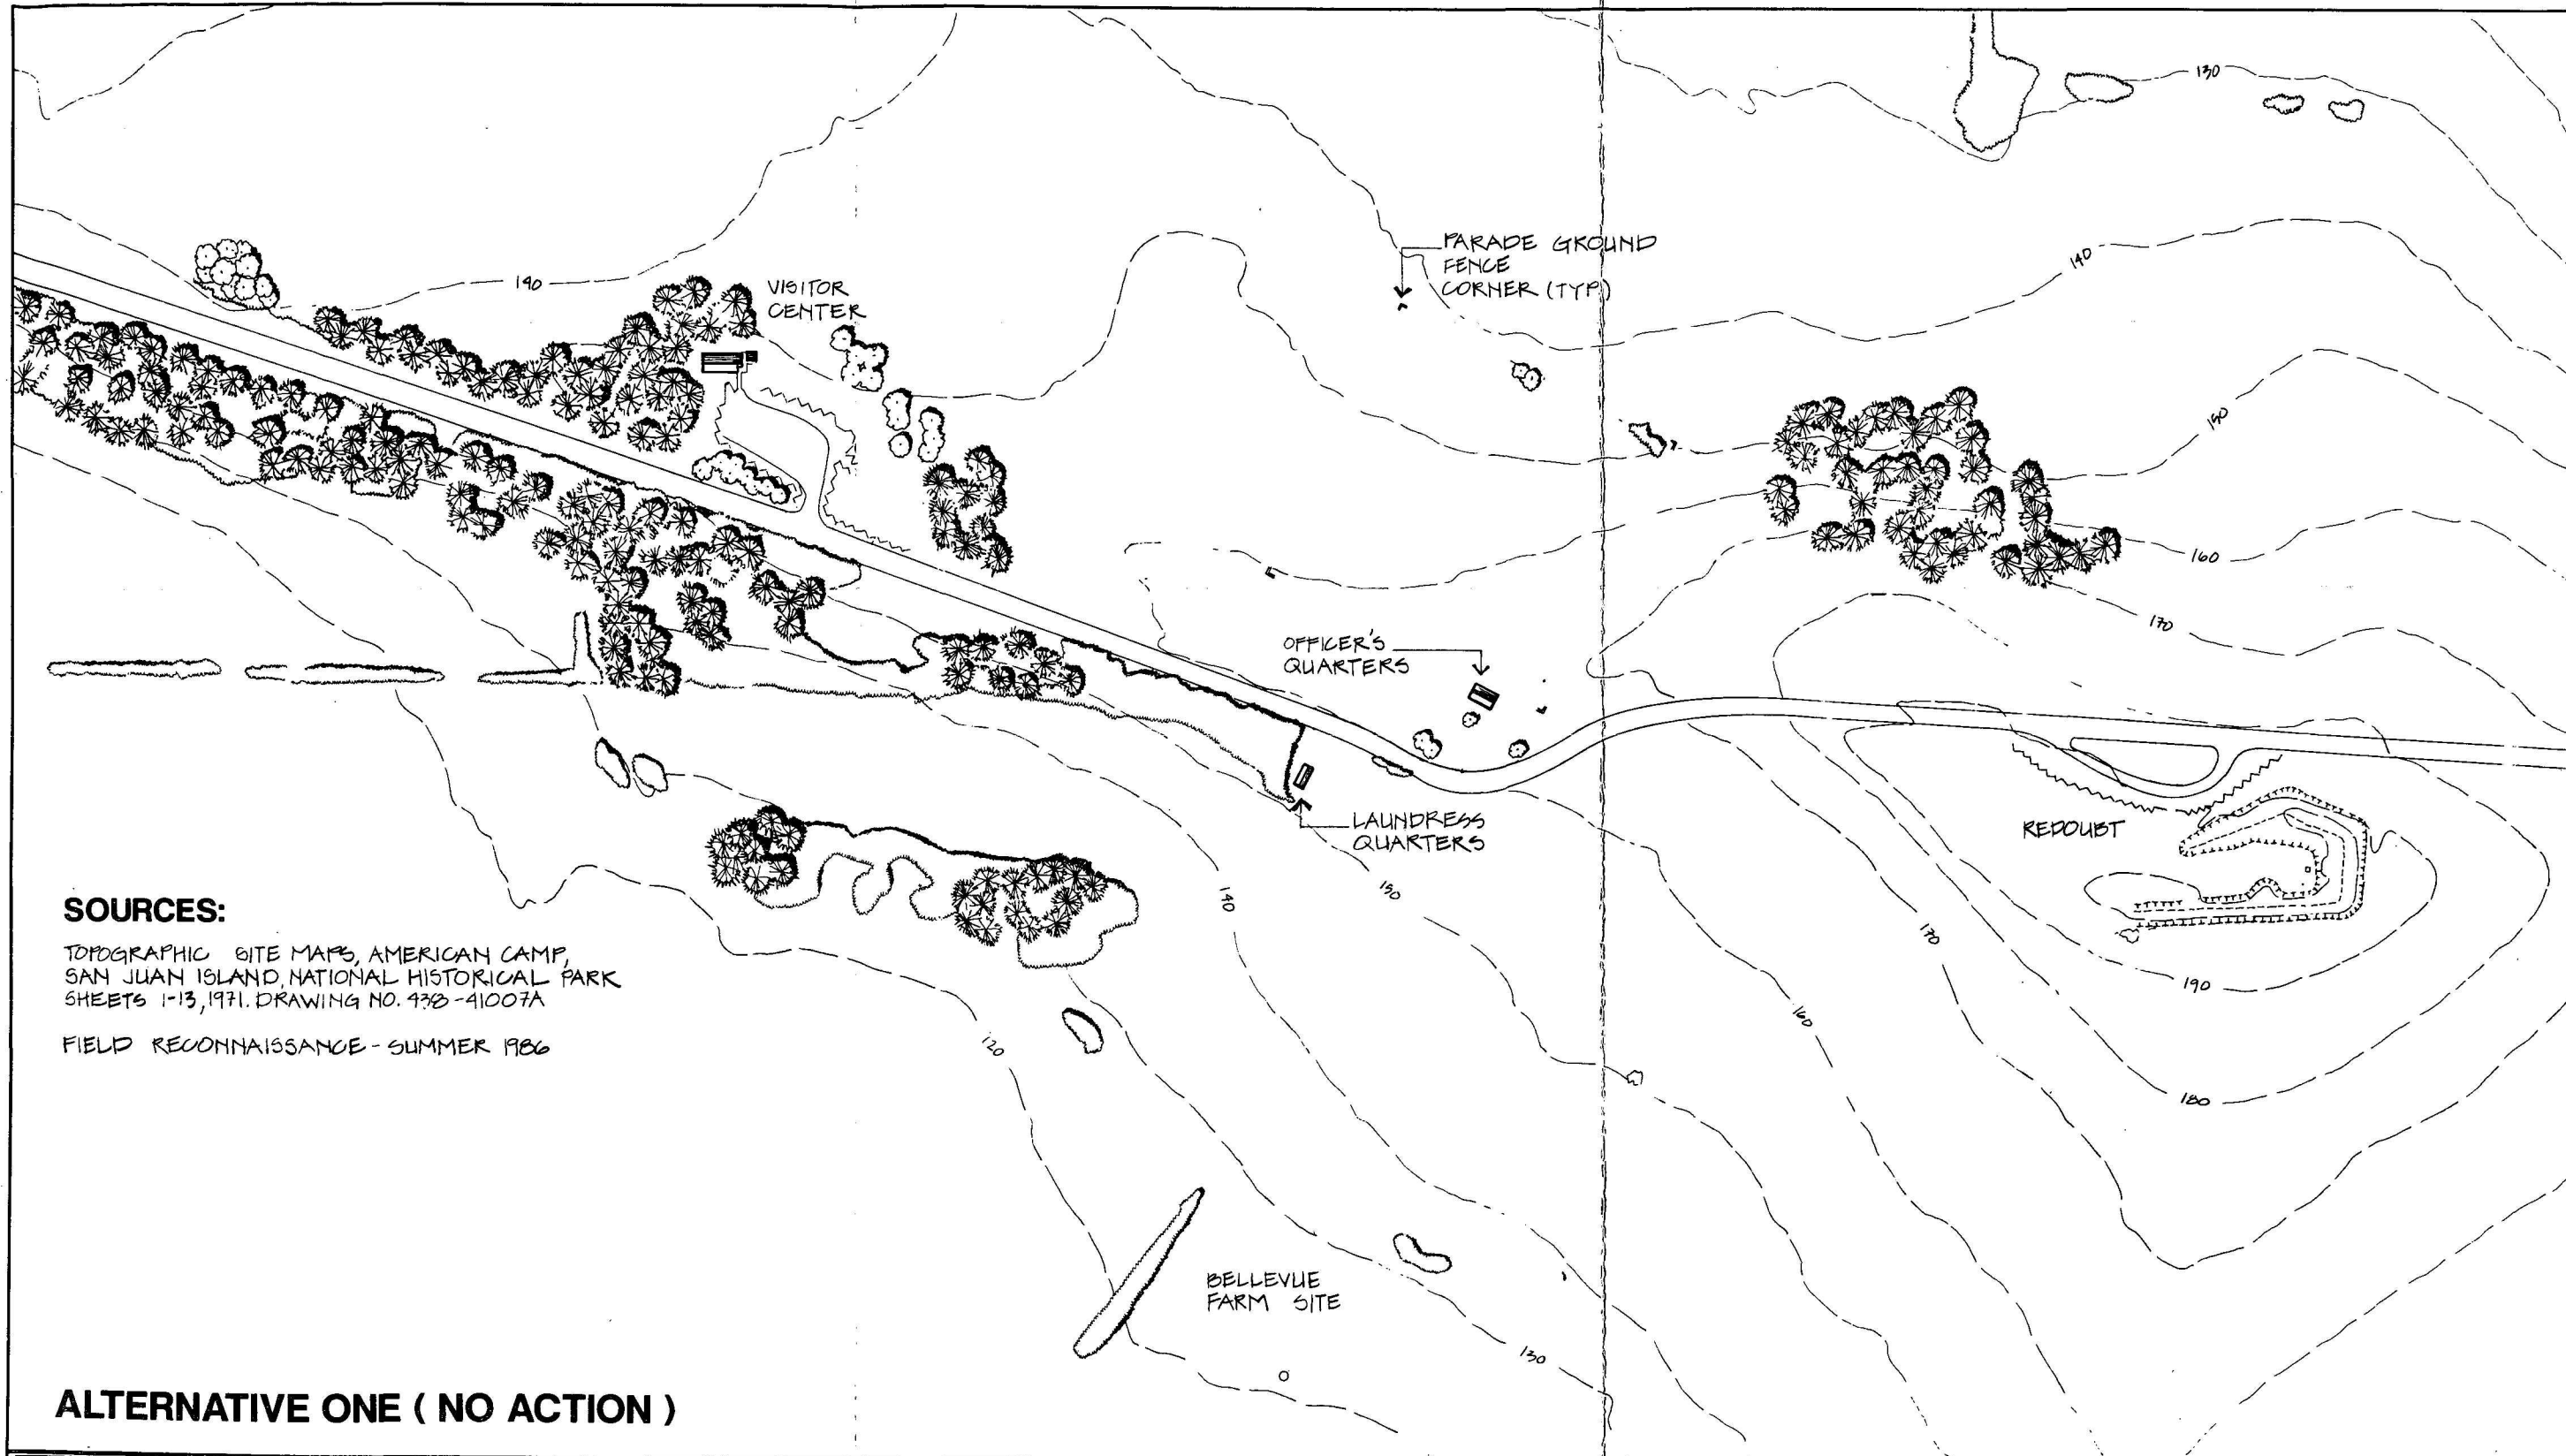
SOURCES:

TOPOGRAPHIC SITE MAPS, AMERICAN CAMP,
 SAN JUAN ISLAND, NATIONAL HISTORICAL PARK
 SHEETS 1-13, 1971. DRAWING NO. 438-41007A
 FIELD RECONNAISSANCE - SUMMER 1986

DESIGNED: DRAWN: <i>GILBERT</i> TECH. REVIEW: DATE: 9/86	SUB SHEET NO.	TITLE OF SHEET EXISTING CONDITIONS AMERICAN CAMP	DRAWING NO. 80013 438 -
					PKG. NO.	SHEET 4 OF 13

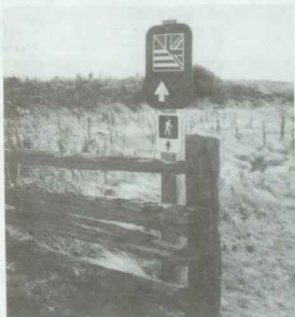
As part of the design, all new trails should be marked in a consistent manner. (Photo by L. Hugie, NPS, 1987)

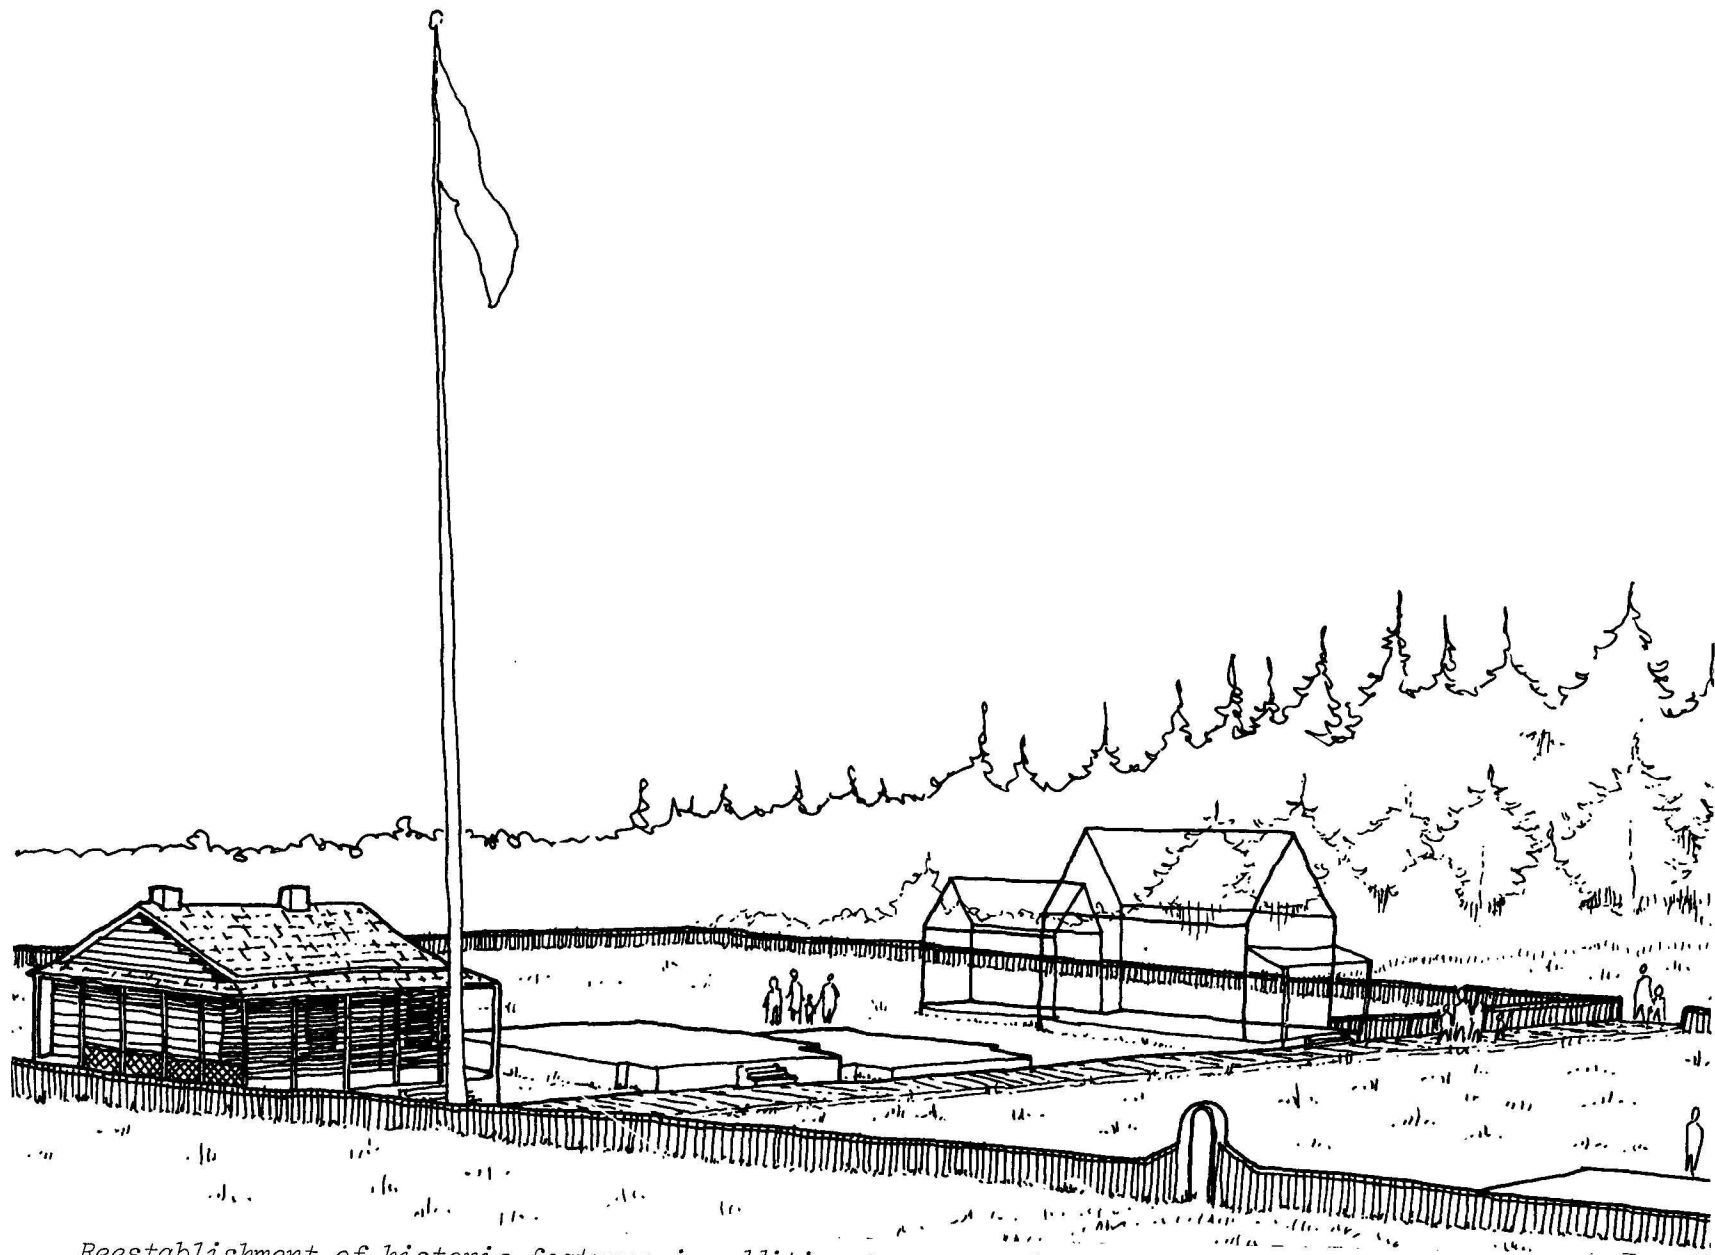
Reestablishment of historic features in addition to proposed foundation treatments will have a significant impact on the "readability" of the historic scene.

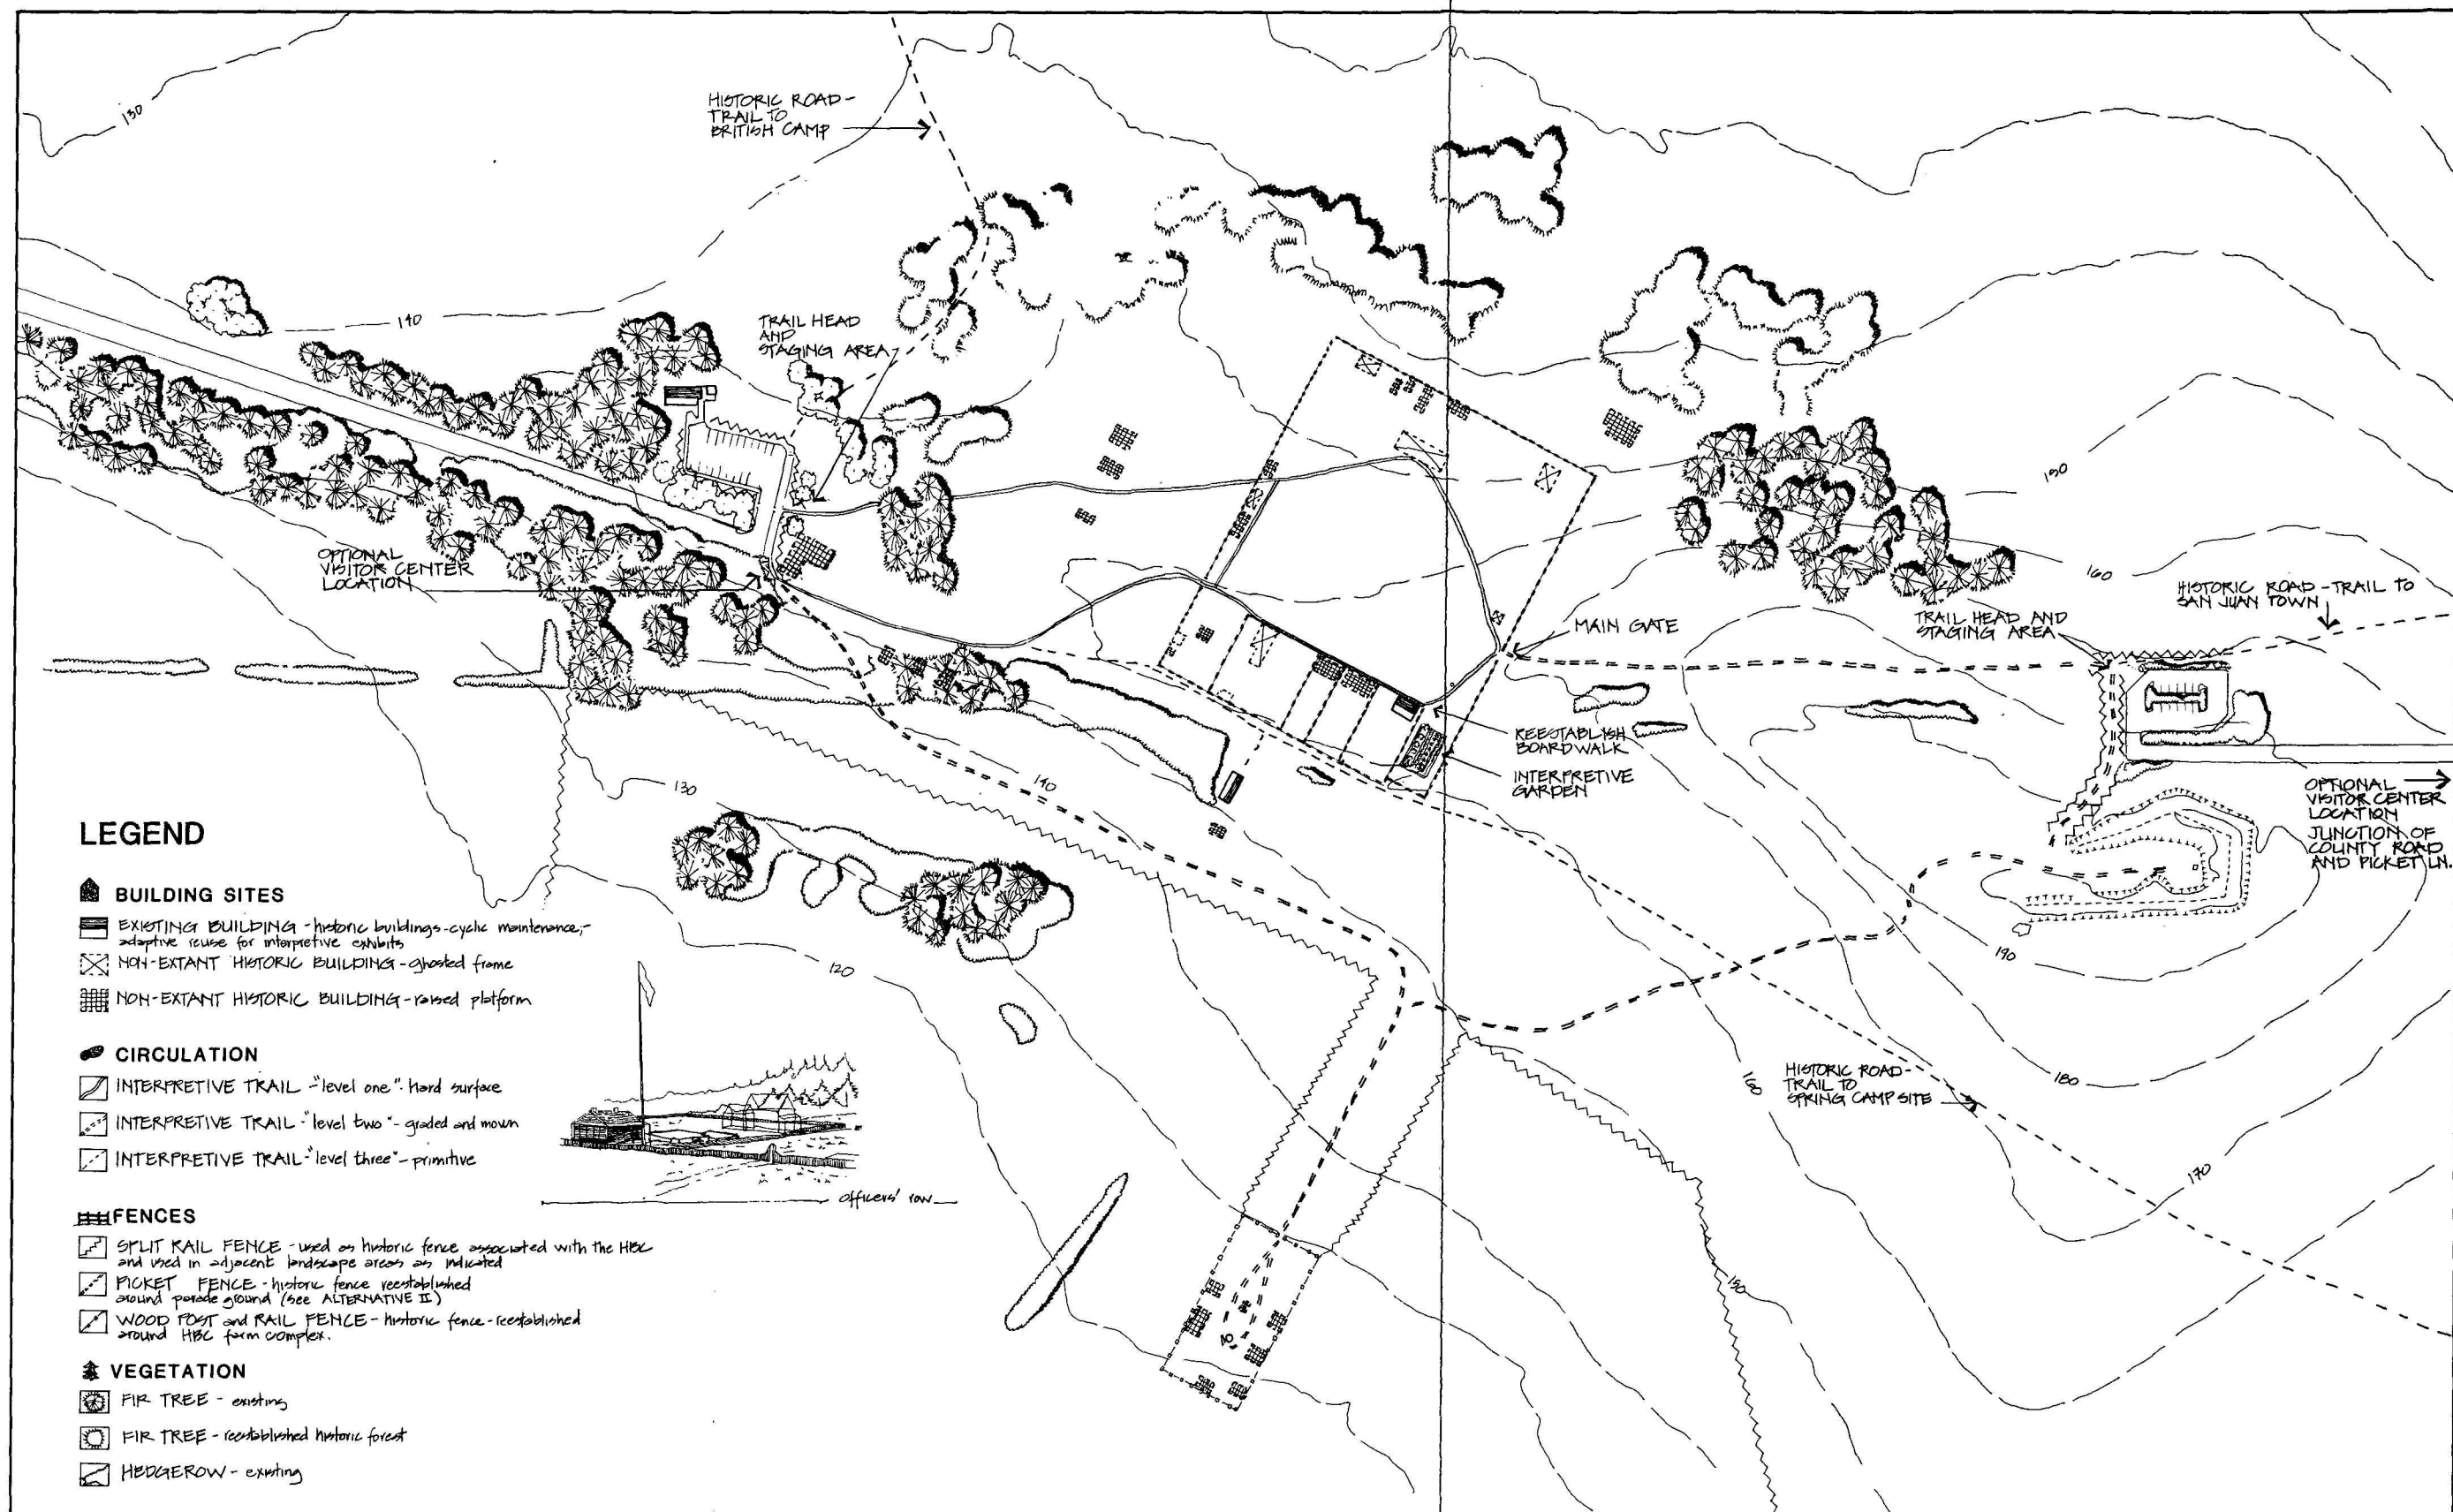
<p>SAN JUAN ISLAND NATIONAL HISTORICAL PARK HISTORIC LANDSCAPE STUDY</p>	<p>NATIONAL PARK SERVICE PACIFIC NORTHWEST REGION CULTURAL RESOURCE DIVISION</p> <p>DRAWN BY: GILBERT DATE: 9/87</p>	<p>100 50 0 100 200 300</p> <p>SCALE 1"=100'</p>	<p>NORTH</p>	<p>ALTERNATIVE THREE AMERICAN CAMP</p>	<p>DRAWING NO. 438 - 80018</p> <p>SHEET 7 OF 13</p>
--	---------------------------------------------------------------------------------------------------------	------------------------------------------------------------------------------------------------------------------------------------------------	--------------------------------------------------	--------------	-----------------------------------------------------------	-------------------------------------------------------------------------------

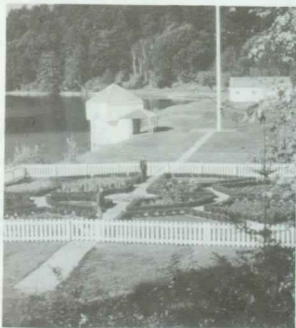
The reconstructed formal garden at British Camp, with the blockhouse and commissary storehouse in the background. (Photo by C. Gilbert, NPS, 1987)

In addition to these remnant structures, the formal garden at the base of Officers' Hill and the camp flagpole in front of the blockhouse have been reconstructed. The British Camp cemetery, a small plot with seven graves, enclosed by a picket fence, remains on the slope of Young Hill.

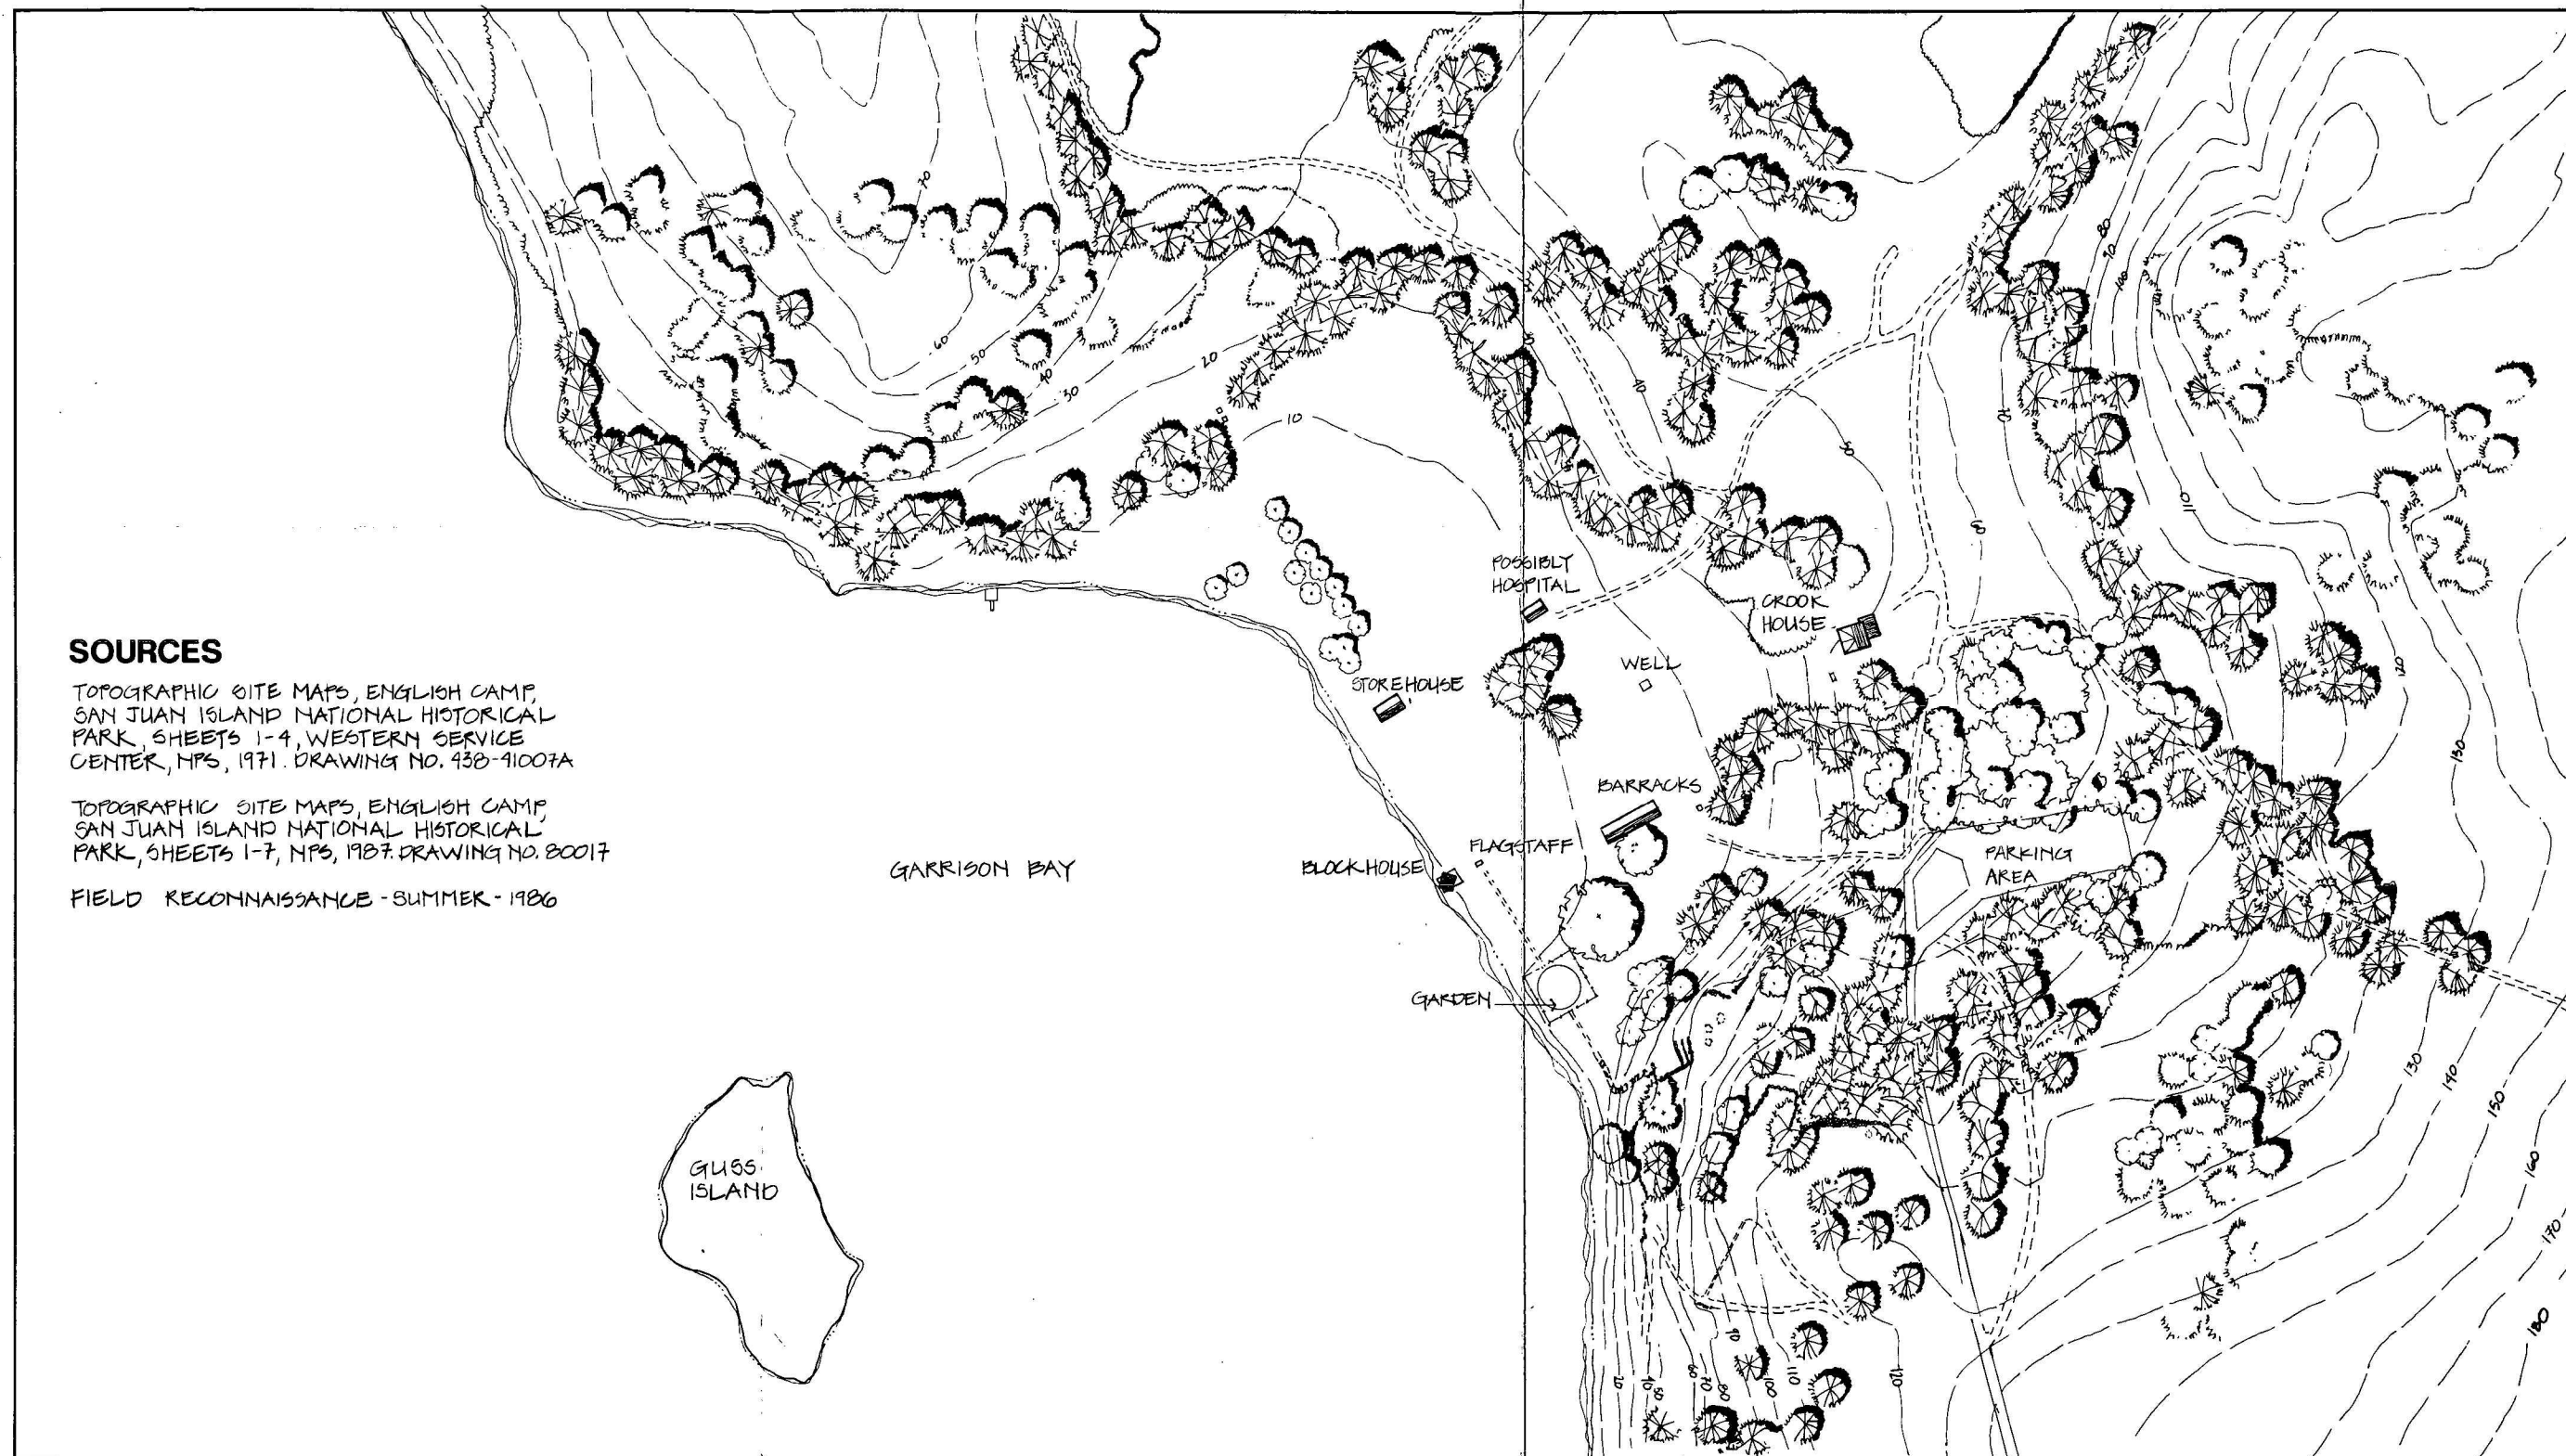
**EXISTING
CONDITIONS
BRITISH CAMP**

TOPOGRAPHIC SITE MAPS, ENGLISH CAMP,
SAN JUAN ISLAND NATIONAL HISTORICAL
PARK, SHEETS 1-7, NPS, 1987. DRAWING NO. 80017

FIELD RECONNAISSANCE - SUMMER - 1986

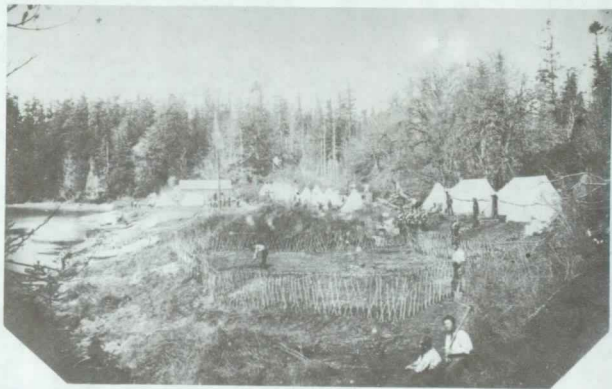
Earliest known photograph of the British Camp site on the shore of Garrison Bay. Note the early structures, the garden, dense vegetation and the earthen mound in the center. This mound and much of the landscape pictured here is the result of land use practices by prehistoric culture groups. (Provincial Archives, Victoria, B.C.: SAJH photo file)

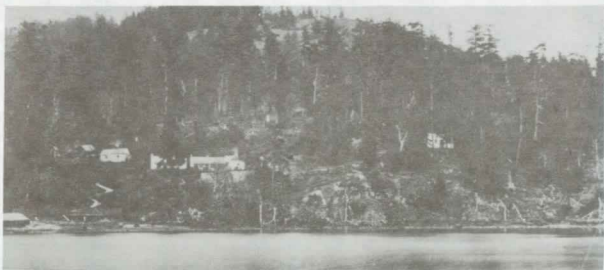
Photograph of Officers' Hill in the early 1860s showing landscape changes, new buildings, pathways, rock walls and the birdhouse on the first terrace. (Public Archives of Canada, Ottawa: SAJH photo file)
