**HISTORIC LANDSCAPE
REPORT:
AMERICAN CAMP
& BRITISH CAMP
1987**

**SAN JUAN ISLAND
NATIONAL HISTORICAL PARK**

**HISTORIC LANDSCAPE REPORT :
AMERICAN CAMP AND BRITISH CAMP
SAN JUAN ISLAND NATIONAL HISTORICAL PARK
WASHINGTON**

**Cathy A. Gilbert
Historical Landscape Architect**

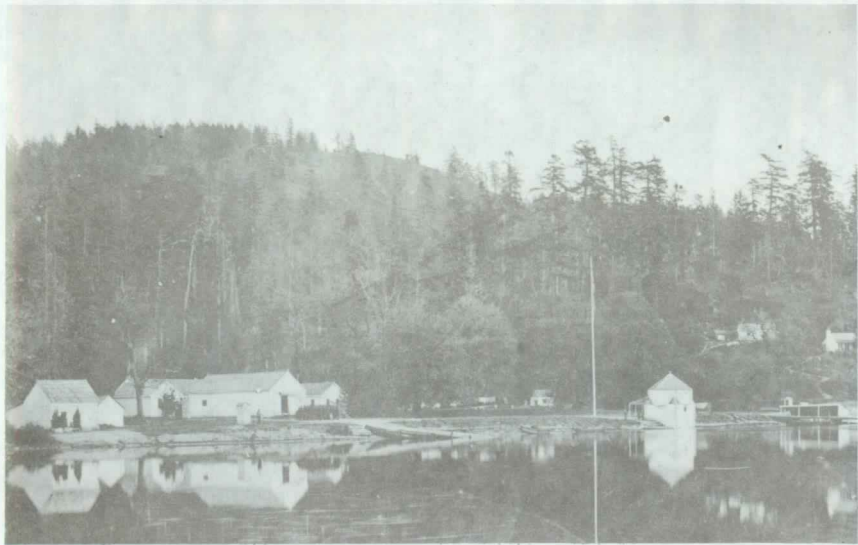
Storehouse and service area along the waterfront at British Camp, ca. 1865. Note the officers' quarters on the hillside and the sentry boxes on each end of the shore. View from the northwest. (Provincial Archives, Victoria, B.C.: SAdH photo file)

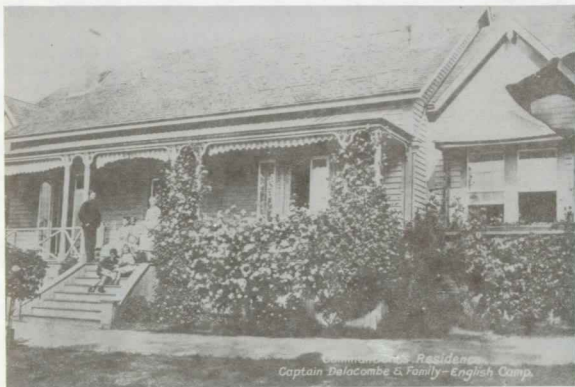
*Ornamental vines and climbing roses were planted to embellish the house and grounds surrounding the main residence. View from the W, ca. 1870.
(Provincial Archives, Victoria, B.C.: SAJH photo file)*

of rock terraces similar to the walls built around the officers' quarters below. Constructed in layers beside the house and stepping down the hill, these rock terraces wrapped around the earthen terraces of the house site. The main wall below the house was upright and angular, creating a formal edge. A wooden fence was built on top of this wall to enclose the yard. The other main wall, built near the carriage house, provided reinforcement and stabilization of the back terrace for the construction of other outbuildings. Although the size of the rock walls varied, the maximum height of any single section was eight feet.[12]

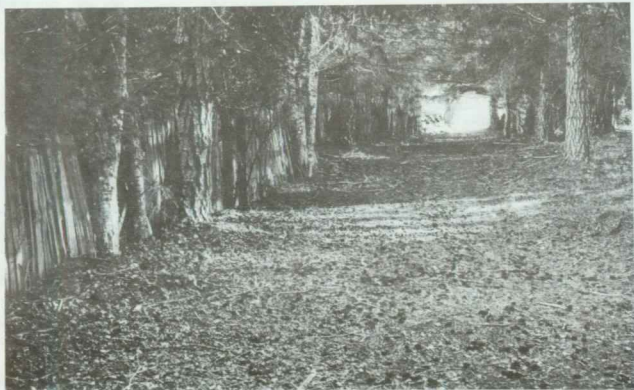
Tree-lined road that led to Captain Delacombe's residence on the top of Officers' Hill. View from the E, ca. 1875. (SAJH photo file)

Access to the Captain's house from the main camp road led two hundred feet across the slope of the hill. The road was approximately 15 feet wide, with fir trees planted on both sides of the road, creating a rather rustic, if not somewhat formal, entryway. The road ended at the carriage house.[14]

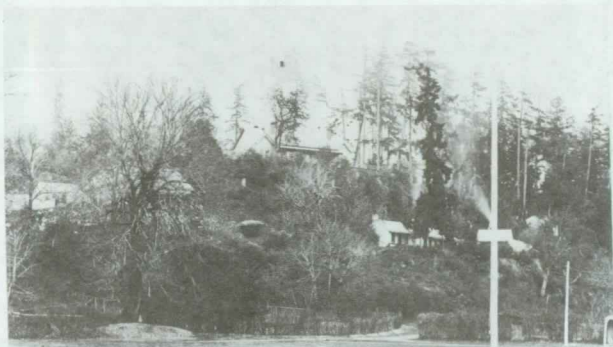
View of Officers' Hill, ca. 1868, showing new rock walls, Married Subaltern's residence and new Captain's house on the third terrace. Also note a second garden has been added next to the existing one. View from the NW. (Provincial Archives, Victoria B.C.: SAJH photo file)

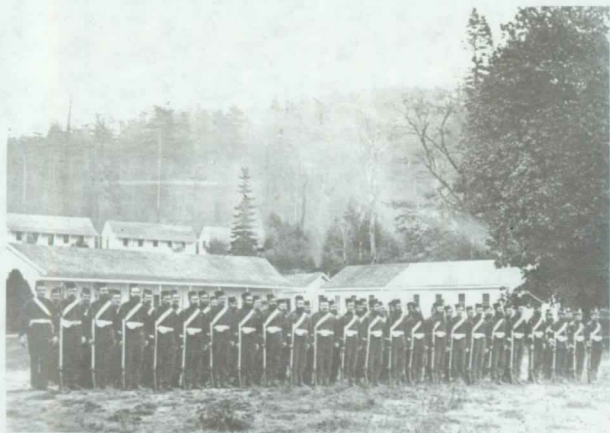
Photograph of the new service buildings on the hill behind the barracks. Also note the extension of the barracks on the right. View from the NW, ca. 1869. (Provincial Archives, Victoria, B.C.: SAJH photo file)

This structure most likely was the company mess room. Like other structures on the hill, it was oriented toward the bay. Photographs indicate it had a porch across the west facade and was whitewashed. The final structure on the hill above the barracks was the blacksmith's shop. The masonry ruin standing today is believed to be the forge. [19]

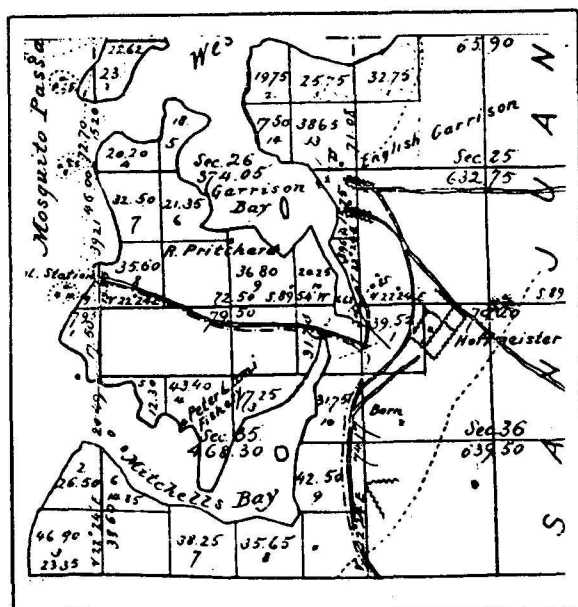
Roads in the vicinity of British Camp as documented on an 1875 Government Land Office map of the island.

The primary road to British Camp branched off of a main road which ran the length of the island between Bellevue Farm and Roche Harbor. Evidence suggests that portions of this road were built by Indian labor in 1854 under the direction of the Hudson's Bay Company.[20] The road angled north from Bellevue Farm across the island toward Young Hill, and continued around the base of the landform. At a point above the British encampment, the road cut down through the forest toward the camp, linking the site to points both north and south. Historic documentation also indicates another road followed the western shoreline, leading south from the complex of officers' quarters.[21]

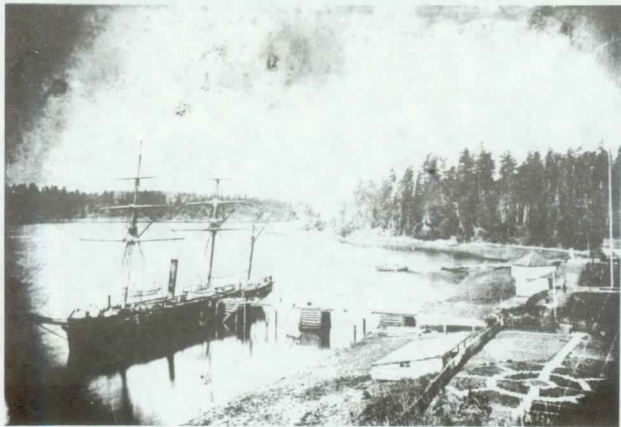
The waterfront at British Camp ca. 1870, showing the large wharf, blockhouse, service buildings and formal garden. (Provincial Archives, Victoria, B.C.: SAJH photo file)

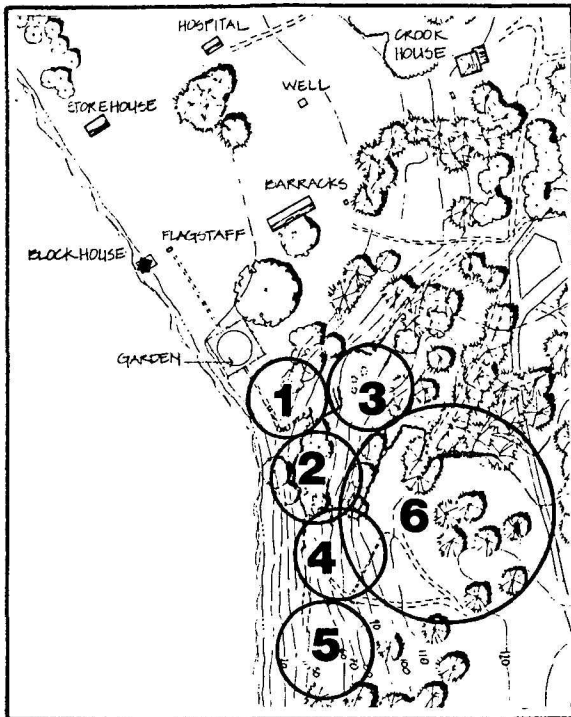
Diagram and location of the six conceptual zones on Officers' Hill.

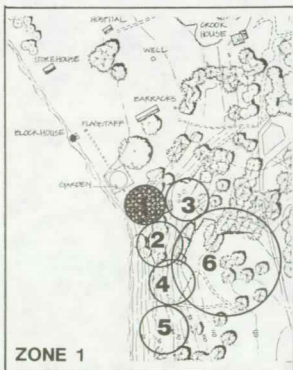
ZONE 1

*Detail showing cut stone steps on the trail to the first terrace.
(Photo by C. Gilbert, NPS, 1987)*

- There are six individual stones per step and, on the average, four of the six stones are dressed. Tooth and crosshatched chisel marks are evident on several individual stones. Other stones are natural basalt stone.
- Individual steps are five feet long.
- Steps are edged and braced with a single wood riser four to six inches high.
- A large amount of shell midden is evident along the pathway.
- These twelve steps may be original fabric.

- Nine of the twelve steps are in good condition.

- Counting from the bottom:
 - * Step #3 is missing one stone.
 - * Step #9 is missing two to four stones.
 - * Step #12 has one stone that is slipping.
- Moss and duff obscure portions of the steps.

- Keep steps clear of intrusive vegetation.
- Replace wood edge/brace as needed.
- Additional investigation will indicate:
 - * Source of stone (use existing loose stone for sample).
 - * Construction techniques.
 - * Reconstruction techniques.
 - * Correlation with historic photographs.

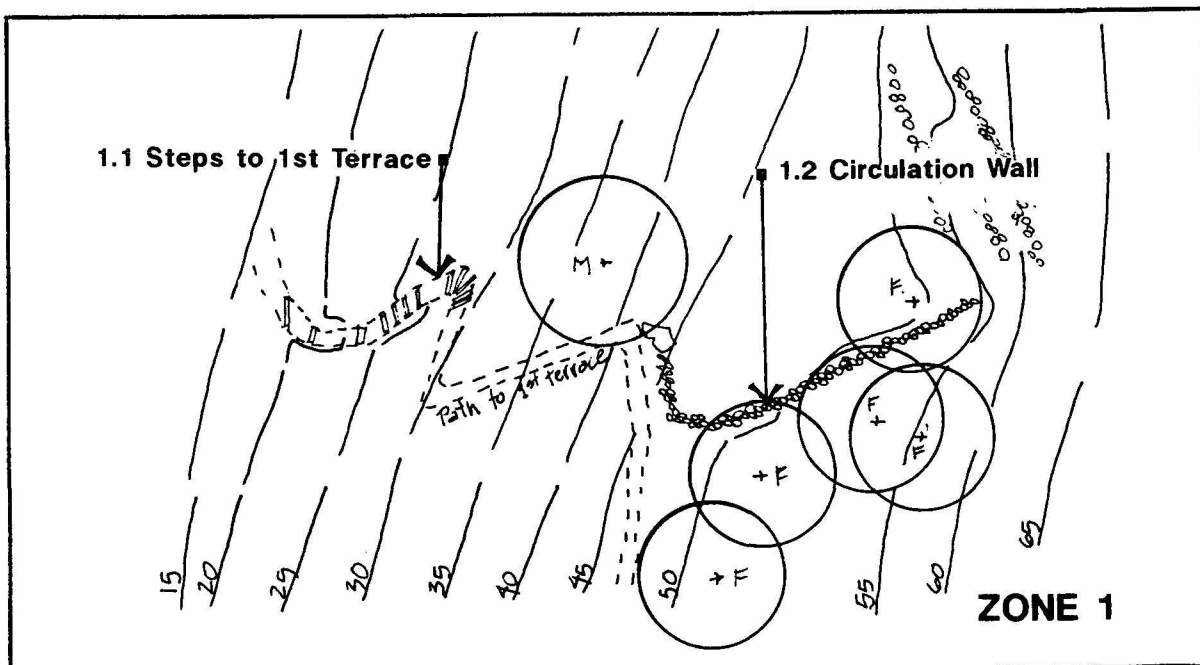
- This wall has two segments. The first segment begins approximately 25 feet down slope from the first terrace on the southeast side of the path. The wall follows the path up the hill retaining a cut slope in a N-S direction. The north end of the wall abuts a natural basalt outcrop.
- This portion of the wall is approximately seven feet long (linear length) and approximately 18 inches high (vertical).
- The wall is comprised of native basalt (angular and rounded stones) that range in size from 8" x 10" to 1.5' x 2'.
- The second segment of this wall abuts the south end of the first segment at a 90°+ angle, leading generally east toward the second terrace.

- This portion of the wall can be tracked for approximately 50 feet and ranges in height between zero and four feet.
- The second segment of wall is composed of basalt and granite with rounded and blocky stones approximately .5' X 1'.
- Mortar is evident in the cracks and interior portions of the wall.
- The land forms associated with this segment of the wall suggests that the width of the road (or path) to the second terrace may have been over eight feet wide - from the top of the wall into the hillside.

- 70% of the surface of the wall is covered by vegetation, including scrub, duff and moss.
- The first segment of the wall is stable. Along the second segment, 80% + of the wall is intact but in a generally unstable condition because of intrusive vegetation.

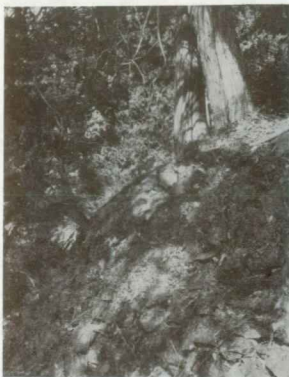
2.1 STRUCTURAL WALL

- This wall begins at the south end of the terrace where it tucks into the hill, meeting grade and extends west, approximately four feet before angling in a northerly direction across the fill of the bench.
- The wall is approximately 60 feet long and ranges in height from zero to fifteen feet.
- Although visible as a single unit, the wall has three distinct sections (see map).
- The first section includes the first 18 linear feet of wall, beginning at the south corner of the entire wall and moving north.

- Individual stones are difficult to see because of moss cover (see below).
- The north end of this wall abuts and incorporates a natural basalt rock outcrop.

- The height of the wall along this section ranges between six and ten feet.
- This section of the wall is composed of blocky basalt stones that range in size from 1/2' x 1' to 1' x 1'. Small stones (less than 3" x 5") are evident and appear to have been used almost like chinking.

- The first section of the wall, as described, has a high degree of integrity and is very stable.
- Moss and ferns are present on the face of the wall but do not adversely impact stability.
- Vegetation at the toe of the wall covers a minimum of one rock along the base of the wall.
- The middle section of the wall has slumped and some material from this section is evident further down the hillside.
- Where the wall has fallen, a section view into the wall indicates that at a point, five feet from the toe of the wall, the horizontal section measures approximately two and one half feet deep (into the fill).

Portion of structural wall 2.1 on the first terrace. (Photo by C. Gilbert, NPS, 1986)

- On either side of the caved in portion of this wall, the wall is relatively stable.
- Some intrusive vegetation is evident including two large juniper trees at the top of the wall and one at the base.
- On the third segment of the wall (northernmost section), approximately 95% of the surface is covered with moss and fern.
- A large amount of scrub is also evident.
- This last segment of the wall retains the area of greatest fill on this terrace. Approximately nine feet of soil behind this wall appears to be fill soil. The top of the wall is rounded which suggests that the fill is settling and physically taking the wall with it. So, while this segment of the wall as a unit appears intact, it is somewhat unstable and being undermined by soil movement.

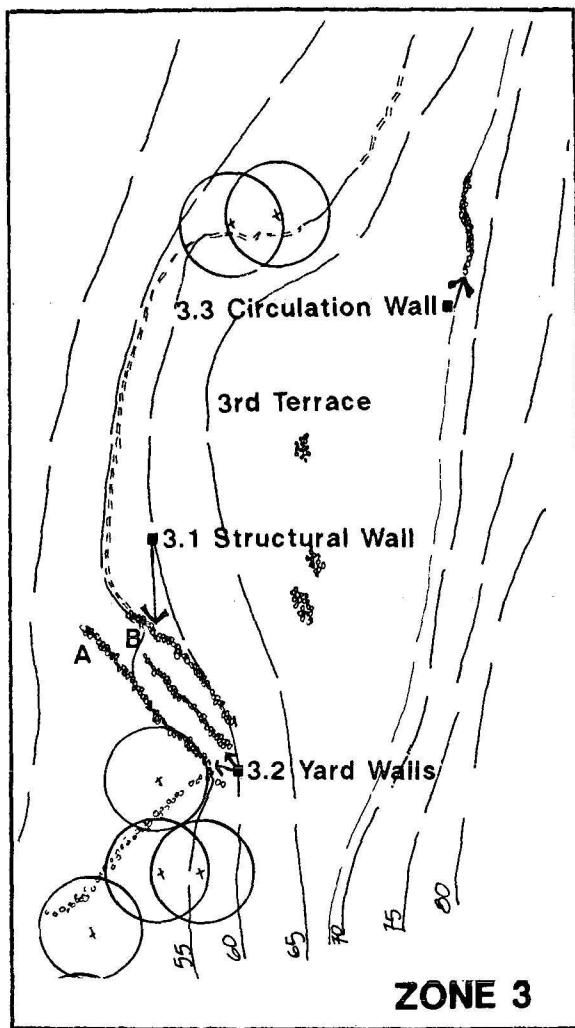
3.1 STRUCTURAL WALL

- This wall begins at the western edge of the terrace where it meets grade at the end of Circulation Wall 1.2. This segment of the wall is parallel to the yard walls (see below) running generally N-S. The wall curves around the bench and angles east for a short distance before tying into the bank on the NE corner of the terrace. It should be noted that significant portions of this wall are missing and a degree of interpolation is included in the calculations and descriptions.
- As a whole, the wall unit extends (can be interpolated) approximately 150 feet (linear

- The west face and east face of this wall are relatively intact and stable. Some slumping is evident and may be due to the settlement of fill material behind the wall.
- A primary loss of integrity for this wall is due to the physical loss of the north face. Seventy percent of the

wall (as a whole) is missing, due to mining, erosion or other removal.

- Stones and cobbles from the wall are also evident in areas down the hillside.
- Scrub vegetation is evident, primarily on the western portion of the wall above the yard walls.

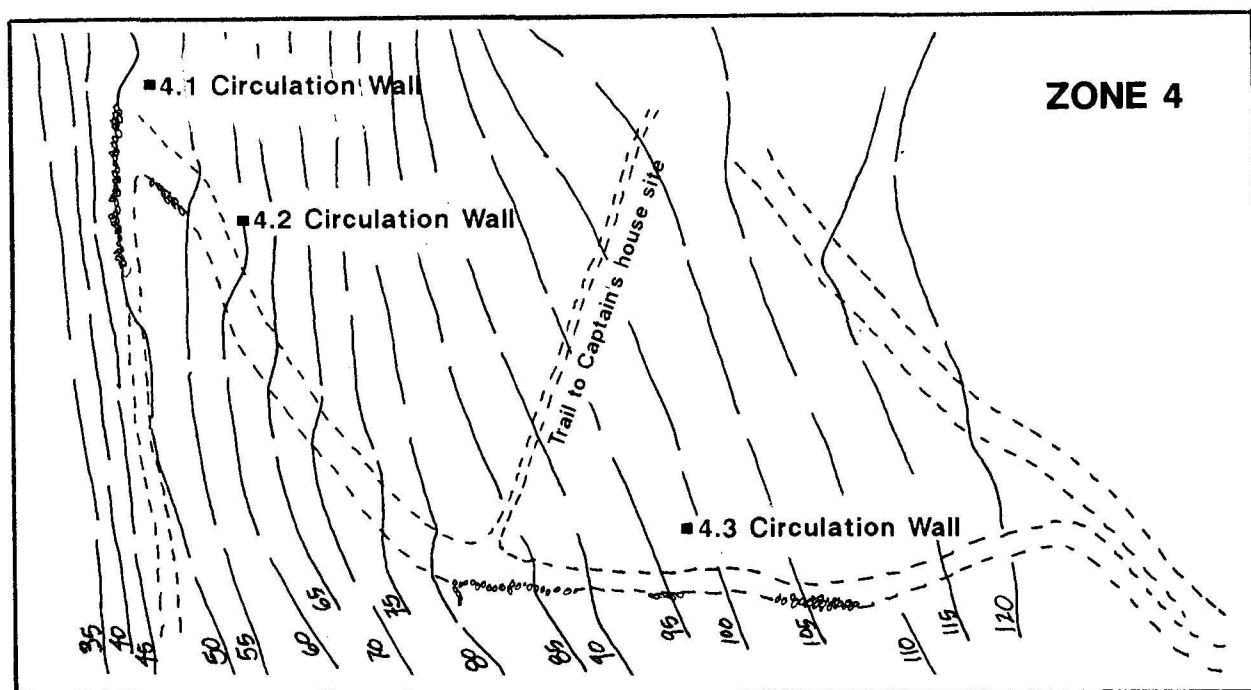
- At a point along the west face of the hill (approximately 30 feet south of the first terrace) the NPS path to the Captain's house site branches. One path leads SE up the hill and the other, more or less, follows the shoreline south. At this junction, a wall (remnant) is located on the cut slope (west edge of path). It is unclear whether this wall was associated with the route which historically followed the shoreline or the road that carried over the hill.
- The portion of wall that is visible is 1 to 2 stones high (\pm 2 feet vertical).
- The wall is composed of basalt stones .5' x 1' \pm .

- Only approximately 10% of the wall remains intact.
- Tallis is evident at the toe of the hill and several loose stones are evident around the fir trees.

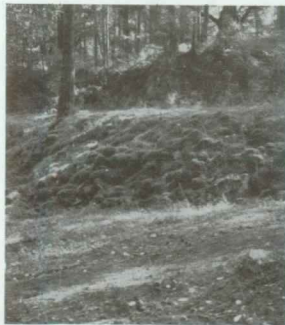
- This wall is a large curving structure that is located on the northern edge of the terrace.
- Portions of this wall retain fill material from the cut slope (shell midden evident).

Structural wall 6.3. View from the NW. (Photo by C. Gilbert, NPS, 1987)

- Portions of the wall are vertical but as the wall curves east around the fill bench, it is significantly battered.
- The wall is approximately 105 feet long and ranges between three and nine feet tall (slope height).
- Shell midden is evident throughout the interior portions of the wall.

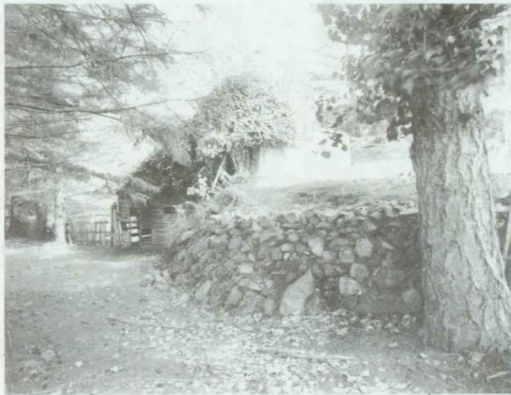
Structural wall 6.3, ca. 1900. Compare the condition of the wall with the existing feature pictured on the previous page. (SAJH photo file)

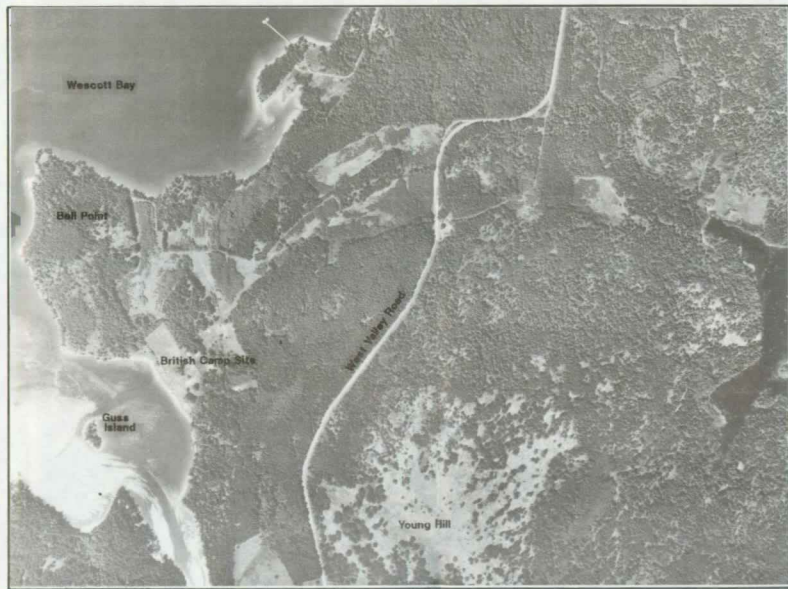
Historically British Camp was located on a broad level area extending inland from the shores of Garrison Bay. Land surrounding the main encampment was densely forested and stepped-up in elevation, creating natural site boundaries to the north, south and east. Garrison Bay created the western edge of the site, and provided access to the camp. Land routes south of the camp provided additional access. These broad organizational patterns remain today. Current access is from the south off of West Valley Road. A parking area east of the site provides an area for visitor information and trailheads to Young Hill and the camp. Although the forest has changed since 1872, the landforms and physical enclosure have remained.

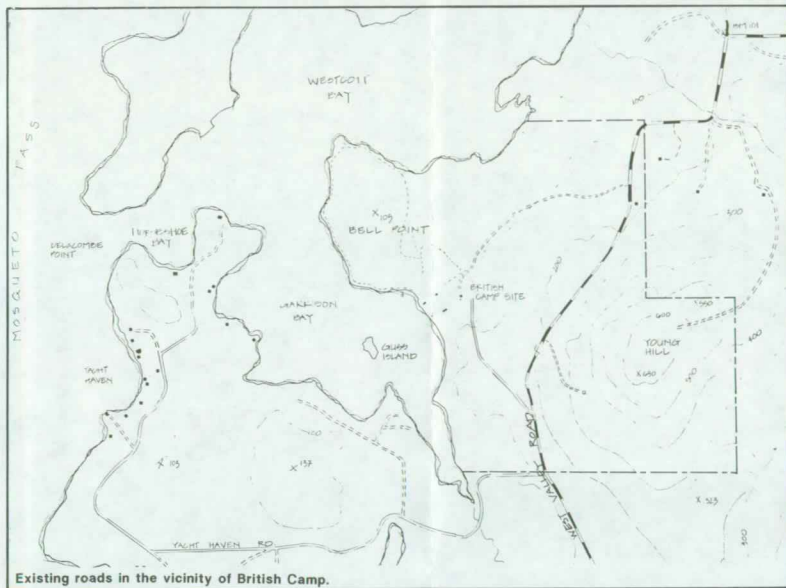
The primary historic road to British Camp branched off of the main island road between Bellevue Farm and Roche Harbor, and continued down through the forest to the barracks area. Additional roads on Officers' Hill and south along the shore provided access to the officers' quarters and to the telegraph station located near the camp. Current access to the site is off of West Valley Road, nine miles north of Friday Harbor. This road ends in a parking lot located east of the site. Circulation on the site is confined to pedestrian trails which extend up Young Hill, through Officers' Hill, to the camp and to Bell Point.

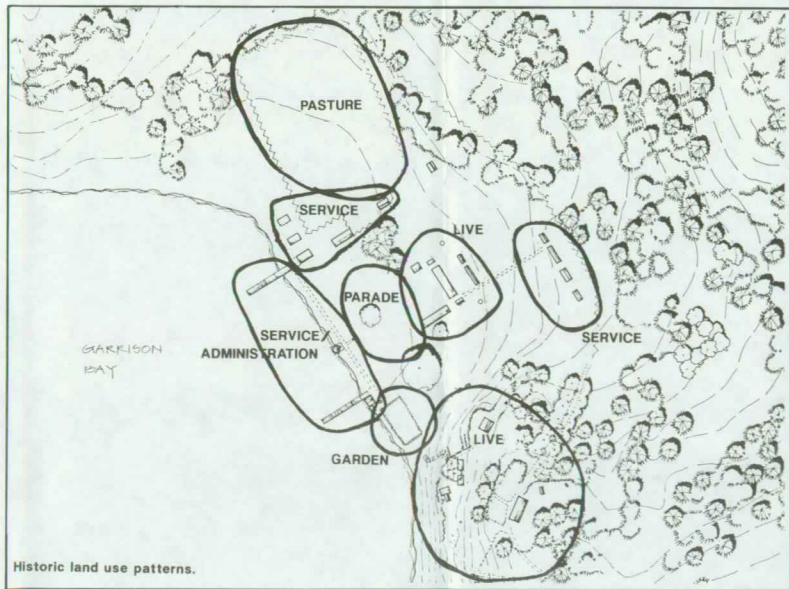
Historic land use patterns.

Land uses at British Camp included living areas, administrative facilities, service and support activities. The majority of marines lived in barracks at the edge of the parade and in quarters on the hill south of the camp. The waterfront was a contained district of administrative and service structures (wharf and storehouse). Most of the service buildings wrapped around the edge of the complex defining the north and east edges of the encampment. Pasture areas north of the site and forest to the east and south provided additional land for support services. Current land uses focus on interpretation of the historic scene, using exhibits and trails.

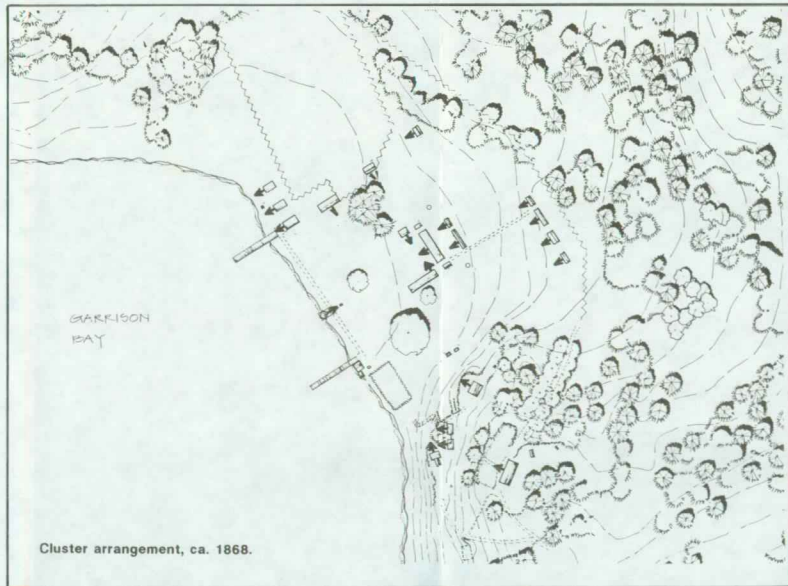
Cluster arrangement, ca. 1868.

The structural complex at British Camp developed with an overall orientation to the waterfront. Early barracks buildings faced the bay with other structures clustered around the edges of the parade ground, enclosing and defining the space. Service buildings were grouped next to the shore and on the hill behind the barracks. Officers' quarters stepped up the hill south of the main encampment, overlooking the bay, with views to the straits and Vancouver Island. Today only four buildings remain at the site and although they define the general extent of the historic encampment, they do not reflect the functional relationships among clusters of buildings.

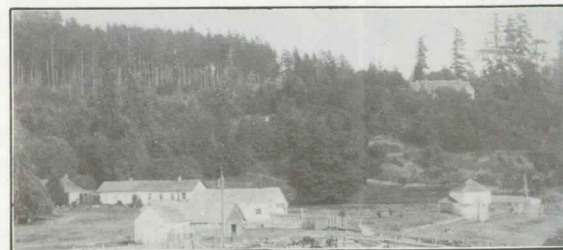
View of Officers' Hill after the occupation showing early revegetation of the forest. Photograph ca. 1880, view from the northwest.

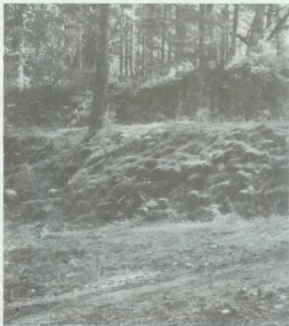
Stabilization of remnant features on Officers' Hill is a component of design alternatives I & II.

2. All above-ground remnant structures, including the masonry ruin of the forge/bakery, the rock retaining walls and other structural walls identified on the hillside (where the officers were housed), should be stabilized and maintained to the degree that no further deterioration occurs. (See below, and see Plant Materials and Access and Circulation sections.)

1. Historic roads and pathways identified on the hillside where the officers' houses were located should be stabilized and maintained to the degree that no further deterioration occurs. In some instances, preservation of the feature requires no intervention.

1. A plan for selective and careful removal of vegetation undermining the structural stability of the remnant rock walls on the hillside is recommended (see 3. Buildings and Structures and see Appendix).

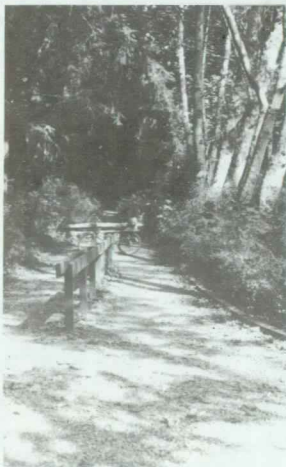
The area currently used for bicycle parking can be incorporated into the redeveloped entry system for the site. In this alternative, vehicular parking would be located to the right (east) of the area pictured above. The main pedestrian trail to the Crook House (visitor center) would be located to the left (west) of the area, providing an accessible route to the main camp site. (Photo by C. Gilbert, NPS, 1987)

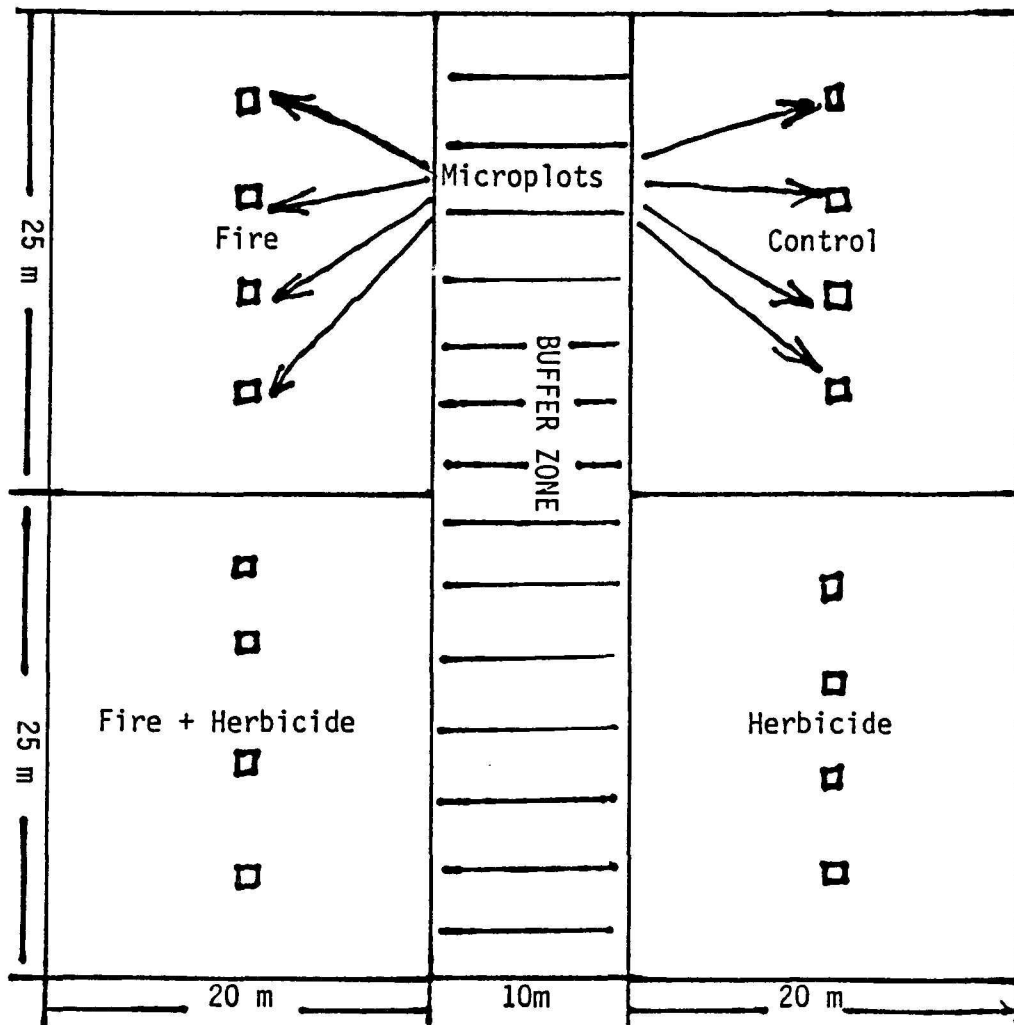
Schematic of block, plot, and microplot layout for studying the effects of fire, fire and herbicides, and herbicides in controlling tansy ragwort.

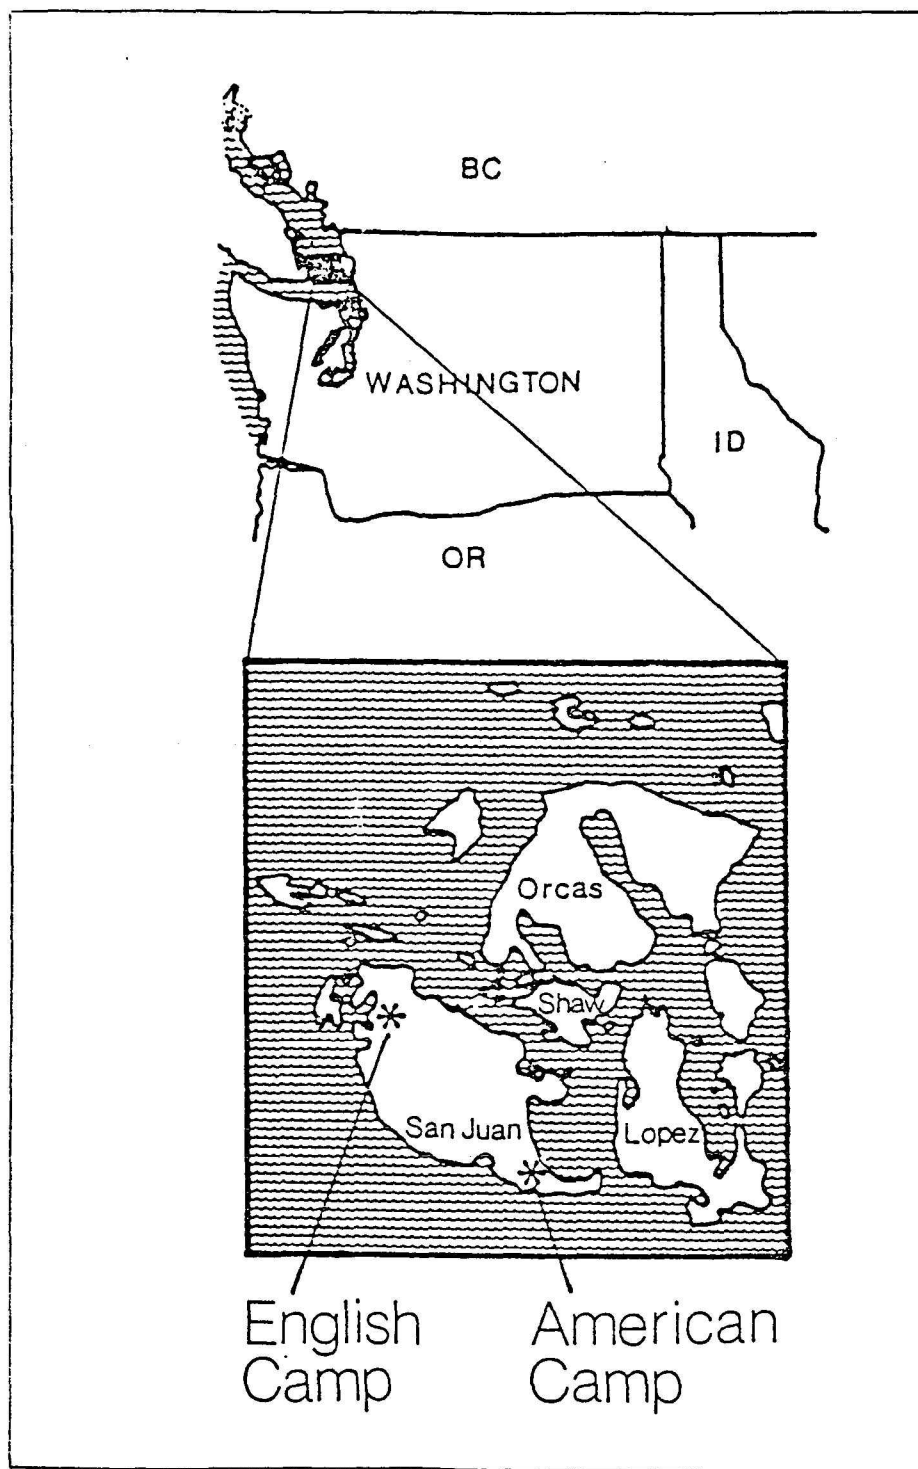
FIGURE 1

Figure 1. San Juan Island National Historical Park is comprised of two former military camps.

This study was conducted at American Camp on San Juan Island National Historical Park (SAJN), San Juan Island Archipelago in Washington State. American Camp is located on the southern end of the island near South Beach (Figure 1) and receives less than 20 inches of rain per year as it is in the rain shadow of the Olympic Mountains. The area is comprised of open prairie with gently rolling slopes and surrounded by second growth Douglas Fir, lodgepole pine and Sitka spruce.

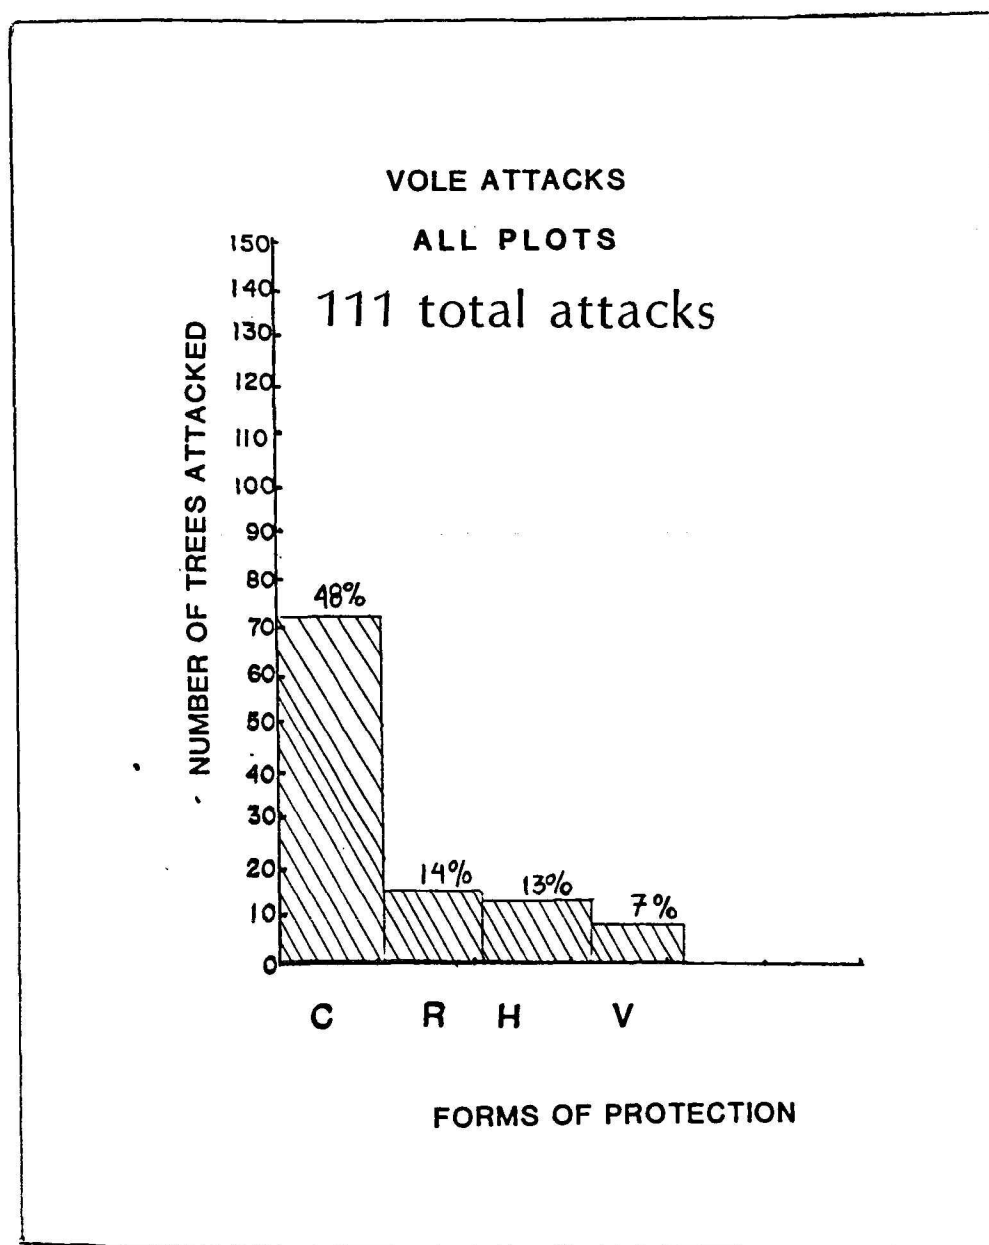
FIGURE 3

C.....CONTROL

H.....HARDWARE CLOTH

V.....VOLE FOIL

other (Figure 3).

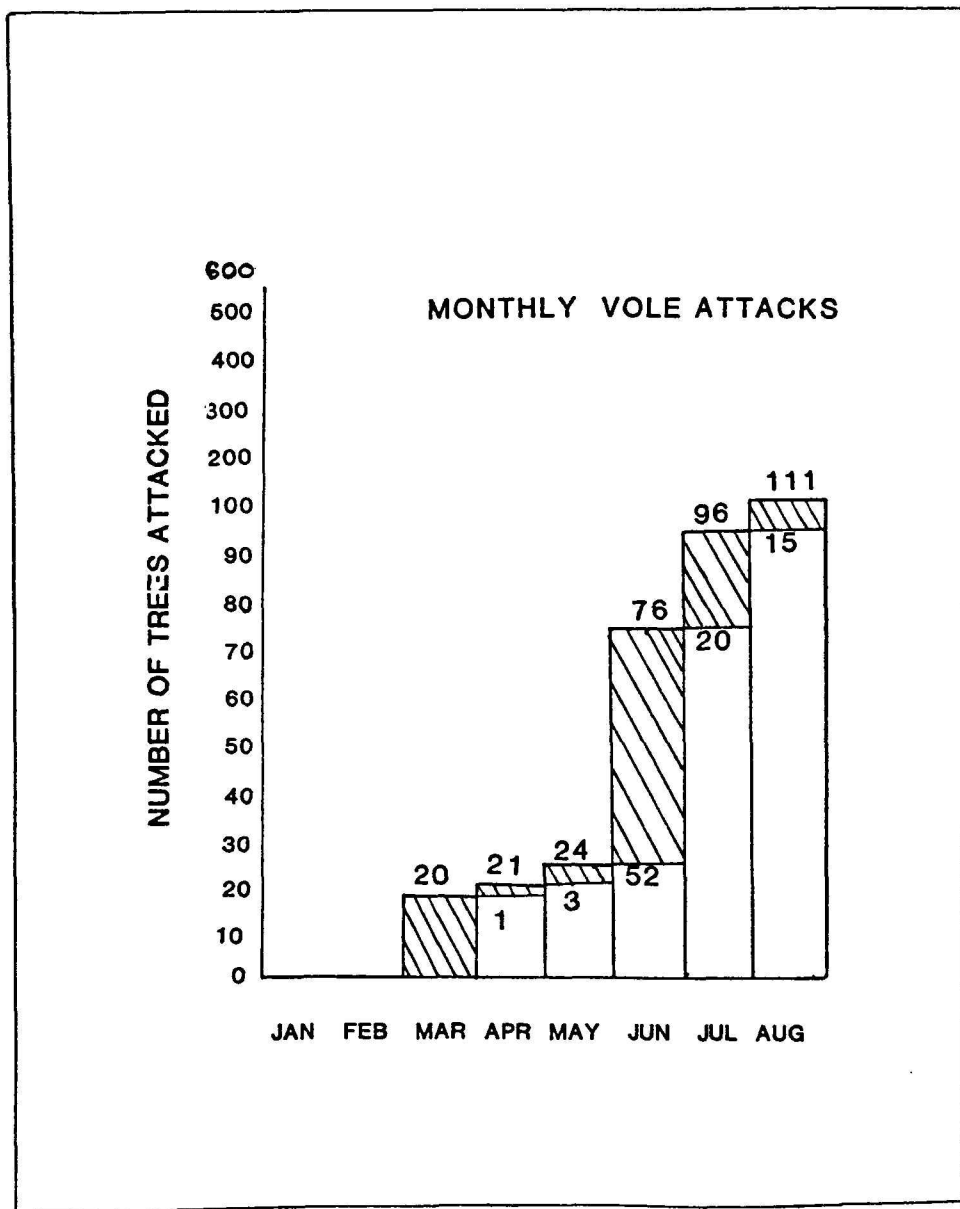
18% ATTACKED

81.5% UNATTACKED

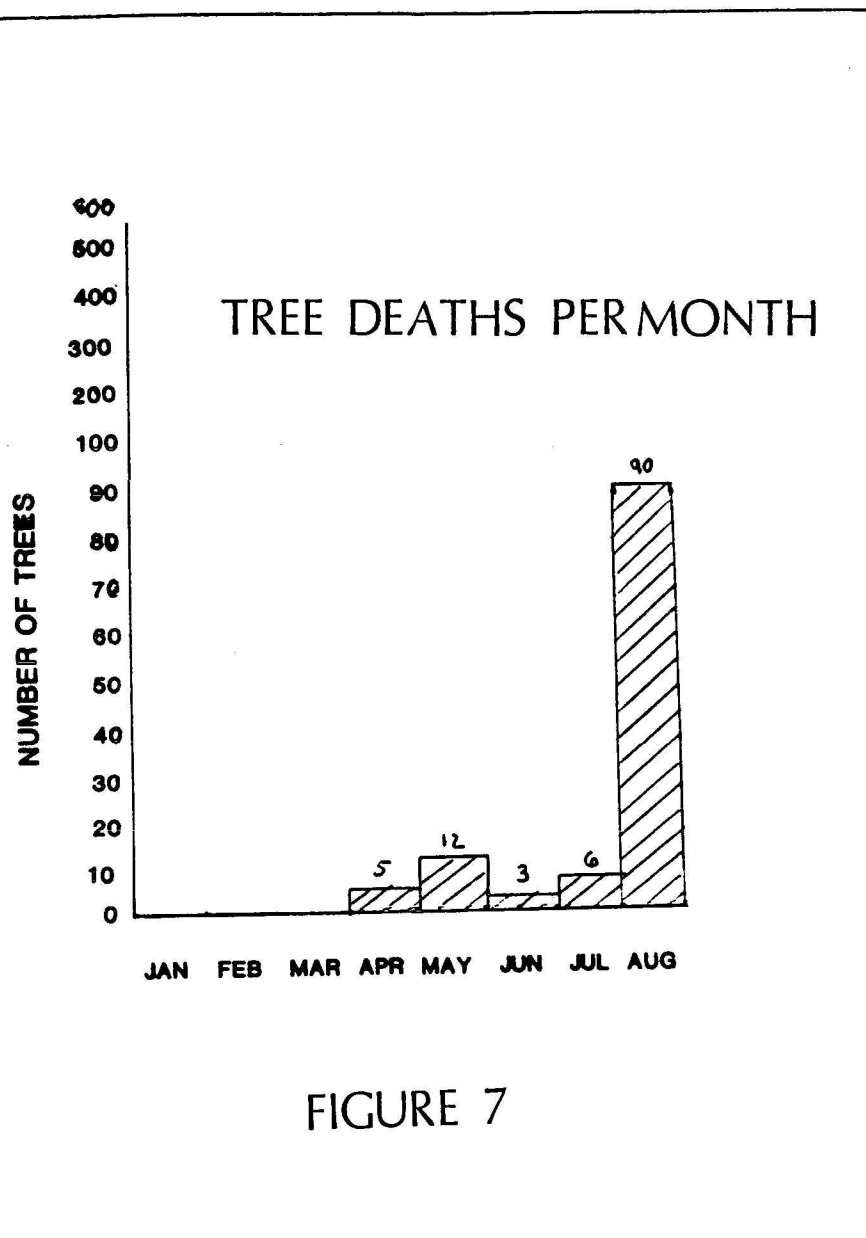
TREE DEATHS PER PLOT

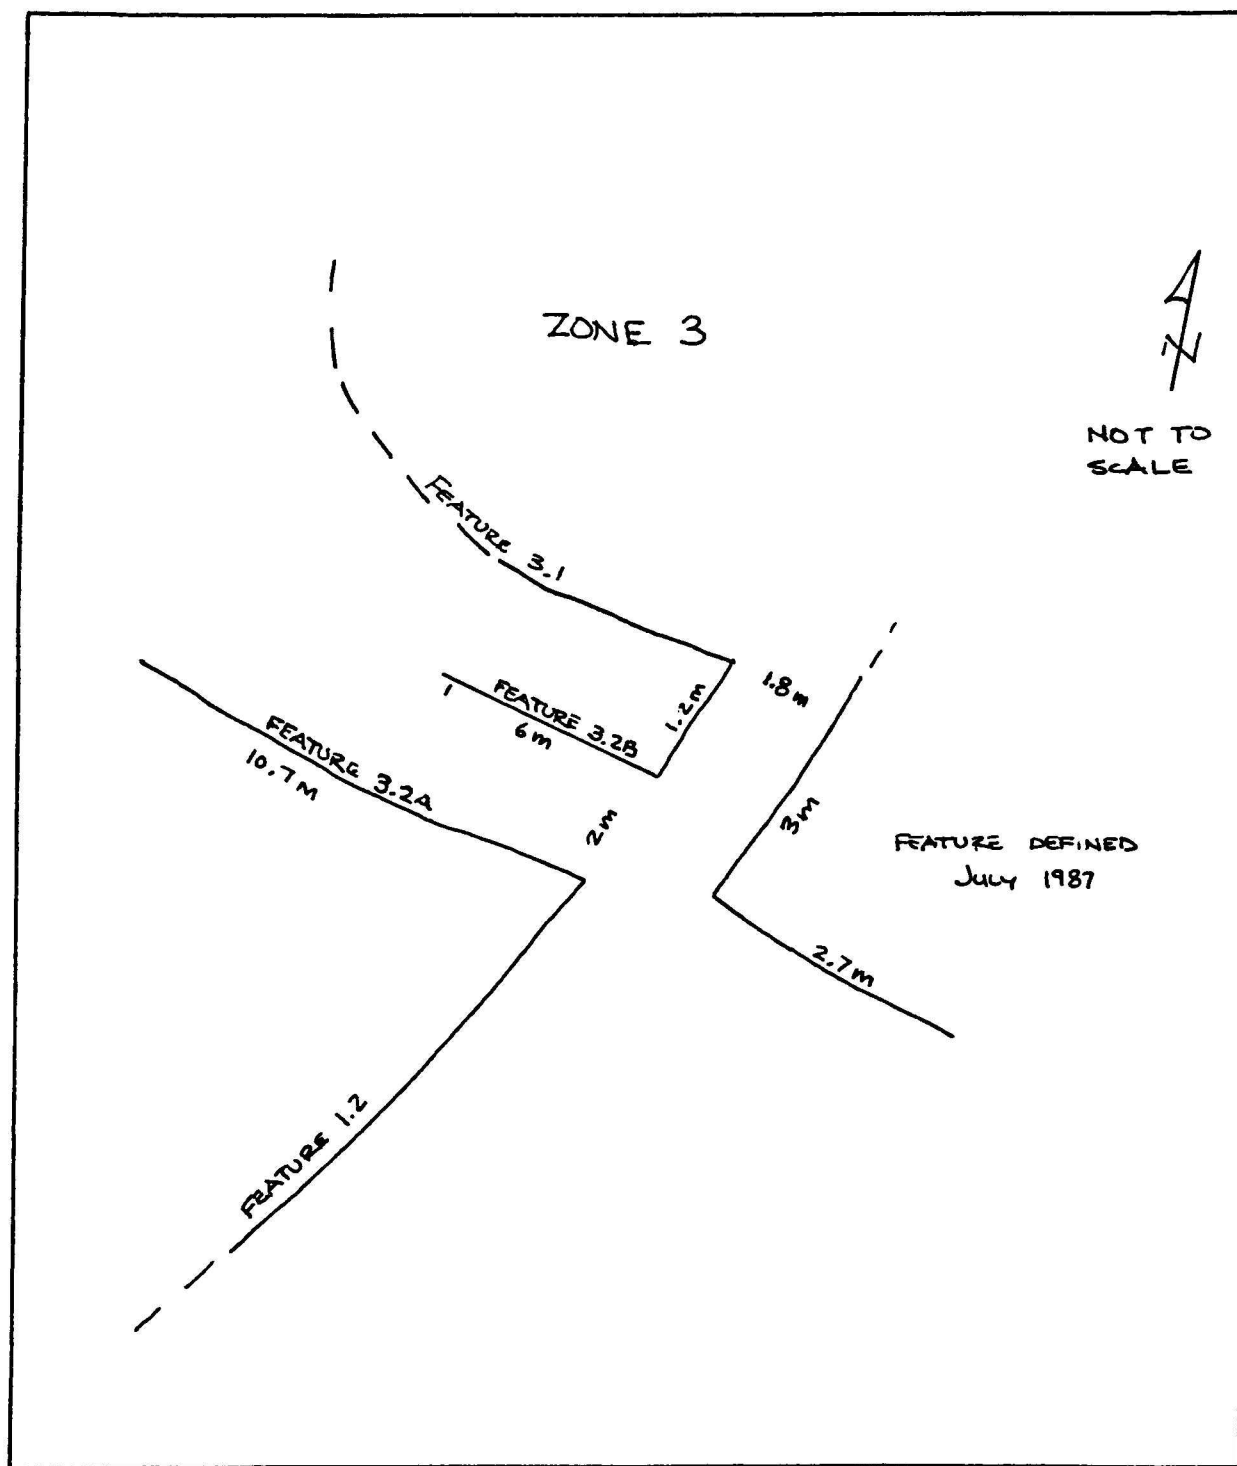
Figure 1. Diagram of stone features located at the southern end of the Second Terrace. British Camp, San Juan Historical Park.

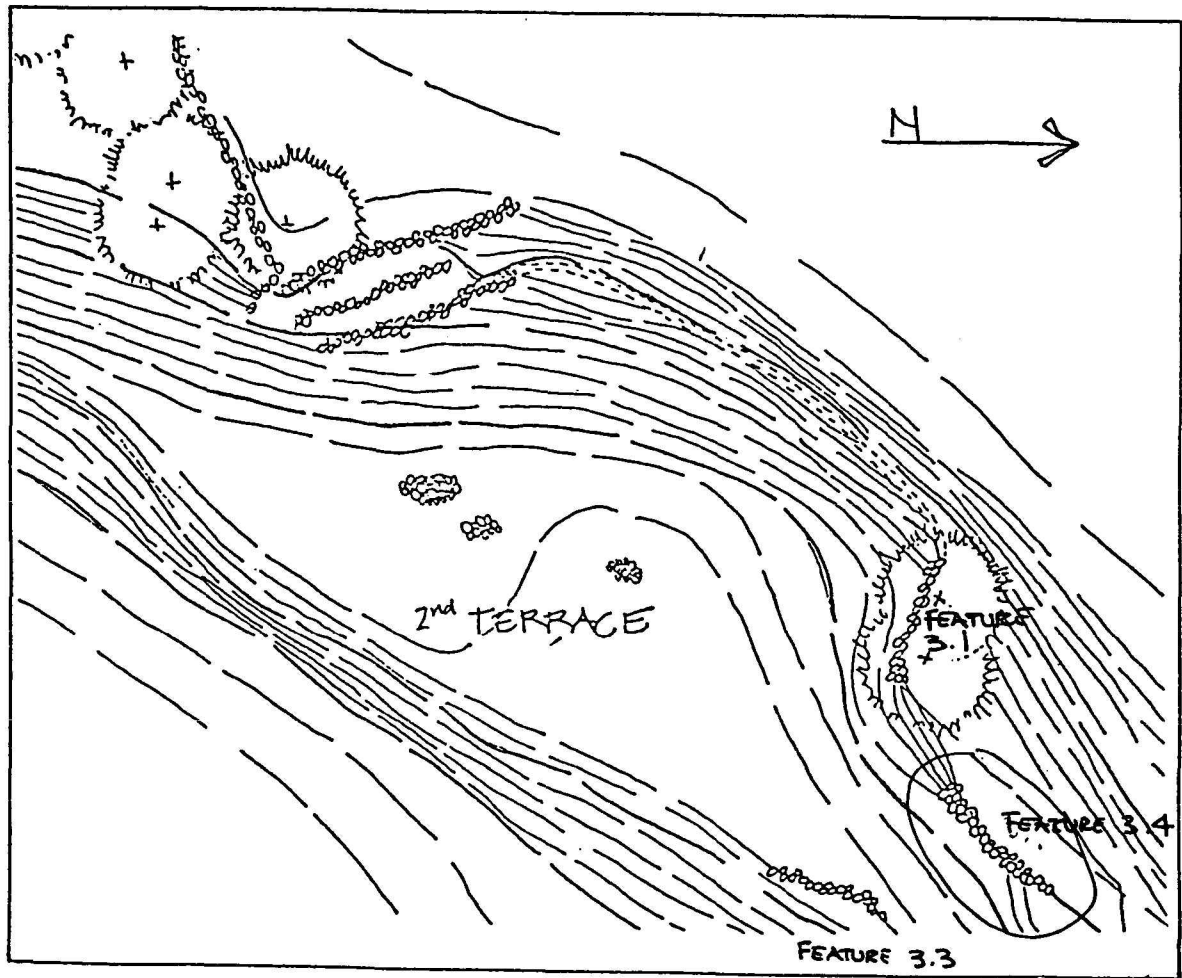
Figure 2. Map of stone features located at the northern end of the Second Terrace. British Camp, San Juan Historical Park.
