National Park Service  
Cultural Landscapes Inventory  
2004

Rancho Sierra Vista Historic District  
Santa Monica Mountains National Recreation Area

**RANCHO SIERRA VISTA HISTORIC DISTRICT (Proposed)**  
**SANTA MONICA MOUNTAINS NATIONAL RECREATION AREA**

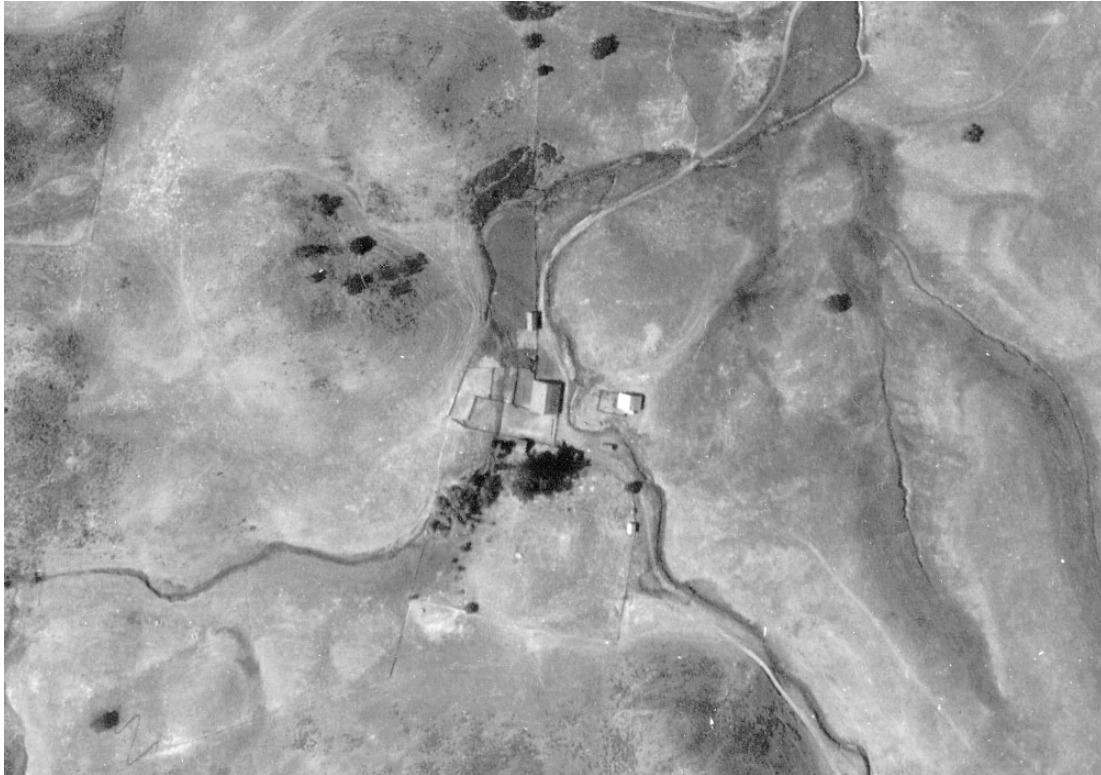
*History #3: Aerial photo of the Beal developments (SAMO 1142.5.37, 1937).*

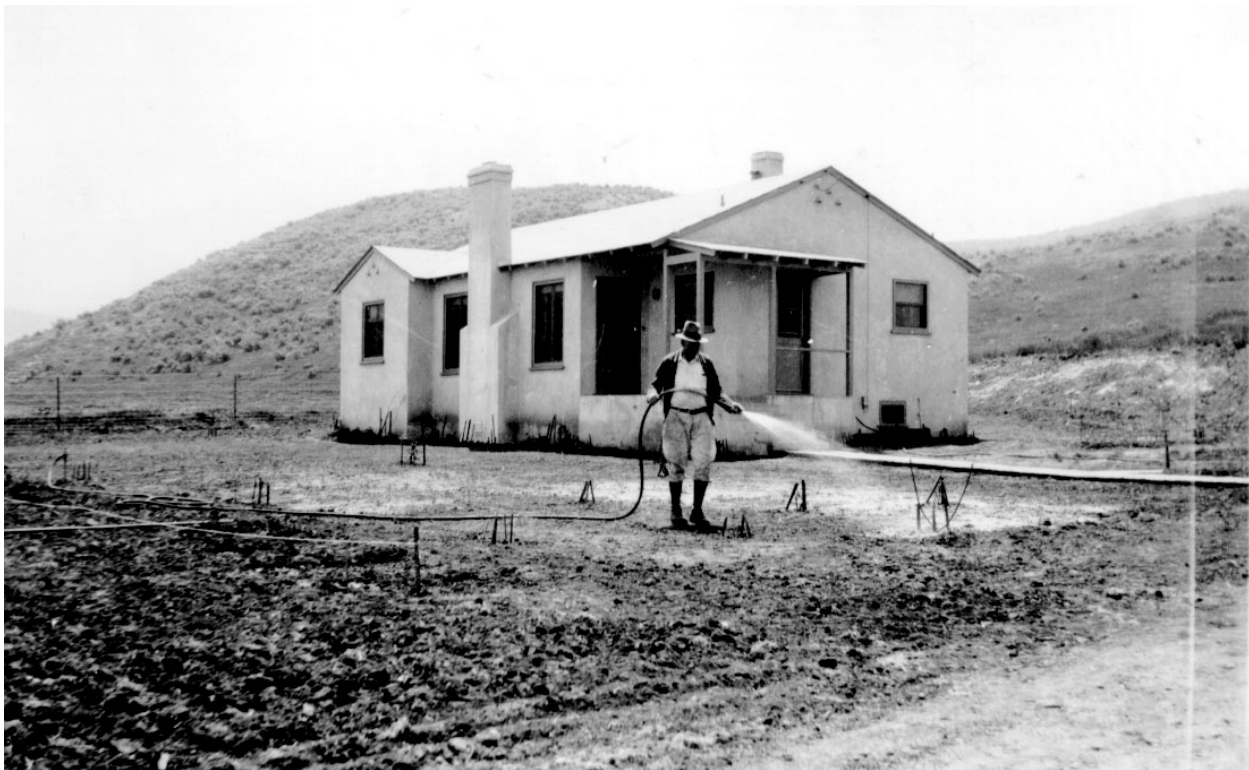
*History #4: Beal residence with seedlings (SAMO 2178, 1938).*

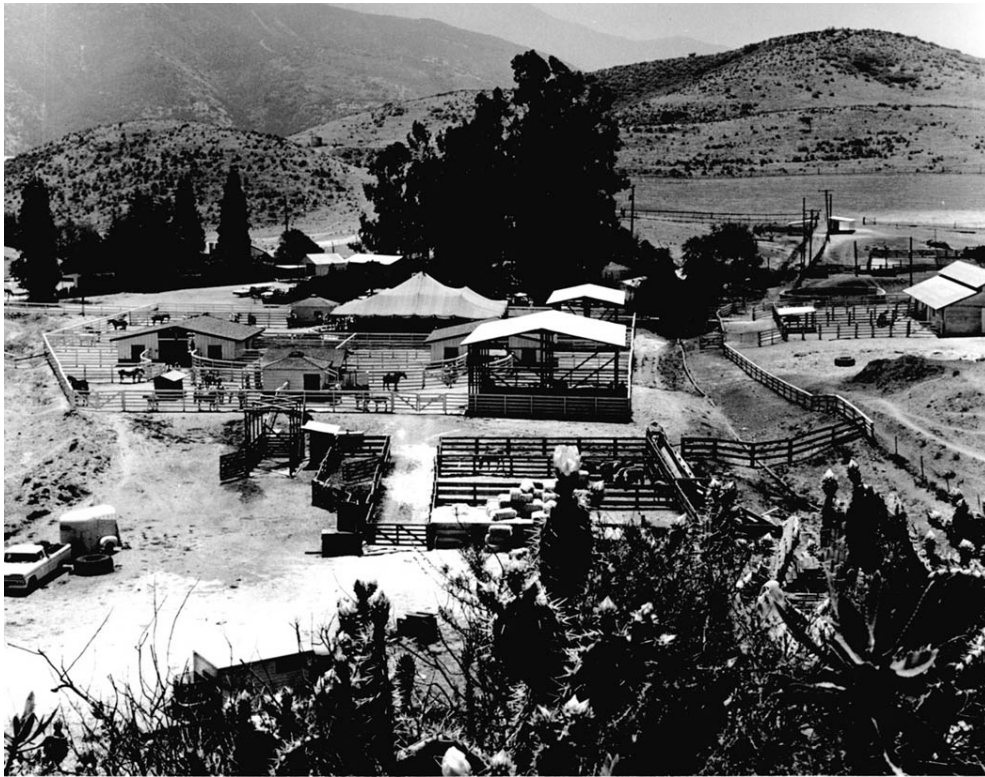
*History #7: Danielson period corral developments, note likely Beal period corrals in foreground (SAMO 2193, ca.1973).*

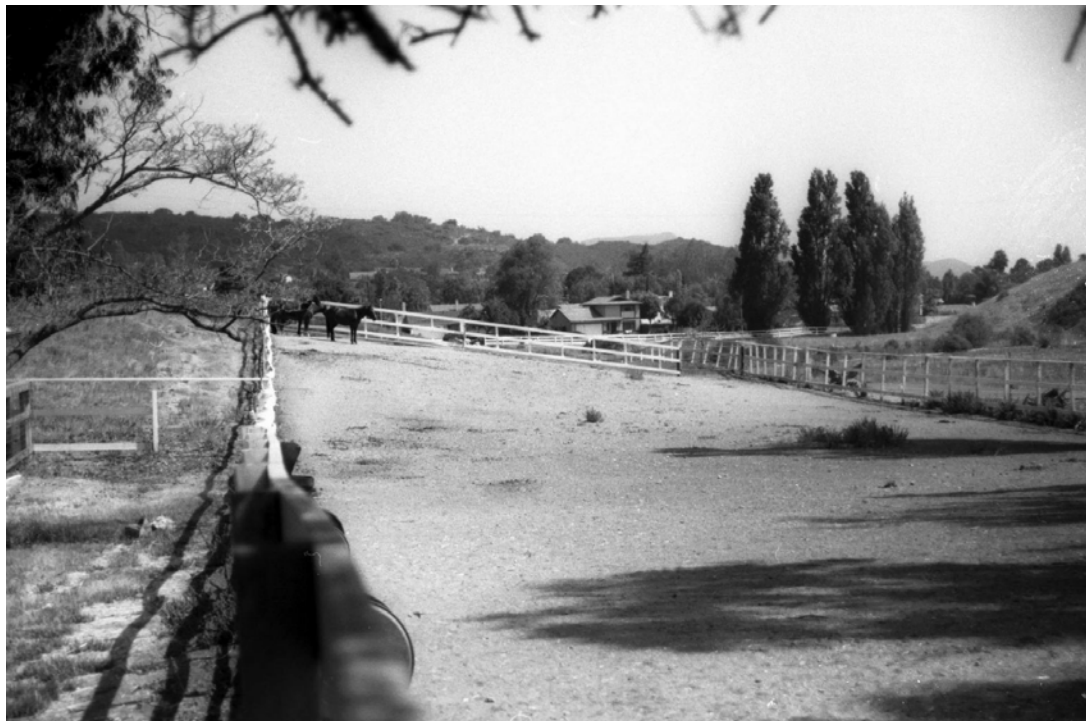
*Land Use #1: NPS horses stabled at Horse Ranch. (CLI, SAMO-N-0006-37, 2002)*

Currently, the NPS stables a number of horses at the ranch (see photo, Land Use #1) and has an existing Ranch Management Plan for Rancho Sierra Vista that was adopted by the SMMNRA in 1996. The plan thoroughly outlines restoration efforts, paddock, pasture, and manure management, and interpretation for an operational and sustainable ranch.

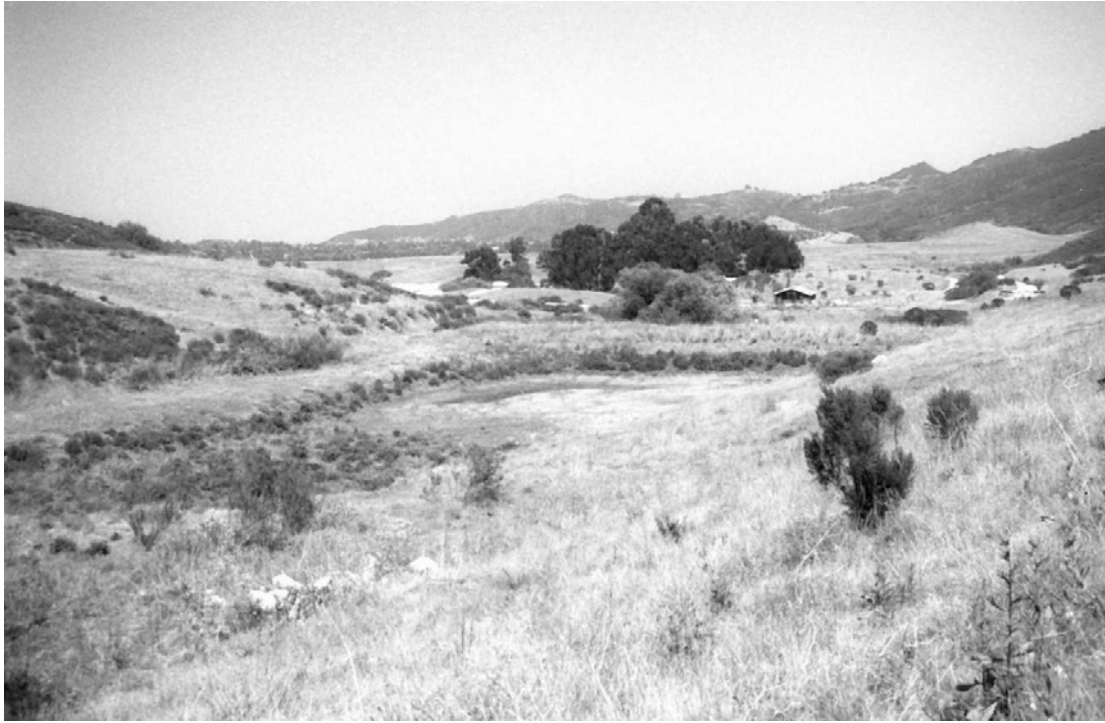
*Topography #1: Looking down on the contributing reservoir #1. (PGSO, CLI, SAMO-N-0004-21, 2002)*

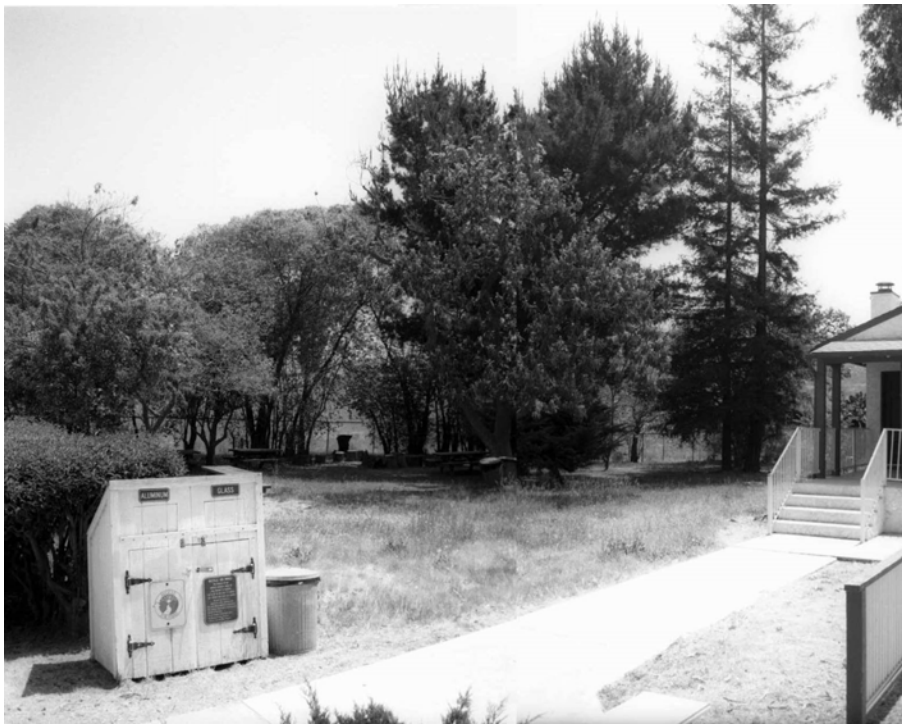
*Vegetation #1: Contributing vegetation in Beal residence yard. (PGSO, CLI, SAMO-N-0003-32/33, 2002)*

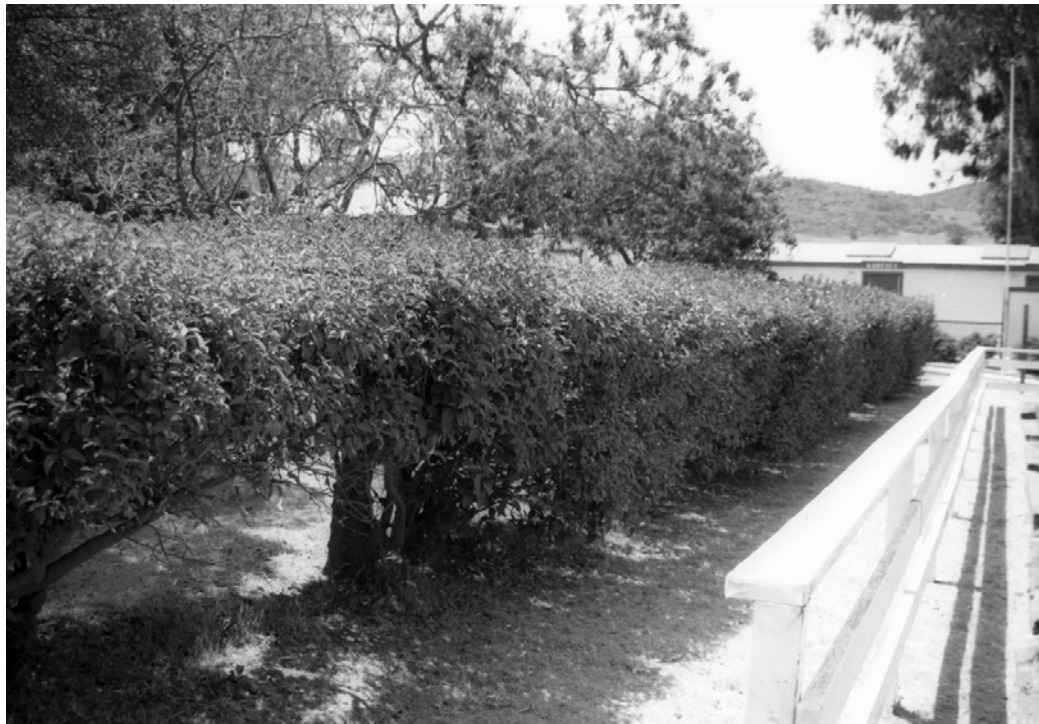
*Vegetation #2: Looking down the contributing Photinia hedge row. (PGSO, CLI, SAMO-N-0003-30, 2002)*

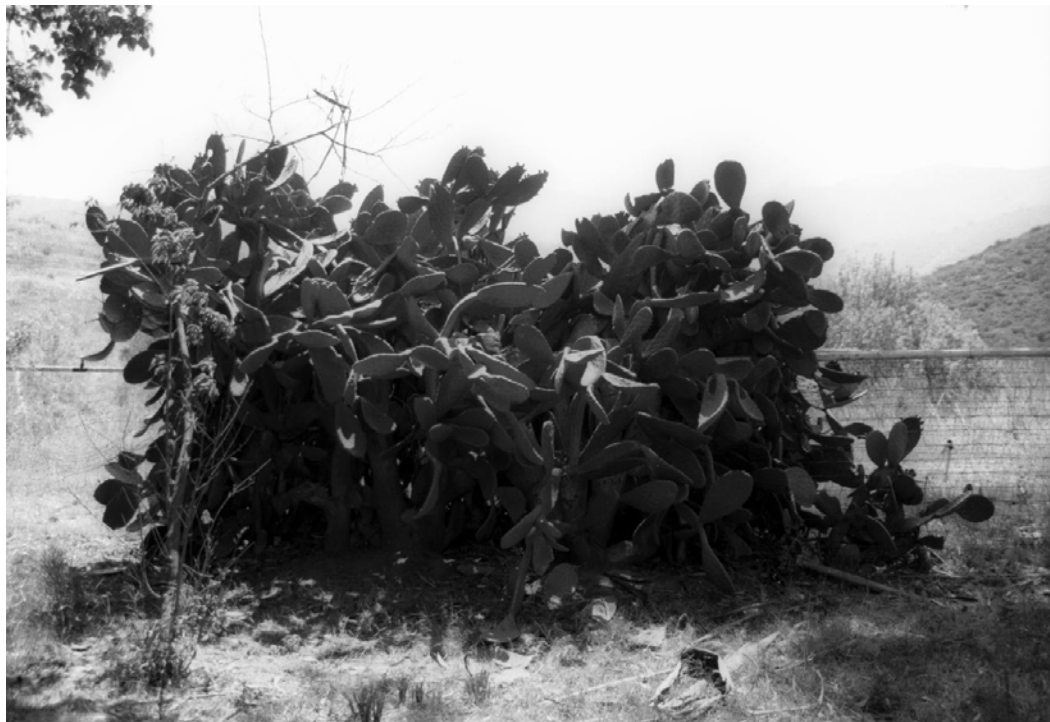
*Vegetation #3: A view of the contributing prickly pear cactus near the Beal residence. (PGSO, CLI, SAMO-N-0003-36, 2002)*

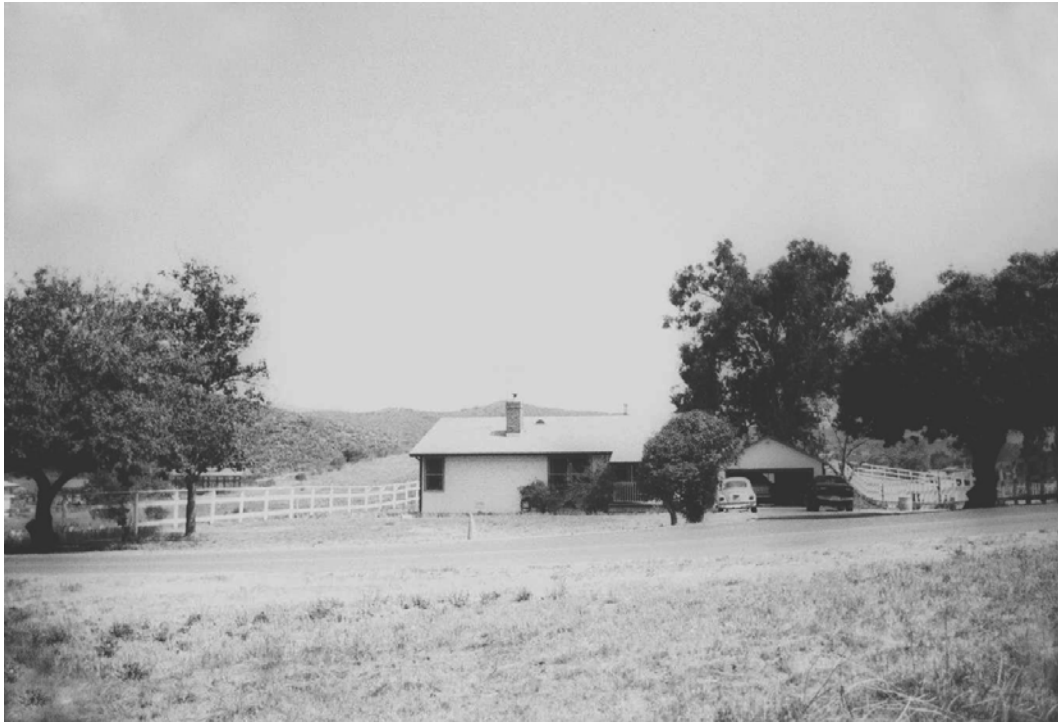
*Vegetation #4: A view of the caretaker's residence and surrounding contributing vegetation. (PGSO, CLI, SAMO-N-0005-5, 2002)*

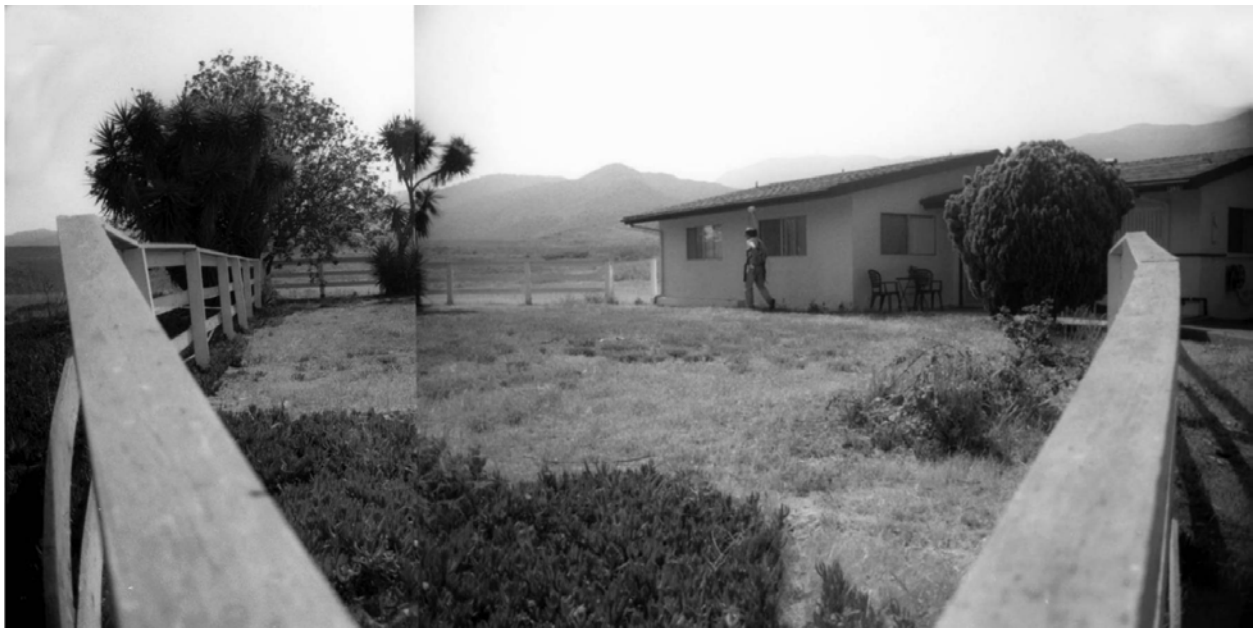
*Vegetation #5: A panoramic view of the noncontributing ranger residence vegetation, the Arborvitae to the right has since been removed. (PGSO, CLI, SAMO-N-0006-22, 23, 2002)*

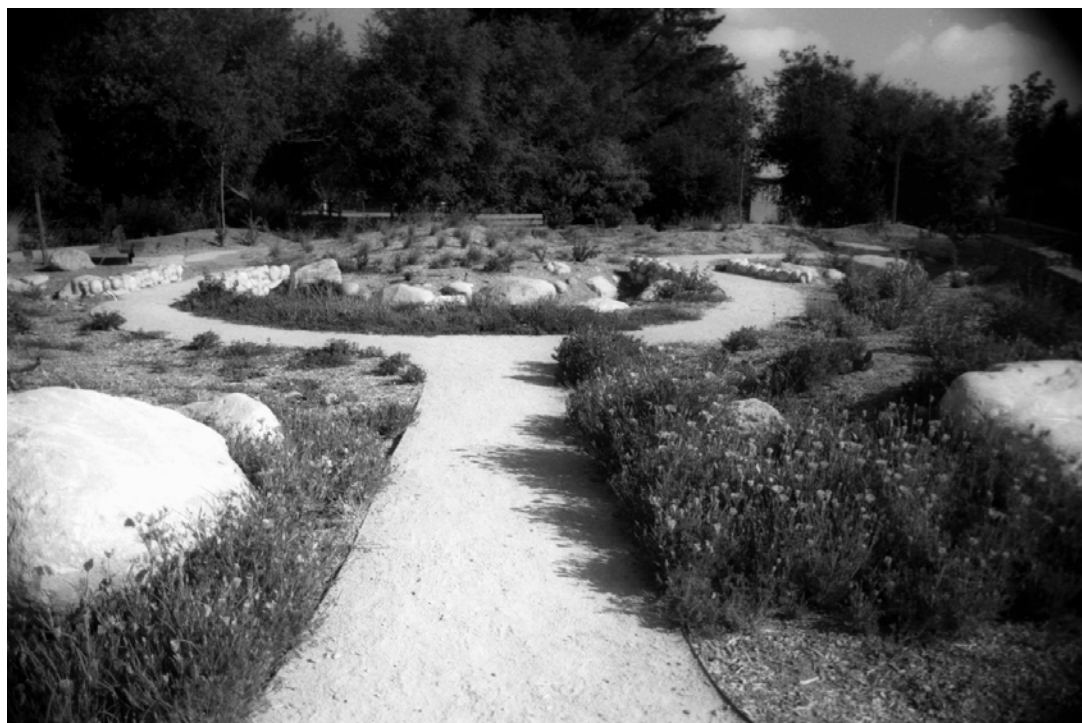
*Vegetation #6: A view of the noncontributing Satwiwa Cultural Center garden. (PGSO, CLI, SAMO-N-0006-13, 2002)*

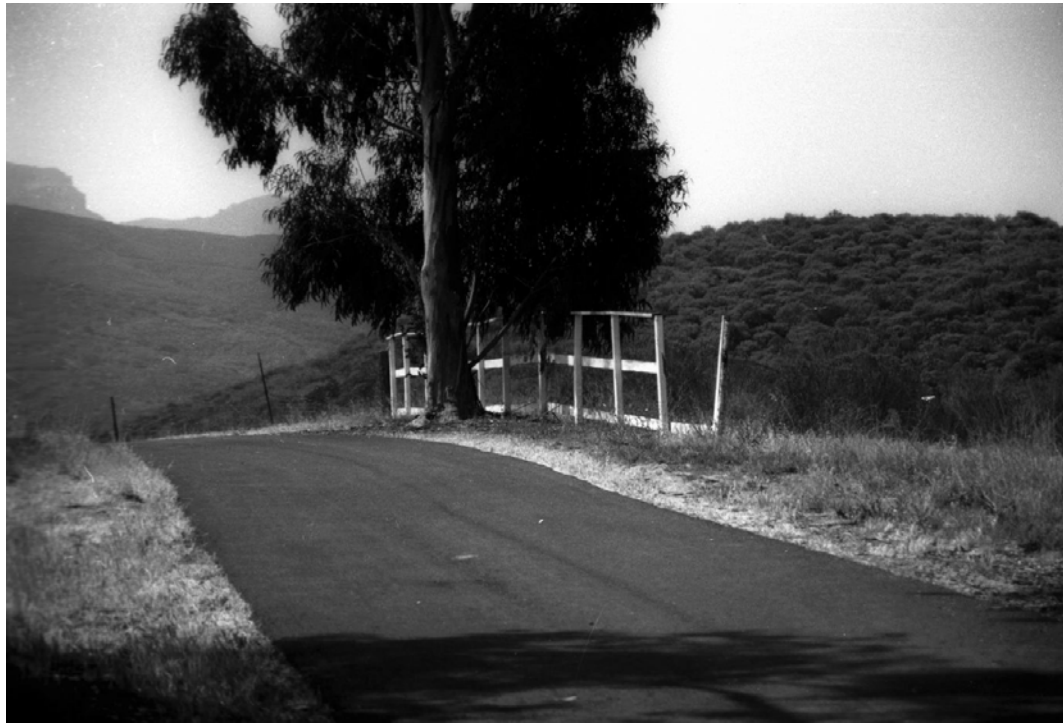
*Circulation #1: A view down the contributing Big Sycamore Canyon Road with eucalyptus. (PGSO, CLI, SAMO-N-0006-32, 2002)*

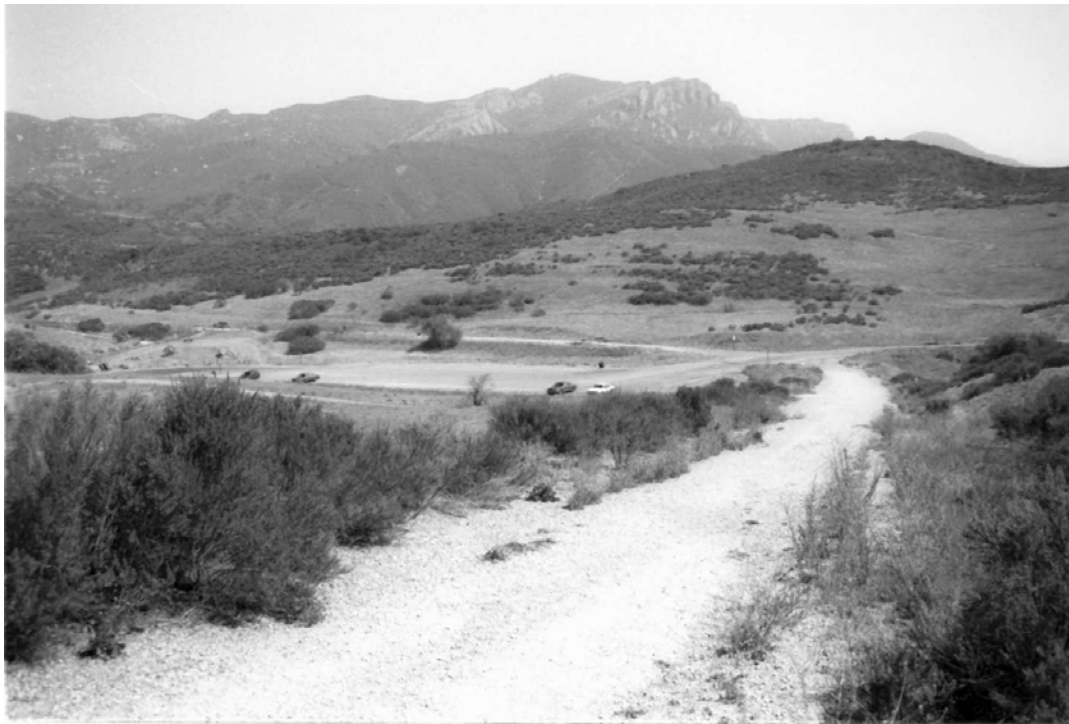
*Circulation #2: A view down the contributing Old Service Road near the NPS parking area. (PGSO, CLI, SAMO-N-0004-18, 2002)*

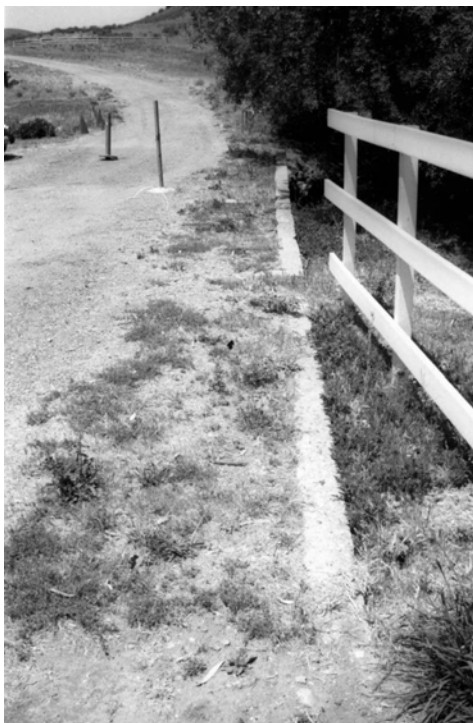
*Circulation #3: A view down the contributing main entry road. (PGSO, CLI, SAMO-N-0004-4, 2002)*

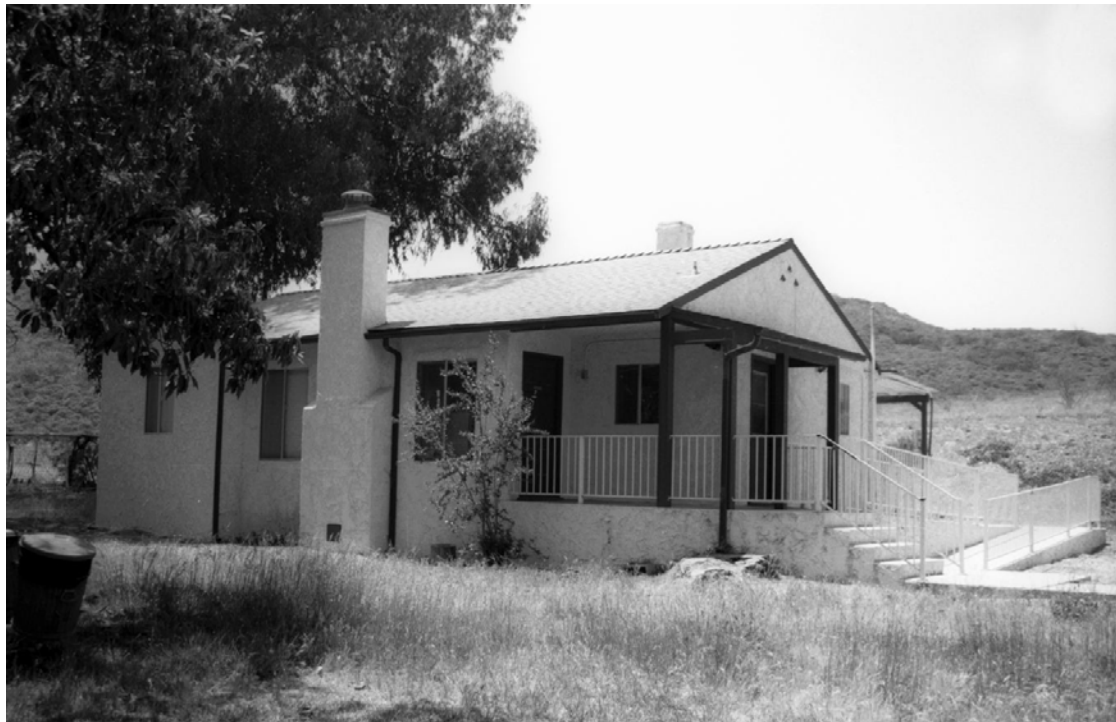
*Buildings and Structures #1: A view of the contributing Beal residence (NPS#417). (PGSO, CLI, SAMO-N-0003-34, 2002)*

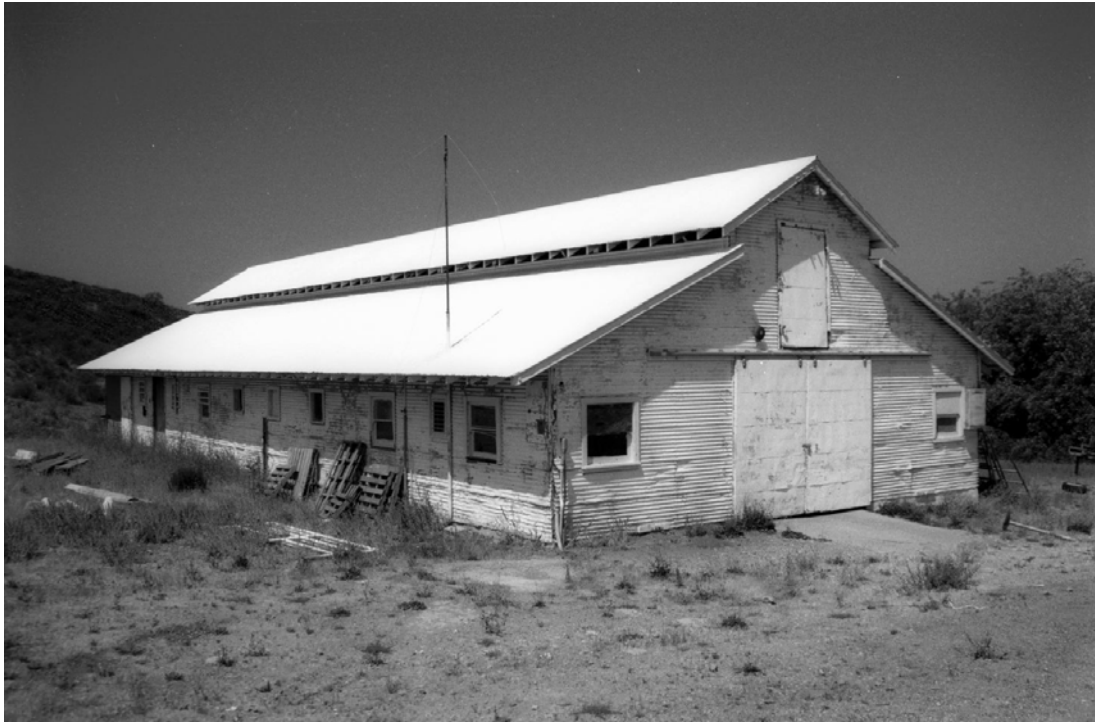
This horse and hay barn was built by Carl Beal in 1938. The barn is a typical western style or prairie barn with a tall two-story gable roofed portion in the center flanked by one story shed roofs on each side (see photo, Buildings and Structures #2). Rafters are exposed under the eaves and the roof is covered with corrugated metal. The south side has a large opening with sliding wood doors on a track. A hay loft door is located above the entry. A second hay loft door is found on the north side where a ridge pole extends with a cable used to raise hay into the loft. Openings occur along the east and west sides of the barn as well. The barn is covered with clapboard siding and rests on a concrete foundation. The barn is 3,240 square feet with the interior divided into stalls, feed rooms, tack room and hay loft. Plans are being discussed to adaptively reuse the building for educational purposes.

*Buildings and Structures #2: A view of the contributing barn (NPS# 413). (PGSO, CLI, SAMO-N-0004-8, 2002)*

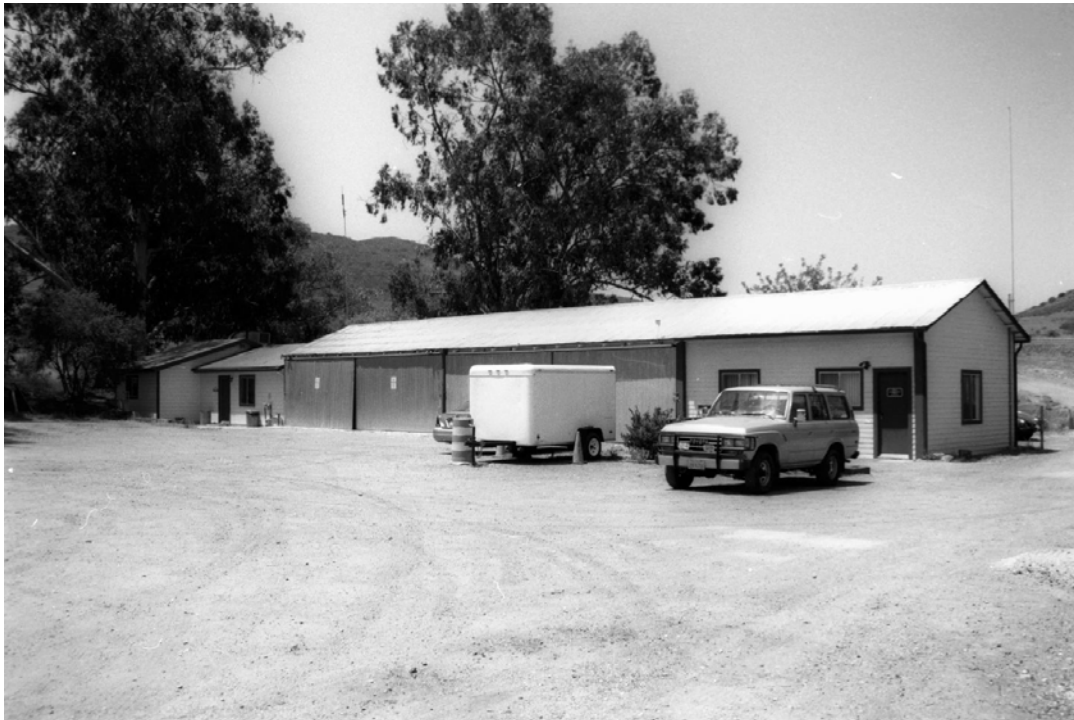
At the south end of the shed, a thirty foot-long building was attached for use as an apartment (NPS #108), with a gable roof covered in composition shingles and horizontal wood siding. The original wood frame windows have been replaced with aluminum sliding windows when this portion was rebuilt by the NPS in 1987.

*Buildings and Structures #3: A view of the contributing equipment shed (NPS# 108-408). (PGSO, CLI, SAMO-N-0004-0, 2002)*

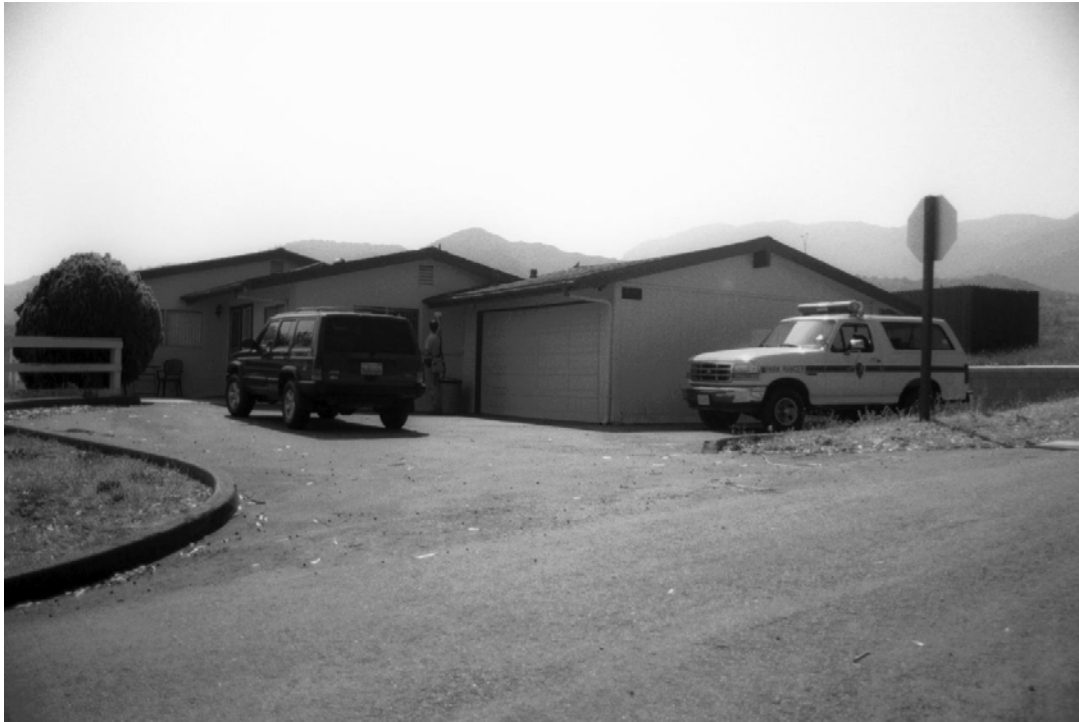
*Buildings and Structures #4: A view of the noncontributing eastern residence (NPS#101). (PGSO, CLI, SAMO-N-0006-21, 2002)*

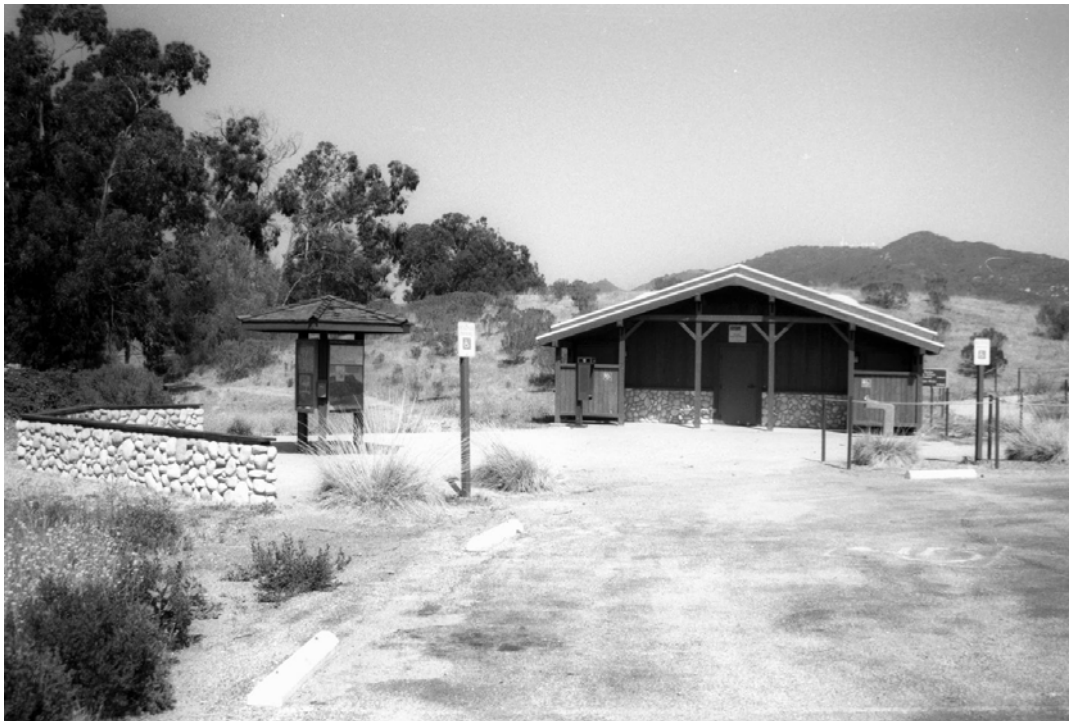
*Buildings and Structures #5: A view of the noncontributing modern restroom (no NPS #). (PGSO, CLI, SAMO-N-0004-22, 2002)*

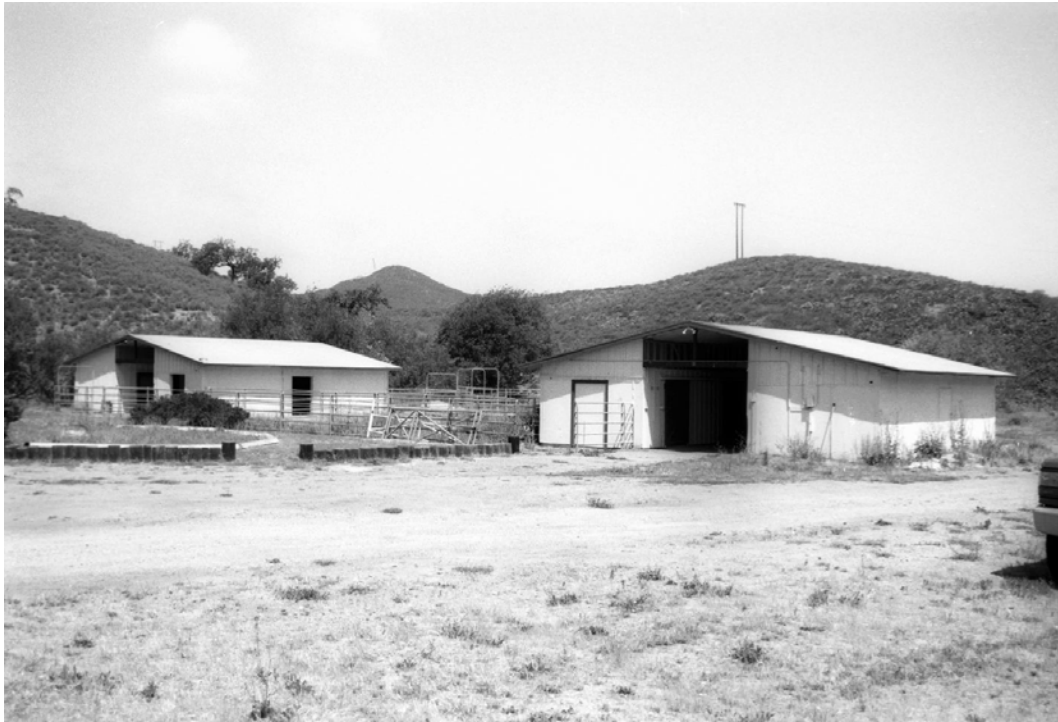
Within the corral are two horse stables designed to accommodate one to six horses. These buildings are square in plan with a low pitched gable roof covered with composition shingles (see photo, Buildings and Structures #6). There are individual stable openings on the east and west sides with a central north-south access. The buildings are covered with board-and-batten siding and rest on a concrete foundation. The stables were moved to the ranch by Danielson from the Janss Ranch between 1972 and 1978.

*Buildings and Structures #6: A view both noncontributing parallel horse stables (NPS#409/410). (PGSO, CLI, SAMO-N-0003-11, 2002)*

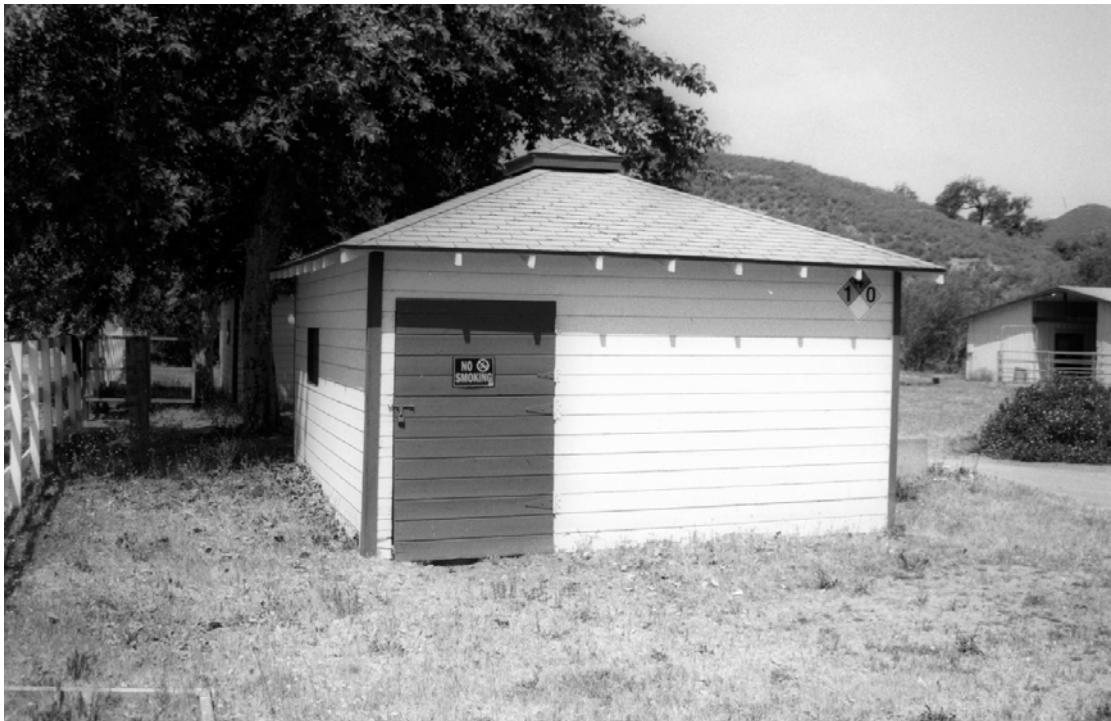
*Buildings and Structures #7: A view one of the noncontributing stallion barns with a parallel stable in the background (NPS# 412). (PGSO, CLI, SAMO-N-0003-09, 2002)*

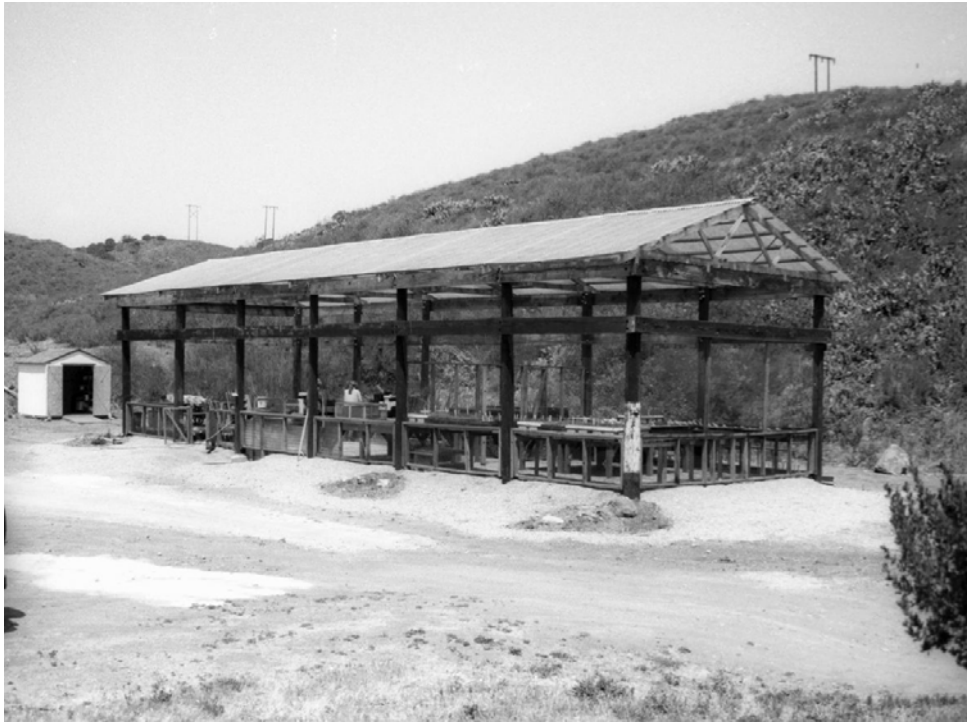
Just west of the planting barn is a small, prefabricated shed used to store nursery equipment and materials. A single door is located on the eastern gabled end of the shed which sits on a concrete foundation (see photo, Buildings and Structures #8).

*Buildings and Structures #8: A view of the noncontributing planting barn (no NPS #), note the shed in the background to the left. (PGSO, CLI, SAMO-N-0003-24, 2002)*

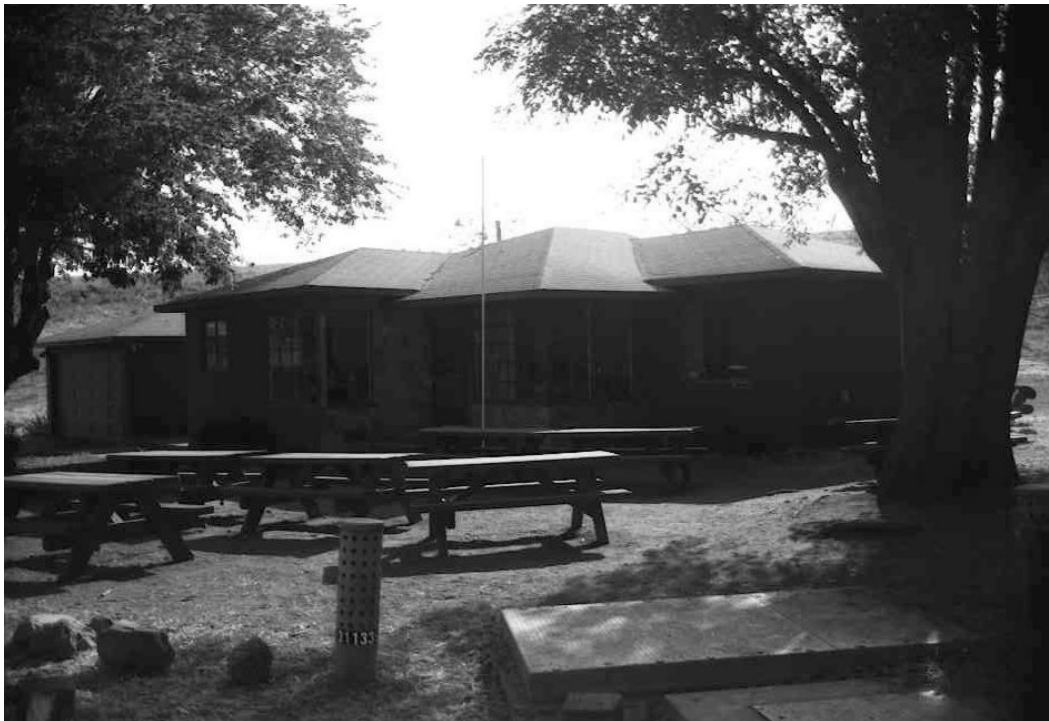
*Buildings and Structures #9: A view of the noncontributing residence (old Danielson/Satwiwa Cultural Center building, NPS #402). (PGSO, CLI, SAMO-N-0006-5, 2002)*

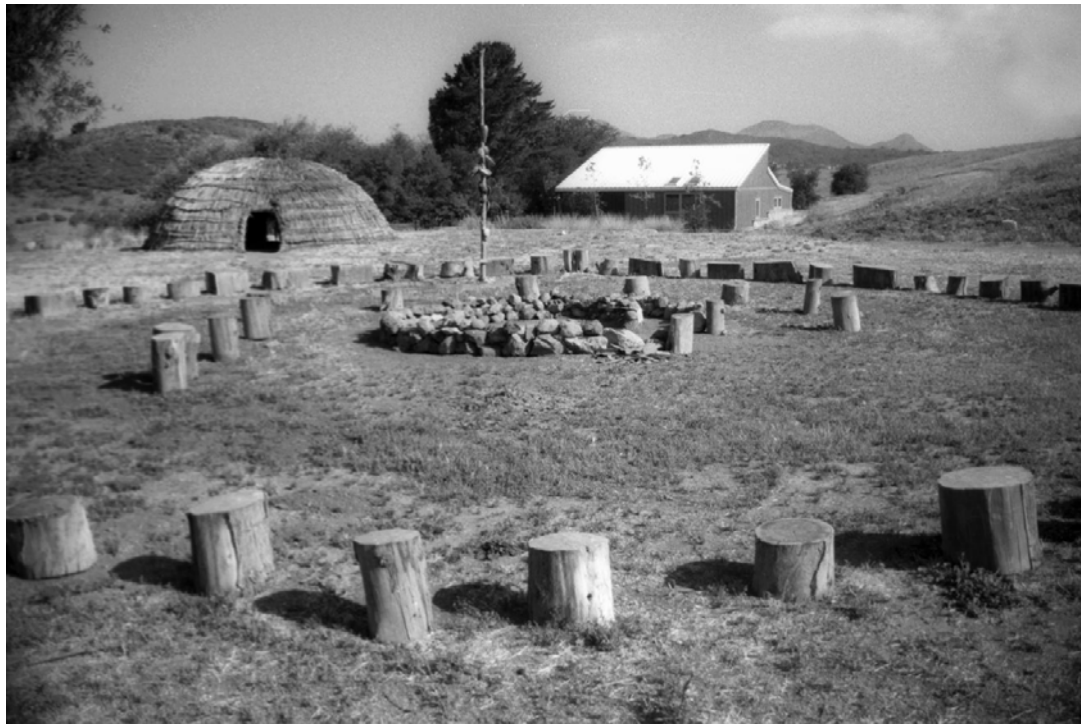
*Cluster Arrangement #1: A view of a portion of the noncontributing Satwiwa cluster. (PGSO, CLI, SAMO-N-0006-17, 2002)*

Of the three clusters found at Horse Ranch, the contemporary NPS visitor cluster and the Satwiwa cluster do not contribute to the significance of the landscape. They are, however, small groupings, located in isolated areas, well hidden by vegetation and the rolling topography, out of sight of the main parts of Rancho Sierra Vista, and therefore offer minimal impact to the integrity of the cluster arrangement of Horse Ranch. The Horse Ranch cluster arrangement retains integrity as a contributing landscape characteristic of Horse Ranch.

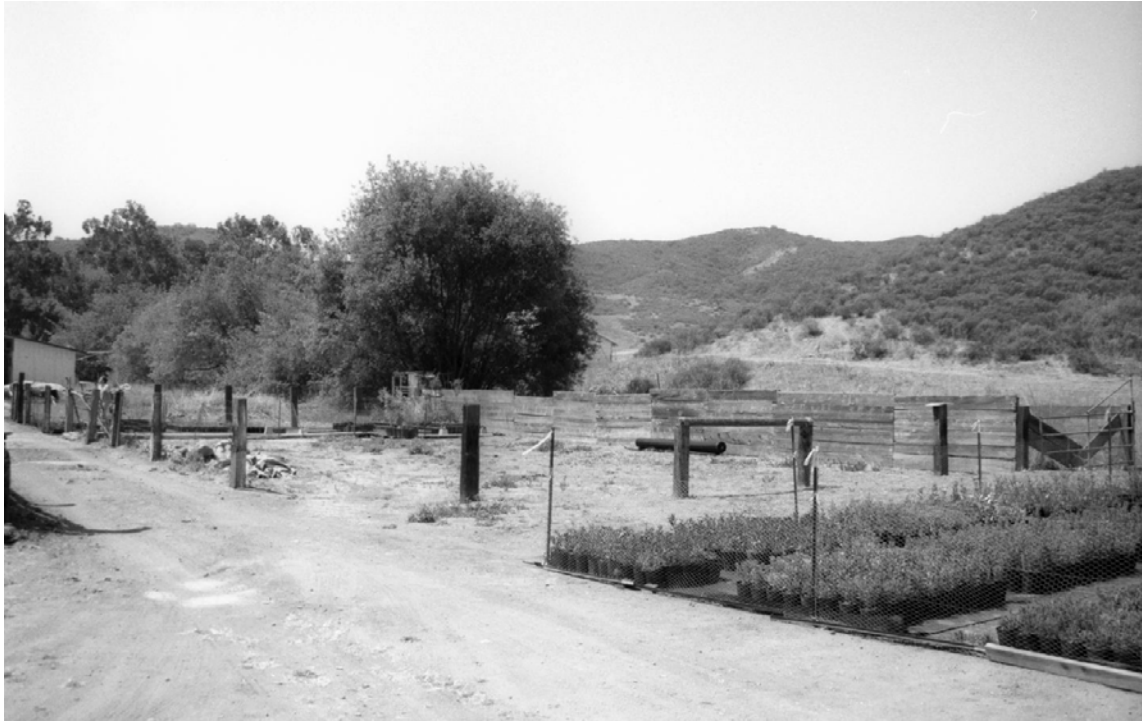
Small scale features at Horse Ranch have been heavily impacted through the removal of Beal period features during both the Danielson and NPS periods. This trend is most visible in the alteration and replacement of nearly all the fences within Horse Ranch. The further addition of numerous utilitarian and utility features by the NPS has caused small scale features at Horse Ranch to lose integrity as a landscape characteristic as a whole. Small scale features no longer retain integrity as a contributing landscape characteristic of Horse Ranch, although certain small-scale features date from the Beal-period and should be treated as historic resources.

*Small Scale Features #1: A view of the contributing remains of the corral and hitching post, just right of center. (PGSO, CLI, SAMO-N-0003-17, 2002)*

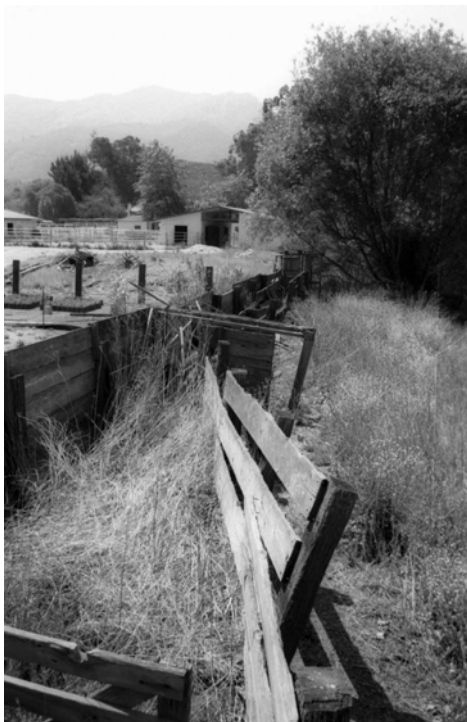
*Small Scale Features #2: A detail view of the contributing chute along the eastern fence of the corral remains. (PGSO, CLI, SAMO-N-0003-19, 2002)*

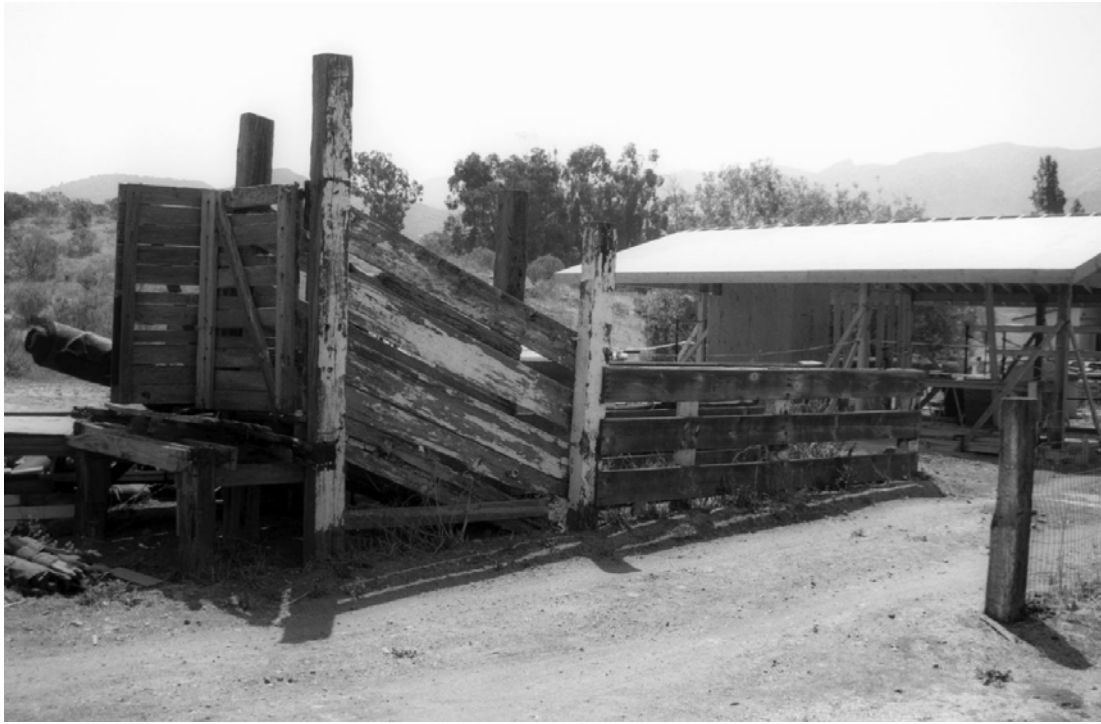
*Small Scale Features #3: A view of the remains of a contributing chute, note the new shed in the background. (PGSO, CLI, SAMO-N-0003-16, 2002)*

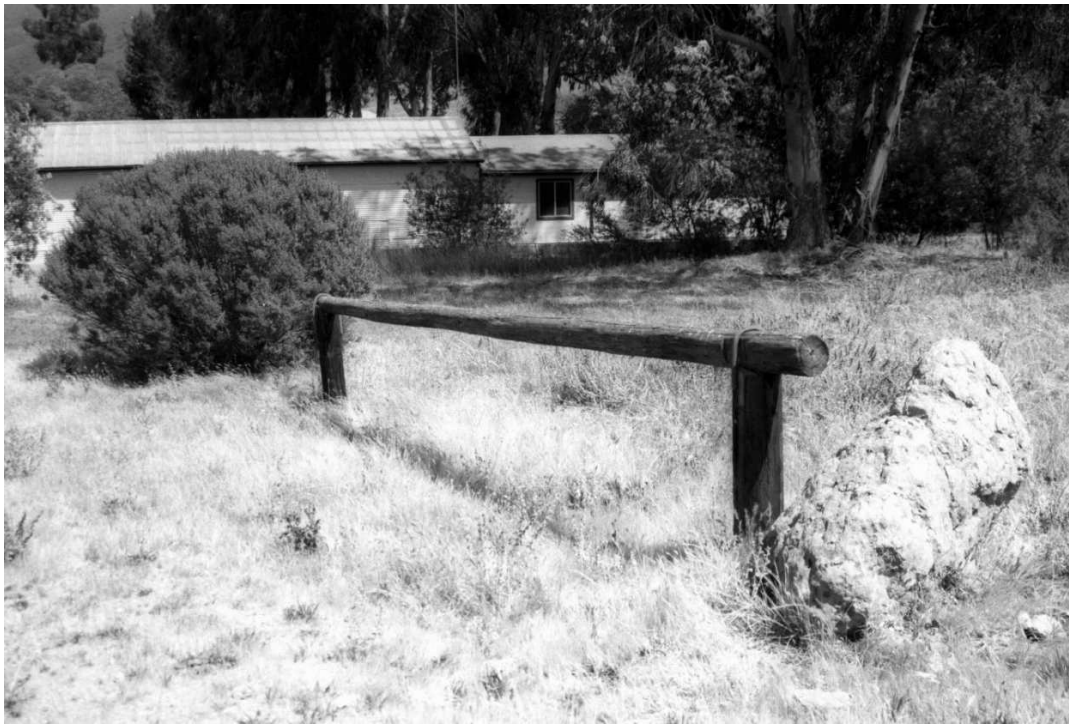
*Small Scale Features #4: A view of the contributing hitching post near the barn. (PGSO, CLI, SAMO-N-0004-9, 2002)*
