National Park Service  
Cultural Landscapes Inventory  
2004

Rancho Sierra Vista Historic District  
Santa Monica Mountains National Recreation Area

**RANCHO SIERRA VISTA HISTORIC DISTRICT (Proposed)**  
**SANTA MONICA MOUNTAINS NATIONAL RECREATION AREA**

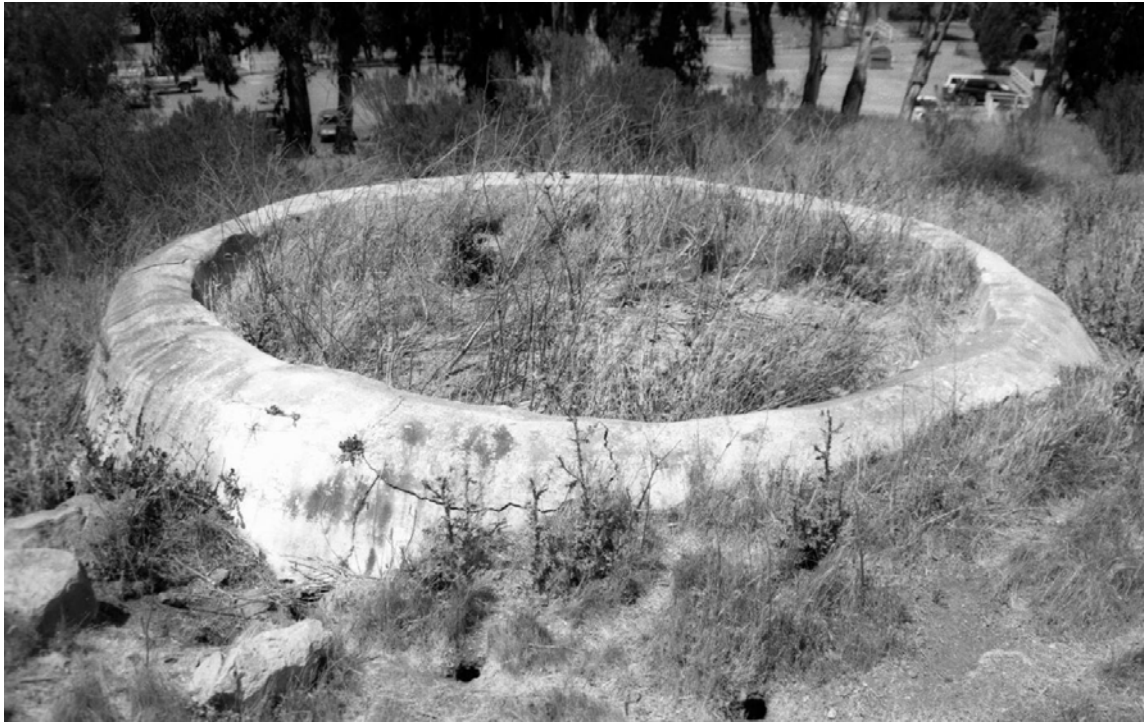
*Small Scale Features #5: A view of the contributing concrete cistern. (PGSO, CLI, SAMO-N-0004-6, 2002)*

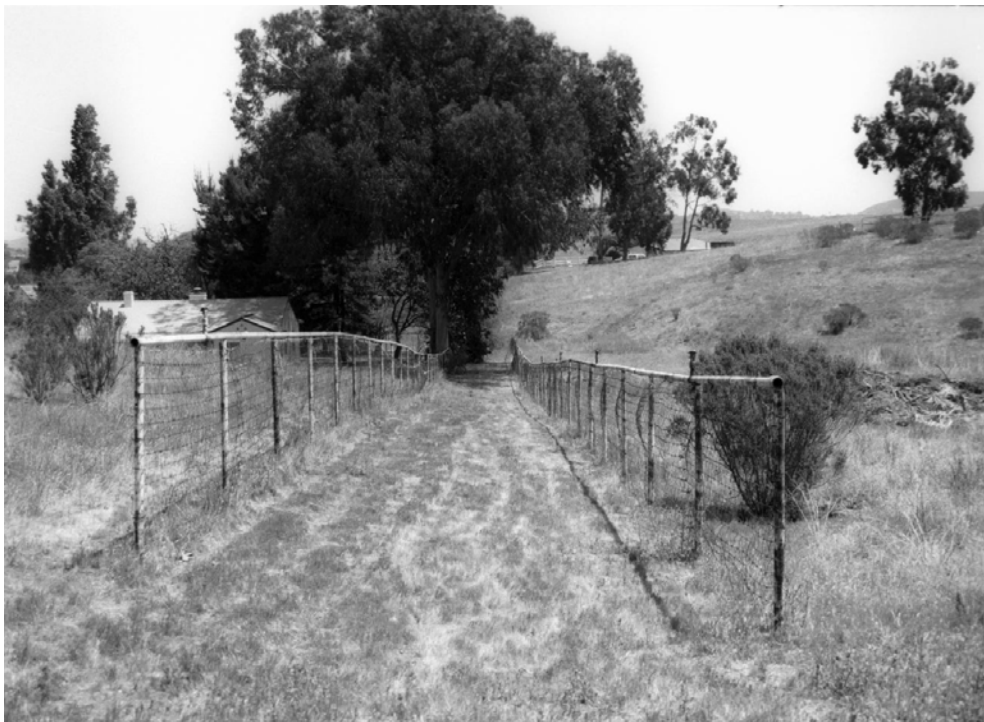
*Small Scale Features #6: A view of the contributing parallel fences from which the end has been cut. (PGSO, CLI, SAMO-N-0003-36, 2002)*

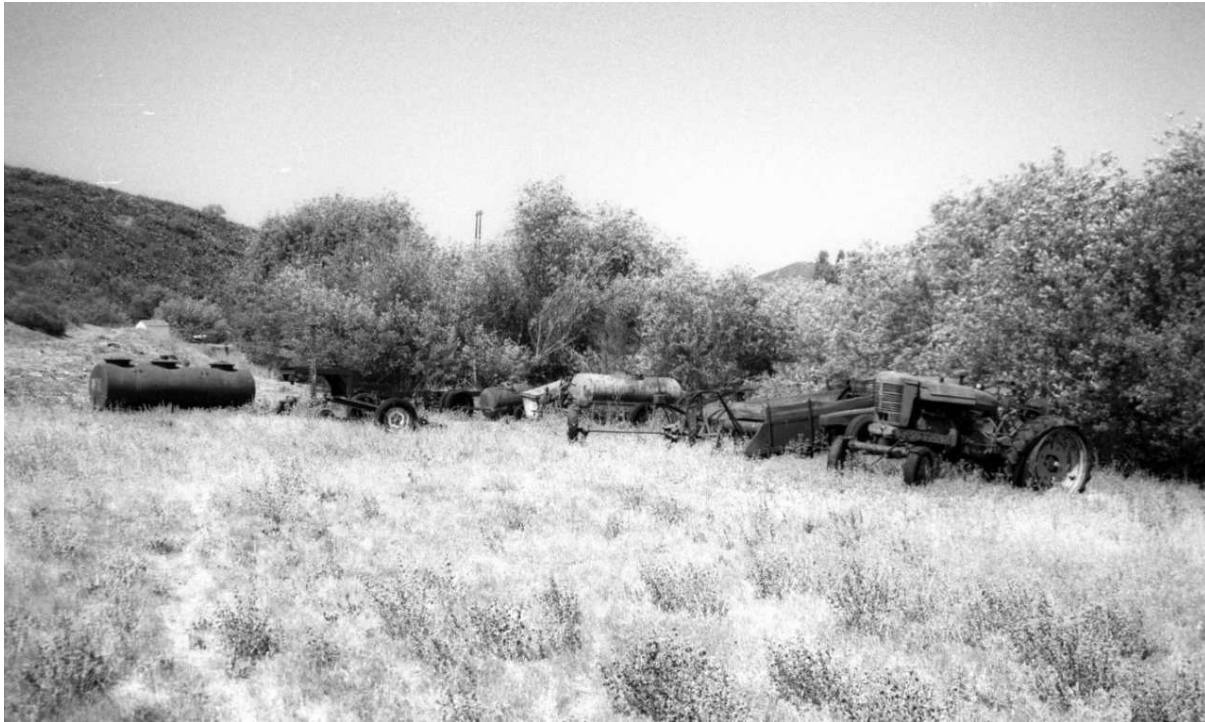
*Small Scale Features #7: A view of some of the noncontributing machinery found around the ranch. (PGSO, CLI, SAMO-N-0004-11, 2002)*

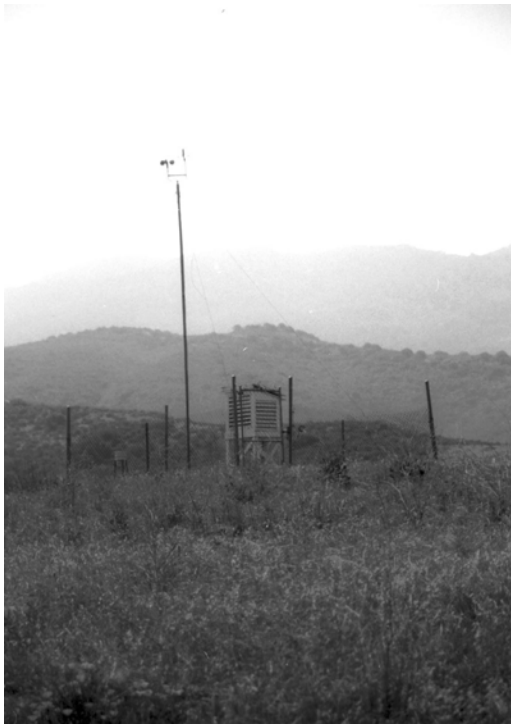
*Small Scale Features #8: A view of the noncontributing weather station near the ranger residence. (PGSO, CLI, SAMO-N-0006-33, 2002)*
