RE: Section 110 Consultation for the Gran Quivira Mission 66 Resources Determination of Eligibility at the Gran Quivira Unit at Salinas Pueblo Missions National Monument (NMCRIS Activity 158979/PEPC 130630)

**National Register of Historic Places  
Eligibility Recommendation  
For Mission 66 Resources**  
NMCRI Activity #158979  
Salinas Pueblo National Monument  
Gran Quivira Unit  
Torrance and Socorro Counties, New Mexico

# Gran Quivira Mission 66 Determination of Eligibility

Salinas Pueblo Missions National Monument  
Gran Quivira Unit, Mountainair, New Mexico

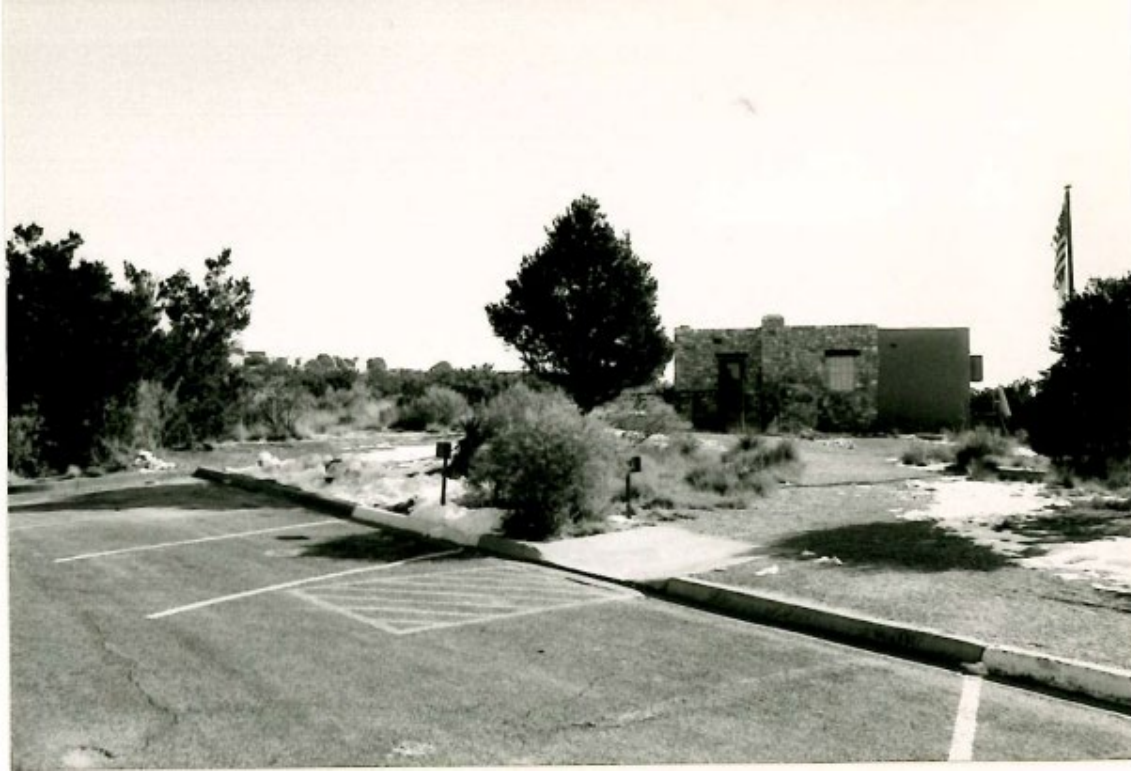
*Figure 5 Original Visitor Center. Source: SAPU Photocard, 1991.*

The Custodian's Residence, later repurposed as the park's first visitor center, was constructed in 1932 as part of early National Park Service development efforts. Designed by the NPS Landscape Division in 1929, the single-story Pueblo Revival style building reflected regional architectural traditions. Characterized by simple massing, a flat roof, and wooden vigas extending through the walls, the building featured a masonry and stucco exterior with simple windows. Construction took place between July and September 1932, providing essential residential and administrative facility for park staff. The building was demolished in 1997.

By the mid-20th century, the residence was repurposed as a visitor contact station. This transition aligned with broader NPS trends of adapting existing structures to meet the growing needs of park interpretation and public engagement. However, despite these efforts to modernize the facility, the structure's modifications were ultimately deemed insufficient for long-term visitor services, leading to its removal in 1997.

The Custodian Residence was altered in 1975, 1977, 1978 and eventually demolished in 1997.

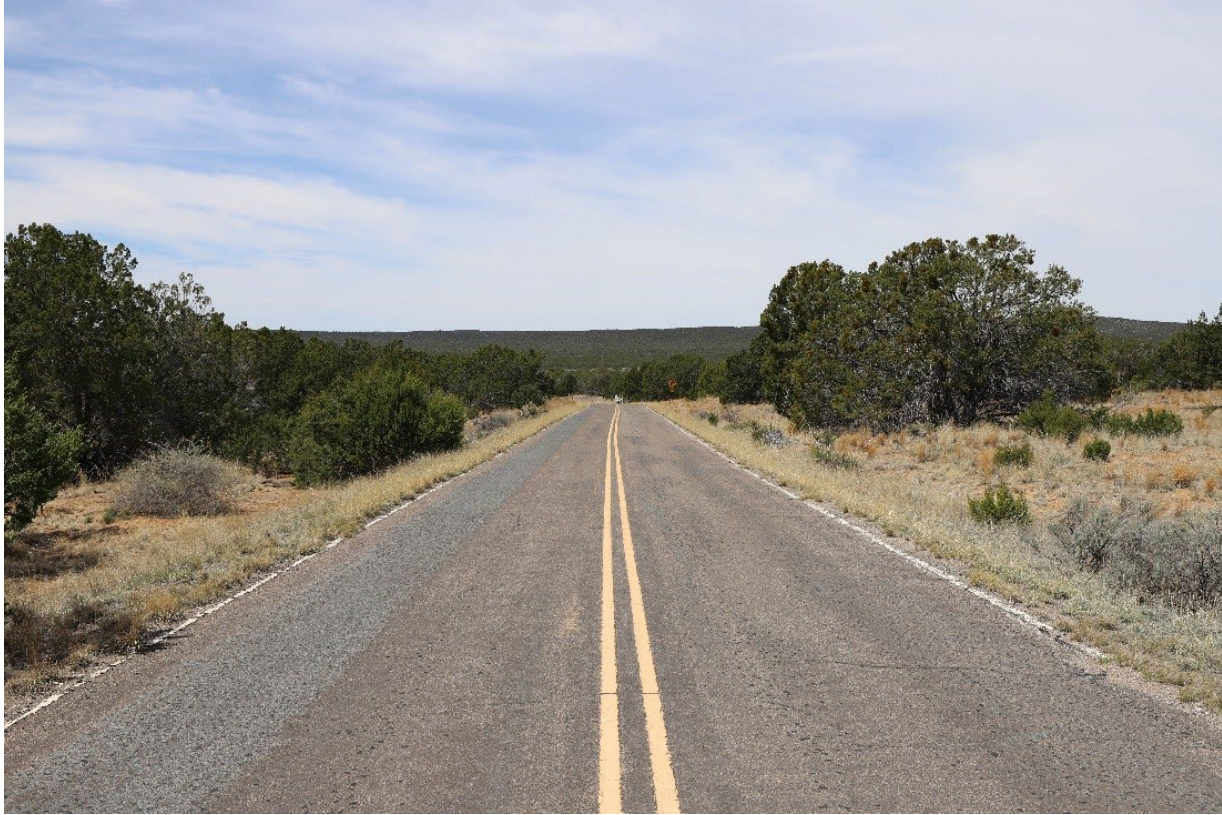
*Figure 6 Entrance Road Framed by Native Vegetation / Looking West, April 2024*

The Mission 66 entrance road, shown in contemporary maps as Salinas Pueblo Road, provides primary access to the Grand Quivira Unit, linking WSMR (White Sands Missile Range) Route 41 to the visitor center and associated facilities. The asphalt-paved road is approximately 20 feet wide, with a double solid yellow center line, and extends 0.75 miles east from WSMR Route 41 to the Visitor Parking Lot. There is a 1-foot paved shoulder throughout the entrance road. A spur road branches off 0.18 miles east of WSMR Route 41, providing access to the Mission 66 Residential and Utility areas, which are discussed in their respective sections. The road follows the natural contours of the landscape, winding through dense vegetation and varied topography before terminating at the Visitor Parking Lot. The design incorporates existing native vegetation to enhance the visitor experience while minimizing visual intrusions.

The entrance road is a defining feature of the Mission 66-era redevelopment at the Grand Quivira Unit, embodying the National Park Service's modern approach to visitor experience. Before these improvements, the park's circulation system consisted of a 0.7-mile gravel road that approached the monument from the north, passing the principal ruins before terminating in an unstructured parking area. This configuration was considered inadequate, as it diminished both the interpretive experience and the visual integrity of the site.

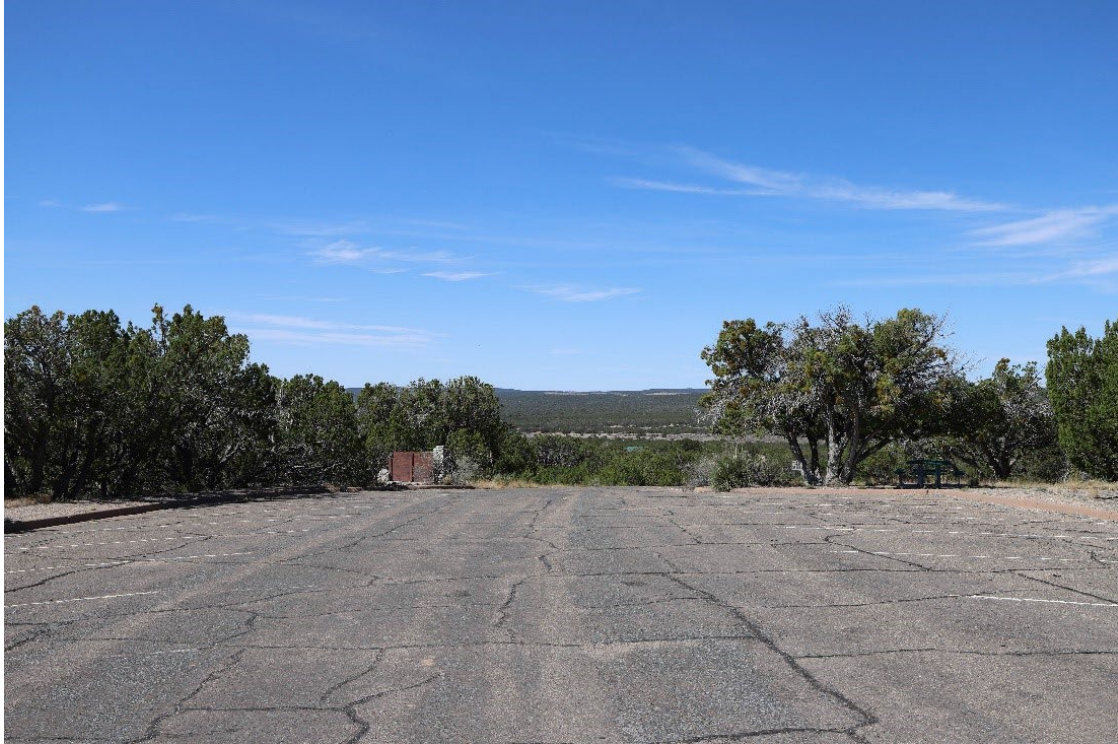
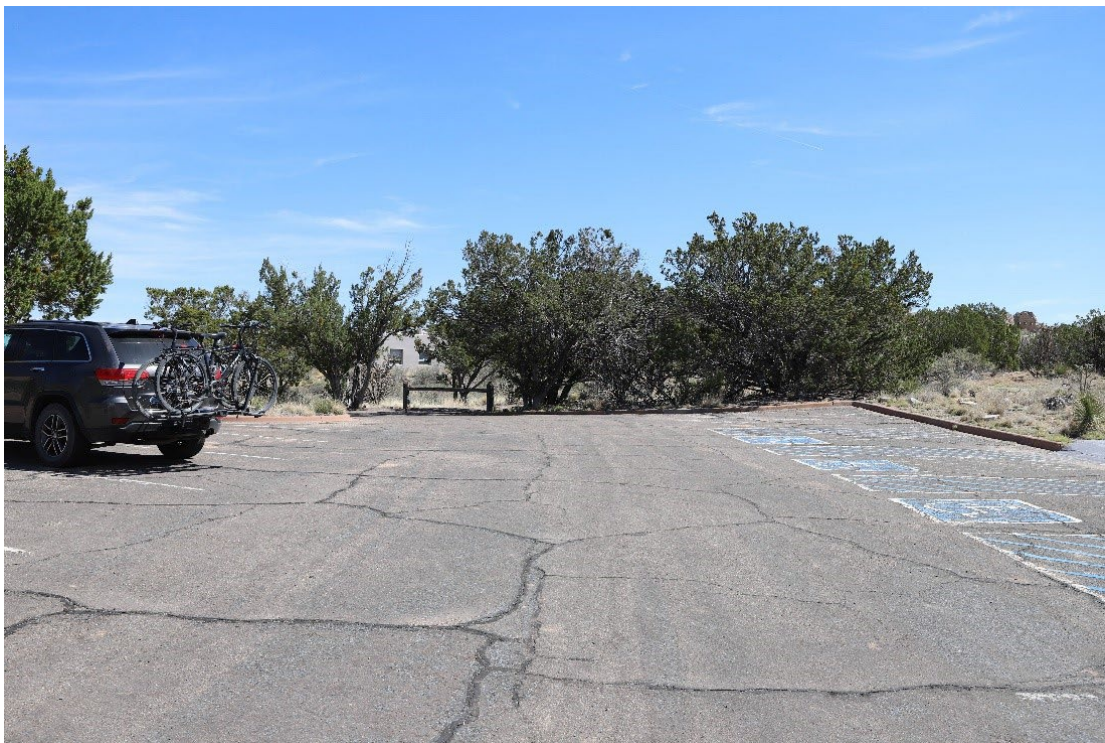
The Mission 66 Entrance Road terminates at the Visitor Parking Lot, a one-way loop that proceeds up and east, and then west to meet the Entrance Road again. The Visitor Parking Lot acts as a turn-around for the Mission 66 Entry Road and offers approximately 30 angled parking spaces, four barrier-free spaces, and five over-sized parallel parking spaces. The parking lot was constructed in 1960. The Visitor Parking Lot is intentionally located west of the Gran Quivira National Monument Pueblo Sites and Mission. From the large, paved asphalt parking lot, a trail screened with vegetation takes visitors towards the 1997 Visitor Center and monument's prehistoric and historic resources.

*Figure 7 Parking Lot Facing Entrance Road / Looking West, April 2024*

*Figure 8 Parking Lot Facing Visitor Center / Looking East, April 2024*

During Mission 66 era, many pre-WWII parking lots were expanded to accommodate increasing visitation and larger vehicles while providing greater parkwide circulation (Carr et al. 2015:93). The Visitor Parking Lot location was planned during Mission 66 for a more enjoyable and organized entrance to the archaeological sites. The parking lot provides a view and access to the visitor center, visitor facilities, and interpretive elements such as signage and trails. The parking lot is an example of Mission 66 landscape architect's work to accommodate the increased visitation without degradation to the resources or the quality of the visitor experience. The parking lot retains a high level of integrity. The parking lot would be a contributing resource to a historic district but is not individually eligible.

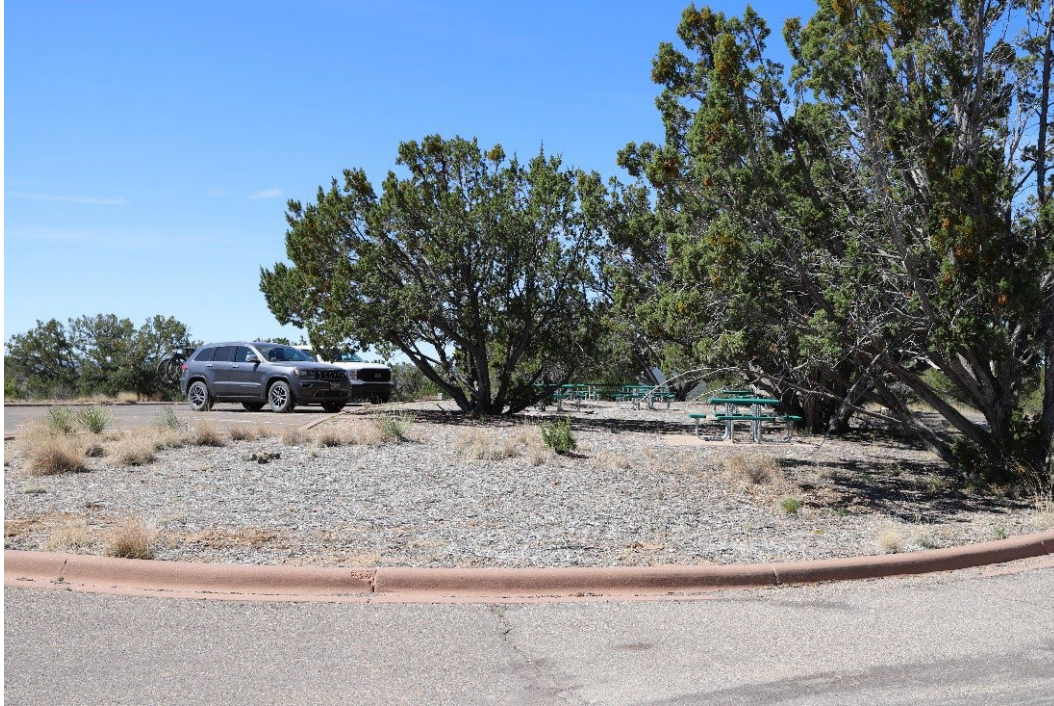
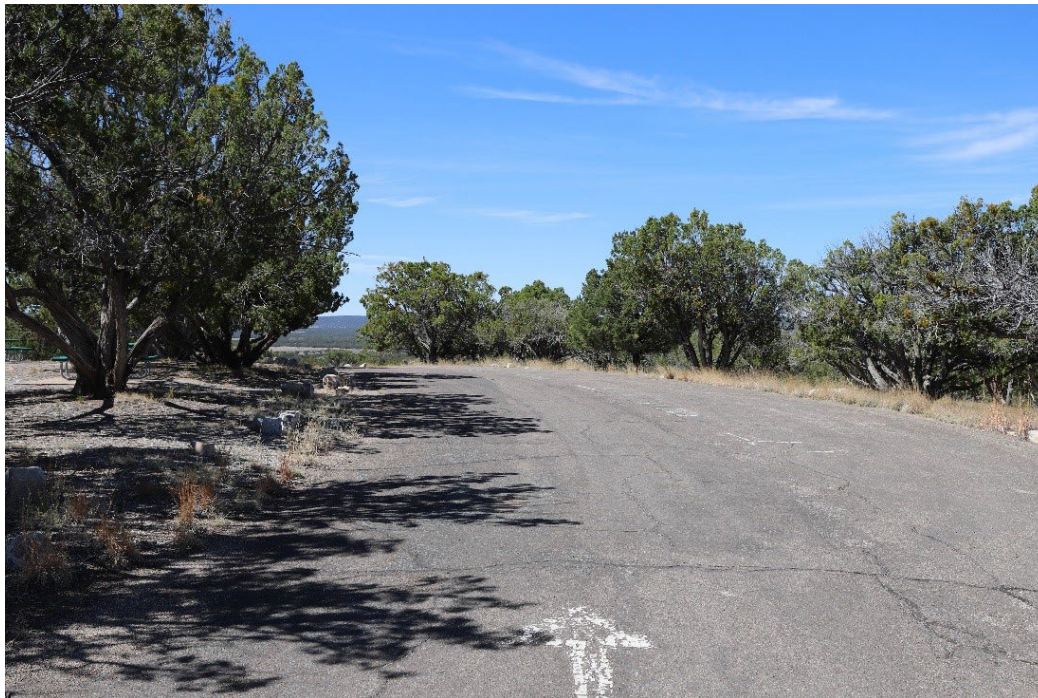
*Figure 9 Visitor Picnic Area on Island in Parking Lot Loop Looking Northwest, April 2024*

*Figure 10 Visitor Picnic Area and Parking Lot, Looking West, April 2024*

In the middle of the Visitor Parking Lot is the Visitor Picnic Area. The Visitor Picnic Area is an island within the parking lot with established Juniper trees as screening and twelve contemporary green aluminum picnic tables and firepits.

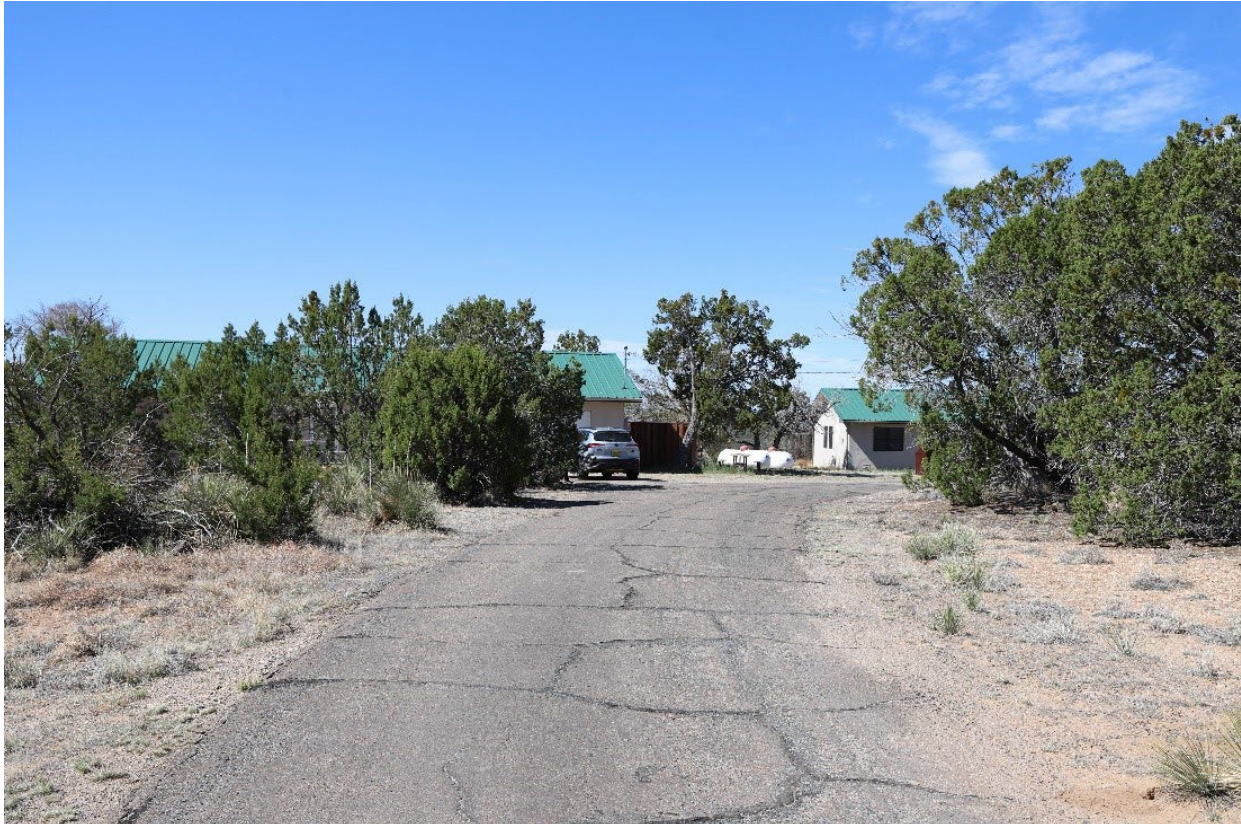
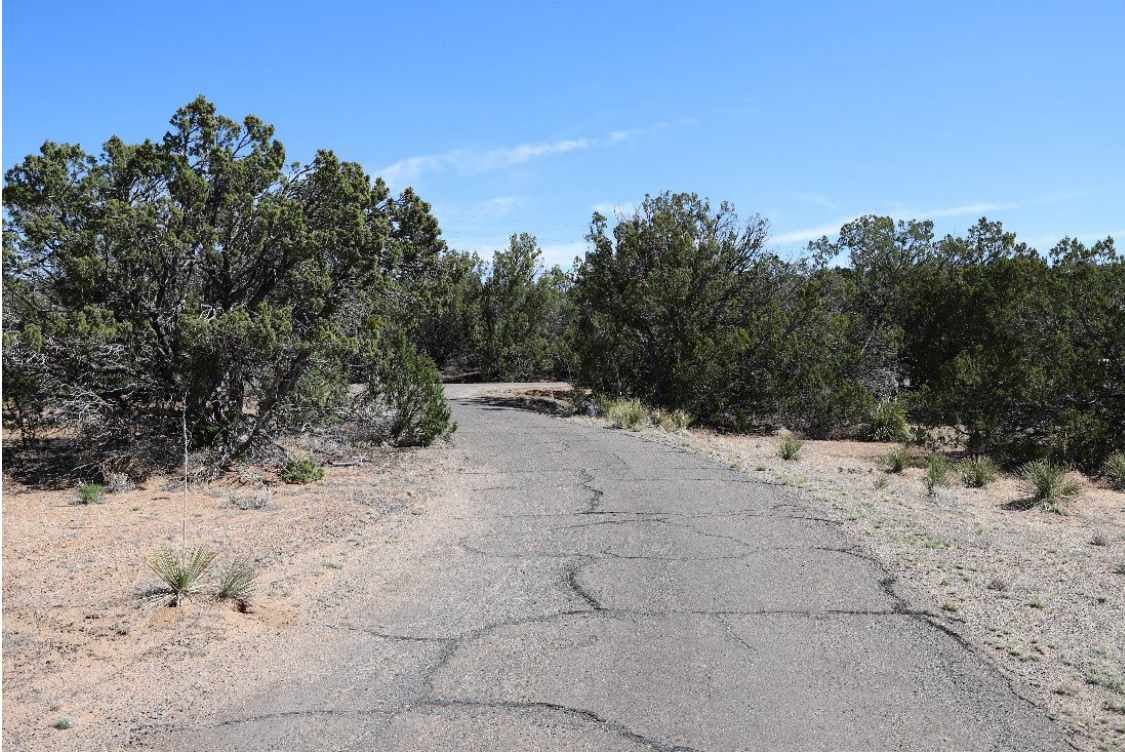
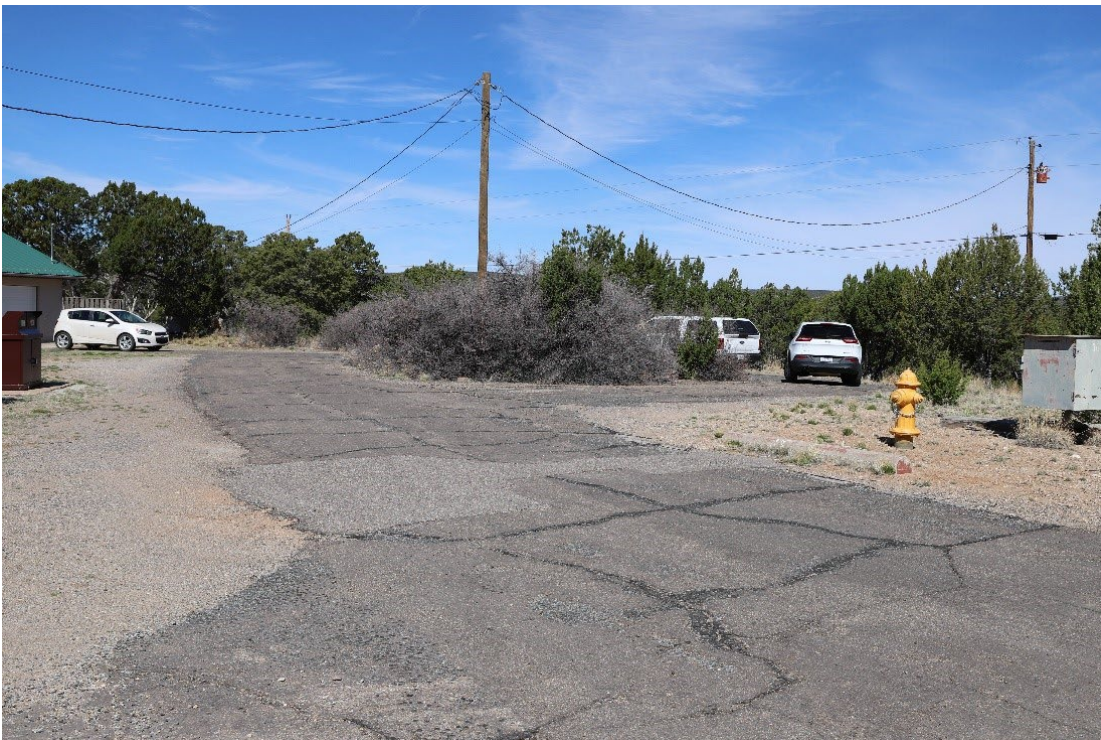
The Residential Road is 0.11 miles of asphalt paved spur loop road. It extends south-southwest from the Park's main entrance road and is screened with native vegetation ensuring privacy for the residences.

*Figure 11 Residential Road / Looking West, April 2024*

*Figure 12 Residential Road / Looking East, April 2024*

*Figure 13 Residential Loop / Facing East, April 2024*

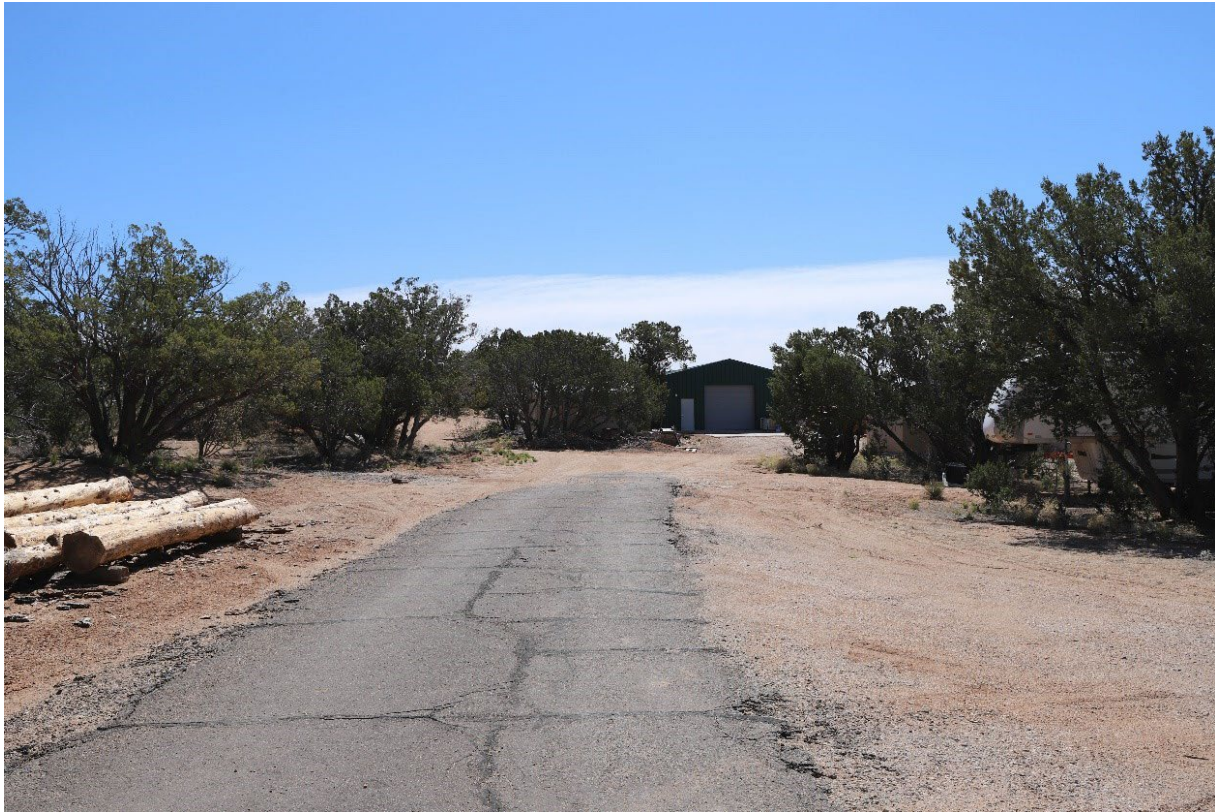
*Figure 14 Maintenance Road toward Utility Building / Looking North-East, April 2024*

The Maintenance Road is 0.10 miles of both surfaced and graded road. The Maintenance Road begins paved and turns into graded gravel as you continue down the path towards and around the Maintenance Building.

The Maintenance Building is on a concrete block foundation in the gravel utility lot. The building is a prefabricated front gabled aluminum shed with a 50 foot by 30-foot footprint, installed in 2007. The building has a large garage door entrance in the front with a contemporary wooden door beside it.

Notably, planners and landscape architects intended to replace the New Deal-era visitor center with a new facility, but this was not constructed during the period of significance. Instead, a new visitor center was built in 1997 at a different location, making it ineligible as a Mission 66 resource due to its contemporary construction. Additionally, the Mission 66 Headquarters Master Plan included a duplex and an apartment complex east of the existing residences, but these structures were never realized. Further compromising the area's historic integrity, the Mission 66-era utility building was demolished and replaced in 2007.

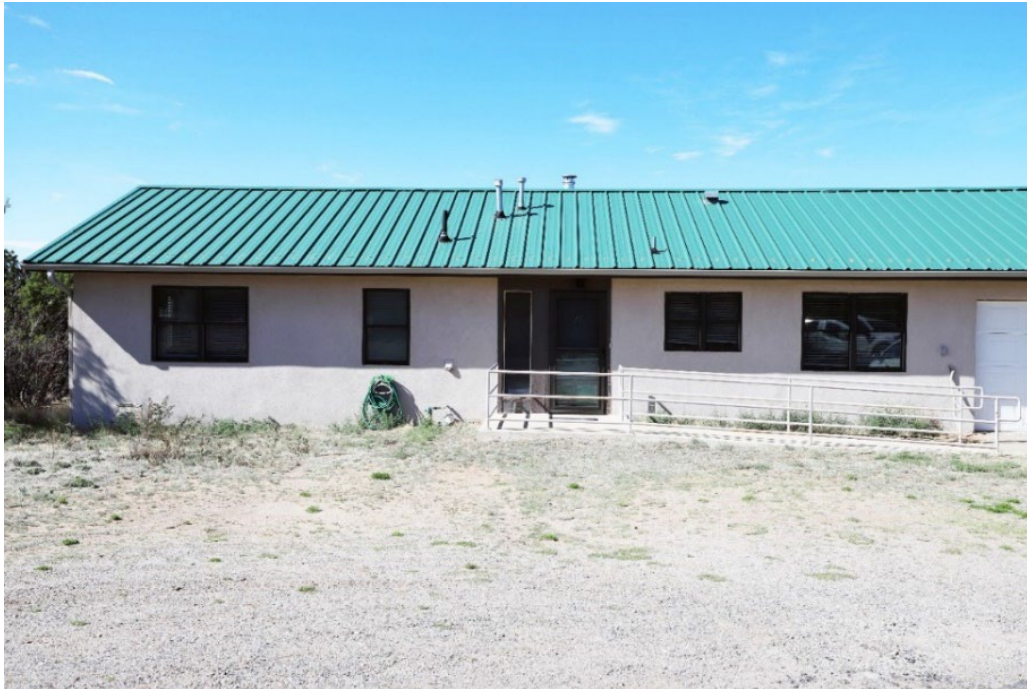
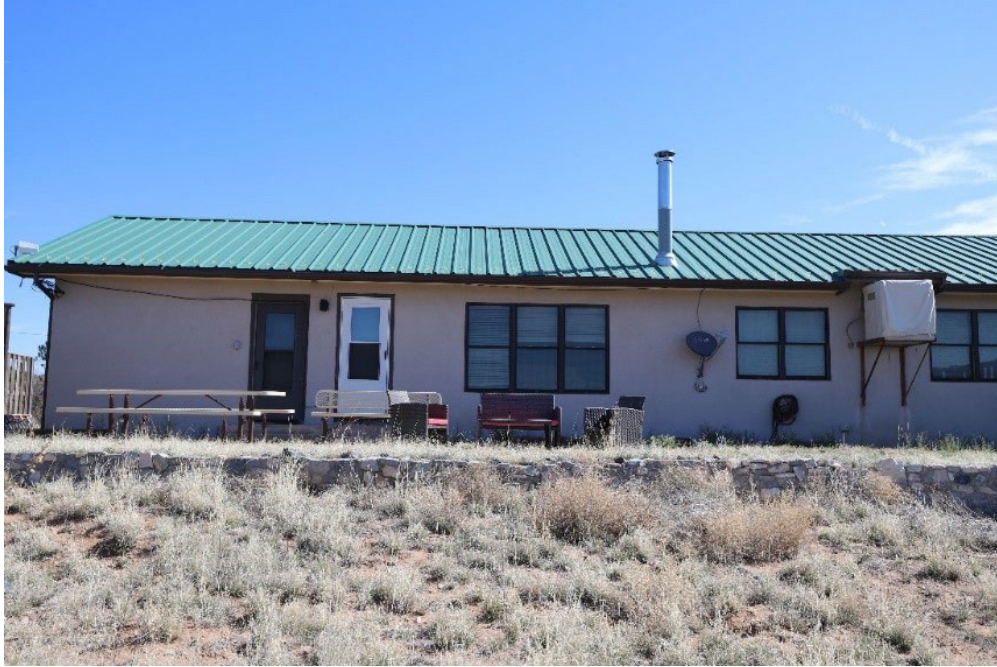
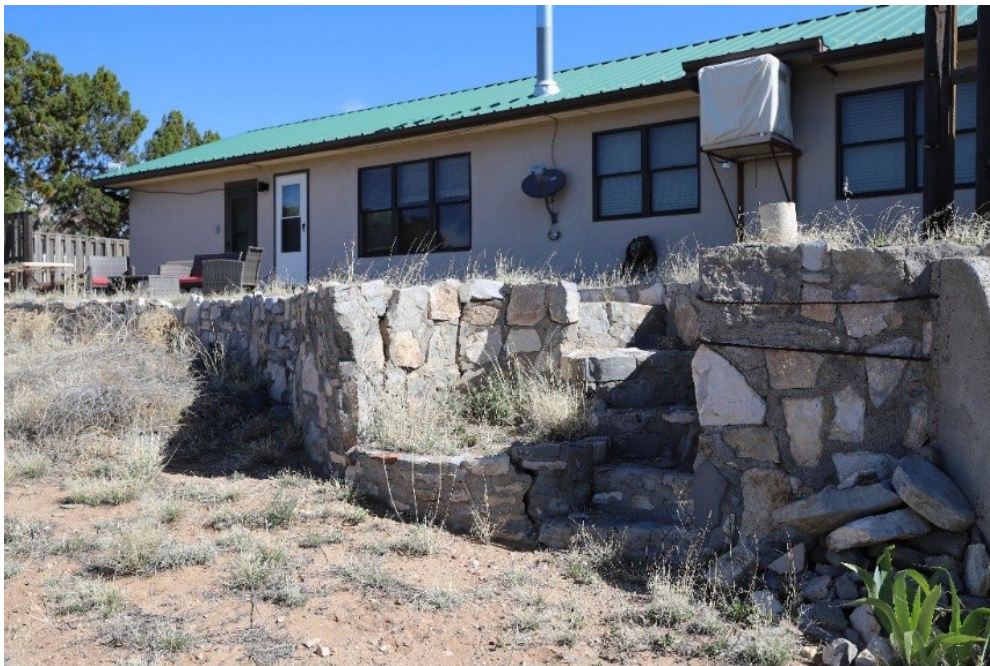
The building adheres to the classic ranch form, set back from the road, characterized by its one-story profile and attached carport. The building faces northwest and spans four bays. The side gabled roof has a medium pitch clad in green metal. The fenestration features single hung aluminum windows with a steel exterior trim. The centered front entry draws attention to the main access point, complimented by a full-view sidelight on the west end of the entrance door. The entrance door and sidelight are encased in dark brown wooden trim. A planting bed runs along half of the front façade, defining the entrance by terminating at the door. An ADA accessible walkway runs from the front driveway to the entrance door.

The rear elevation faces southeast. It has an irregular arrangement of three large asymmetrical vinyl windows with steel exterior trim. There are two rear doors on the east end of the house, one entering the garage, and the other into the living room. Continuing the design language from the front facade, long planters frame the doorway. The back doors are demarcated with a concrete stoop that steps down into the backyard. A low masonry retaining wall further defines the property edge.

*Figure 15 Residence 13 Front Facade / Facing Southwest, April 2024*

*Figure 16 Residence 13 Rear Elevation and Retaining Wall/ Facing North, April 2024*

*Figure 17 Residence 13 Stone Retaining Wall / Facing Northwest, April 2024*

Residence 13 retains some original features such as the door and sidelight. However, the roofline has been altered from its original low pitch to a medium pitch, altering the buildings low-profile horizontal effect. According to the 2015 NPS Mission 66 MPD, a “new roof structure that is nonreversible and completely alters the exterior appearance of the building, such as a pitched, raised-seam metal roof replacing the original flat roof,” is an example of “alterations or remodeling that may impair the historical integrity of a house or housing.” During the roof alteration the cultural resource manager at the time made sure to maintain the original roofline underneath the added green metal sheath and medium pitch roofline. Therefore, this alteration may be reversible. However, in its current state with the altered exterior appearance, the building is not individually eligible, nor is it contributing to a historic district.

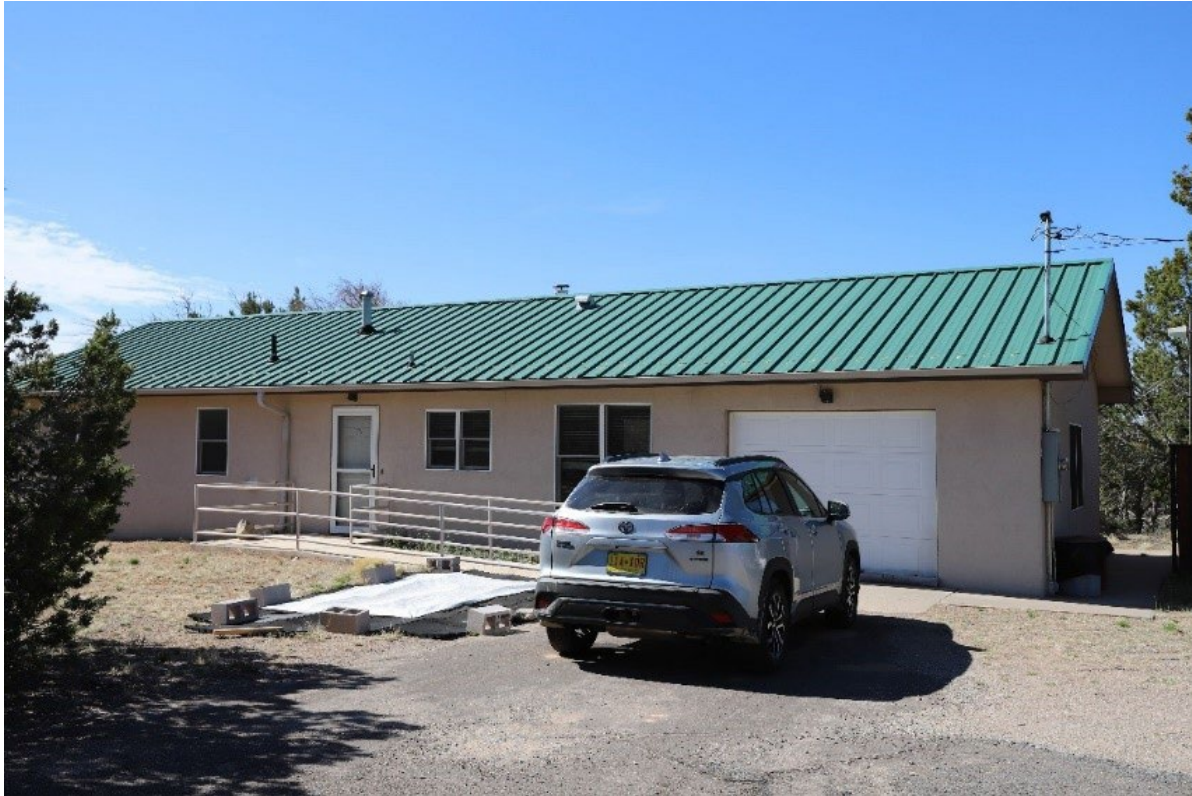
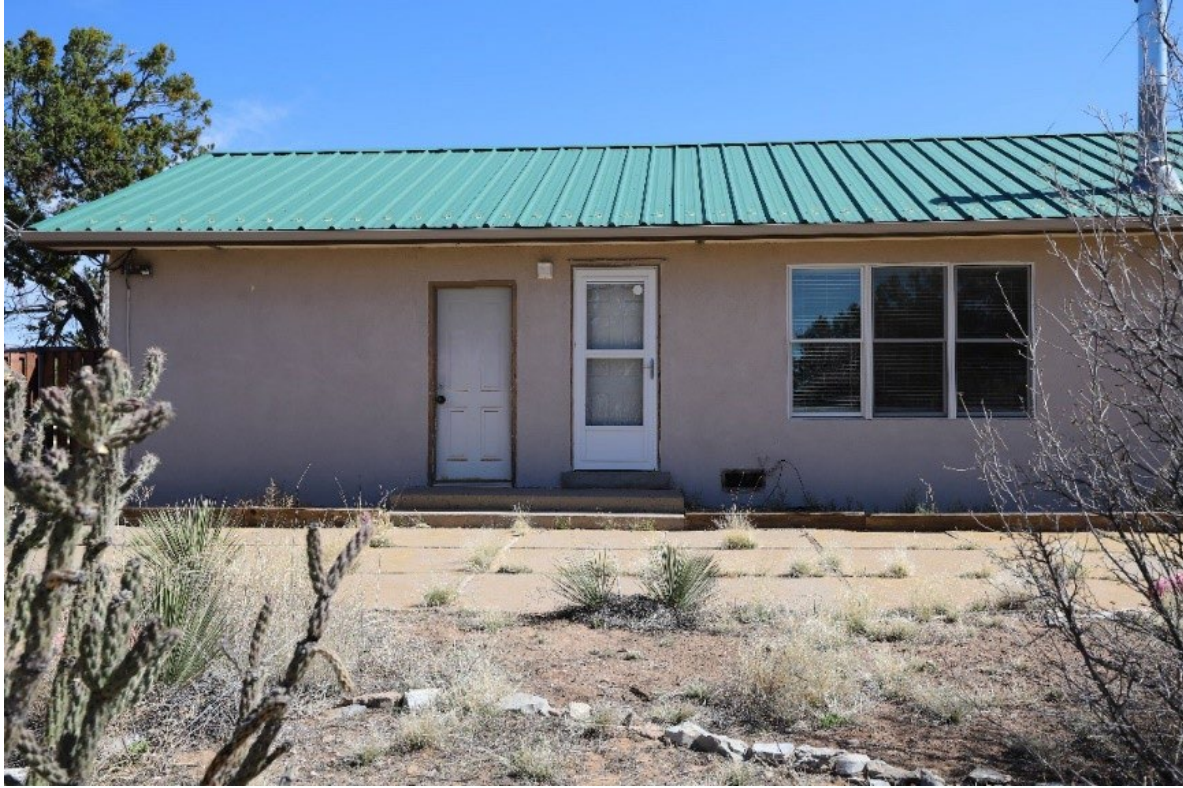
The front facade of the building features a four-bay width with asymmetrical window openings, typical of ranch-style homes from the era. The centered front entryway is defined by a narrow planter running along half of the facade, terminating at the entrance door. It features a contemporary wooden door and screen. The house is set back from the street, with a lawn and asphalt driveway in front. An ADA-accessible walkway connects the driveway to the front entrance. This building adheres to the traditional ranch form, characterized by its one-story profile and a carport attached to the main facade on the western end. The roofline is medium-pitch side-gabled roof covered in green metal.

The western facing elevation is characterized by boxed overhanging eaves and a large vinyl window in the center of the facade. There is a clothing drying yard on the side of the residence, original to the Mission 66 design. The rectangular drying yard encompasses a drying rack on concrete pavement with wooden fencing surrounding the area. A concrete walkway runs from the front entrance to the driveway and surrounds the side providing circulation around the building to the back outdoor terrace.

The rear elevation faces southeast. It has an irregular arrangement of three large asymmetrical vinyl windows with steel exterior trim. There are two rear doors on the east end of the house, one entering the garage, and the other into the living room. Long planters and a concrete stoop emphasize the back doorway. The backdoor opens into an outdoor terrace comprised of large square concrete tiling.

*Figure 18 Residence 12 Front Facade / Oblique View, April 2024*

*Figure 19 Residence 12 Side Elevation + Drying Yard / Oblique View, April 2024*

*Figure 20 Residence 12 Rear Elevation, April 2024*

All the original fenestration in Residence 12 has been replaced. Most recently in 2016, five steel casement windows (non-original) were swapped out for energy-efficient vinyl windows. Both the interior and exterior wood case trim on the windows were updated to stucco and steel trim. The original door and sidelight have been replaced with a contemporary wooden door and screen. The roofline, originally low-pitched, has been modified to a medium-pitch side-gabled roof covered in green metal. The original roof framing is concealed under the existing roof. On the rear elevation, all original doors appear to have been replaced, their original location remaining intact. The original wooden trim surrounding the doorway has been removed and replaced with stucco.

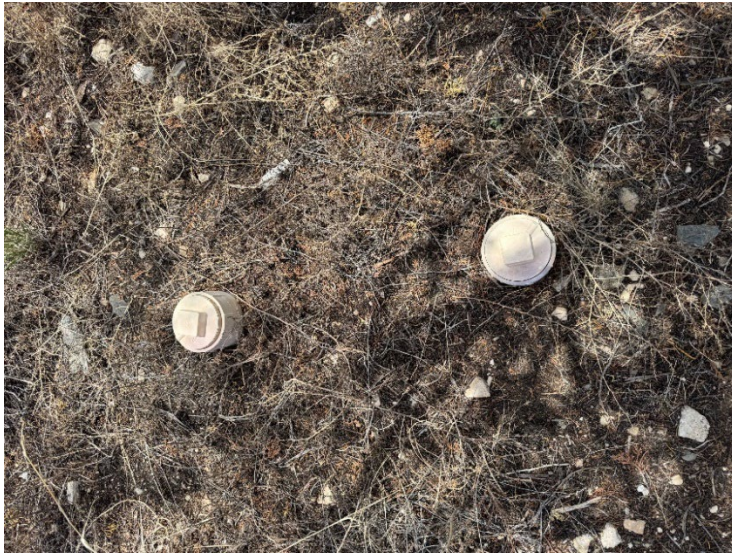
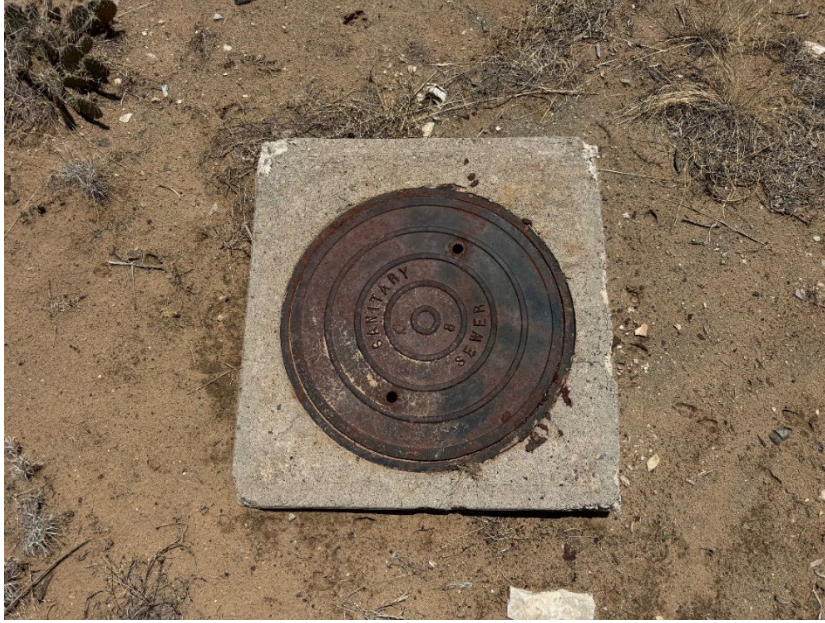
*Figure 21 GQ Residence Wastewater System*

*Figure 22 GQ Water System Potable*

The GQ water utilities system, implemented during the Mission 66 period of significance is largely underground. Above ground features that represent the systems are shown in Figure 21 and Figure 22. The GQ Wastewater System was implemented in 1955, and the Residential Water System was implemented in 1966.

Utility infrastructure implemented during the Mission 66 time period- underground water, sewer, and electric service lines- are noncontributing. The features wear out before they are 50 years old and need to be replaced to meet updated health and safety standards.

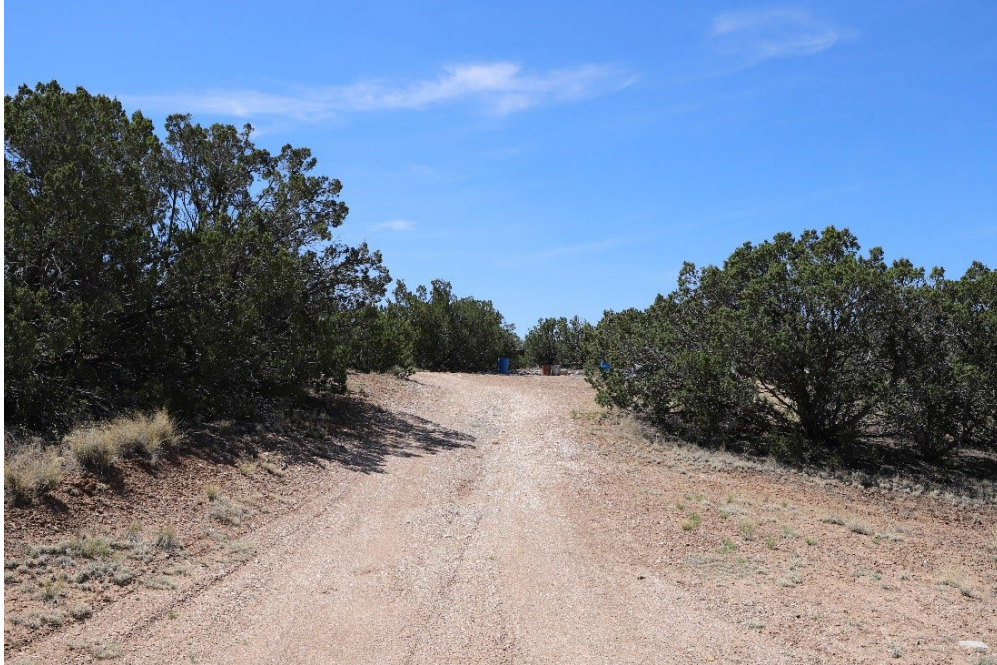
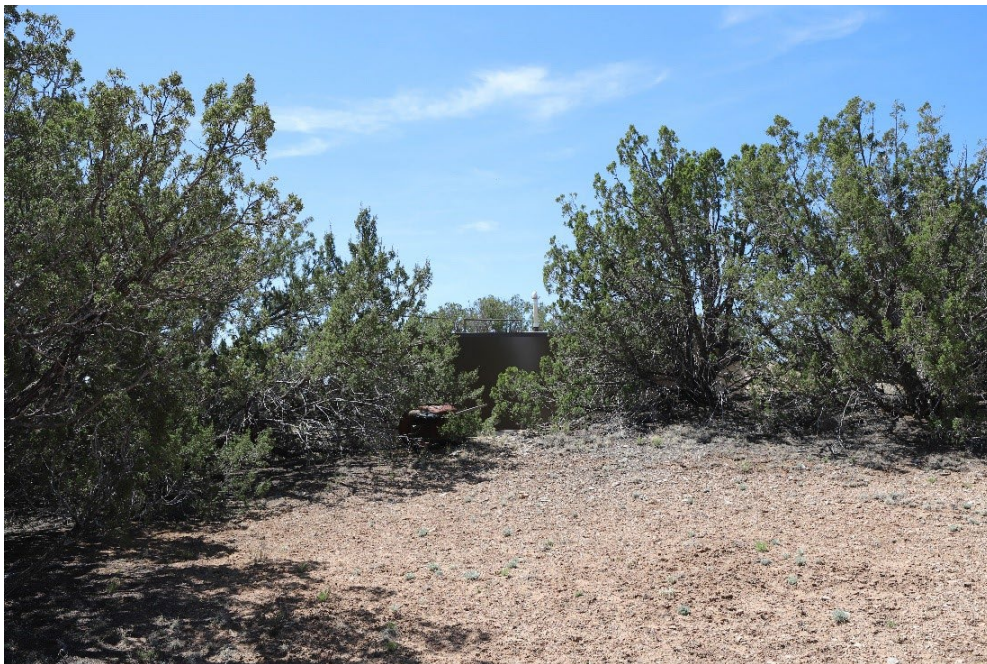
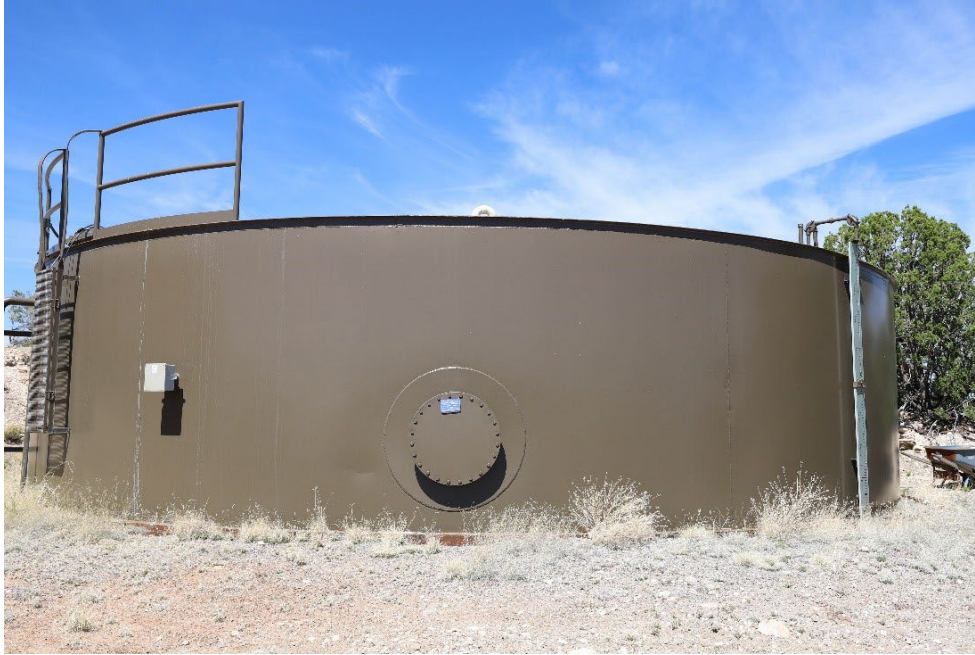
The Mission 66-era dirt road leading to the water storage tank remains intact and continues to serve an essential function within the park. Constructed in 1965, this graded unpaved road, designated as Route #0403, extends east of the pueblo and mission site, providing access to the park's water infrastructure. It is screened by native vegetation.

The GQ Water Tank is a round 55,000-gallon steel potable water tank found on the GQ Water Storage Tank Road. It is painted brown.

*Figure 23 Road to Water Storage Tank / Looking North, April 2024*

*Figure 24 Water Storage Tank / Looking North, April 2024*

*Figure 25 Water Storage Tank / Looking South, April 2024*

The water tank at Gran Quivira was originally placed in this location during the Mission 66 period however due to the nature of utilities, it needs to be updated or changed every twenty to thirty years for public safety, making the water tank noncontributing. Park documents show that the 55,000-gallon steel potable water tank at Gran Quivira was last replaced in 1992 when the tank was 26 years old. Interior surfaces were rusting, and paint was chipping and peeling, making it a public health hazard. A new 55,000-gallon steel/glass lined tank was installed with a new water meter and chlorination system.

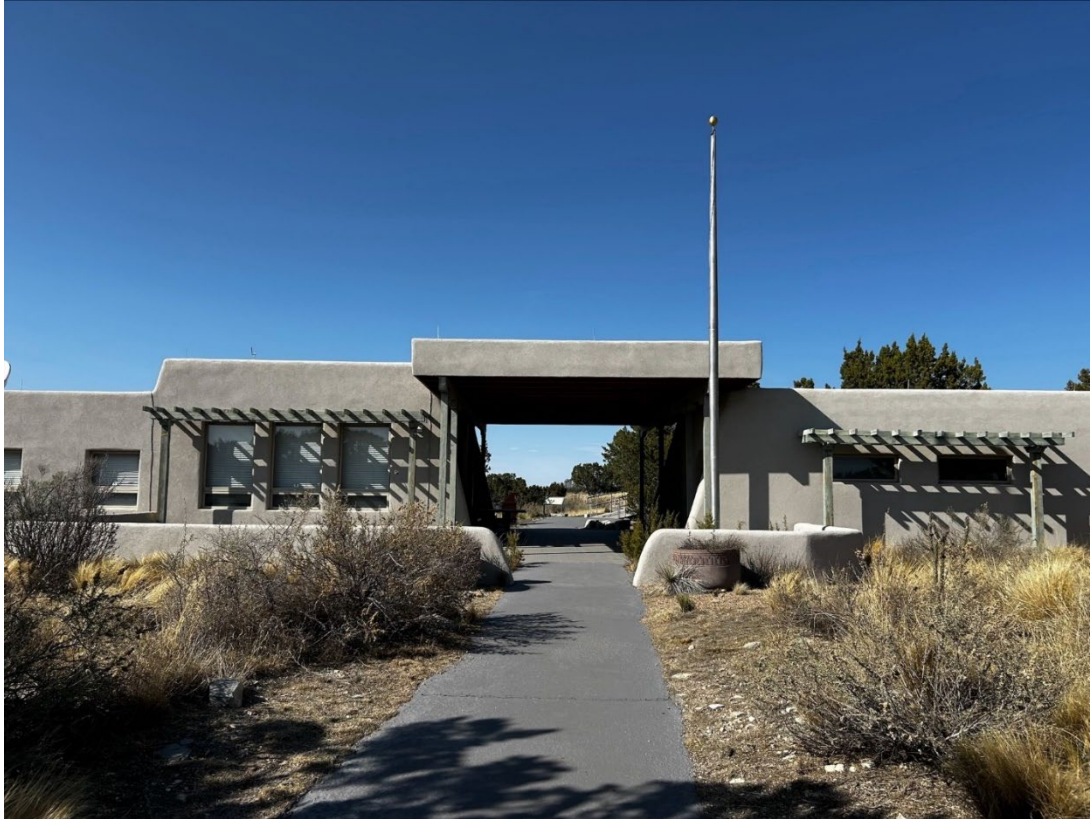
*Figure 26 Gran Quivira National Monument Contemporary Visitor Center. Looking Northeast. NPS 2025.*

Located north of the parking lot, the Visitor Center at Gran Quivira is deliberately sited out of view from the site's prehistoric and historic resources. Constructed in 1997, the single-story Pueblo Revival-style building replaced the former New Deal-era Custodian's Residence, which had been adapted for visitor use. The structure features a flat roof, stucco exterior, and tiered, layered massing characteristic of the style. The Visitor Center is connected to the restroom facilities by an asphalt-paved trail that runs between the two buildings.

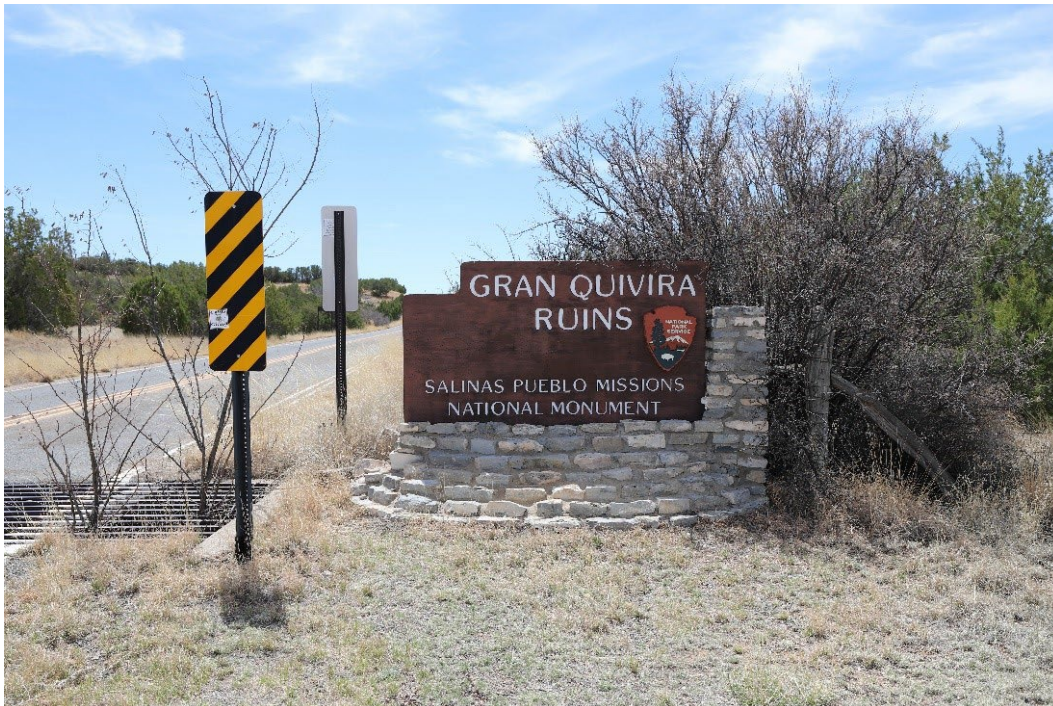
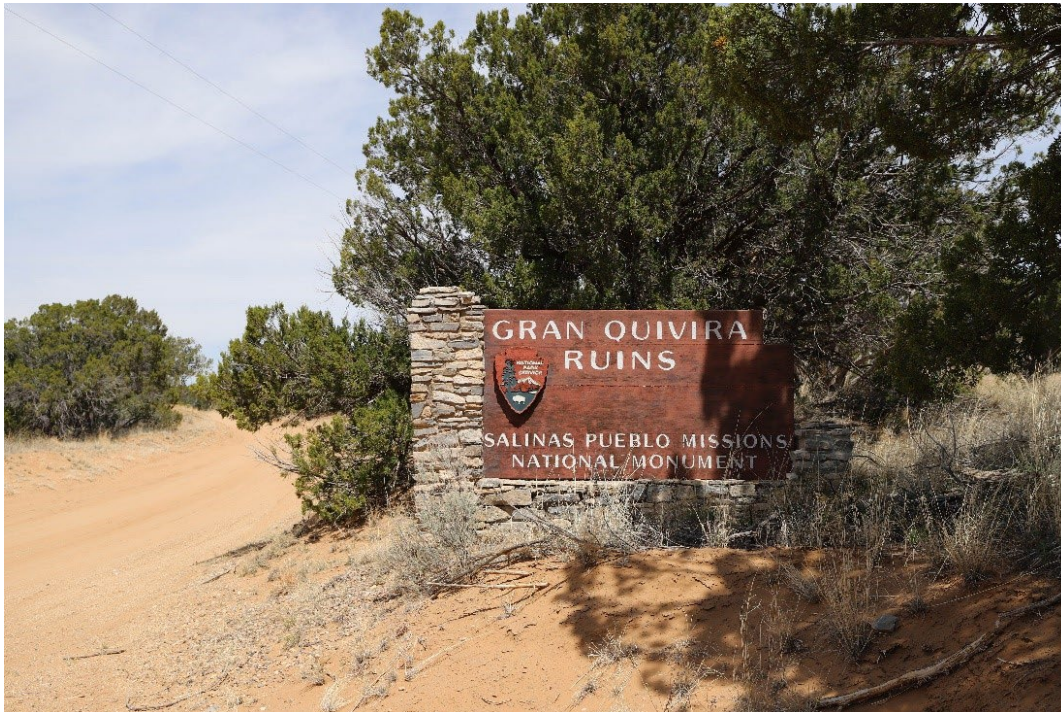
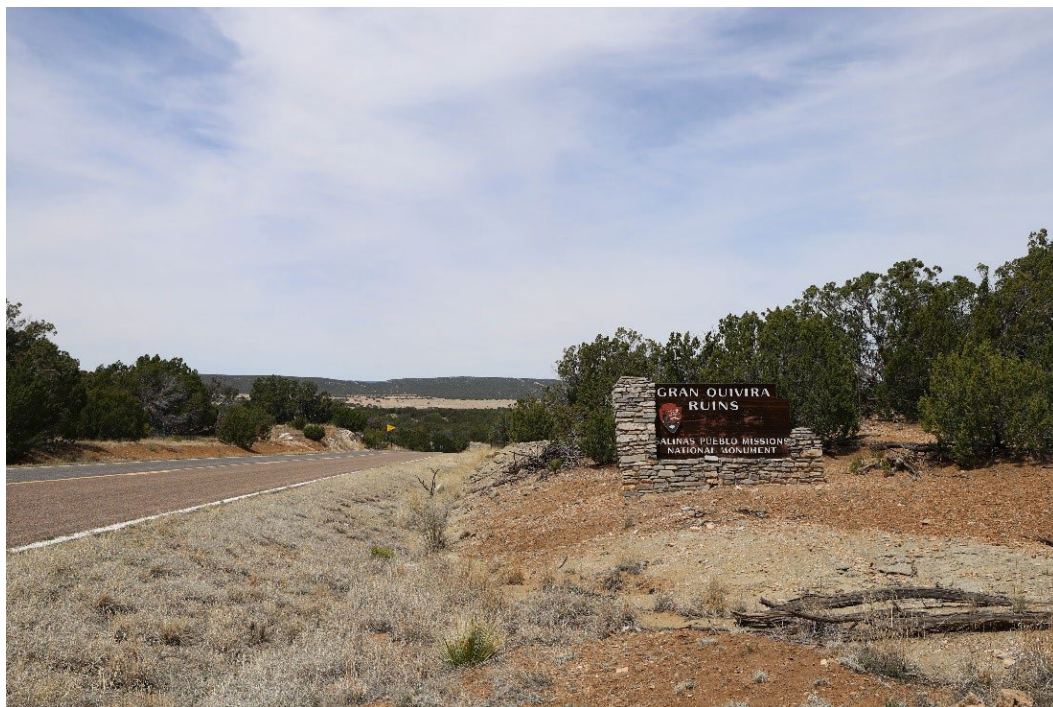
*Figure 27 Gran Quivira Sign off Entrance Road / Looking Northwest, April 2024*

*Figure 29 Gran Quivira Sign / Looking Southeast, April 2024*

Figure 30 GQ sign off NM55 / Looking Southwest, April 2024

The Park entrance signage at Gran Quivira is in the standard park service style with a stone masonry base and wooden sign.
