RE: Section 110 Consultation for the Gran Quivira Mission 66 Resources Determination of Eligibility at the Gran Quivira Unit at Salinas Pueblo Missions National Monument (NMCRIS Activity 158979/PEPC 130630)

**National Register of Historic Places  
Eligibility Recommendation  
For Mission 66 Resources**  
NMCRI Activity #158979  
Salinas Pueblo National Monument  
Gran Quivira Unit  
Torrance and Socorro Counties, New Mexico

# Gran Quivira Mission 66 Determination of Eligibility

Salinas Pueblo Missions National Monument  
Gran Quivira Unit, Mountainair, New Mexico

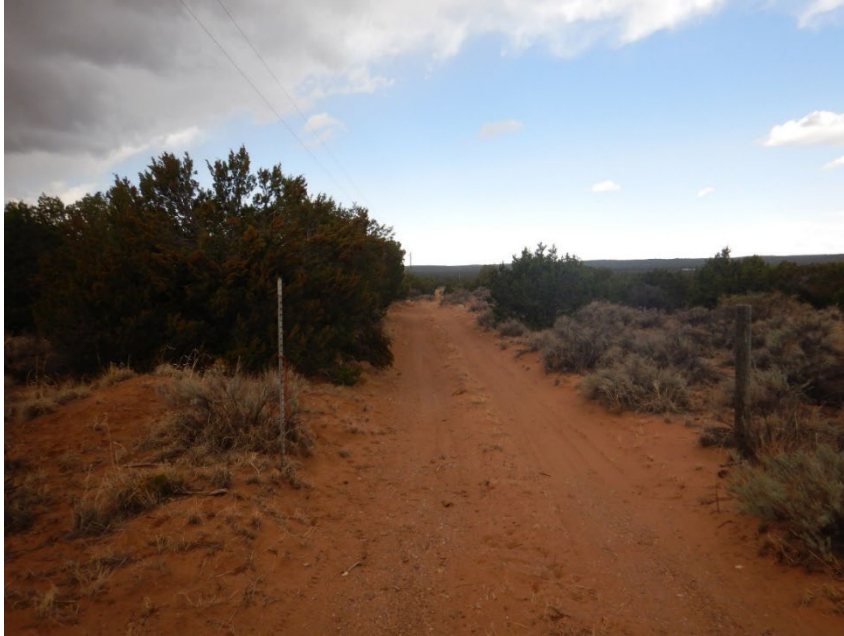
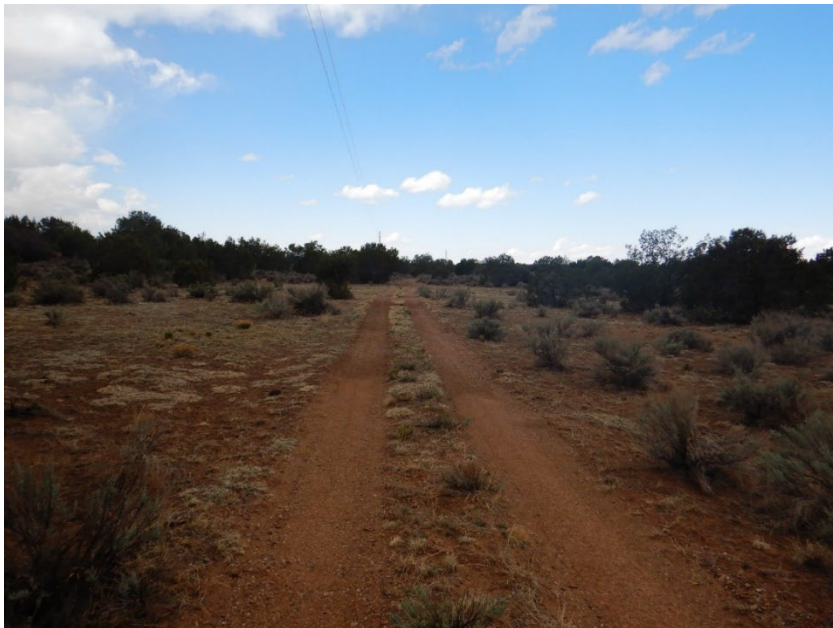
GQ Well Road is a graded two-track dirt road located outside the administrative boundary of Gran Quivira, currently maintained under an easement. It extends southwest, terminating at the monument's well and well house.

*Figure 32 Start of well road, May 2025.*

*Figure 33 Well road, May 2025.*

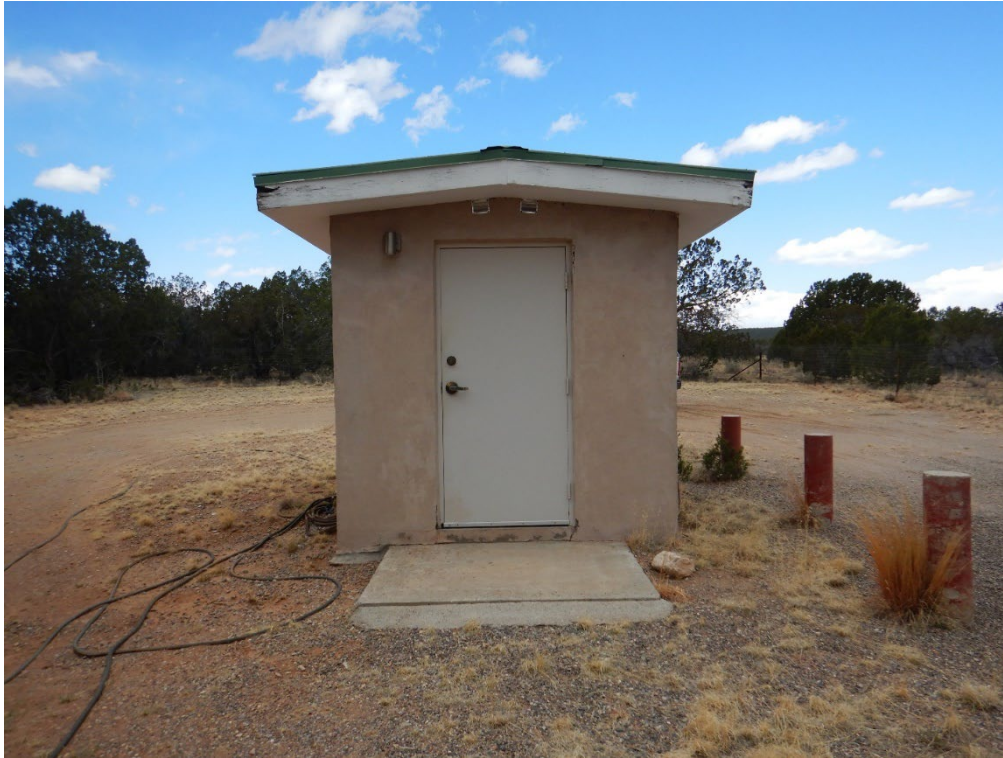
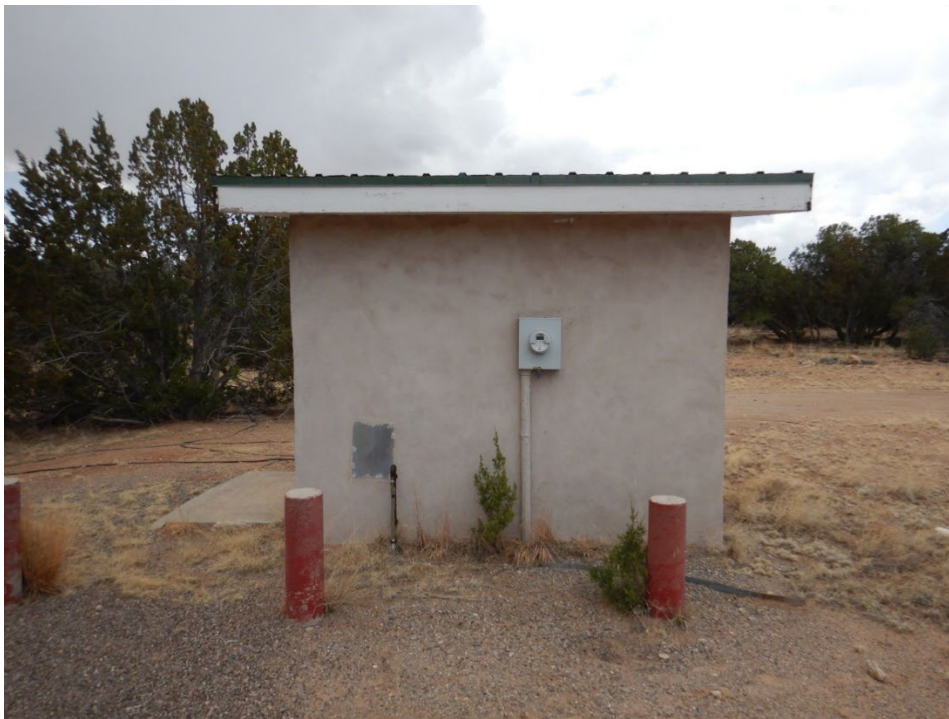
The single-story well house is located at the terminus of GQ Well Road. It features a low-profile, front-gabled roof with overhanging eaves that lend a subtle horizontal emphasis to the structure. A

contemporary door is centered on the primary façade, accessed via a simple concrete stoop. Three protective bollards are positioned along the north side of the building.

*Figure 34 Well house entrance straight ahead, May 2025*

*Figure 35 North Wall of Well House straight ahead, May 2025.*

The well house is not individually eligible for listing in the National Register of Historic Places due to its primarily utilitarian character, function, and the extent of alterations over time. The architectural character of the well house is like the Mission 66 Park Service Modern Style of original residences before roof alterations were made. Like the residences, the well house has undergone material replacements, including the replacement of the door in 2012. No documentation has been found regarding its original condition, with the earliest documented photograph being from 2012.

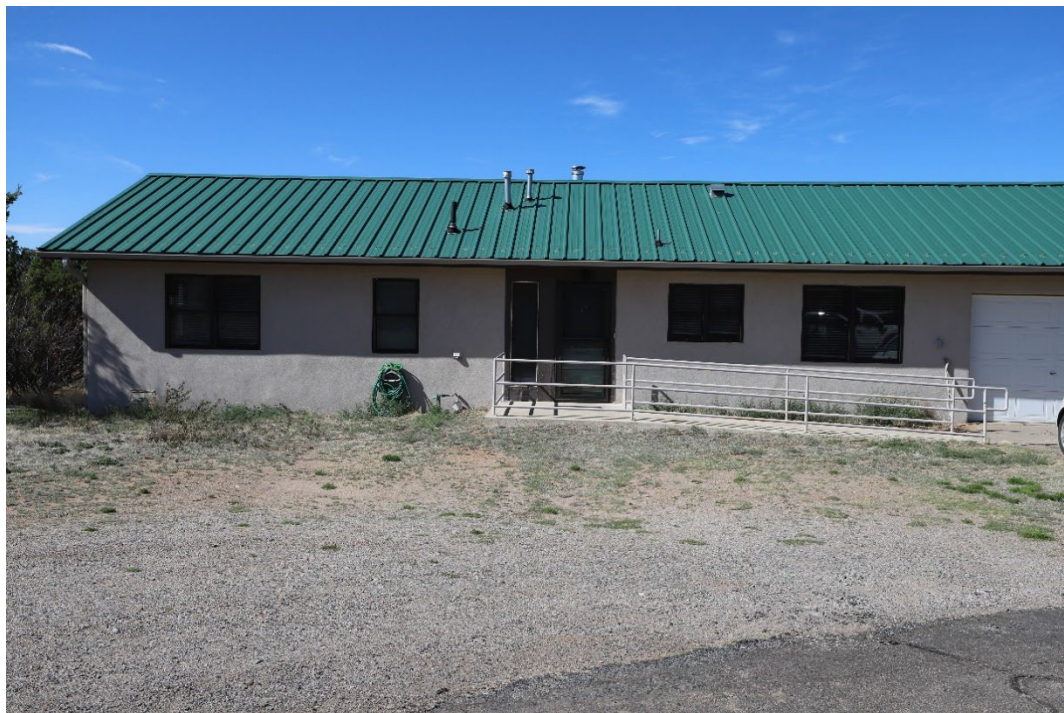
*Figure 42 Residence 13, note how change in roofline alters overall design, feeling, and association of the property. Source: NPS, April 2024.*

Residence 13 retains some original features such as the door and sidelight. However, the roofline has been altered from its original low pitch to a medium pitch, altering the buildings low-profile horizontal effect. According to the 2015 NPS Mission 66 MPD, a “new roof structure that is nonreversible and completely alters the exterior appearance of the building, such as a pitched, raised-seam metal roof replacing the original flat roof,” is an example of “alterations or remodeling that may impair the historical integrity of a house or housing.” During the roof alteration the cultural resource manager at the time made sure to maintain the original roofline underneath the added green metal sheath and medium pitch roofline. Therefore, this alteration may be reversible. However, in its current state with the altered exterior appearance, the building is not individually eligible, nor is it contributing to a historic district.

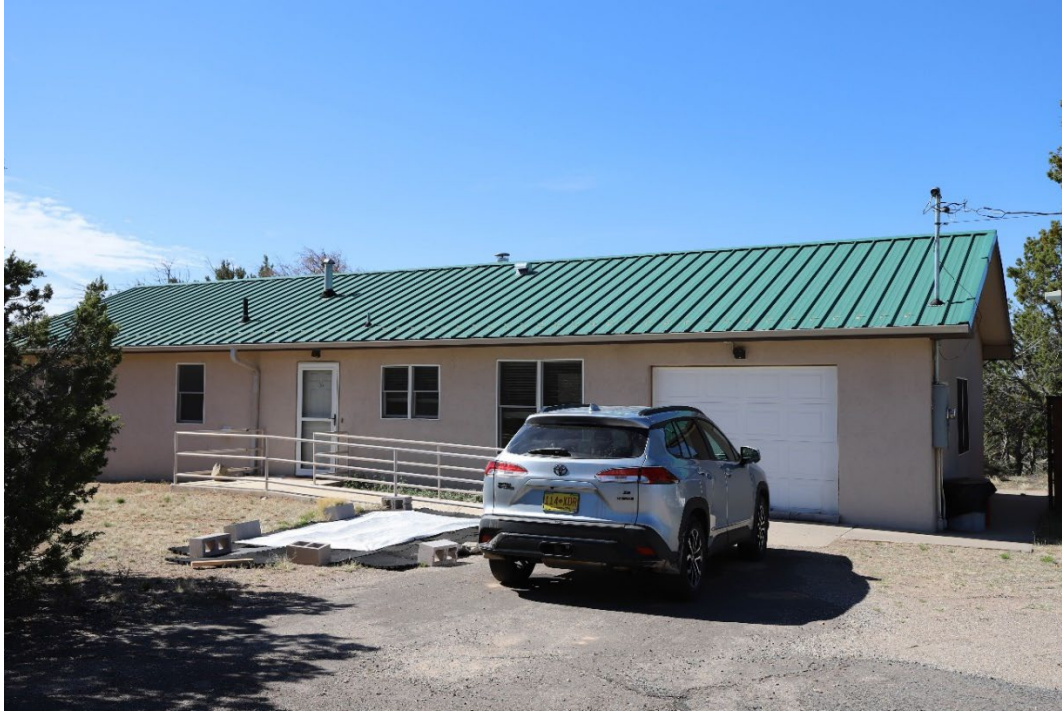
*Figure 43 Residence 12- Note material changes and roofline alteration. Source: NPS April 2024.*

All the original fenestration in Residence 12 has been replaced. Most recently in 2016, five steel casement windows (non-original) were swapped out for energy-efficient vinyl windows. Both the interior and exterior wood case trim on the windows were updated to stucco and steel trim. The original door and sidelight have been replaced with a contemporary wooden door and screen. The roofline, originally low-pitched, has been modified to a medium-pitch side-gabled roof covered in green metal. The original roof framing is concealed under the existing roof. On the rear elevation, all original doors appear to have been replaced, their original location remaining intact. The original wooden trim surrounding the doorway has been removed and replaced with stucco.
